USFS, Gifford Pinchot National Forest

Project Title	Pine Creek Instream Restoration
Agency	US Forest Service Gifford Pinchot National Forest Mount St. Helens Ranger District
Project Manager	Adam Haspiel (360) 449-7833 ahaspiel@fs.fed.us
Project Approved By	Aquatic Coordination Committee
Project Funding	ACC Funding \$65,000 USFS Funding \$41,000 Partner Funding \$ 1,000 Project Total \$107,000

Pine Creek Instream Habitat Restoration

Monitoring Report February 2013

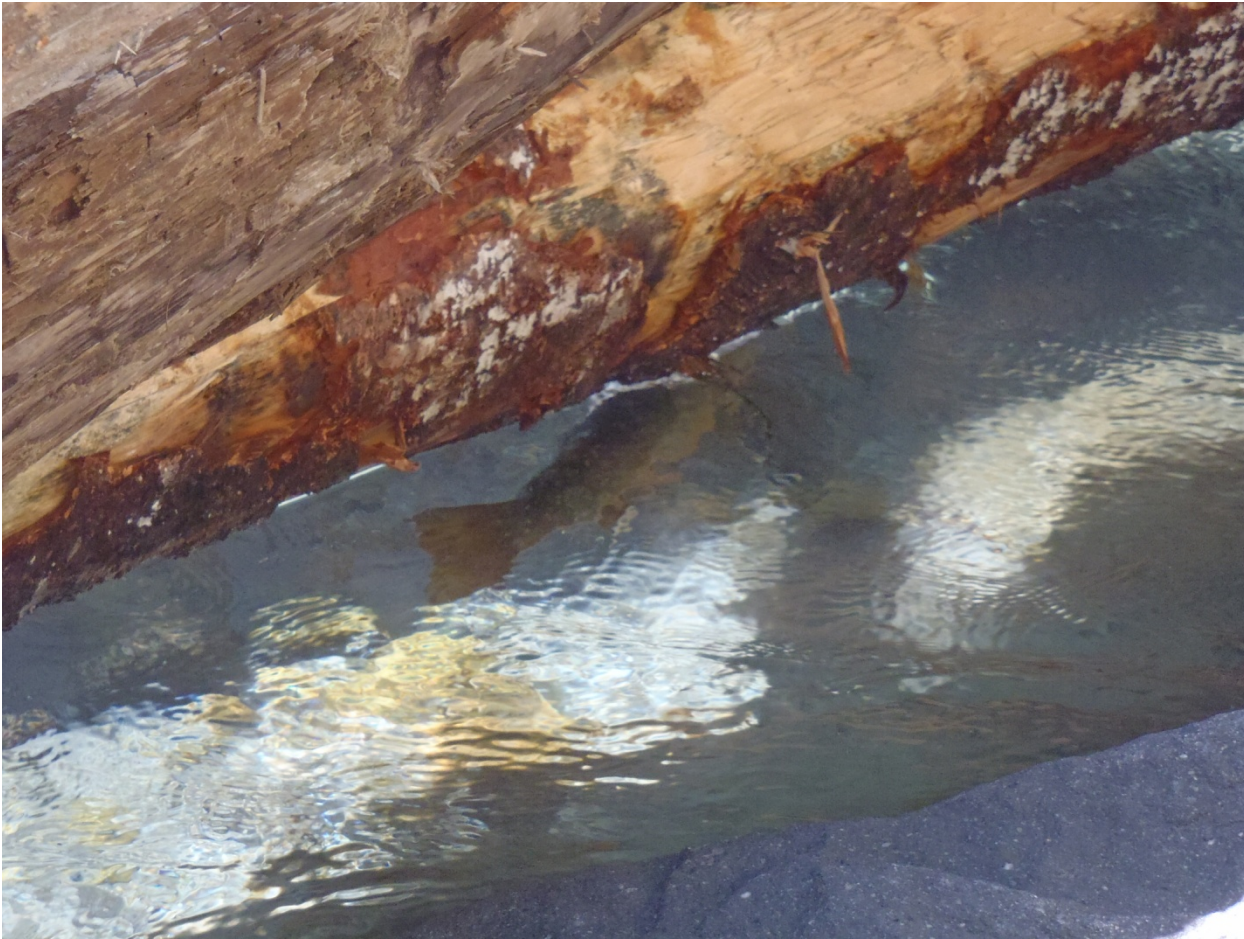
Figure 2. Adult bull trout using new structure on Pine Creek

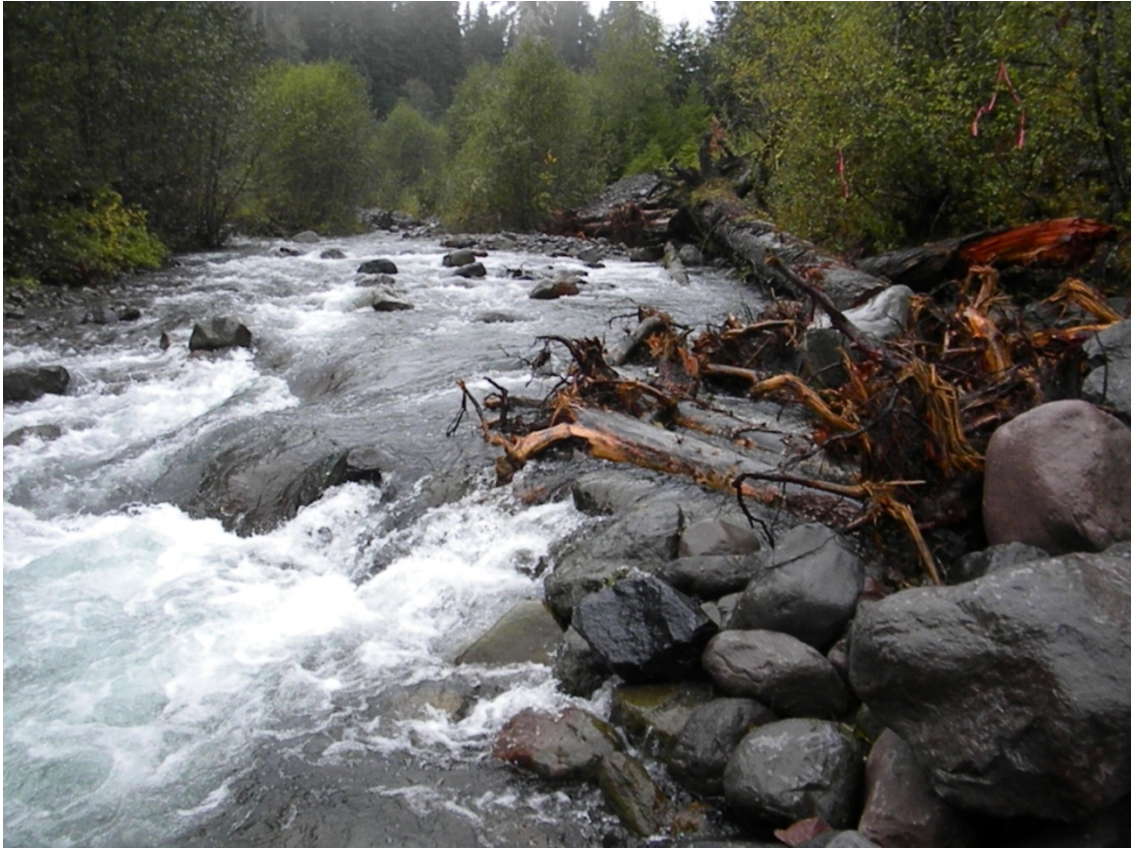
Structure 7 had no cross sectional information taken because it was more of a bank protection structure than a pool forming structure.

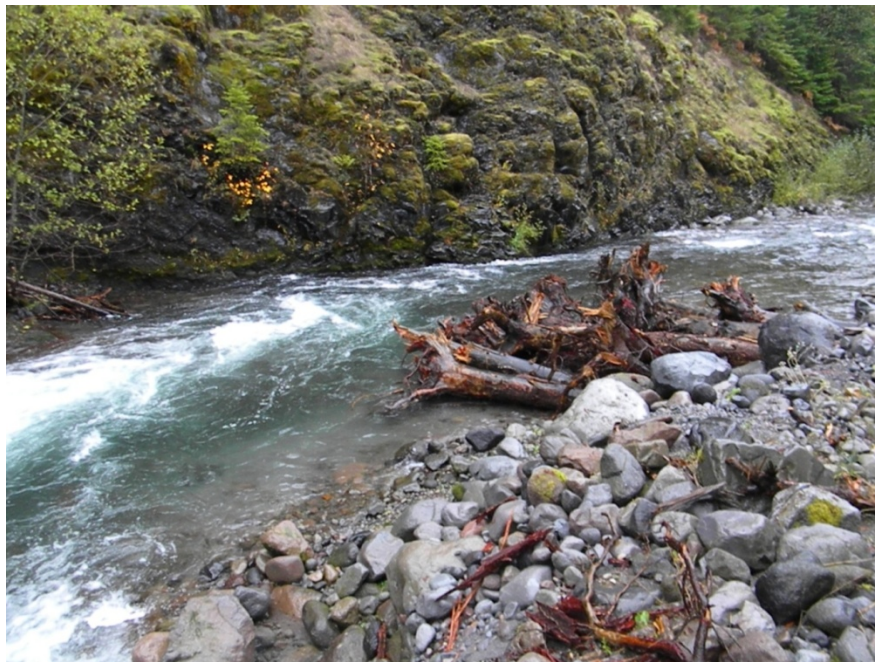
Structure 12 had no cross section information taken because it was mainly a bank protection structure more than a pool forming structure.

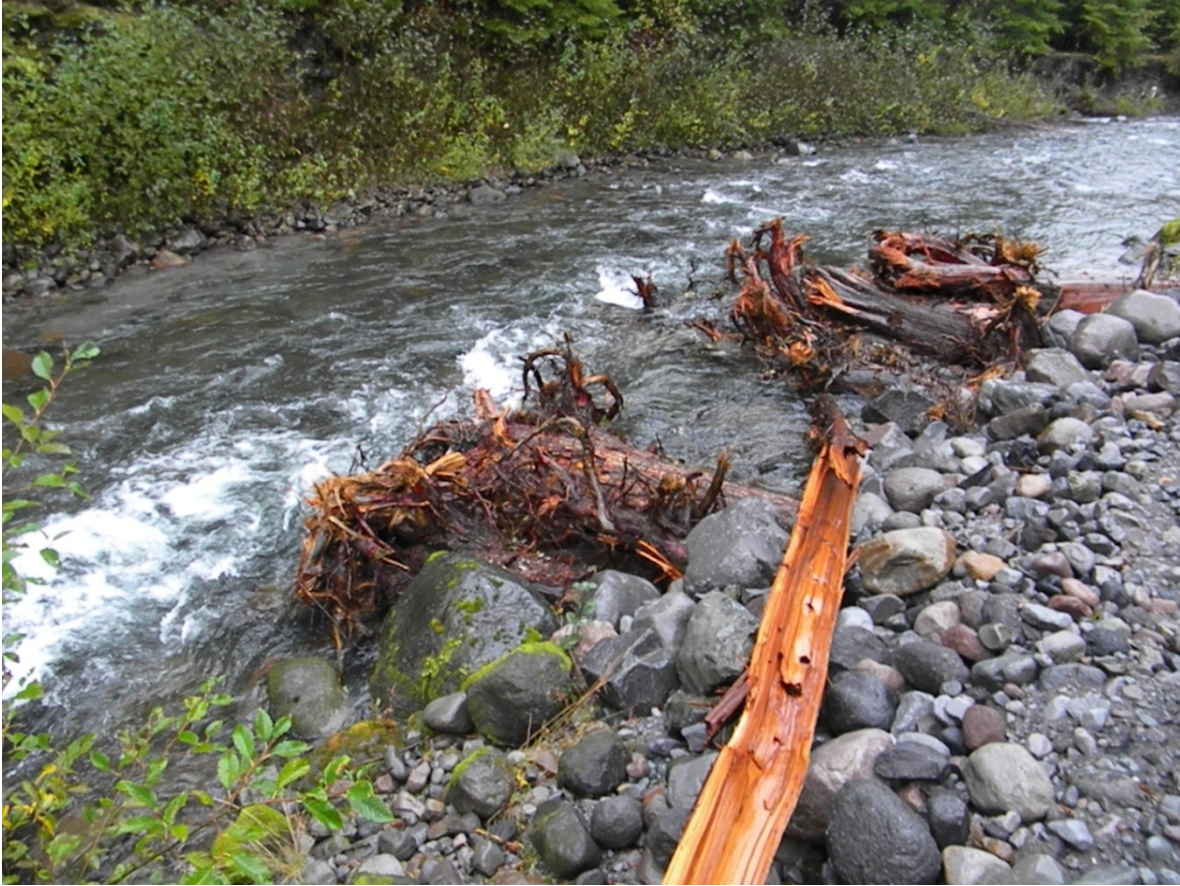
Structure 13 had no cross sectional information taken because of the depth of pool and unsafe conditions.
