## Clearwater Creek In-stream Habitat Restoration Project Closeout Report

**Project Title:** Clearwater Creek in-stream Habitat Restoration

**Agency:** US Forest Service  
Gifford Pinchot National Forest  
Mount St. Helens National Volcanic Monument

# Post-implementation Status Report Clearwater Creek Fish Habitat Restoration

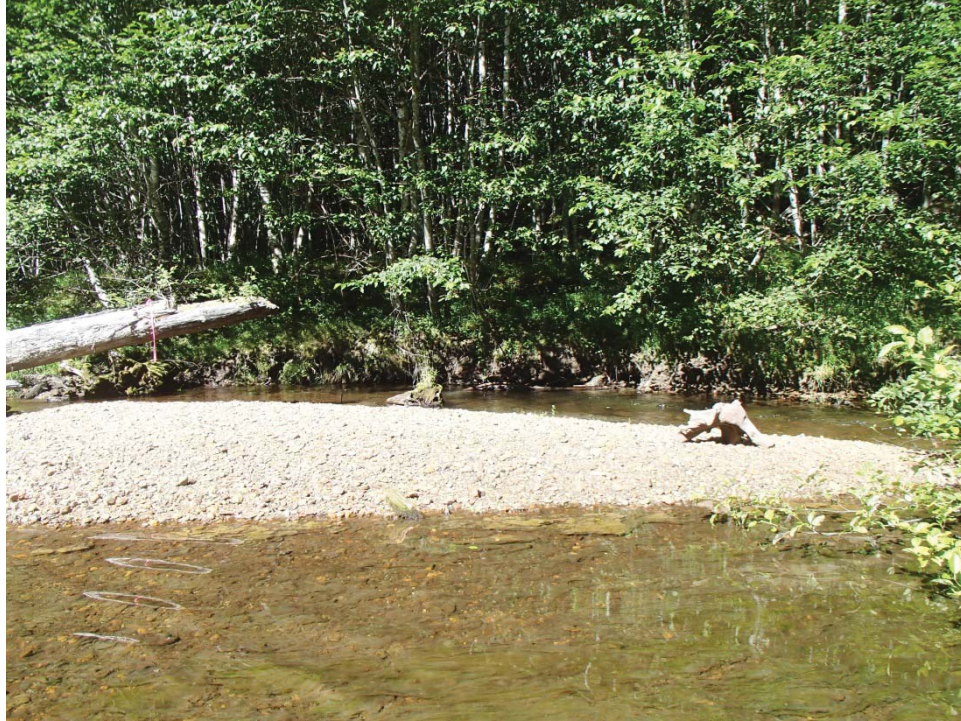
Structure 62 before construction

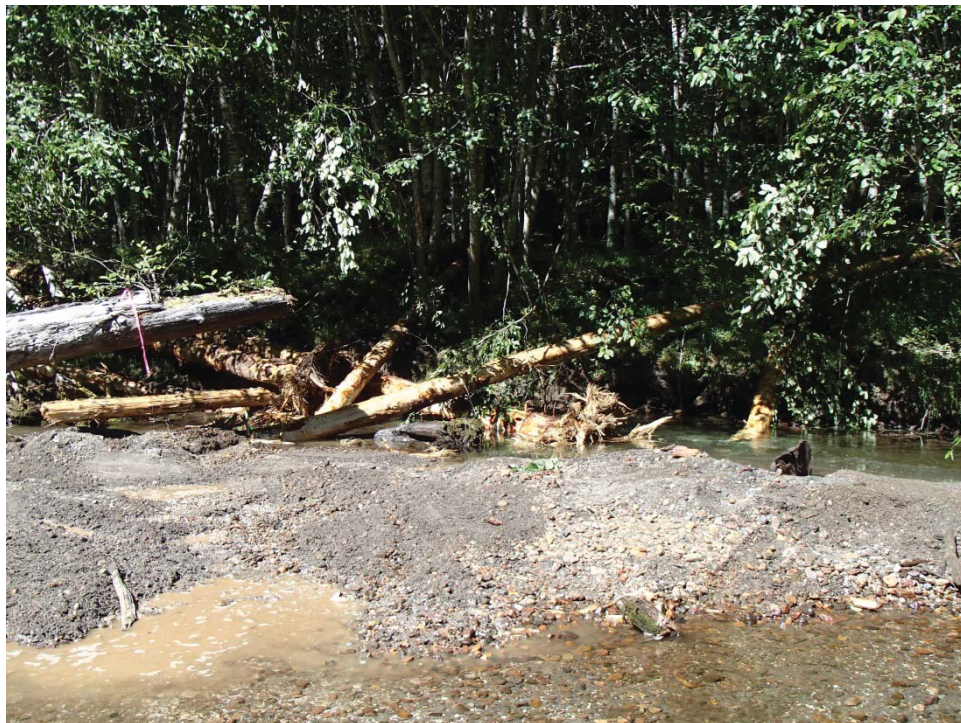
Structure 62 during construction 18 logs (fish cover structure)

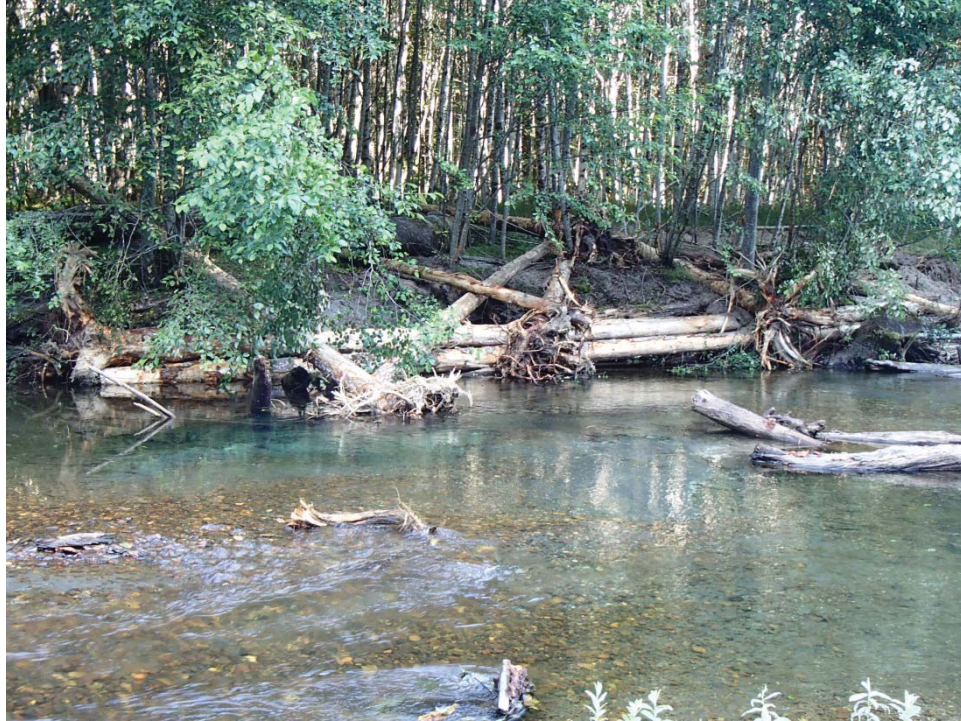
Structure 22 bank stabilization structure 22 logs

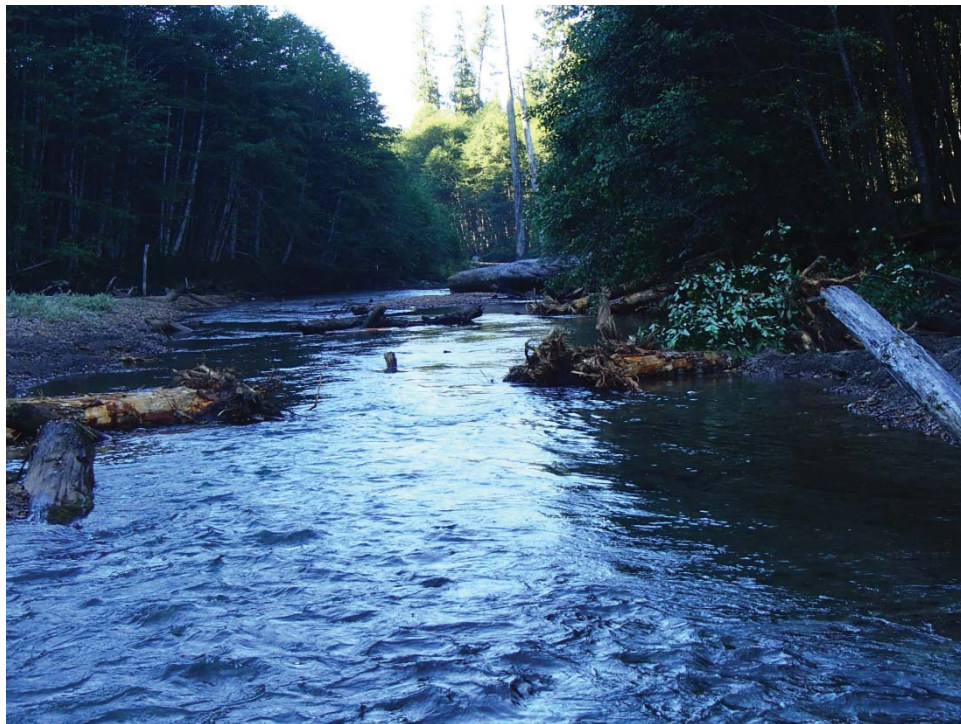
Structure 46 is designed to keep holding pool scoured out and deep
