# Lewis River Aquatic Fund Projects (SA 7.5.3.2)

## Project Closeout Report

Project: Cedar Creek Reach 1A Habitat Restoration Project

## As-Built and ground photos for Lower Cedar Creek Restoration project 12-1170

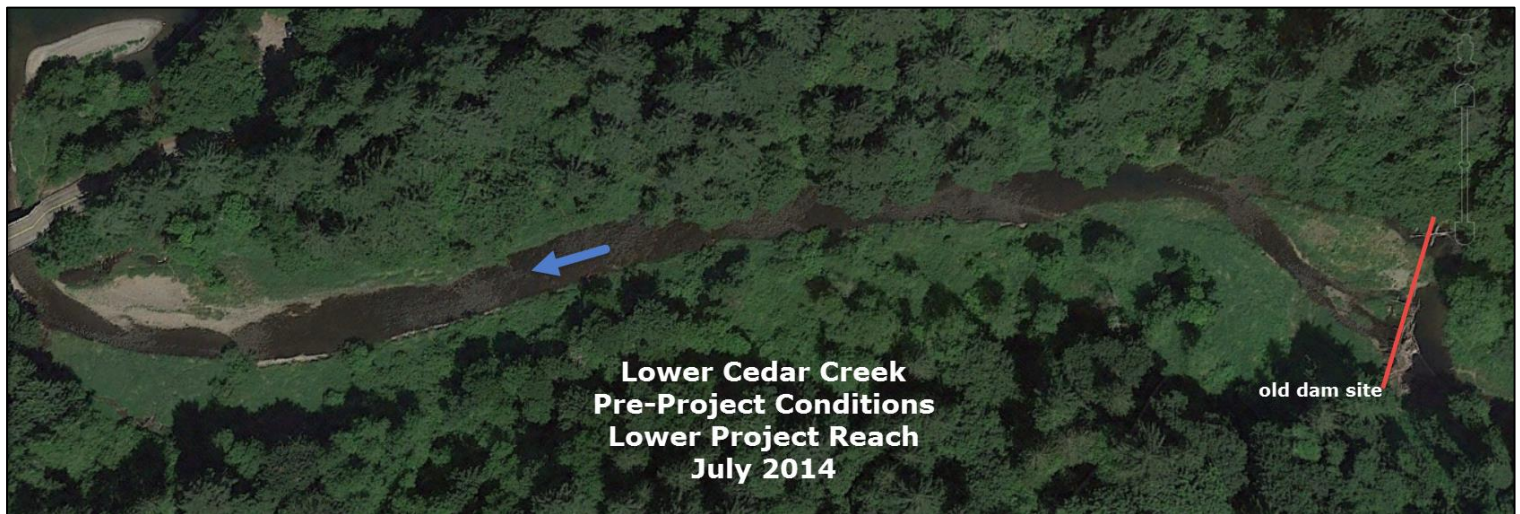
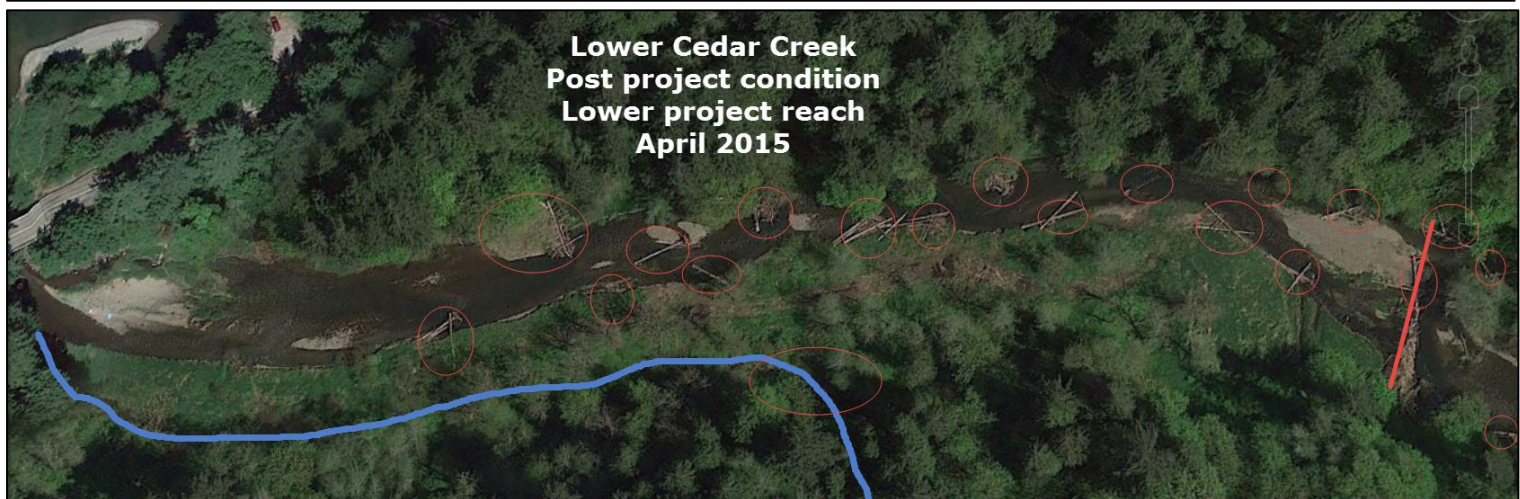
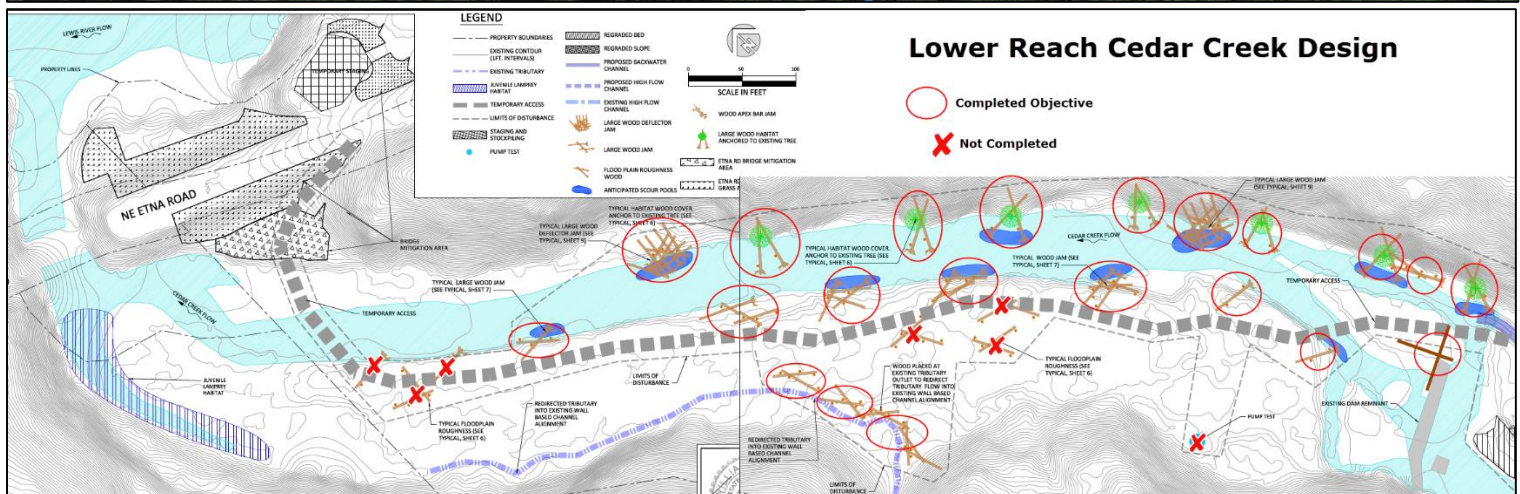
# AS-BUILT

- Deleted floodplain roughness wood due to cost
- Added 1 log on end of dam to direct flow, added 1 root-wad to increase scour
- Deleted lower left bank structures due to concern with lamprey habitat
- Did not complete pump test due to cost, vegetation impact and low likelihood of future need

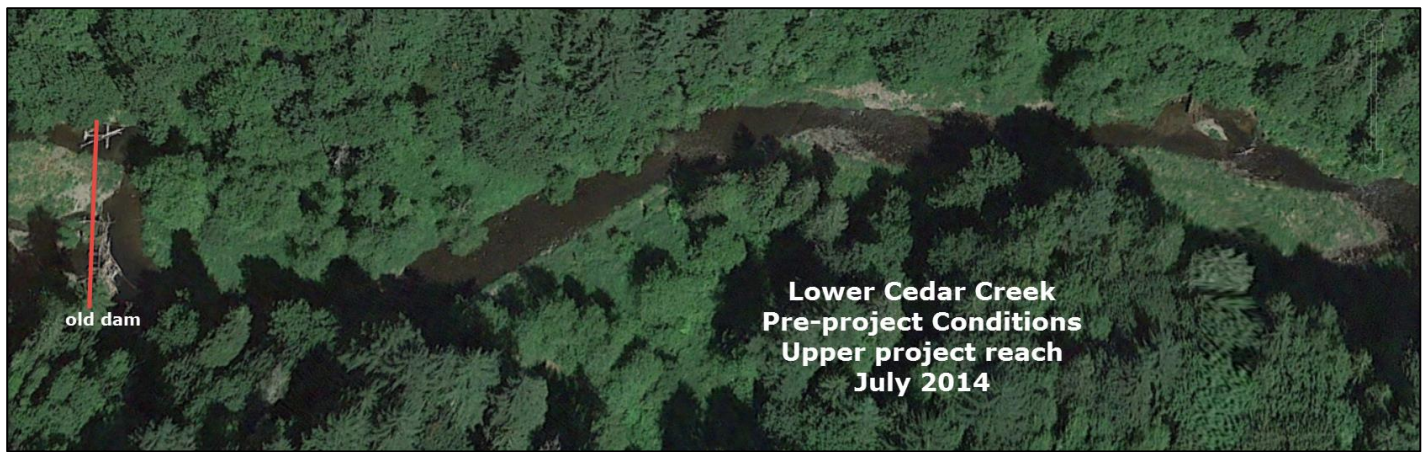
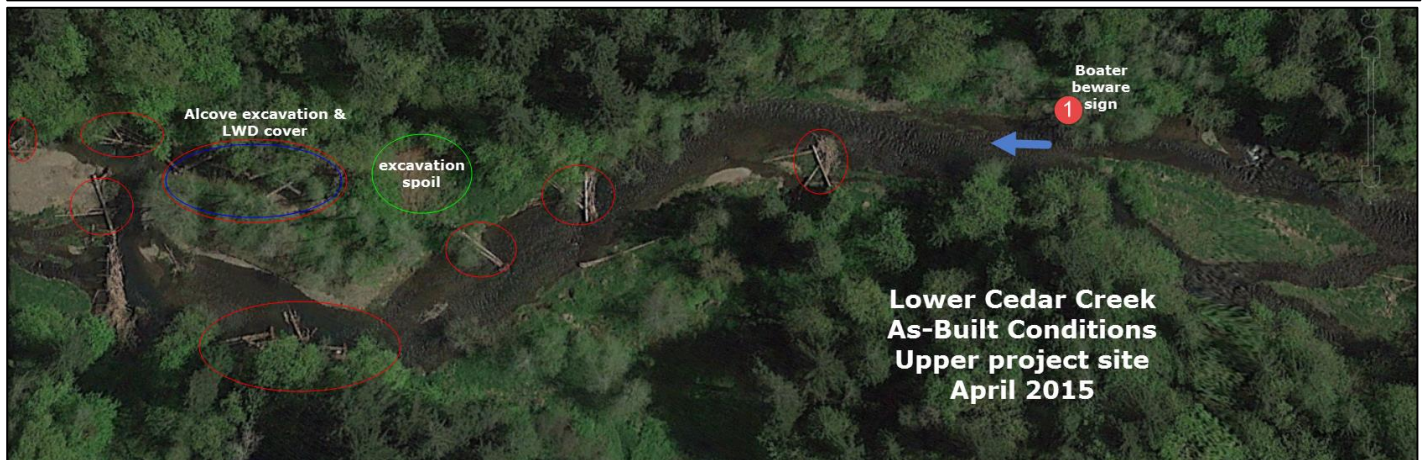
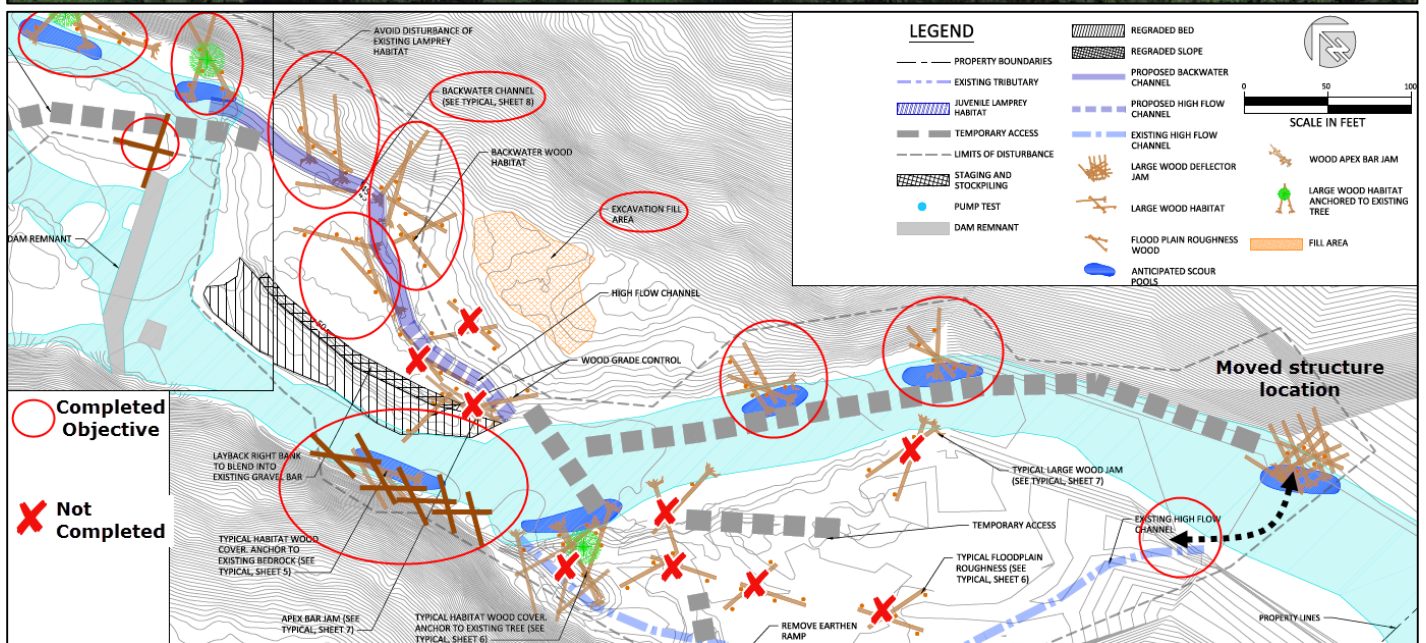
### Lower Reach- Cedar Creek Design

- Deleted floodplain roughness logs due to cost and level of disturbance to floodplain
- Deleted 3 left bank instream structures due to cost & boater safety concerns
- Added logs to lower left bank structure and dam
- Added boater beware sign upstream of project

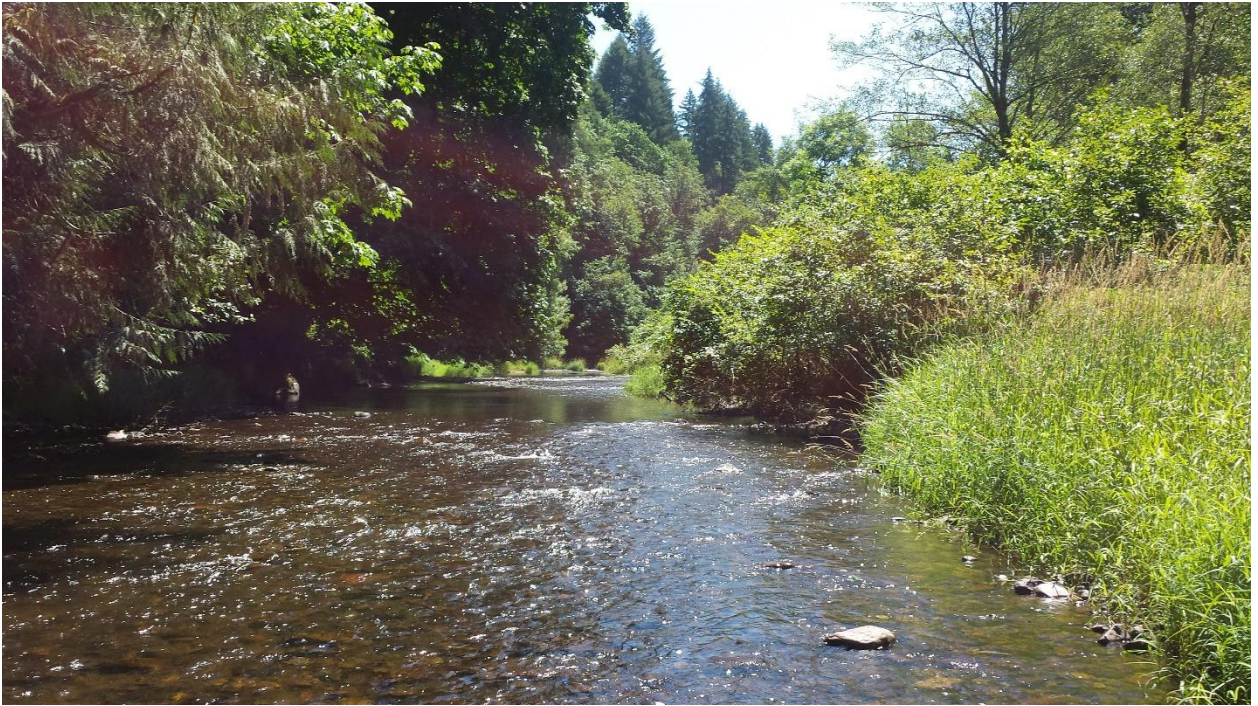
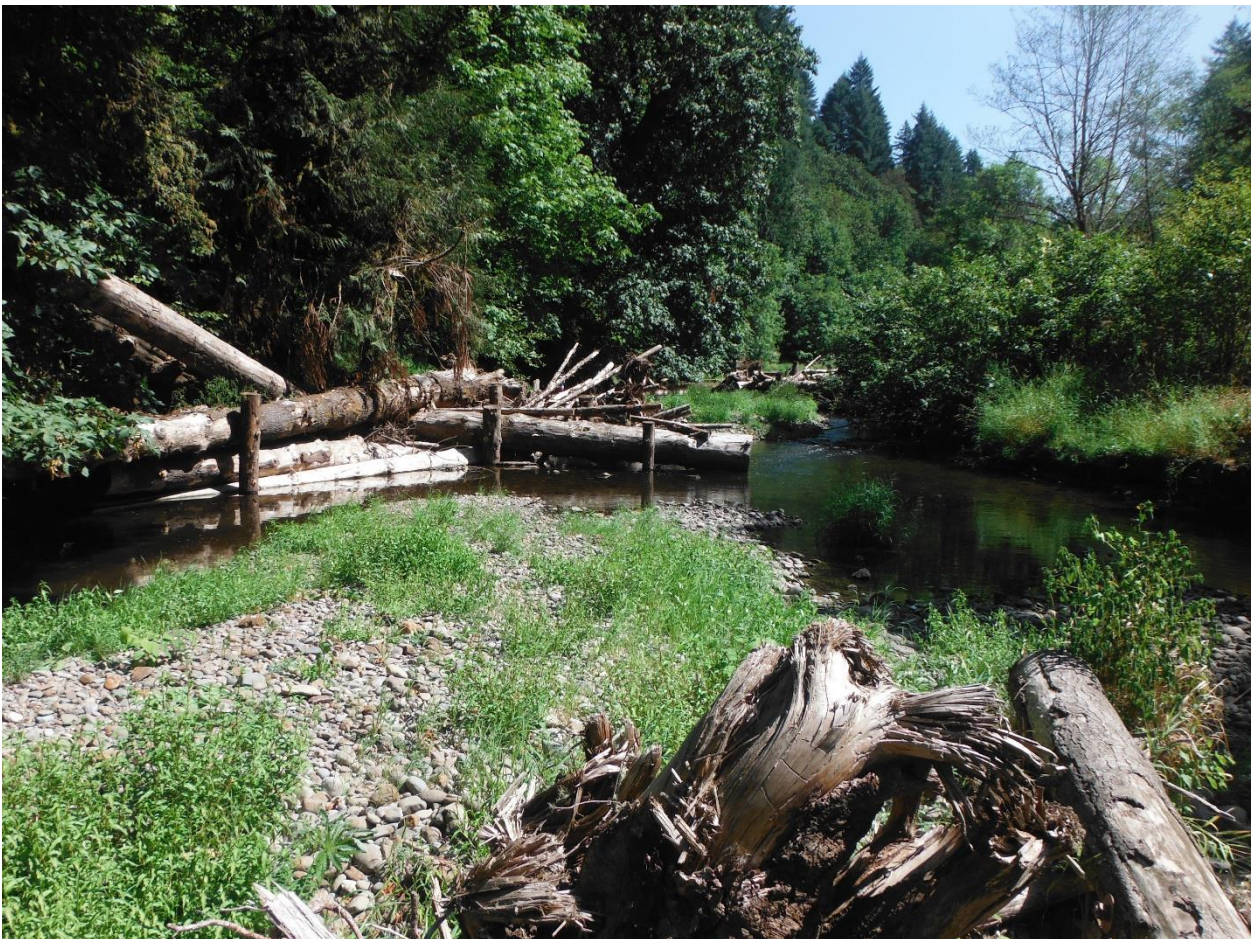
Note formation of new mid-channel bar

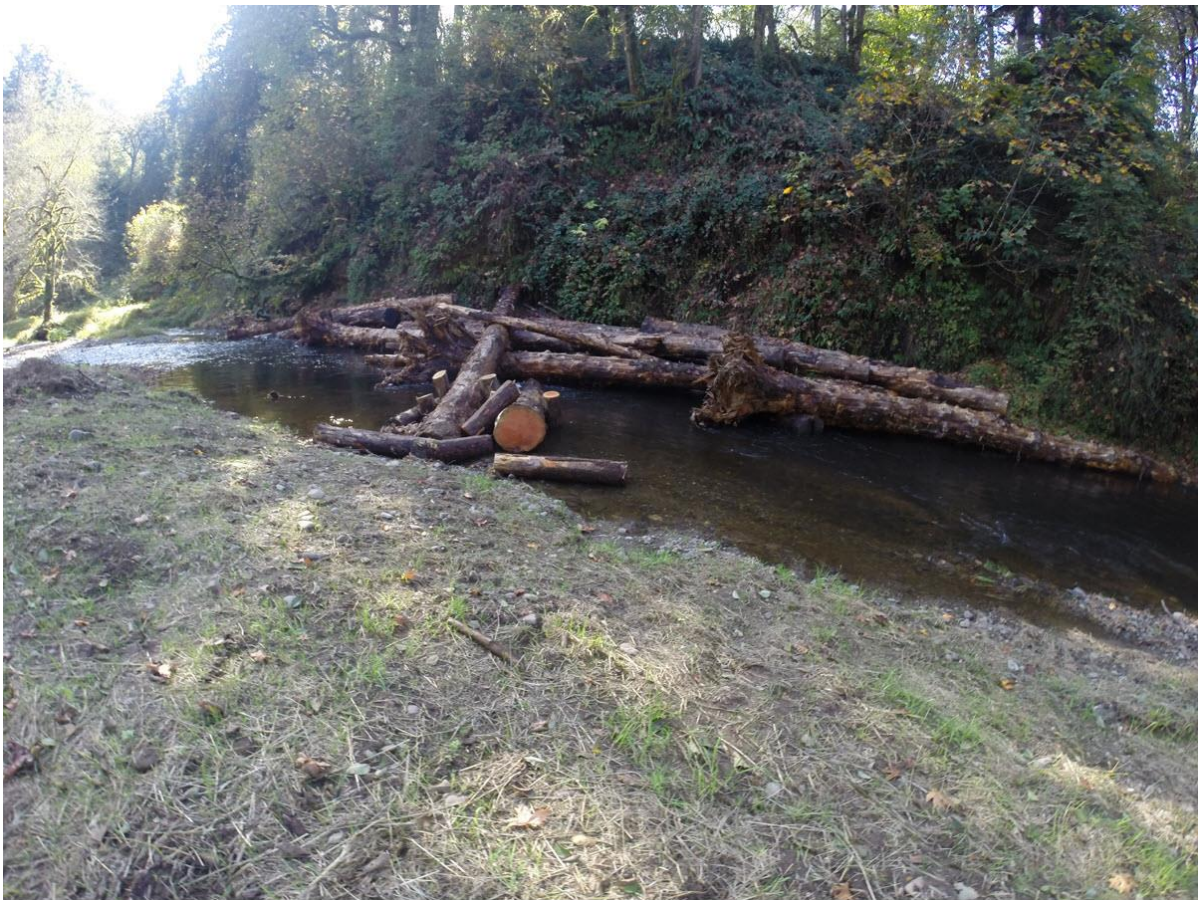
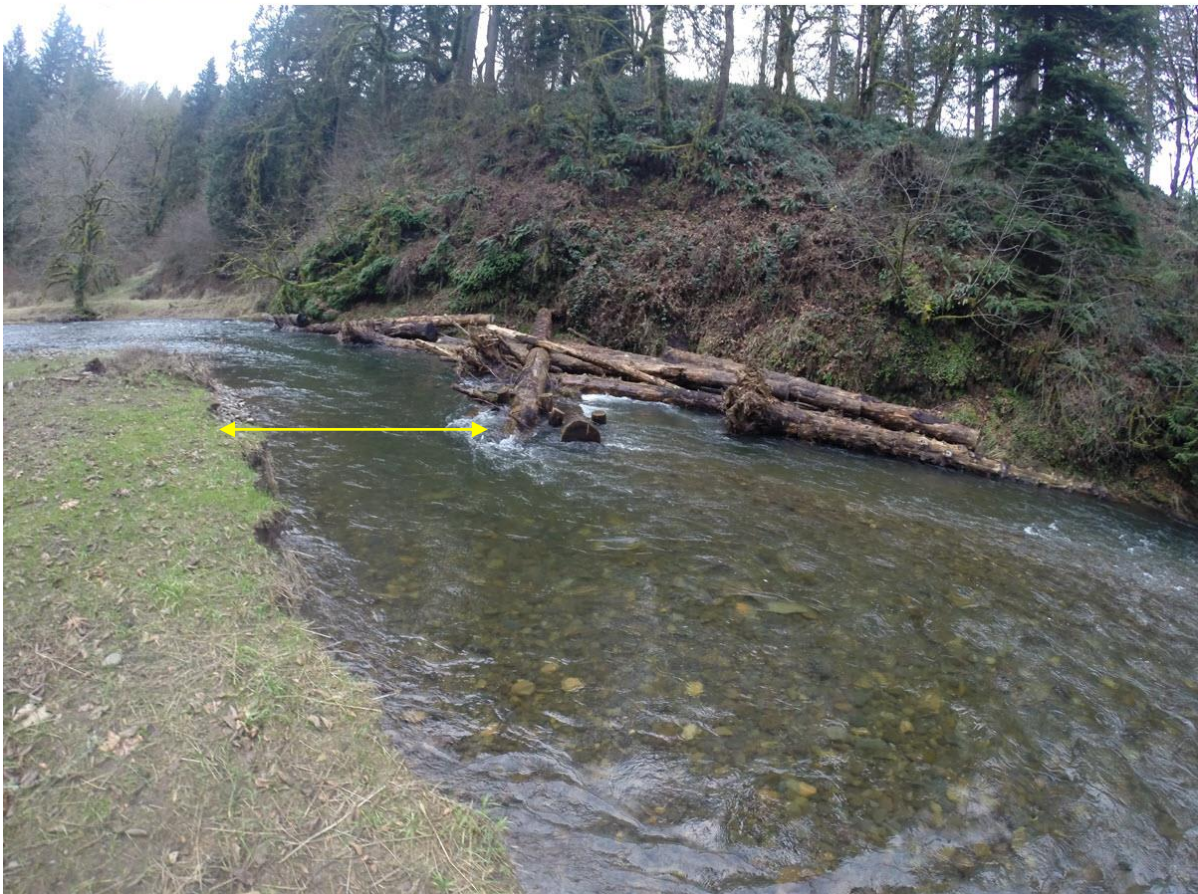
LWD significantly increased hydraulic complexity, note lateral channel expansion

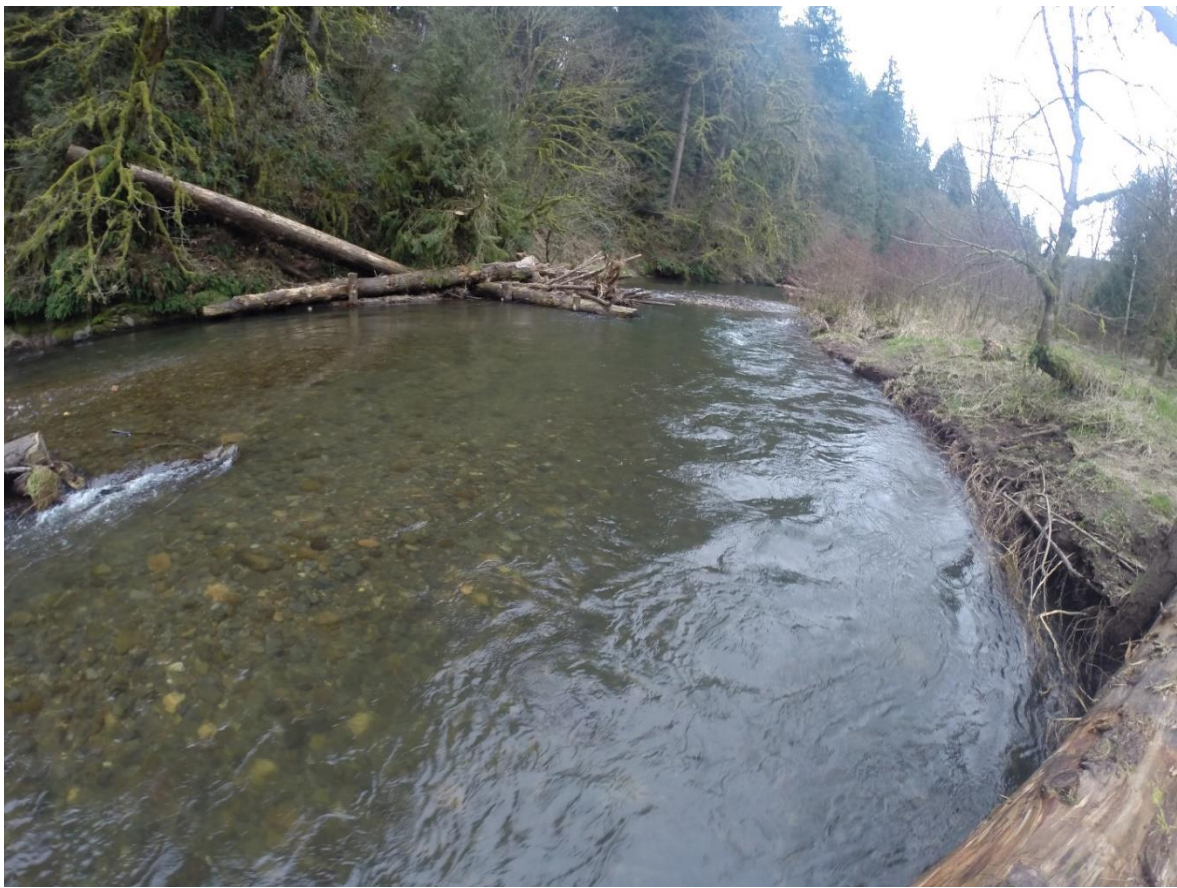
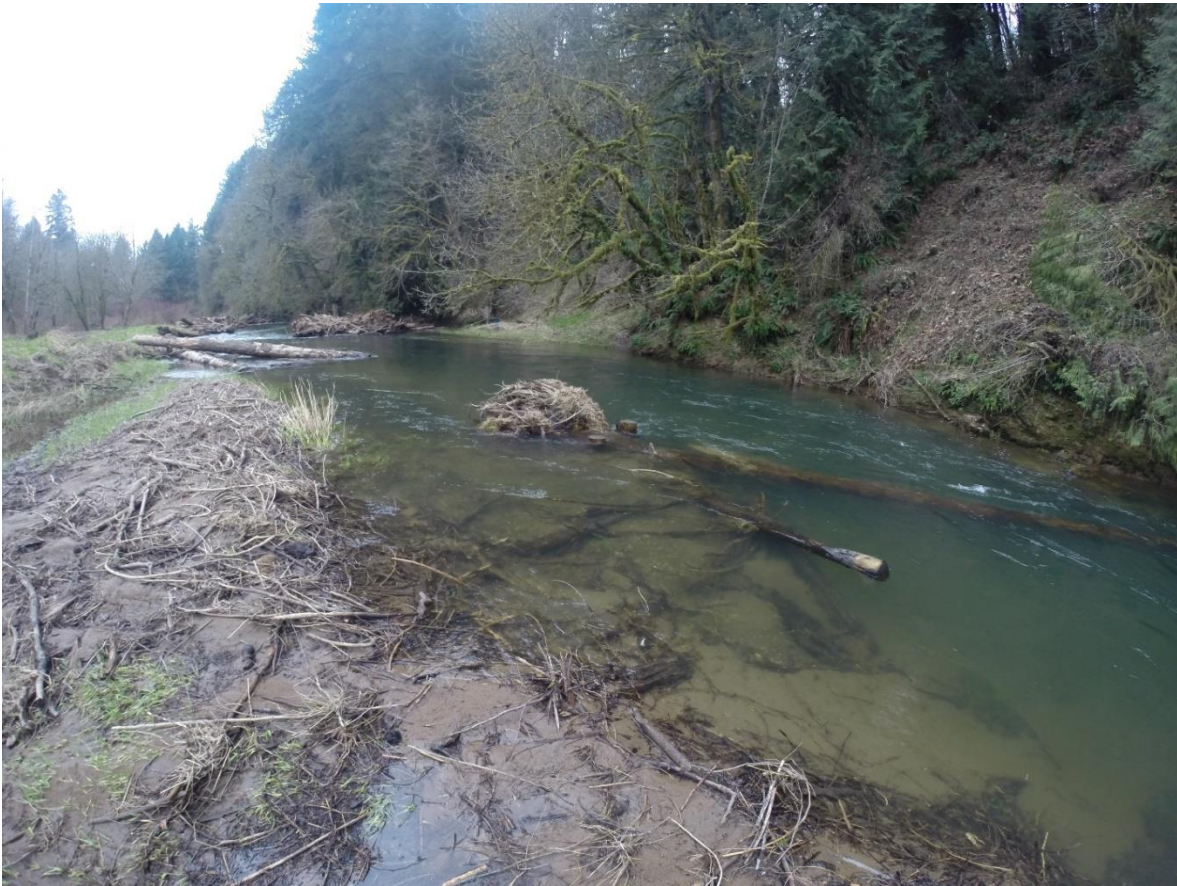
Excellent spawning and rearing habitat, diverse seasonal flow conditions

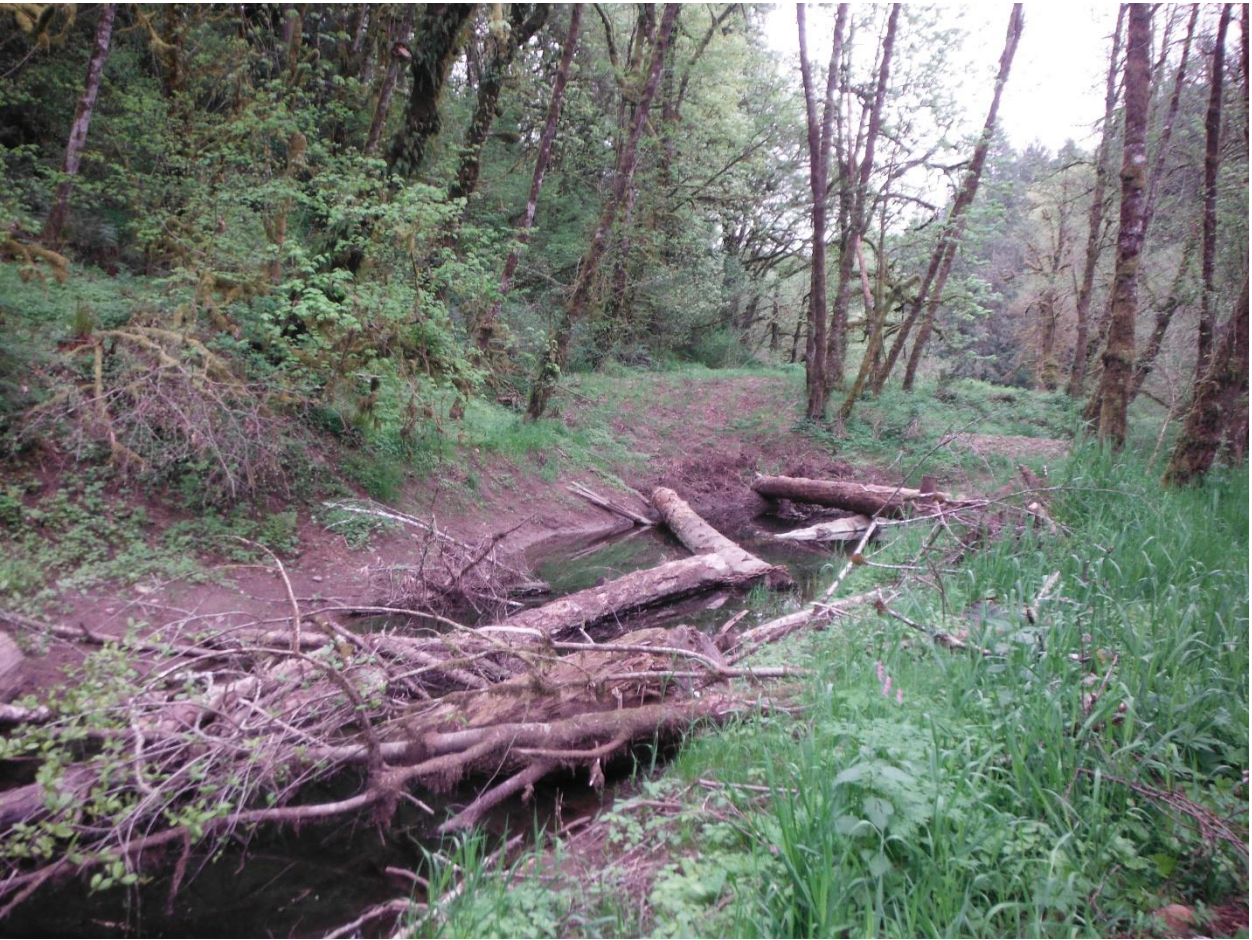
Alcove rearing pond contains juvenile salmon, lamprey and beaver

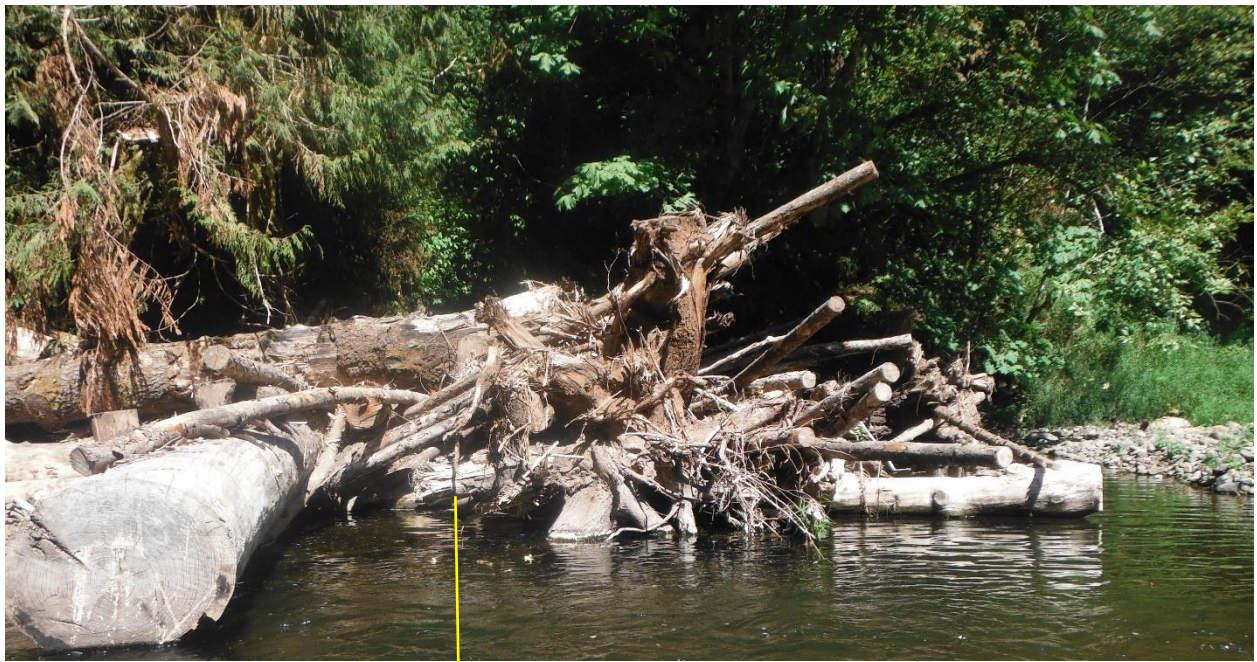
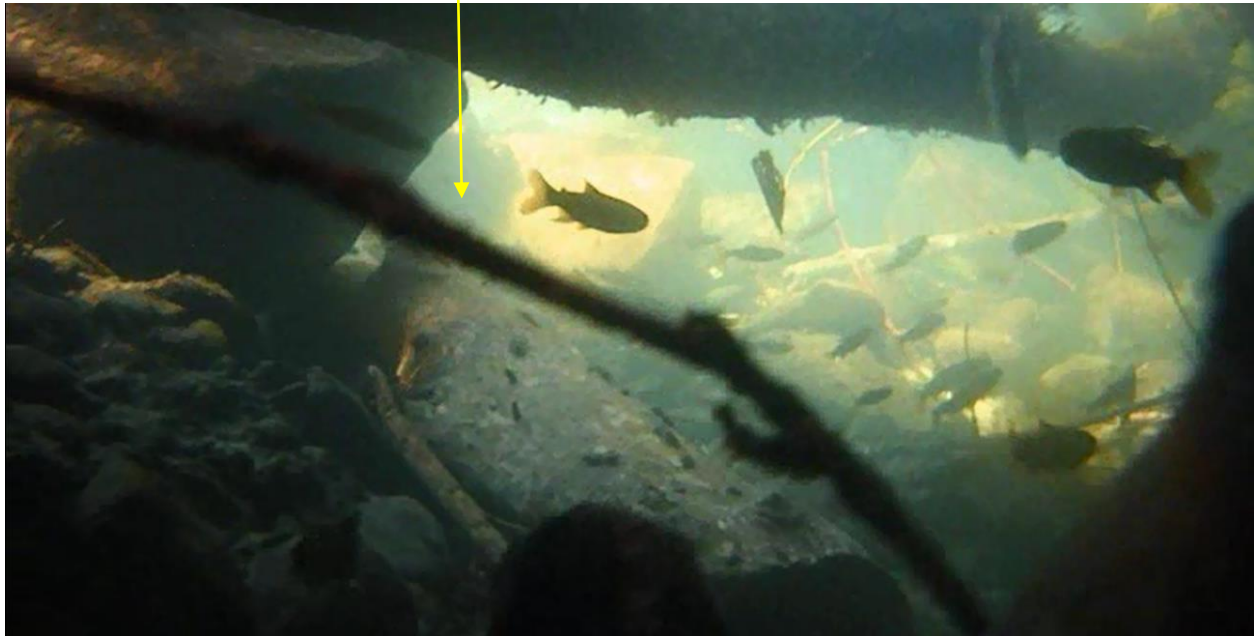
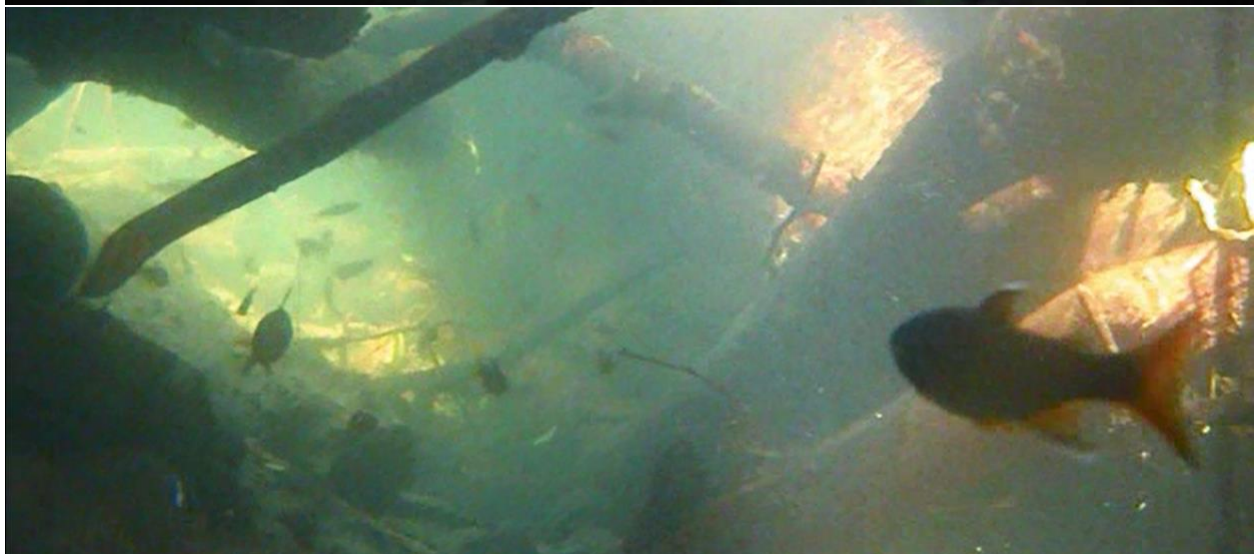
Even with extreme (75F) warm water conditions in lower Cedar creek in 2015 we found large numbers of juvenile salmonids in the pools under the log jams. Water temperatures are lower in the pools due to heavy shade and hyporeic/ ground water upwelling.
