Lewis River Aquatic Fund Projects (SA 7.5.3.2)

Project Closeout Report

Project Title: Lewis River Hydroelectric Project

HAAPA PHASE I PROJECT

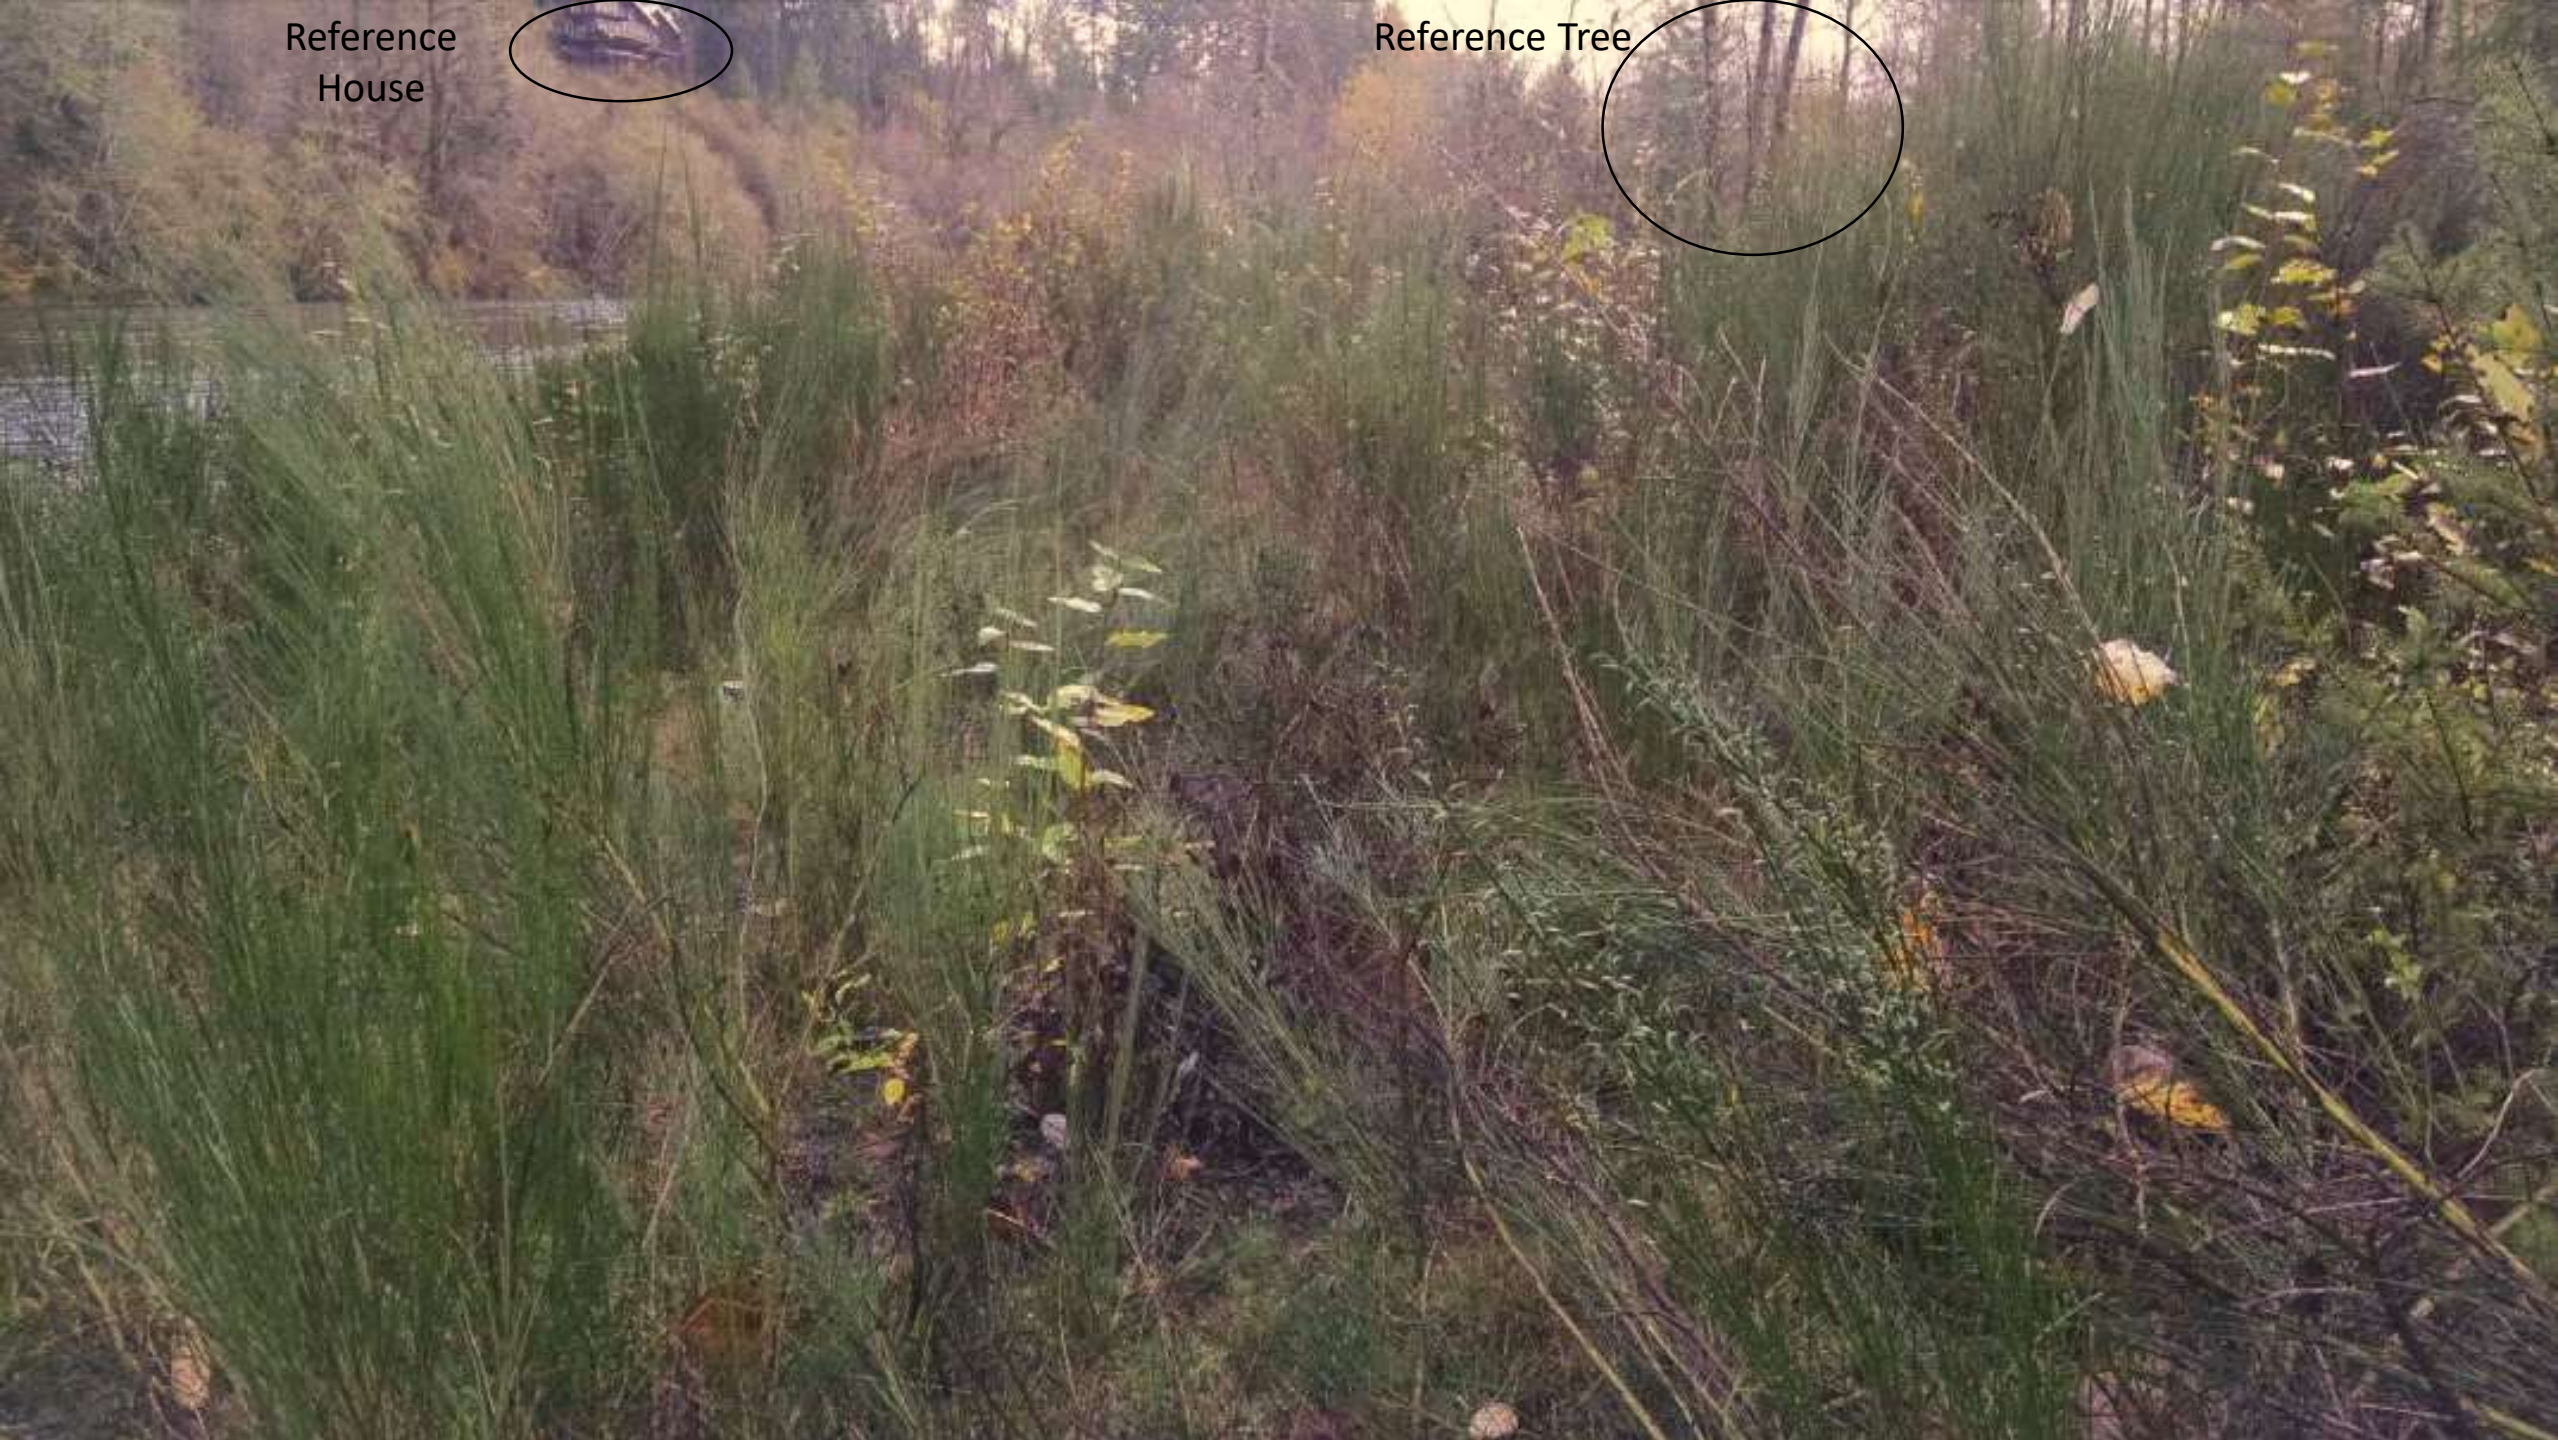
March 2016
HAAPA HABITAT RESTORATION PHASE I
PHOTOGRAPHER: MAURICE FRANK
PRE-TREATMENT OF SCOTCH BROOM

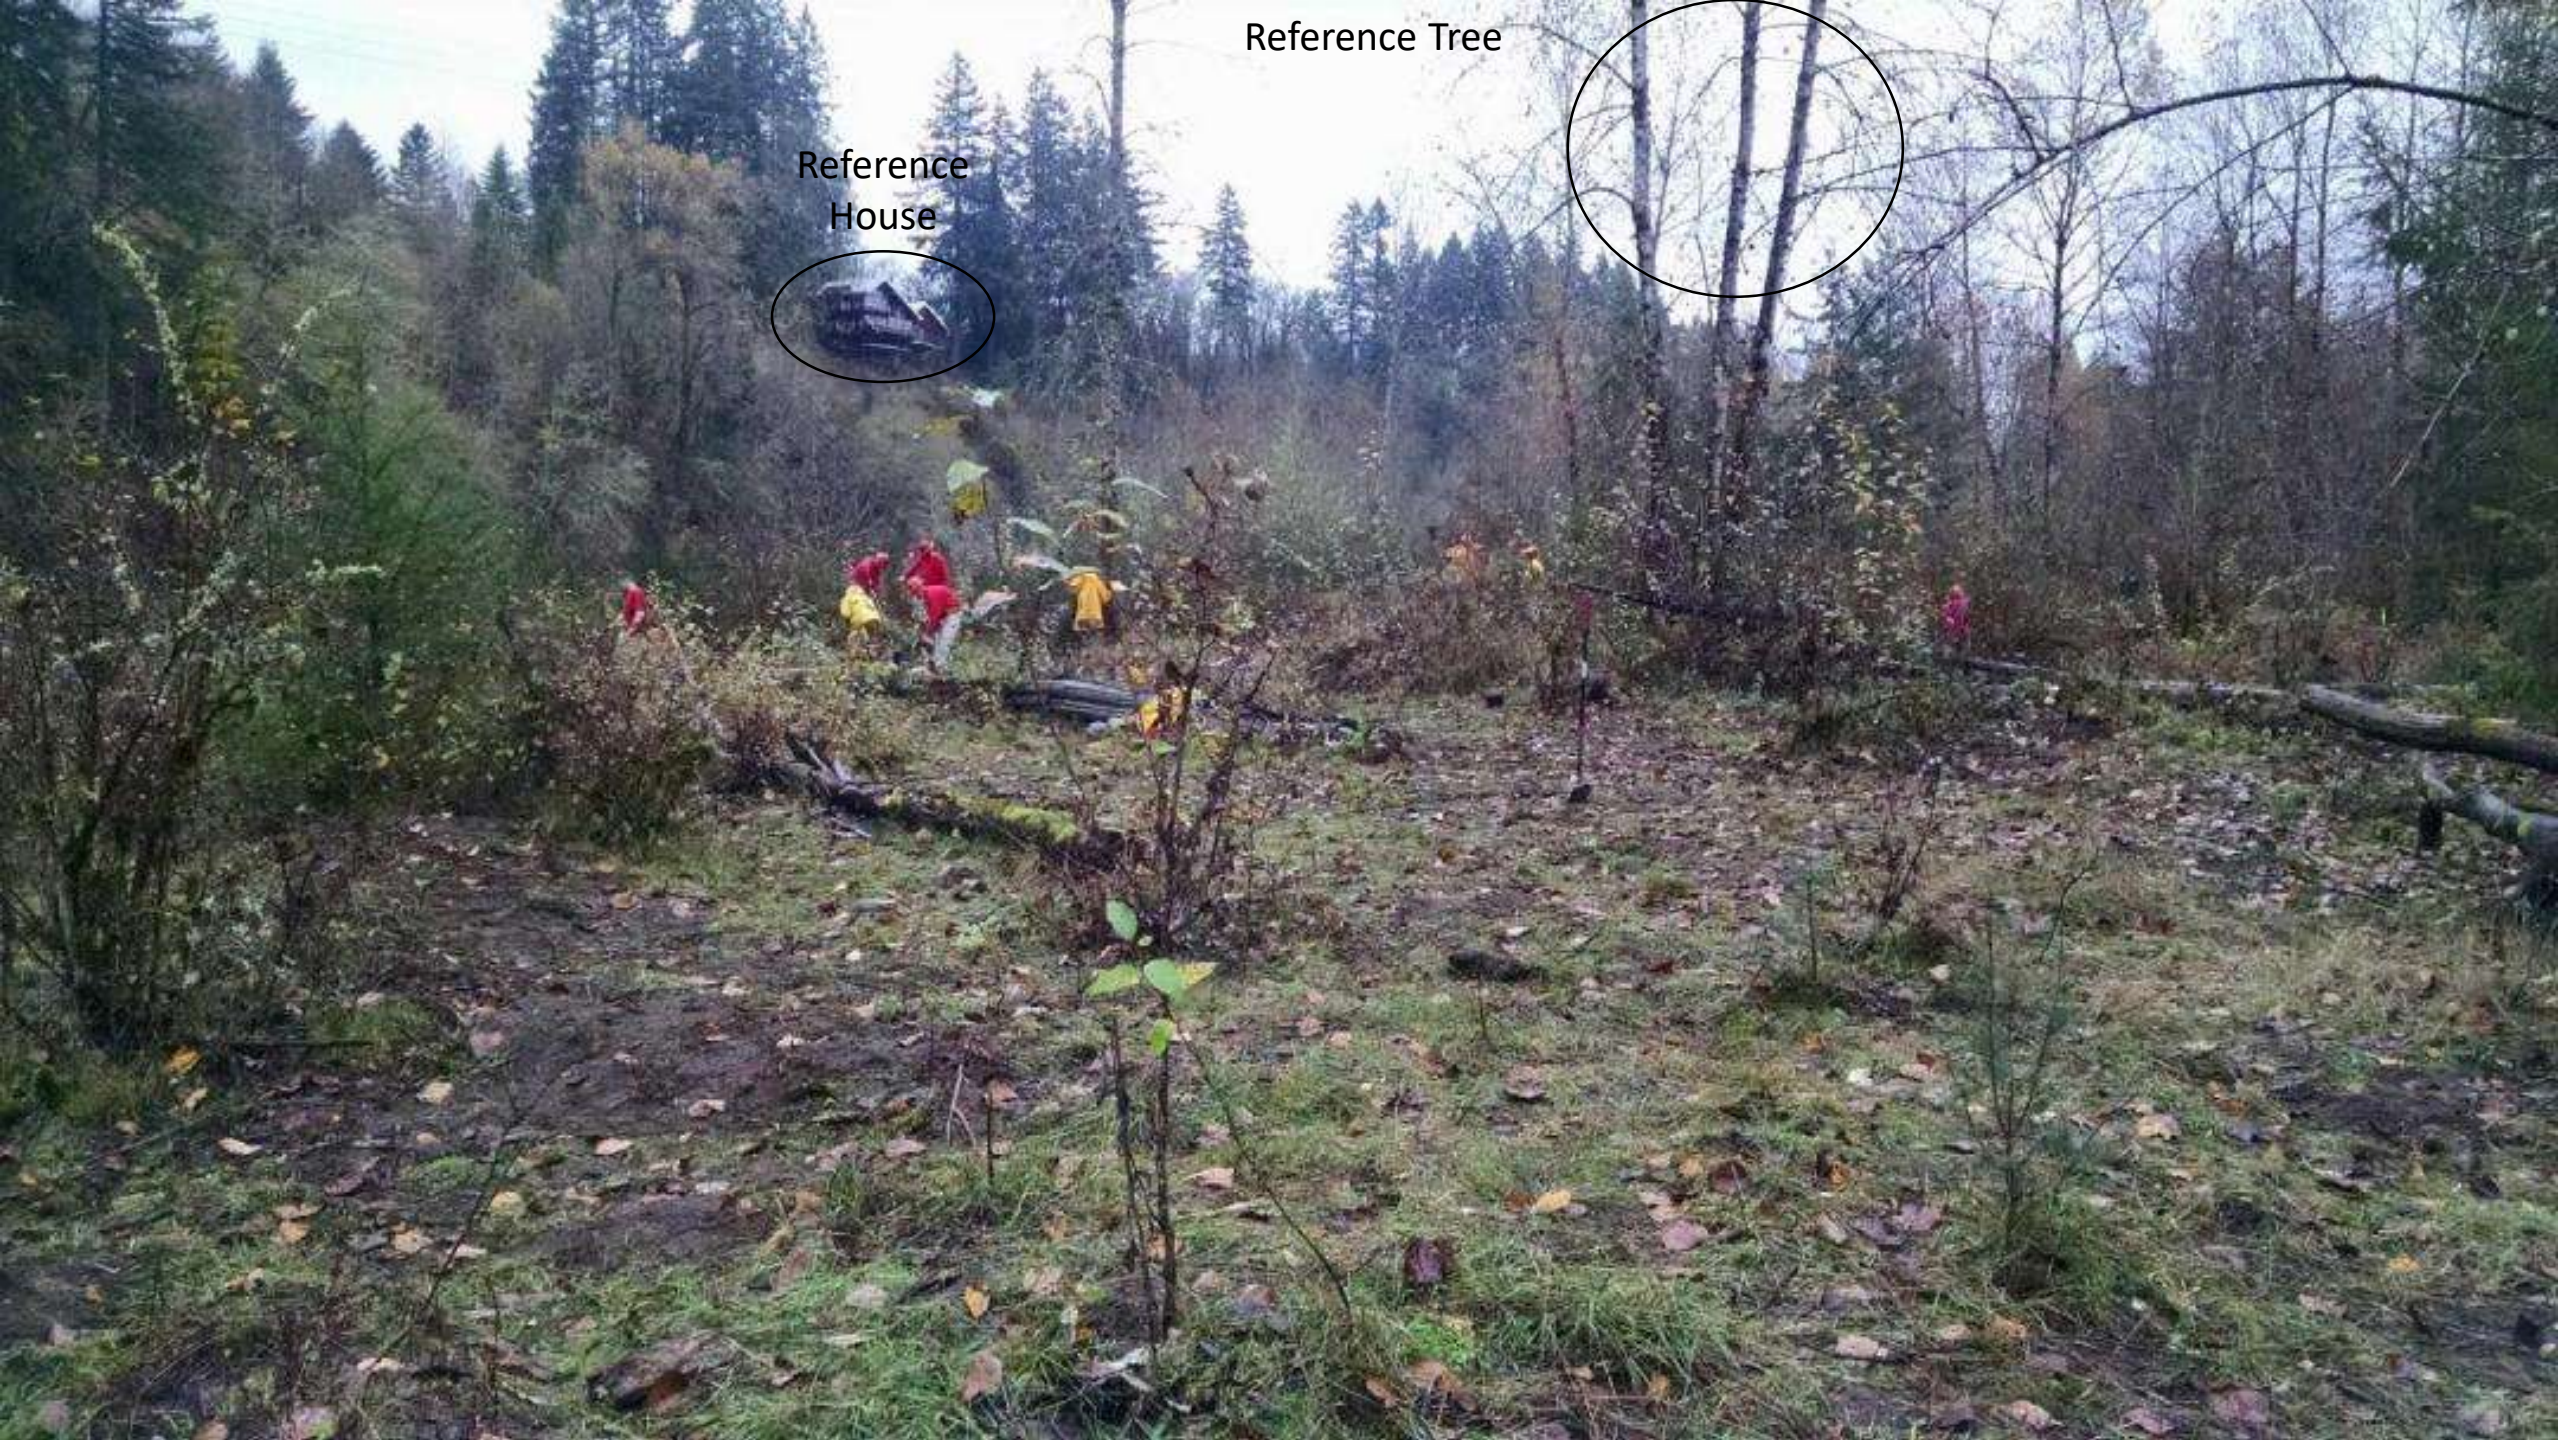
POST TREATMENT OF SCOTCH BROOM

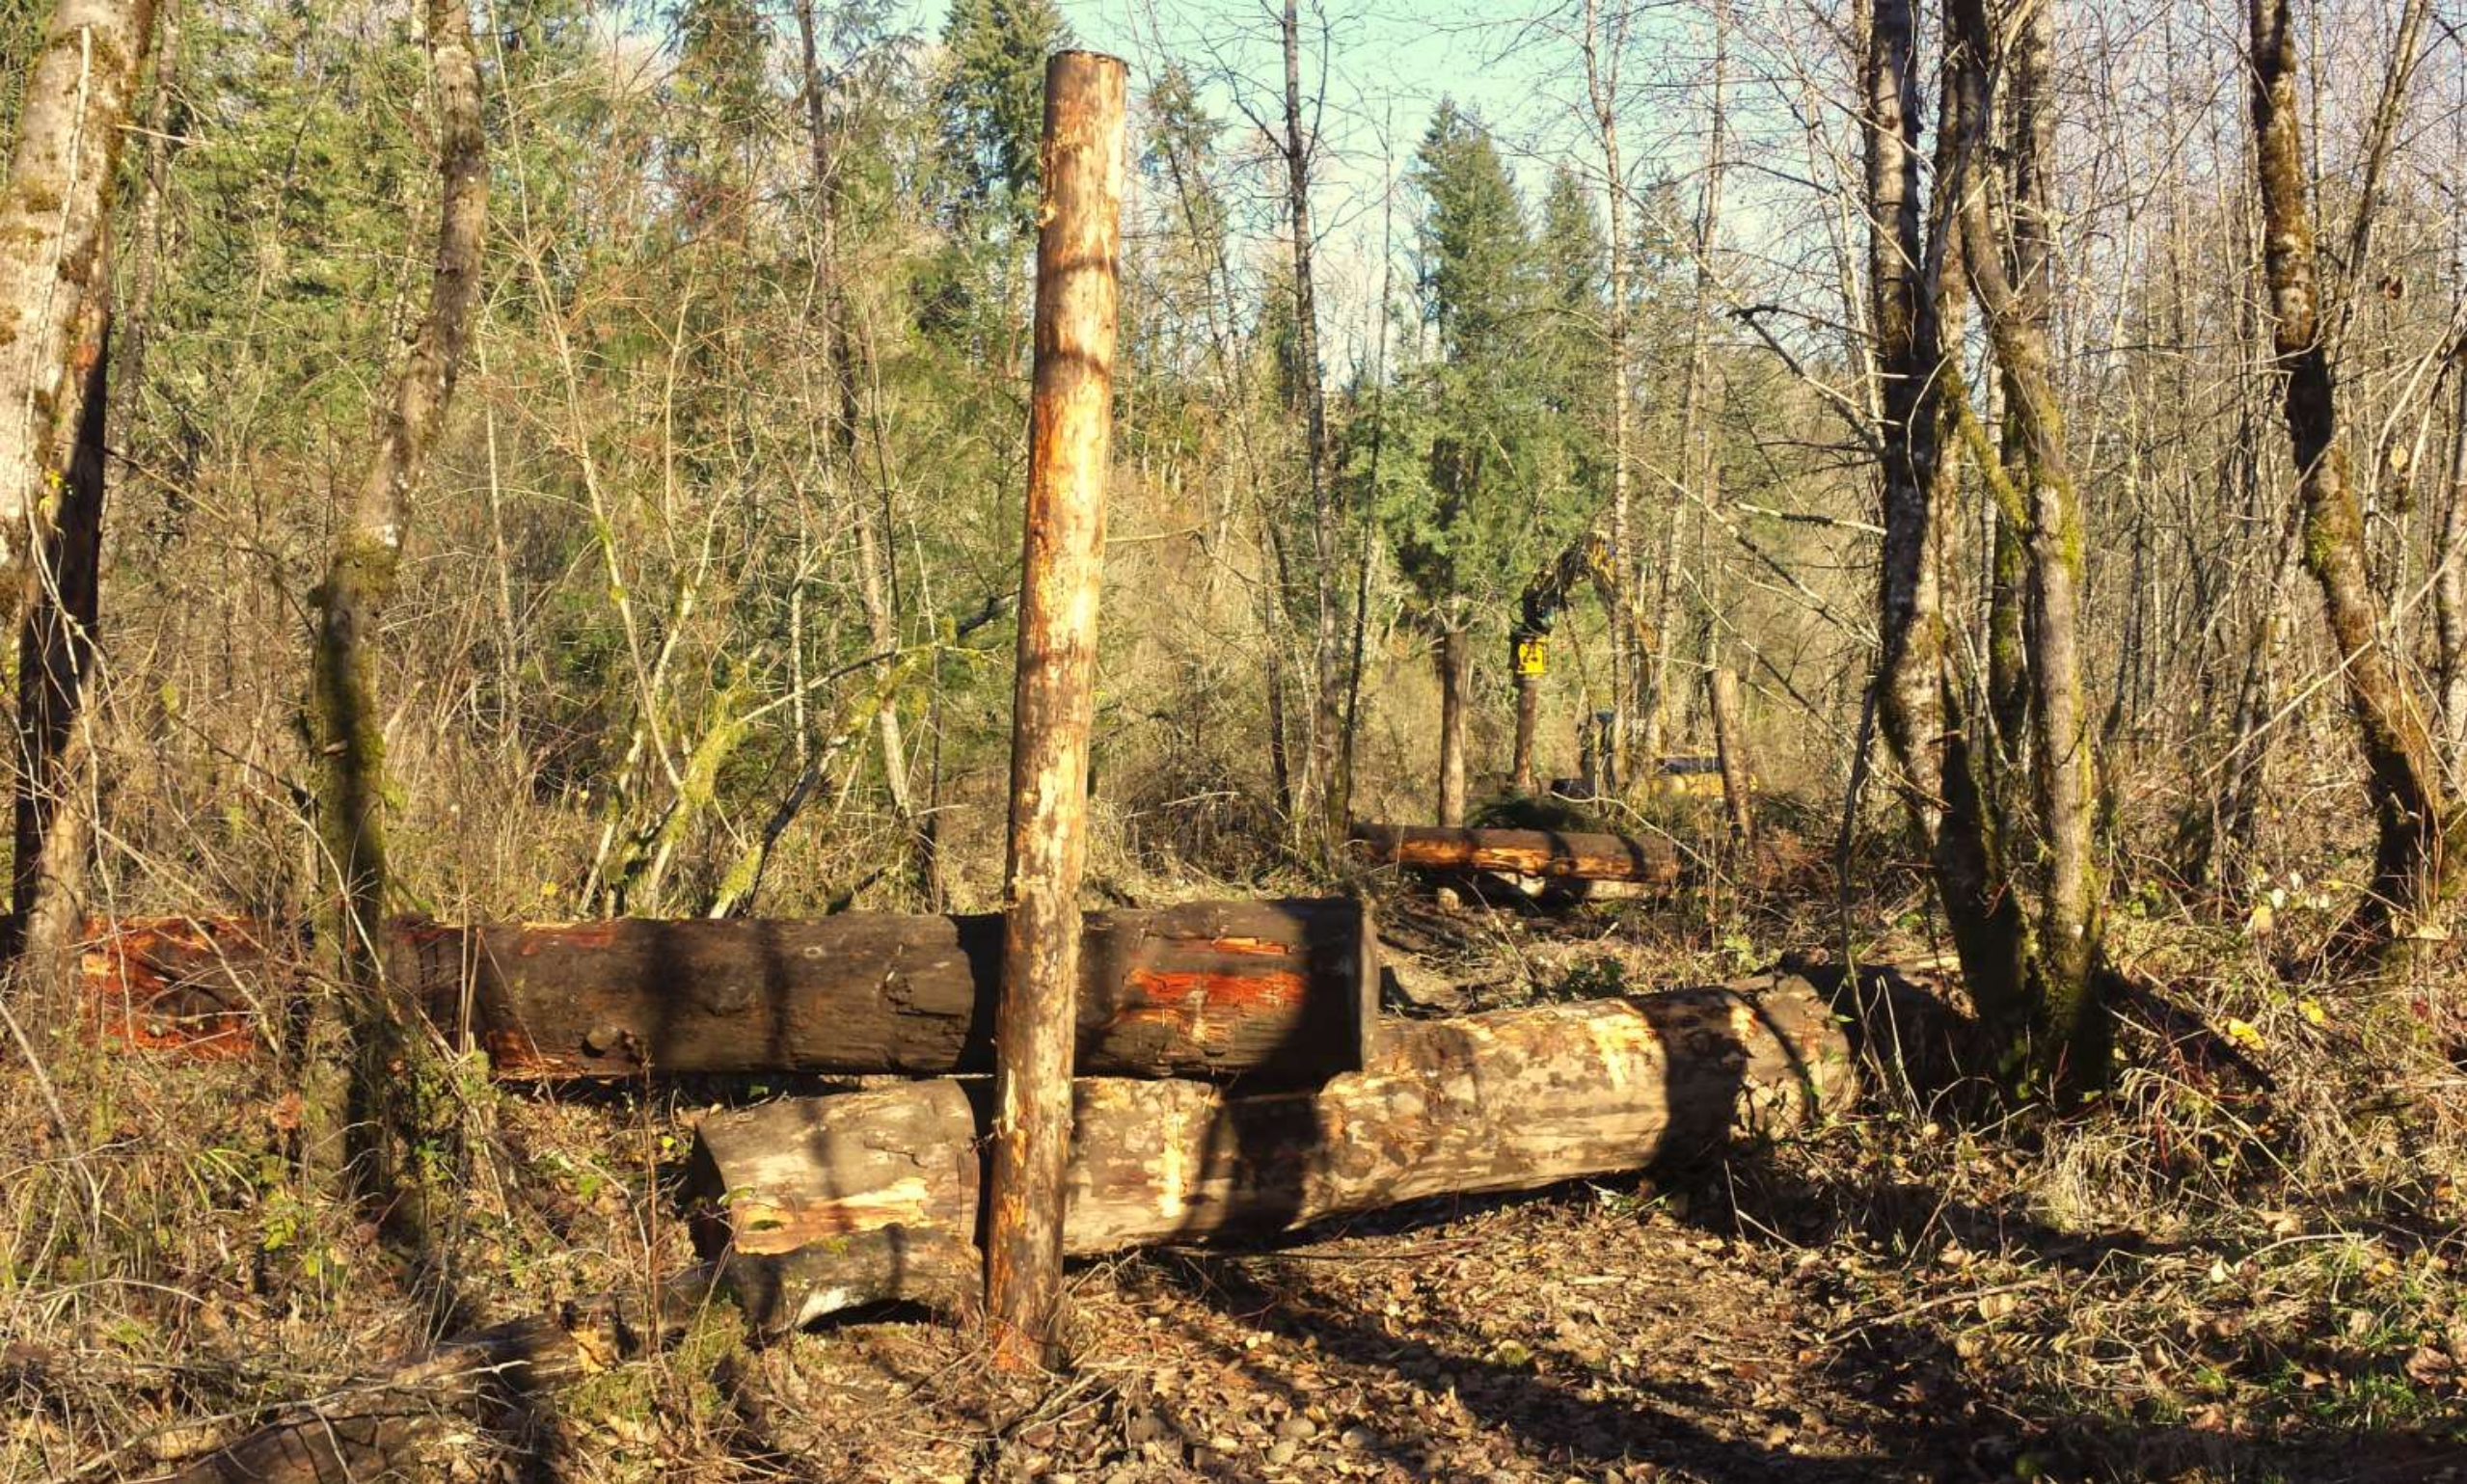
FLOODPLAIN ROUGHNESS INSTALLATION ON PRIVATE LAND

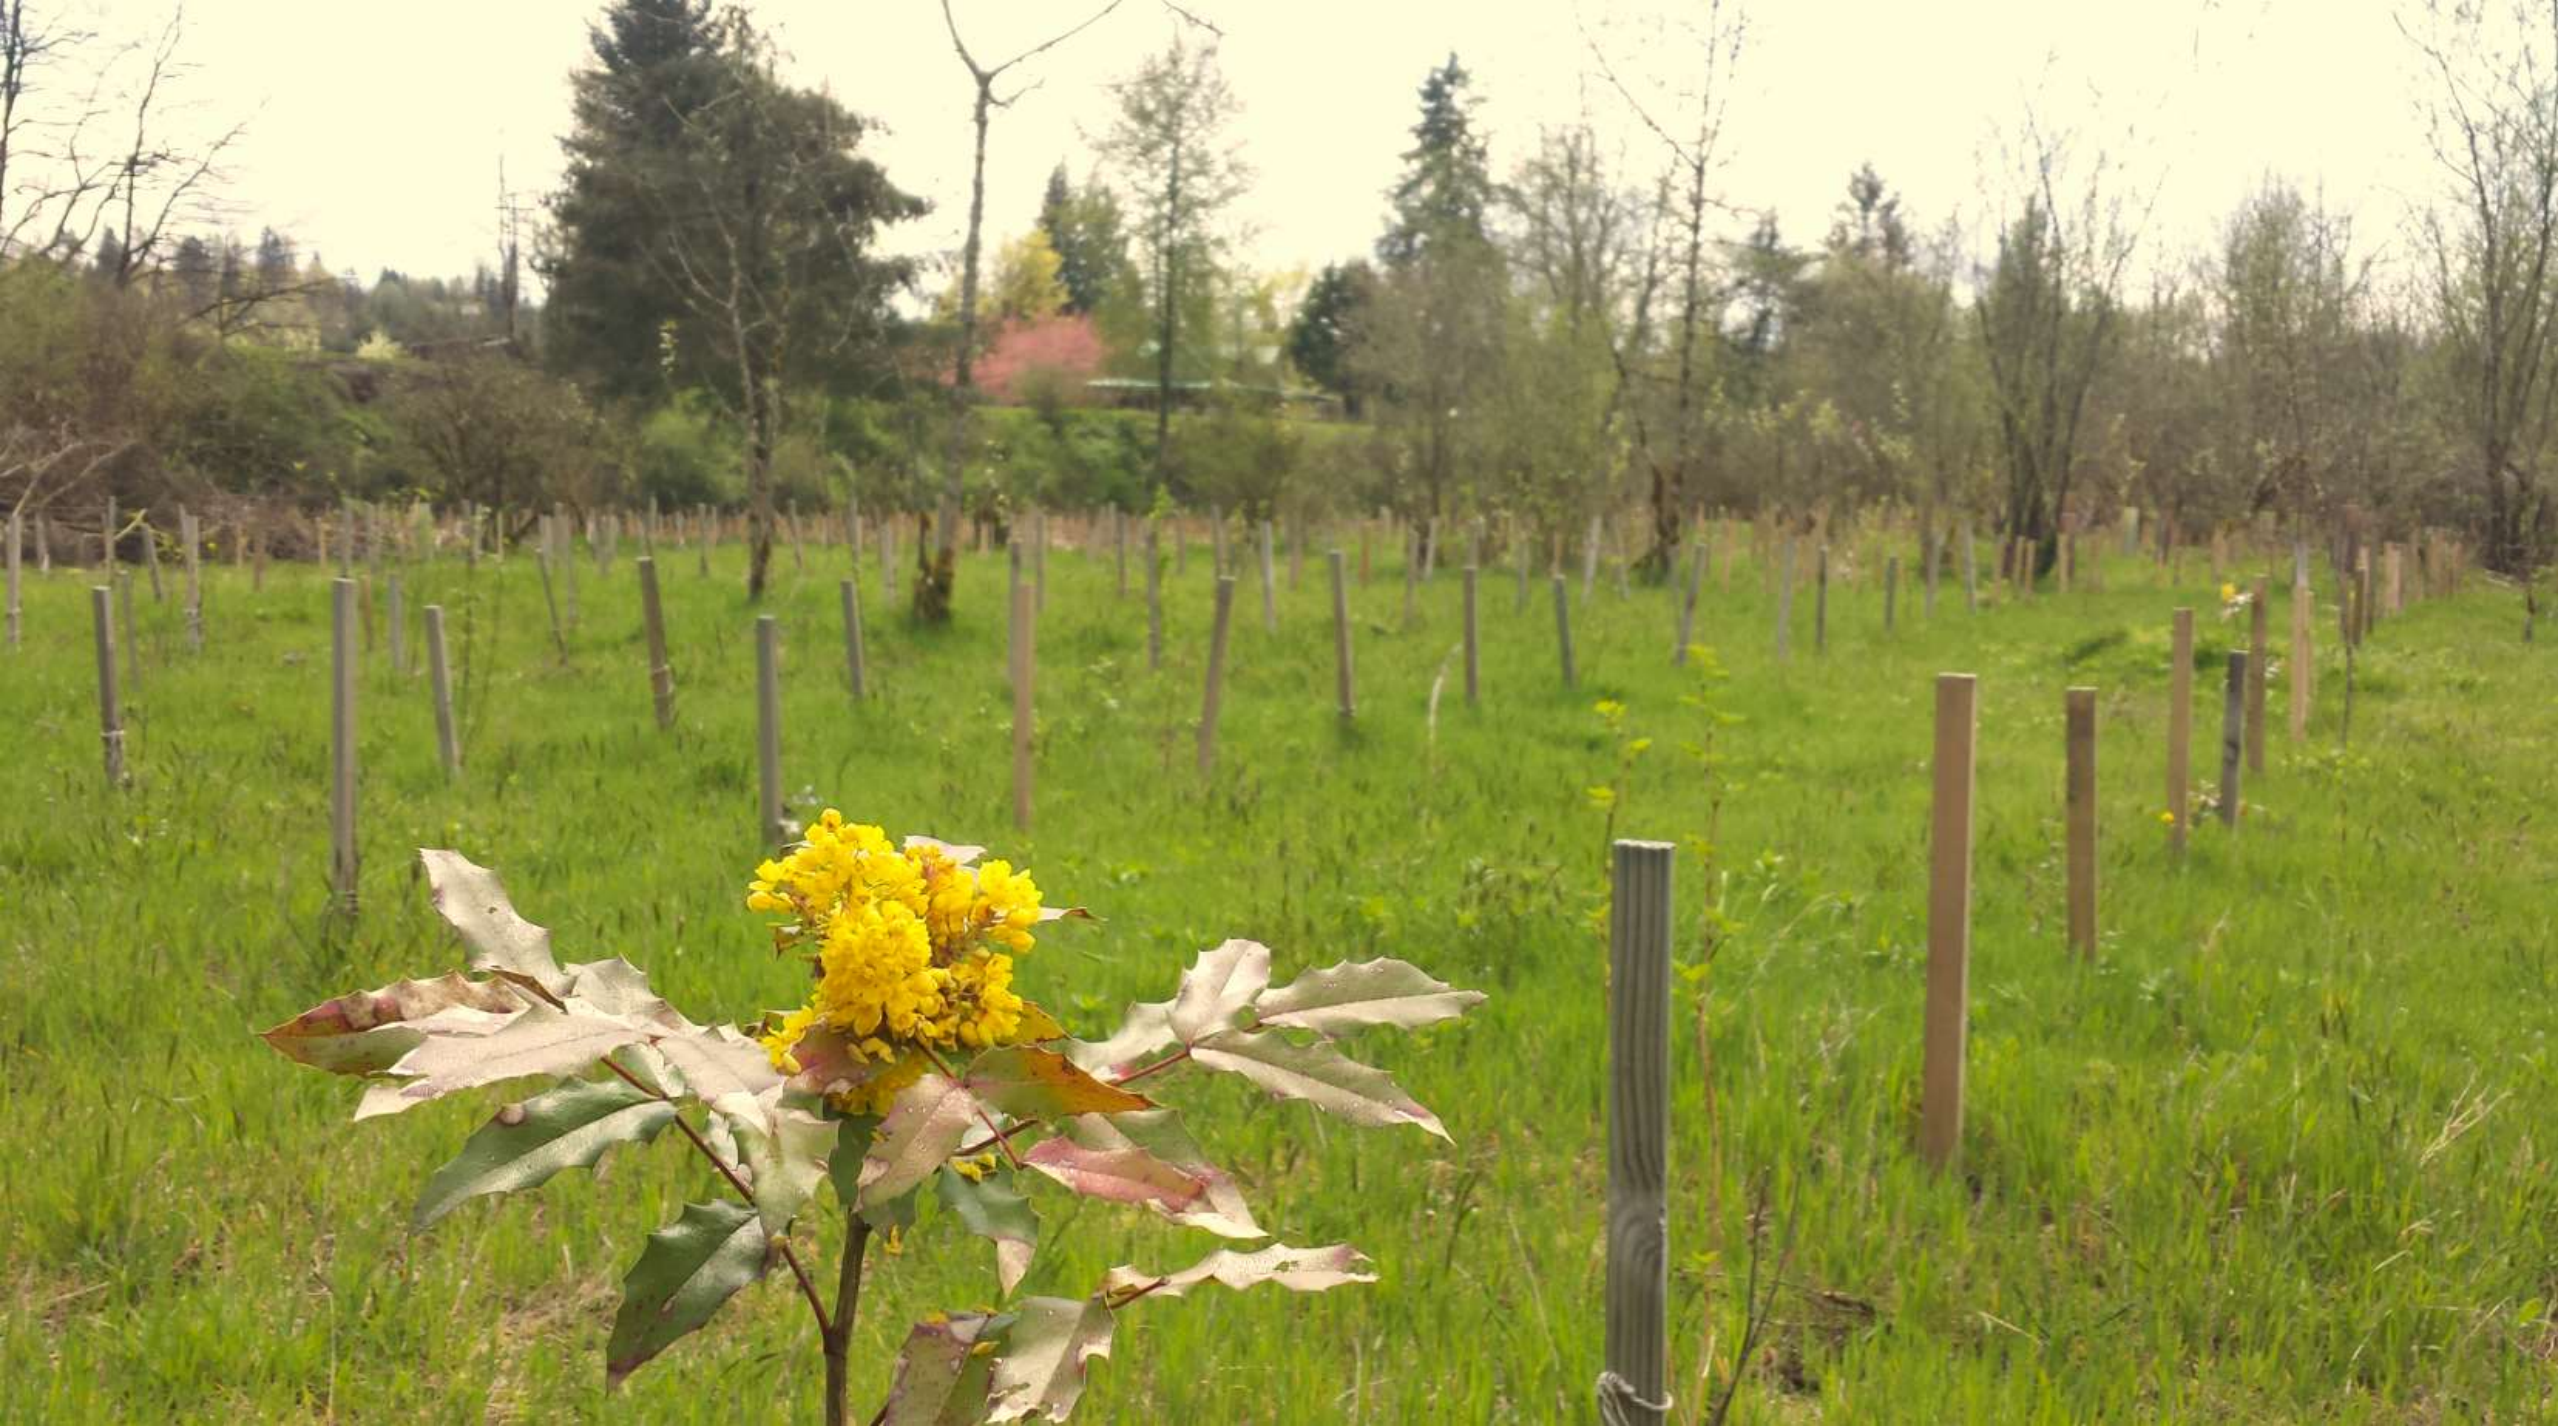
SPRING SURVIVAL ASSESSMENT

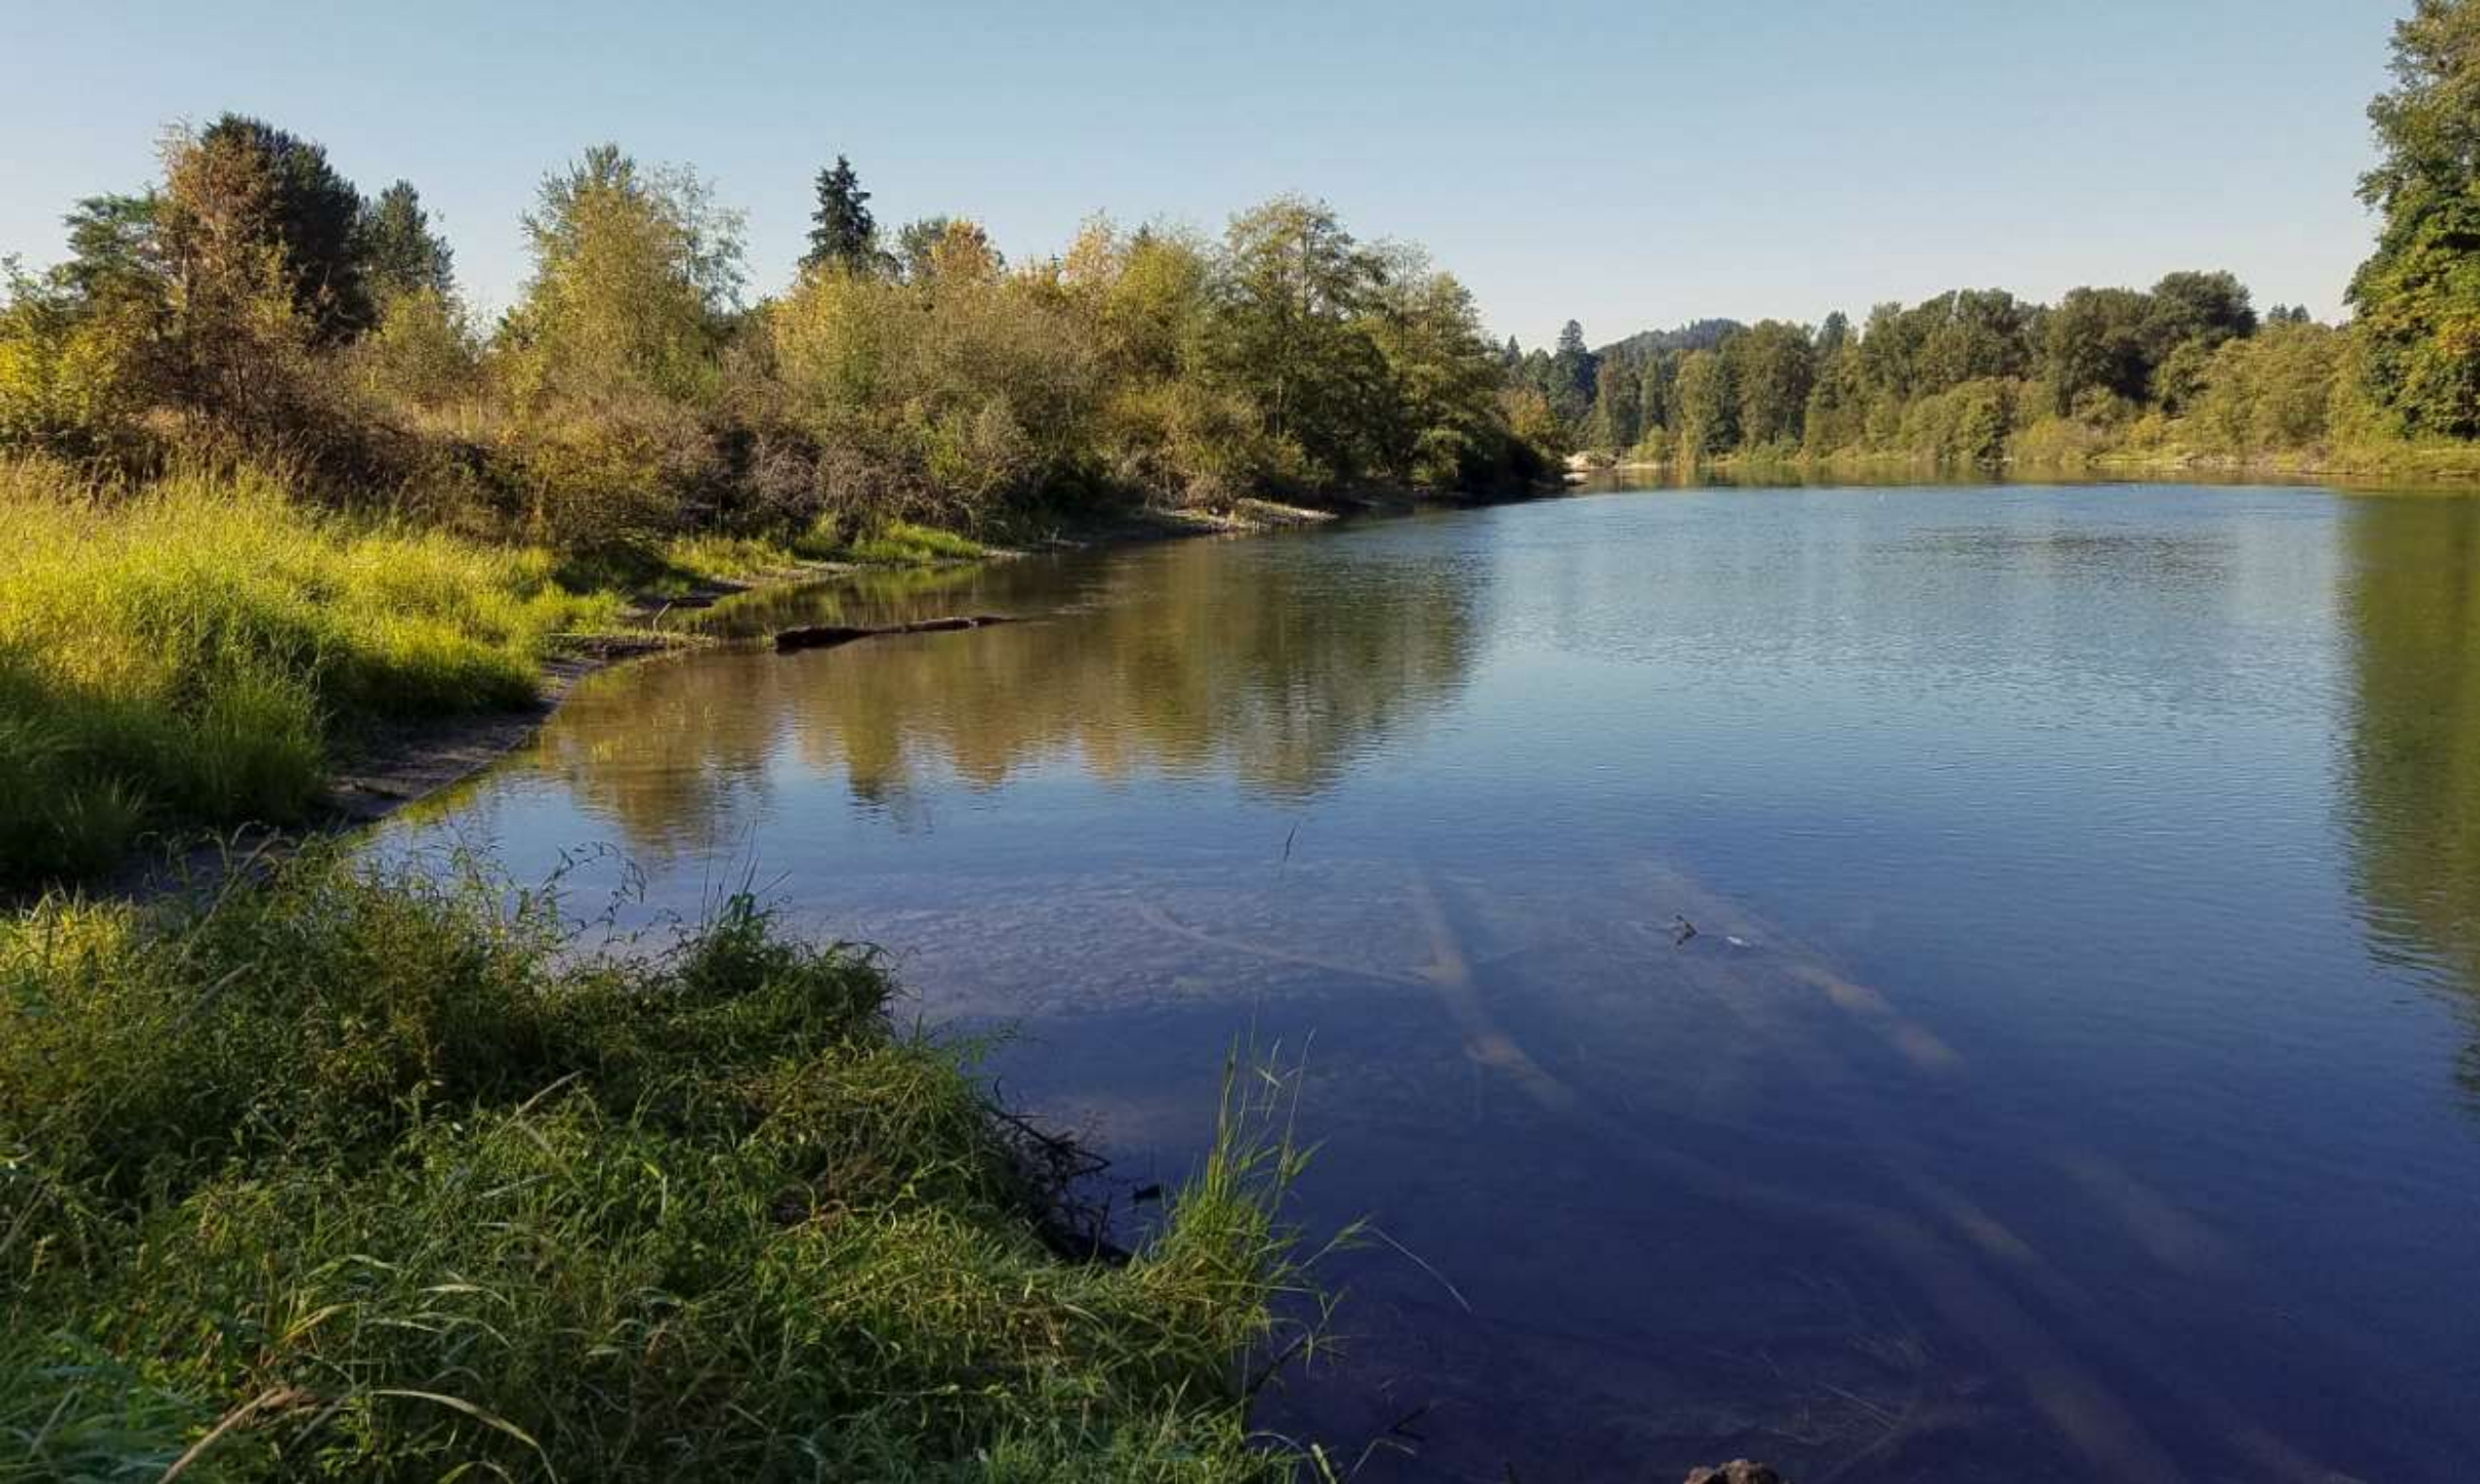
BEFORE - IMAGE OF INSTREAM LWD CONSTRUCTION SITE (LOOKING DOWNSTREAM)

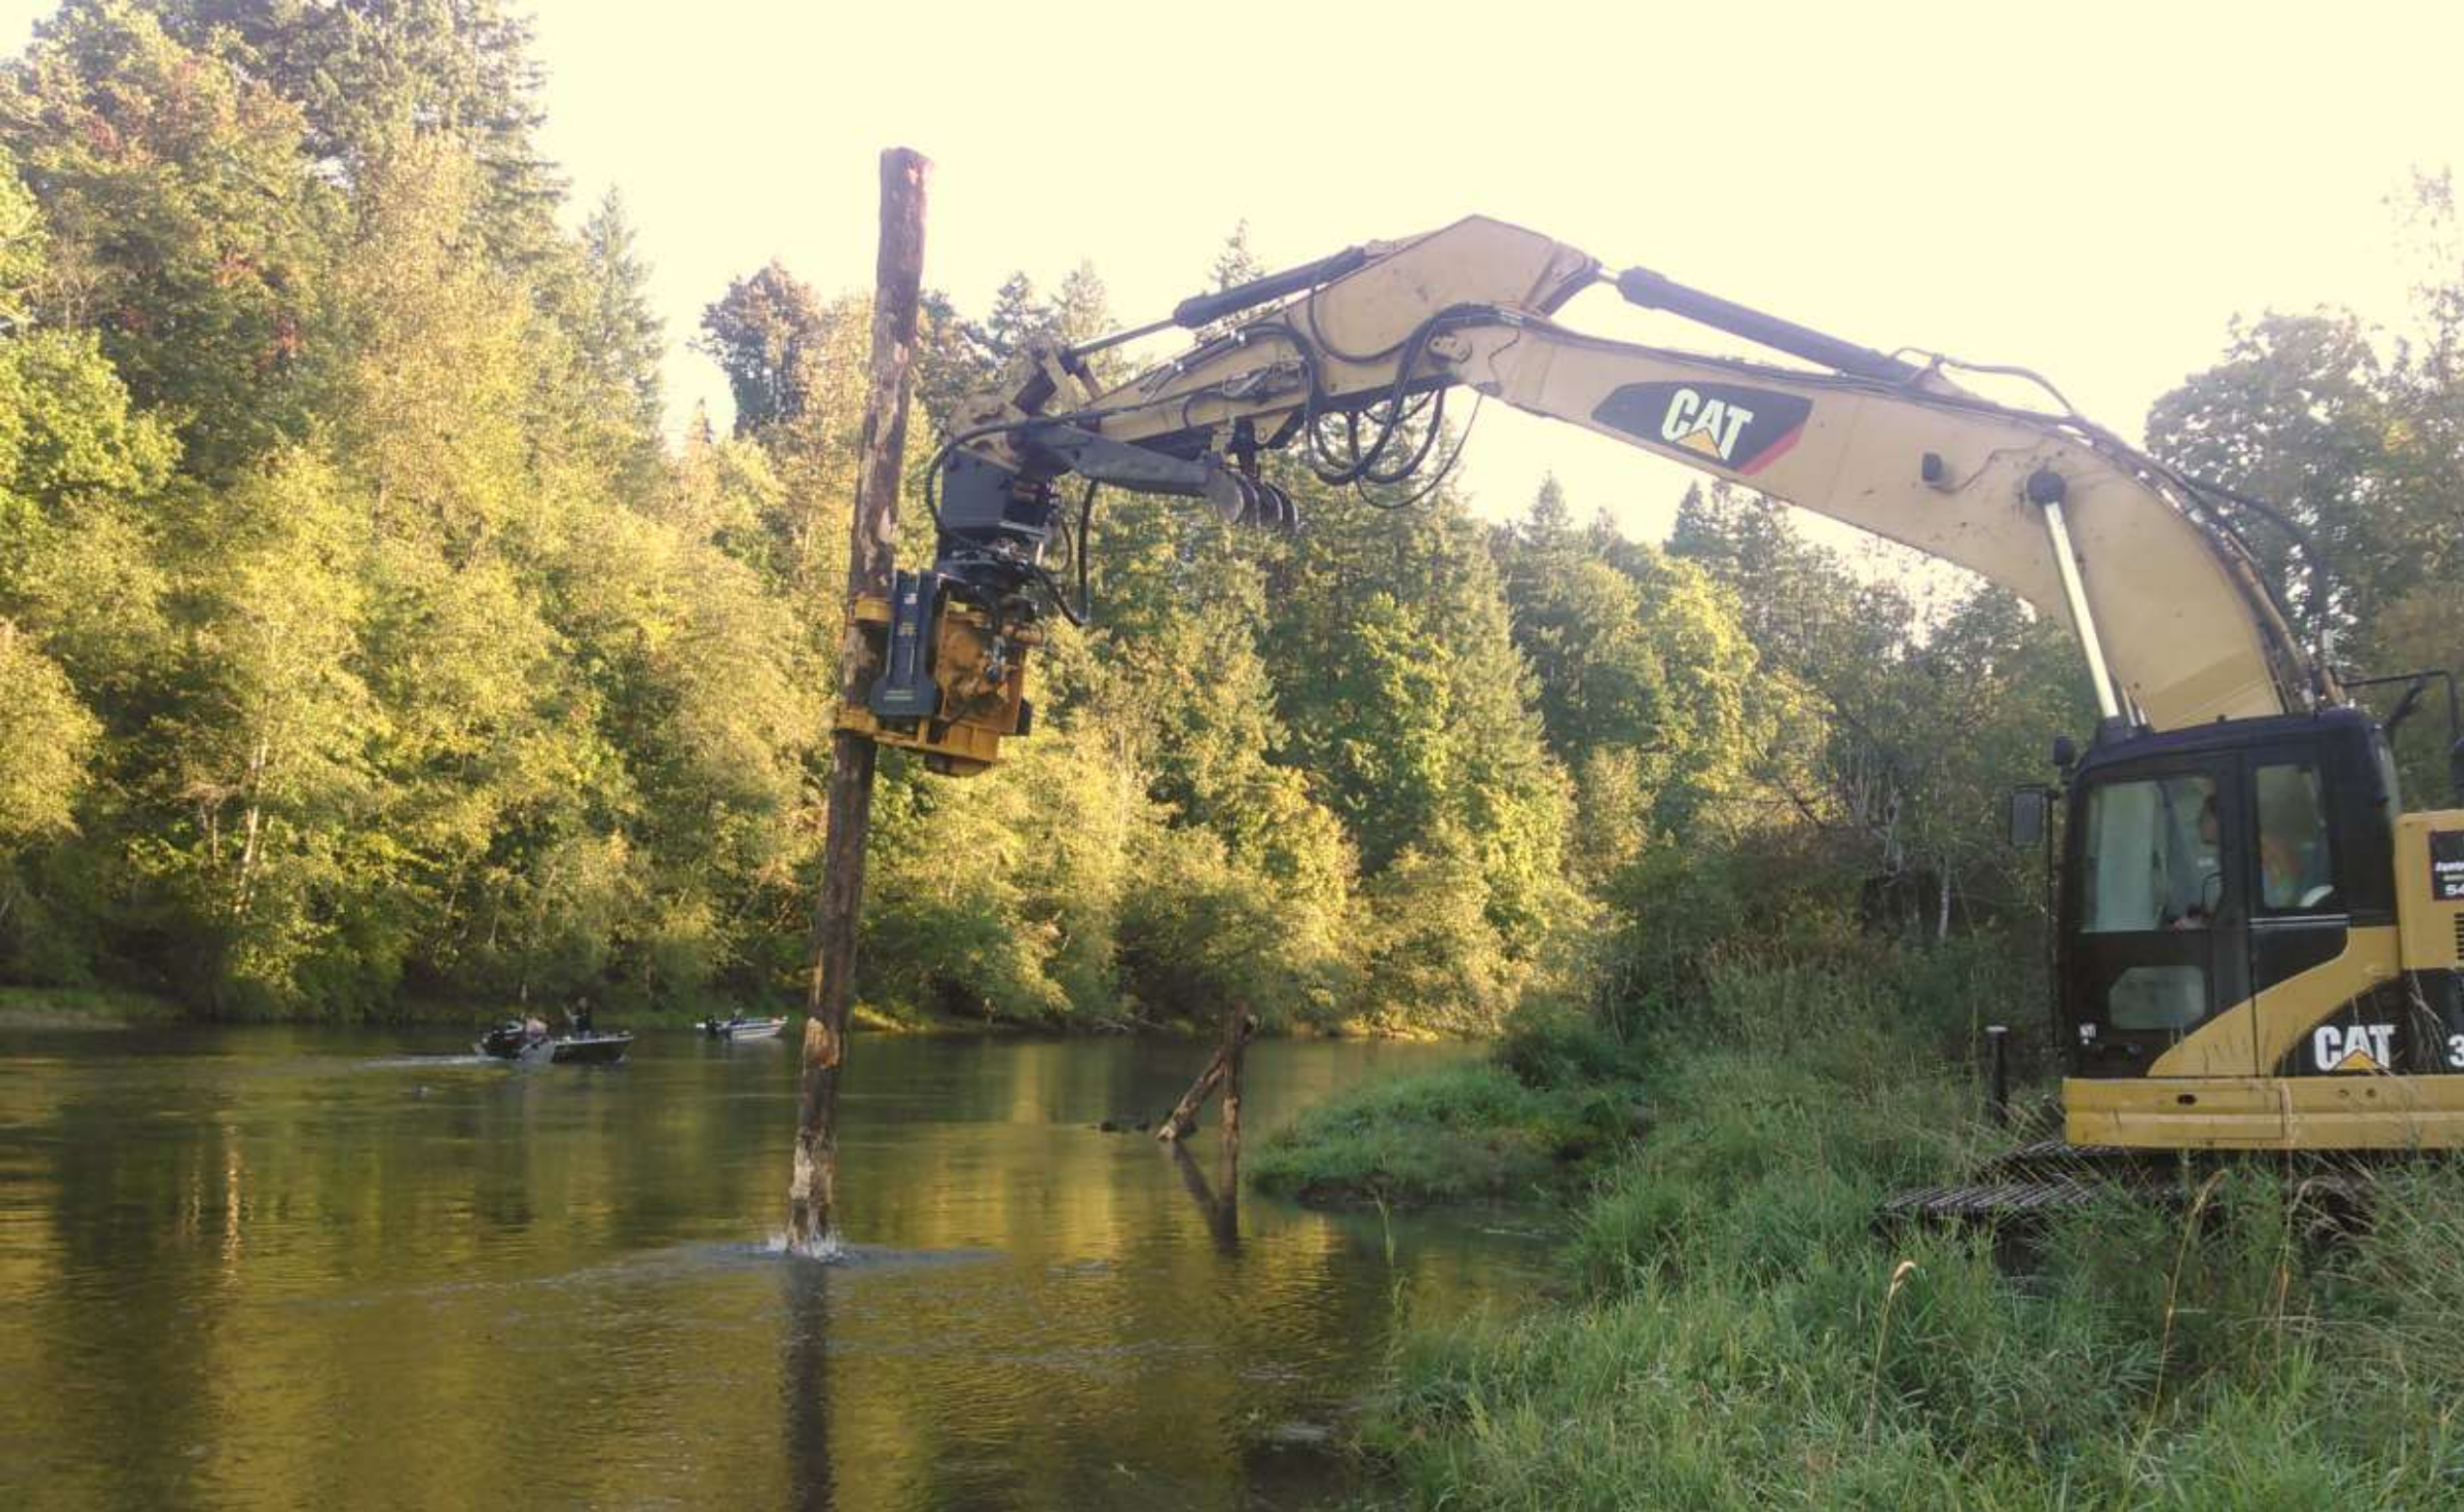
DURING - CONSTRUCTION IMAGE OF INSTREAM LWD CONSTRUCTION SITE (LOOKING UPSTREAM)
