Lewis River Aquatic Fund Projects (SA 7.5.3.2)

Project Closeout Report

Project Title: Lewis River Hydroelectric Project

HAAPA PHASE I PROJECT

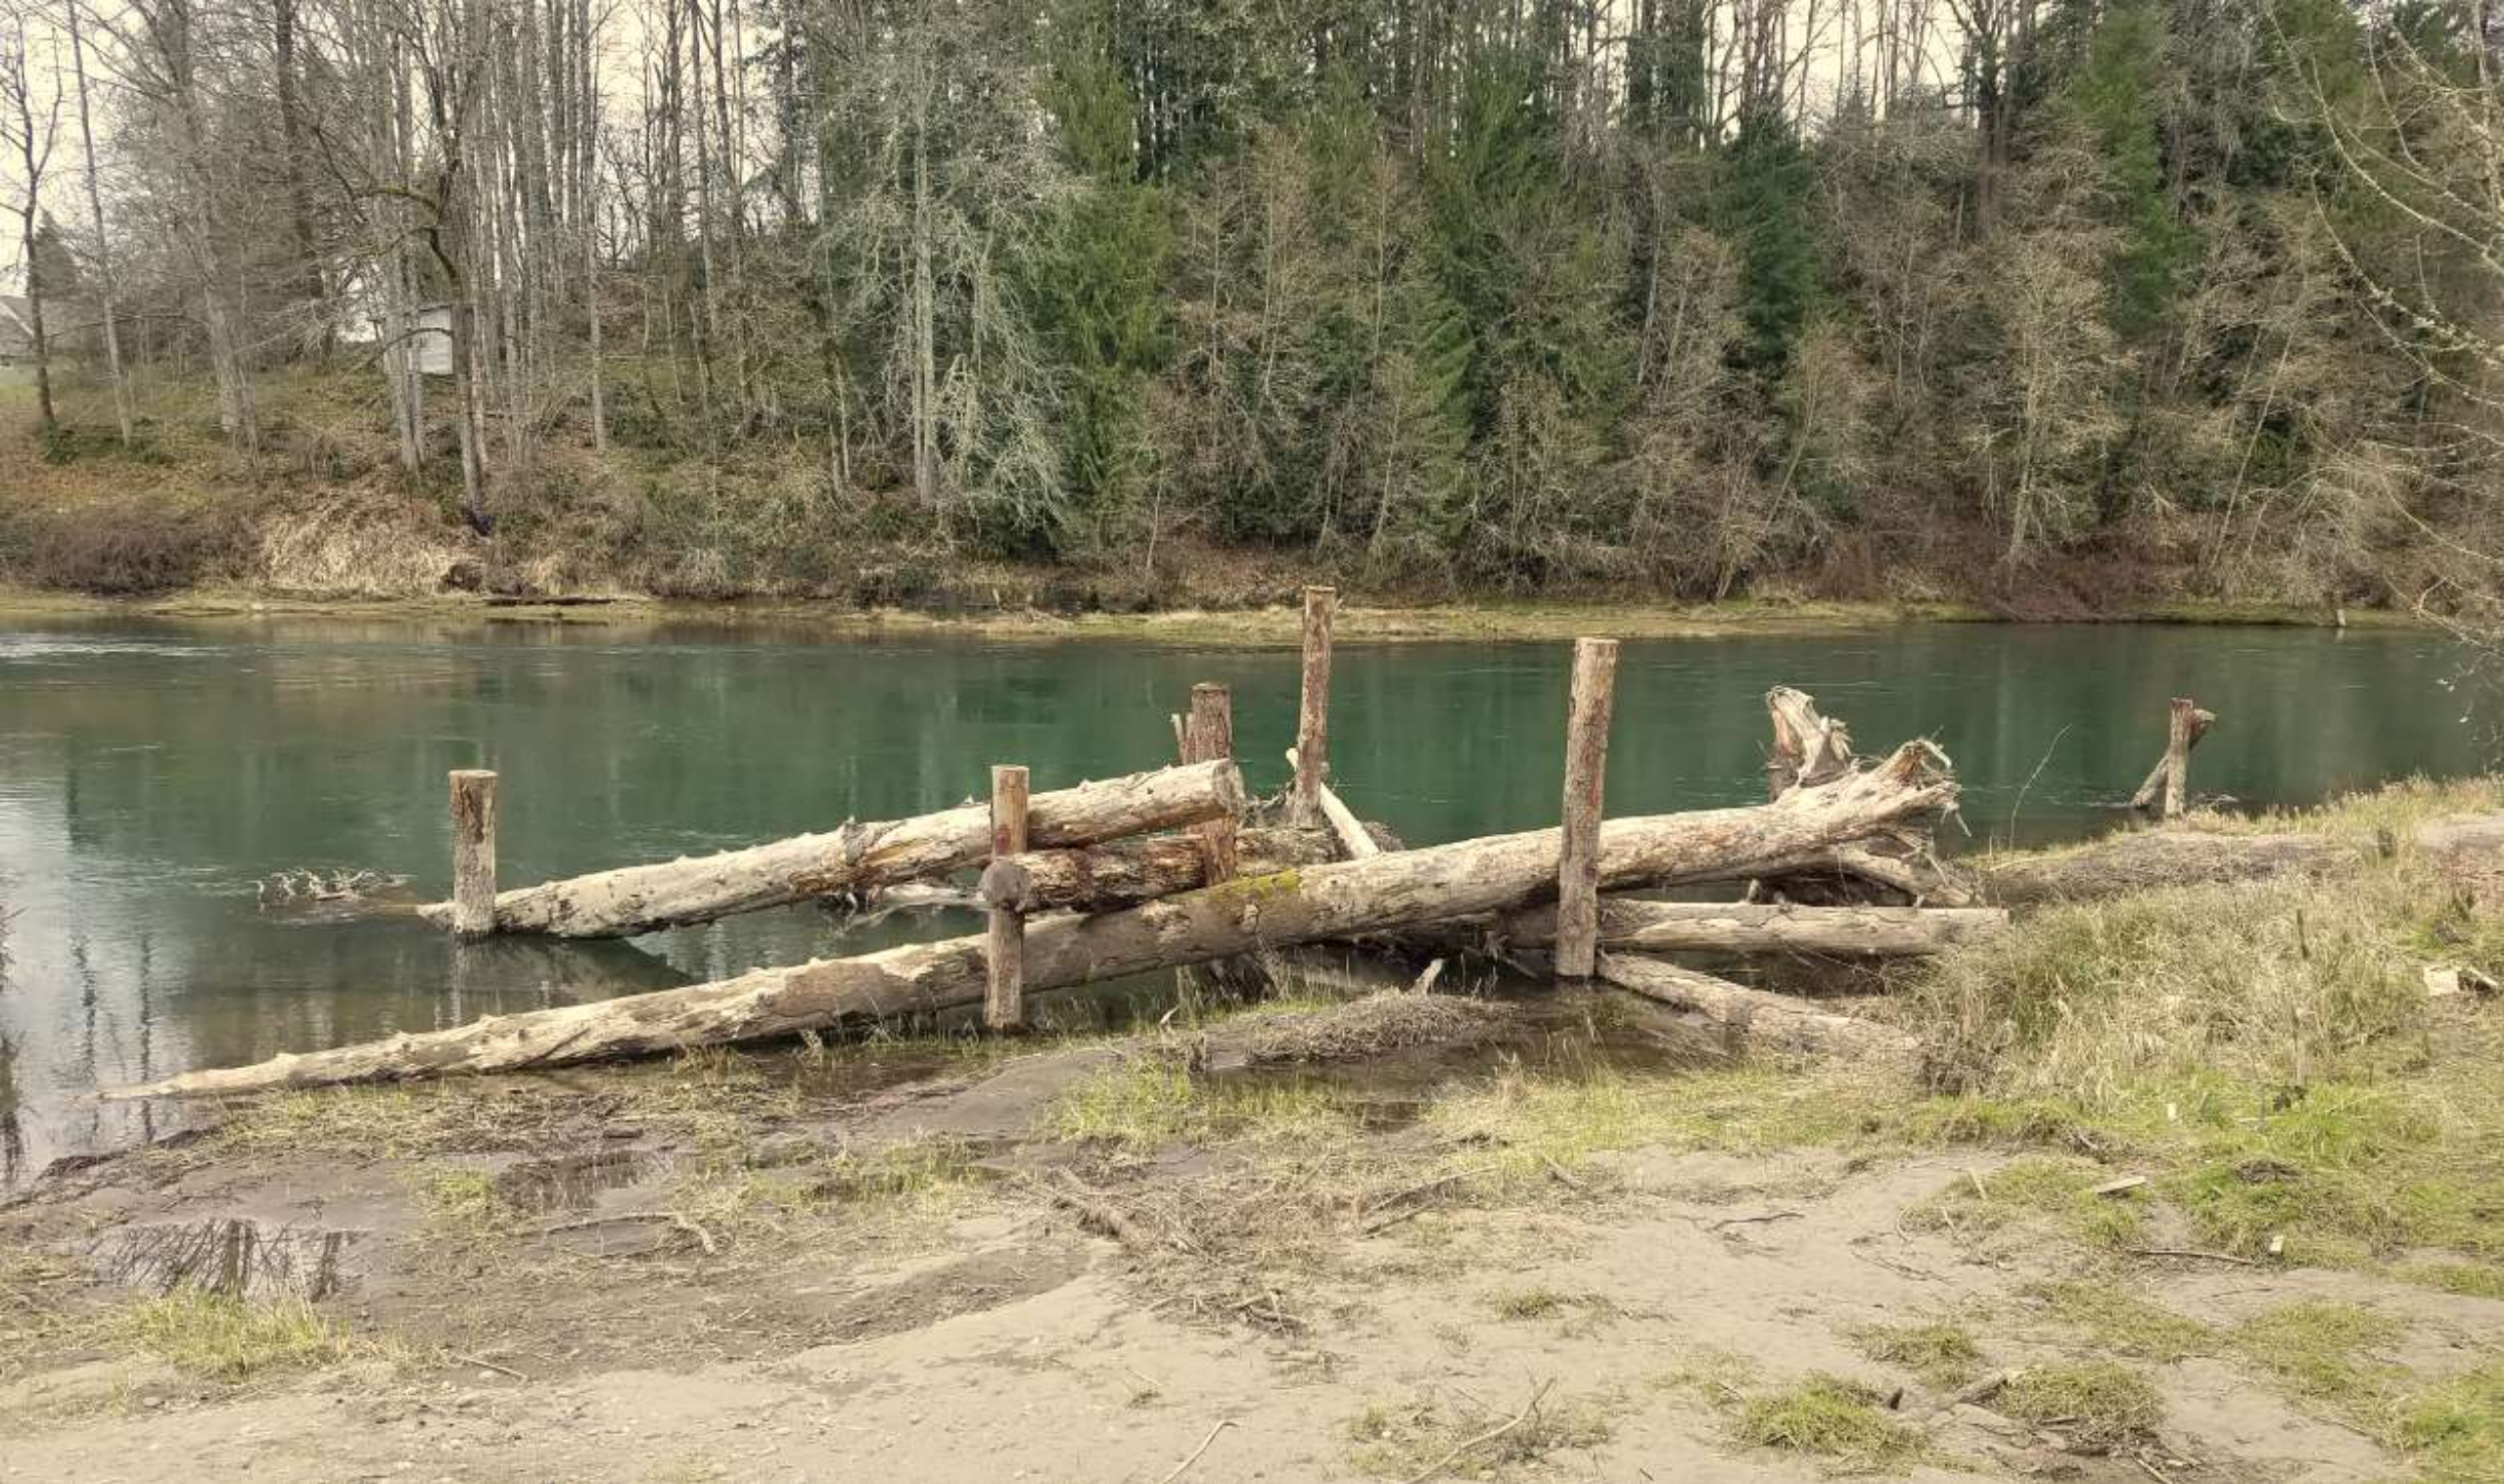
AFTER - CONSTRUCTION IMAGE OF INSTREAM LWD CONSTRUCTION SITE (LOOKING SLIGHTLY UPSTREAM)

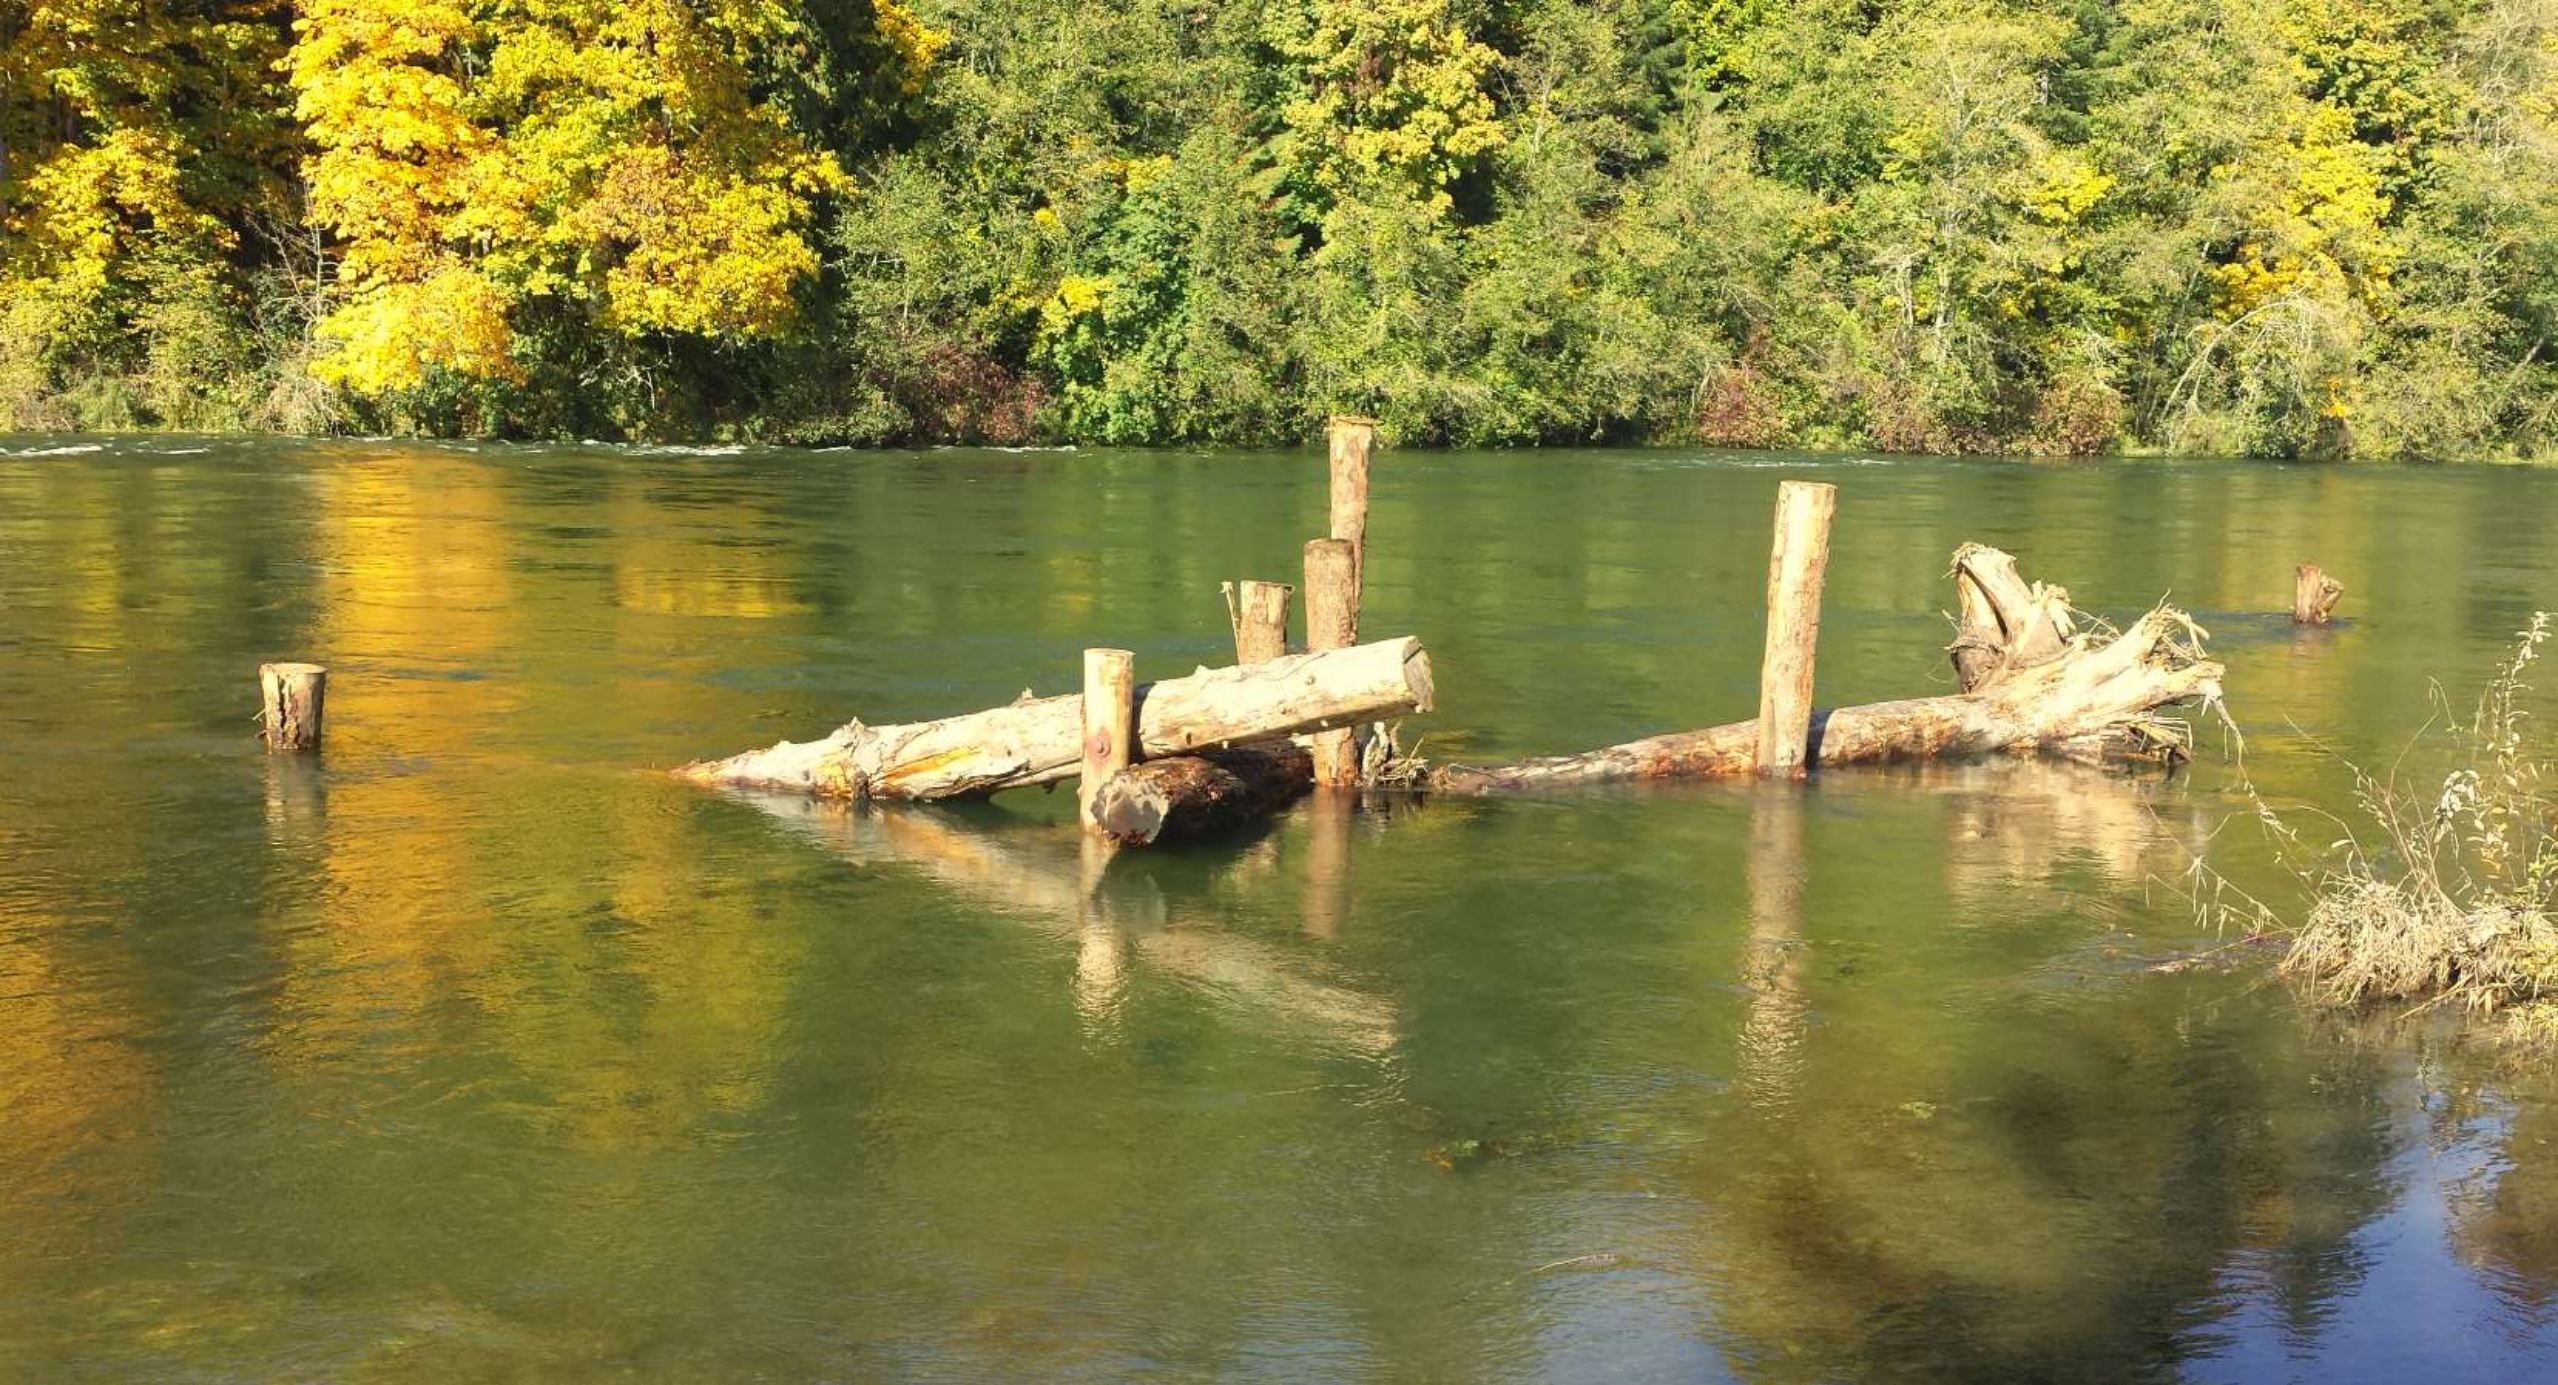
AFTER - CONSTRUCTION IMAGE OF INSTREAM LWD CONSTRUCTION SITE AT HIGH FLOWS (LOOKING UPSTREAM)

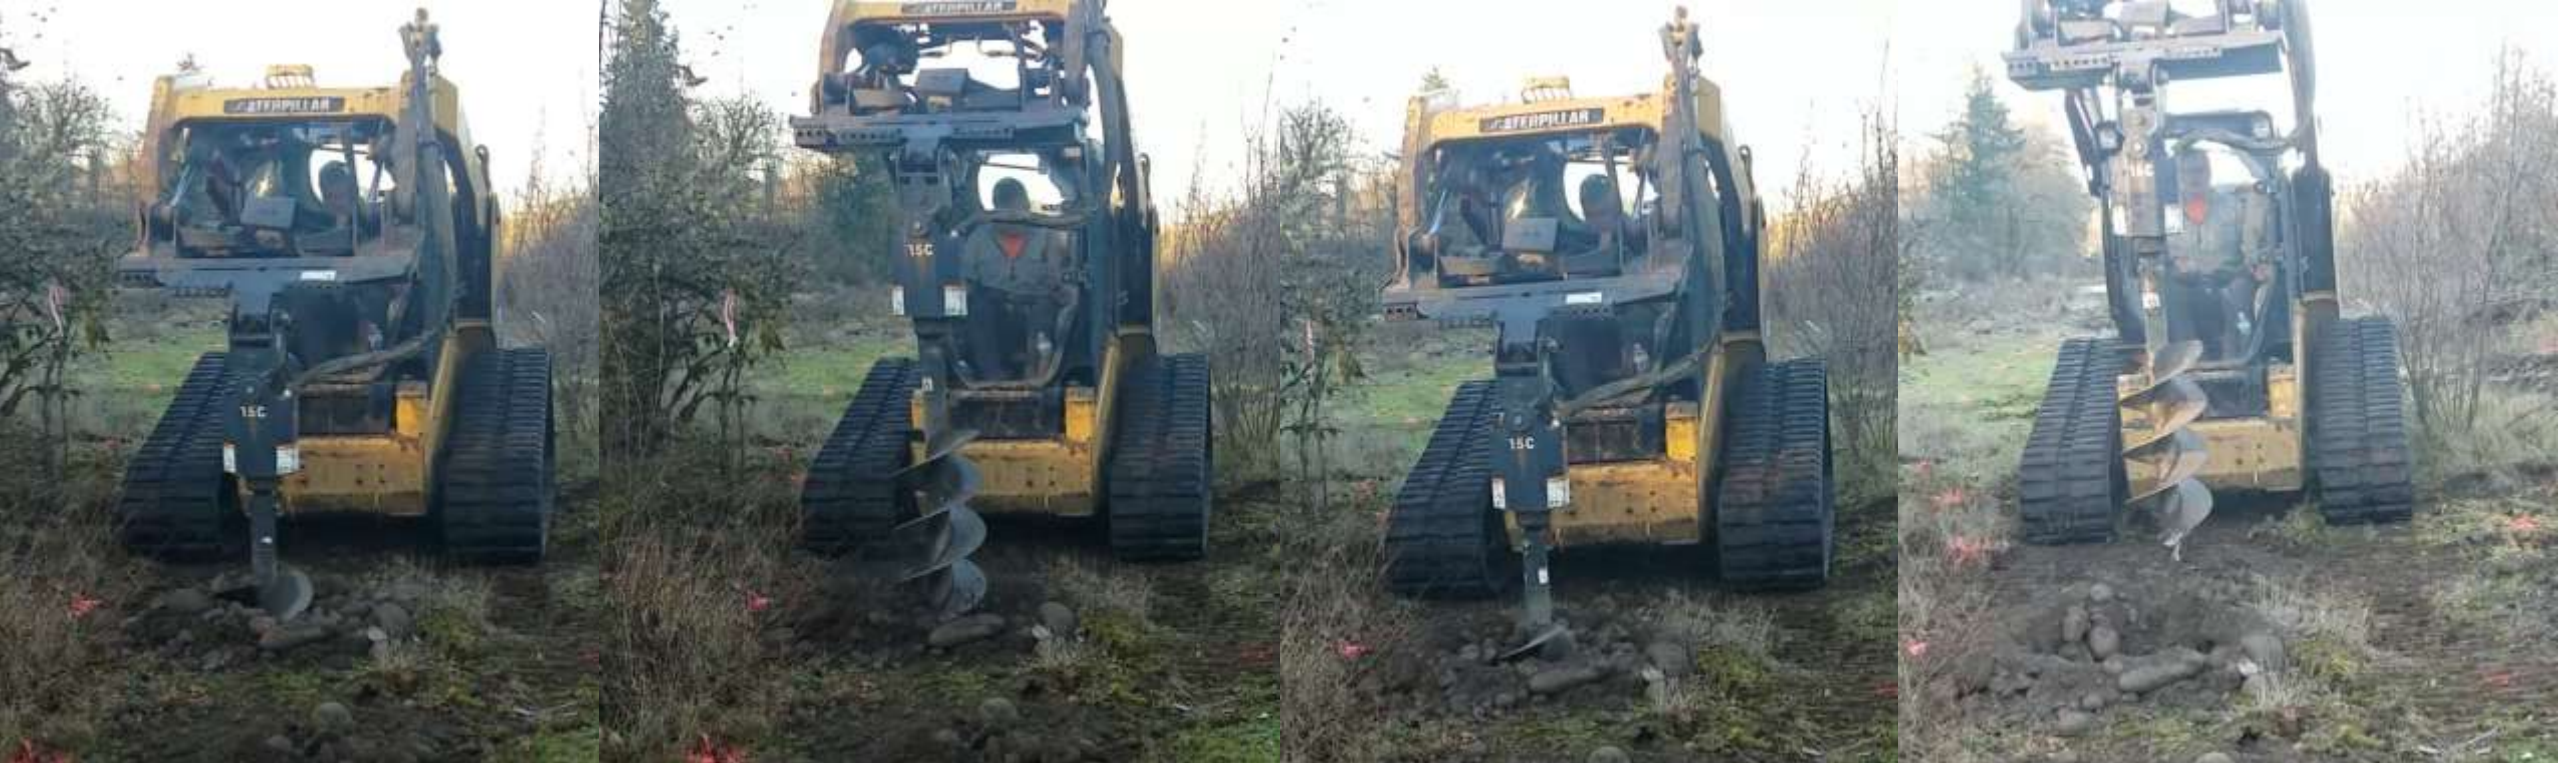
- Areas dominated by scotch broom likely have underlying soil content issues. At this project, we discovered that areas that were originally dominated by scotch broom had a substrate composition of about 60% cobble, 20% gravel, and 20% sand. To try and get plants established in these areas we dug holes with a 12” diameter x 48” long bit mounted on a skidsteer on about 6-8’ centers. These holes had to be manually excavated by hand before they could be planted. Each hole received 5 gallons of compost as it was backfilled during plant installation. This was completed in spring 2019 and results will not be available for a few years.

PHOTO SERIES FROM VIDEO OF SKIDSTEER-AUGER HOLE DIGGING; EACH HOLE TOOK 30-60 SECONDS TO DIG.

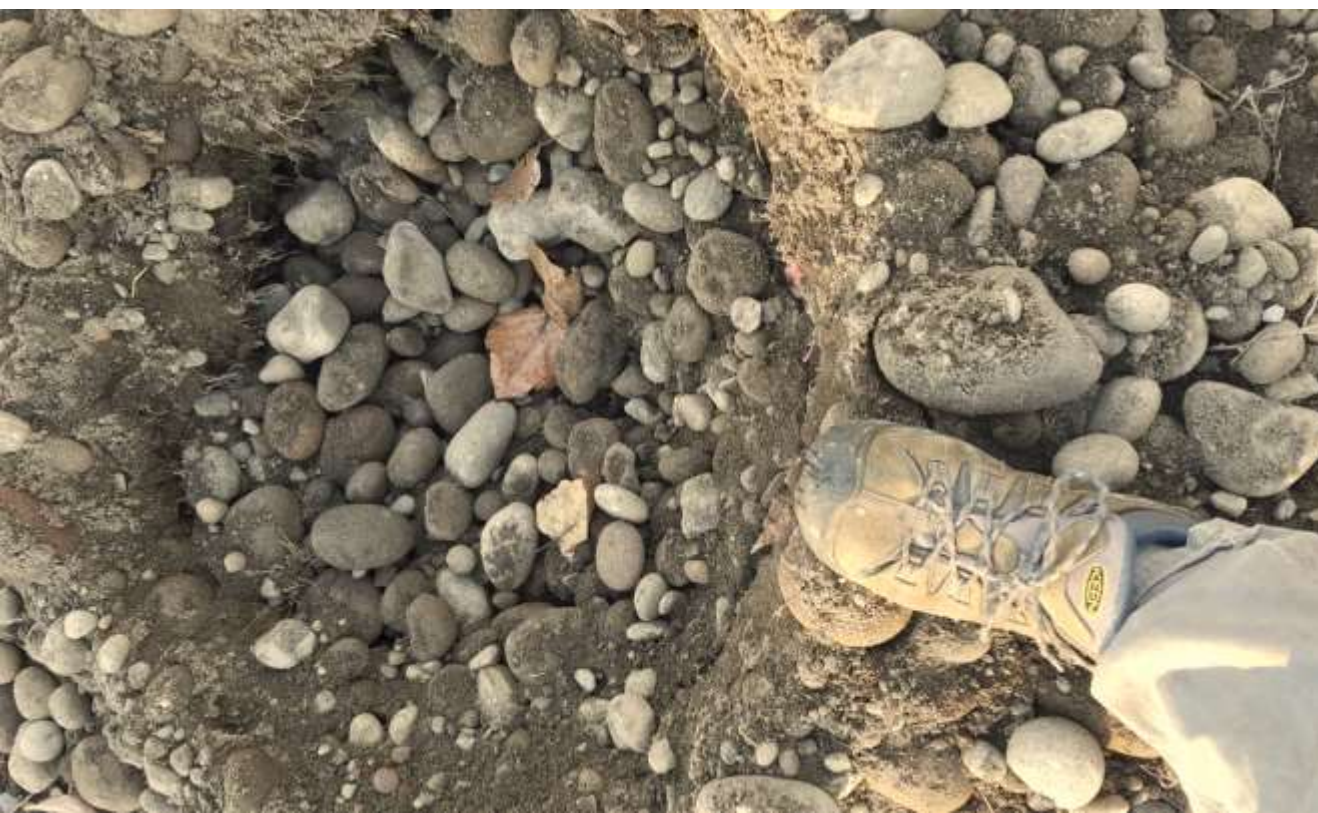
SHOWING HOLE COMPOSITION, DEPTH AND SUBSTRATE SIZE AFTER SKIDSTEER AUGER FINISHES

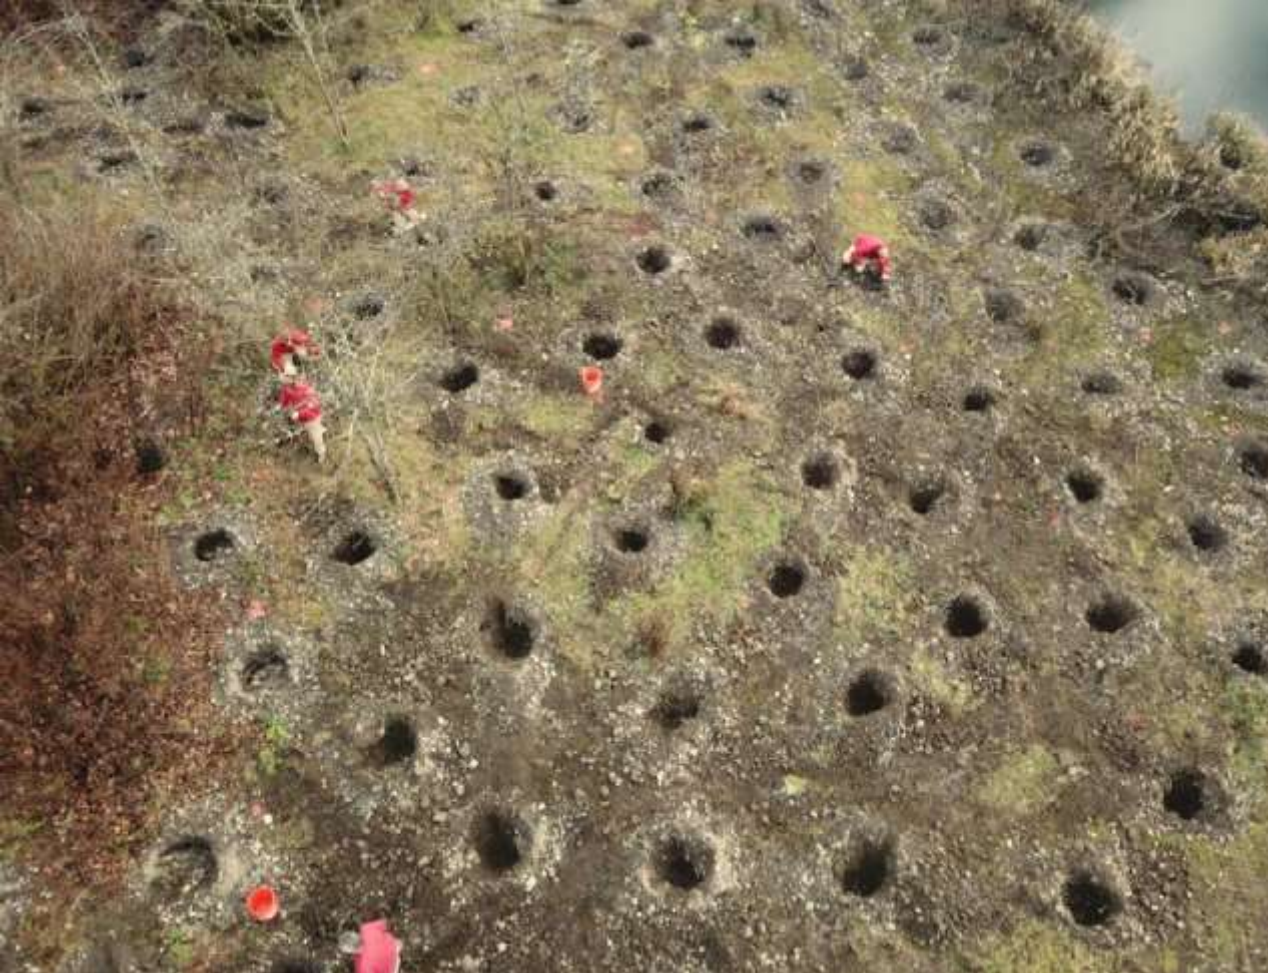
HOLES WERE DUG OUT MANUALLY BY DOC CREWS

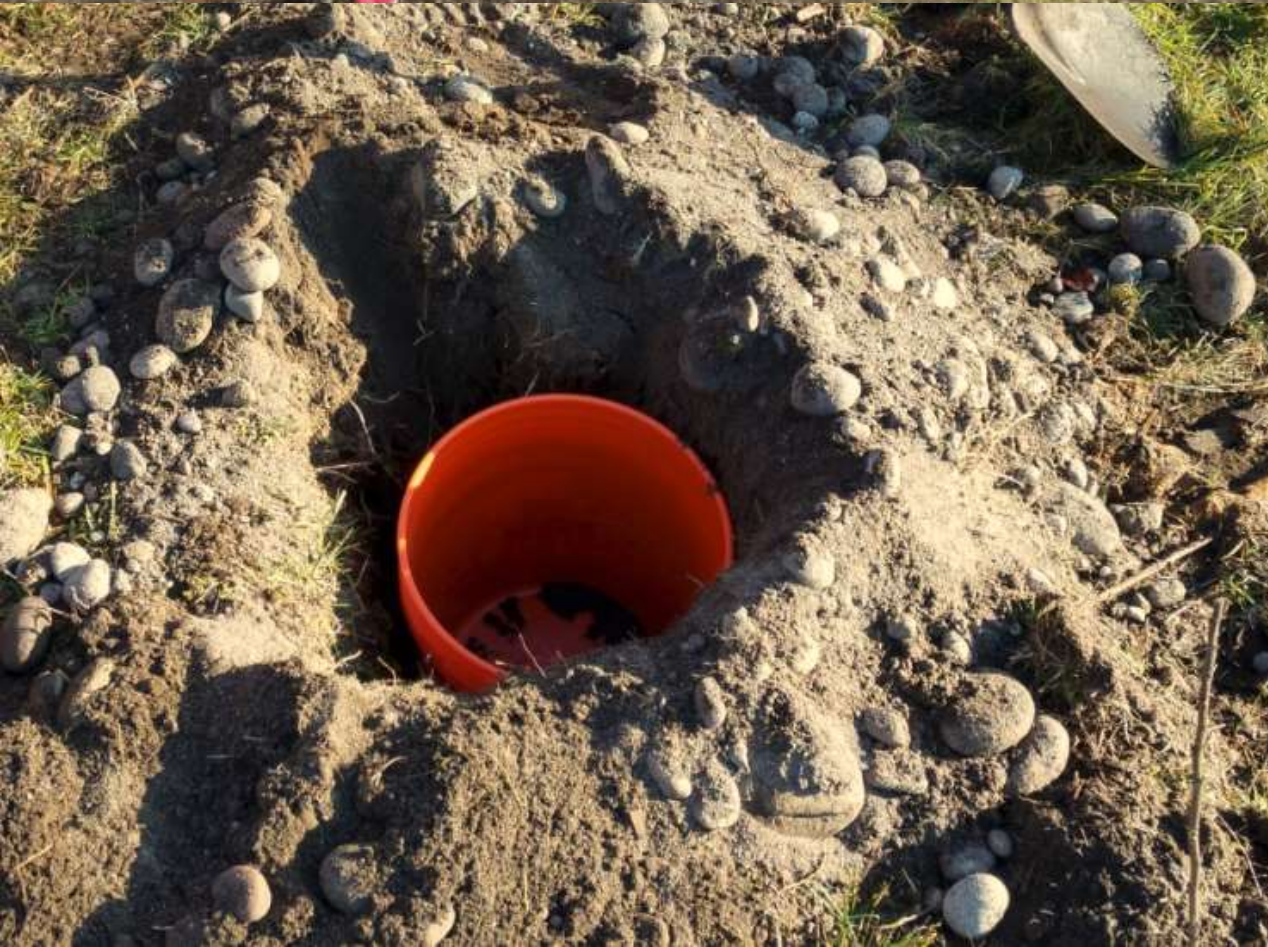
EACH HOLE WAS DUG OUT DEEP AND WIDE ENOUGH TO FIT A 5-GALLON BUCKET. 5 GALLONS OF COMPOST WAS ADDED TO EACH HOLE.

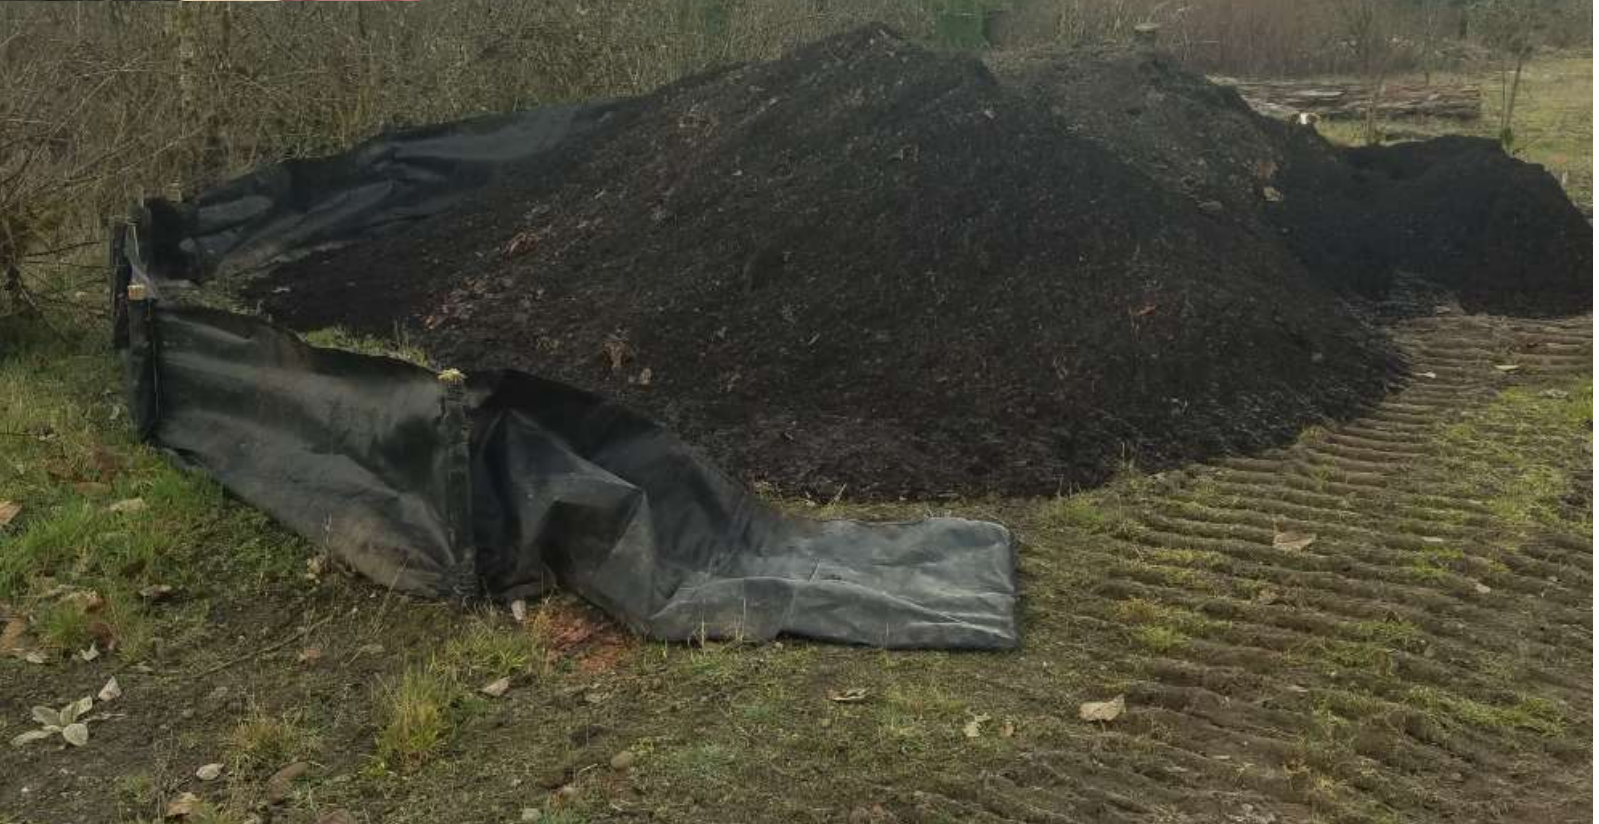
50 YARDS OF COMPOST IMPORTED TO AMEND SOIL

AND MULCH PLANTS

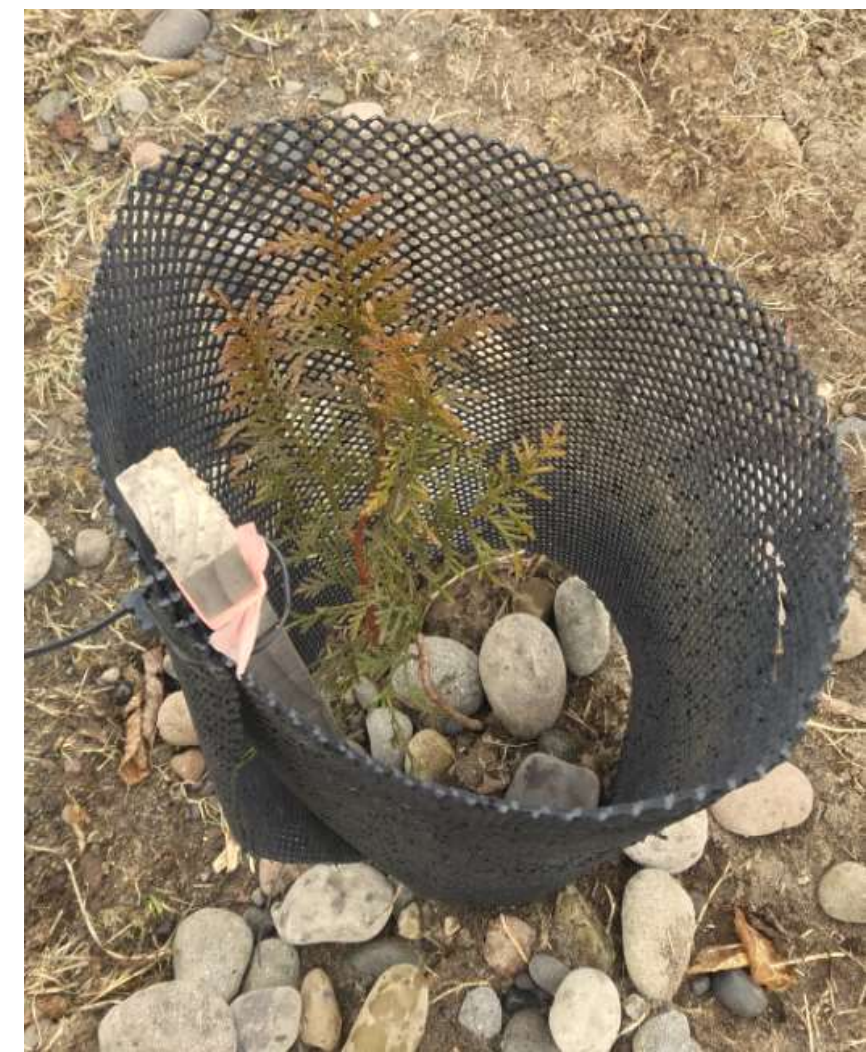
WESTERN RED CEDAR WERE
SHADED AND PROTECTED FROM

DEER BROWSE

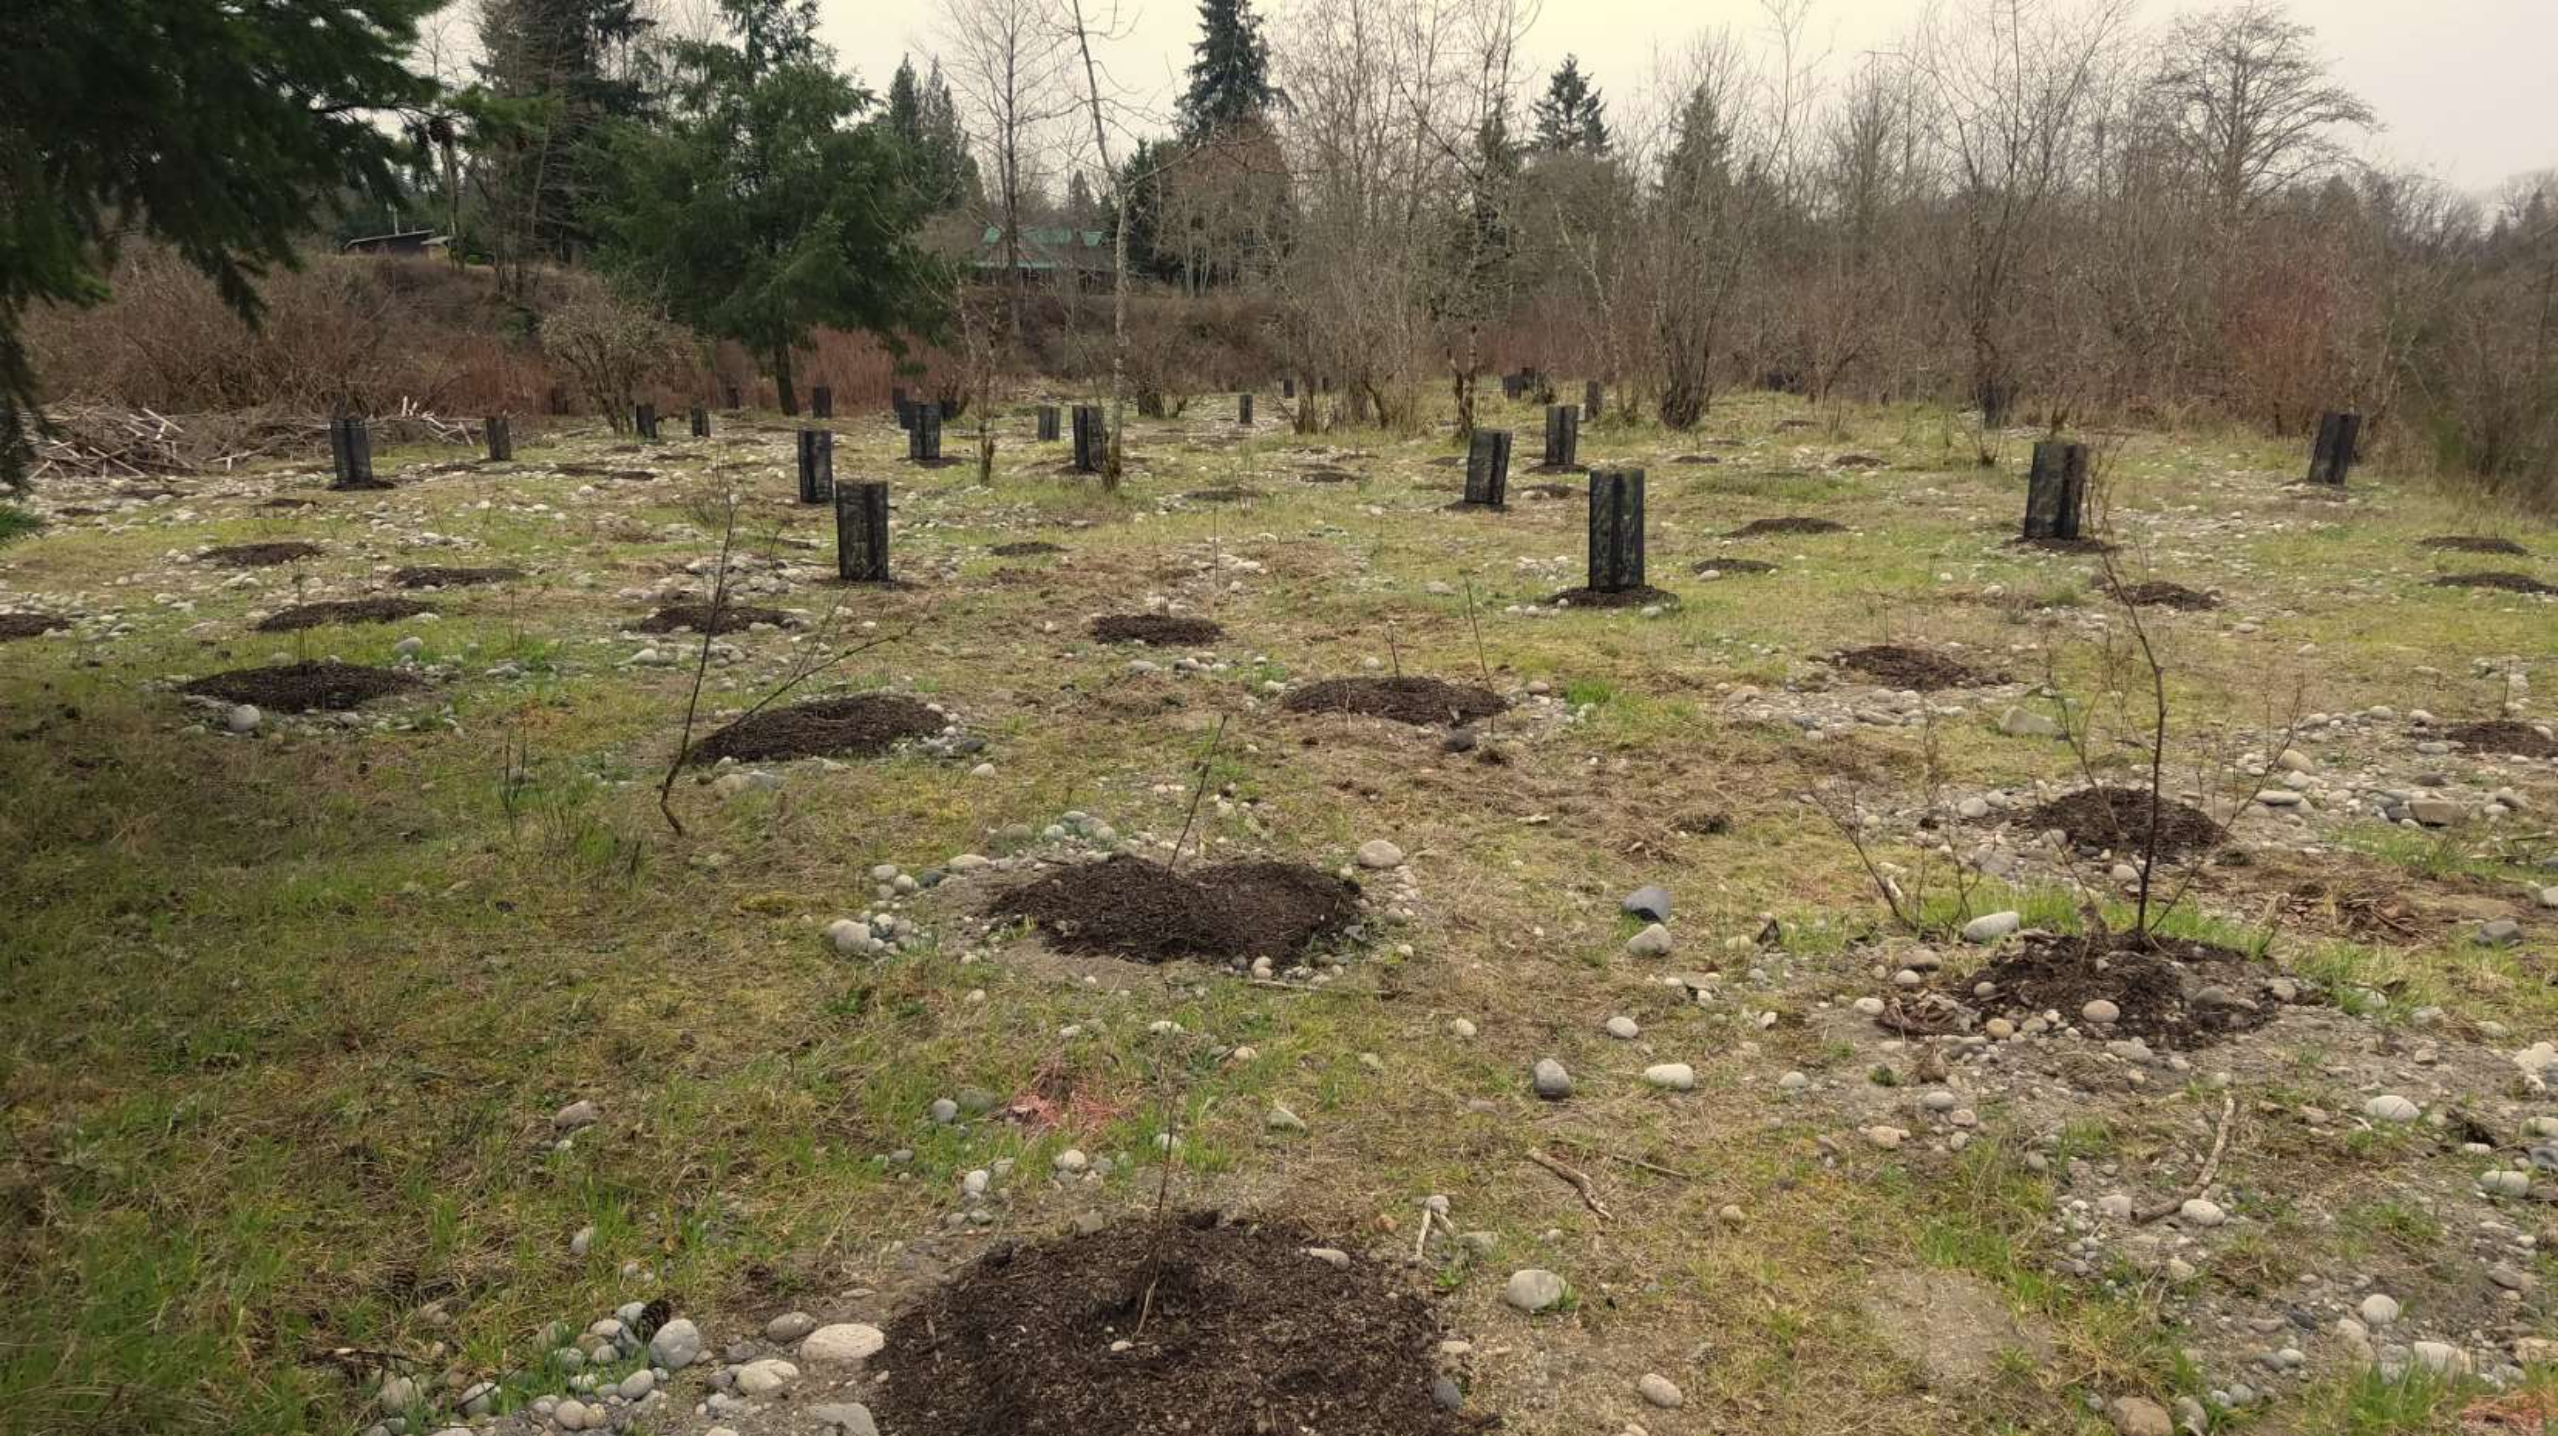
FINAL PRODUCT OF RIPARIAN ENHANCEMENT
