ROLLING 5-YEAR VEGETATION ACTION PLAN CALENDAR YEAR 2012

North Umpqua Hydroelectric Project
FERC Project No. 1927

**2011 ROW Vegetation Management
Completion and Compliance Review Report
North Umpqua Hydroelectric Project (FERC 1927)**

Mitigation and Monitoring Data Form	
Vegetation Management Plan, ACOE and DSL permit compliance, North Umpqua Hydroelectric Project	
Site: Gravel Bin T-line Screening Trees	Date: 8.2.11
Personnel: Steve Albertelli	
Photos (brief description and photo #, if available):	% Aerial Cover:
1. View of trees on the east end of turn-out	N/A
2. View of trees on the west end of turn-out	% Mortality:
3.	Gravel Bin: 10% from 2009 plantings
4.	Augmentation Recommended?
5.	No
6.	Noxious weeds present?
7.	Yes: St. John's wort, blackberry, Queen Anne's lace
8.	Weed Treatment Recommended?
9.	No additional
10.	Weed Treatment Performed?
11.	Yes: removed weeds around base of plantings.
Notes (include any additional information regarding weeds):	
No additional plantings recommended. All of the main trees at Gravel Bin showed new growth at the tips. Most of the plantings are now ~6' tall.

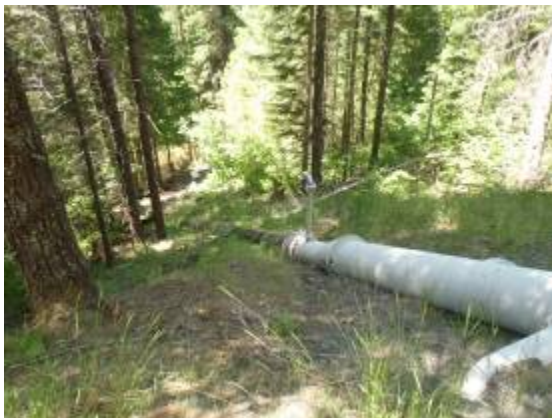
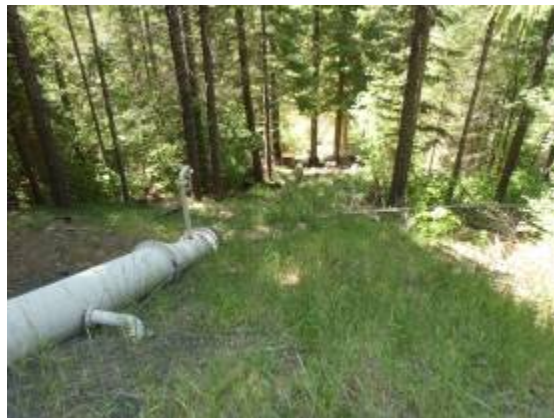
Mitigation and Monitoring Data Form	
Vegetation Management Plan, ACOE and DSL permit compliance, North Umpqua Hydroelectric Project	
Site: FC CSDS Site 1	Date: 7.27.11
Personnel: Steve Albertelli	
Photos (brief description and photo #, if available):	% Aerial Cover:
1. Overview looking west	85
2. Overview looking east	% Mortality:
3.	Original Douglas-fir and pines: 50
4.	Augmentation Recommended?
5.	No
6.	Noxious weeds present?
7.	No
8.	Weed Treatment Recommended?
9.	No
10.	Weed Treatment Performed?
11.	No
Notes (include any additional information regarding weeds):	
Minor improvement from last year. Native recruitment continuing along edges. Still predominantly grasses (i.e. few trees or shrubs). 2012 will be final monitoring year.

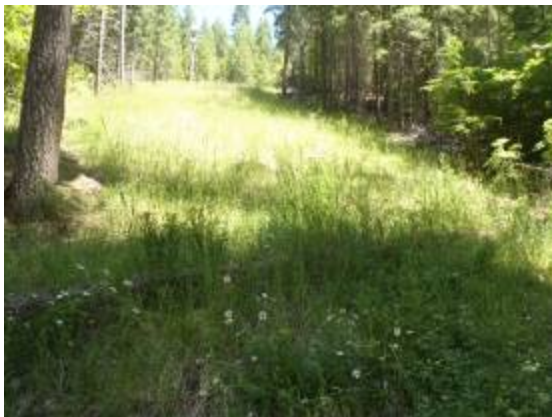
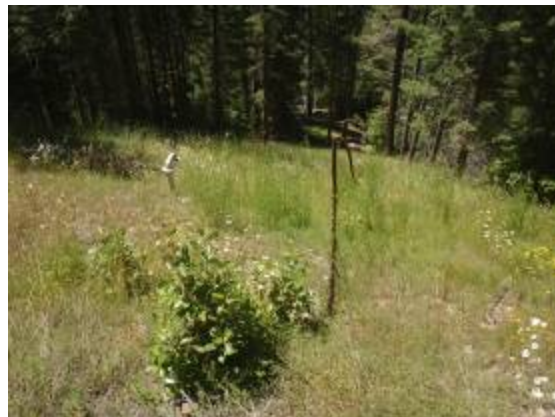
Mitigation and Monitoring Data Form	
Vegetation Management Plan, ACOE and DSL permit compliance, North Umpqua Hydroelectric Project	
Site: FC CSDS Site 2	Date: 7.27.11
Personnel: Steve Albertelli	
Photos (brief description and photo #, if available):	% Aerial Cover:
1. Overview from below	100
2. Overview from above	% Mortality:
3.	No new
4.	Augmentation Recommended?
5.	No
6.	Noxious weeds present?
7.	Yes: <i>Lotus corniculatus</i> , <i>Melilotus alba</i> , oxeye daisy
8.	Weed Treatment Recommended?
9.	No additional
10.	Weed Treatment Performed?
11.	Yes, pulled oxeye daisy.
Notes (include any additional information regarding weeds):	
First year with no thistle. Vigorous alder growth. Pines and Douglas-firs doing good on the lower slope. Madrones persisting on the upper slope. 2012 will be the final monitoring year.

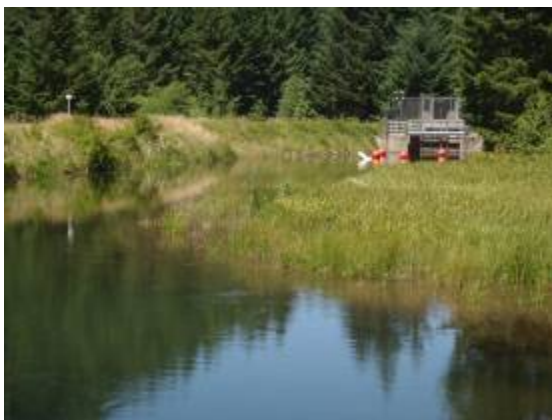
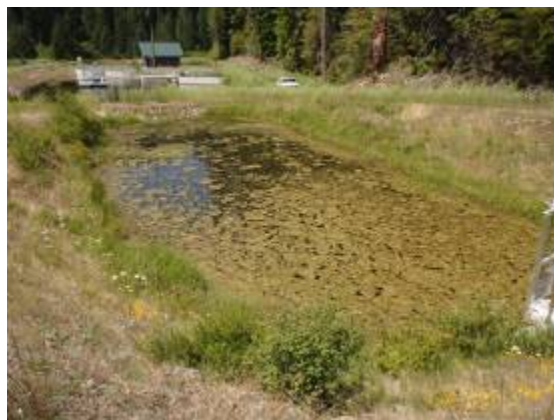
Mitigation and Monitoring Data Form	
Vegetation Management Plan, ACOE and DSL permit compliance, North Umpqua Hydroelectric Project	
Site: FC Screen Ponds and Wetlands	Date: 7.27.11
Personnel: Steve Albertelli	
Photos (brief description and photo #, if available):	% Aerial Cover:
1. Looking west at intake wetland	100
2. Overview of pond, looking west	% Mortality:
3.	0
4.	Augmentation Recommended?
5.	No
6.	Noxious weeds present?
7.	No
8.	Weed Treatment Recommended?
9.	No
10.	Weed Treatment Performed?
11.	No
Notes (include any additional information regarding weeds):	
<i>Melilotus</i> explosion on adjacent roads. Wetland emergents thriving. <i>Carex</i> and <i>Glyceria</i> progressing out onto shallow shelf. 2012 will be the final monitoring period.

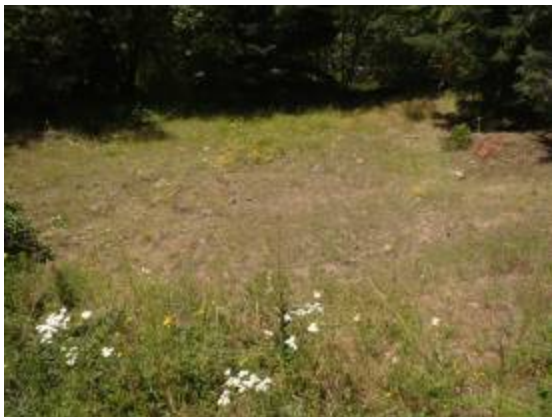
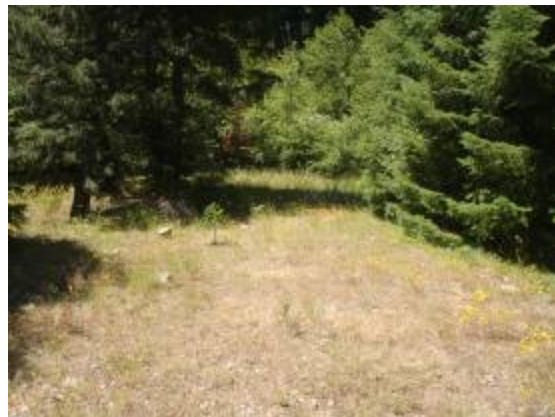
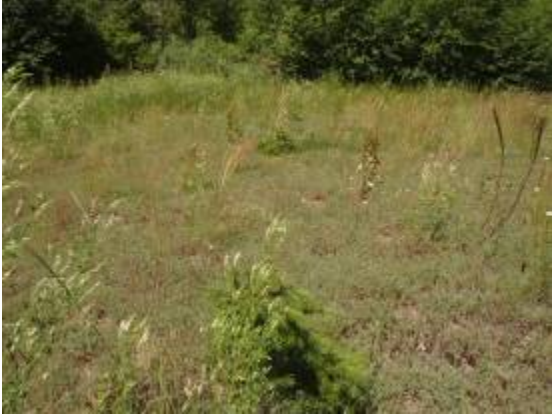
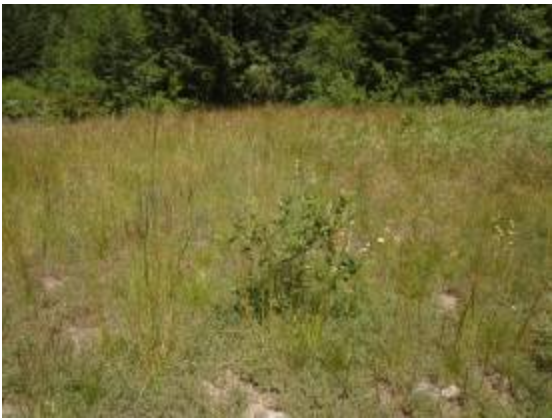
Mitigation and Monitoring Data Form	
Vegetation Management Plan, ACOE and DSL permit compliance, North Umpqua Hydroelectric Project	
Site: FC Screen Staging Areas	Date: 7.27.11
Personnel: Steve Albertelli	
Photos (brief description and photo #, if available):	% Aerial Cover:
1. Overview of northern-most pad	Average 75%
2. Looking east at old roadbed	% Mortality:
3. Overview of middle staging area	Cedars 100%, D-f 50%, Other 10%
4. Overview of southern-most pad adjacent to river	Augmentation Recommended?
5.	Yes, additional plantings
6.	Noxious weeds present?
7.	Yes, bull thistle
8.	Weed Treatment Recommended?
9.	No additional
10.	Weed Treatment Performed?
11.	Yes, pulled thistle
Notes (include any additional information regarding weeds):	
<i>Melilotus</i> is back. <i>Lotus unifoliolatus</i> still present. <i>Rumex</i> in center pad. Alders and Douglas-firs persisting.

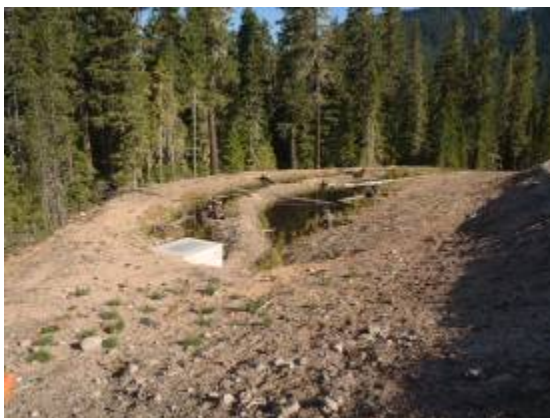
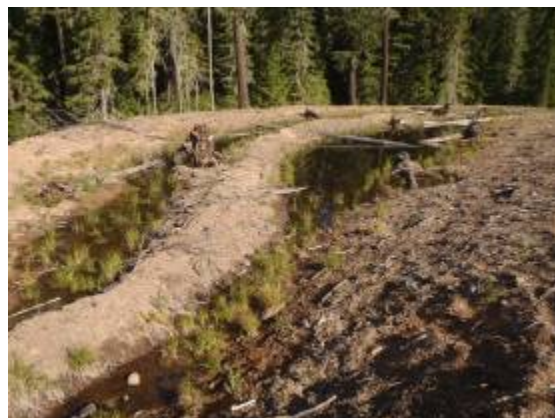
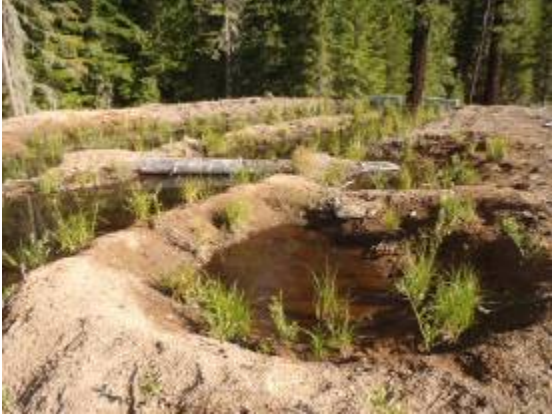
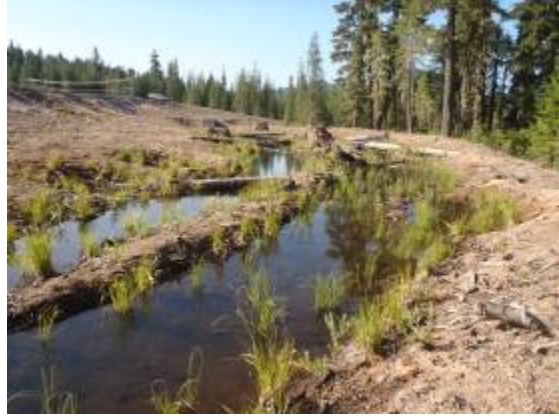
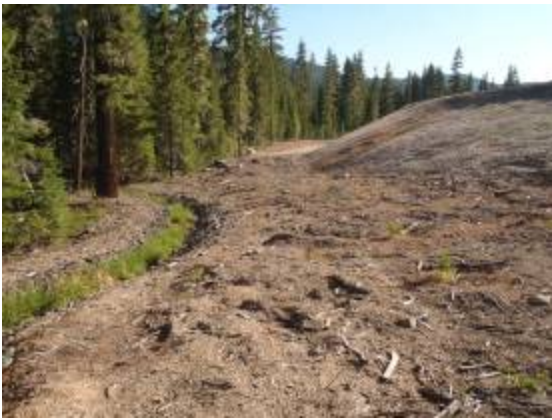
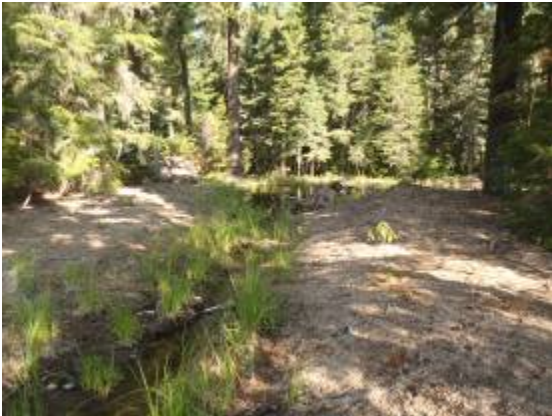
Mitigation and Monitoring Data Form	
Vegetation Management Plan, ACOE and DSL permit compliance, North Umpqua Hydroelectric Project	
Site: Lemolo 1 Forebay Wetland	7.27.11
Personnel: Steve Albertelli	
Photos (brief description and photo #, if available):	% Aerial Cover:

1. Overview looking north from road	Wetland areas 30%, Upland 5%
2. Detail of looking north from weir	% Mortality:
3. Detail of emergents in micro-depression	Pines 50%, Alder/Willow 5%, Df/Hemlock 30%, Emergents <5%

4. Looking north at transition swale	Augmentation Recommended?
5. Looking west at swale and overflow	No
6. Detail looking south from weir	Noxious weeds present?

7.	No
8.	Weed Treatment Recommended?
9.	No
10.	Weed Treatment Performed?
11.	No
Notes (include any additional information regarding weeds):	
Emergents and wetland scrub/shrub doing great for year one. Significant bare ground in upland. Lupine doing great. Upland mortality similar to adjacent forebay disturbed area.

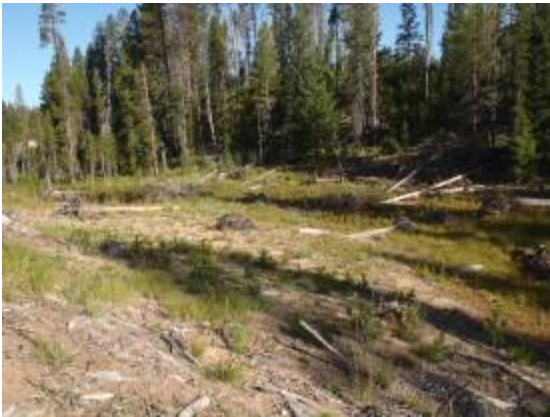
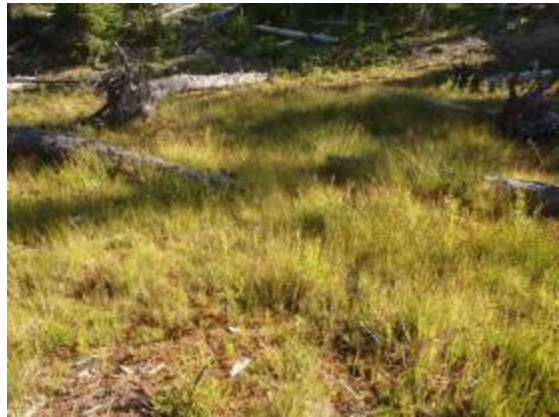
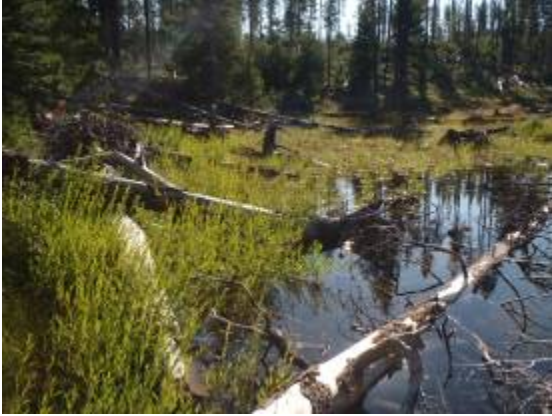
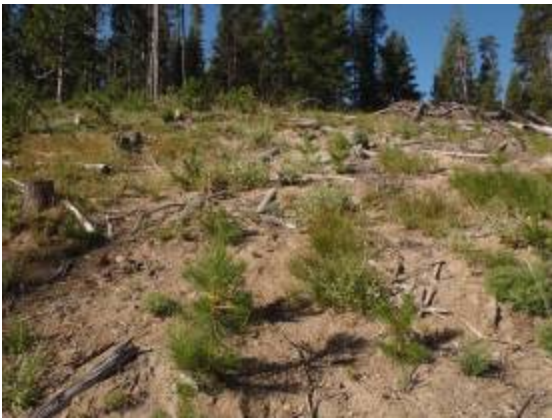
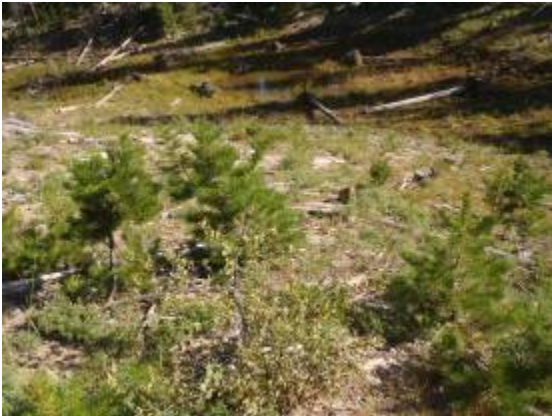
Mitigation and Monitoring Data Form	
Vegetation Management Plan, ACOE and DSL permit compliance, North Umpqua Hydroelectric Project	
Site: Lemolo Lake Wetland	Date: 8.17.11
Personnel: Steve Albertelli	
Photos (brief description and photo #, if available):	% Aerial Cover:

1. Overview from above	Wetland areas 100%, Upland 45%
2. Detail of wetland between upper ponds	% Mortality:
3. Looking south at lower pond	5%
4. Detail of uplands from below	Augmentation Recommended?

5. Detail of uplands from above	No
6.	Noxious weeds present?
7.	No
8.	Weed Treatment Recommended?
9.	No
10.	Weed Treatment Performed?
11.	No
Notes (include any additional information regarding weeds):	
First year of good progress in the upland areas. Lupine, <i>Ribes</i> , pines, spruces, et al. are thriving. Attention given to willows, aspens and other transitional species has been beneficial. Wetland emergents are established and supporting amphibian breeding.

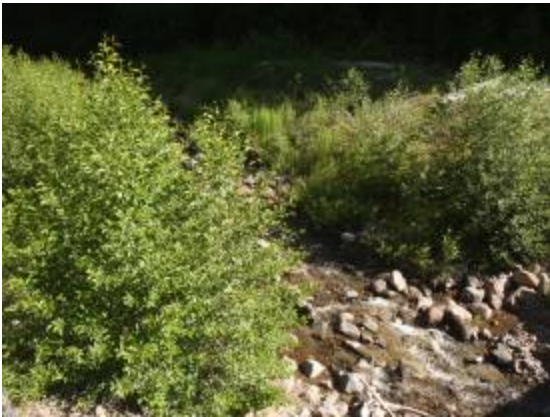
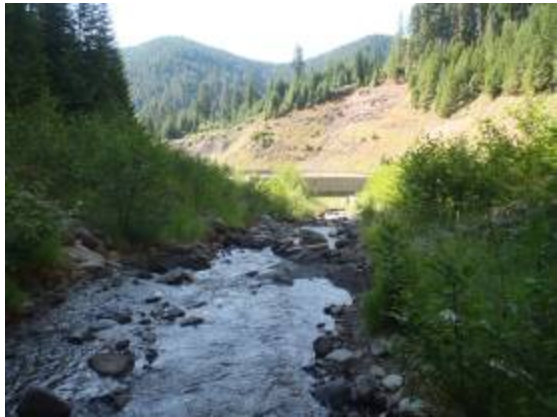
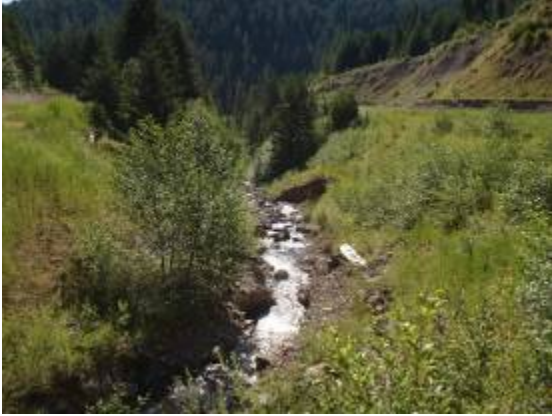
Mitigation and Monitoring Data Form	
Vegetation Management Plan, ACOE and DSL permit compliance, North Umpqua Hydroelectric Project	
Site: Potter Creek	7.27.11
Personnel: Steve Albertelli	
Photos (brief description and photo #, if available):	% Aerial Cover:
1. Overview looking upstream from road	100
2. Looking downstream toward canal	% Mortality:
3. Looking downstream from road	No additional
4.	Augmentation Recommended?
5.	No
6.	Noxious weeds present?
7.	Yes, bull thistle
8.	Weed Treatment Recommended?
9.	No additional
10.	Weed Treatment Performed?
11.	Yes, pulled thistle
Notes (include any additional information regarding weeds):	
Weeds from years past scoured and/or buried after high flows. Alders thriving and providing shade for creek. Final year of monitoring. No additional maintenance required.

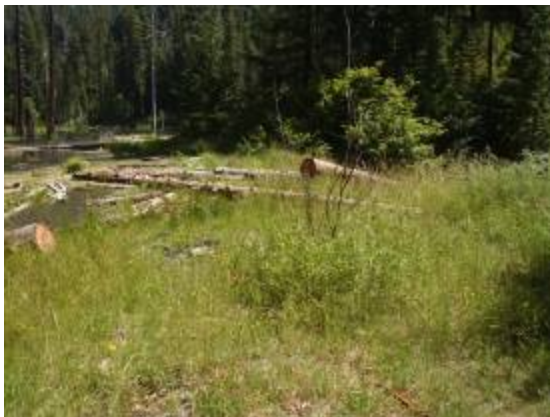
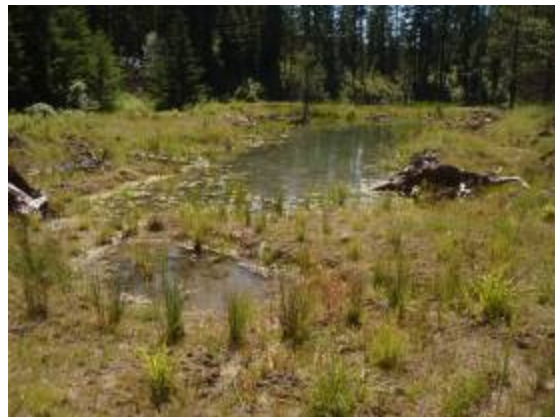
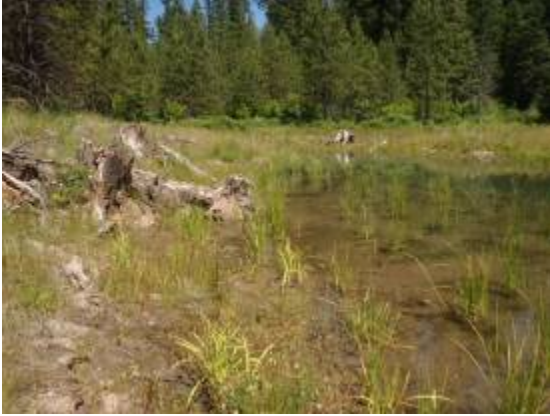
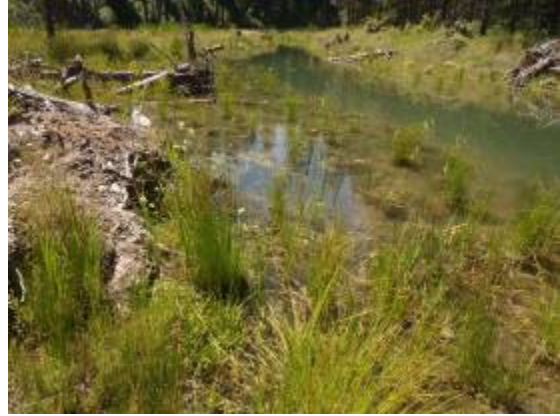
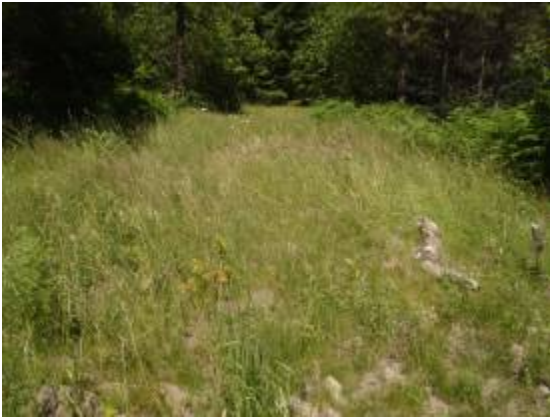
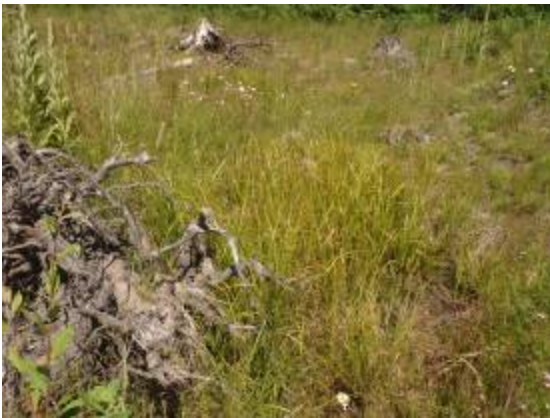
Mitigation and Monitoring Data Form	
Vegetation Management Plan, ACOE and DSL permit compliance, North Umpqua Hydroelectric Project	
Site: Ranawapiti	7.27.11
Personnel: Steve Albertelli	
Photos (brief description and photo #, if available):	% Aerial Cover:

1. Looking south at willows on dam	Average 90%
2. Overview looking southwest	% Mortality:
3. Detail of north bank looking east	Conifers 50%, Other 0%
4. Looking east at decommissioned road	Augmentation Recommended?

5. Detail of emergents in micro-depression	Yes, willow stakes and alders
6. Overview looking northwest	Noxious weeds present?
7.	Yes, bull thistle, Canada thistle, <i>Lotus</i> spp., St. John's wort

8.	Weed Treatment Recommended?
9.	Yes
10.	Weed Treatment Performed?
11.	Some, pulled thistle
Notes (include any additional information regarding weeds):	
Vegetation filling in during year two; no more bare slopes. Grass augmentation was helpful. Emergents are thriving and filling in areas with lower relative WSEL. Needs augmentation of tree/shrub height classes.

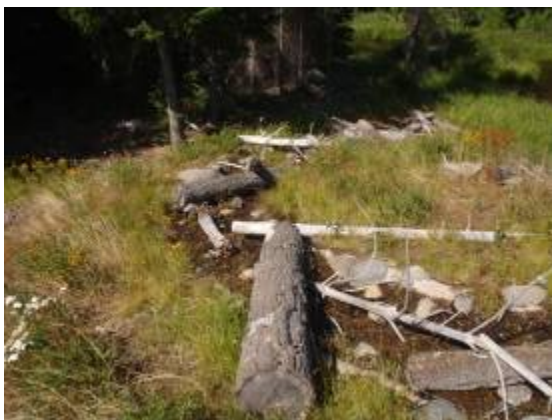
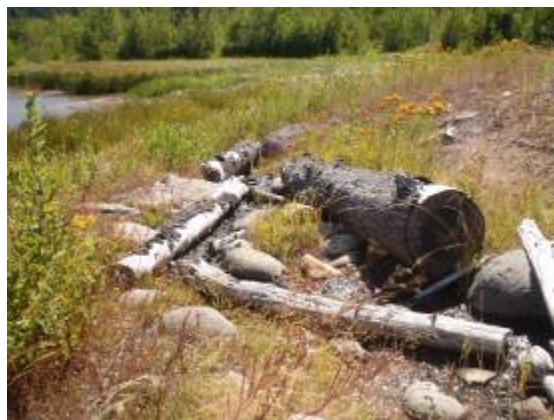
Mitigation and Monitoring Data Form	
Vegetation Management Plan, ACOE and DSL permit compliance, North Umpqua Hydroelectric Project	
Site: Stump Lake Connectivity Ramp	8.17.11
Personnel: Steve Albertelli	
Photos (brief description and photo #, if available):	% Aerial Cover:
1. Downstream side from the top of dam	80
2. Upstream side from the top of the dam	% Mortality:
3.	0
4.	Augmentation Recommended?
5.	No
6.	Noxious weeds present?
7.	Yes, St. John's wort
8.	Weed Treatment Recommended?
9.	No
10.	Weed Treatment Performed?
11.	No
Notes (include any additional information regarding weeds):	
More paintbrush, thimbleberry, and blackcap filling in this year. Continued growth of emergents/in-channel plantings. Looks good overall.

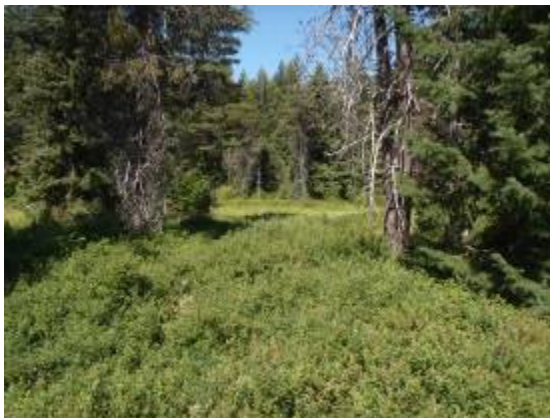
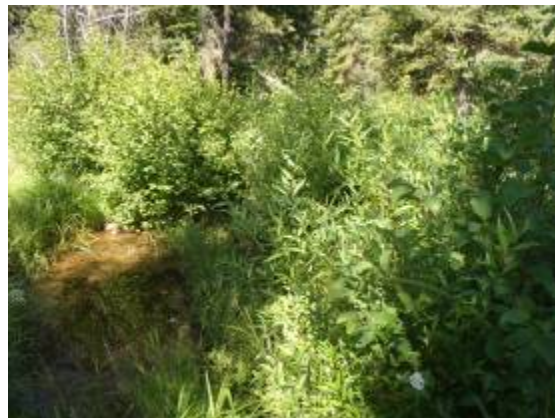
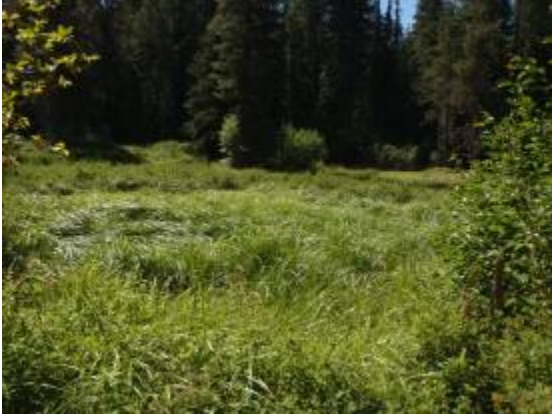
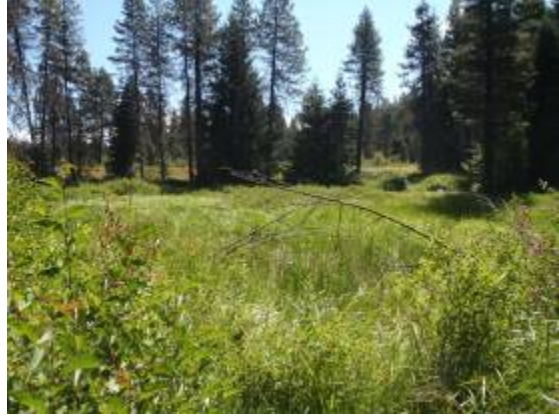
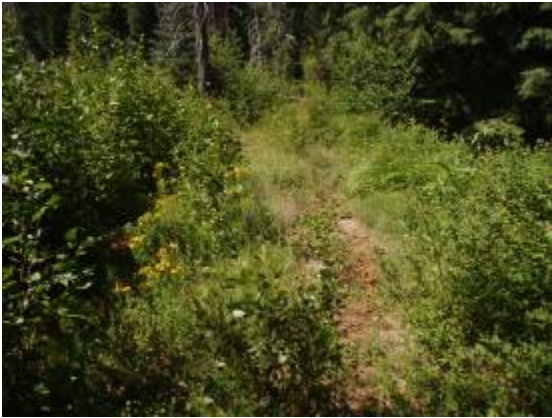
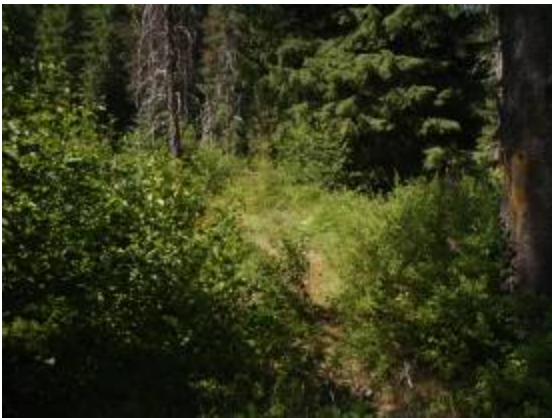
Mitigation and Monitoring Data Form	
Vegetation Management Plan, ACOE and DSL permit compliance, North Umpqua Hydroelectric Project	
Site: Stump Lake Wetland	8.17.11
Personnel: Steve Albertelli	
Photos (brief description and photo #, if available):	% Aerial Cover:
1. Overview from north	Wetland 100%, Clay cap/road 75%
2. Willow and alders at north weir	% Mortality:
3. Overview from west	No new
4. Northern cap/road segment	Augmentation Recommended?
5. Middle cap/road segment	No
6. Overview from south	Noxious weeds present?
7.	Yes, bull thistle
8.	Weed Treatment Recommended?
9.	Yes
10.	Weed Treatment Performed?
11.	Yes, pulled thistle
Notes (include any additional information regarding weeds):	
Wetland maturing. Alder, Manzanita, and pines on cap/road are growing. Vegetation targets achieved. Final year of monitoring.

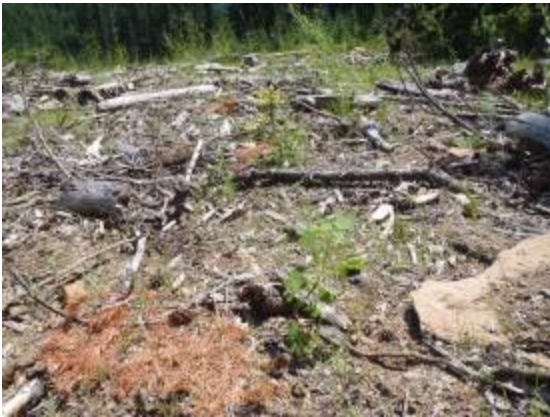
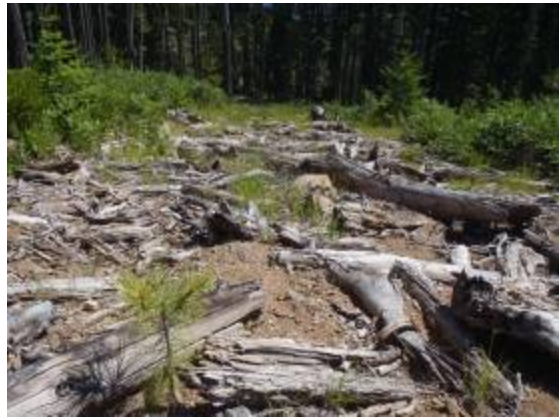
Mitigation and Monitoring Data Form	
Vegetation Management Plan, ACOE and DSL permit compliance, North Umpqua Hydroelectric Project	
Site: Watson Ridge	8.17.11
Personnel: Steve Albertelli	
Photos (brief description and photo #, if available):	% Aerial Cover:
1. View of cable ROW from lower road	10
2. View of cable ROW from comm. tower road	% Mortality:
3.	10
4.	Augmentation Recommended?
5.	No
6.	Noxious weeds present?
7.	No
8.	Weed Treatment Recommended?
9.	No
10.	Weed Treatment Performed?
11.	No
Notes (include any additional information regarding weeds):	
Limited grass growth due to heavy slash treatment on ROW. Soils stabilized. Plantings persisting, but could use fertilizer treatment.

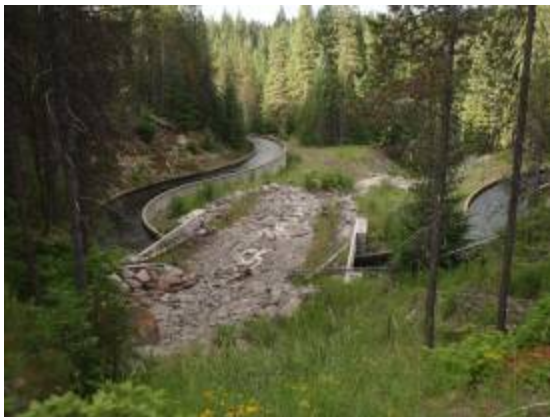
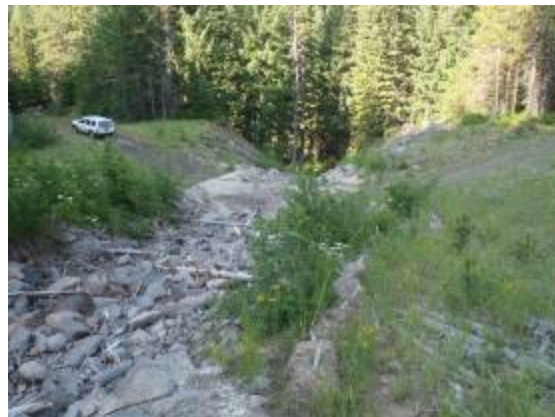
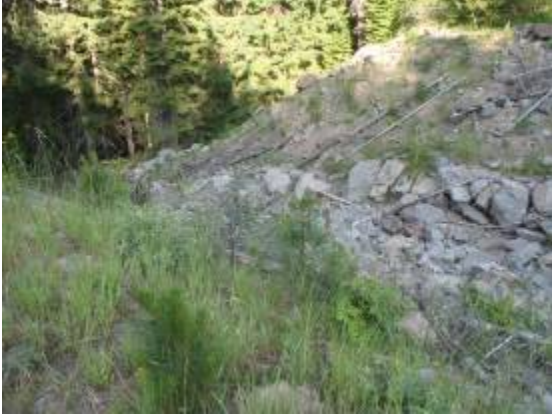
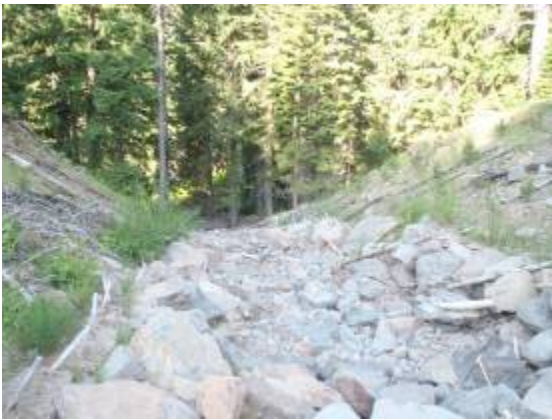
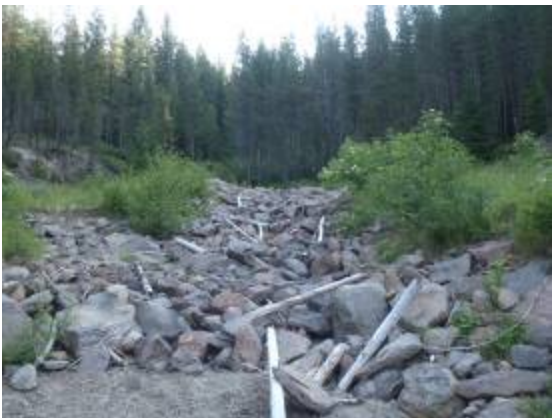
Mitigation and Monitoring Data Form	
Vegetation Management Plan, ACOE and DSL permit compliance, North Umpqua Hydroelectric Project	
Site: White Mule Creek	7.27.11
Personnel: Steve Albertelli	
Photos (brief description and photo #, if available):	% Aerial Cover:
1. Overview from Bird's Point Road	85
2. Detail of riparian plantings	% Mortality:
3. Looking southwest from downstream side of road	0
4. Downstream channel from canal road	Augmentation Recommended?
5. Upstream channel from canal road	No
6.	Noxious weeds present?
7.	Yes, St. John's wort, oxeye daisy
8.	Weed Treatment Recommended?
9.	No
10.	Weed Treatment Performed?
11.	No
Notes (include any additional information regarding weeds):	
Strong growth this year. Additional cover on problematic downstream side of road. Elderberry, alder and pines doing great. 2012 will be final monitoring year.
