Figure 1. Assessment area.

Figure 2. Four priority enhancement sites identified by the Technical Work Group.

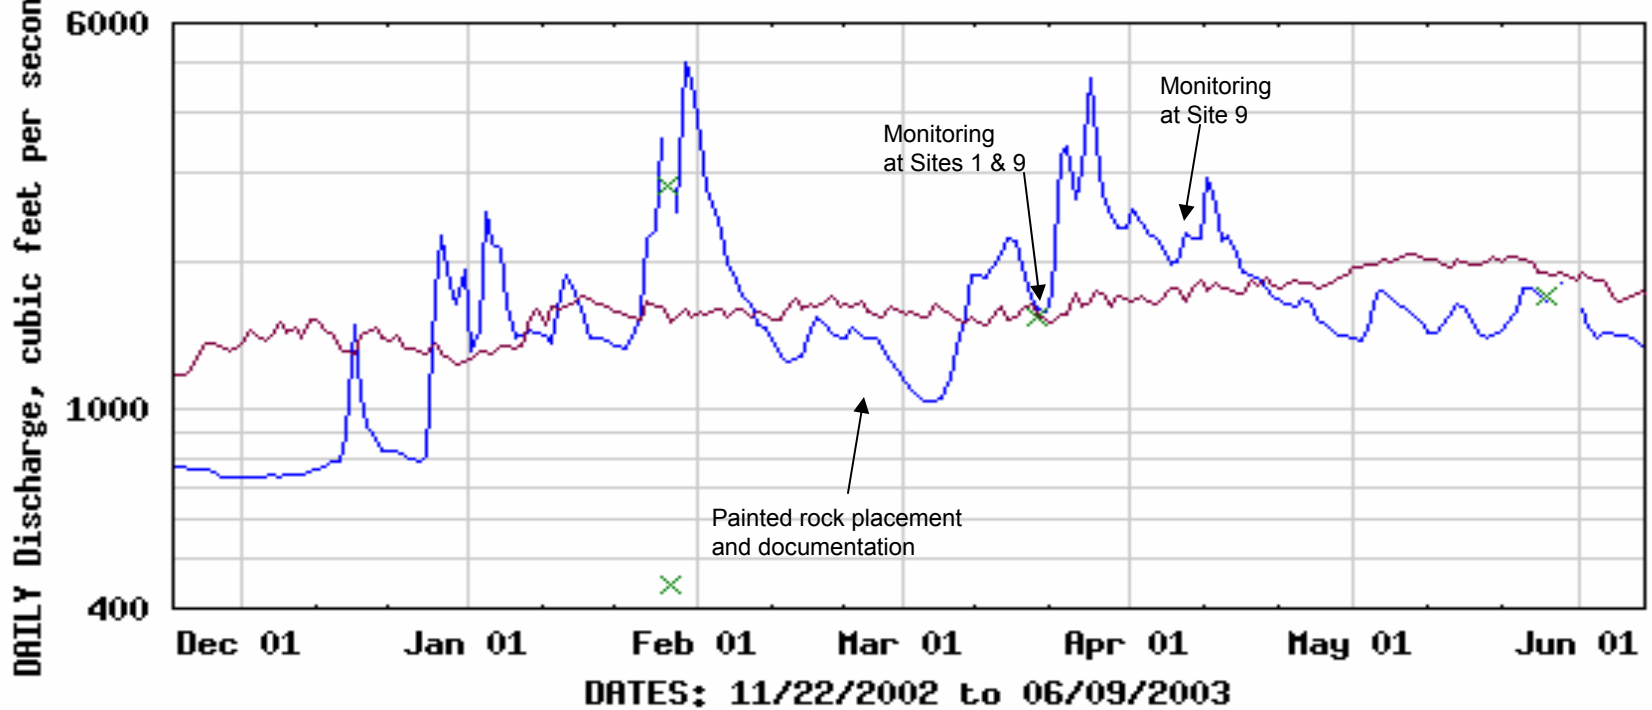
USGS 14316500 N LMPQUA RIVER ABV COPELAND CK NR TOKETEE FALLS, OR

— **DAILY MEAN DISCHARGE**

— **MEDIAN DAILY STREAMFLOW BASED ON 52 YEARS OF RECORD**

× **MEASURED Discharge**

Figure 3. USGS hydrograph of daily mean discharge at the Copeland gage, indicating when painted rocks at Sites 1 and 9 were placed and monitored.

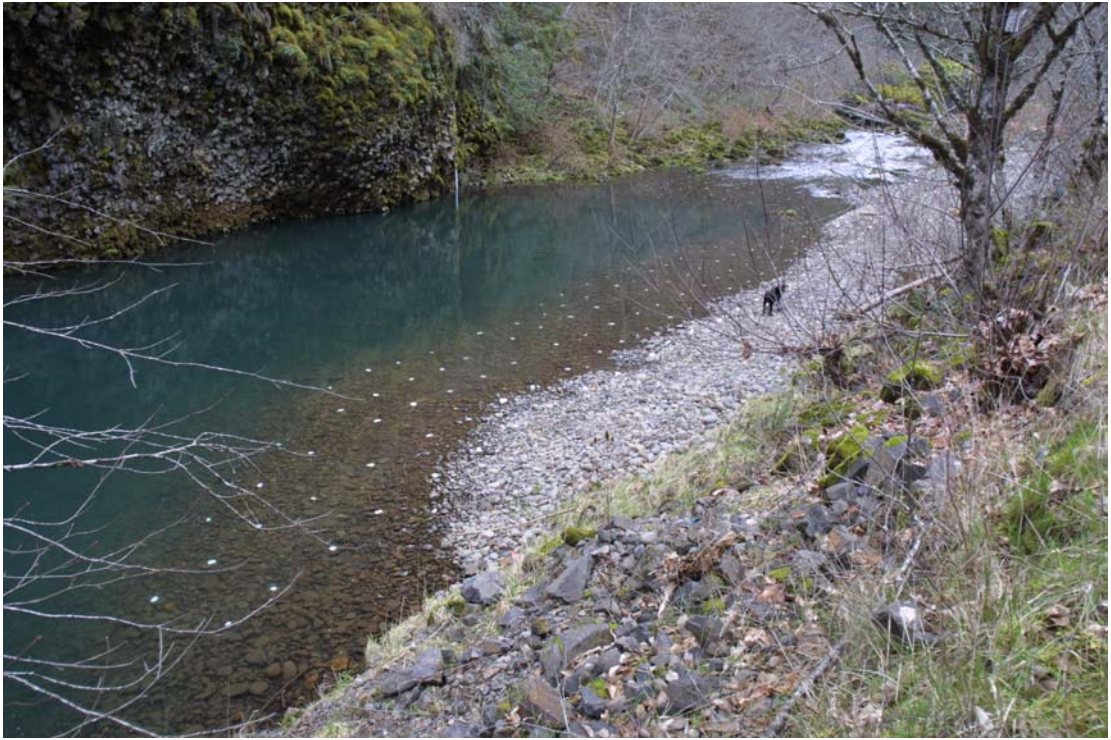
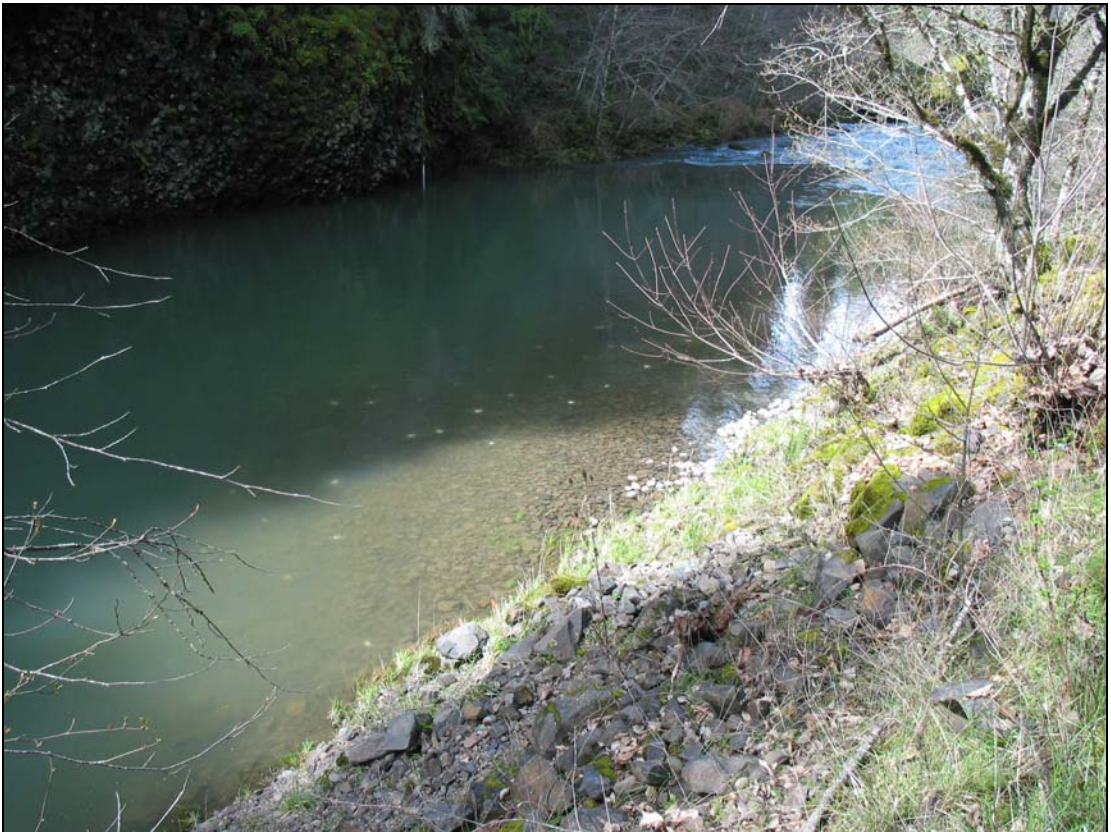
26 February 2003, installation of painted rocks

7 April 2003, monitoring of painted rocks

Figure 4. Site 1a from photo point 1 during winter and spring 2003.

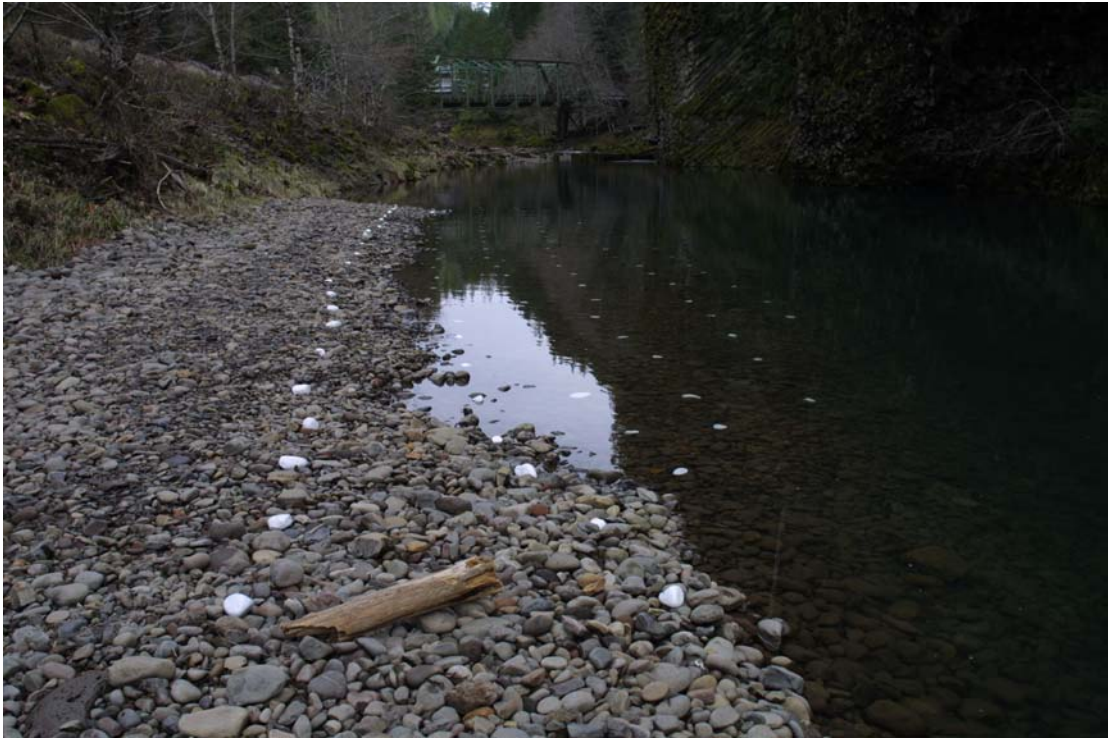
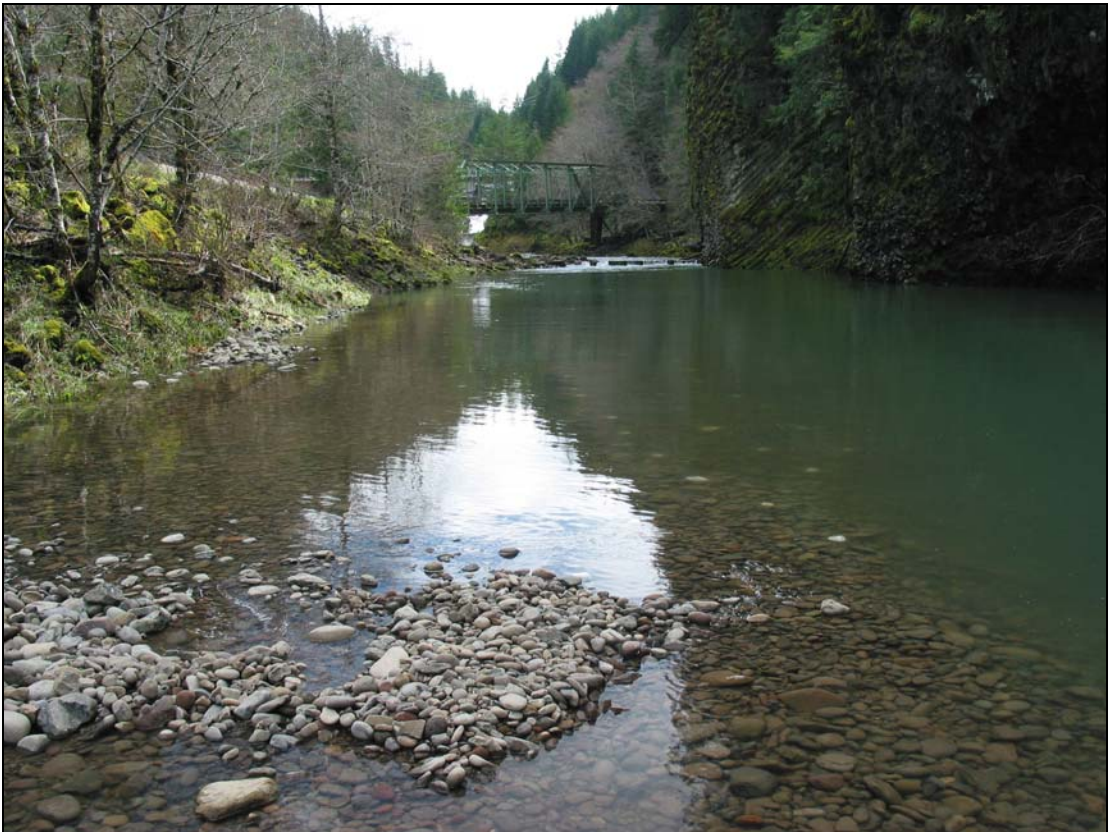
26 February 2003, installation of painted rocks

7 April 2003, monitoring of painted rocks

Figure 5. Site 1a from photo point 4 during winter and spring 2003.

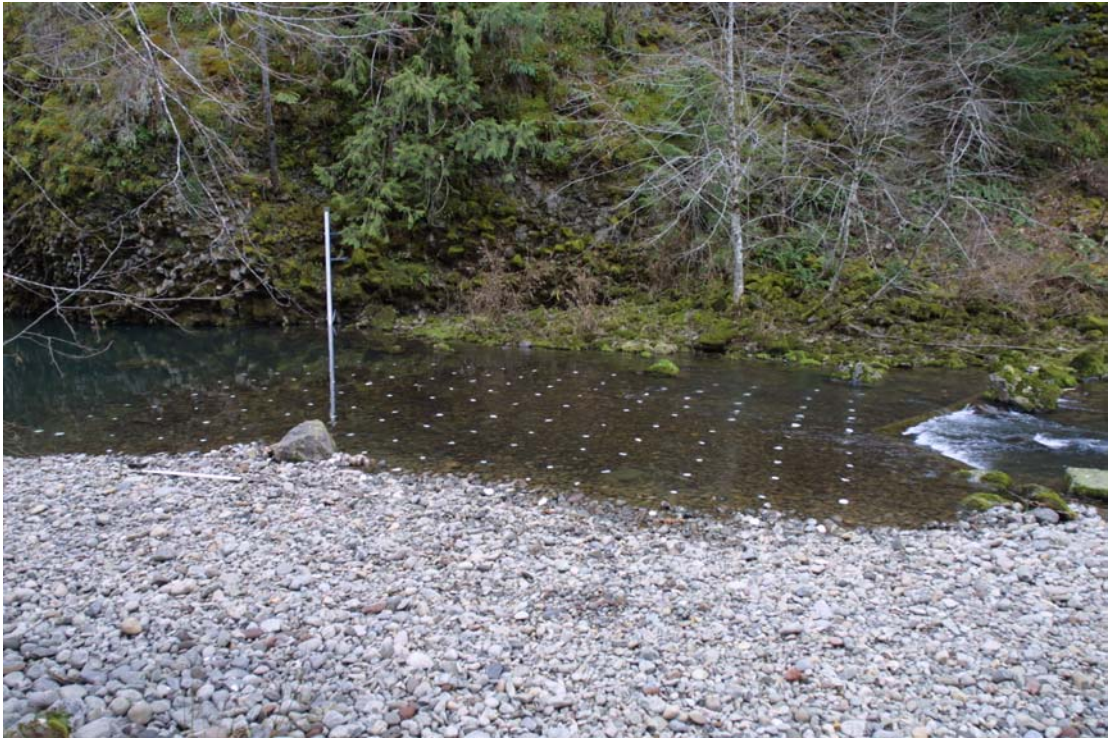
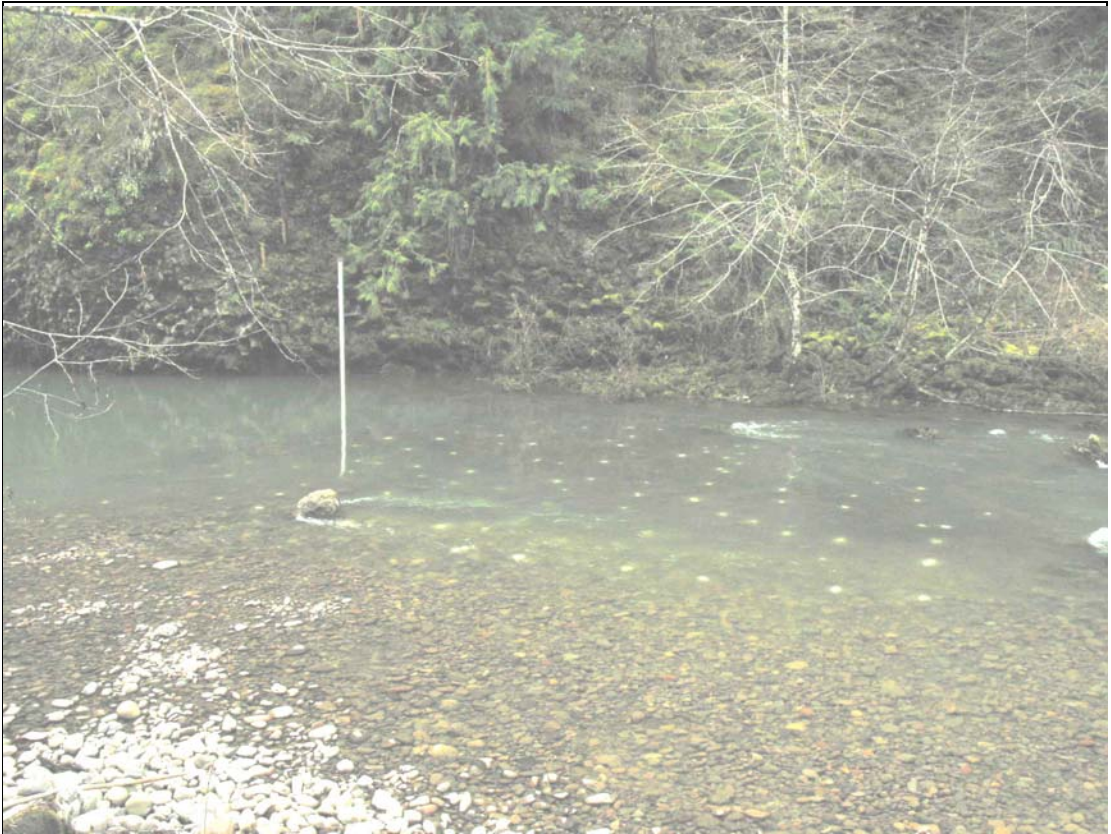
26 February 2003, installation of painted rocks

7 April 2003, monitoring of painted rocks

Figure 7. Site 1b from photo point 2 during winter and spring 2003.

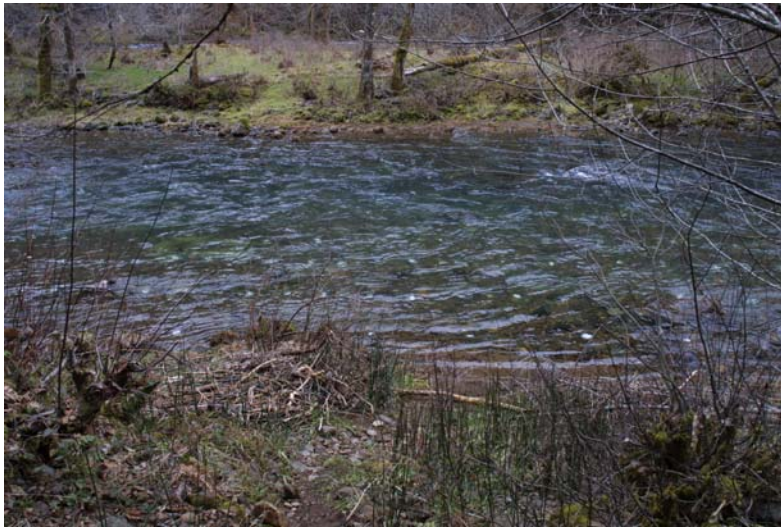
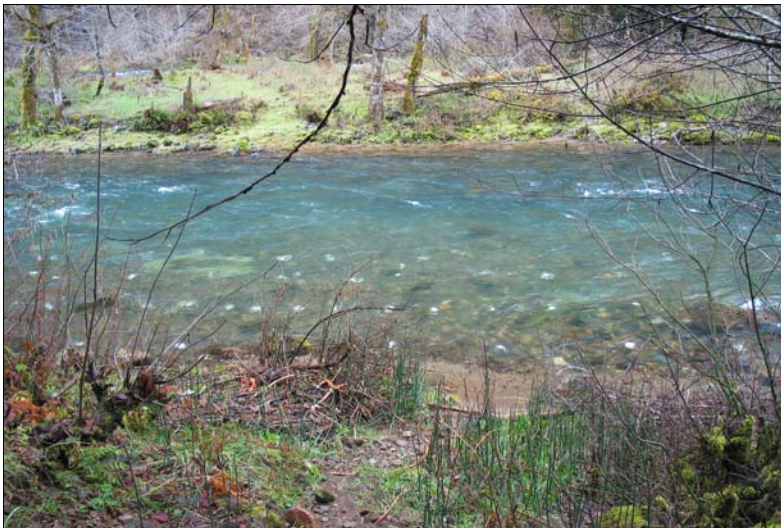
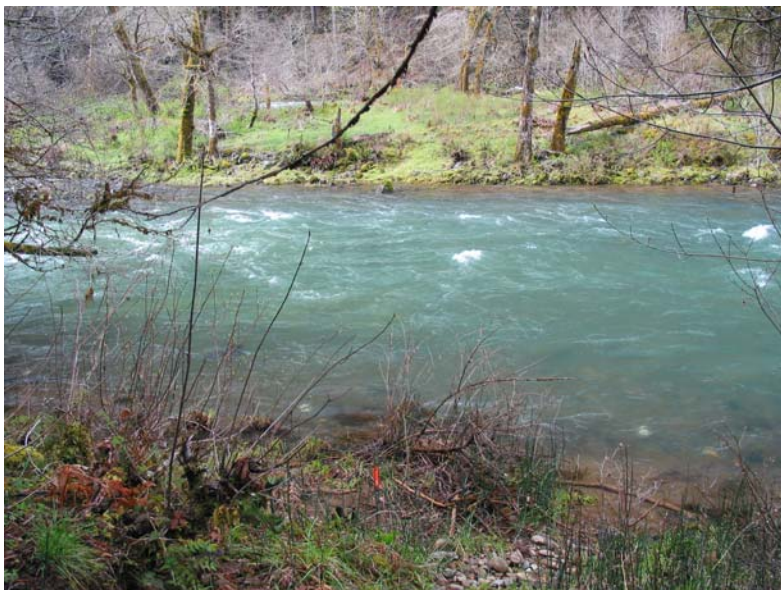
*26 February 2003
installation of painted rocks*

*20 March 2003
monitoring of painted rocks*

*7 April 2003
monitoring of painted rocks*

Figure 9. Site 9 from photo point 1 during winter and spring 2003.

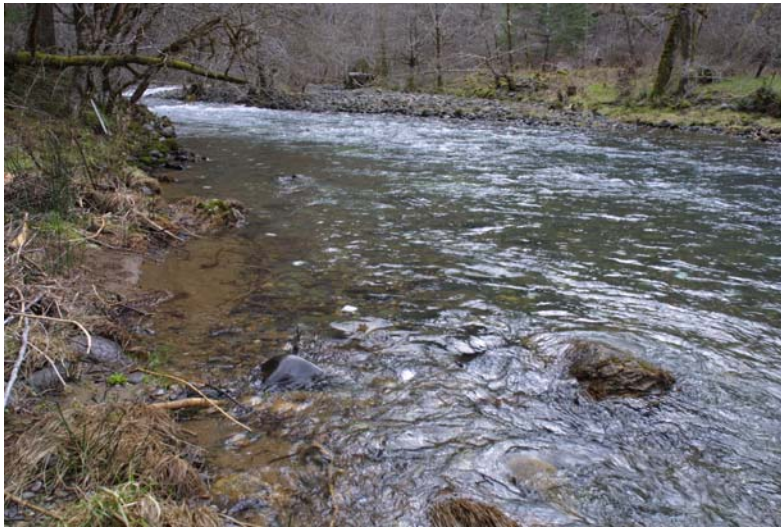
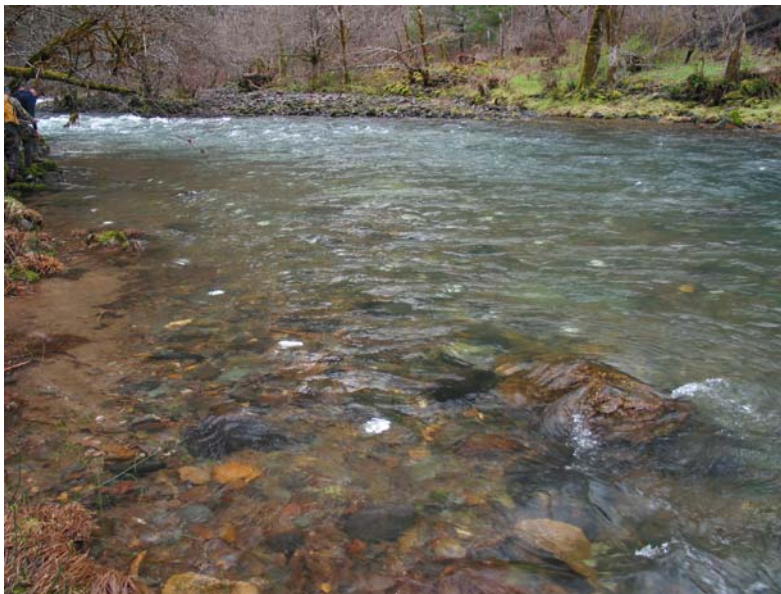
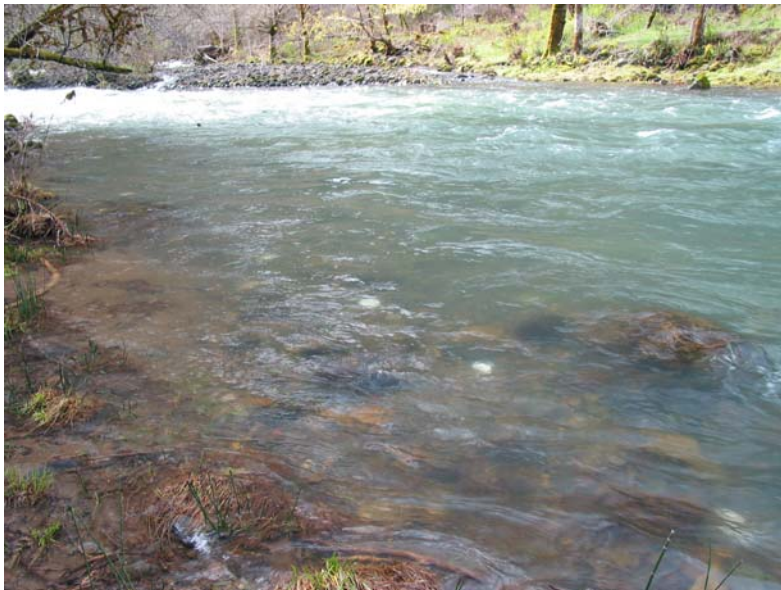
*26 February 2003
installation of painted rocks*

*20 March 2003
monitoring of painted rocks*

*7 April 2003
monitoring of painted rocks*

Figure 10. Site 9 from photo point 5 during winter and spring 2003.

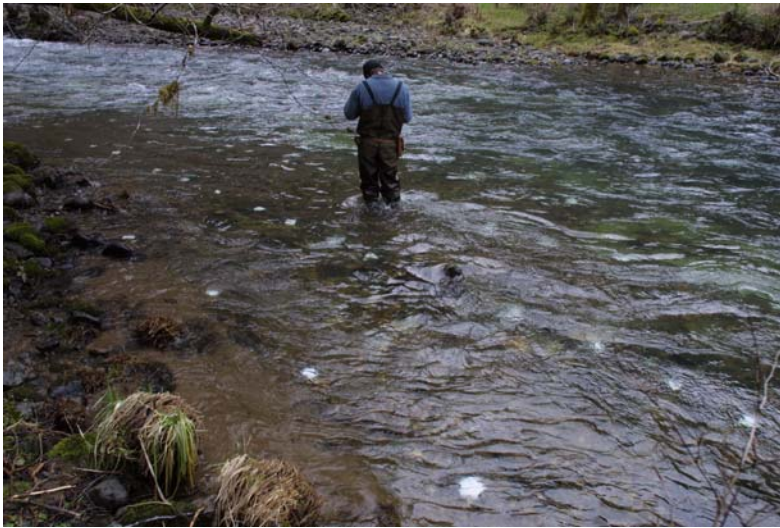
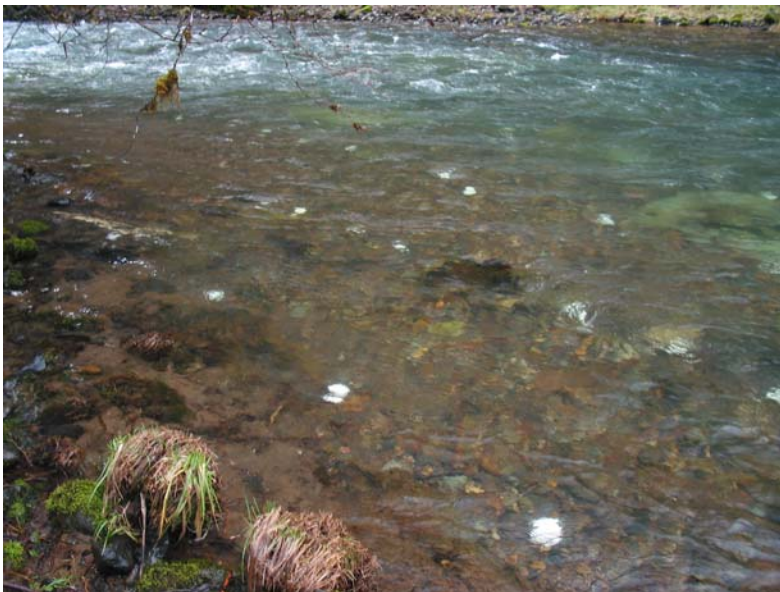
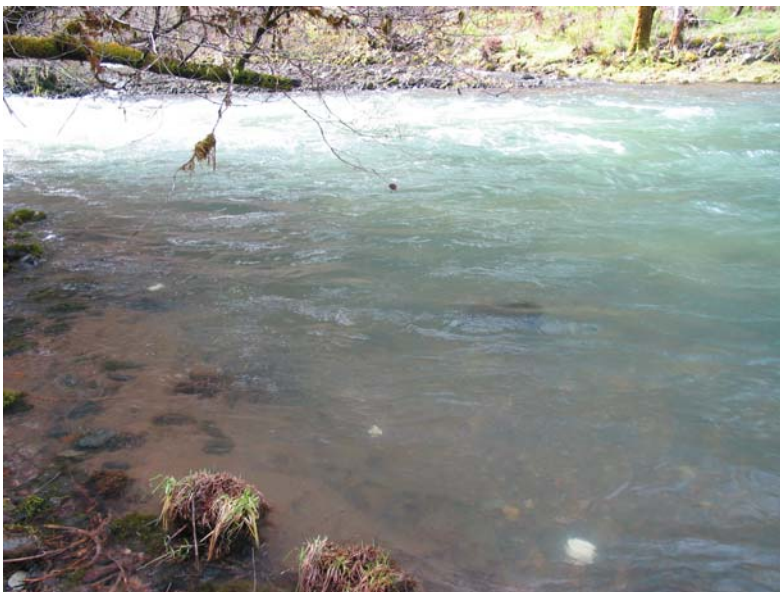
*26 February 2003
installation of painted rocks*

*20 March 2003
monitoring of painted rocks*

*7 April 2003
monitoring of painted rocks*

Figure 11. Site 9 from photo point 4 during winter and spring 2003.
