# Bear River Hydroelectric Project

*FERC Project No. P-20*

## 2018 Annual Report

*Summary of License Implementation and Compliance*

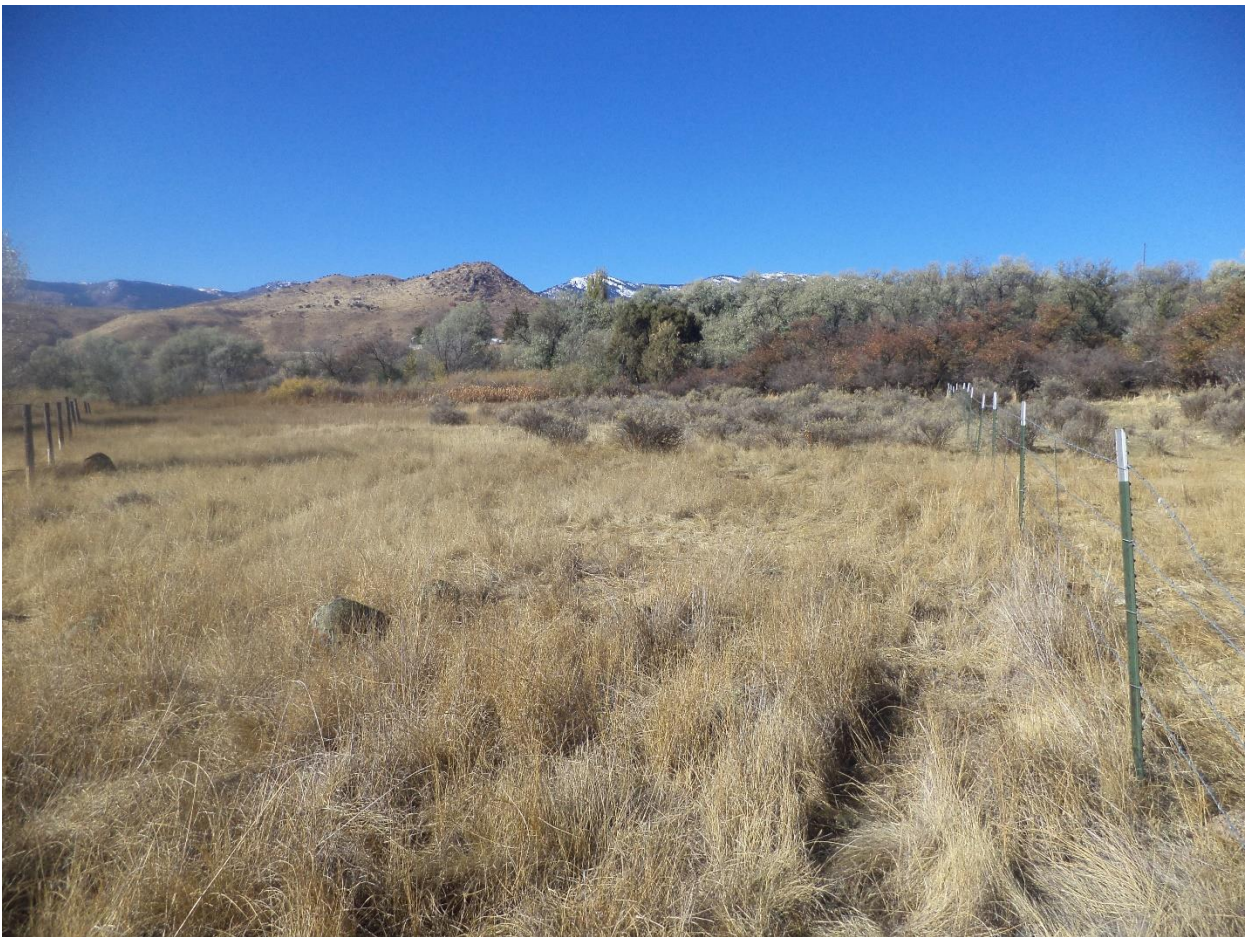
**Olsen I 2018**

**2018 Easement Conflict:** Cattle were present at time of monitoring, appeared as though grazing had been permitted for a significant amount of time.

**2018 Photo taken looking west from fence corner.**

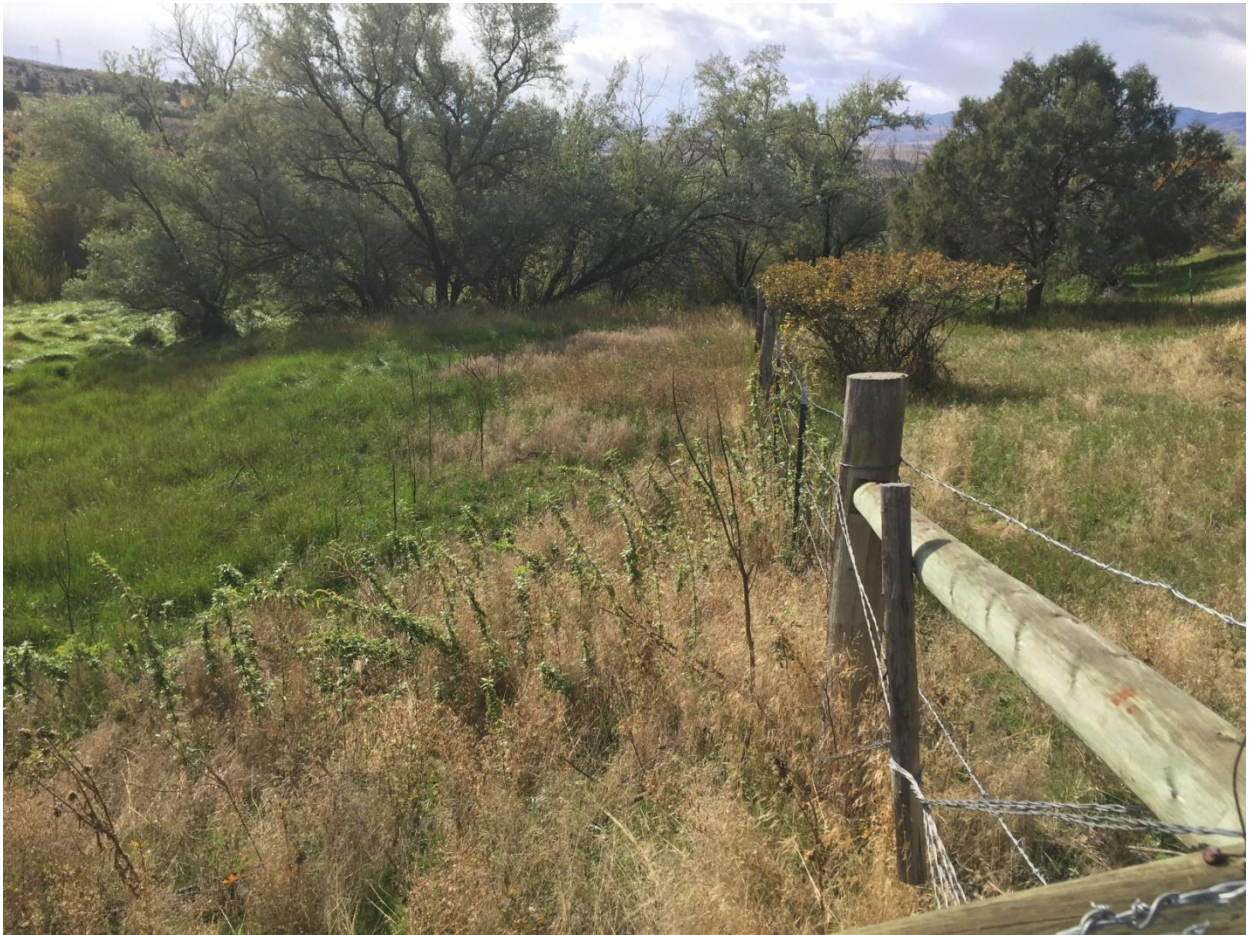
**McCurdy I 2018**

**2018 Easement Conflict:** Cattle were present at time of monitoring, appeared as though grazing had been permitted for a significant amount of time.

**2018 photo looking South on West boundary.**

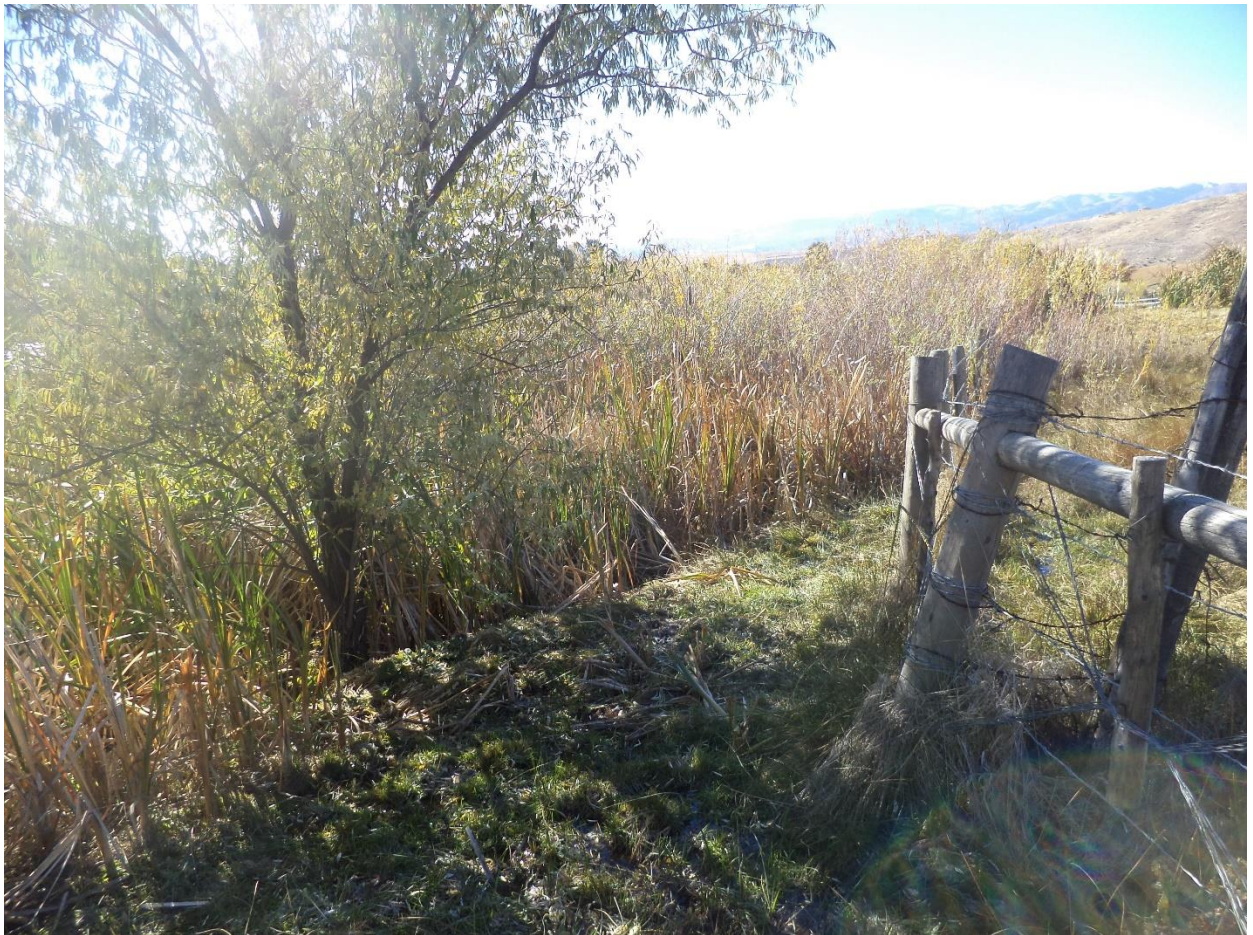
**Hansen 2018**

**2018 Easement Conflict:** Grazing along riparian area and rivers edge, cattle moving down river from Olsen 1

**2018 photo looking South through Hansen riparian.**

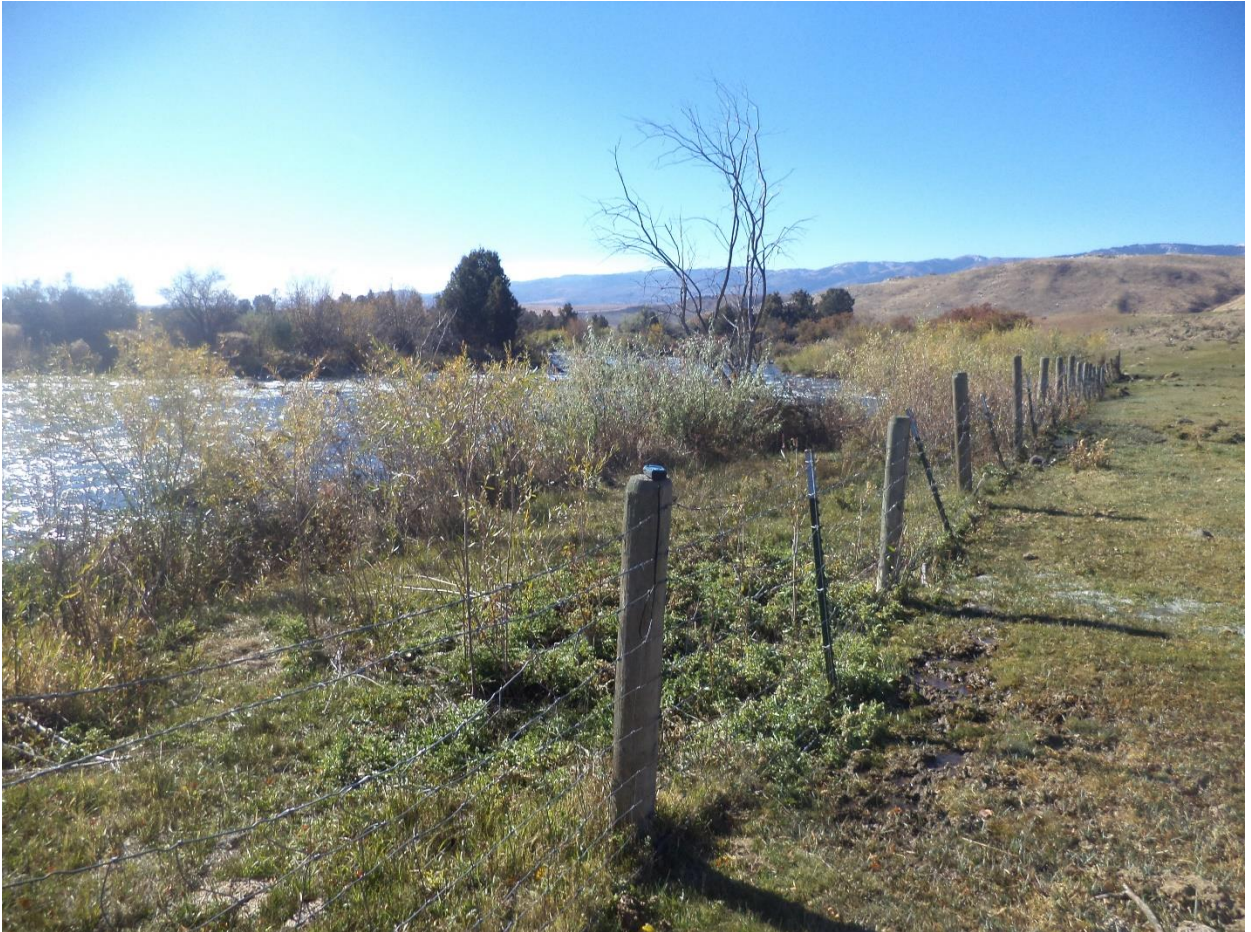
**2018 McCurdy II**

**2018 Easement Conflict:** Some Grazing, Cattle walking down river from Olsen 1

**2018 photo looking South through McCurdy II riparian zone.**

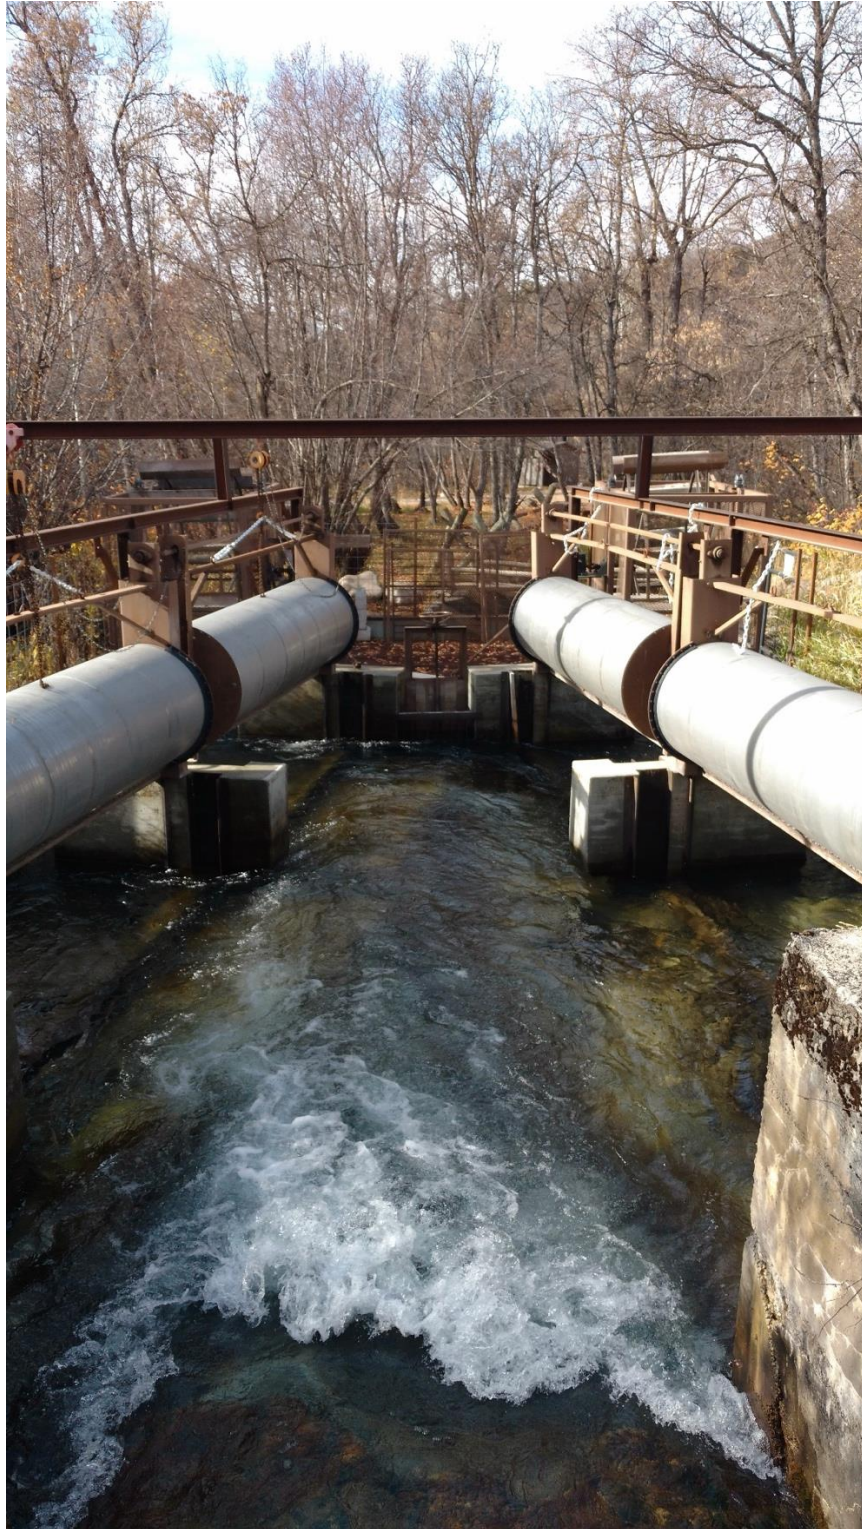
**Albert Moser Fish Screen**

This screen is inoperable at this time. Necessary corrective action may be to change the screening out for a larger size perforated plate. However, this would require removing the drums from the structure completely which may require large heavy equipment.

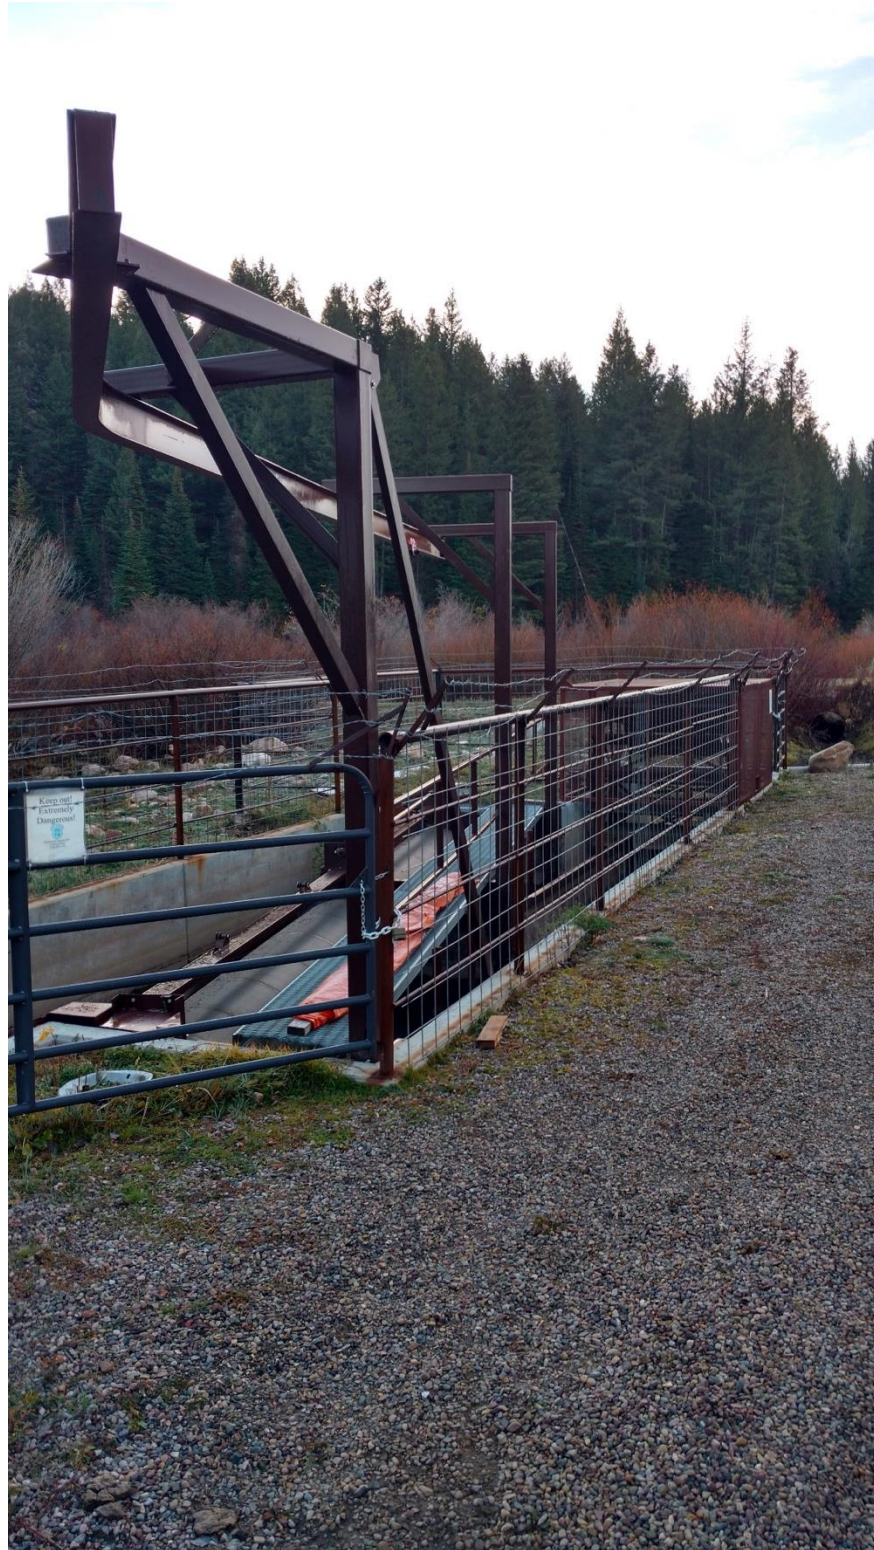
**Davis Fish Screen**

This fish ladder would take a considerable amount of maintenance to become fully functional again.

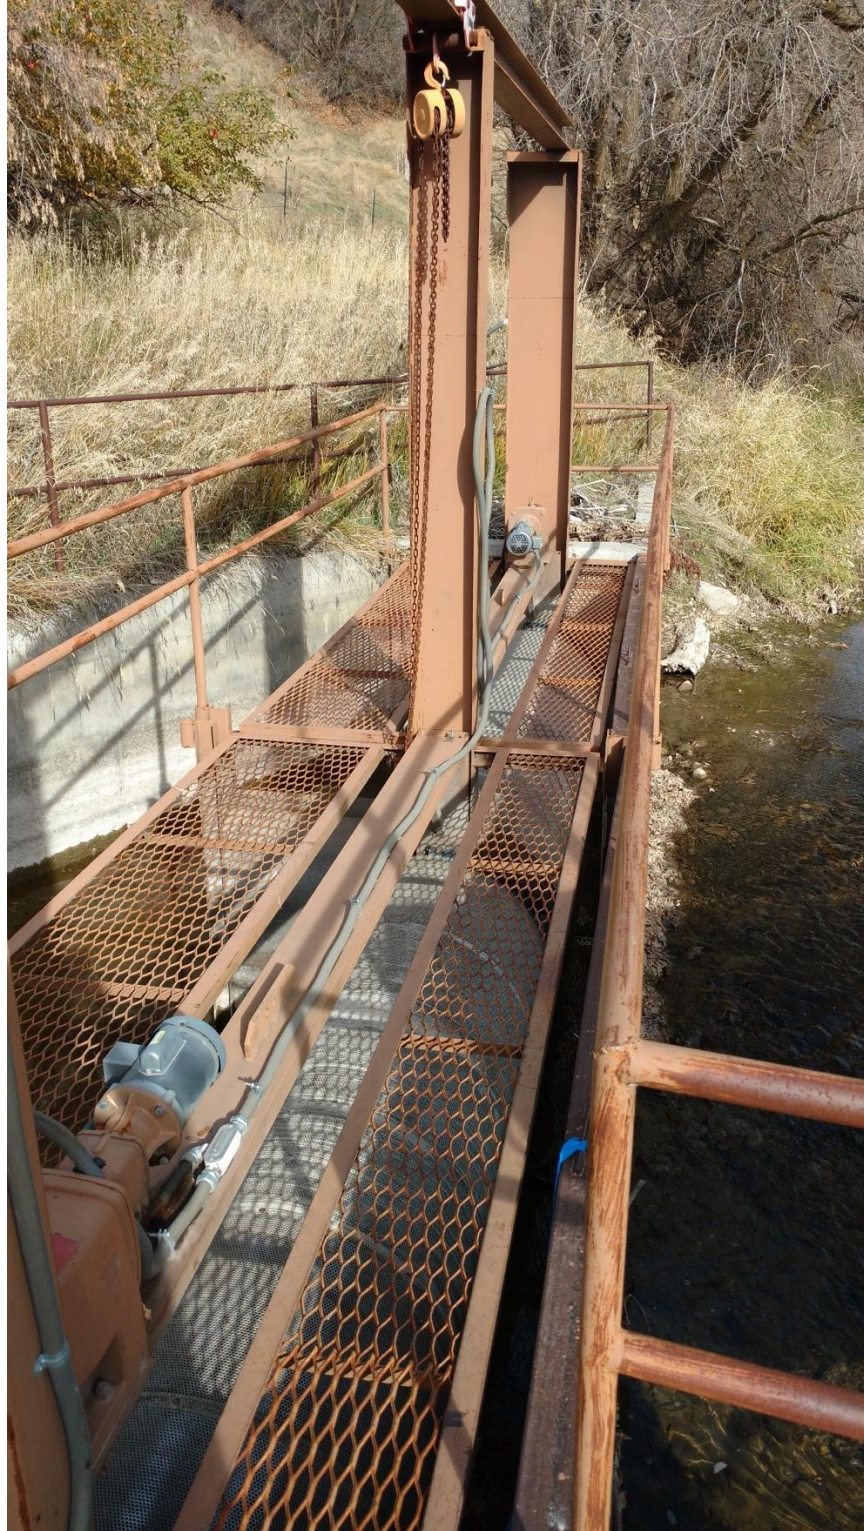
**Knapp Fish Screen**

The drive chain on these screens are beginning to pop and snap a lot due to the sprockets being worn out. The necessary corrective action will be to lift these screens out and replace the sprockets. Otherwise these screens had no major issues and required only normal preventative maintenance and cleaning.

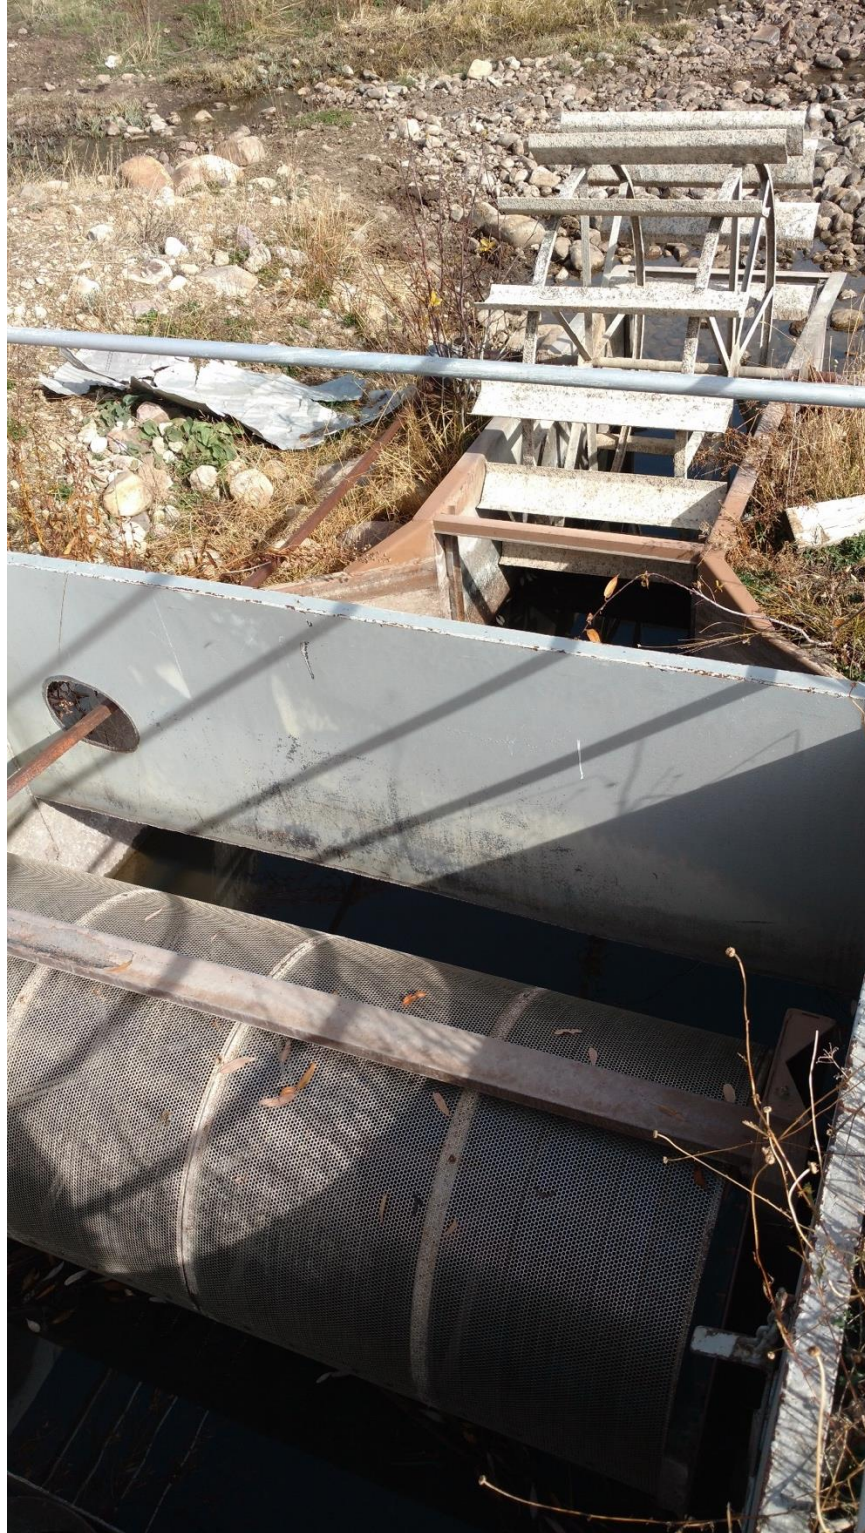
**Ovid Fish Screen**

This screen has a problem with entraining fish that make it into the top end of the screen and have a hard time finding the bypass pipe to make it back to the creek. I believe that the necessary corrective action for this problem is to completely rebuild this structure. The reason that the bypass pipe is hard for the fish to find is because it is just below the waterline and it is very small. The bypass pipe is in this position because this screen structure was originally built to be a Goobi bubbler and later retrofitted to be a drum screen.
