Grace-Cove Site Plan

Prepared for:

PacifiCorp
Portland, Oregon

September 2, 2005

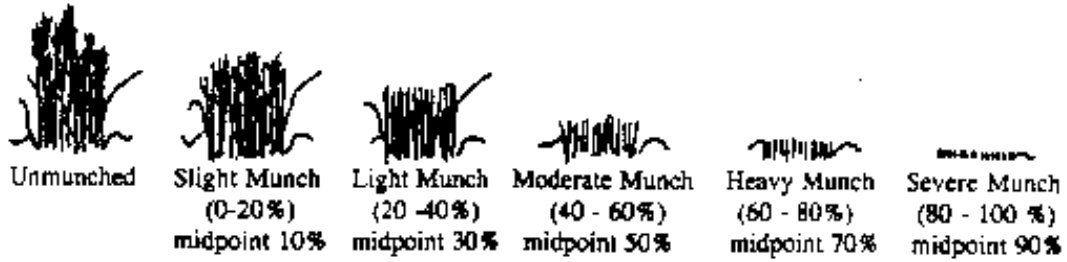
Guide for “even” utilization:

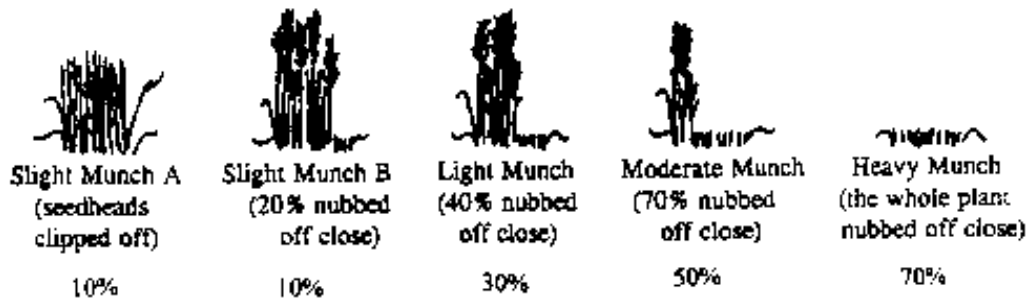
Guide for “uneven” utilization:

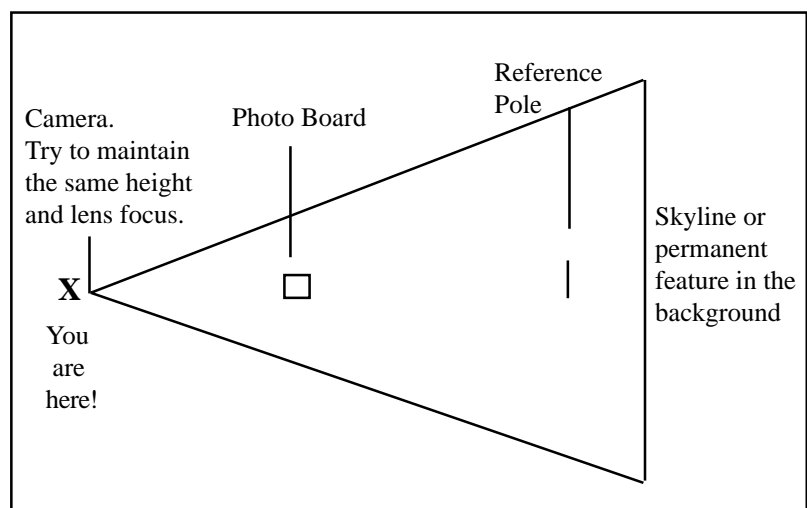
Photo Board: After writing the date and the location of the monitoring site on your photo board, place it in the foreground of your picture. Check through your viewfinder again. Is the board legible? Be sure the sun's glare will not prevent you from reading the information on the board once the photo has been printed. With the photo board visible, check to see that your landmarks are also still in the frame.

Setting up the Picture

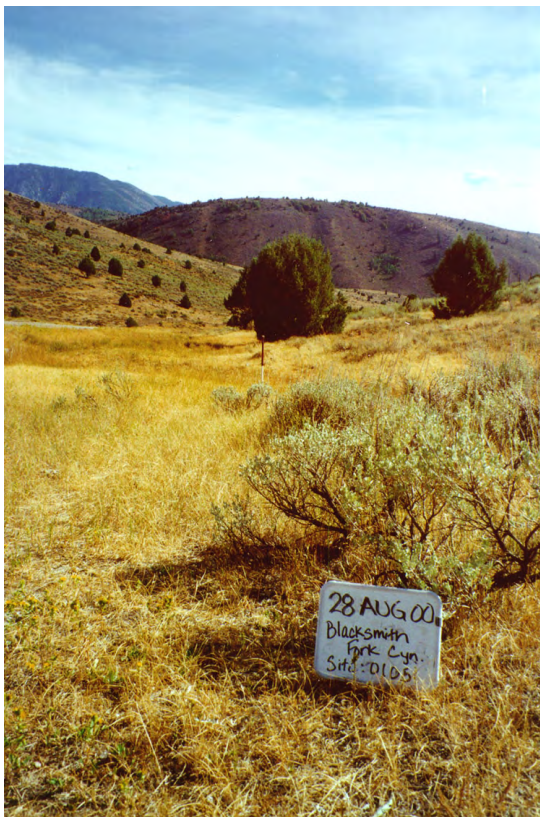
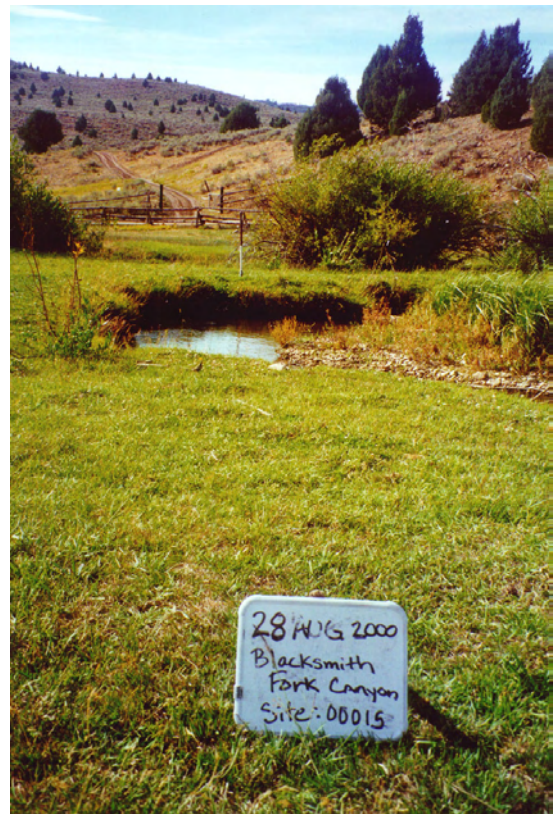
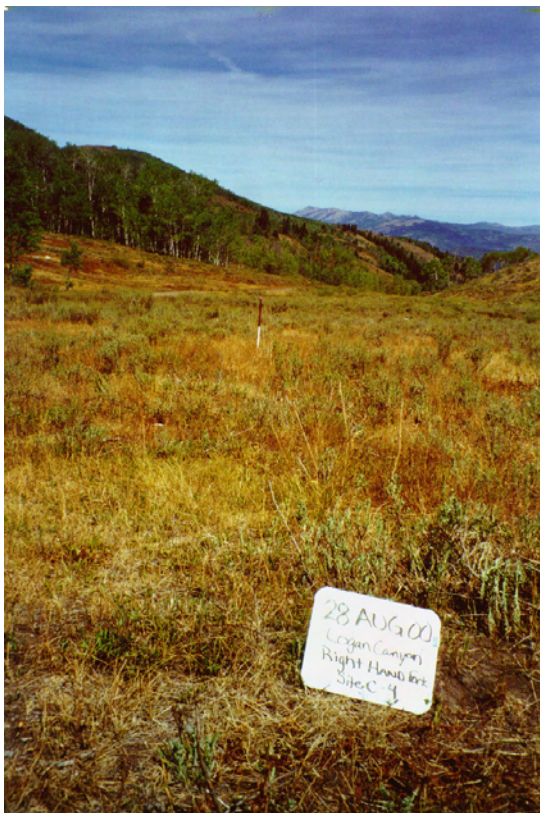
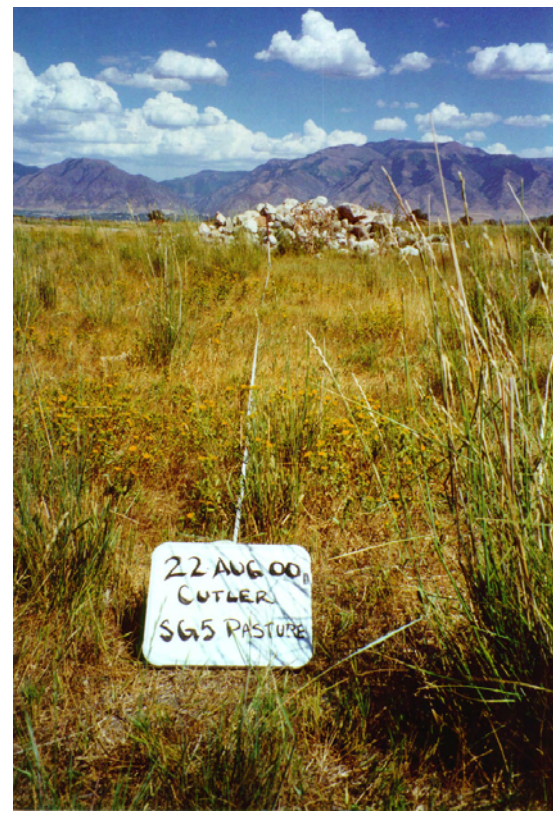
Figure 1. Four examples of photographs that have everything needed for monitoring changes. They each have the date, location, a reference pole, and some type of permanent feature that can be recognized. Note how the background skyline makes it easier to find these sites in the future.

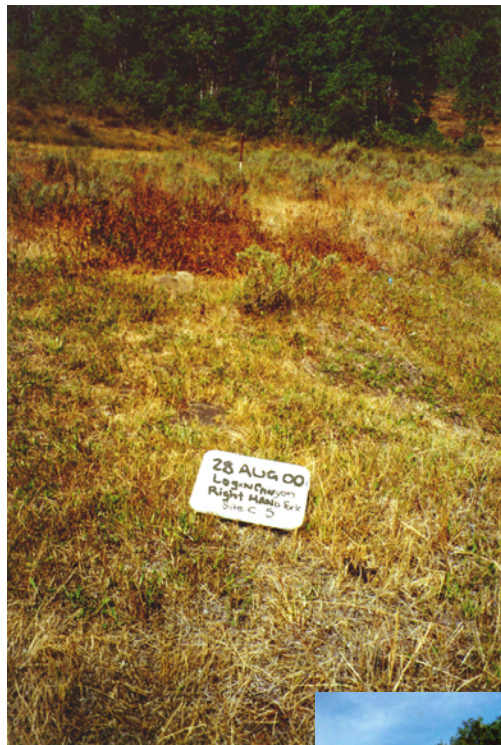
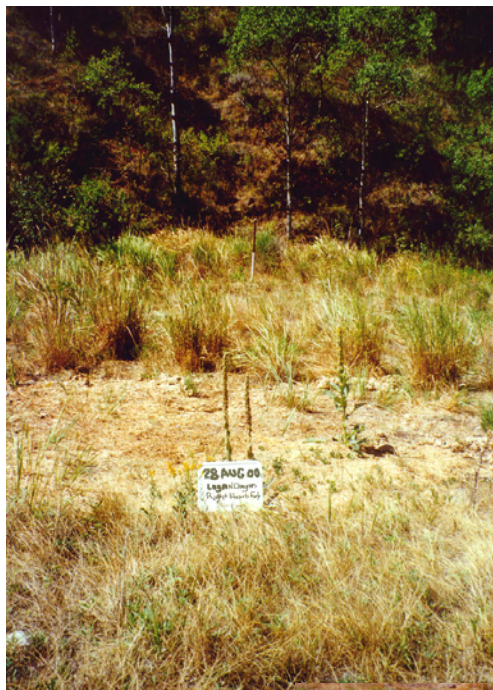
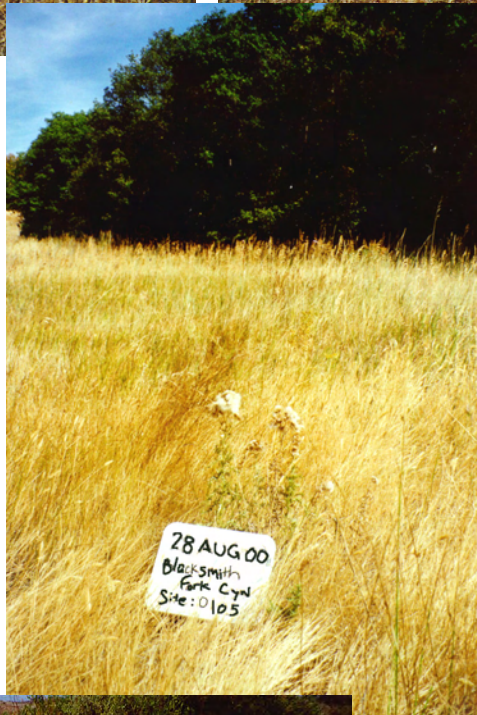
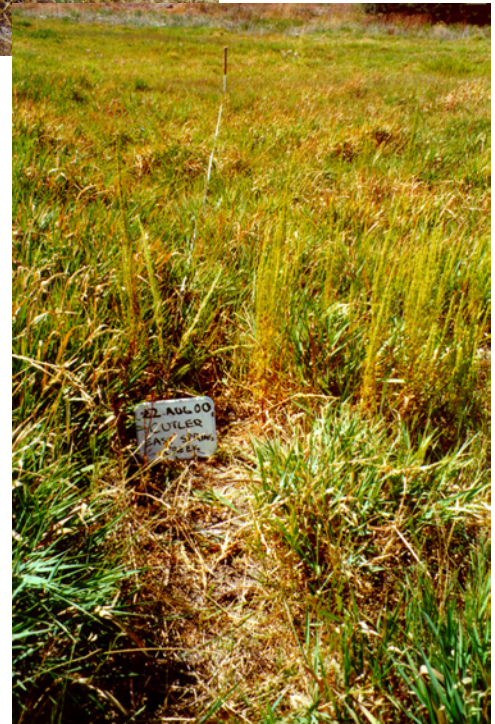
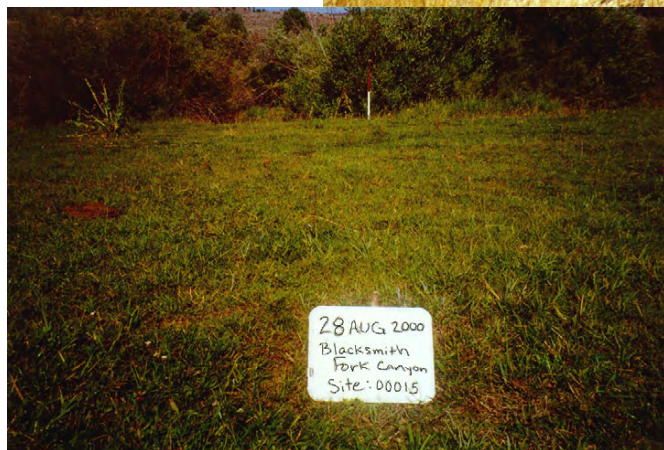
Figure 2. These photographs are less useful. All have the date, location and reference pole which make them very useful for monitoring. However, because there is no permanent feature or a distinguishable skyline, it will be difficult, or impossible to relocate them.

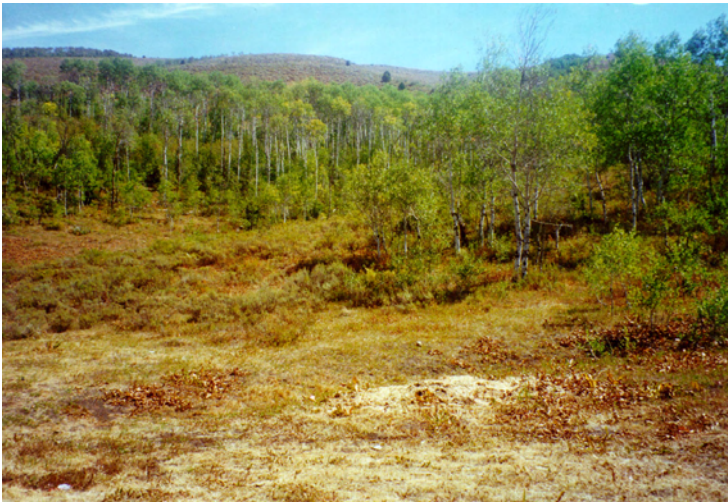
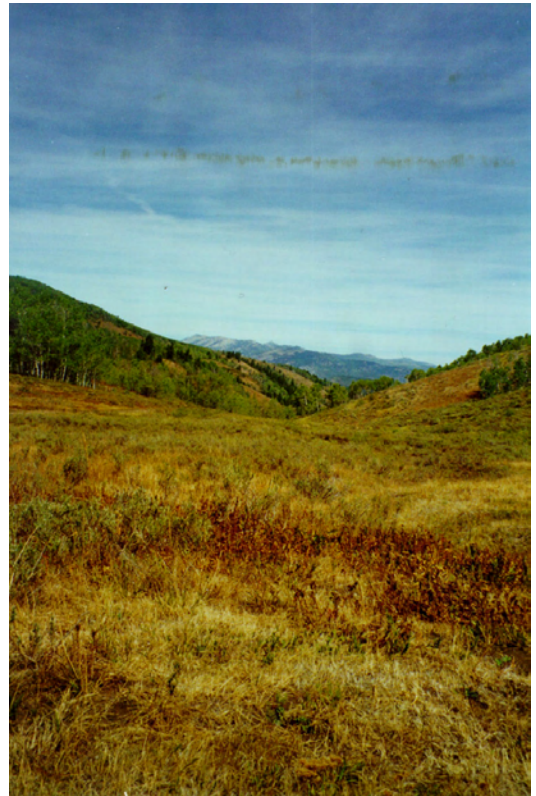
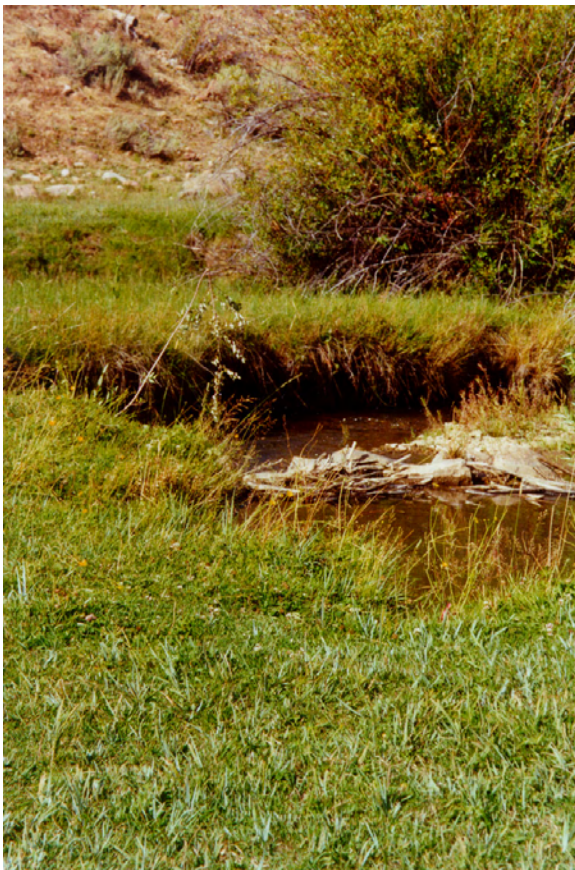
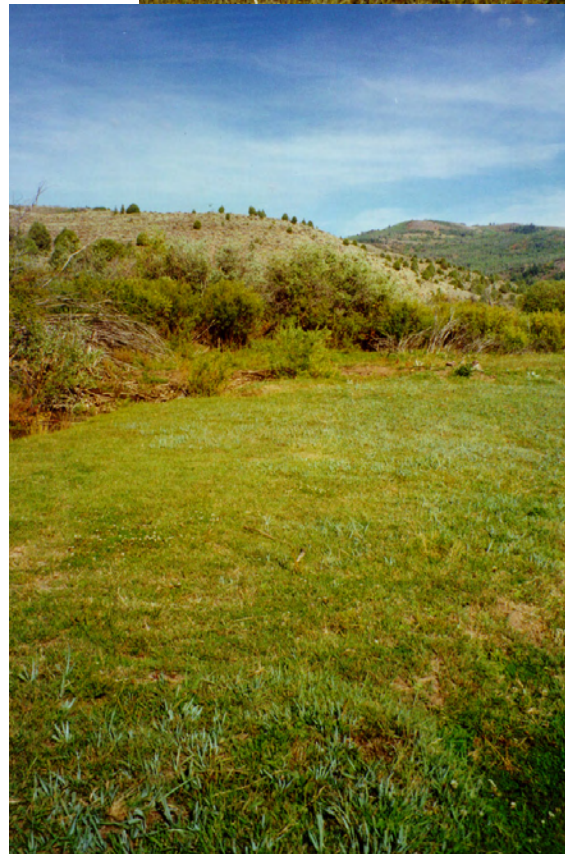
Figure 3. These photographs are the least useful for monitoring. They are nice landscape pictures but do not contain the date, location or a reference pole. These are very difficult to use for monitoring, and then only by the person who took the original photo. To make them more usable, they should be attached to a sheet with the date and location. A map of how to find the site would be valuable as well.
