Grace-Cove Site Plan

PacifiCorp
Portland, Oregon

Cirrus Ecological Solutions, LC
Logan, Utah

September 2, 2005

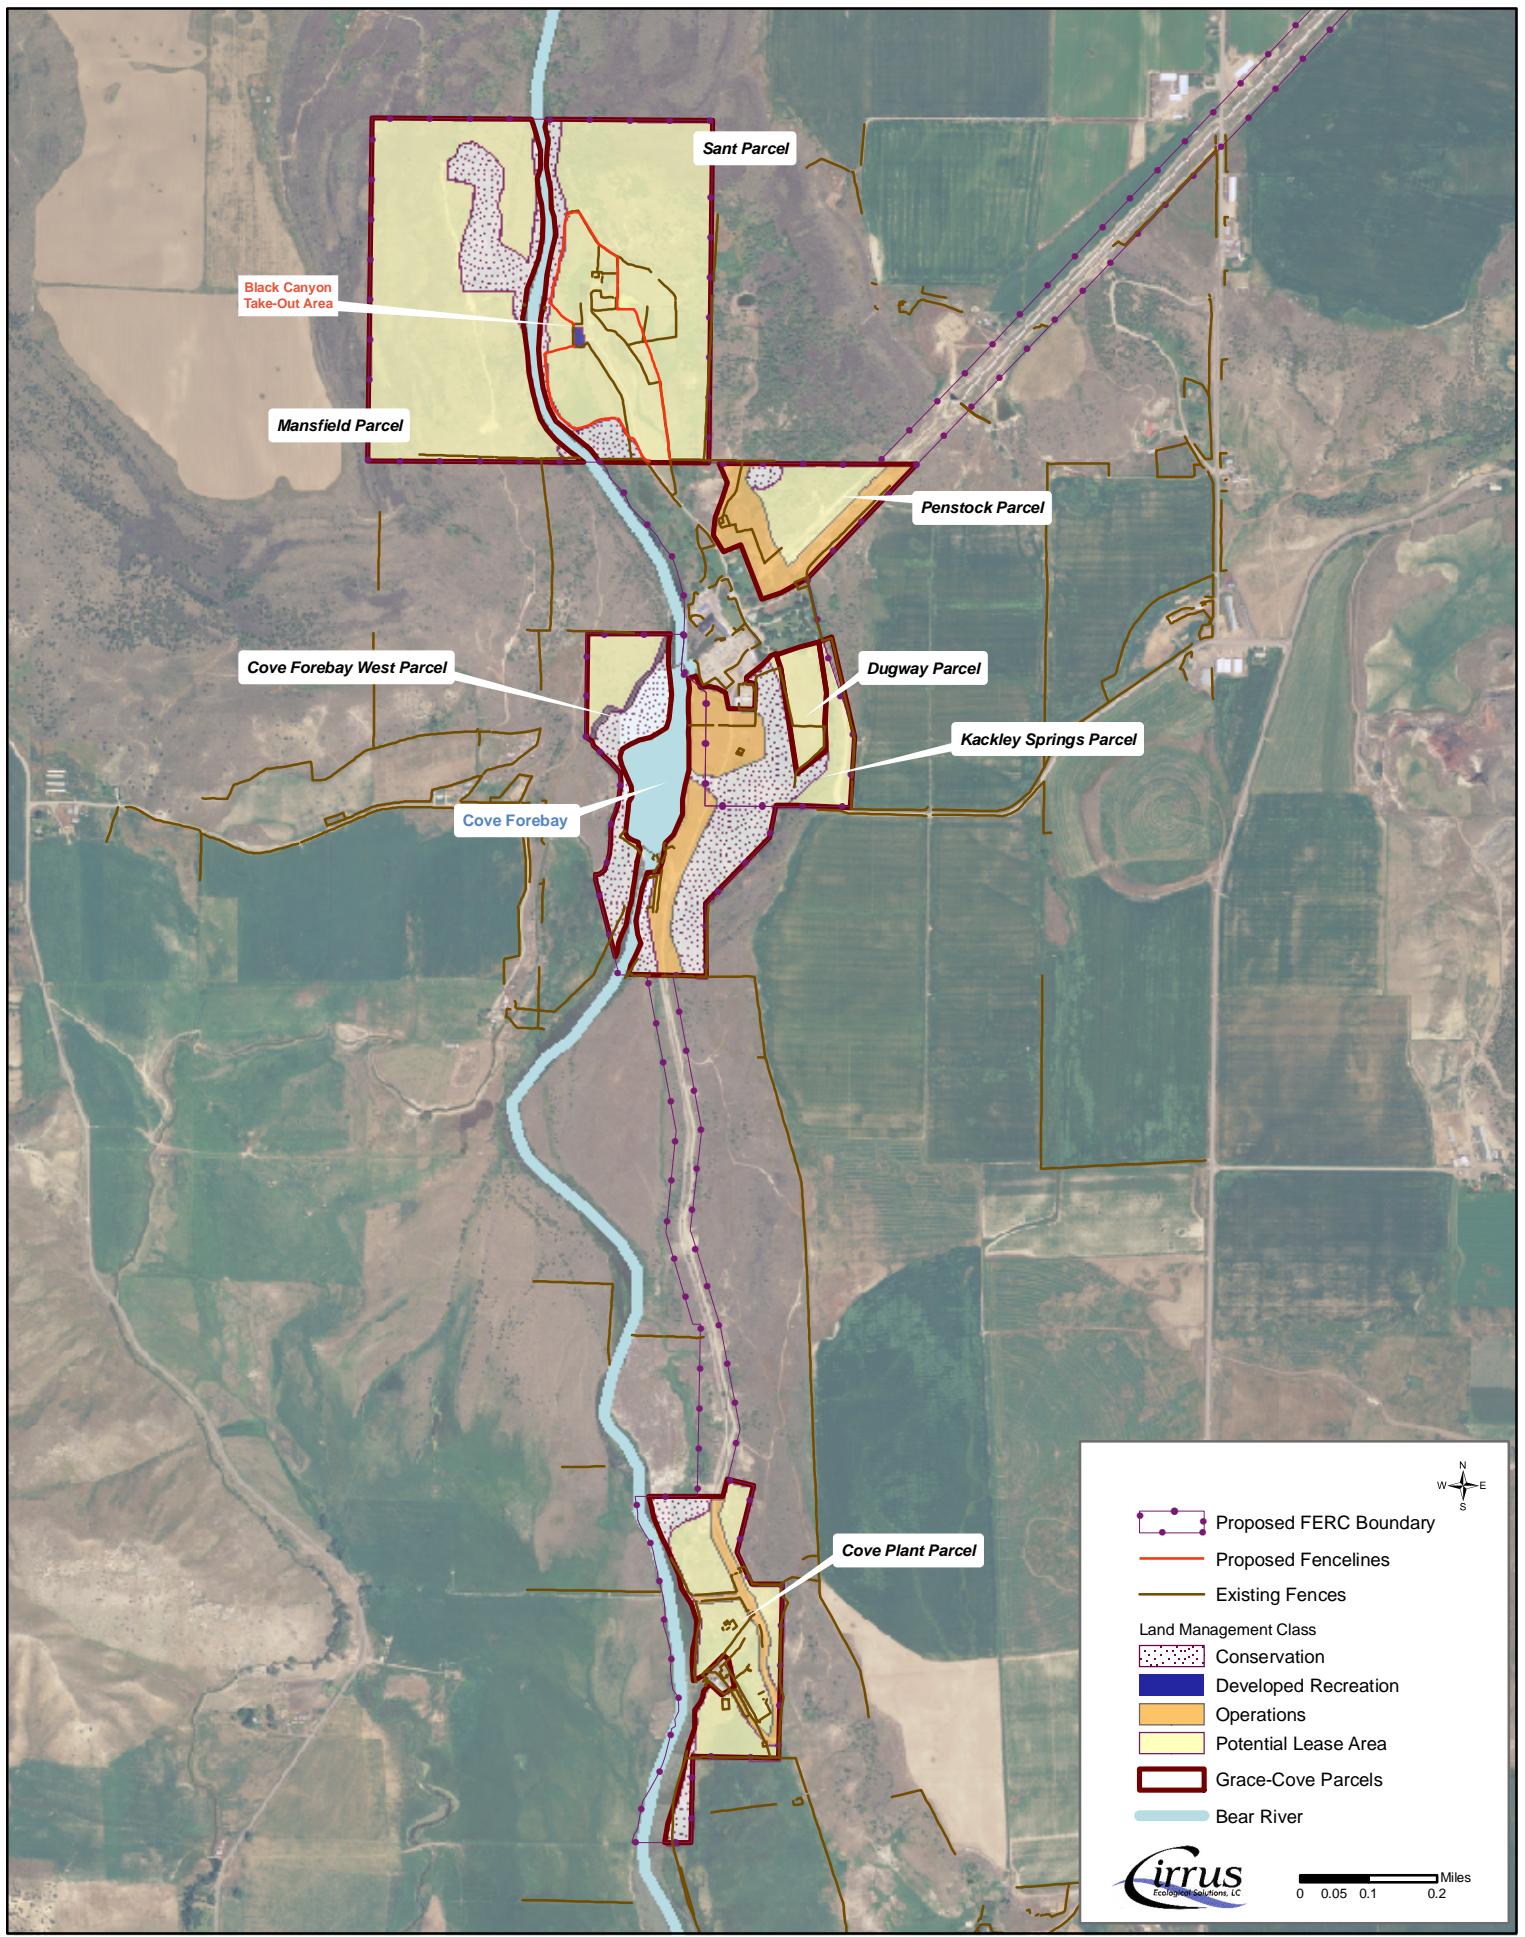
Figure 1. Grace-Cove Planning Area.

PacifiCorp and the Federal Regulatory Energy Commission (FERC) recently completed the relicensing process for the Bear River Hydroelectric Project (Project), FERC Project No. 20. Among the conditions of the new license is a requirement that a land management plan be developed for PacifiCorp-owned lands within the FERC Project boundary. This plan is intended to address various concerns associated with natural resources, safety, recreation, and agricultural activities identified through the relicensing process. The Land Management Plan (LMP) was prepared in consultation with the stakeholder group, the Environmental Coordination Committee (ECC). The LMP provided for the development of various Site Plans for PacifiCorp-owned parcels. The Grace-Cove Site Plan covers PacifiCorp-owned property in the vicinity of the Cove development and the lower end of the Grace development (Figure 1).

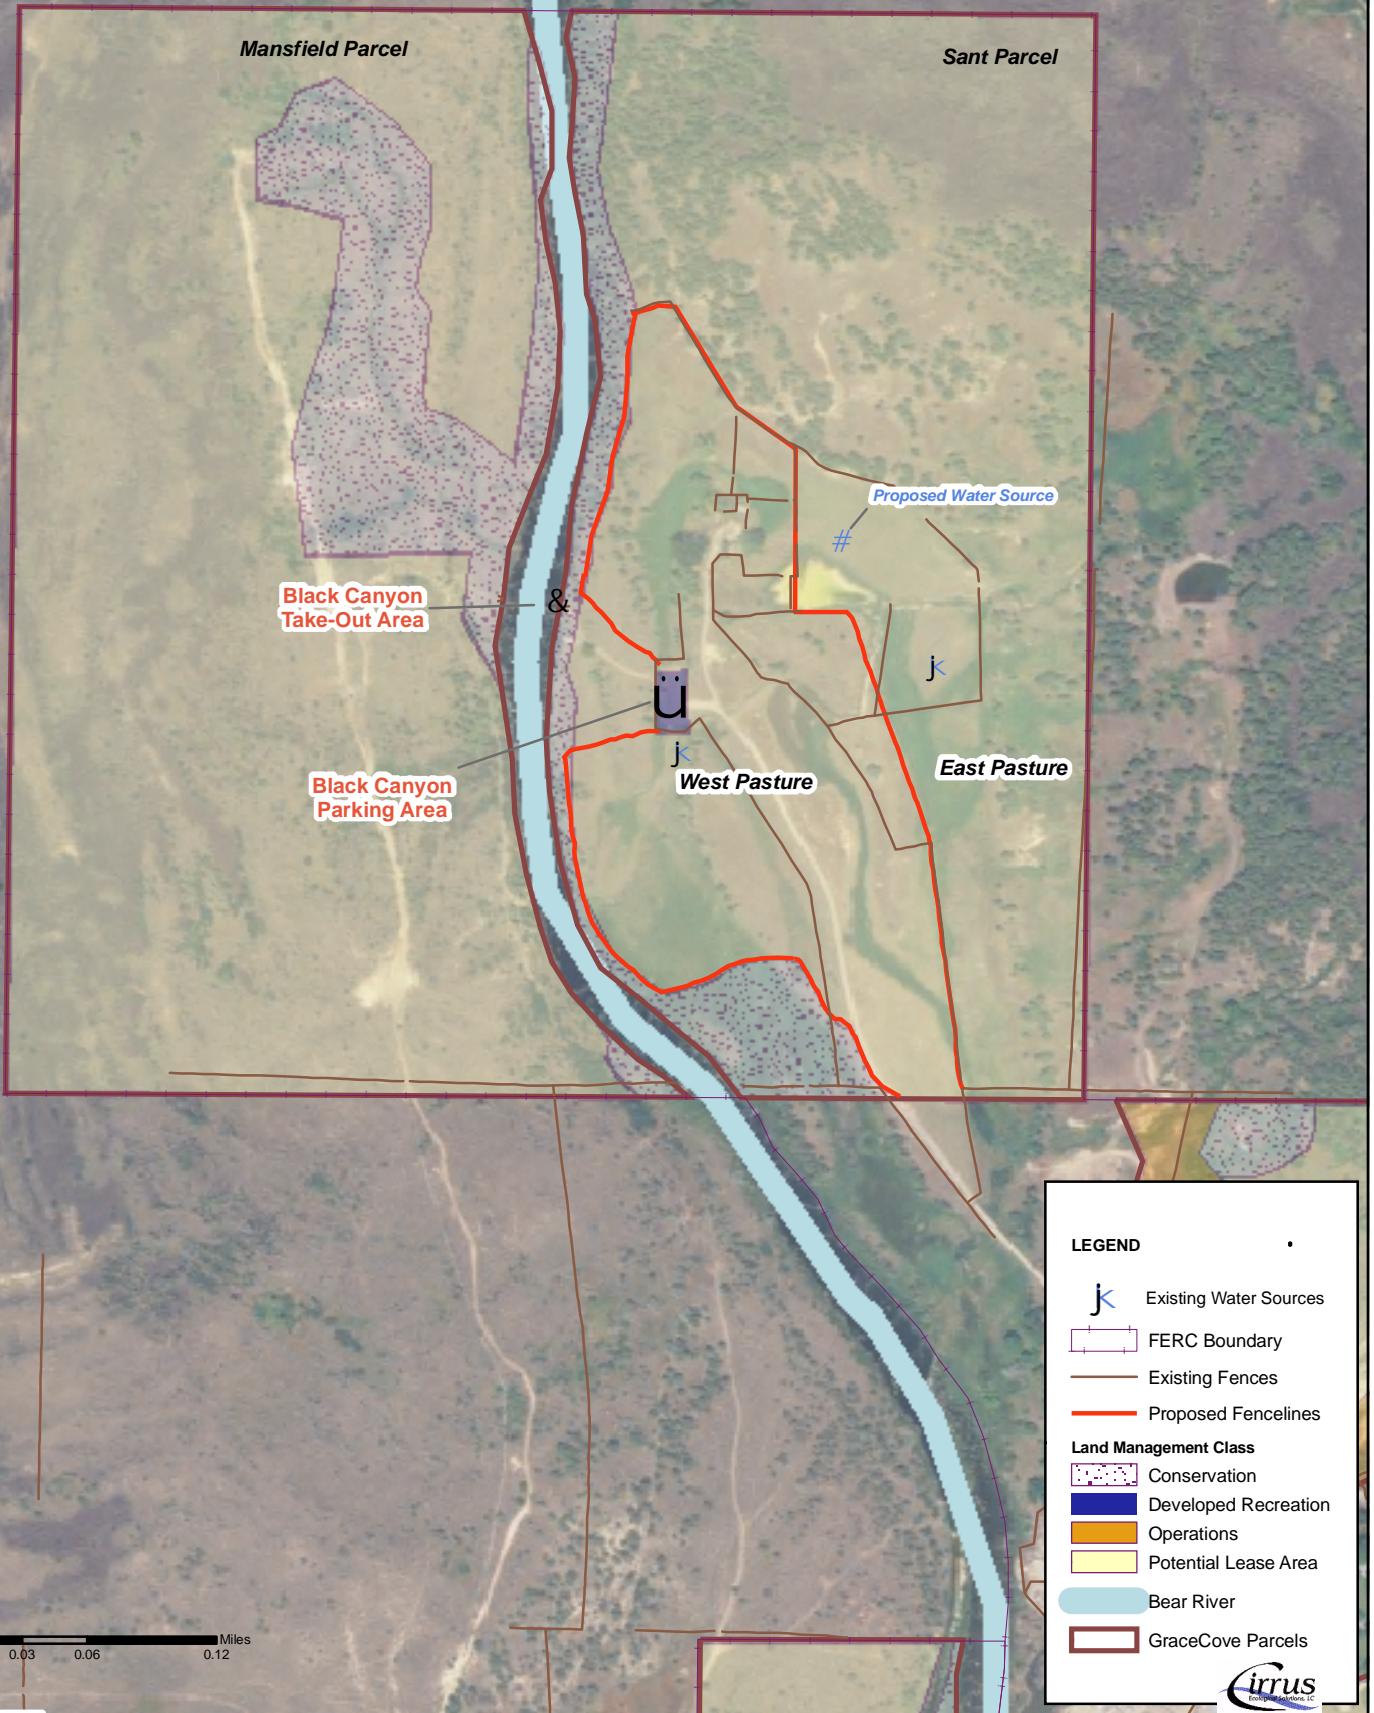
FIGURE 2. SANT & MANSFIELD PARCELS

The disturbed area was not reclaimed or revegetated and remains as a noticeable linear disturbance on the landscape (Figure 2). Exposed bare soil has resulted in significant weed infestations including several species of thistle, houndstongue (*Cynoglossum officinale L.*), and whitetop, along with burr buttercup and annual grasses. Along much of the pipeline route, a work road was left intact, as was the former construction staging area at the parcel's southern end. Additional weed concentrations are found in areas near the river, particularly along 0.3-mile length of the area around the take-out where grazing was historically concentrated. Prior to 2005, weed control measures were not implemented on the parcel.

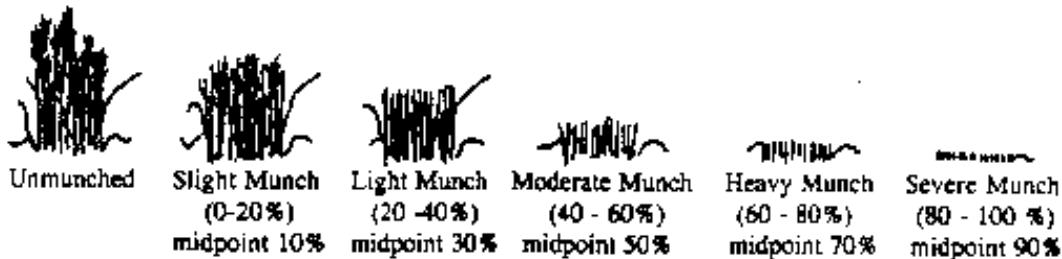
Guide for “even” utilization:

Figures taken from McKinney. 1997. Rangelands. 19:4-7.

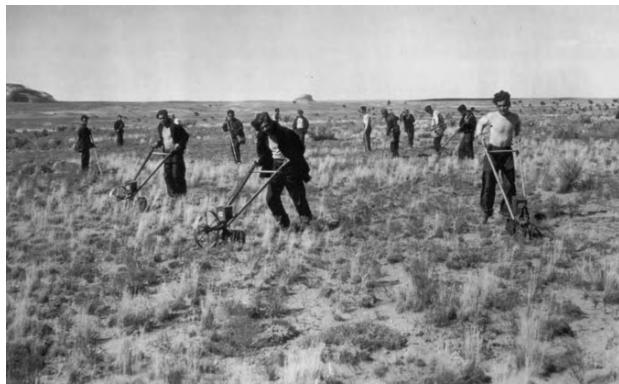
Dry Valley 1940, Bureau of Land Management photo

Use of Historic Photos

Old family albums, historic records at the courthouse, and even the library are additional sources for photos you can use to tell a story about your the management of your area. Look for old photos that have some identifiable feature, maybe from a family picnic, or a round-up. By finding that location today, and putting yourself in the same location as the original photographer, you can take a picture that will show conditions today. The examples shown here are from "A Photographic History of Vegetation and stream Channel Changes in San Juan County, Utah" by Hindley, Bowns et al.

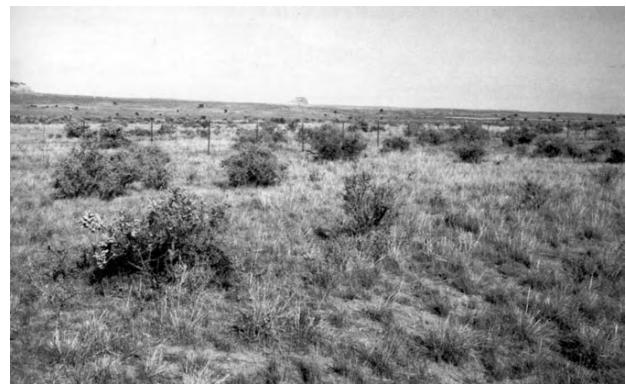
1998, Earl Hindley photo

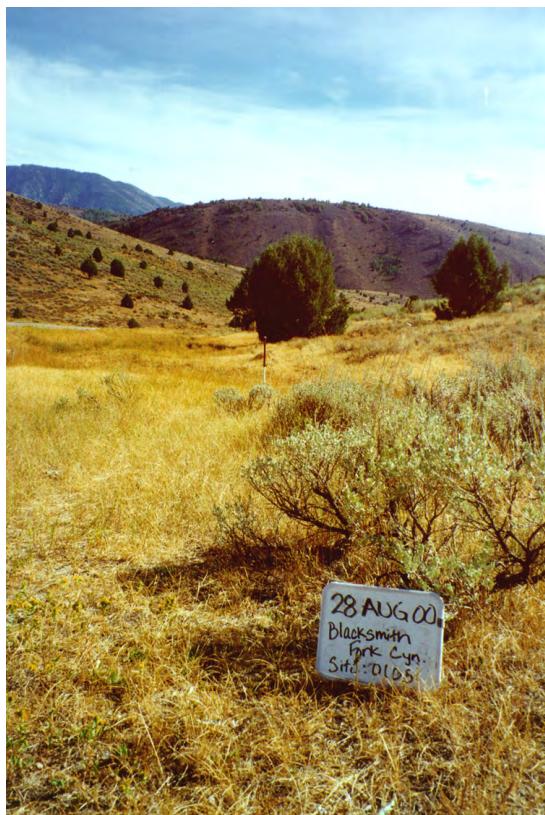
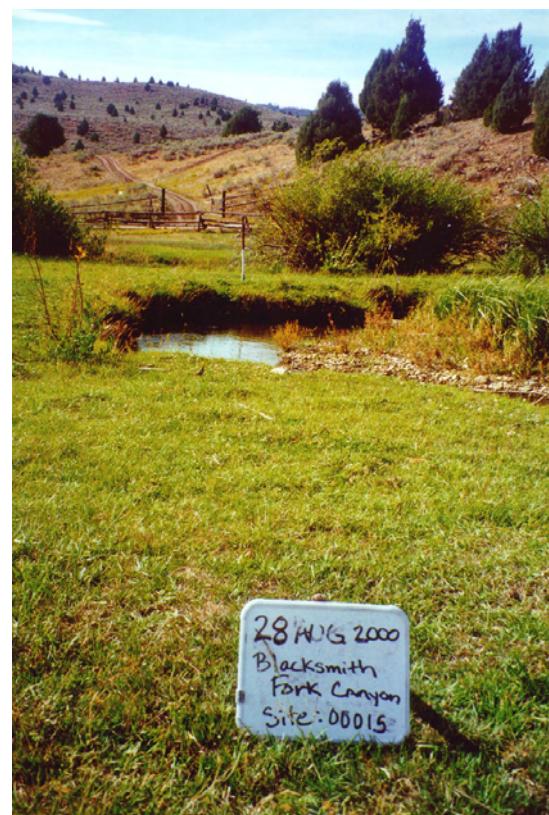
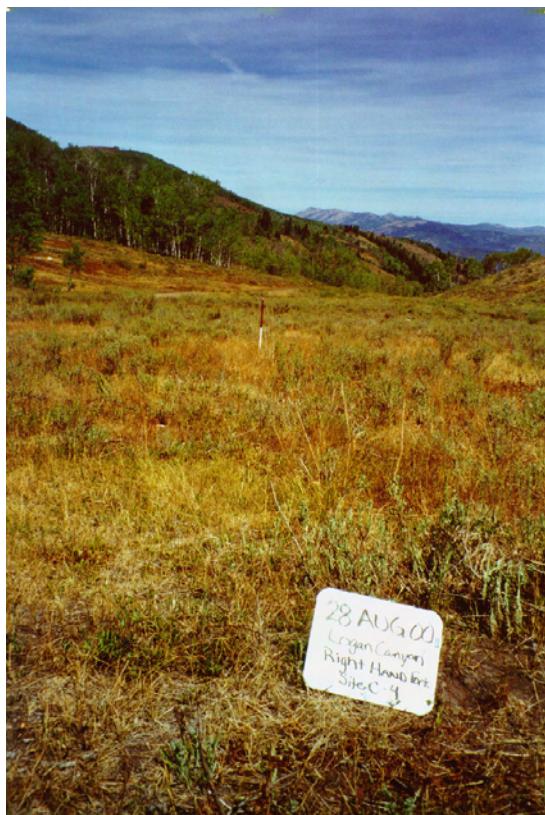
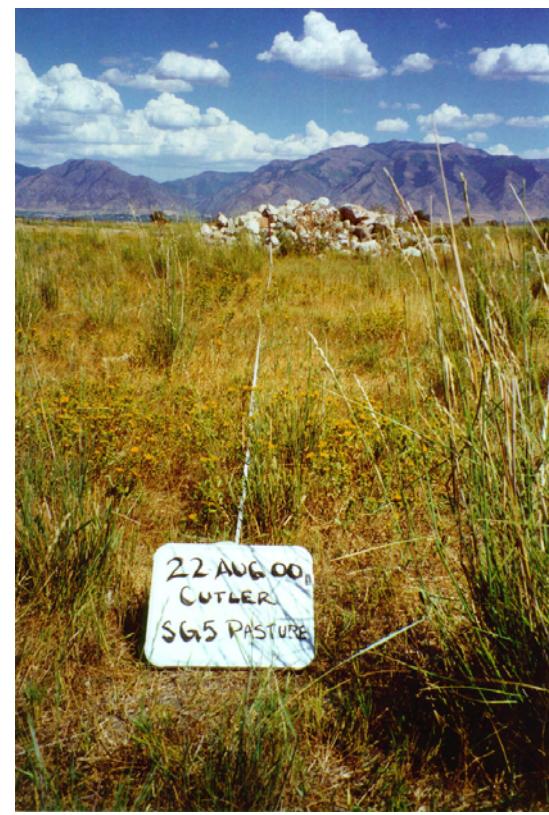
Figure 1. Four examples of photographs that have everything needed for monitoring changes. They each have the date, location, a reference pole, and some type of permanent feature that can be recognized. Note how the background skyline makes it easier to find these sites in the future.

Figures 1 - 3 show examples of monitoring photographs that range from useful to not useful.

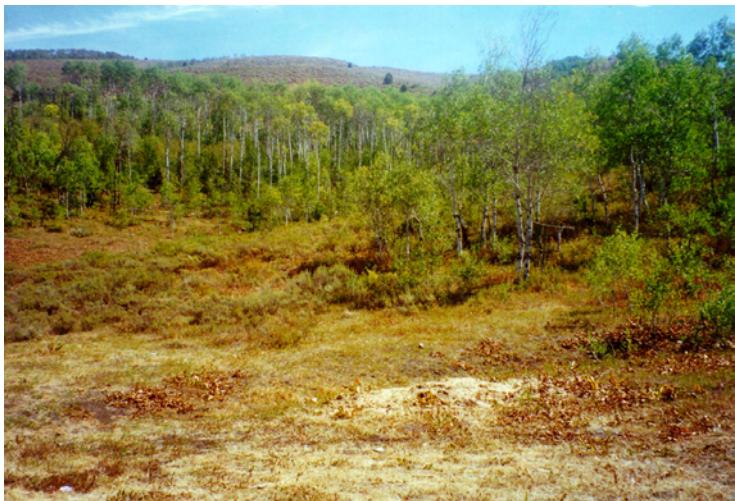
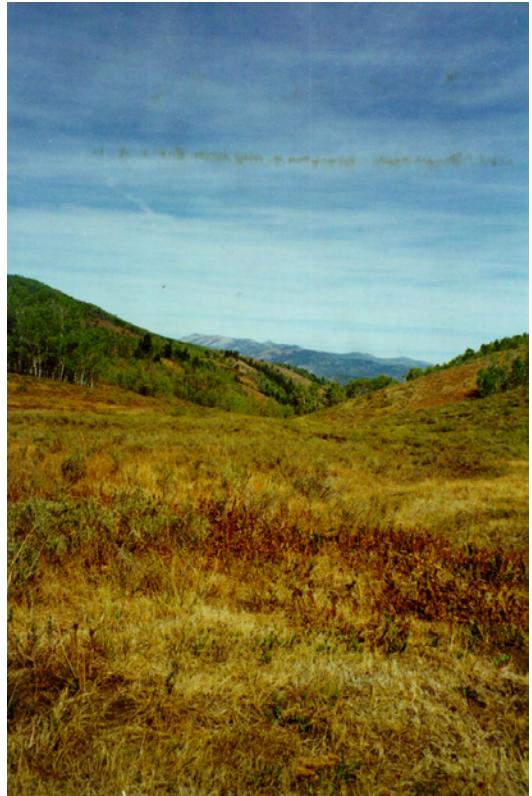
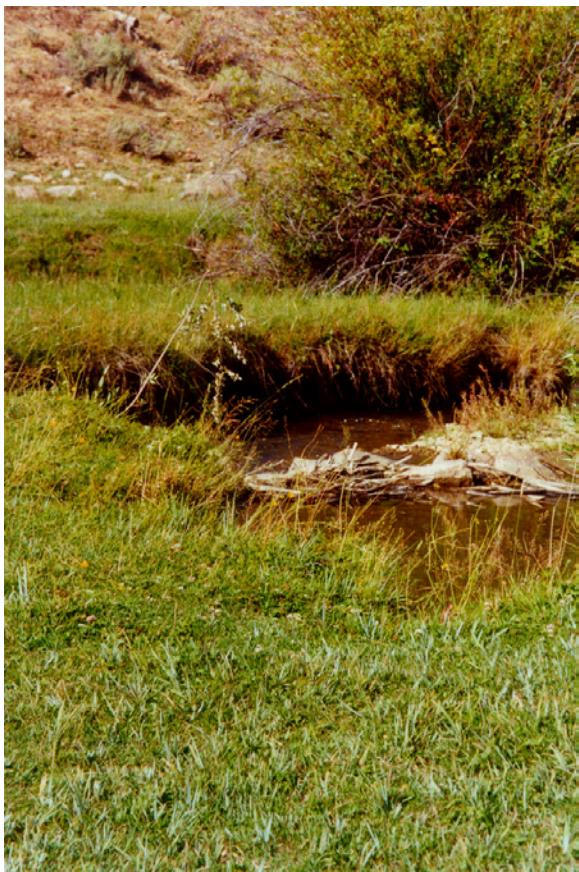
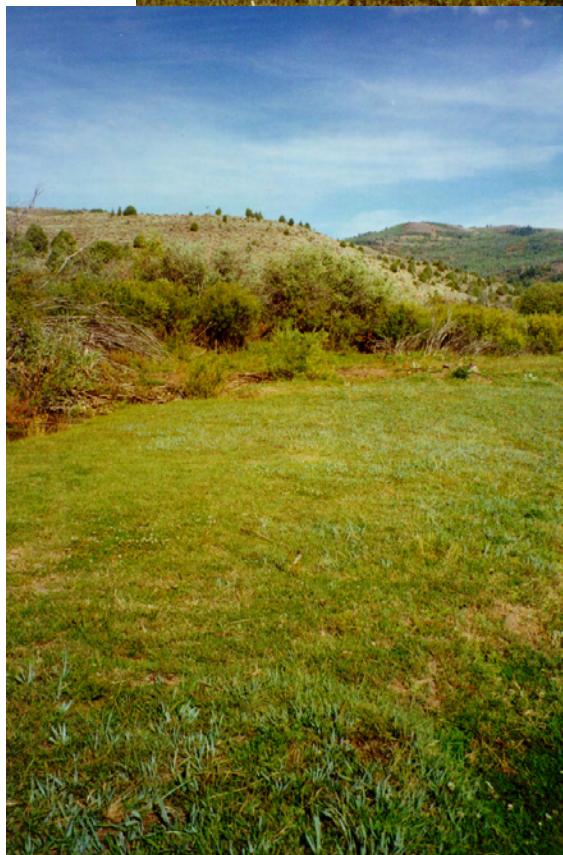
Figure 2. These photographs are less useful. All have the date, location and reference pole which make them very useful for monitoring. However, because there is no permanent feature or a distinguishable skyline, it will be difficult, or impossible to relocate them.
