Condit Hydroelectric Project Decommissioning

FERC Project No. 2342

WOODY DEBRIS ANNUAL MONITORING REPORT 2012

December 19, 2012

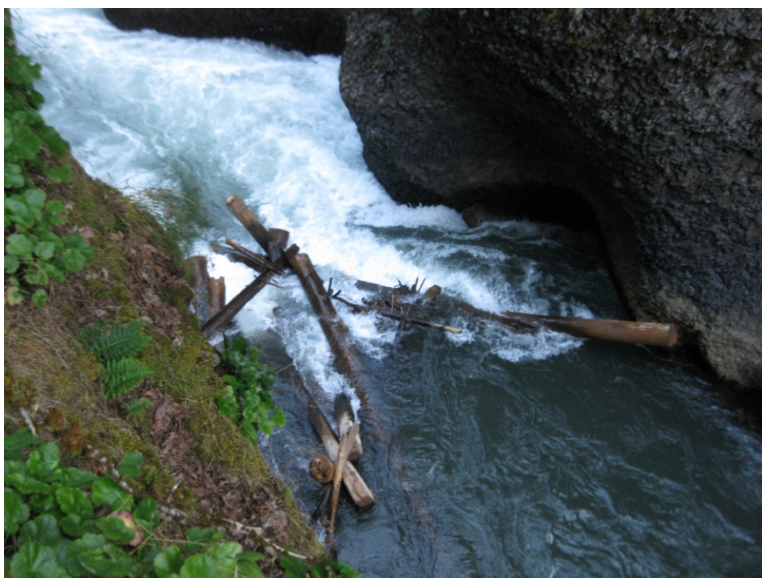
Large woody debris jam at The Narrows. Creates an extreme hazard for boating. July, 2012.

Consultation with stakeholders regarding the need to remove the logjam at The Narrows based on public safety considerations was completed during August 2012 per the consultation record in Appendix A. After a delay related to risk of wildfires on the project site and diversion of construction crew members to fighting fires nearby, removal efforts commenced on September 12, 2012, stopped on September 15, to reduce the possibility of disturbing fall Chinook during the spawning period, and then were concluded in the later part of October 2012 under a regulatory extension of time. Due to the height of the canyon walls in The Narrows, direct access to the logjam with heavy equipment was infeasible. In addition, swift water and the threat of submerged entrapment made it infeasible to safely access this logjam from a boat. Therefore, a cable yarder was rigged across the canyon using excavators to anchor cables, steel slings to hoist logs and a bulldozer to provide the pulling power necessary to dislodge the complex tangle of logs. This removal effort opened the waterway to allow for boater passage. Given the history of logjams in The Narrows, PacifiCorp Energy and the boating community recognize that naturally occurring woody debris has the potential to lodge at this location in the future. However, PacifiCorp Energy does not believe it has an ongoing requirement to remove naturally-formed logjams.

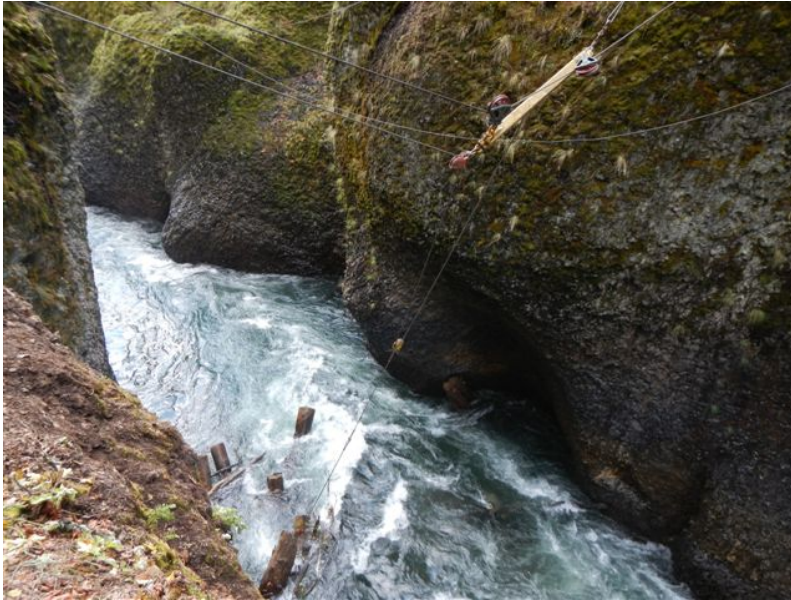
Logjam at The Narrows September, 2012. Cable yarder and wire slings were used to pull out logs.

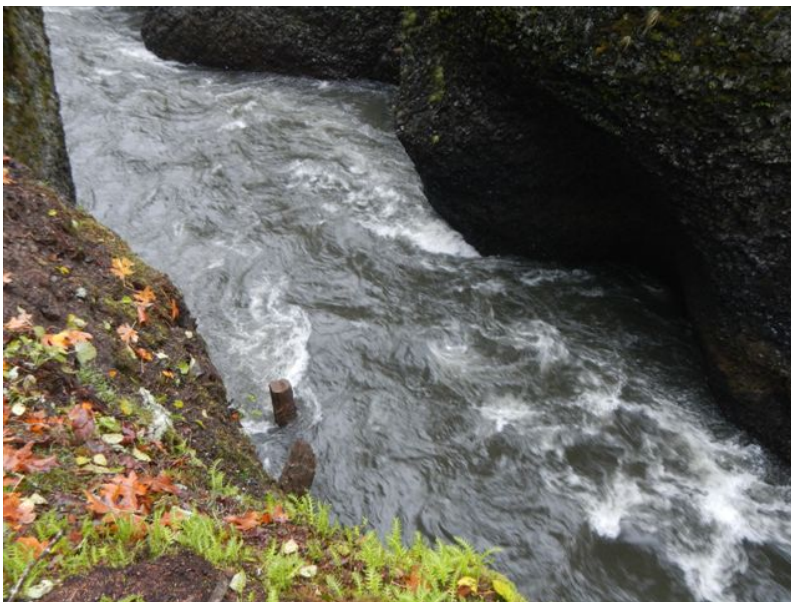
The Narrows upon completion of removal work with a couple of remaining logs on river left that could not be removed. Open water on river right allows for safe boater passage.

During the removal of the logjam in The Narrows, some woody debris that was dislodged moved downstream approximately 150 feet and a secondary woody debris jam began to form. At this secondary location several embedded logs were sawn off at water level with a chain saw

operated from a tethered inflatable raft. In addition, two logs at this location that were lodged across the river channel above the normal water surface were removed using the chain saw.

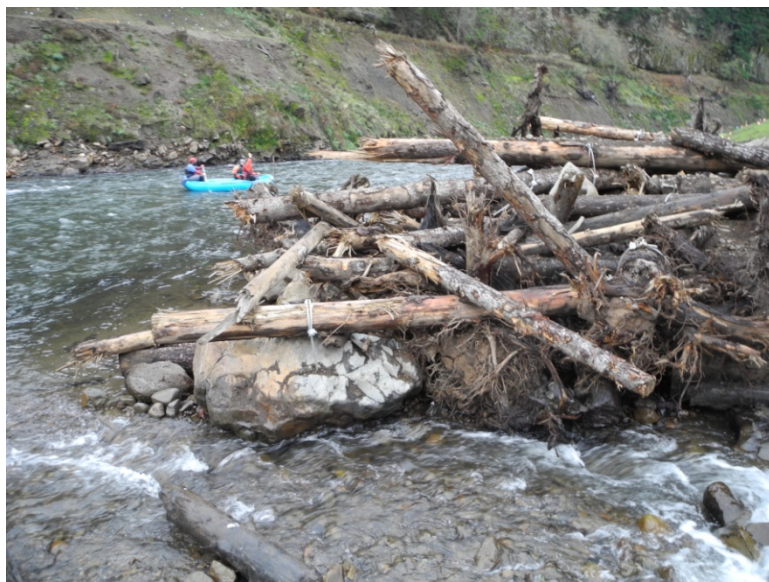
ELJs constructed at the side of the White Salmon River.

Seven Engineered Log Jam Structures (ELJs) were constructed within the reservoir reach in the locations shown and as described in Appendix B. In the original Woody Debris Management Plan, the construction of woody debris jams (or ELJs) was anticipated as a means to improve riparian habitat. Once the reservoir sediments had eroded down to the old river bed profile it became evident that both the reservoir and the canyon reaches were primarily transport reaches, where woody debris jams were not likely to form in alluvial sediments, but where constructed woody debris structures would be beneficial in trapping sediments on surfaces adjacent to the active river channel and in reducing the velocity of overbank floodwaters to reduce erosion of riparian areas. The locations of the ELJs were selected to enhance the establishment of riparian vegetation on low benches next to the river.

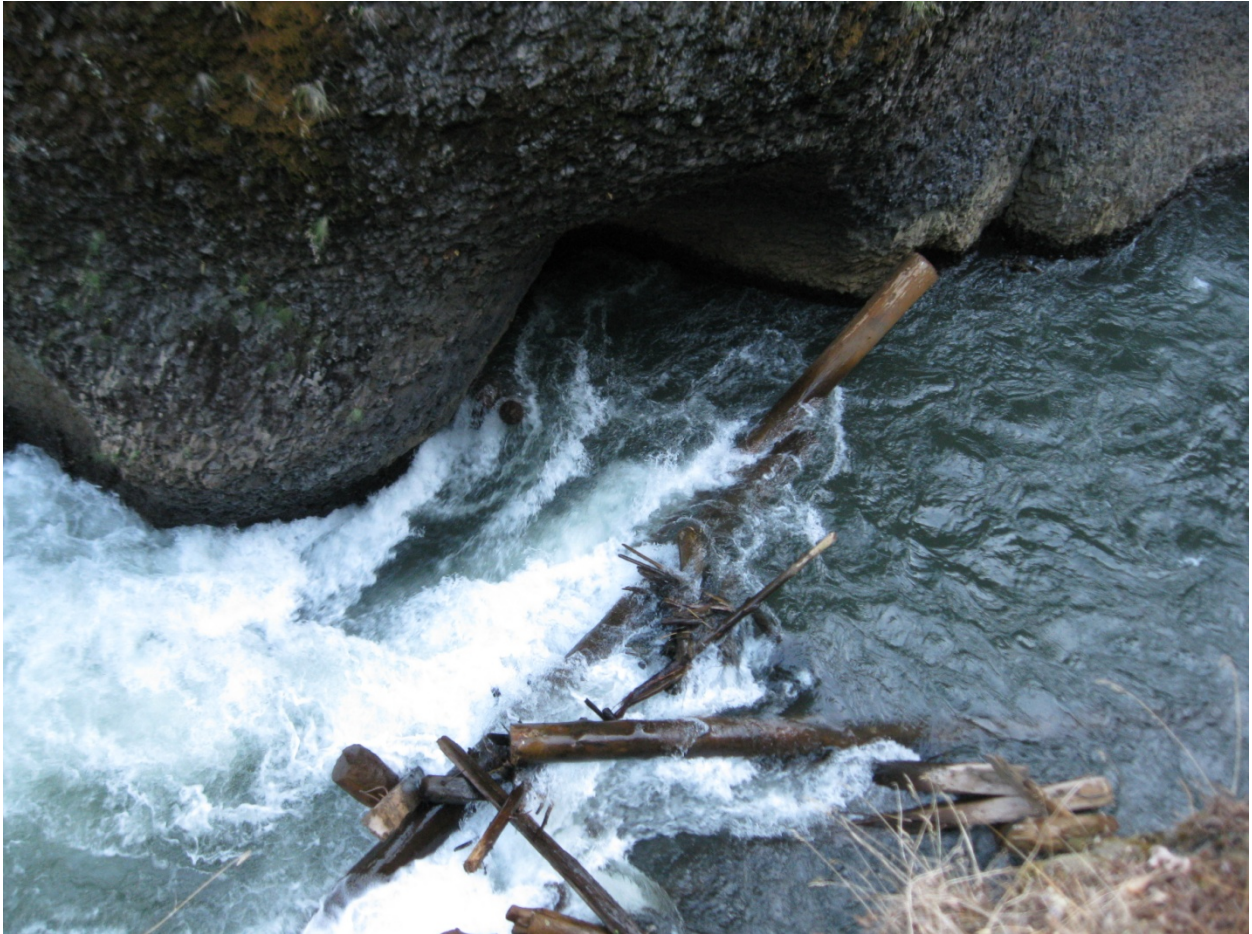
Photo 1. White Salmon River. Log jam in the Narrows. July 2012

- From the flow line alignment we propose to utilize a cable logging system installed across the river and over the top of the log jam comprised of a skyline, main line, and a haul back line. See attached drawing.

- From the skyline, a carriage with log tongs suspended below will be utilized to grab key logs in the jam. This method may allow the jam to fall apart and flow on downstream. If that does not happen then the method of grabbing logs until the jam falls apart will be employed.

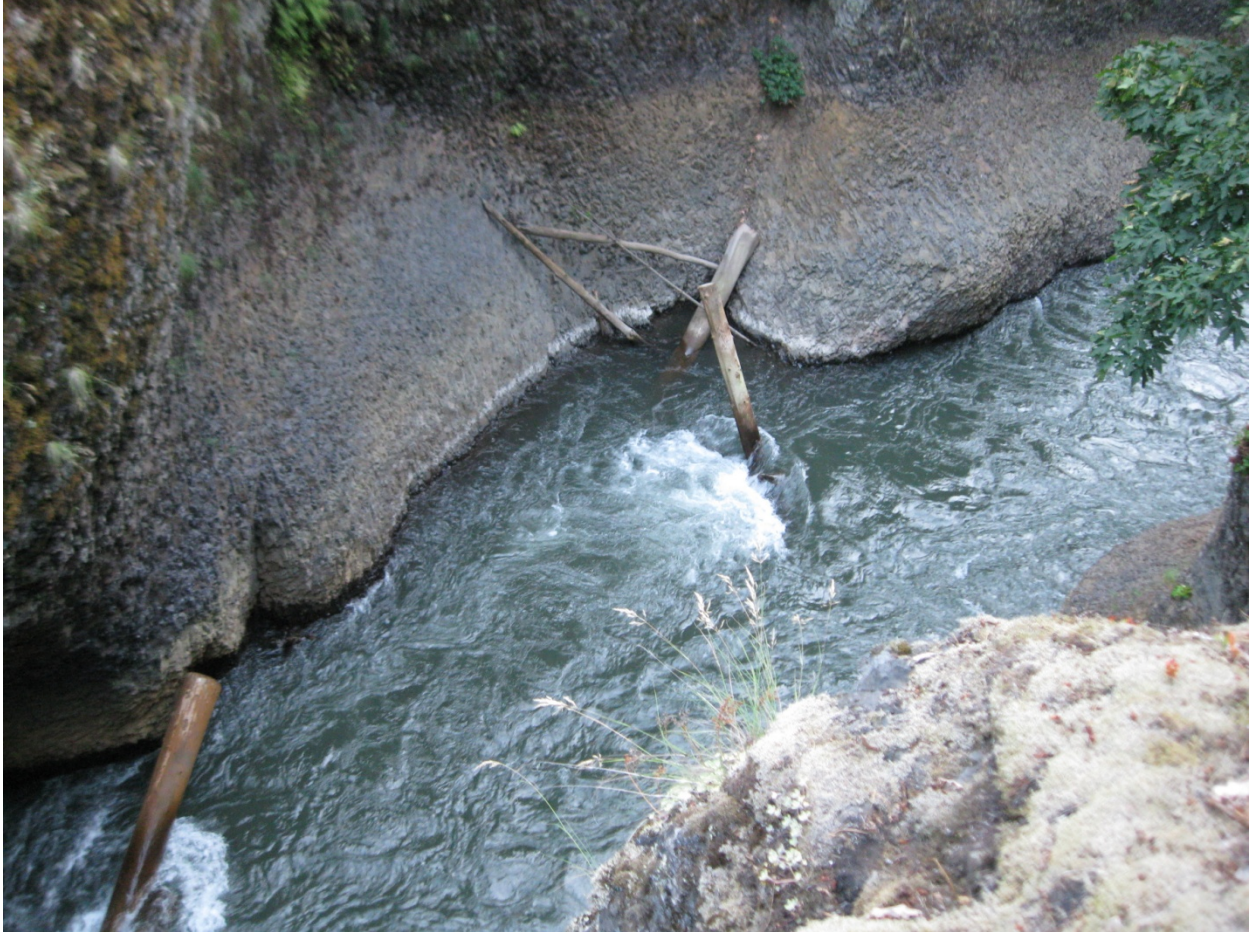
Photo 2. White Salmon River. Log jam in the Narrows. July 2012

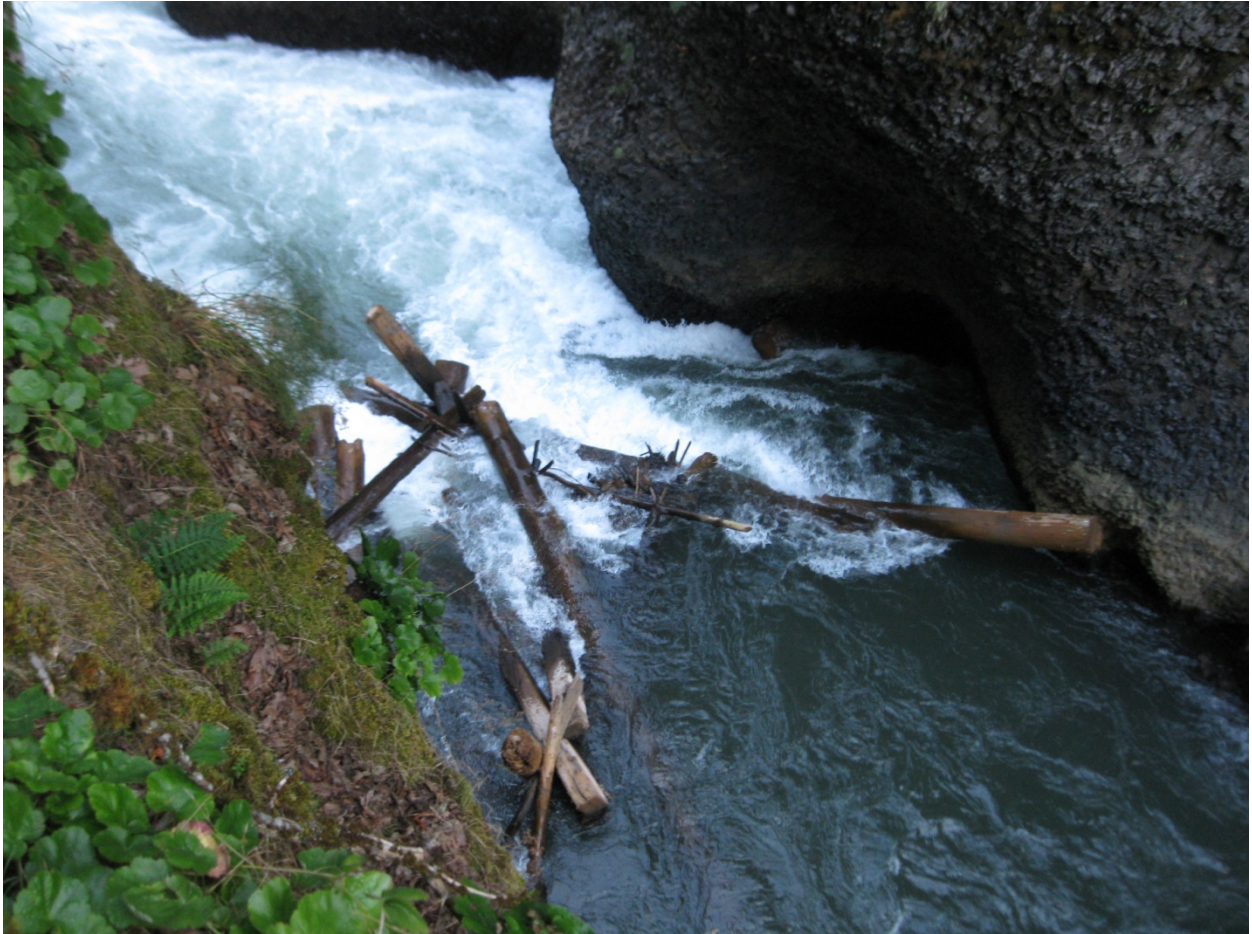
Photo 3. White Salmon River. Log jam in the Narrows. July 2012
