Condit Hydroelectric Project Decommissioning

FERC Project No. 2342

WOODY DEBRIS ANNUAL MONITORING REPORT 2013

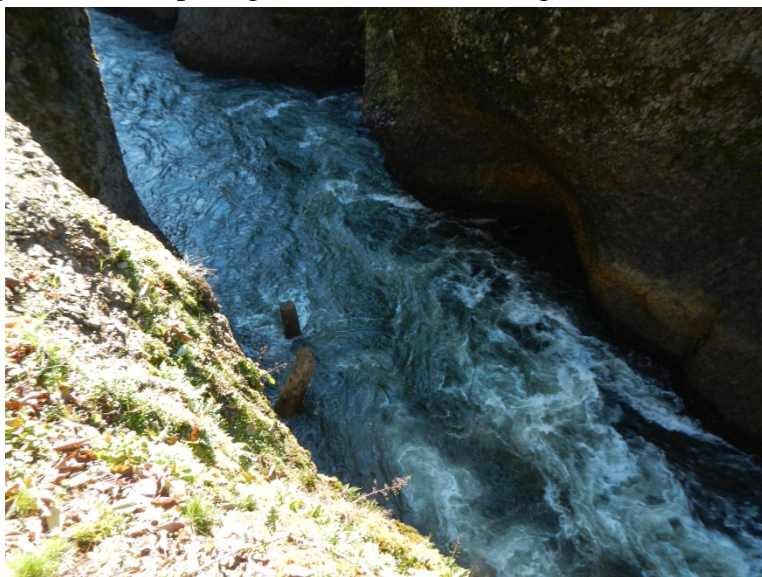
2.2 Canyon Reach

The Narrows remains clear for boater passage. November, 2013.

PacifiCorp Energy and the local boating community recognize that The Narrows location will remain a potential site for naturally occurring logjams and there is an active informal communications network among the community that spreads the word on conditions. These

communications have indicated that there have been some independent efforts to dislodge woody debris from the canyon reach. Surveys of the area by project personnel have noted signs of removal activities. Any independent actions were taken with neither PacifiCorp Energy involvement nor prior knowledge.

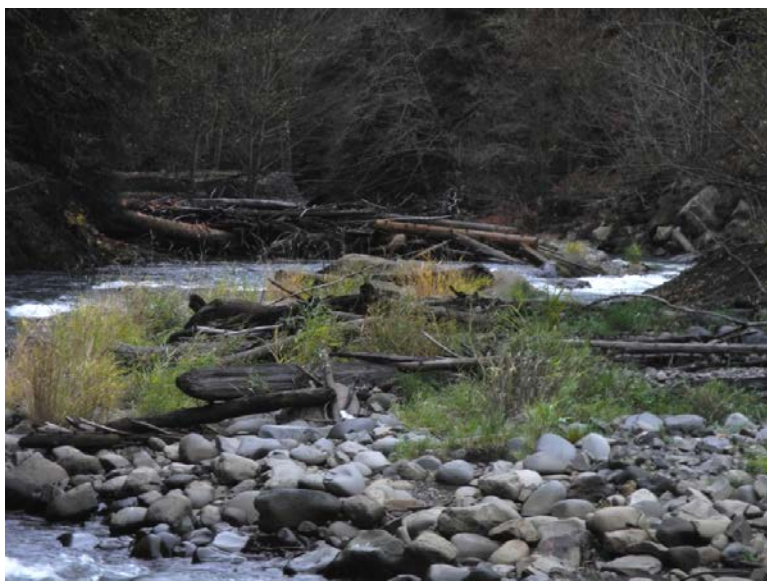
Also as previously reported, downstream of the U.S. Fish and Wildlife Service facility at the Big White Salmon Ponds, a pile of woody debris has accumulated on river left at a location where the river channel widens and a bedrock outcrop controls the channel bed form. The volume of this woody debris pile does not appear to have changed in size and the depositional form still does not show any anchoring to the channel bed or river banks. As noted, this woody debris may re-mobilize during a high flow event.

Woody debris downstream of Big White Salmon Ponds.

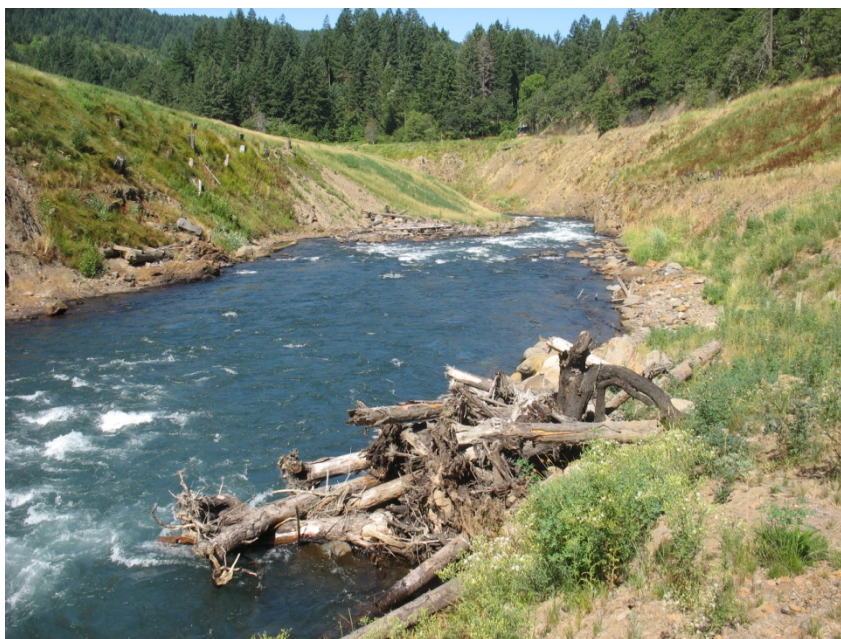
As part of decommissioning efforts, seven Engineered Log Jams (ELJs) were constructed within the reservoir reach in the locations shown on the drawing included at Appendix A. In the original Woody Debris Management Plan, the construction of ELJs was anticipated as a means to improve fish habitat, but after observing conditions once the reservoir sediments had eroded down to the old river bed profile, the ELJs were pursued primarily to enhance the establishment of riparian vegetation on low benches next to the river.

Engineered Log Jams constructed on the banks of the White Salmon River within the former reservoir area – December 2013.

The ELJs have proven entirely stable and conducive to the creation of downstream eddies, bank protection and minor fish spawning and resting areas.

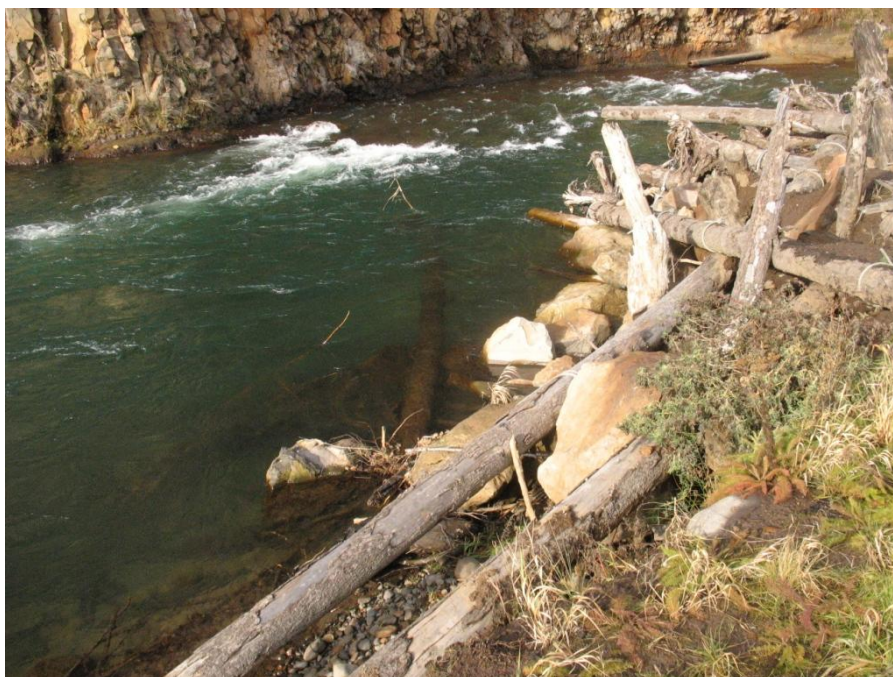
4.2.4 Structure No. 4, Location 4, Next to the Unnamed Tributary Stream The location on the inside of a bend opposite a vertical rock wall could encourage more material to deposit naturally during high water events, but little material has been deposited so far. This structure protrudes a little more into the river channel than the other ELJs, but does not impede boater traffic or present a hazard. This protrusion causes an eddy behind it that provides an area of refuge for fish and boaters to rest out of the main current. This eddy also promotes stability of the bank for riparian vegetation to propagate in this zone. The adjacent unnamed tributary is very small and would not likely transport woody debris of any size, but it has brought small material down into the structure. One log on the downstream side of the structure has shifted further downstream and mostly separated from the ELJ. This submerged log is located in the pool behind the ELJ and does not present a hazard to boating. Overall, the ELJ is stable and intact.

Engineered Log Jam No. 4 on the banks of the White Salmon River – December 2013
