Cutler Hydroelectric Project

FERC Project No. 2420

Resource Management Plan Five-Year Monitoring Report 2013-2017

**Cutler Hydroelectric Project
FERC Project No. 2420
Box Elder and Cache Counties, Utah**

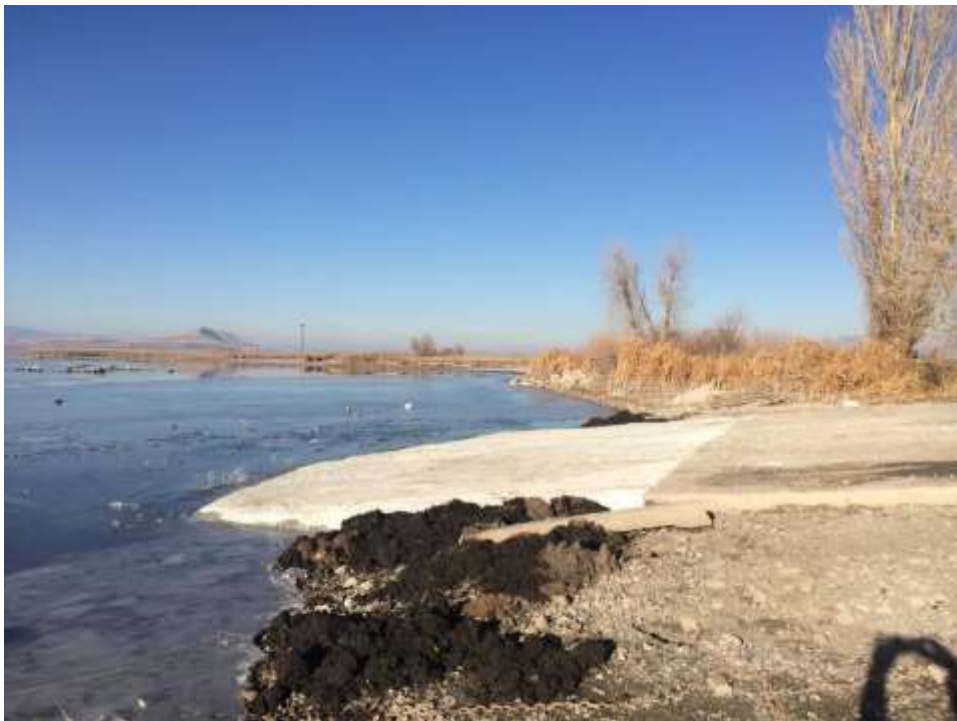
Photo D-6. Major ramp repair work at Benson Marina during reservoir draw down.

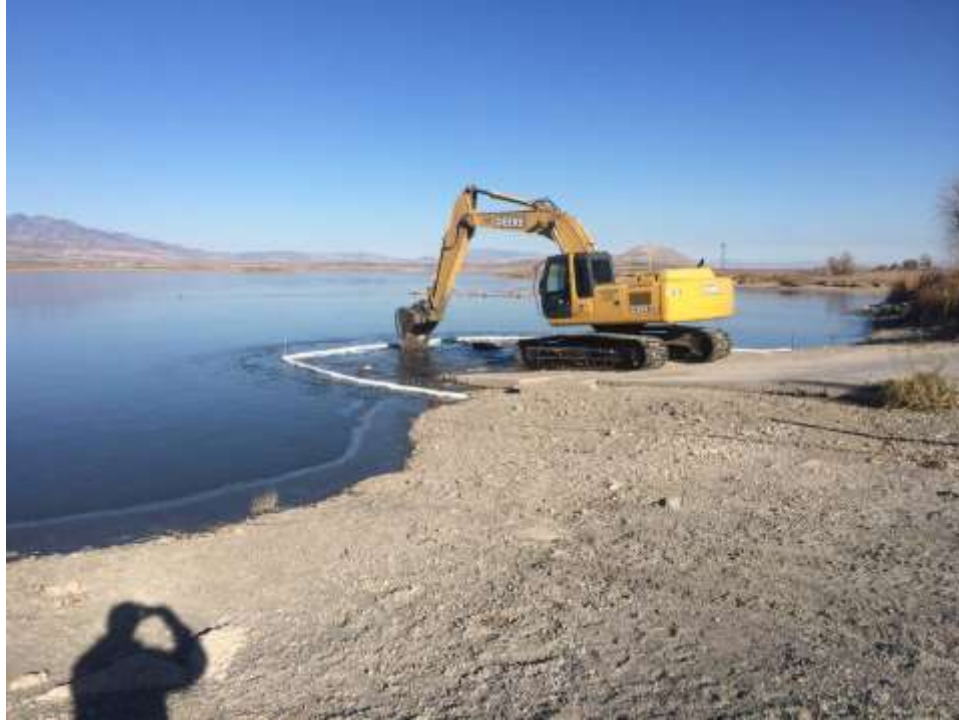
Photo D-7. Major ramp repair work at Benson Marina during reservoir draw down.

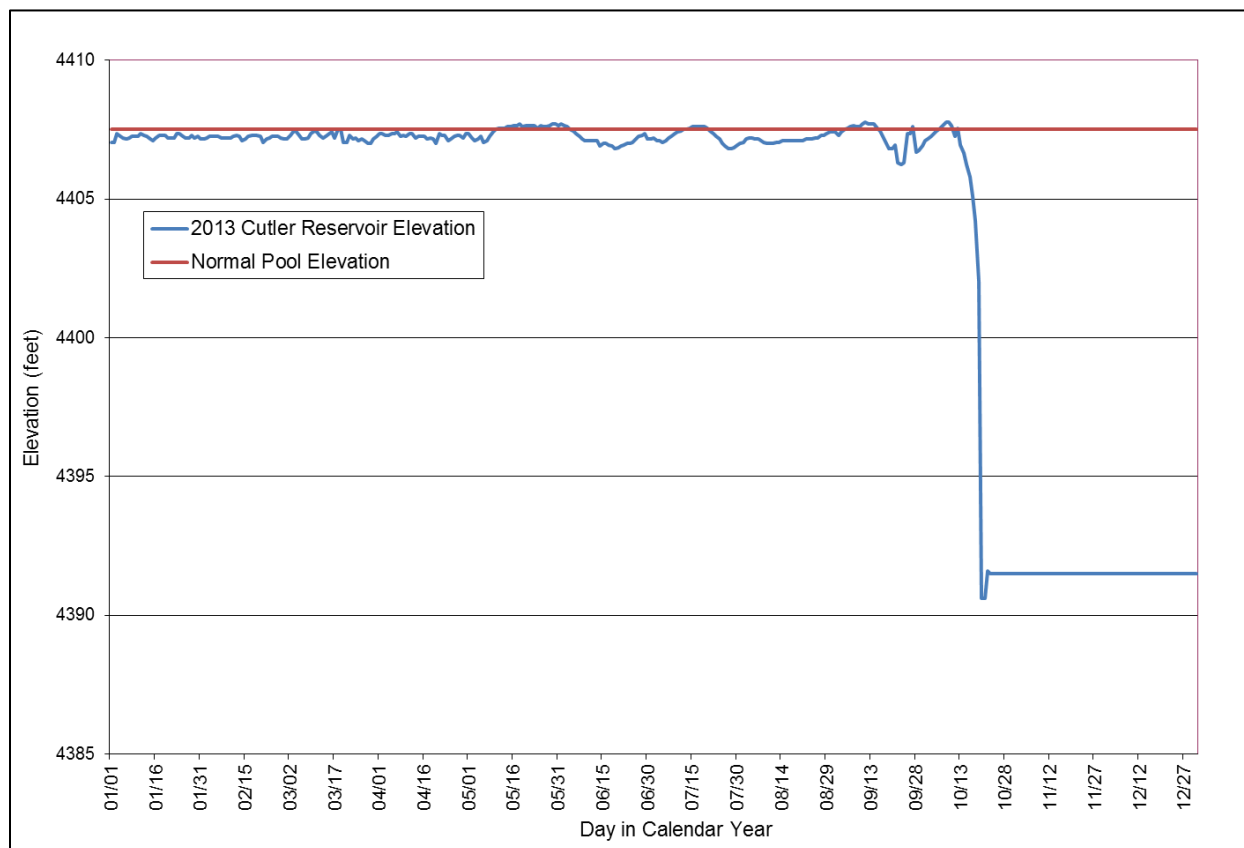
As discussed previously, Cutler Reservoir is operated in run-of-river mode such that water surface elevation is maintained between 4,406.25 feet and 4,407.75 feet from March 1 through December 1, and from 4,405.5 to 4,407.75 from December 2 through February 28. Although the surface elevation of the reservoir is managed according to FERC license specifications, in October 2013 a drawdown to 4,390.6

began for maintenance on the spill gates, which resulted in the reservoir being held lower than the standard operating levels until the first phase of repairs was complete, in early 2014 (Figure 4).

Figure 4. Cutler Reservoir surface elevations during 2013.

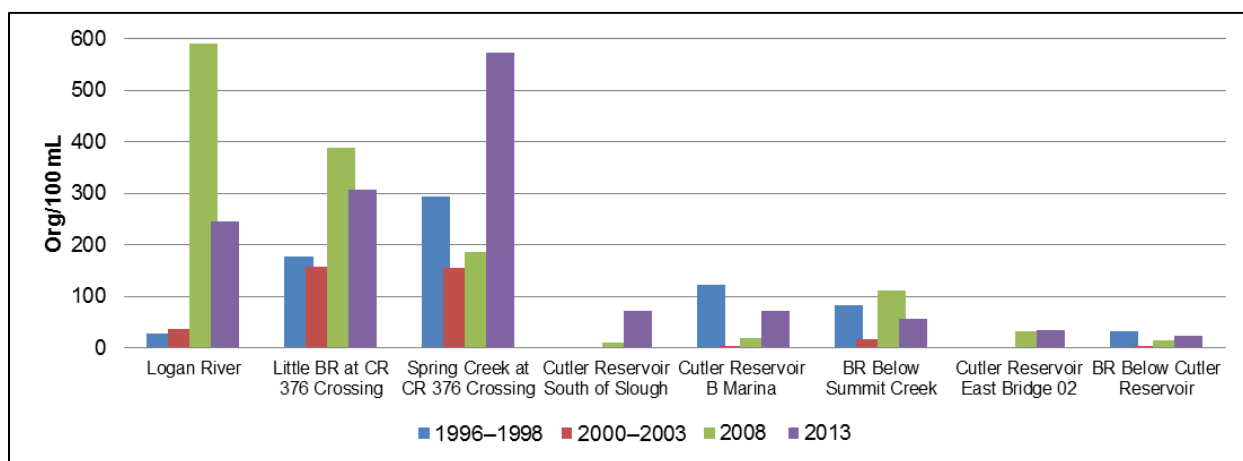
Figure 5. *E. coli* concentrations in the Cutler Reservoir system during baseflow for all monitoring periods.

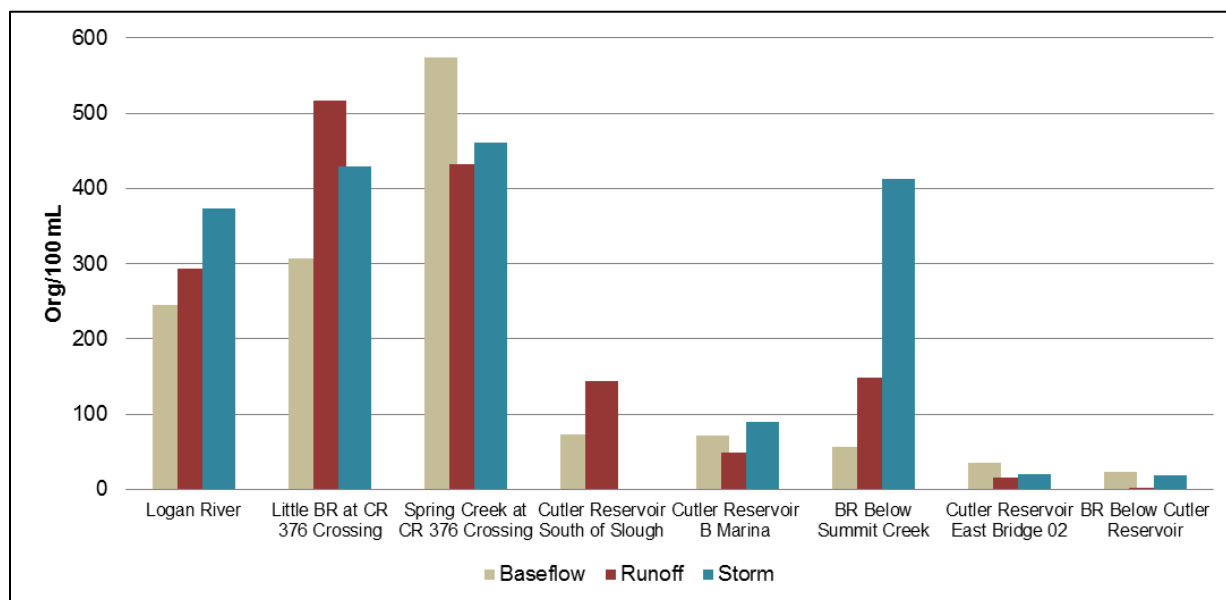
E. coli concentrations in the Cutler Reservoir system varied throughout the 2013 sampling period. In general, average *E. coli* concentrations were lowest during baseflow periods, and increased during runoff and storm conditions by 16% and 42%, respectively (Figure 6). The general increase in *E. coli* from baseflow conditions is expected because surface runoff, including storms, is the process that can transport bacteria to surface waters (e.g., runoff from agricultural sources). Additionally, high concentrations during fall storms are also expected due to surface runoff and warmer temperatures, which increase the survivability of bacteria relative to colder runoff conditions. However, at three of the sampling sites, baseflow concentrations were greater than runoff or storm concentrations. The most notable of these sites is Spring Creek, which, as discussed, is located near the EA Miller meat-packing plant. Average *E. coli* concentrations at tributary sites during baseflow, runoff, and storm events were 391%, 400%, and 664% higher than the average concentrations at Cutler Reservoir sites during the same conditions. These results suggest that the flushing of terrestrial areas, especially during storms, can concentrate bacteria prior to subsequent dilution in Cutler Reservoir.

Figure 6. *E. coli* concentrations in the Cutler Reservoir system during the 2013 sampling period.

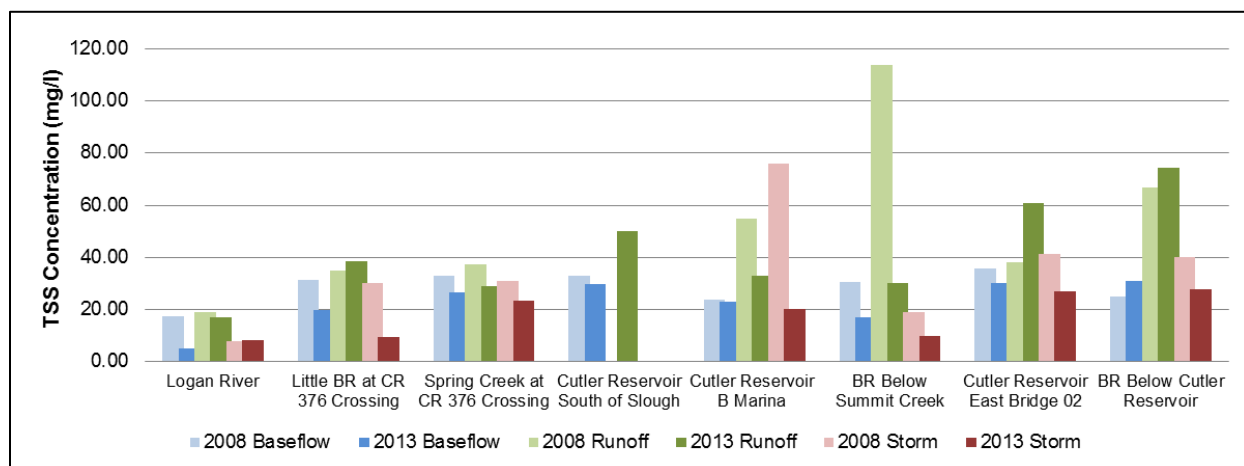
Turbidity samples were also collected during all hydroperiods in 2008 and in 2013. A comparison of TSS results during baseflow, runoff, and storm conditions in 2008 and 2013 is presented in Figure 11. In general, TSS follows a similar seasonal trend as turbidity, with the highest values collected during runoff conditions, and at Cutler Reservoir sites. These results also suggest that storms have the potential to increase TSS more than turbidity in this system, which can result in higher nutrient inputs. These results also suggest that turbidity and TSS only correlate at some sites, such as the Bear River below the dam and

Figure 11. Average total suspended solids (TSS) for sampling sites by 2008 and 2013 hydroperiod.
