# **CUTLER HYDROELECTRIC PROJECT**

**FERC NO. 2420**

## **INITIAL STUDY REPORT**

### **VOLUME I**

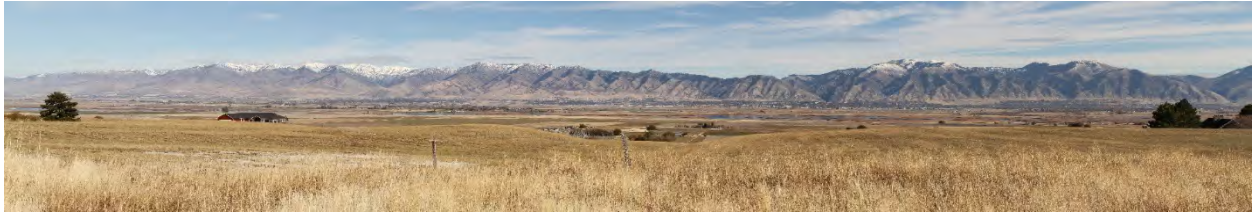
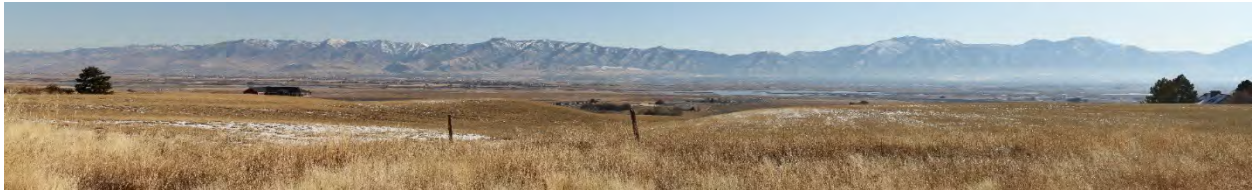
**FIGURE 6-3 HIGHWAY 30 AND 2100 NORTH, MENDON, UTAH**

October 24, 2019, baseline (full-pool; elevation as measured at Cutler Dam 4,407.3 feet, per transducer data).

November 1, 2019, drawdown (elevation as measured at Cutler Dam 4,392.4 feet, per transducer data).

Referencing Figure 6-3, no exposed reservoir bed is visible at that distance before or during drawdown from the Highway 30 photopoint. At Cutler Marsh Marina (Figure 6-4), the November 1 drawdown photo, the primary reference for this photopoint, shows a narrow band of muddy reservoir bed in the foreground. The proposed increase in drawdown limit would translate to 0.5 feet higher elevation than illustrated in the November 1 photo, which would marginally reduce the band of exposed reservoir bed.

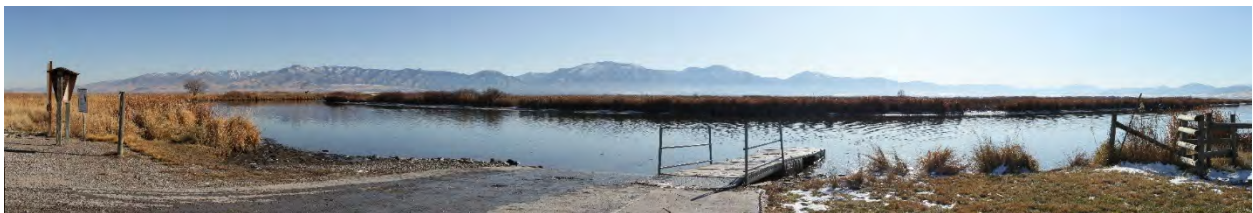
**FIGURE 6-4 CUTLER MARSH MARINA**

November 1, 2019, drawdown (elevation as measured at Cutler Dam 4,392.4 feet; elevation at Cutler Marsh Marina 4,405.8 feet, per transducer data).

below the elevation of the relatively flat reservoir bed. Second, these gaps may be evident from a bird's-eye view but become less visible from lower-angle perspectives at or near reservoir elevation (Figure 6-4 and Figure 6-5). They are much more visible from a bridge than from a shoreline recreation site. The steeper topography in Cutler Canyon make exposed reservoir bed and banks more visible (Figure 6-6).

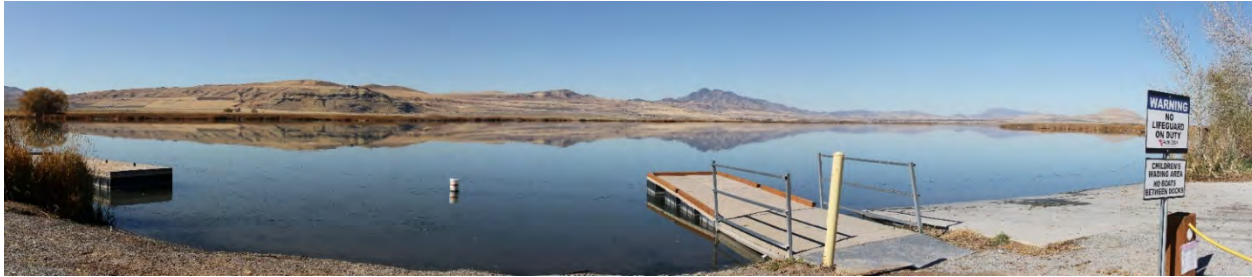
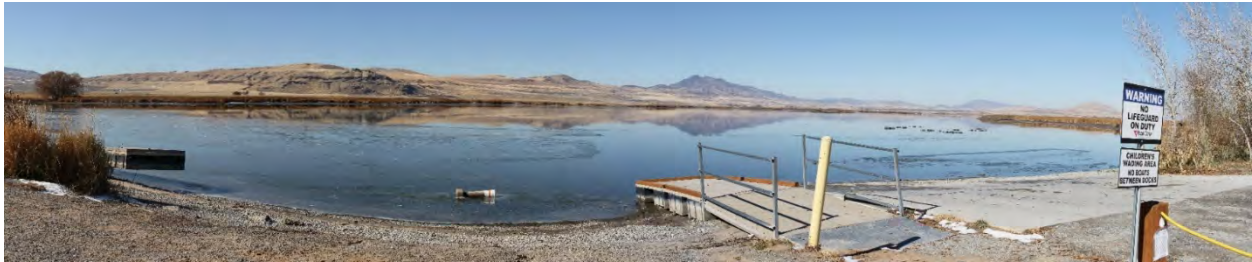
**FIGURE 6-5 BENSON MARINA**

October 24, 2019, baseline (full-pool; elevation as measured at Cutler Dam 4,407.3 feet; elevation at Benson Marina 4,407.4 feet, per transducer data).

November 1, 2019, Drawdown (elevation as measured at Cutler Dam 4,392.4 feet; elevation at Benson Marina 4,404.8 feet, per transducer data).

While they occur within the viewsheds of some of the non-representative photopoints (see Attachment D3), eroding banks are generally low enough to be difficult to discern or have been stabilized with plantings, as is the case on the west bank across from the Benson Marina photopoint (Figure 6-5). Based on these considerations, assessment of changes in bank erosion focuses on the Cutler Canyon photopoint (Figure 6-6), representing Cutler Canyon and the transition area into the canyon.

At Benson Marina (Figure 6-5), interpolating between the October 24 baseline and November 1 drawdown photos, a wider band of rocky reservoir bed would be exposed, reflecting roughly the midpoint between the October 24 and November 1 photos.

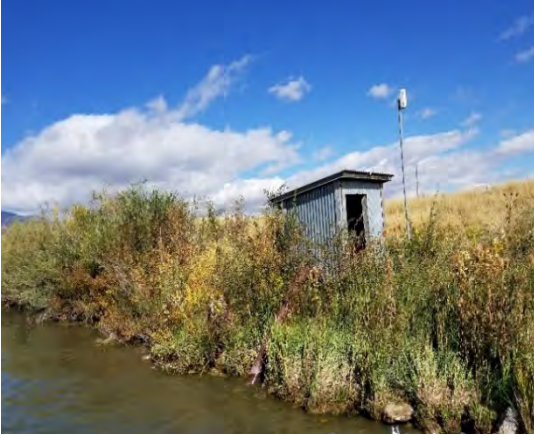
WID:	1
Northing	4632826.375
Easting	417201.5165
WR# (map)	25-7329
WR name (map)	46 DALE BENSON
WR# (POD)	25-7329, 25-8297
WR owner (POD)	JANICE R. BENSON
Power source	Electricity

Description:	Surveyed 9/27/19. Photo shows pump house and intake. This site will receive an additional pump, managed by West Cache Irrigation Co. in the future. Existing pump has a single inflow, 8–10 in. diam pipe extending out ~40 feet, end of pipe is perforated, no screen. Currently has electric pressure pump with on/off pressure sensor, active condition with telemetry (see antenna), flow record rated good (1989-2019).
Elevation of withdrawal (ft. msl)	4,407.80
Operational status	Potentially operational.

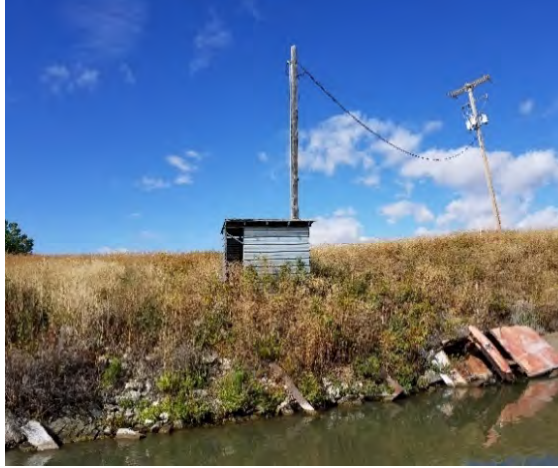
WID:	2
Northing	4631930.891
Easting	417216.6507
WR# (map)	–
WR name (map)	–
WR# (POD)	25-7174
WR owner (POD)	DUANE W. GRIFFIN
Power source	Electricity

Description:	Surveyed 9/27/19. Photo shows pump house and flexible intake line, ~6 in. diameter extending out ~20 feet from shoreline, end of pipe enclosed in screen. Pump in working order. No telemetry visible, no UDWRi record.
Elevation of withdrawal (ft. msl)	4,408.10
Operational status	Potentially operational

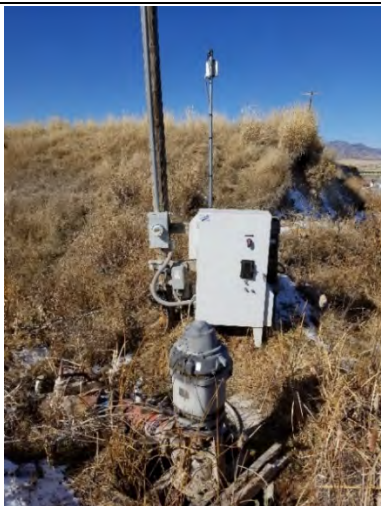
Description:	Surveyed 11/2/19. Photos shows pump and connection to stilling well. Intake pipe to well is ~12 in. PVC pipe extending 105 feet, no screen on end, sediment deposit on pipe for most of length. Ultrasonic flow sensor, pump is active, connected to antenna, flow record rated fair (1989-2019).
Elevation of withdrawal (ft. msl)	4,408.02
Operational status	Potentially operational

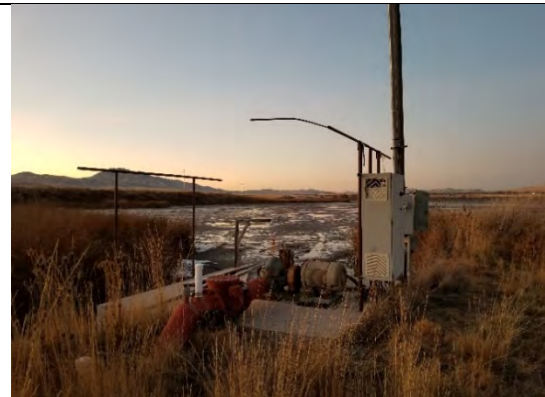
Description:	Surveyed 11/6/19. Photo shows pump (50 HP electric) and ~12 diam steel discharge pipe set on 14 ft. square concrete pad. Intake connected to adjustable (floating) withdrawal, rotating screen at end, draws from tributary pond. Flow monitored by ultrasonic sensor, flow record rated fair (1989–2019).
Elevation of withdrawal (ft. msl)	4,410.14
Operational status	Potentially operational

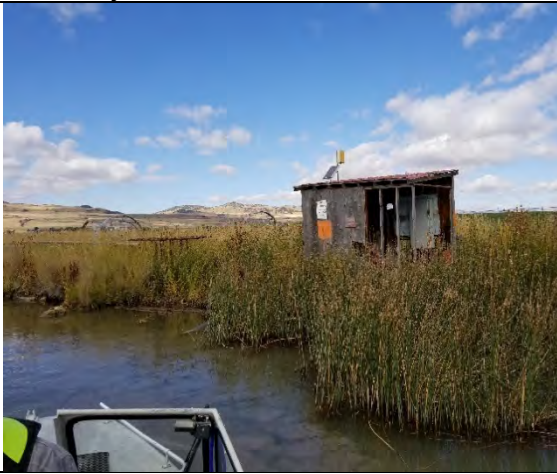
Description:	Surveyed 9/27/19. Photo shows electric pressure pump with on/off pressure sensor and telemetry (see antenna). Connected to 75 ft. intake with 6 in. pipe and 4 ft. screen at end, partially buried in sediment, flow record rated good (1989-2019).
Elevation of withdrawal (ft. msl)	4,409.08
Operational status	Potentially operational

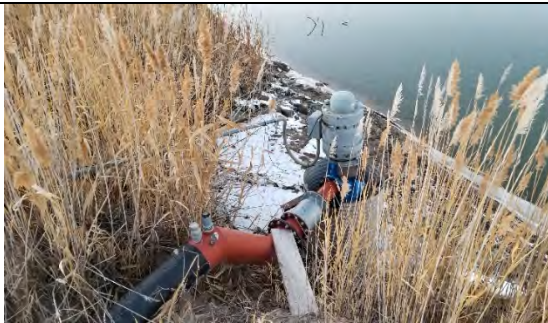
Description:	Surveyed 11/6/19. Photo shows 50 HP electric pressure pump above stilling well (~ 5 ft. diam) and steel discharge pipe (~ 10 in. diam), power pole and telemetry outside of photo, no intake pipe visible, flow monitored by ultrasonic sensor, flow record rated fair (1989-2019).
Elevation of withdrawal (ft. msl)	End of pipe was submerged during drawdown.
Operational status	Potentially operational

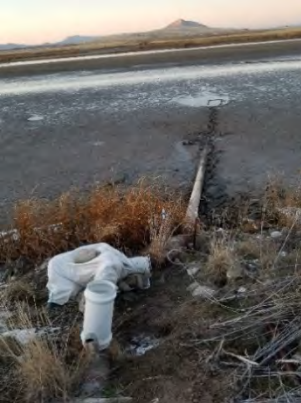
Description:	Surveyed 11/6/19. Photos show electric pump (covered) and ~6 in. PVC intake extending 32 feet, mesh screen at end buried in sediment, power pole and telemetry outside of photo. UDWRi records indicate diesel pump at this location, flow monitored by ultrasonic flow sensor, record rated fair (1989-2019)
Elevation of withdrawal (ft. msl)	4,410.79
Operational status	Potentially operational

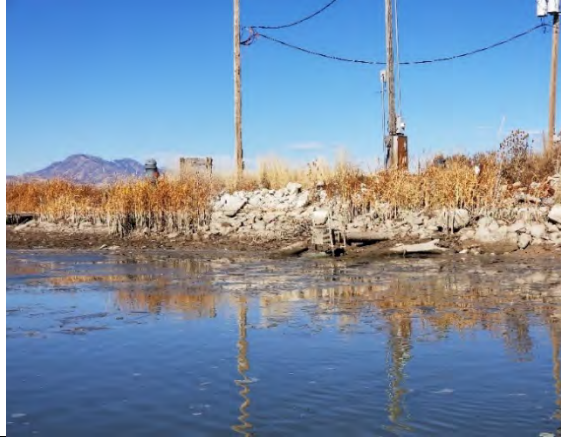
Description:	Surveyed 11/2/19. Photos show two pumps. The left pump (75 HP electric pump) is WID 8, intake pipe (~ 8 in. diam) is underwater but visible near shore and extends out of sight, flow measured by ultrasonic sensor, record rated fair (1989-2019).
Elevation of withdrawal (ft. msl)	End of pipe was submerged during drawdown.
Operational status	Potentially operational

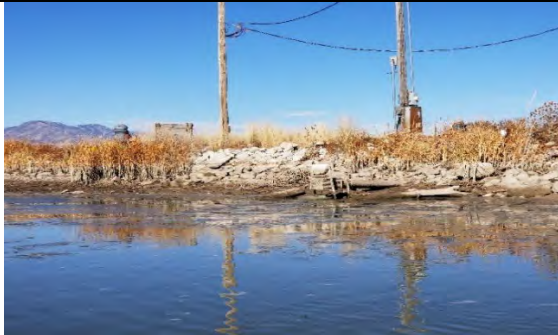
Description:	Surveyed 11/2/19. Photos show two pumps. The right pump (WID 9), visible intake (~ 8 in. diam) at center of photo extends ~ 10 ft. with cage on end and secured to fence posts directly above the intake for WID 8, no flow records available for WID 9.
Elevation of withdrawal (ft. msl)	4,408.05
Operational status	Potentially operational

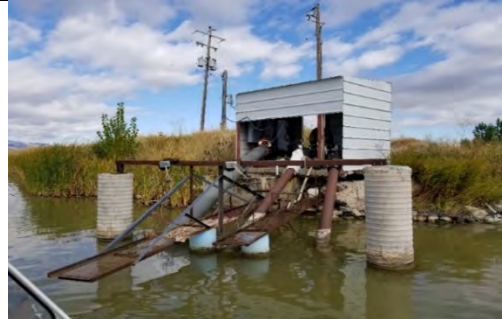
Description:	Surveyed 9/27/19. Photo shows pumps and three steel intake pipes 12–16 in. diam with screens, extending ~ 10 feet into water, adjustable with cable and motor, electric pressure pumps monitored by ultrasonic flow sensors, flow record rated fair 1989–2019.
Operational status	Potentially operational

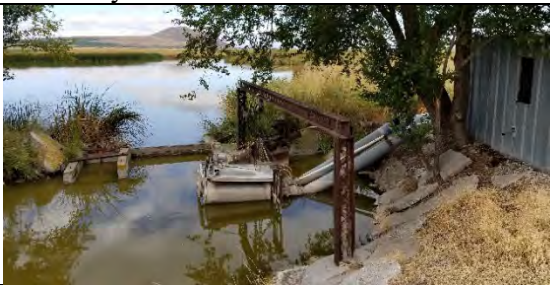
Description:	Surveyed 9/27/19. Photo shows pumphouse and dual ~10 in. intakes with adjustable spinning screens, water pumped from stilling basin with intake (left), pumps monitored with ultrasonic flow sensors, flow record rated fair (1989-2019).
Elevation of withdrawal (ft. msl)	4,408.84
Operational status	Potentially operational

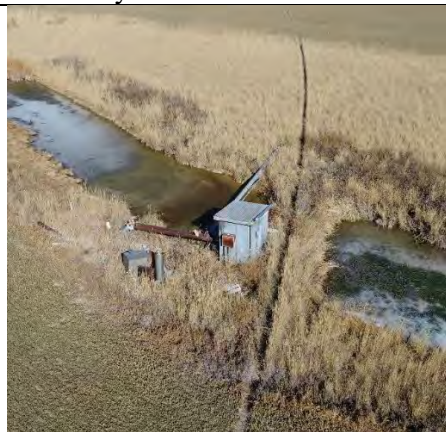
Description:	Surveyed 11/5/19. Photo shows pumphouse and two discharge pipes (one left and one above pumphouse) into pond. Pump collects water from pond to left, excess water flows into pond at right. Photo collected by drone. Flow records are unrated (1991–2019).
Elevation of withdrawal (ft. msl)	Variable, water elevation regulated by control structure at road crossing on Clay Slough.
Operational status	Potentially operational

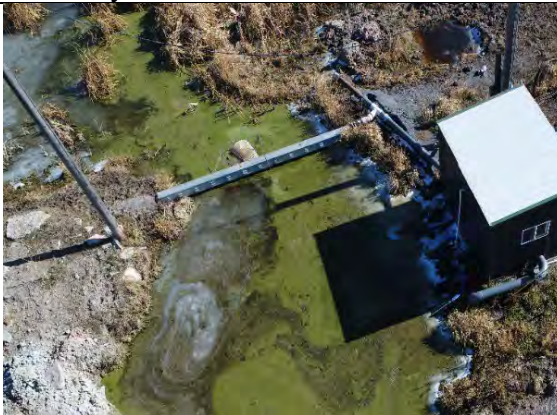
Description:	Surveyed 11/5/19. Photo shows pumphouse and one intake pipe into pond at left. Photo collected by drone, no flow records available.
Elevation of withdrawal (ft. msl)	Variable, water elevation regulated by control structure at road crossing on Clay Slough.
Operational status	Potentially operational

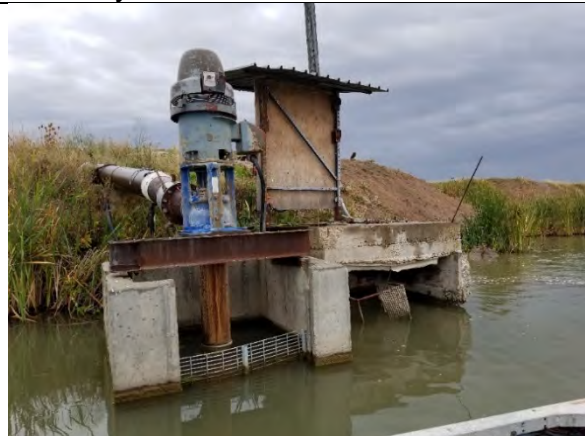
Description:	Surveyed 9/27/19. Photo shows pumphouse and steel intake pipe ~14-16 in. diameter connected to bottom of pump and extending down into screened concrete well. Discharge from pump connected to the back of pump. Pump and intake are functional, no flow records identified.
Elevation of withdrawal (ft. msl)	End of pipe was submerged during drawdown.
Operational status	Potentially operational

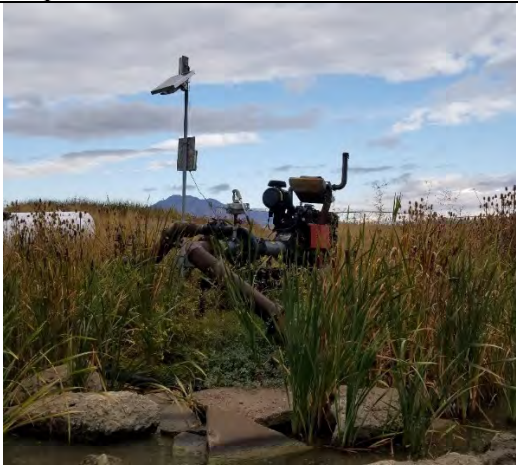
Description:	Surveyed 9/27/19. Photo shows 80 HP Ford propane pump connected to ~12 in. steel intake pipe (center of photo). Pump draws from pond at shoreline and filled by 3-foot plastic culvert. Pump controlled by on/off pressure sensor, flow record rated fair (1989-2019).
Elevation of withdrawal (ft. msl)	4,410.22
Operational status	Potentially operational

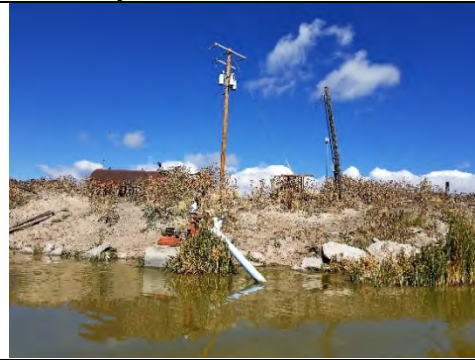
Description:	Photo shows electric pump installed on small concrete base at shoreline and intake pipe (6 in. PVC) to center of photo, flow monitored by telemetry (see antenna near pole). Pump and intake are functional, no flow records identified.
Elevation of withdrawal (ft. msl)	End of pipe was submerged during drawdown.
Operational status	Potentially operational

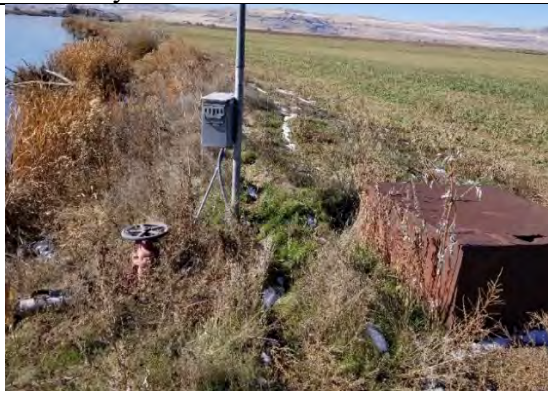
Description:	Photo shows antenna and utility box containing 25 HP pump, pipe with gate valve to left of antenna. Survey identified two small 3 in. pipes at bottom of slope to left, assume these are intake, flow monitored by on/off pressure sensor, flow record is unrated (2005–2019).
Elevation of withdrawal (ft. msl)	4,409.14
Operational status	Potentially operational

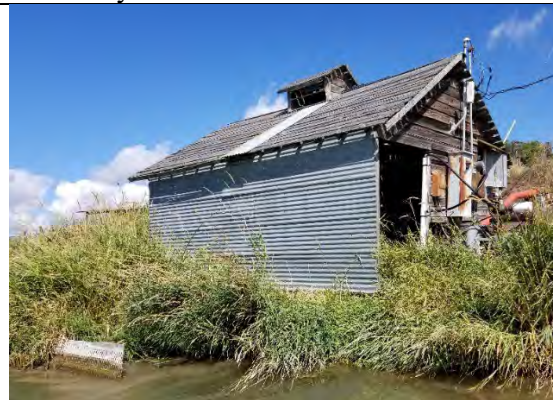
Description:	Surveyed 9/27/19. Photo shows pumphouse and antenna, intake is behind screen to photo left at water surface, pump is 60 HP electric pressure pump monitored with ultrasonic flow sensor, flow record is rated fair (1989–2019). If pipe was submerged during drawdown.
Elevation of withdrawal (ft. msl)	2019
Operational status	Potentially operational

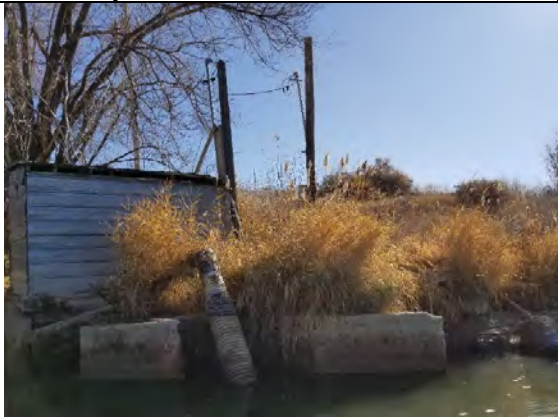
Description:	Surveyed 11/6/19. Photo shows pumphouse to left and ~14-inch diameter intake pipe in concrete box, small pump and barrel screen to right. Main pump is 10 HP electric flood pump, monitored by on/off pressure sensor, flow record rated fair (1989-2019). No UDWRi record for small pump to right.
Elevation of withdrawal (ft. msl)	End of pipe was submerged during drawdown.
Operational status	Potentially operational

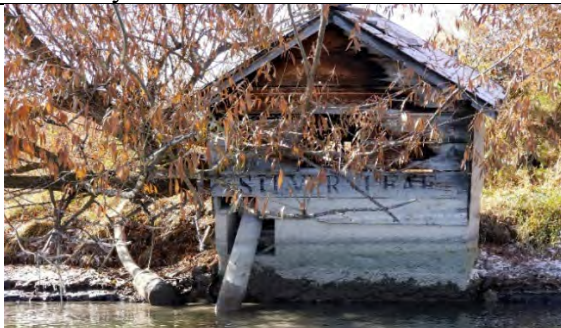
Description:	Surveyed 11/1/19. Photo shows pumphouse and two intake pipes including 6 in. flexible pipe and screen to left and ~12 steel pipe at center. Pump is 12 HP electric flood pump monitored with on/off pressure sensor, flow record is rated fair (1989-2019)
Elevation of withdrawal (ft. msl)	Small intake pipe (left): 4,407.68 Large intake pipe (center): end of pipe was submerged during drawdown.
Operational status	Potentially operational

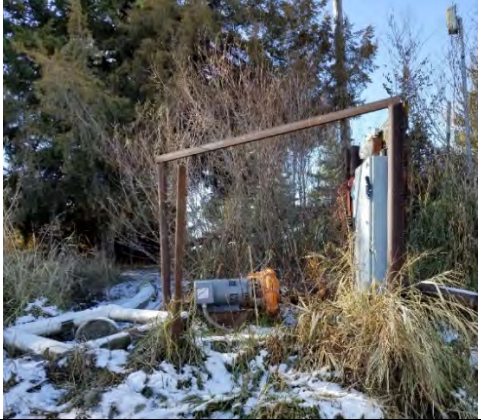
Description:	Surveyed 11/1/19. Photo shows winterized pump and 10-foot section of intake pipe (flexible 8 in. diam) to left of pipe, likely suspended during summer from floating frame (see left of pump). Pump and intake are functional, No flow records identified.
Elevation of withdrawal (ft. msl)	Variable.
Operational status	Potentially operational

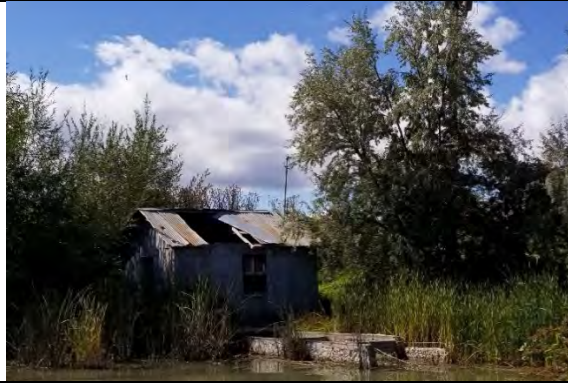
Description:	Surveyed 9/27/19. Photo shows pumphouse, antenna top of pumphouse, and concrete intake throughout structure to center of photo. Pump is 30 HP electric flood pump, measured with 18-inch Parshall Flume, flow record is rated good (1989–2019).
Elevation of withdrawal (ft. msl)	4,410.93
Operational status	Potentially operational

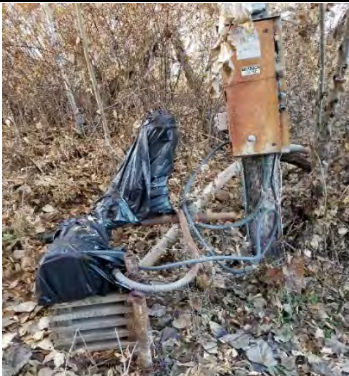
Description:	Surveyed 11/5/19. Photo shows winterized pump and plumbing connection, electric meter box, and 3-inch flexible intake pipe that was removed from water for the year. Pump and intake are functional, no flow records identified.
Elevation of withdrawal (ft. msl)	4,412.72
Operational status	Potentially operational

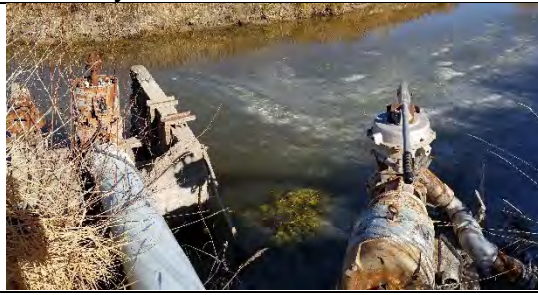
Description:	Surveyed 11/5/19. Photo shows small electric pressure pump (photo right) connected to flexible 4-inch diameter intake in pond. Concrete structure and pipe to photo left are inactive. Pond is filled by diversion ditch off Bear River. Flow monitored by on/ off pressure sensor, flow record rated fair (1989-2019)
Elevation of withdrawal (ft. msl)	End of pipe was submerged during drawdown.
Operational status	Potentially operational

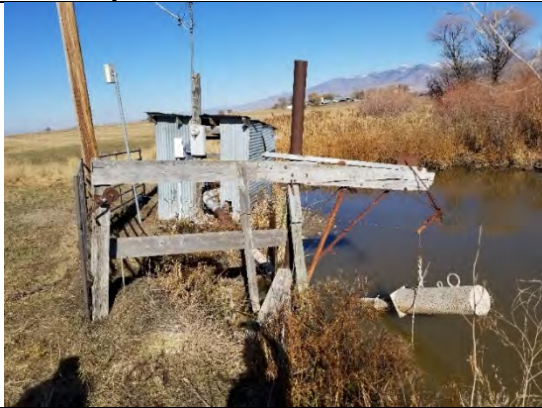
Description:	Surveyed 11/5/19. Photo shows pumphouse, radio antenna (photo left), and adjustable intake with screen (photo right) above small pond. Pump and intake are functional, no flow records identified.
Elevation of withdrawal (ft. msl)	Variable.
Operational status	Potentially operational

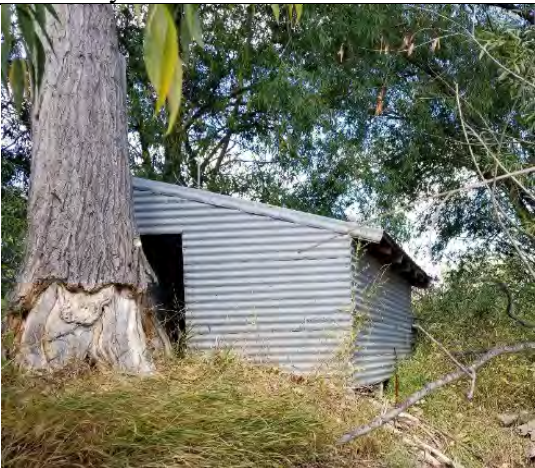
Description:	Surveyed 9/9/27. Photo shows pumphouse only. Pump inside, no visible intake at surface to pump, large pond behind pumphouse filled by diversion from river. Pump and intake are functional, no flow records identified.
Elevation of withdrawal (ft. msl)	None visible
Operational status	Potentially operational

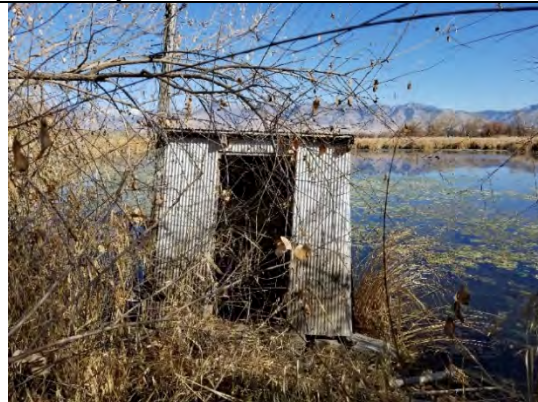
Description:	Surveyed 11/5/19. Photo shows pumphouse adjacent to irrigation pond. General location of this pump on irrigation district map, pump has been removed from house, two metal pipes (4-inch and 1-inch extend into pond), adjacent landowner did not know current location of pump.
Elevation of withdrawal (ft. msl)	None.
Operational status	Non-operational (no pump at site).

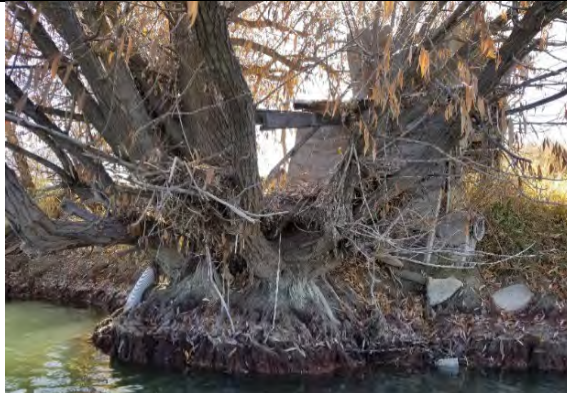
Description:	Surveyed 9/29/19. Photo shows wooden shelter above pump, and flexible pump intake to left of tree, the mount of an old intake is visible to right of tree near grass. Pump and intake are functional, no flow records identified.
Elevation of withdrawal (ft. msl)	End of pipe was submerged during drawdown.
Operational status	Potentially operational

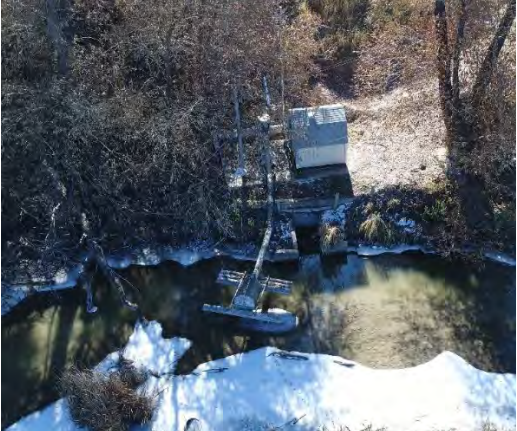
Description:	Surveyed 11/5/20. Photo shows pumphouse and intake pipe attached to float with rotating screen at end of pipe. Photo collected by drone. Pump draws from ditch that drains large pond to north. Pond is filled by diversion from Bear River. Pump and intake appear functional, no flow records identified.
Elevation of withdrawal (ft. msl)	Variable
Operational status	Potentially operational

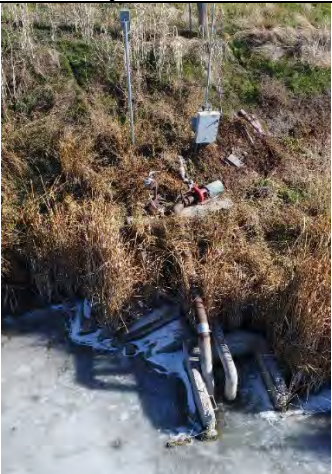
Description:	Surveyed 11/5/20. Photo shows 20 HP electric flood pump, two intake pipes (~12-inch diameter) in concrete well, power box and radio antenna (upper photo left). Flow is monitored by an on/off pressure sensor, record is rated fair (1989-2019).
Elevation of withdrawal (ft. msl)	End of pipe was submerged during drawdown.
Operational status	Potentially operational

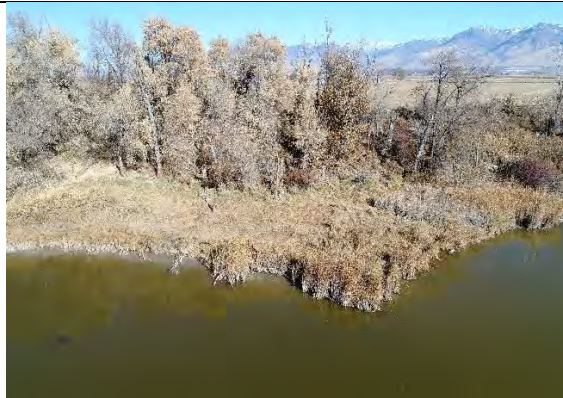
Description:	Surveyed 11/5/19. Photo shows shoreline area of the location on irrigation district map where pump should be. Photo collected by drone. No sign of pump, intake pipe, or Power source (i.e. power pole or line) at this location.
Elevation of withdrawal (ft. msl)	None.
Operational status	Non-operational (no infrastructure identified)

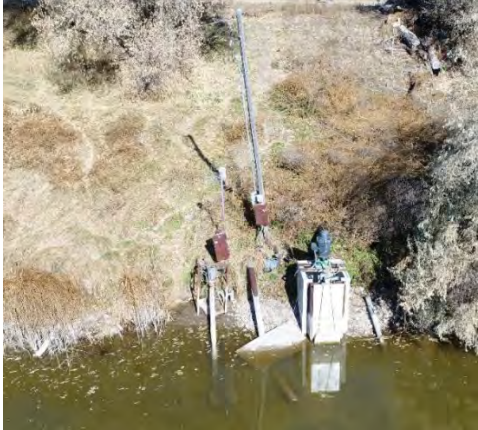
Description:	Surveyed 11/5/19. Photo shows three irrigation pump, two intake pipes (~10-inch diameter), concrete stilling well, electrical connection and radio antenna (left of power pole). UDWRi records show a single 15 HP electric pressure pump monitored by on/off pressure sensor, flow record rated fair (1989-2019).
Elevation of withdrawal (ft. msl)	End of pipe was submerged during drawdown.
Operational status	Potentially operational

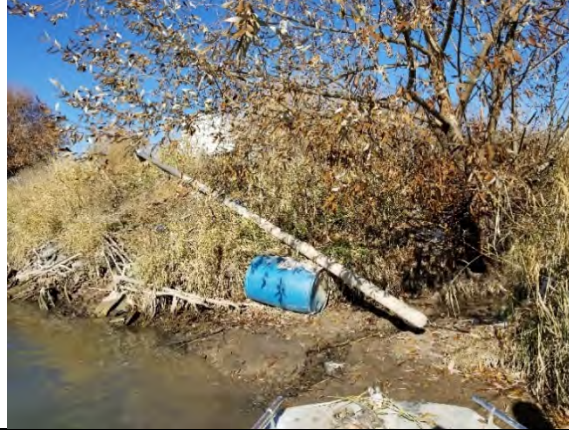
Description:	Surveyed 11/1/19. Photo shows metal intake pipe with perforated end, attached to sealed 50-gallon drum used as a float. Pump is a diesel pressure pump, flow is monitored by an on/off pressure sensor, flow record is rated fair (1989-2019).
Elevation of withdrawal (ft. msl)	Variable
Operational status	Potentially operational

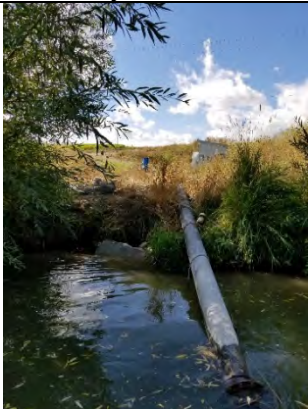
Description:	Surveyed 9/27/19. Photo shows 12-inch diameter intake pipe connected to pump in pumphouse located off bank (to right of blue barrel) and radio antenna. Intake pipe is adjustable with cable and winch. UDWRi record shows two pumps at this site including 25 HP electric flood and 25 HP electric pressure pumps monitored by ultrasonic flow sensor, record is rated fair (1989-2019)
Elevation of withdrawal (ft. msl)	Variable
Operational status	Potentially operational

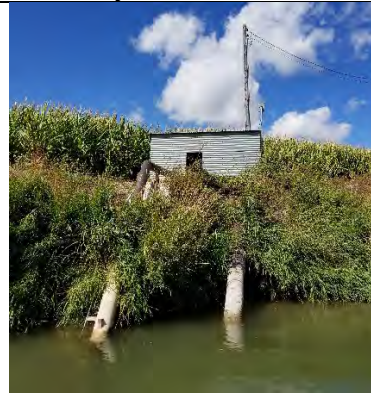
Description:	Surveyed 9/27/19. Photo shows pumphouse, radio antenna (right side of roof), and two metal intake pipes (~12 inch diameter, screened at end), Pump is 30 HP electric flood monitored by ultrasonic flow sensor, flow record is rated fair (2005-2019).
Elevation of withdrawal (ft. msl)	End of pipes were submerged during drawdown, screen on left intake pipe was visible.
Operational status	Potentially operational

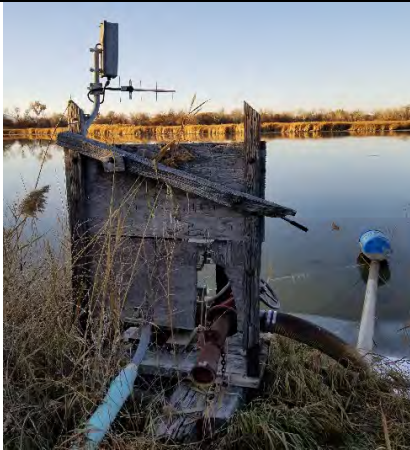
Description:	Surveyed 11/5/19. Photo shows wooden shelter above pump, radio antenna and intake pipe (~6-inch diameter) extending ~ 15 feet into pond. Pipe is connected to sealed barrel used as float. Pump is 25-HP electric pressure pump monitored by on-off pressure sensor, flow record is rated fair (1989-2019).
Elevation of withdrawal (ft. msl)	Variable
Operational status	Potentially operational

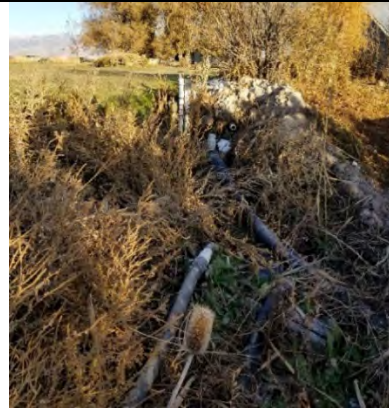
Description:	Surveyed 11/6/19. Photo shows connections to two intake pipes (~ 6-inch diameter) that extend 5 – 10 feet from shoreline. Pump is a propane pressure pump, located outside of photo to left, flow monitored by ultrasonic flow sensor, record rated fair (1989-2019).
Elevation of withdrawal (ft. msl)	4.410.11
Operational status	Potentially operational

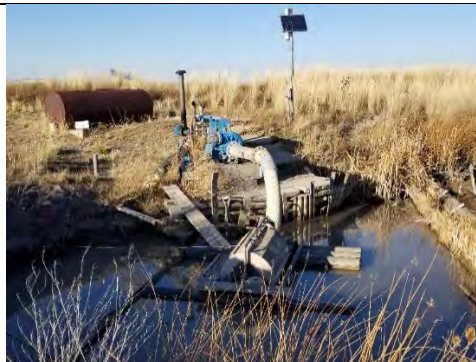
Description:	Surveyed 11/5/19. Photo shows pump (116 HP Deutz Diesel) connected to flexible intake pipe (~10-inch diameter), rotating screen/floating platform in pond, radio antenna with solar panel (right of pump) and fuel tank (left of pump). Pond is filled by large ditch diverting from reservoir. Flow record rated fair (1989-2019).
Elevation of withdrawal (ft. msl)	Bottom of ditch: 4,411.15
Operational status	Potentially operational

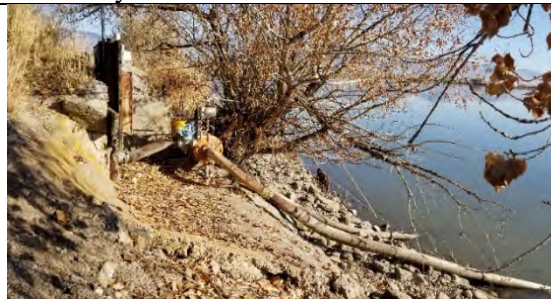
Description:	Surveyed 11/5/19. Photo shows pump (30 HP electric pressure pump) and two flexible intake pipes (~4 inches diameter, screened at end) extending 10 feet from shoreline, and electrical source with base of antenna. A second pump is located directly behind pump shown, both appear functional. First pump monitored by on/off pressure sensor, flow record rated good (1989-2019), no record for other pump
Elevation of withdrawal (ft. msl)	4,409.25 (intake – large pump), the end of small intake pipe was submerged during drawdown.
Operational status	Potentially operational

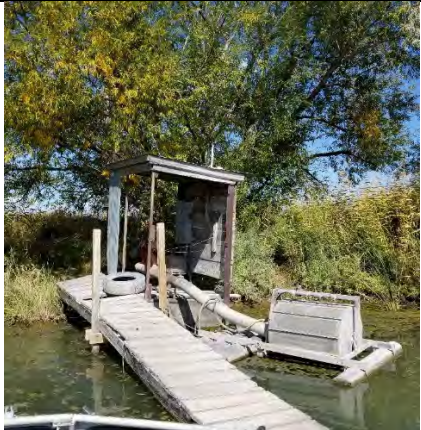
Description:	Surveyed 9/27/19. Photo shows wooden shelter, pump (40 HP electric pressure pump), intake pipe (~10-inch diameter) connected to rotating screen on float. Flow is monitored by on/off pressure sensor, flow record rated good (1989-2019).
Elevation of withdrawal (ft. msl)	Variable
Operational status	Potentially operational

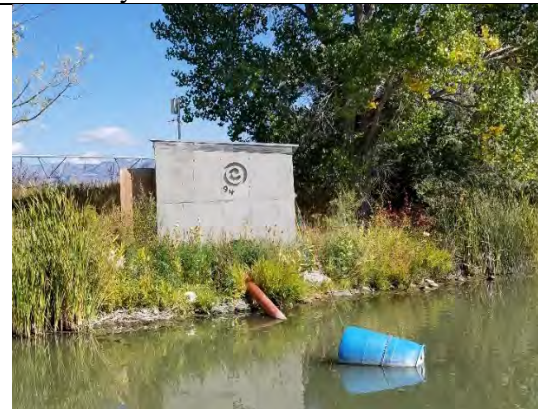
Description:	Surveyed 9/27/19. Photo shows concrete pumphouse, antenna, and steel intake pipe (8-inch diameter) with flex connection, suspended in water by floating barrel. Pipe is screened at end, extends from shoreline ~15 feet, pump is 30 HP electric pressure pump, flow record is rated fair (1989-2019)
Elevation of withdrawal (ft. msl)	Variable
Operational status	Potentially operational

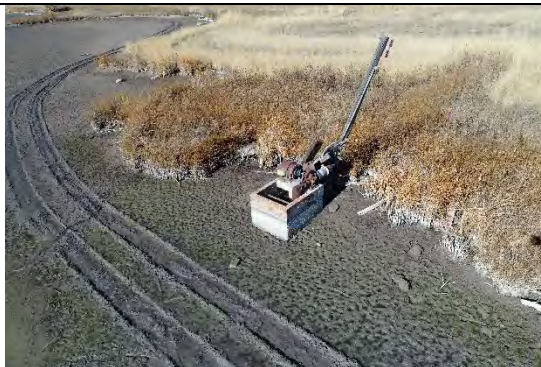
Description:	Surveyed 11/5/20. Photo shows abandoned pump and post for electric power connection. Pump has been abandoned. Remnant of intake pipe is on reservoir bed ~ 25 feet from shore.
Elevation of withdrawal (ft. msl)	None.
Operational status	Non-operational (no intake or Power source)

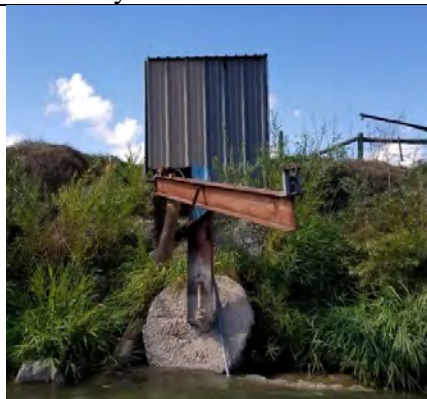
Description:	Surveyed 9/27/19. Photo shows pumphouse, intake pipe (~6-inch diameter to left of concrete), and structure used to adjust intake pipe based on the water surface elevation. No flow records identified.
Elevation of withdrawal (ft. msl)	End of pipe was submerged during drawdown.
Operational status	Potentially operational

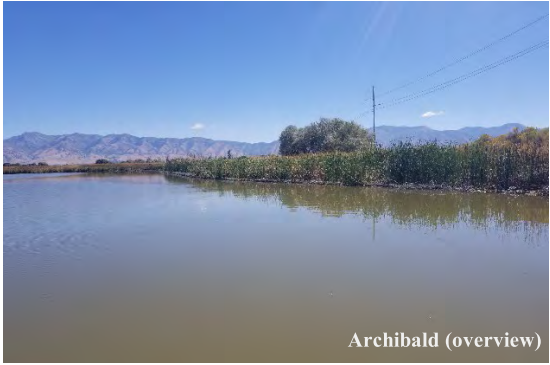
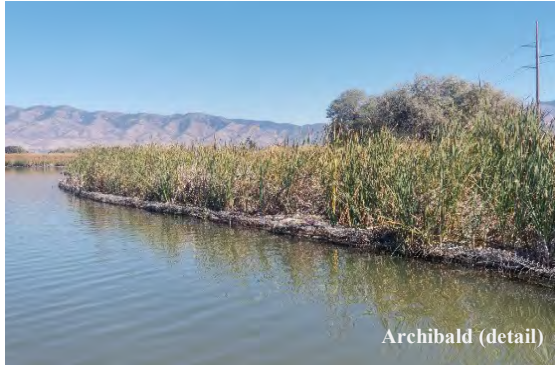
<b>Site Name:</b> Archibald	
<b>Construction date:</b> 1995	<b>Length (ft):</b> 5,358
<b>Bank Stabilization type:</b> Gabion baskets (Note that all bank stabilization project types began with car removal, when present, and minimum 2:1 bank sloping.).	
<p><b>Existing condition:</b> Emergent vegetation is dense on the upstream half of this site where gabions are relatively close to bank, and less so downstream where gabions are &gt;10 ft. from shore. Emergent zone vegetation is primarily mature cattails with some willow. <i>Phragmites</i> is found on the upstream end of the project (left photo) that transition to cattail. Slope vegetation is primarily herbaceous interspersed with mature shrubs (sage and rabbit brush) and few trees (Russian olive). Grass and weeds cover shoreline slopes on the downstream half of the project where cultivated fields are adjacent to the shoreline. Rock gabion and rip-rap are in good condition throughout the length of the project. Gabion is upright, cage is structurally solid without breaks; visible on upstream end of the project near RR Fishing Bridge (right photo) and submerged on the downstream end. Small recreation (fishing-related) trails to water are visible. Active erosion (~100 ft.) is located adjacent to project, between the upstream end of gabion and the RR Fishing Bridge, characterized by steep, unstable banks with recent sloughing. Project is rated in good condition.</p>

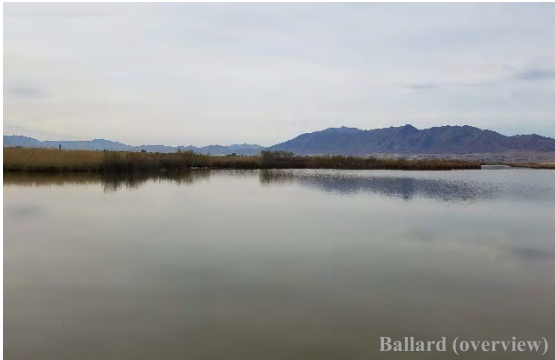
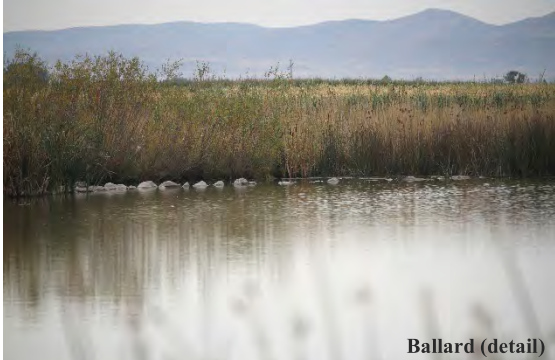
Ballard (overview)	Ballard (detail)

<b>Site Name:</b> Ballard	
<b>Construction date:</b> Fall 1997; reconstructed in 2003.	<b>Length (ft):</b> 1,951
<b>Bank Stabilization type:</b> Originally large straw bales only; subsequently reconstructed in fall 2003 with breakwater rock rip-rap (large rock rip-rap placed parallel to and 3-8 feet from the shoreline), willow bundles (placed horizontally), and cattail and hardstem added in the emergent zone.	
<b>Existing condition:</b> Emergent vegetation is dense through the length of this site. Emergent zone vegetation is primarily cattail and hardstem. Slope vegetation is an equal mix of herbaceous (dense stands of grass) and shrubs (mostly willow) with small amounts of thistle in some areas. Breakwater rock rip-rap is in good condition and visible at shoreline near the middle of the project (see right photo). No active erosion, although old scars on slopes are visible. Project is rated in good condition.

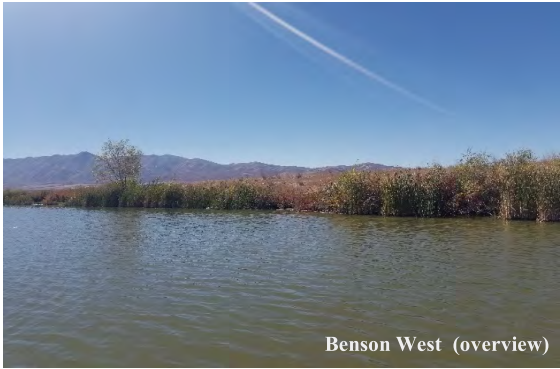
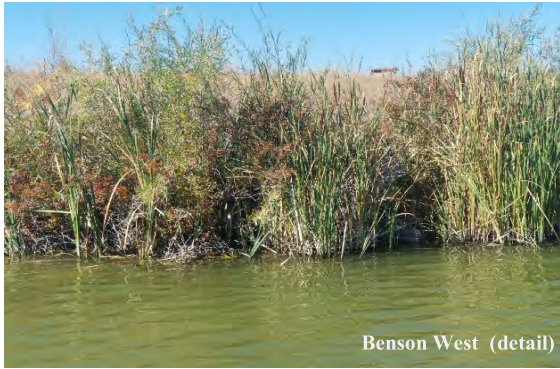
<b>Site Name:</b> Benson West	
<b>Construction date:</b> 2002	<b>Length (ft):</b> 552
<b>Bank Stabilization type:</b> Breakwater rock rip-rap with toe of slope plantings (willow) and emergent zone cattail/hardstem plantings.	
<b>Existing condition:</b> Emergent zone vegetation consists primarily of cattails in large groups. Vegetation is healthy with new growth in colonies found in shallow shoreline areas (see right photo). Slope vegetation is a mix of healthy species of shrub (primarily willow with one Russian olive) and herbaceous grasses that stabilize low banks in the area. Limited numbers of thistle were also observed. Bank and shoreline integrity are good with some user-created trails cutting through the vegetation that provide fishing access to shoreline. These areas are more common on the south end of the project. No active erosion is present but runoff from storm events and snowmelt may occur from user-created trail surfaces. Project is rated in good condition.

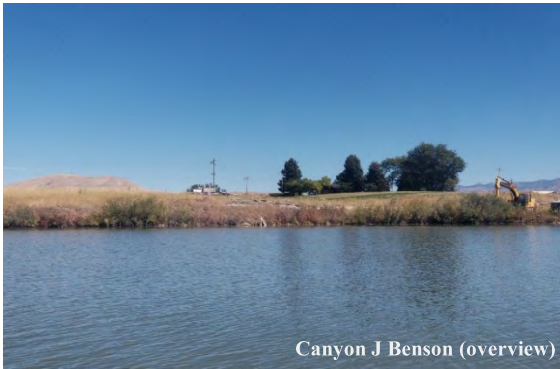
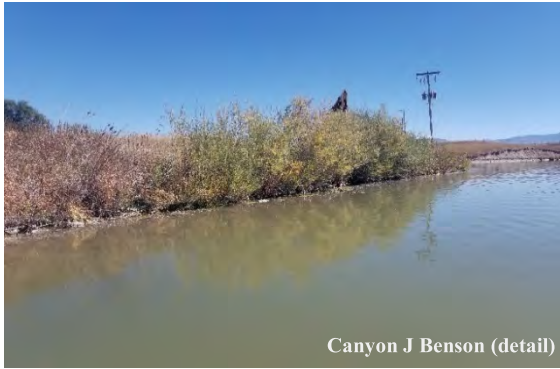
<b>Site Name:</b> Canyon J Benson	
<b>Construction date:</b> Fall 1996	<b>Length (ft):</b> 1,215
<b>Bank Stabilization type:</b> Slope plantings (willow) and rock rip-rap (smaller rock placed directly on shoreline).	
<p><b>Existing condition:</b> No emergent vegetation was observed at this site. Slope vegetation is primarily a dense mixture of willow and other shrubs with a few thistle. Dense grass understory occurs beneath shrubs and adds to slope stability. Vegetation cover is dense throughout the project. Rip-rap is visible along the shoreline in some locations but is mostly submerged at normal reservoir elevations. During the drawdown, extensive smaller riprap extending ~15 ft. from the shoreline was observed on the downstream end of this project. No evidence of active erosion was observed although eroding segments occur just upstream of the site (right photo). Project is rated in good condition.</p>

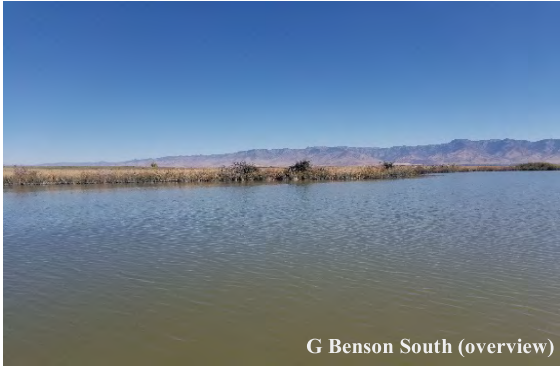
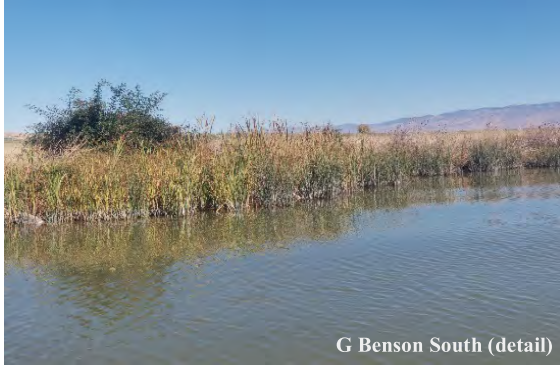
<b>Site Name:</b> G. Benson South	
<b>Construction date:</b> 1999	<b>Length (ft):</b> 1,518
<b>Bank stabilization type:</b> Cars removed during summer 1999. Breakwater rock rip-rap placed adjacent to shoreline (large rock placed several feet out into water to form a quietwater zone for the emergent plantings) followed by slope plantings (willow) and hardstem/cattails in the emergent zone during fall 1999.	
<b>Existing condition:</b> Emergent vegetation primarily consists of cattail with some hardstem. Vegetation is healthy and increasing in some areas. Slope vegetation is primarily herbaceous grass with few willow or other shrubs, following willow mortality from non-target spray by County. Rip-rap is in place along the shoreline and colonized by some emergent vegetation. Bank stability remains high. No sign of active erosion were observed. Project is rated in good condition.

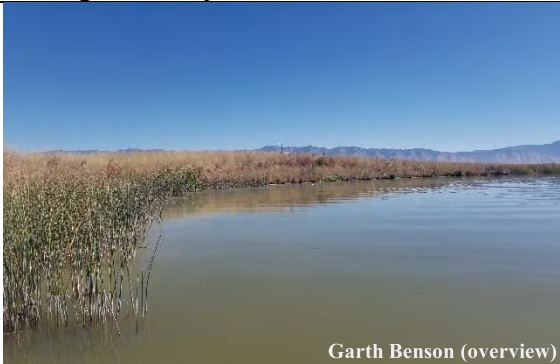
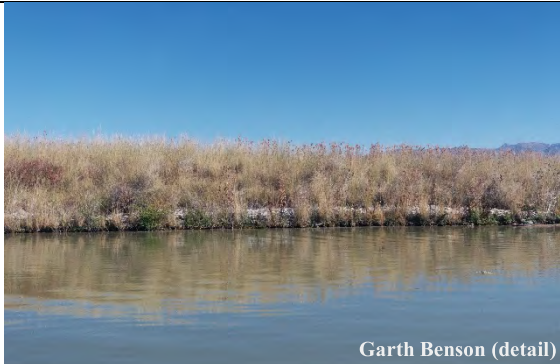
Garth Benson (overview)	Garth Benson (detail)

<b>Site Name:</b> Garth Benson	
<b>Construction date:</b> 1998	<b>Length (ft):</b> 1,704
<b>Bank Stabilization type:</b> Rip-rap (smaller rock placed directly on the shoreline) and slope planting. Rock placed in 1998 followed by shrub plantings.	
<b>Existing condition:</b> Emergent vegetation is limited in some areas of the project. Where it does occur, vegetation is a mixture of healthy cattail and hardstem. Emergent vegetation is moving into shallow areas at some locations (left photo). Slope vegetation is primarily a dense cover of herbaceous grass. Riprap is present and colonized by upslope herbaceous vegetation at some locations (right photo). Two areas of shoreline that did not get original riprap treatment are now showing some signs of active erosion at this site includes one segment (75 ft.) near the middle of the project and another segment (50 ft.) near the downstream end of the project. The emergent zone at the eroding segment near the middle of the project is being colonized by hardstem and cattails growing on slumped bank material. Overall, project is rated in good condition, although eroding areas may become a concern.

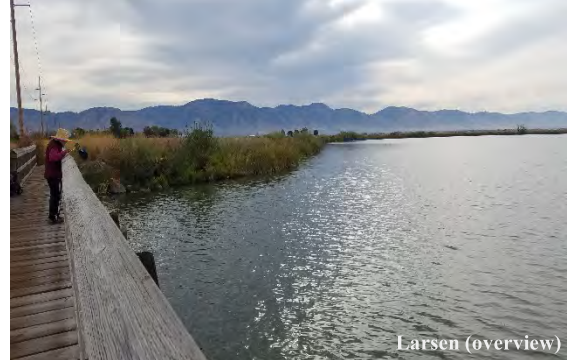
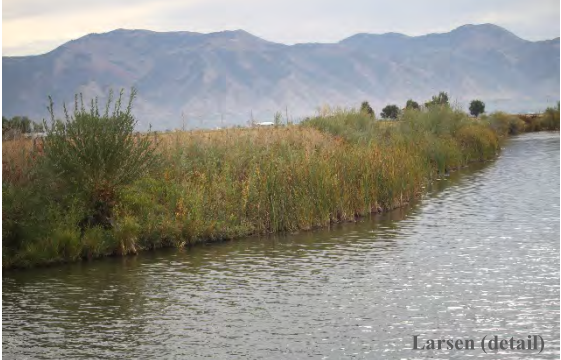
<b>Site Name:</b> Larsen	
<b>Construction date:</b> 1996	<b>Length (ft):</b> 1,855
<b>Bank Stabilization type:</b> Rock rip-rap (smaller) placed directly on shoreline with slope planting (willow).	
<b>Existing condition:</b> Emergent vegetation is dense and well-established for the entire project and could be increasing. Slope vegetation is comprised of shrub species at many locations including a range of willow age classes. Herbaceous grass is present as understory where space allows. No user-created recreation trails observed in slope areas. Rip-rap is generally not visible but still present at some locations based on observations made during the 2019 drawdown. No sign of active erosion. Project is rated in good condition.

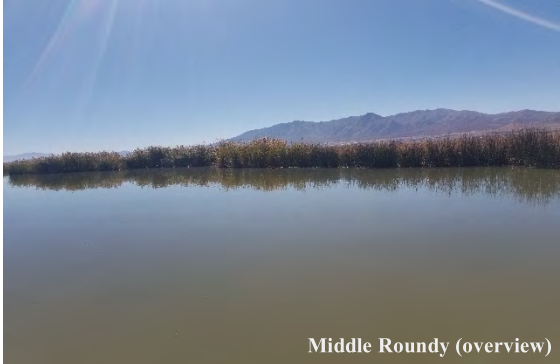
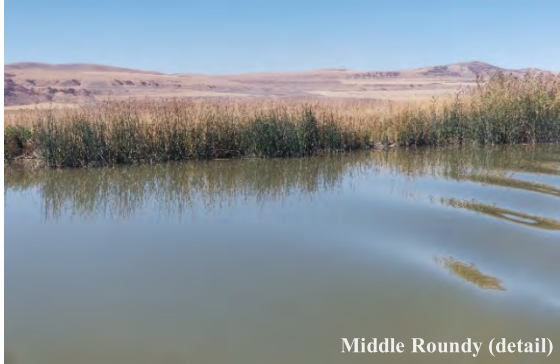
Middle Roundy (overview)	Middle Roundy (detail)

<b>Site Name:</b> Middle Roundy	
<b>Construction date:</b> 2000	<b>Length (ft):</b> 1,330
<b>Activity type:</b> Breakwater rock rip-rap and slope plantings (willow). Cattail and hardstem planted in November 2000; additional shrubs and willow bundles (placed in a trench at the toe of the slope, running parallel to the shoreline) also planted.	
<b>Existing condition:</b> Emergent vegetation includes a mixture of hardstem and <i>Phragmites</i> (concentrated in the upstream/north end), few cattails are present. Emergent vegetation appears to be increasing where water depth allows but most cover is complete. Upslope vegetation is dominated by herbaceous grass with shrubs occurring in the upper portion of the bank slope. No sign of active erosion. Project is rated in good condition.

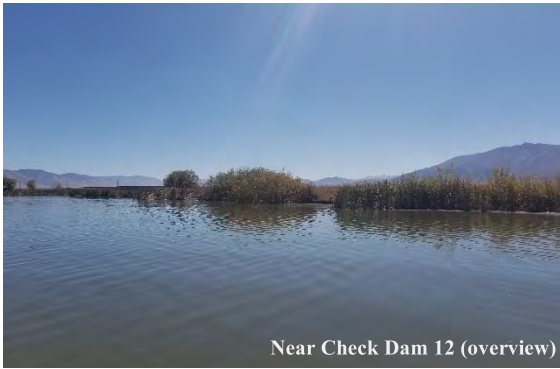
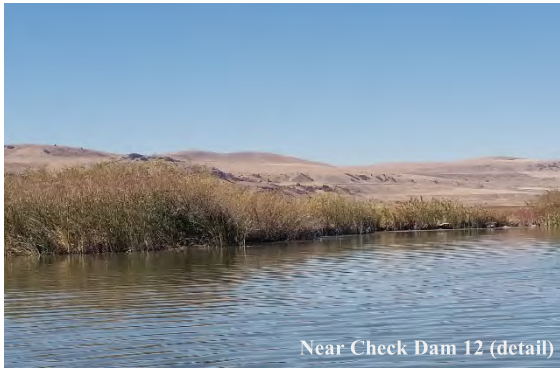
<b>Site Name:</b> Near Check Dam 12	
<b>Construction date:</b> 2001	<b>Length (ft):</b> 831
<b>Bank Stabilization type:</b> Breakwater rock rip-rap with willow bundles placed at the toe of the slope and slope plantings (rose and currant).	
<b>Existing condition:</b> Emergent vegetation consists of a mixture of cattail and hardstem. Vegetation is consistent and increasing in extent throughout most of the project. Slope vegetation includes pockets of shrub (willow) near the shoreline mixed with herbaceous grass and some thistle. Slope vegetation cover is complete (i.e. no bare areas). Breakwater rocks were observed at the downstream (north) end of project during the 2019 drawdown. A few low-elevation (<5 ft.) bank segments were noted to have minor undercutting where emergent vegetation was absent. No slumping, cracking, or signs of instability or active erosion were observed at these locations. This project is rated in good condition.

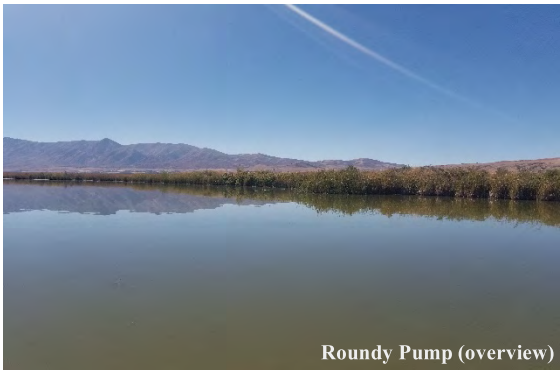
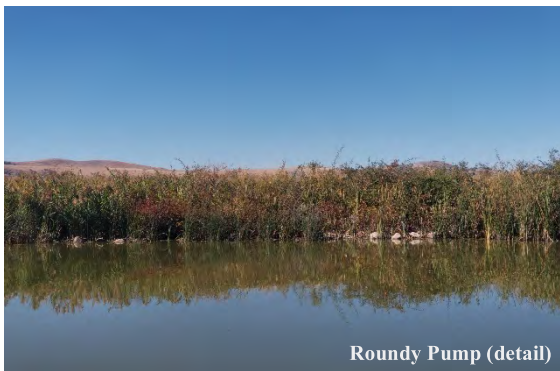
Roundy Pump (overview)	Roundy Pump (detail)

<b>Site Name:</b> Roundy Pump	
<b>Construction date:</b> 2000	<b>Length (ft):</b> 1,697
<b>Bank Stabilization type:</b> Breakwater rock rip-rap, emergent zone vegetation, willow bundles, and slope plantings (rose and currant). Rock, willow, hardstem, cattail, and shrubs placed fall 2000.	
<b>Existing condition:</b> Emergent vegetation includes cattail and hardstem as separate stands and as mixed cover. Emergent vegetation is consistent in most areas with gaps appearing along the upstream end of the project. Slope vegetation is primarily herbaceous grass with shrubs (some willow). Vegetation cover is complete over the length of the project. Breakwater rocks were observed throughout the project during the 2019 drawdown and are visible at times during the irrigation season (right photo). No sign of active erosion was observed in the project although one eroding bank segment (~40 ft.) occurs immediately upstream of where the breakwater rock begins. Project is rated in good condition.
