# **CUTLER HYDROELECTRIC PROJECT**

**FERC NO. 2420**

## **INITIAL STUDY REPORT**

### **VOLUME I**

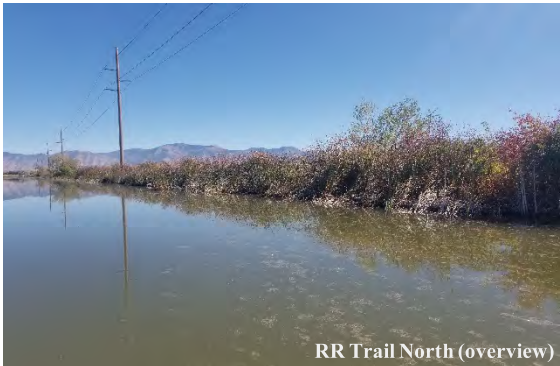
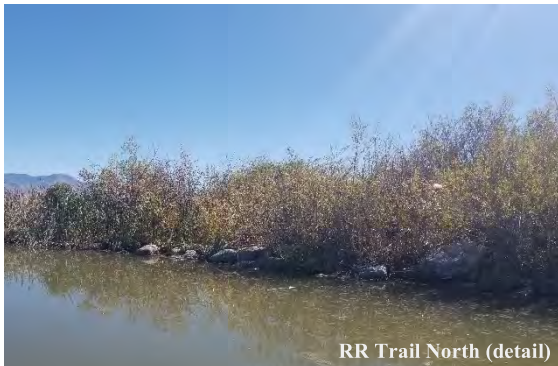
<b>Site Name:</b> RR Trail North	
<b>Construction date:</b> 2000	<b>Length (ft):</b> 3,338
<b>Bank Stabilization type:</b> Rebuilt earthen dike (former RR crossing over reservoir near Benson Marina) with breakwater rock rip-rap, willow bundles, and slope plantings. Rocks placed by July 2000; planting occurred in late 2000 including willow bundles, cattail, and hardstem in the emergent zone areas; rose and currant shrubs on the slopes.	
<b>Existing condition:</b> Emergent vegetation is dense and comprised of a mix of cattail, hardstem, and other marsh vegetation with limited <i>Phragmites</i> . Emergent zone vegetation is mostly contiguous with little new spread. Slope vegetation is primarily herbaceous with larger shrubs on the slopes on the west end of the site and on the east end where good willow (toe of the slope) and upslope growth was observed. Breakwater rocks continue to protect the shoreline and are visible just above the water surface at normal reservoir elevations (right photo). Rock and cobble material are colonized by emergent zone vegetation in most areas. No active erosion observed at any location. Project is rated in good condition.

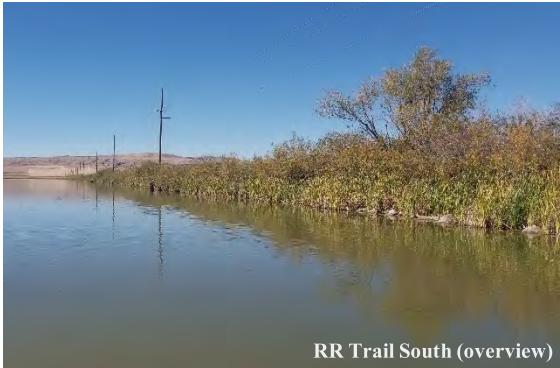
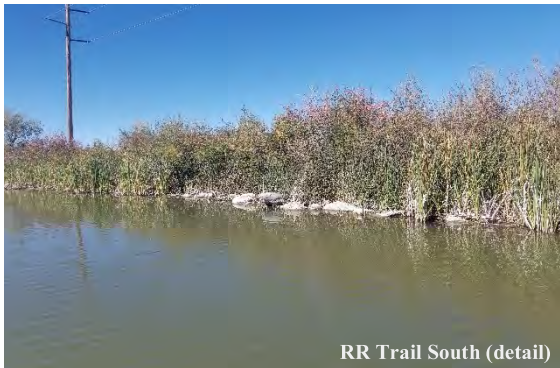
RR Trail South (overview)	RR Trail South (detail)

<b>Site Name:</b> RR Trail South	
<b>Construction date:</b> 2000	<b>Length (ft):</b> 5,856
<b>Bank Stabilization type:</b> Rebuilt earthen dike (former RR crossing over reservoir near Benson Marina) with breakwater rock rip-rap, willow bundles, and slope plantings. Rocks placed by July 2000; planting occurred in late 2000 including willow, cattail, and hardstem in the emergent zone areas; rose and currant shrubs on the slopes.	
<b>Bank Stabilization condition:</b> Emergent zone vegetation is generally dense along the full length of the project including a mix of cattail and hardstem with large shrubs (willow, rose, and currant) on the east end of the site and primarily cattail emergent zone vegetation on the west end of the project, along with a small patch of <i>Phragmites</i> . Slope vegetation on the east end of the project is primarily woody shrubs. Vegetation on the west end is a mixture of herbaceous marsh grass and shrubs. Breakwater rock rip-rap provides consistent cover and protection from erosion. Small boulders used as breakwater rock are visible just above the water surface near the shoreline (right photo) for most of the project. No active erosion identified. Project is rated in good condition.

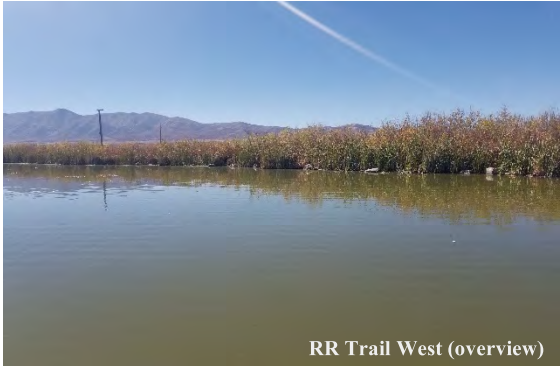
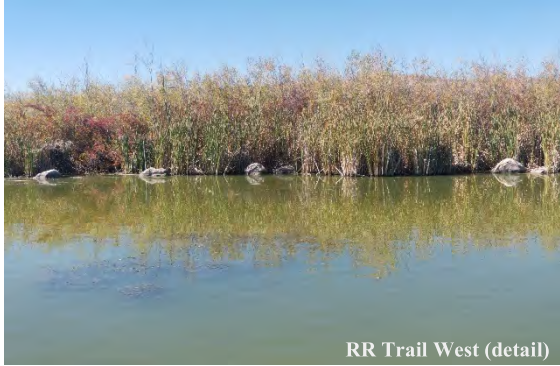
<b>Site Name:</b> RR Trail West	
<b>Construction date:</b> 2000	<b>Length (ft):</b> 1,200
<b>Bank Stabilization type:</b> Breakwater rock rip-rap, emergent zone planting (hardstem/cattail), and willow bundles planted in a trench at the toe of the slope. Willows planted following rock placement in November 2000.	
<b>Existing condition:</b> Emergent vegetation is a mixture of cattail and hardstem. Vegetation is consistent through the length of the project. Slope vegetation is primarily shrubs with some herbaceous grass understory. Willow are found at the waters' edge with other shrub species located further upslope. Vegetation cover is complete (i.e. no bare areas). No active erosion identified. Project is rated in good condition.

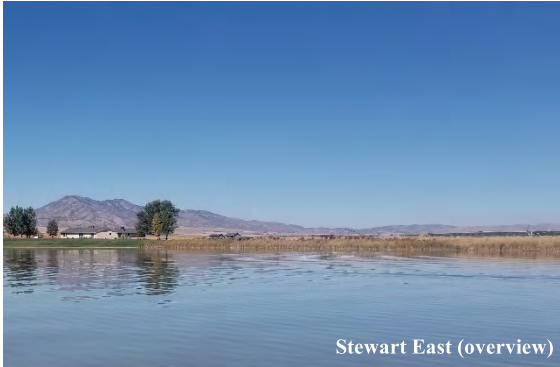
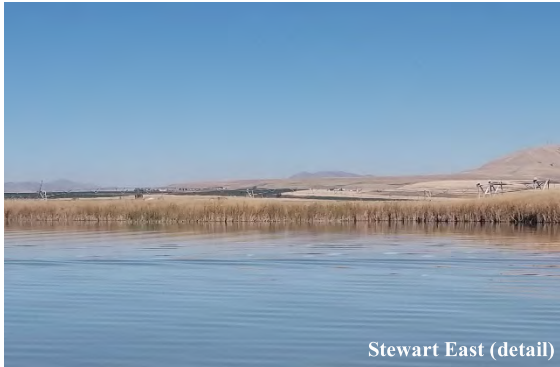
<b>Site Name:</b> Stewart East	
<b>Construction dates:</b> 1996; rebuilt in 2011	<b>Length (ft):</b> 3,110
<b>Bank Stabilization type:</b> Concrete barrier (covering 76 feet of total project length) and large straw bales (originally); later re-construction was breakwater rock, willow bundles, and slope plantings (rose and currant).	
<b>Existing condition:</b> Straw bank protection failed after being placed in 1996 (concrete barrier held but was only used in a small portion of the bank). New bank stabilization efforts were implemented in 2011 including breakwater rock, emergent zone cattail/hardstem plantings, willow bundles, and slope plantings (rose and currant) and renamed W. Larsen East and West to distinguish the new segments in the database. Existing emergent vegetation is a consistent cover of cattail or hardstem on the east side of the site. Emergent vegetation does not exist in the middle (north) section of the site where the concrete barrier was installed (original project). Pockets of cattail are found on the far west end of the site. Slope vegetation is herbaceous with few shrubs. Cover is mostly sparse on the east and west side; landscaped lawn (behind the parallel concrete barrier) provide complete cover in the middle section of the project. Adjacent landowner has planted three rows of trees near the top of slope and east of landscaped area (but outside the PacifiCorp Project Boundary) that extends parallel to the reservoir for 350 ft. Breakwater rock was visible for most of the project during the 2019 drawdown and provides good shoreline projection. No active erosion identified. Project is rated in good condition.

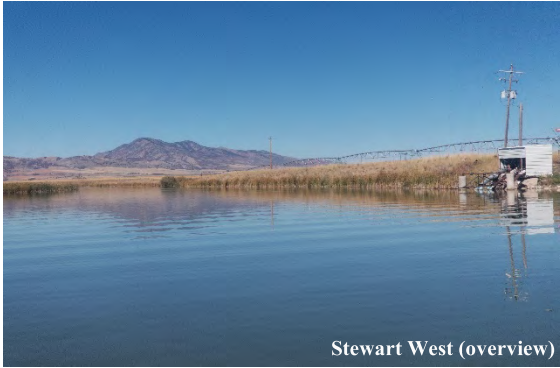
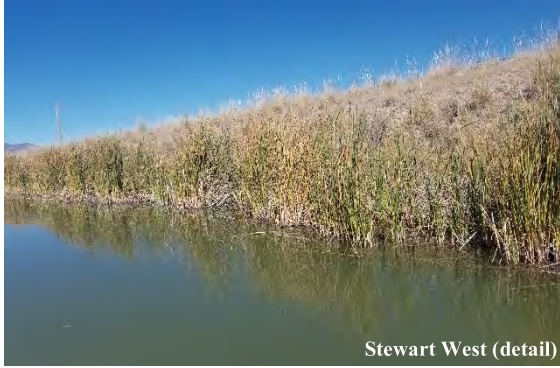
Stewart West (overview)	Stewart West (detail)

<b>Site Name:</b> Stewart West	
<b>Construction date:</b> Originally 1996; later rebuilt in late 2004.	<b>Length (ft):</b> 1,520
<b>Bank Stabilization type:</b> Large straw bales (originally); subsequently breakwater rock rip-rap with cattail/hardstem emergent zone plantings and toe of slope plantings (willow).	
<b>Existing condition:</b> Emergent vegetation is moderately dense cattail for most of the project length. A pocket of hardstem and marsh grass occurs in the emergent zone near the middle of the project. The extent of emergent vegetation is maintaining or slowly increasing based on the age class and condition of observed species. Slope vegetation includes a sparse cover of herbaceous grass. No weeds or invasive species were observed on slopes or in the emergent zone. No willows were observed at this project. Breakwater rock rip-rap is located throughout the project but is visible at the upstream (~60 ft.) and downstream (~90 ft.) ends of the project and continues to prevent erosion. No active erosion was identified. Project is rated in good condition.

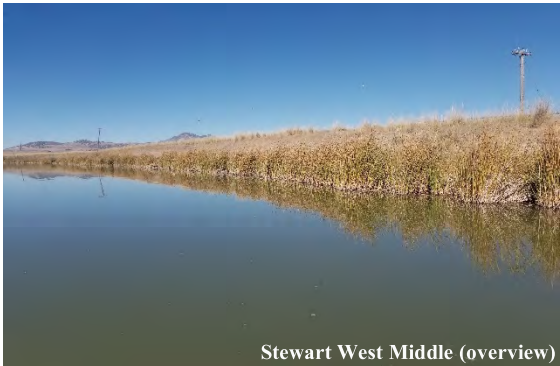
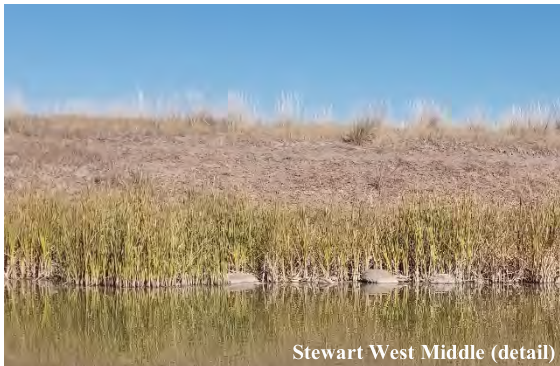
Stewart West Middle (overview)	Stewart West Middle (detail)

<b>Site Name:</b> Stewart West Middle	
<b>Construction date:</b> 2001 (re-construction following failure of original hay bales)	<b>Length (ft):</b> 1,441
<b>Bank Stabilization type:</b> Originally large hay bales placed at the toe of the slope; replaced by breakwater rock rip-rap, emergent zone and willow plantings (toe of the slope).	
<b>Existing condition:</b> Site was originally part of 1996 Stewart West project but was re-constructed in 2001 after original site failure; new name reflects new treatment in database. Emergent zone vegetation is primarily mature cattail but mixed with <i>Phragmites</i> along each end of the project where width of emergent zone increases. Vegetation is healthy. Upslope vegetation is primarily herbaceous with one large group of shrubs (willow) located at upstream end of project. Slope cover is less dense in the middle portion of the project where banks are relatively steep compared to other project slopes. Some breakwater rock is visible (right photo) and mixed with much of the emergent vegetation, providing a stable base for growth. One eroding segment (~5 ft) noted, possibly due to surface runoff channel. All other areas stable. Project is rated in good condition.

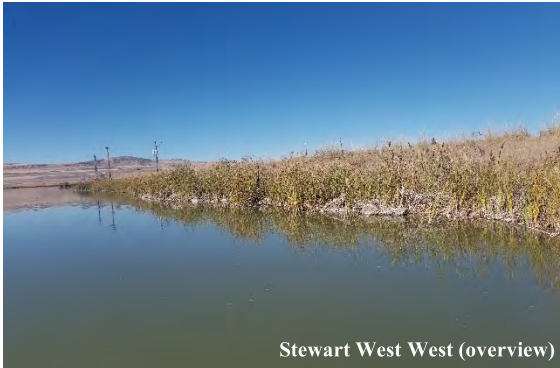
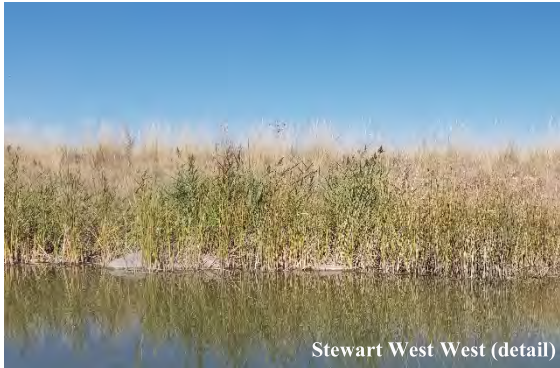
<b>Site Name:</b> Stewart West West	
<b>Construction date:</b> 2001 (re-construction following failure of original hay bales)	<b>Length (ft):</b> 985
<b>Bank Stabilization type:</b> Originally large hay bales placed at the toe of the slope; replaced by breakwater rock rip-rap, emergent zone and willow plantings (toe of the slope).	
<b>Existing condition:</b> Site was originally part of 1996 Stewart West project but was re-constructed in 2001 after original site failure; new name reflects new treatment in database. Emergent vegetation is moderately dense cattail throughout the length of the project. Early growth <i>Phragmites</i> is mixed with cattail at some locations and currently limited to a few individual stems (i.e. no dense clumps). Although cattail growth is consistent, total cover does not appear to be increasing and could be crowded by <i>Phragmites</i> in the future. Slope vegetation is dominated by herbaceous grass; no shrubs observed. Breakwater rock rip-rap is located throughout but visible at the downstream end (110 ft.) of the site, protecting the shoreline. No active erosion identified. Project is rated in good condition.

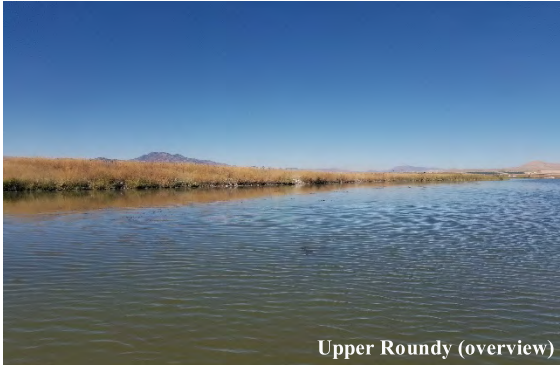
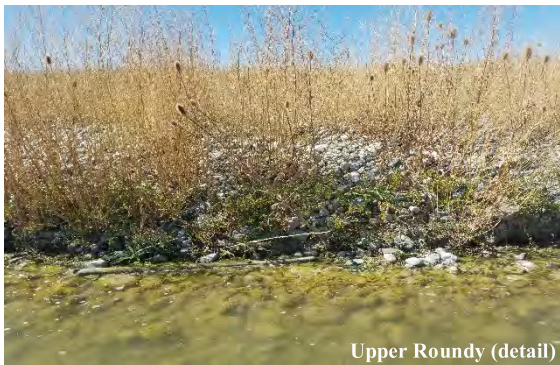
<b>Site Name:</b> Upper Roundy	
<b>Construction date:</b> 1999	<b>Length (ft):</b> 2,442
<b>Bank Stabilization type:</b> Rock rip-rap (smaller), placed directly on shoreline, no revegetation.	
<p><b>Existing condition:</b> Emergent vegetation is primarily cattail and occurs as a mixture with hardstem at some locations. Extent of vegetation is limited to upstream and downstream areas; no emergent vegetation is found in the middle of the site. Slope vegetation is moderately dense herbaceous grass mixed with teasel (right photo). Wildlife trails (Canada goose) cut through the shoreline vegetation at some locations for access to water. Shoreline banks are low elevation and ~1 ft. high or less. Small rock rip-rap covers the full length of the project and functions well in most locations as a barrier to shoreline erosion. A few segments with vertical bank exposure were noted in the middle segment (~560 ft.) of the project where emergent vegetation does not occur. Bank stability is good (i.e. no sloughing or cracks were observed) but potential erosion remains a concern from this segment. Overall, the project is rated in good condition.</p>

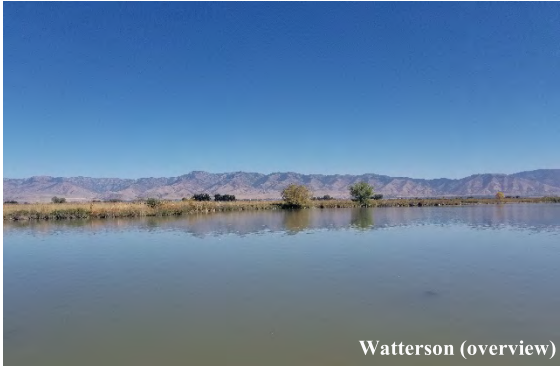
<p>Watterson (overview)</p>

<b>Site Name:</b> Watterson	
<b>Construction date:</b> 1993	<b>Length (ft):</b> 3,988
<b>Bank Stabilization type:</b> Gabion baskets.	
<p><b>Existing condition:</b> Emergent vegetation is predominately cattail, with some hardstem and <i>Phragmites</i>. Emergent vegetation is growing in front of and behind rock gabions. No emergent vegetation occurs in a segment (~550 ft.) near the middle of the project. <i>Phragmites</i> occurs in dense groups that appear to be expanding in several areas. Cattail growth is primarily good but decadent stands were observed behind the gabion at some locations. Slope vegetation is a dense mixture of herbaceous and shrub species including minor amounts of thistle and other weeds. The gabion structure is visible where it isn't covered with heavy vegetation (right photo). The structure has tipped in some locations. This is particularly evident at the upstream end of the site. Active erosion is occurring just upstream of where the gabion begins. No active erosion was identified at the site. Project is rated in good condition.</p>

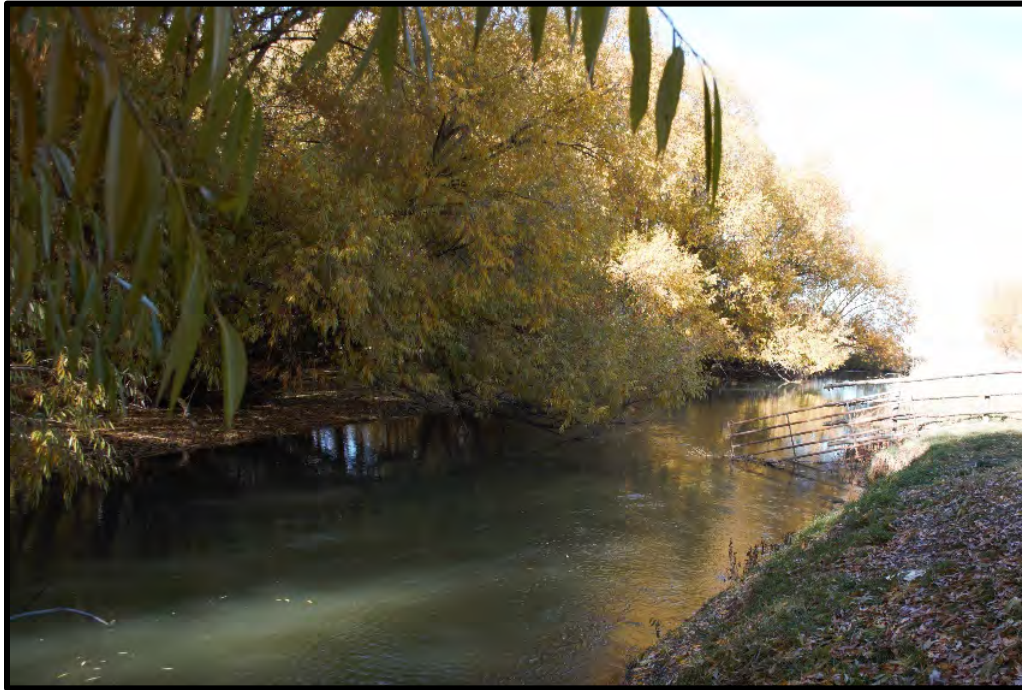
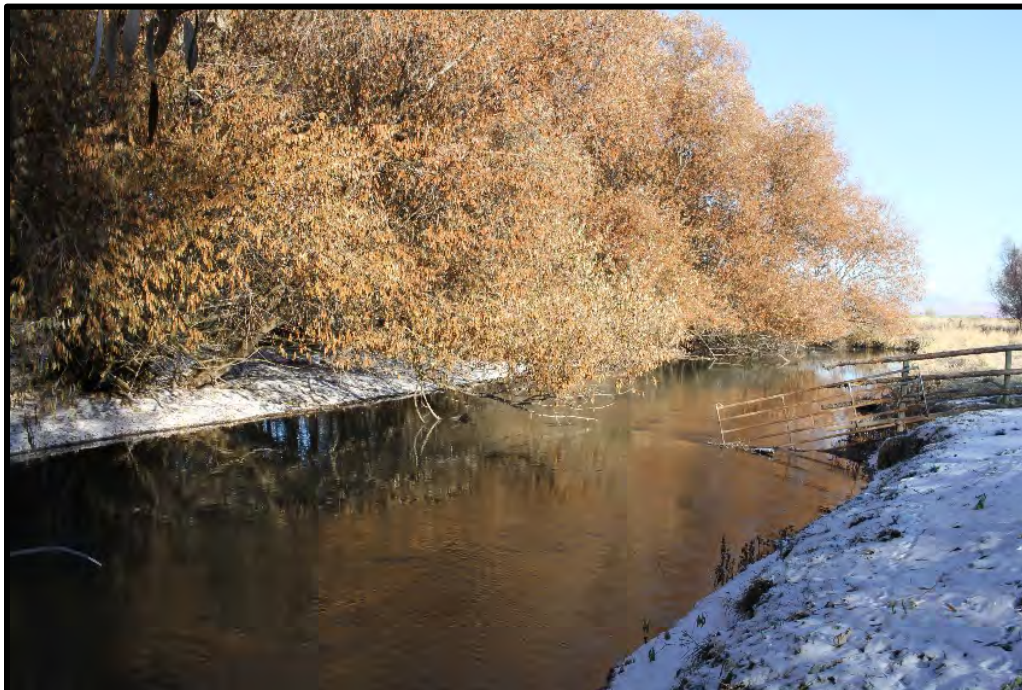
**FIGURE D-1. LITTLE BEAR RIVER ACCESS PHOTO PAIR, LOOKING DOWNSTREAM.**

Note: October 24, 2019, baseline.  
Elevation at Cutler Dam 4,407.3 feet.

Note: November 1, 2019, drawdown.  
Elevation at Cutler Dam 4,392.4 feet.

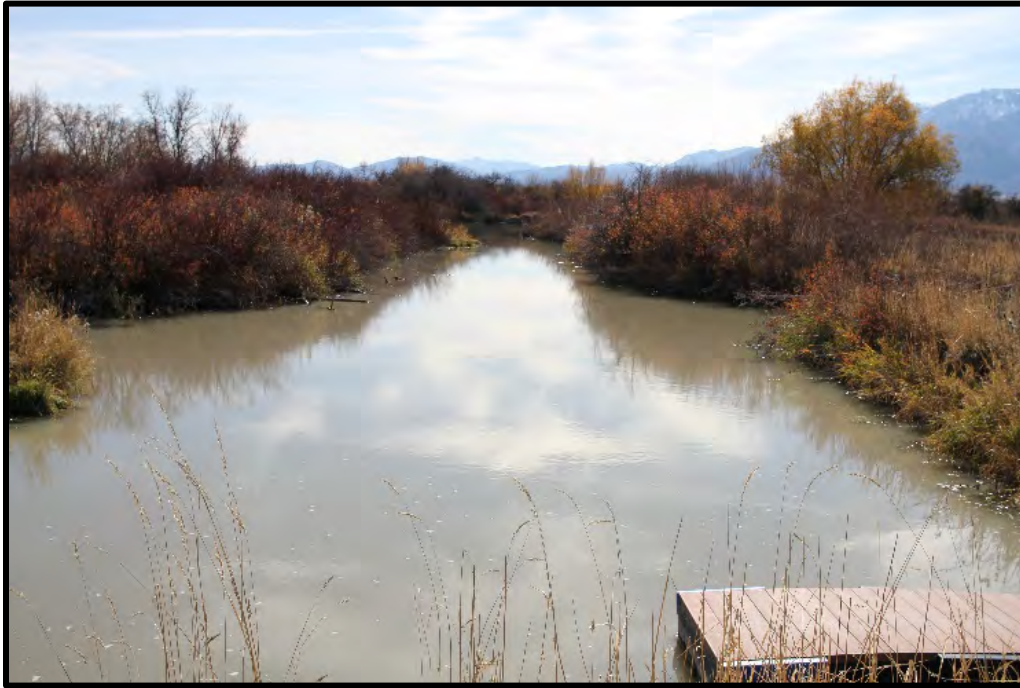
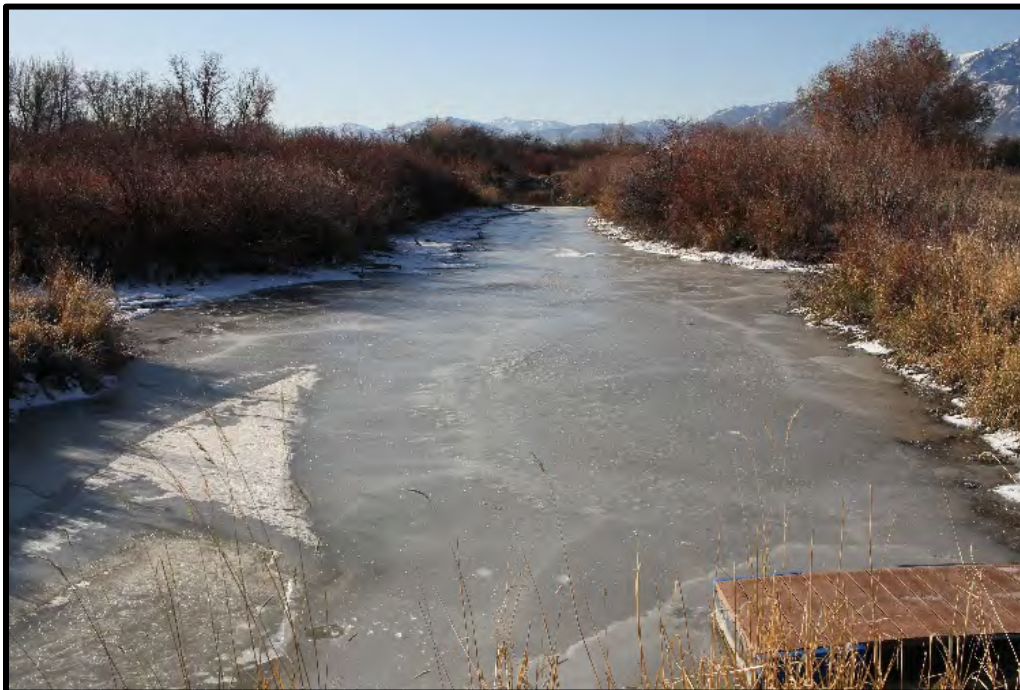
**FIGURE D-2. LOGAN RIVER RECREATION SITE, LOOKING DOWNSTREAM.**

Note: October 24, 2019, baseline.  
Elevation at Cutler Dam 4,407.3 feet

Note: November 1, 2019, drawdown.  
Elevation at Cutler Dam 4,392.4 feet.

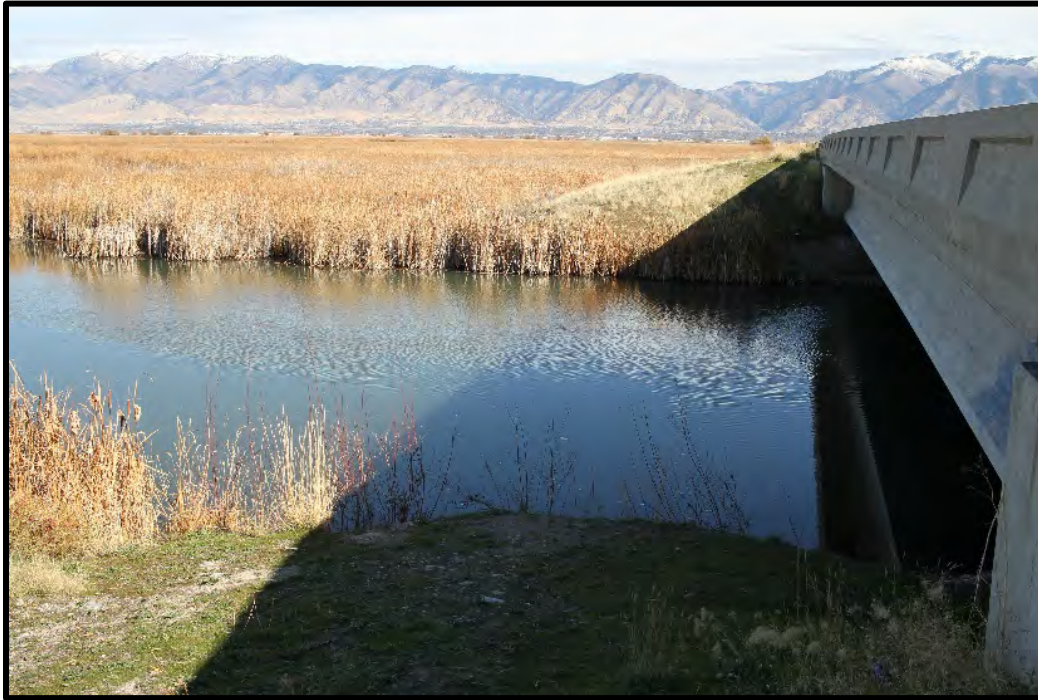
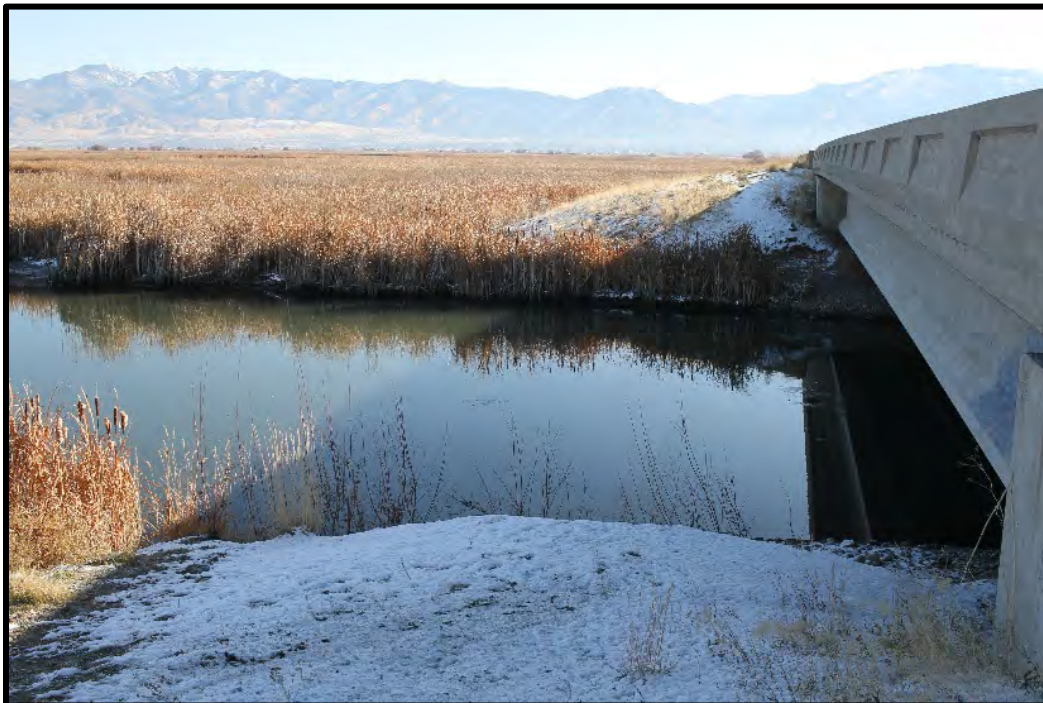
**FIGURE D-3. HIGHWAY 30 BRIDGE, DOWNSTREAM SIDE, LOOKING EAST.**

Note: October 24, 2019, baseline.  
Elevation at Cutler Dam 4,407.3 feet

Note: November 1, 2019, drawdown.  
Elevation at Cutler Dam 4,392.4 feet.

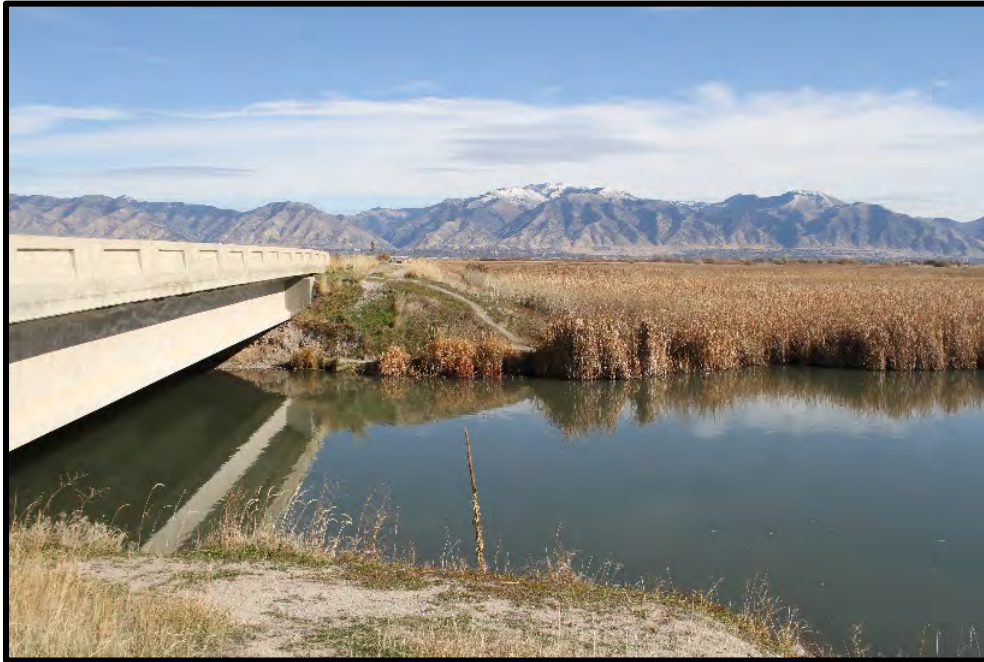
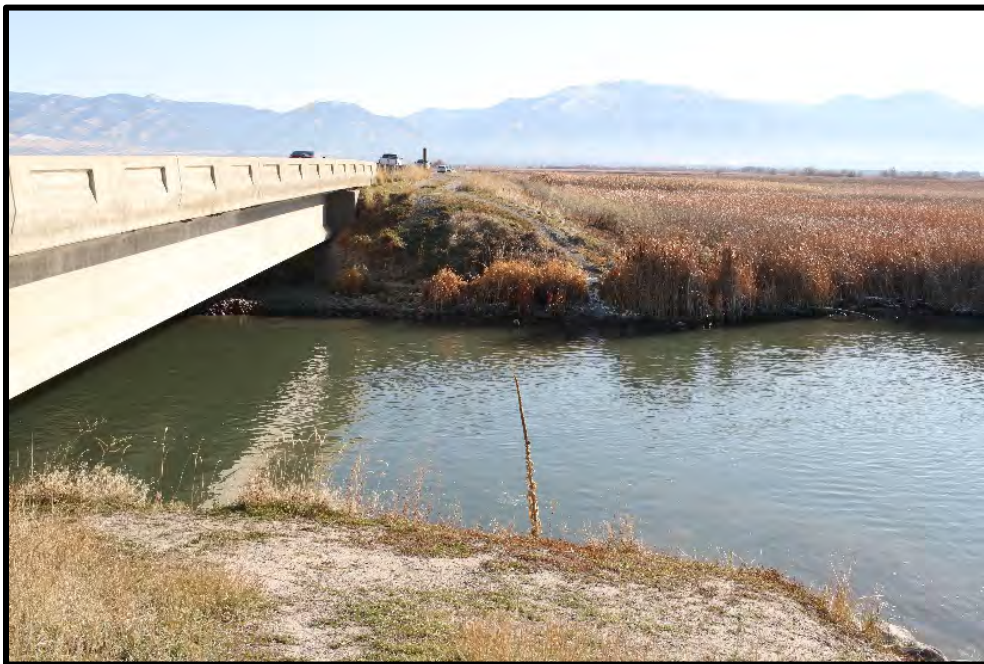
**FIGURE D-4. HIGHWAY 30 BRIDGE, UPSTREAM SIDE, LOOKING EAST.**

Note: October 24, 2019, baseline.  
Elevation at Cutler Dam 4,407.3 feet

Note: November 1, 2019, drawdown.  
Elevation at Cutler Dam 4,392.4 feet.

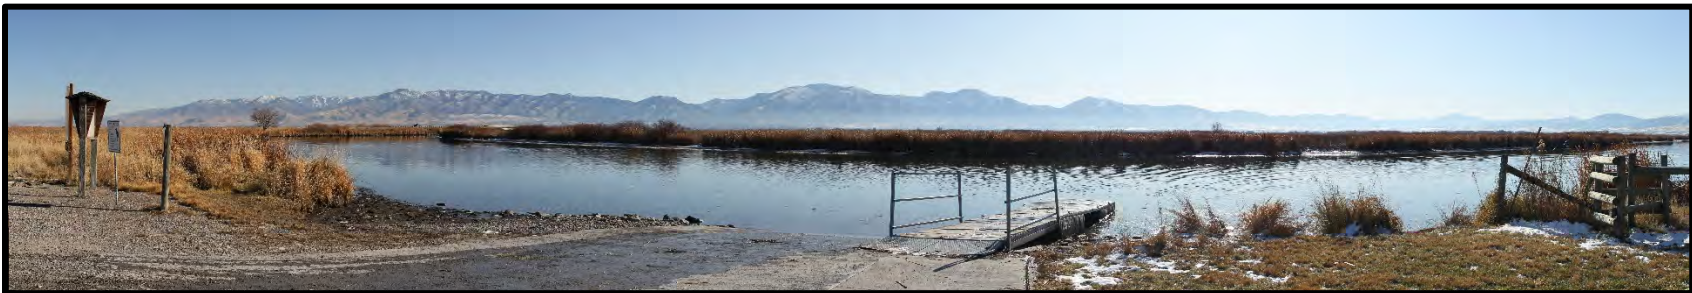
**FIGURE D-5. CUTLER MARSH MARINA (PANORAMA VIEW CENTERED SOUTH).**

Note: November 1, 2019, drawdown.  
Elevation at Cutler Dam 4,392.4 feet.

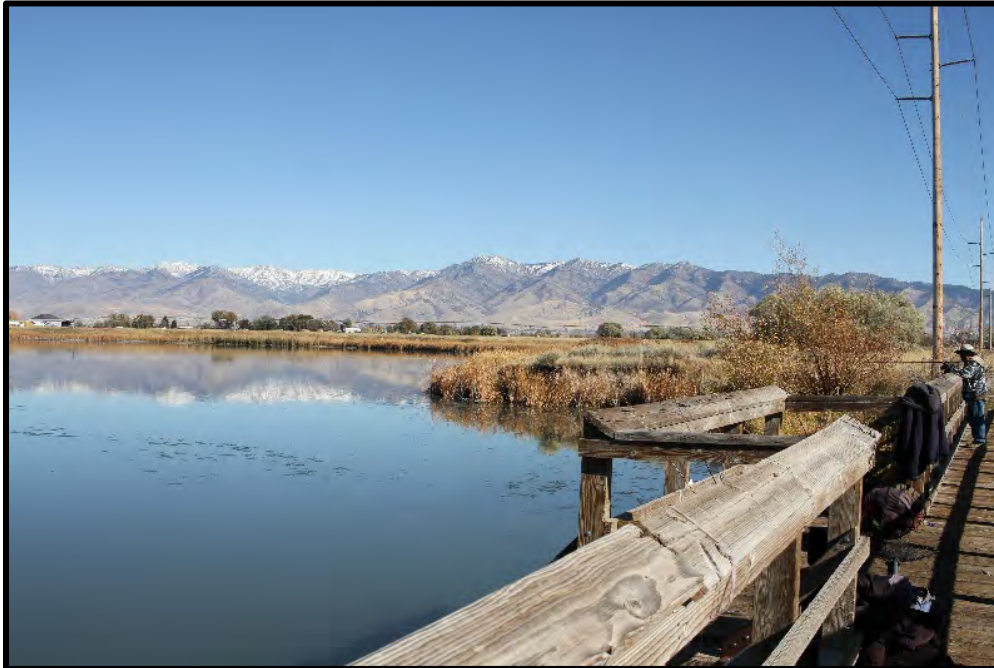
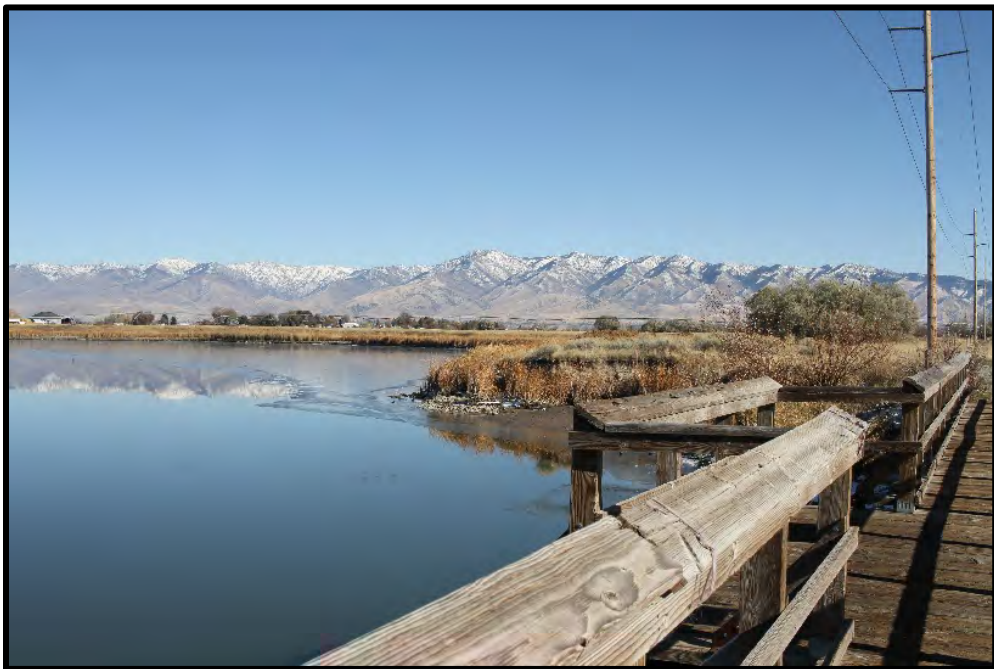
**FIGURE D-6. BENSON RAILROAD BRIDGE, DOWNSTREAM SIDE LOOKING EAST.**

Note: October 24, 2019, baseline.  
Elevation at Cutler Dam 4,407.3 feet

Note: November 1, 2019, drawdown  
Elevation at Cutler Dam 4,392.4 feet.

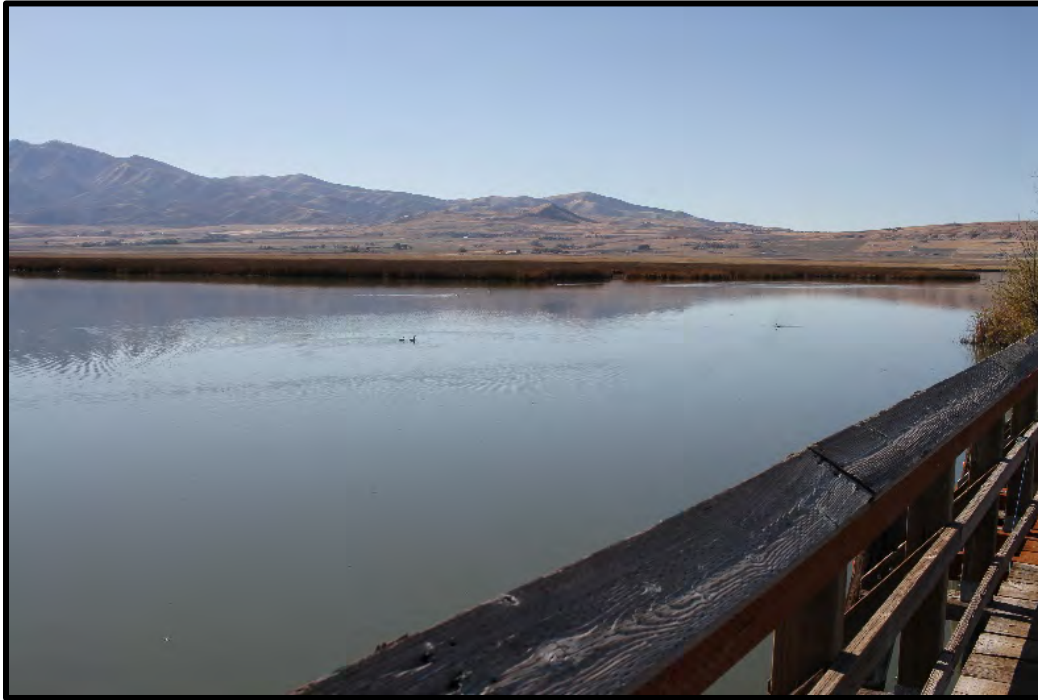
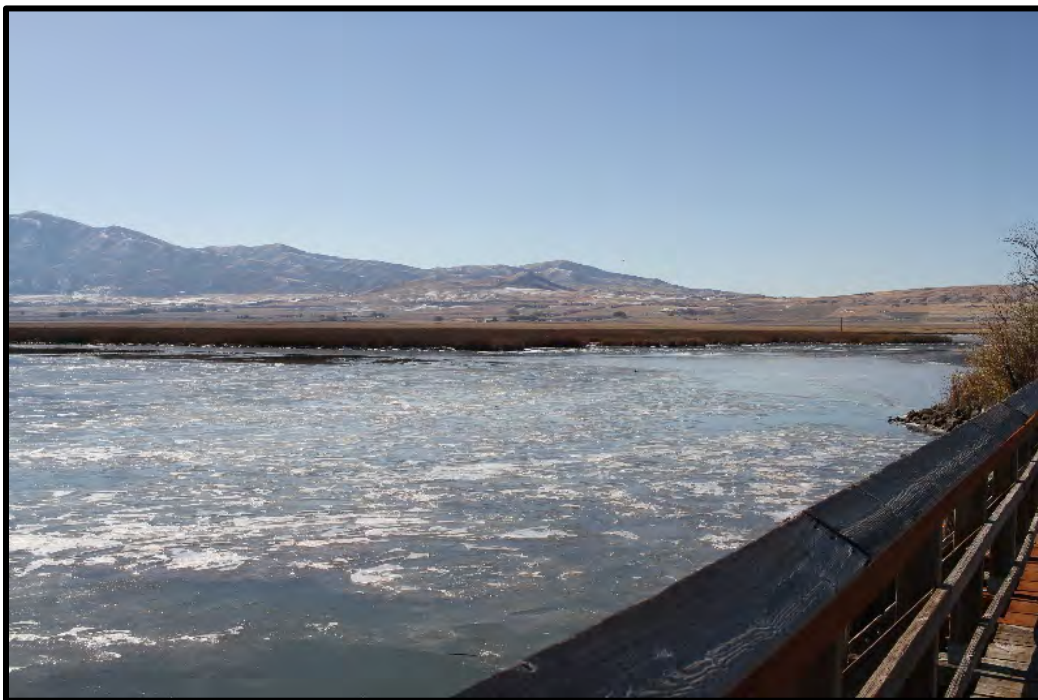
**FIGURE D-7. BENSON RAILROAD BRIDGE, LOOKING UPSTREAM AND SOUTHWEST.**

Note: October 24, 2019, baseline.  
Elevation at Cutler Dam 4,407.3 feet

Note: November 1, 2019, drawdown  
Elevation at Cutler Dam 4,392.4 feet.

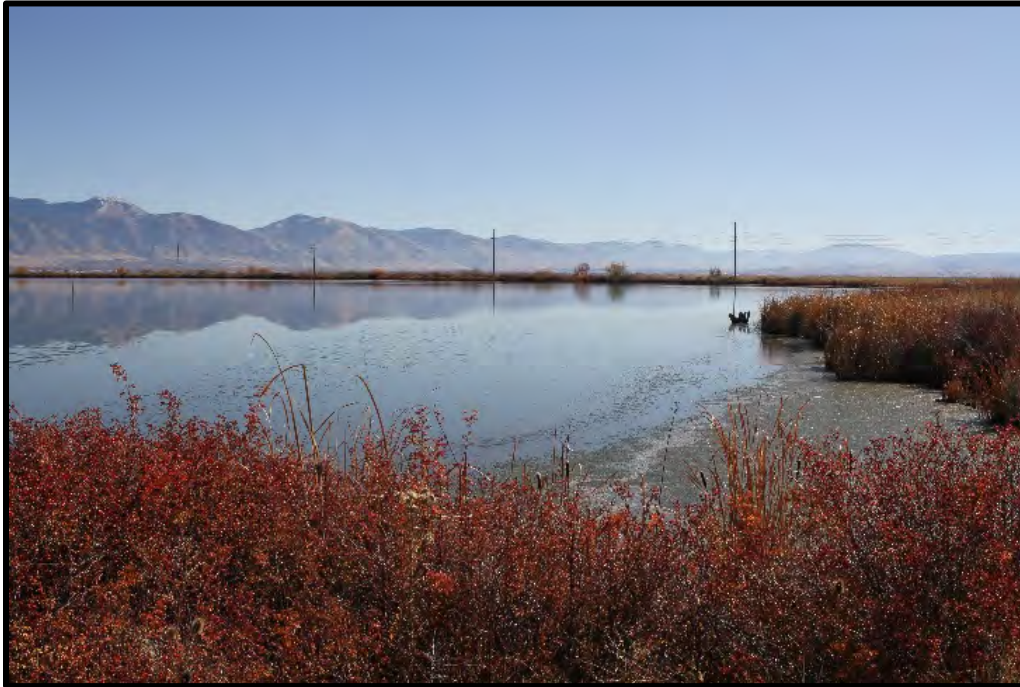
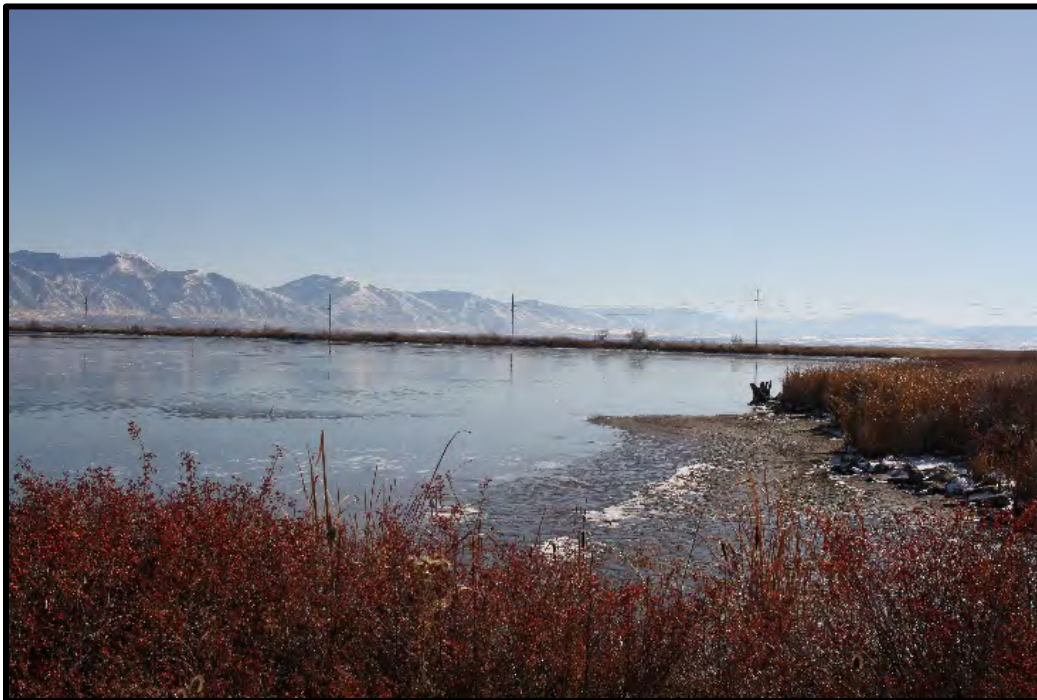
**FIGURE D-8. BENSON RAILROAD BRIDGE TRAILHEAD, LOOKING UPSTREAM AND SOUTHEAST.**

Note: October 24, 2019, baseline.  
Elevation at Cutler Dam 4,407.3 feet

Note: November 1, 2019, drawdown  
Elevation at Cutler Dam 4,392.4 feet.

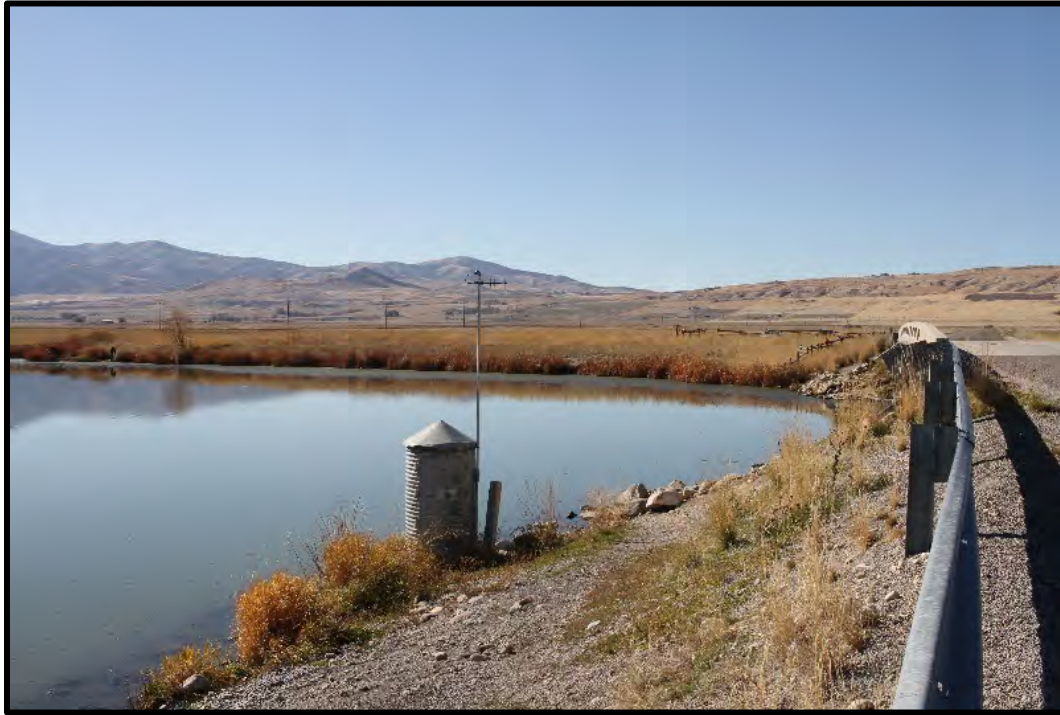
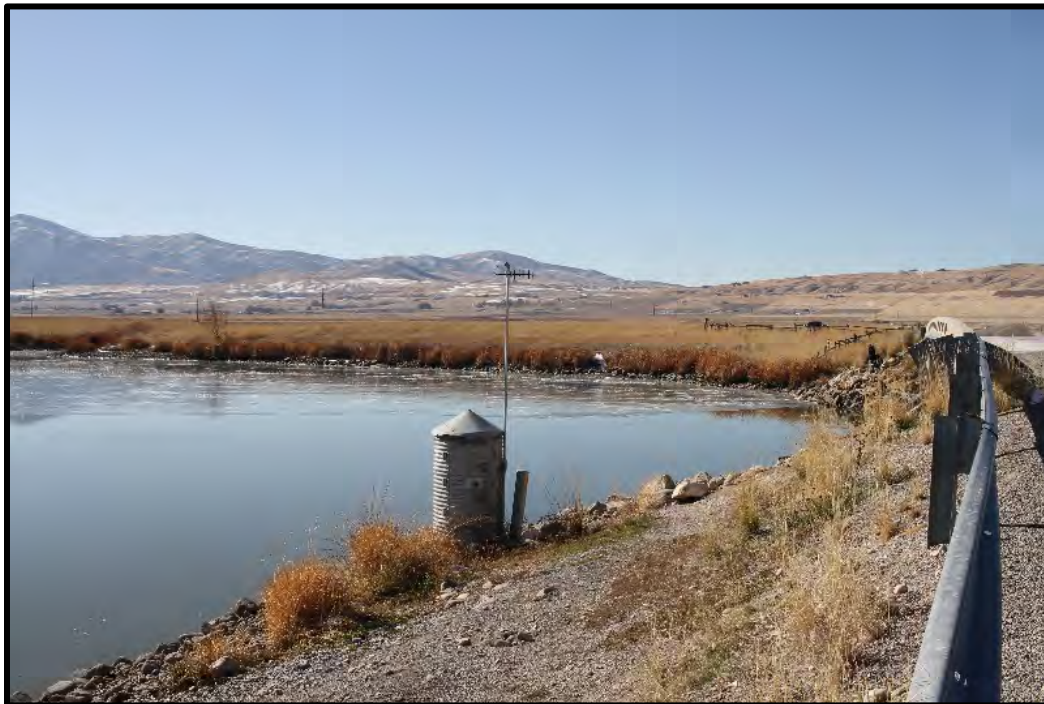
**FIGURE D-9. BENSON MARINA BRIDGE, UPSTREAM SIDE LOOKING WEST.**

Note: October 24, 2019, baseline.  
Elevation at Cutler Dam 4,407.3 feet

Note: November 1, 2019, drawdown  
Elevation at Cutler Dam 4,392.4 feet.

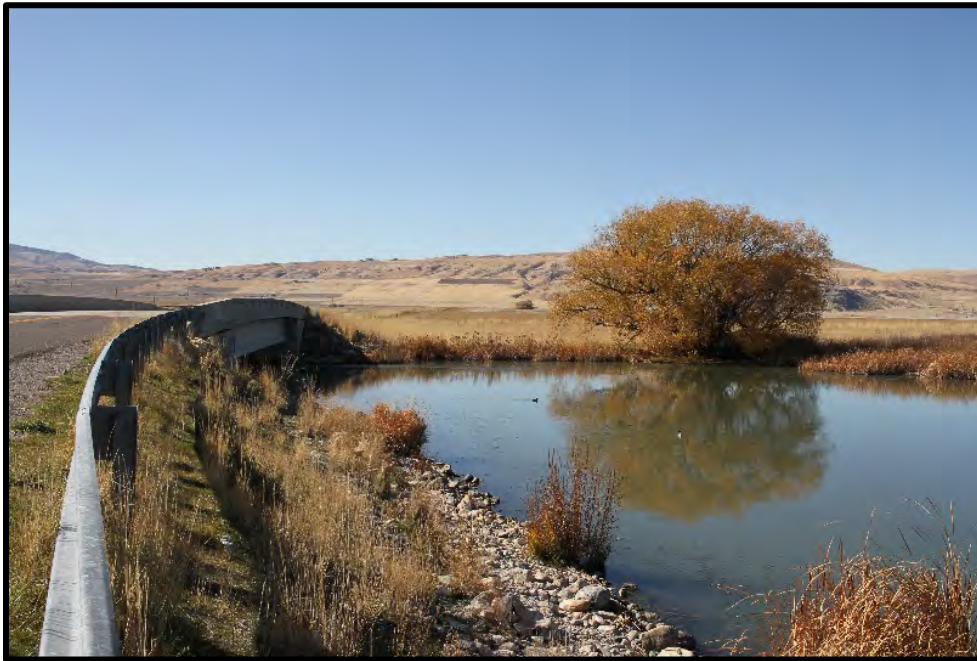
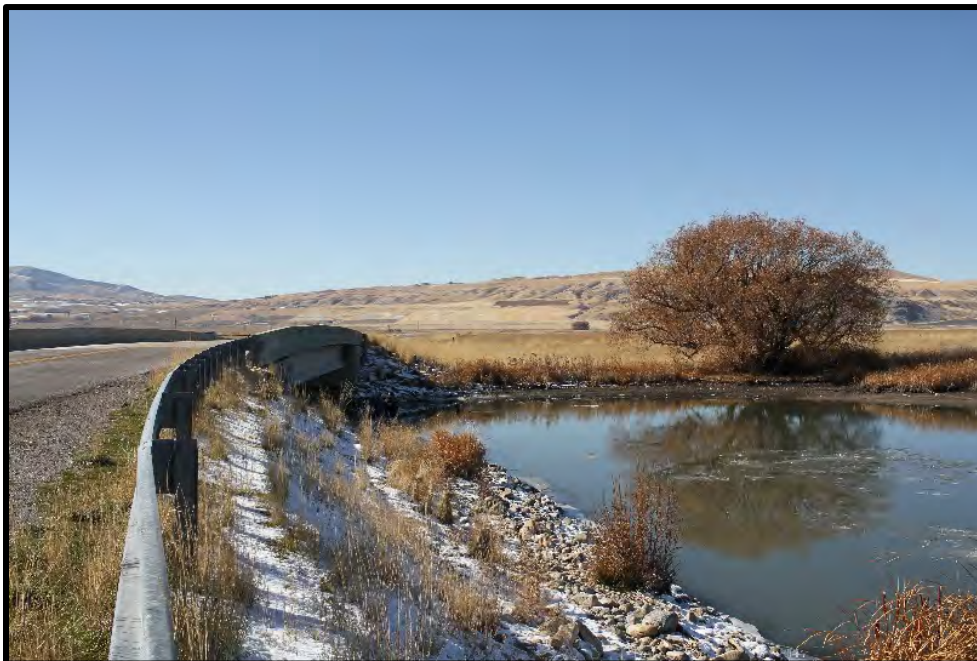
**FIGURE D-10. BENSON MARINA BRIDGE, DOWNSTREAM SIDE LOOKING WEST .**

Note: October 24, 2019, baseline.  
Elevation at Cutler Dam 4,407.3 feet

Note: November 1, 2019, drawdown  
Elevation at Cutler Dam 4,392.4 feet.

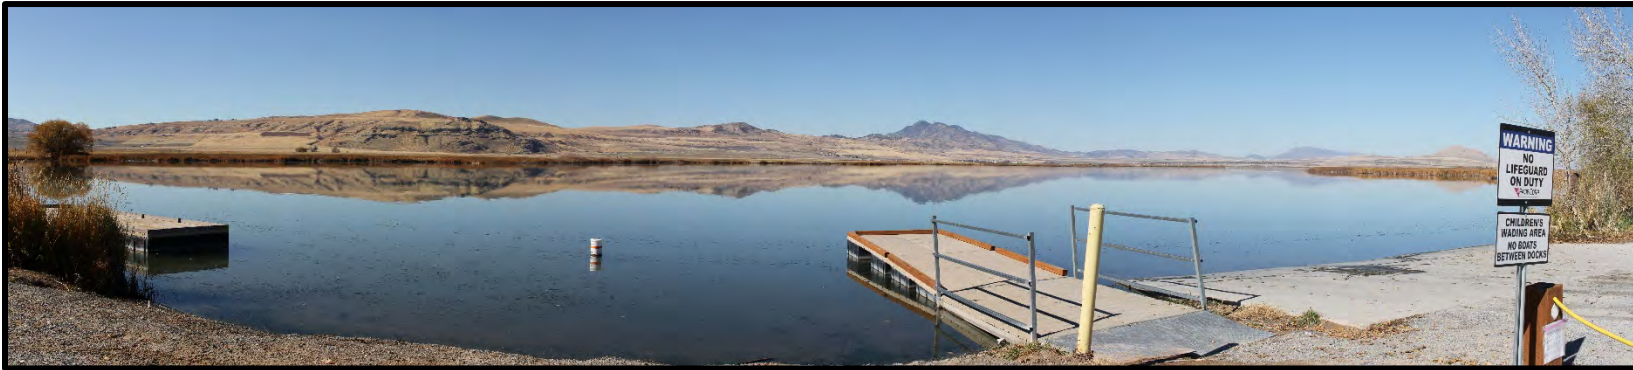
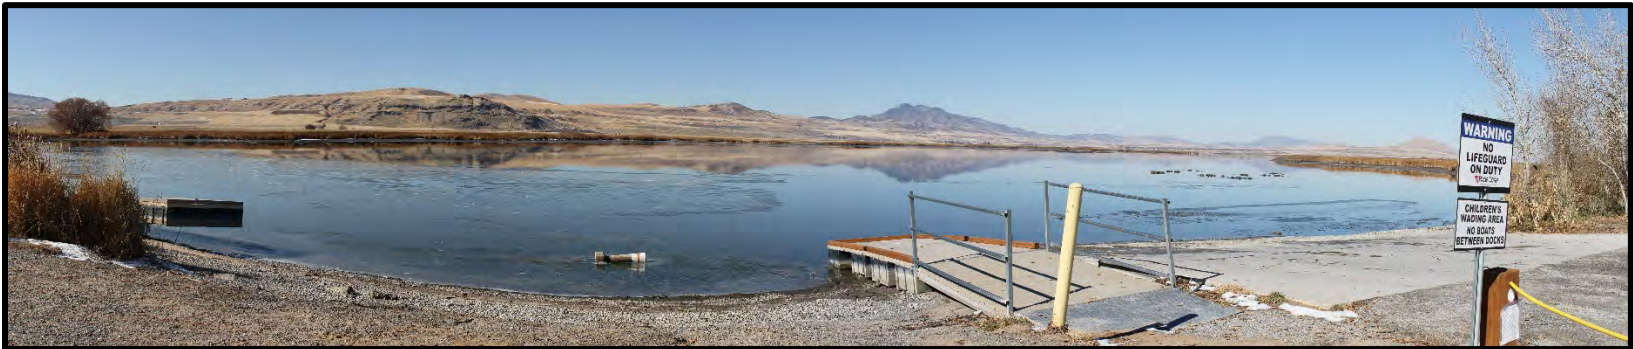
**FIGURE D-11. BENSON MARINA (PANORAMA VIEW, CENTERED WEST, DOWNSTREAM TO THE RIGHT).**

Note: October 24, 2019, baseline.  
Elevation at Cutler Dam 4,407.3 feet

Note: November 1, 2019, drawdown  
Elevation at Cutler Dam 4,392.4 feet.

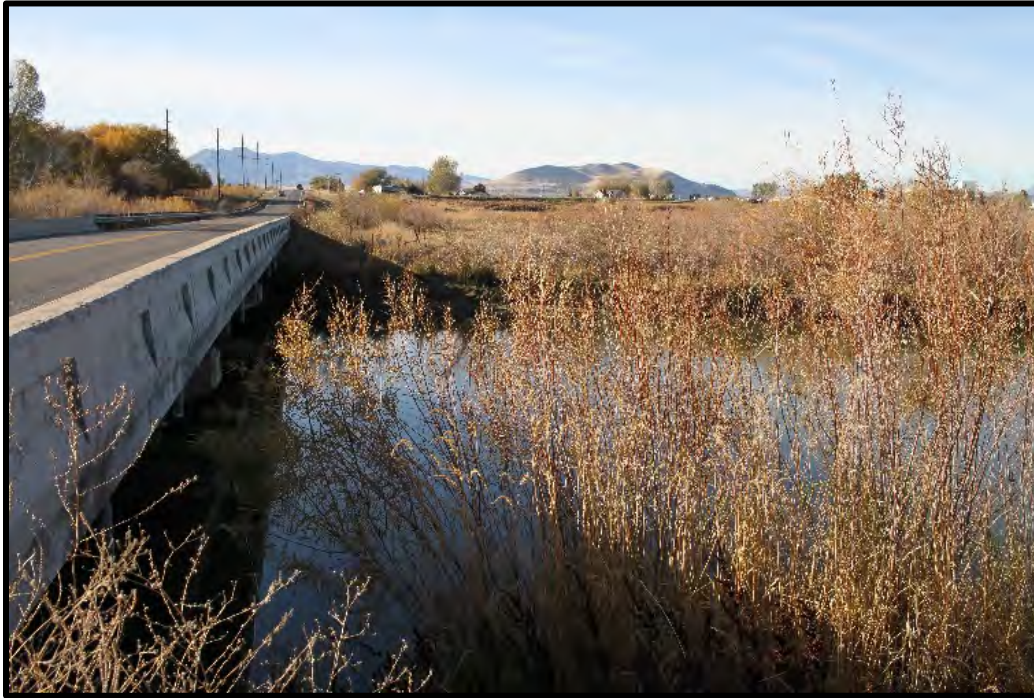
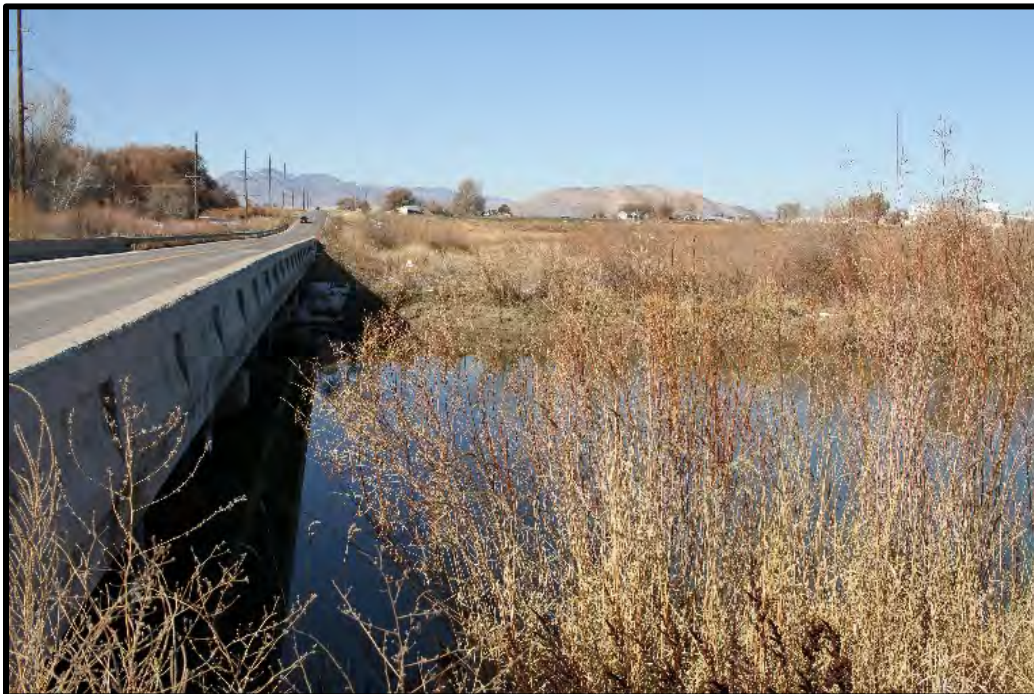
**FIGURE D-12. HIGHWAY 218 BRIDGE, UPSTREAM SIDE, LOOKING WEST, AMALGA, UTAH.**

Note: October 24, 2019, baseline.  
Elevation at Cutler Dam 4,407.3 feet

Note: November 1, 2019, drawdown  
Elevation at Cutler Dam 4,392.4 feet.
