# **CUTLER HYDROELECTRIC PROJECT**

**FERC NO. 2420**

## **INITIAL STUDY REPORT**

### **VOLUME I**

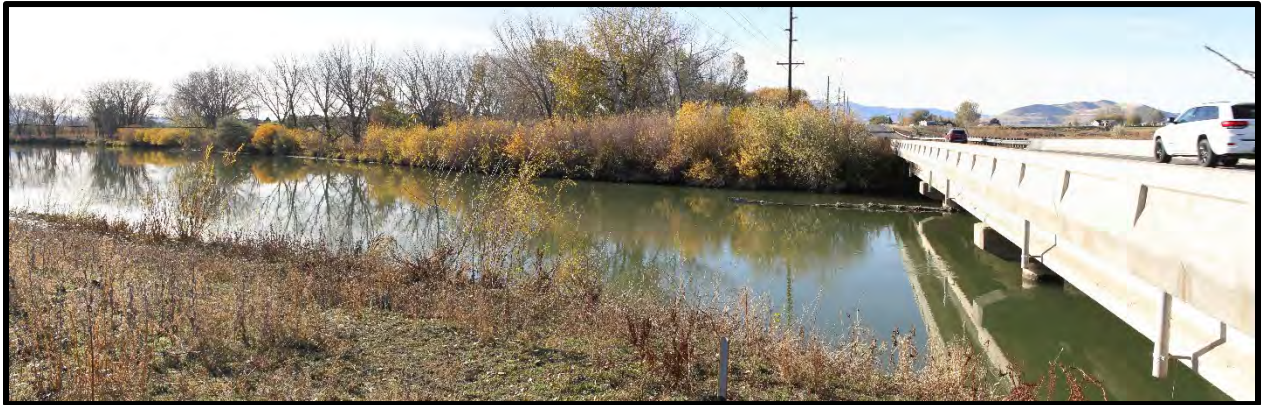
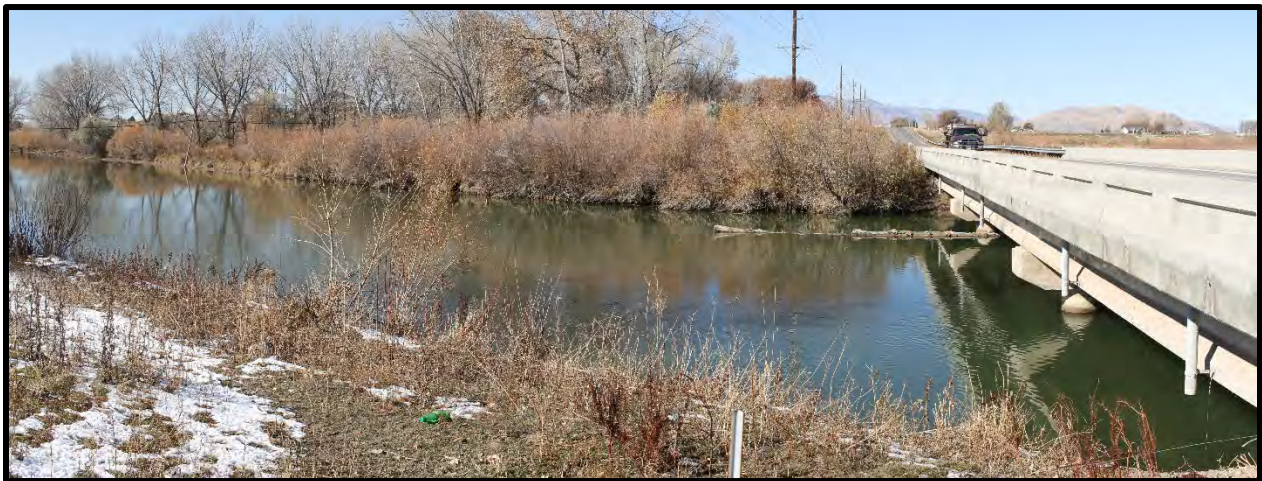
**FIGURE D-13. HIGHWAY 218 BRIDGE, DOWNSTREAM SIDE, LOOKING WEST, AMALGA, UTAH.**

Note: October 24, 2019, baseline.  
Elevation at Cutler Dam 4,407.3 feet

Note: November 1, 2019, drawdown  
Elevation at Cutler Dam 4,392.4 feet.

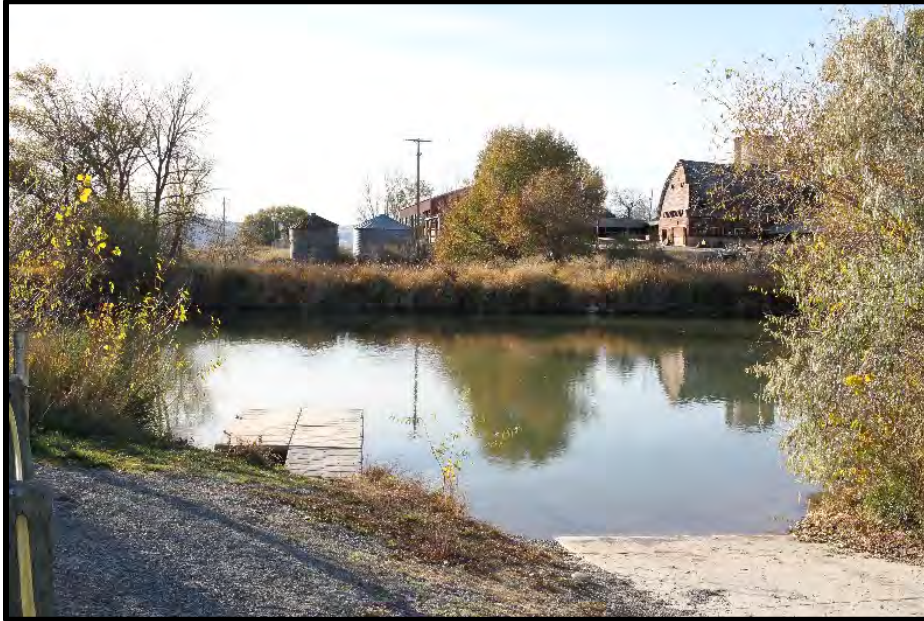
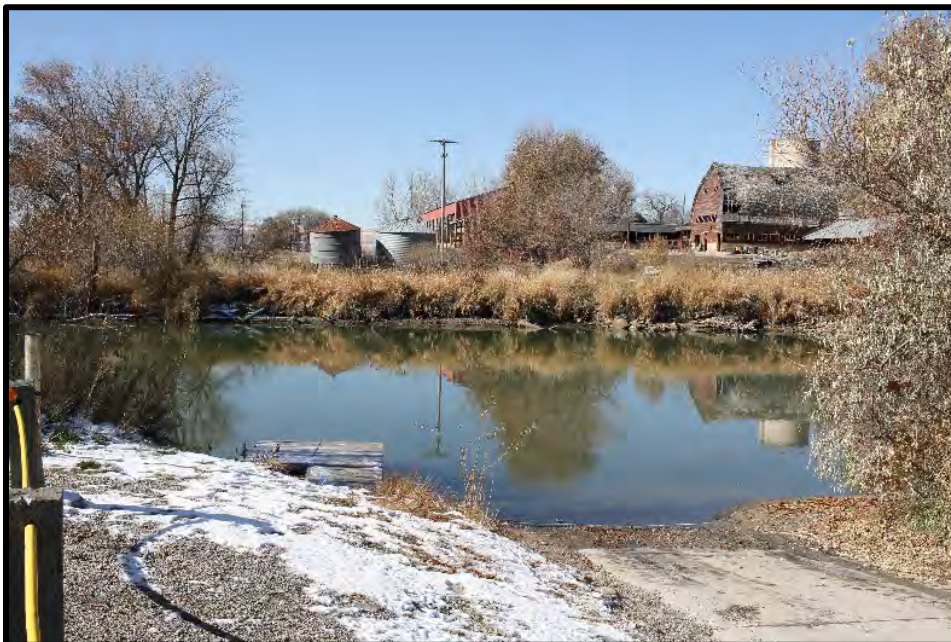
**FIGURE D-14. UPPER BEAR RIVER ACCESS, LOOKING WEST, UPSTREAM TO THE RIGHT.**

Note: October 24, 2019, baseline.  
Elevation at Cutler Dam 4,407.3 feet

Note: November 1, 2019, drawdown  
Elevation at Cutler Dam 4,392.4 feet.

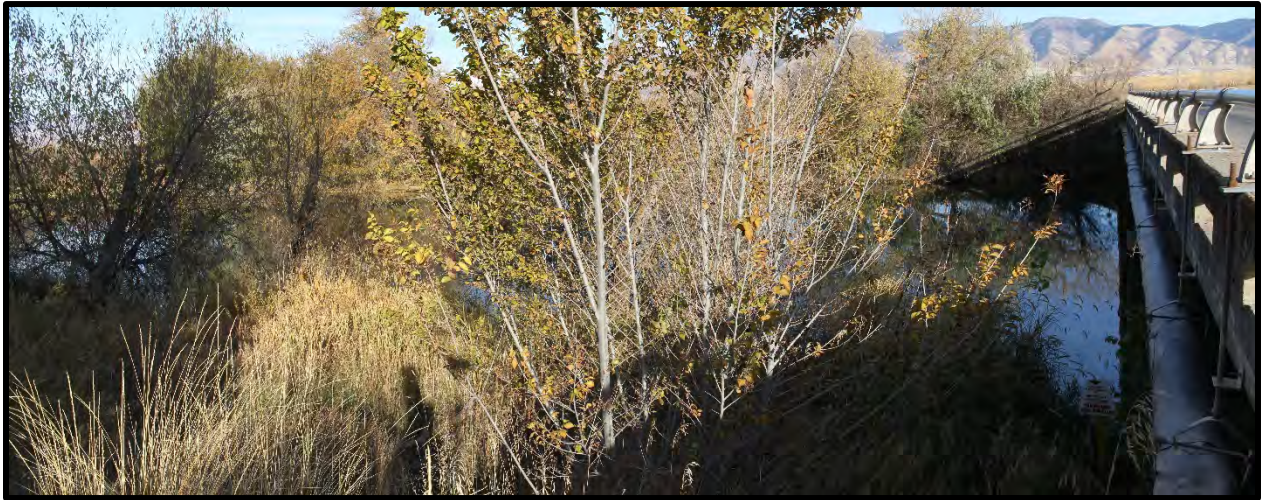
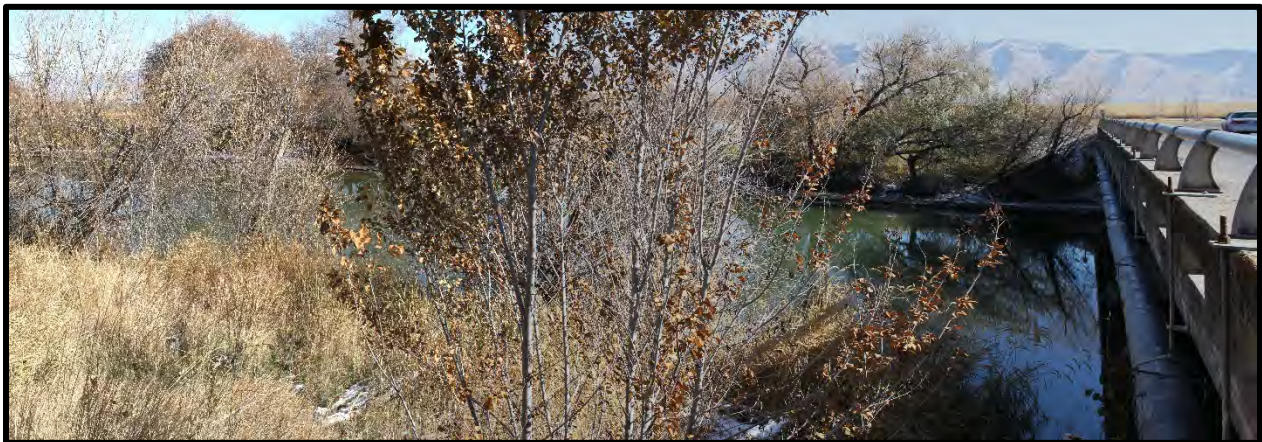
**FIGURE D-15. UPPER BEAR RIVER ACCESS BRIDGE, UPSTREAM SIDE, LOOKING EAST.**

Note: October 24, 2019, baseline.  
Elevation at Cutler Dam 4,407.3 feet

Note: November 1, 2019, drawdown  
Elevation at Cutler Dam 4,392.4 feet.

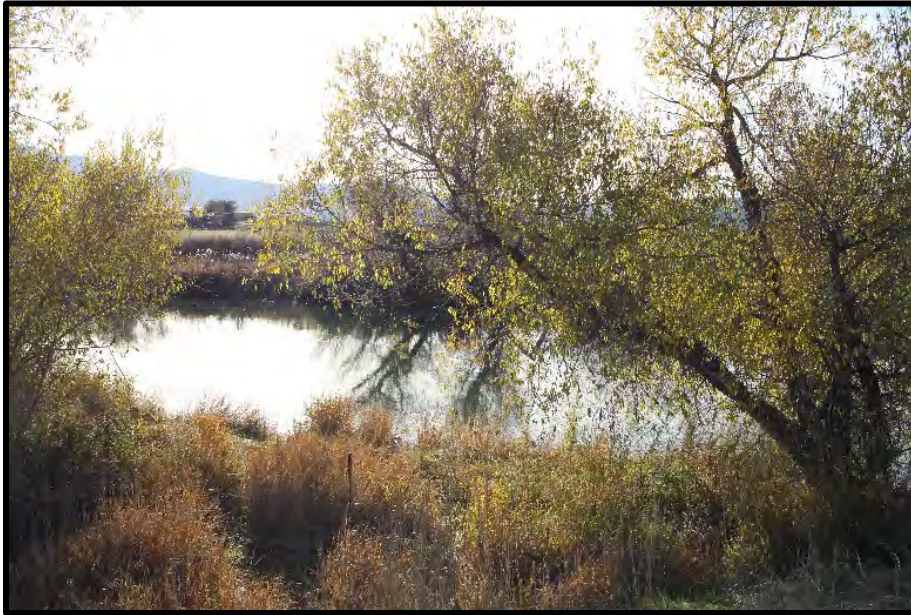
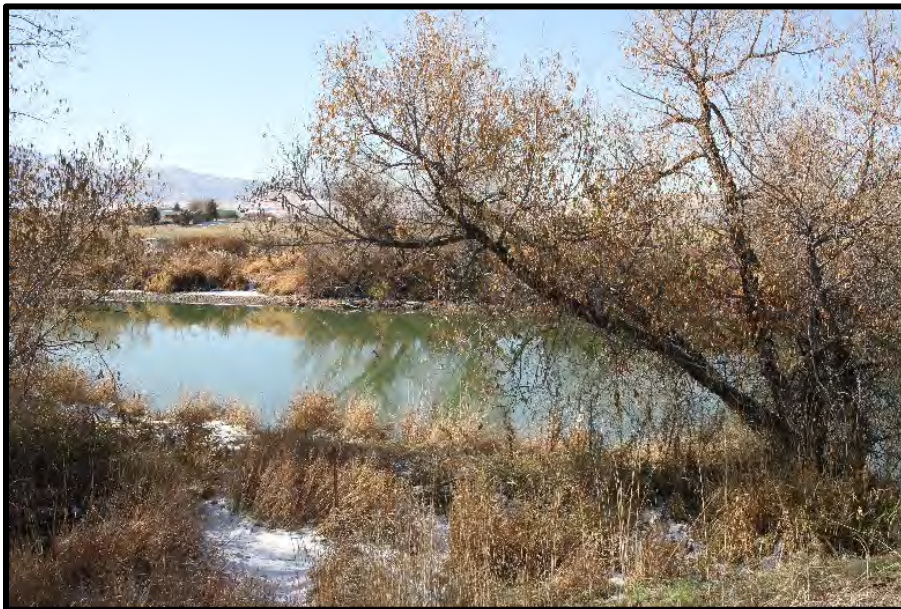
**FIGURE D-16. UPPER BEAR RIVER ACCESS BRIDGE, DOWNSTREAM SIDE, LOOKING WEST.**

Note: October 24, 2019, baseline.  
Elevation at Cutler Dam 4,407.3 feet

Note: November 1, 2019, drawdown  
Elevation at Cutler Dam 4,392.4 feet.

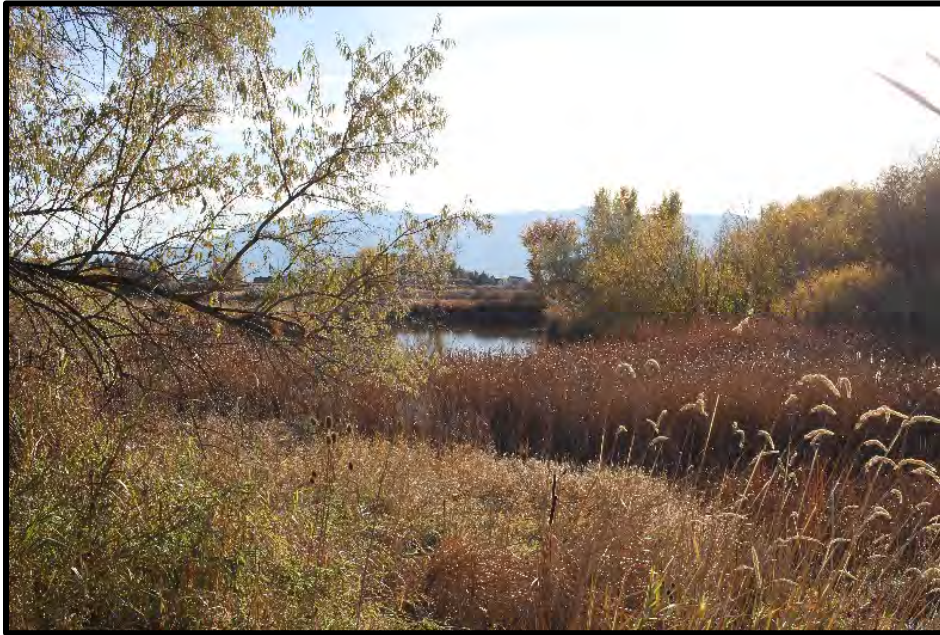
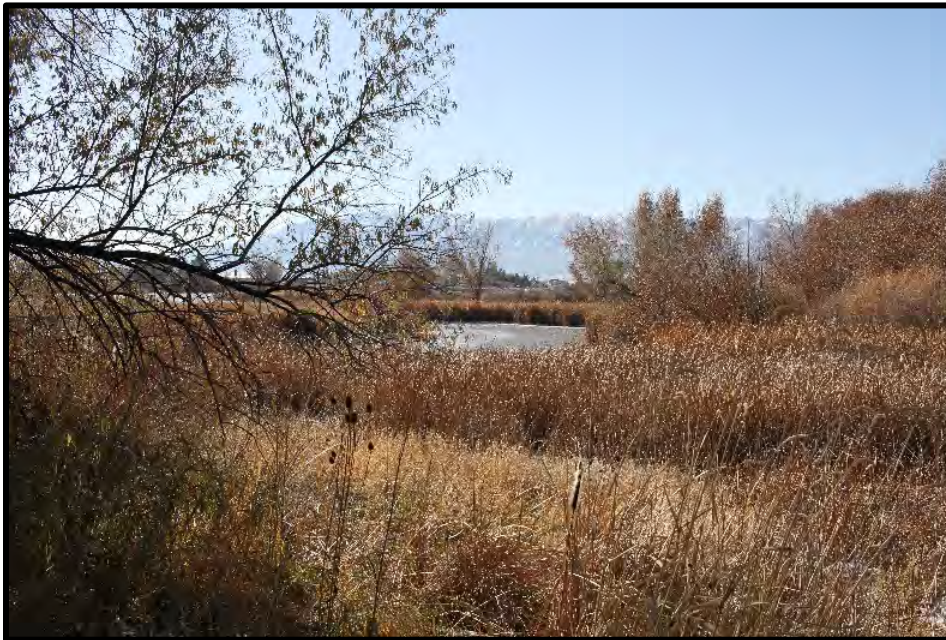
Note: October 24, 2019, baseline.  
Elevation at Cutler Dam 4,407.3 feet

Note: November 1, 2019, drawdown  
Elevation at Cutler Dam 4,392.4 feet.

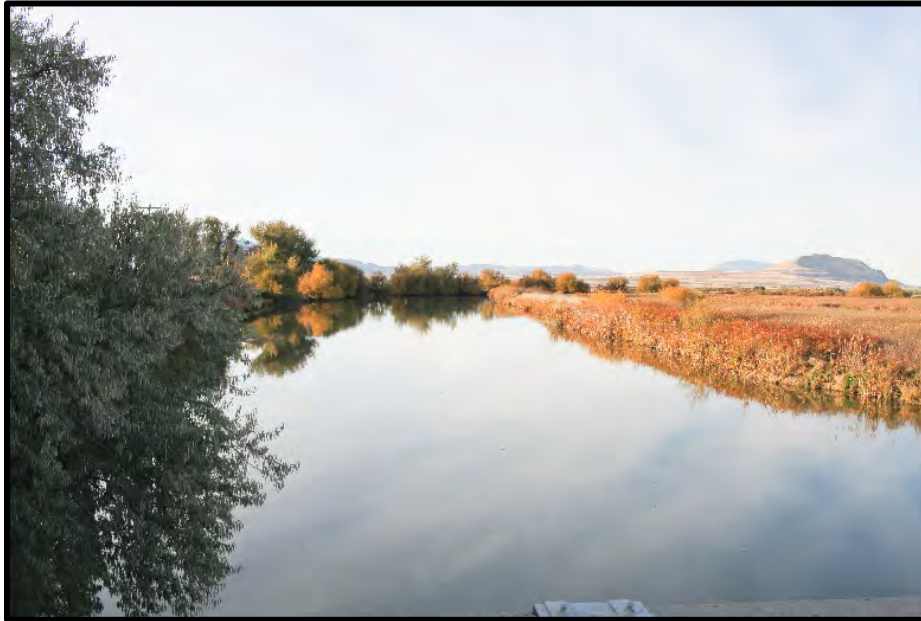
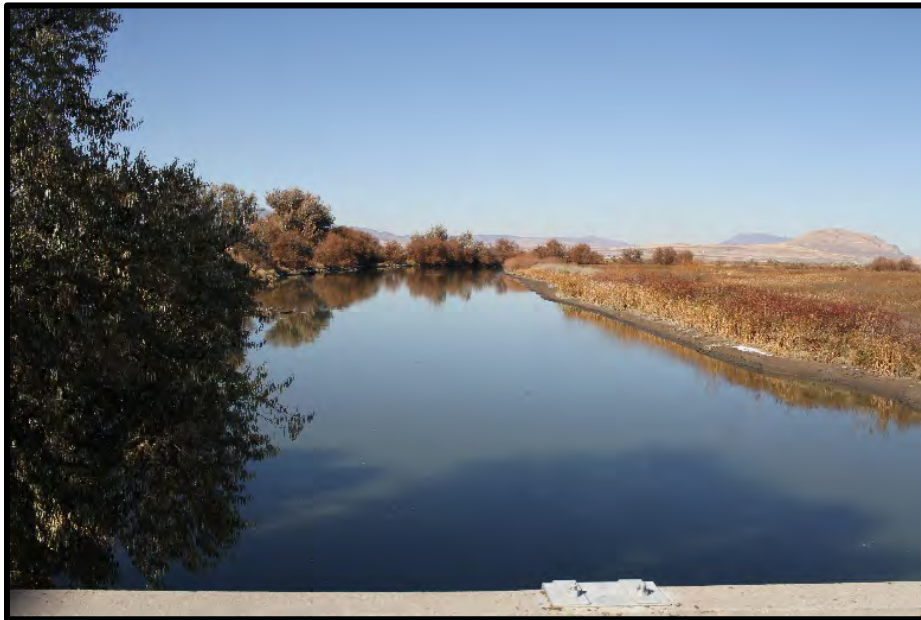
**FIGURE D-17. BEAR RIVER RIPARIAN TRAIL, VIEW OF RIVER OXBOW, LOOKING SOUTHWEST.**

Note: October 24, 2019, baseline.  
Elevation at Cutler Dam 4,407.3 feet

Note: November 1, 2019, drawdown  
Elevation at Cutler Dam 4,392.4 feet.

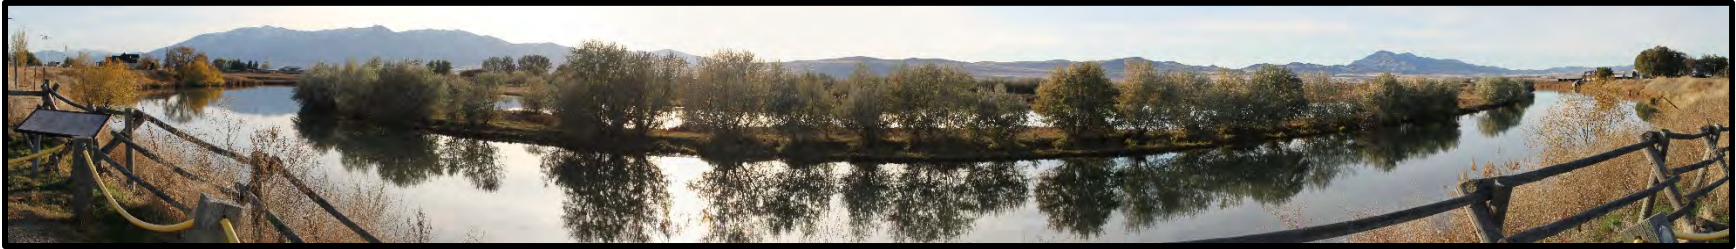
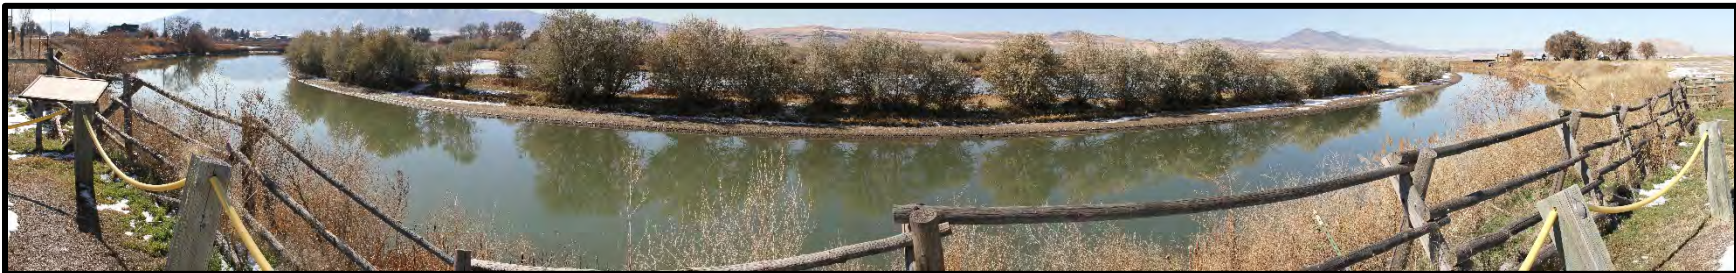
**FIGURE D-18. 3800 N 4000 W (RIVERSIDE) BRIDGE, DOWNSTREAM SIDE, LOOKING  
DOWNSTREAM, BENSON, UTAH.**

Note: October 24, 2019, baseline.  
Elevation at Cutler Dam 4,407.3 feet

Note: November 1, 2019, drawdown  
Elevation at Cutler Dam 4,392.4 feet.

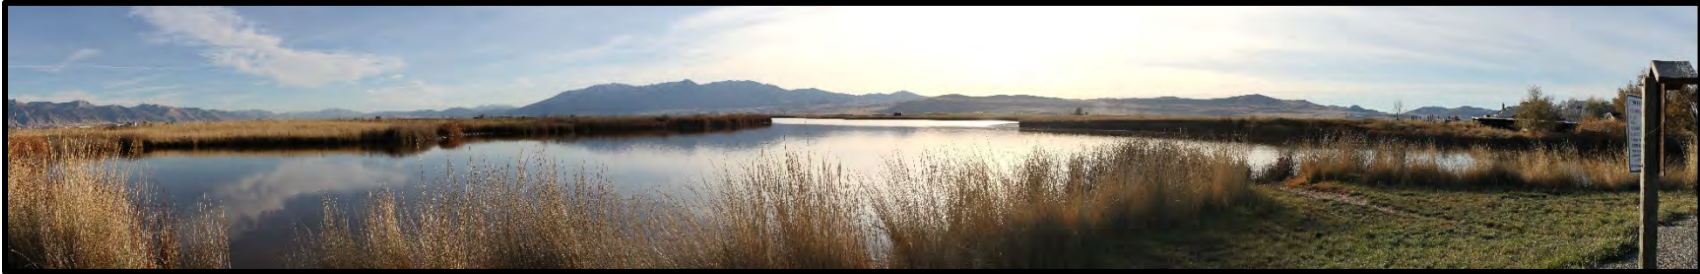
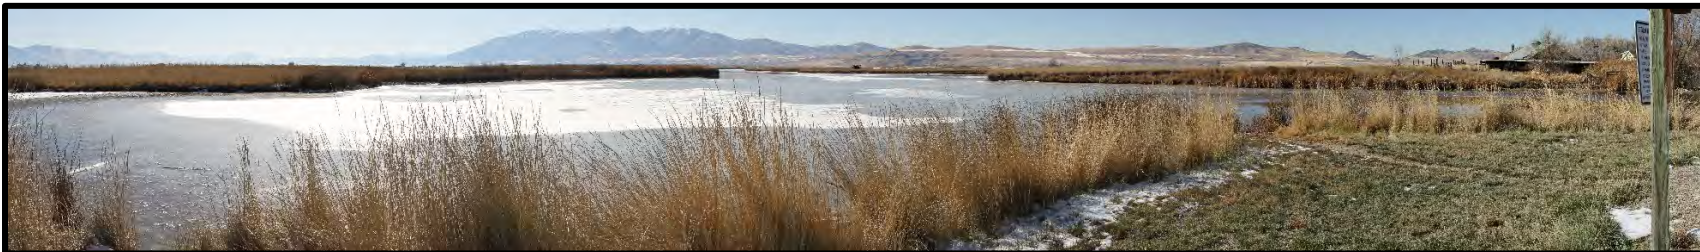
**FIGURE D-19. LOWER BEAR RIVER OVERLOOK, PANORAMA VIEW, CENTERED WEST.**

Note: October 24, 2019, baseline.  
Elevation at Cutler Dam 4,407.3 feet

Note: November 1, 2019, drawdown  
Elevation at Cutler Dam 4,392.4 feet.

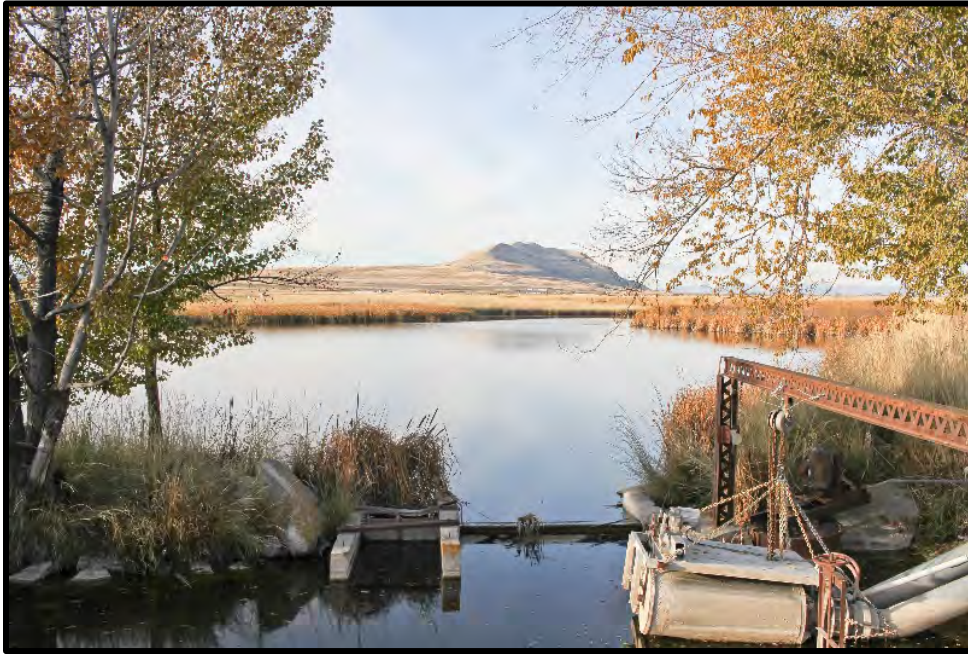
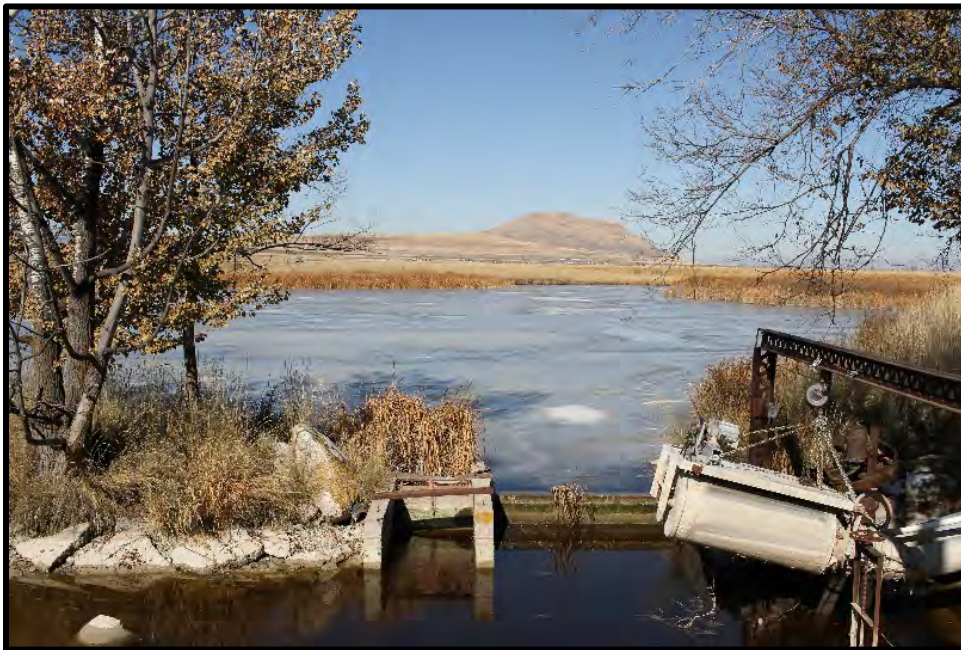
**FIGURE D-20. CLAY SLOUGH ACCESS, DOWNSTREAM, PANORAMA VIEW CENTERED WEST.**

Note: October 24, 2019, baseline.  
Elevation at Cutler Dam 4,407.3 feet

Note: November 1, 2019, drawdown  
Elevation at Cutler Dam 4,392.4 feet.

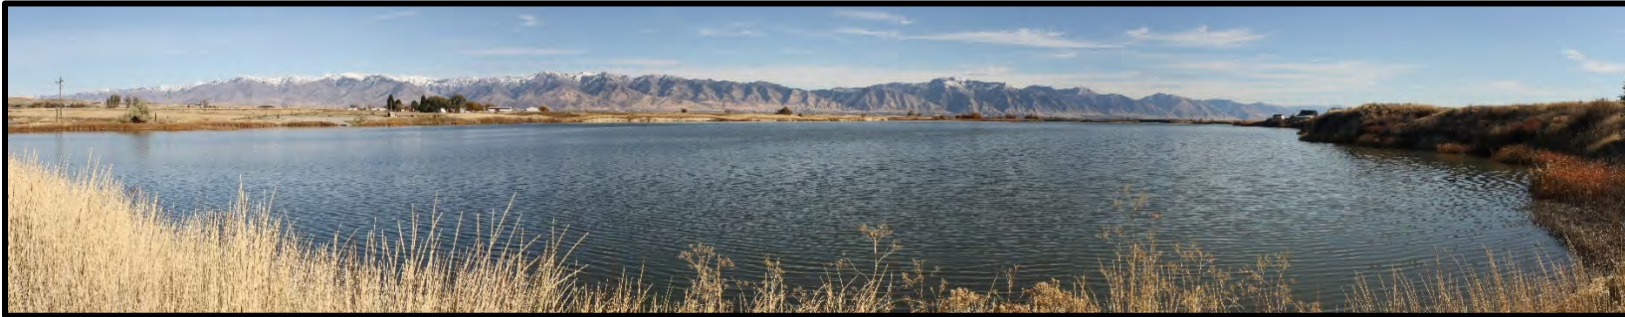
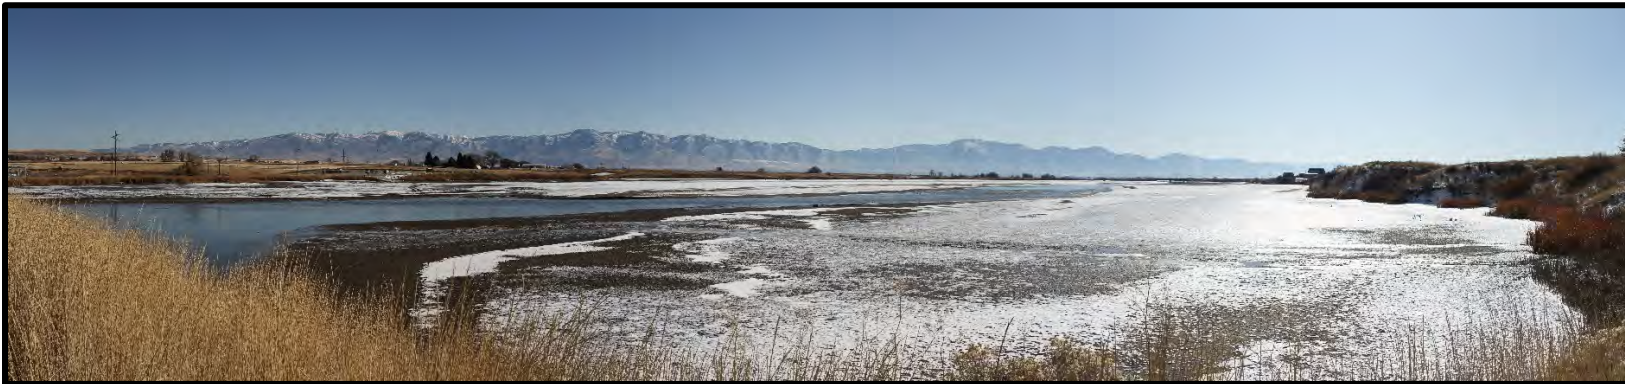
**FIGURE D-21. SAM FELLOW ROAD AT CLAY SLOUGH , UPSTREAM SIDE LOOKING NORTH.**

Note: October 24, 2019, baseline.  
Elevation at Cutler Dam 4,407.3 feet

Note: November 1, 2019, drawdown  
Elevation at Cutler Dam 4,392.4 feet.

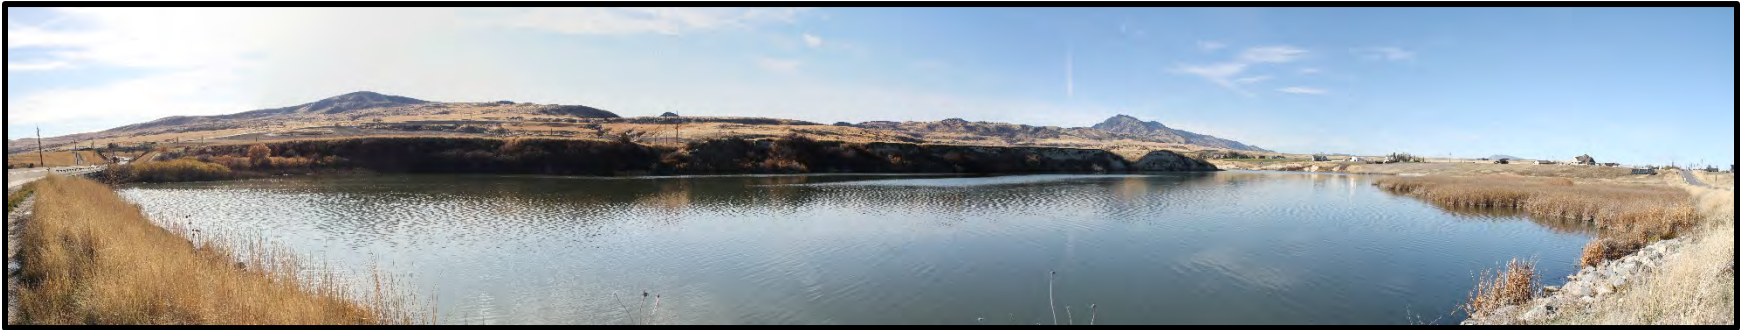
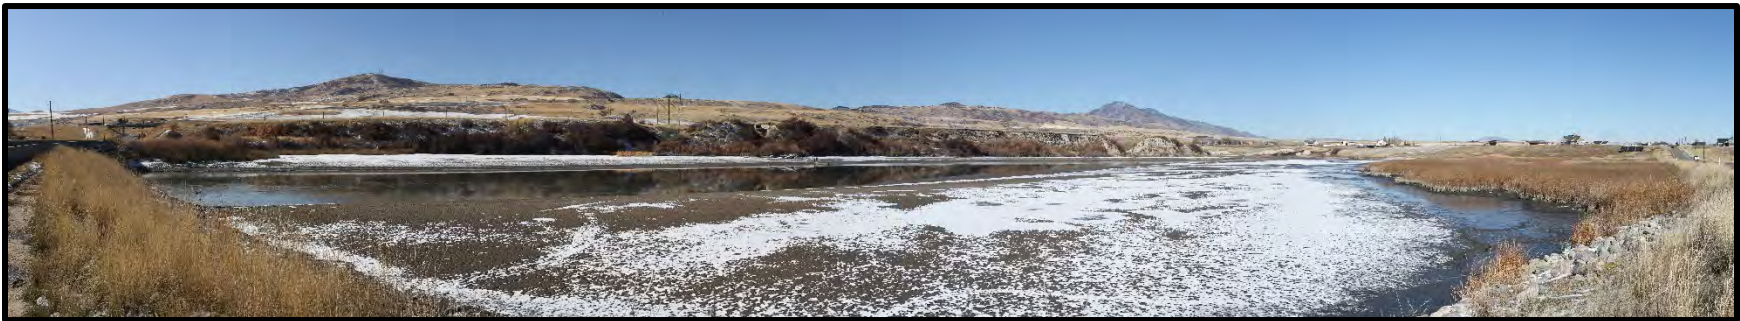
**FIGURE D-22. HIGHWAY 23 (NEWTON) BRIDGE, UPSTREAM SIDE, PANORAMA VIEW CENTERED EAST.**

Note: October 24, 2019, baseline.  
Elevation at Cutler Dam 4,407.3 feet

Note: November 1, 2019, drawdown  
Elevation at Cutler Dam 4,392.4 feet.

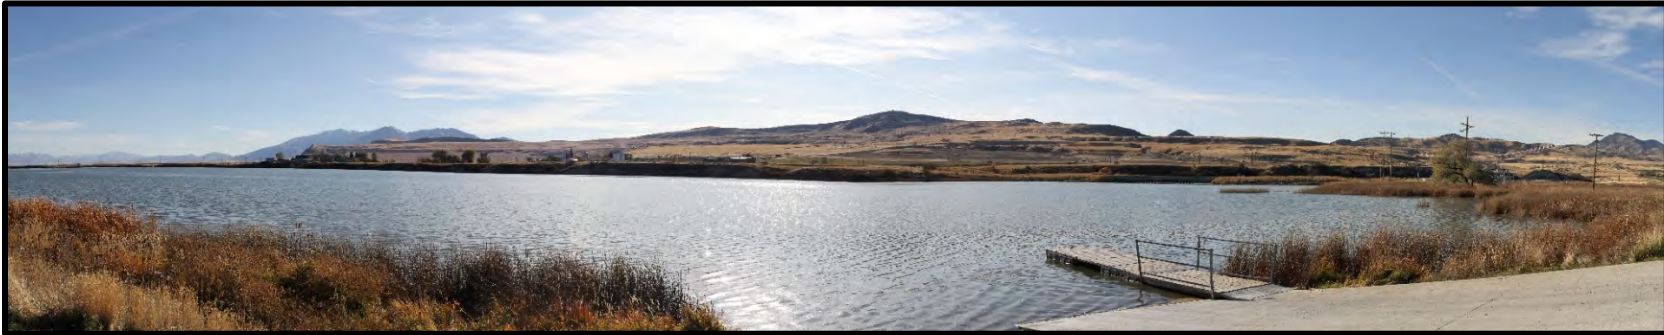
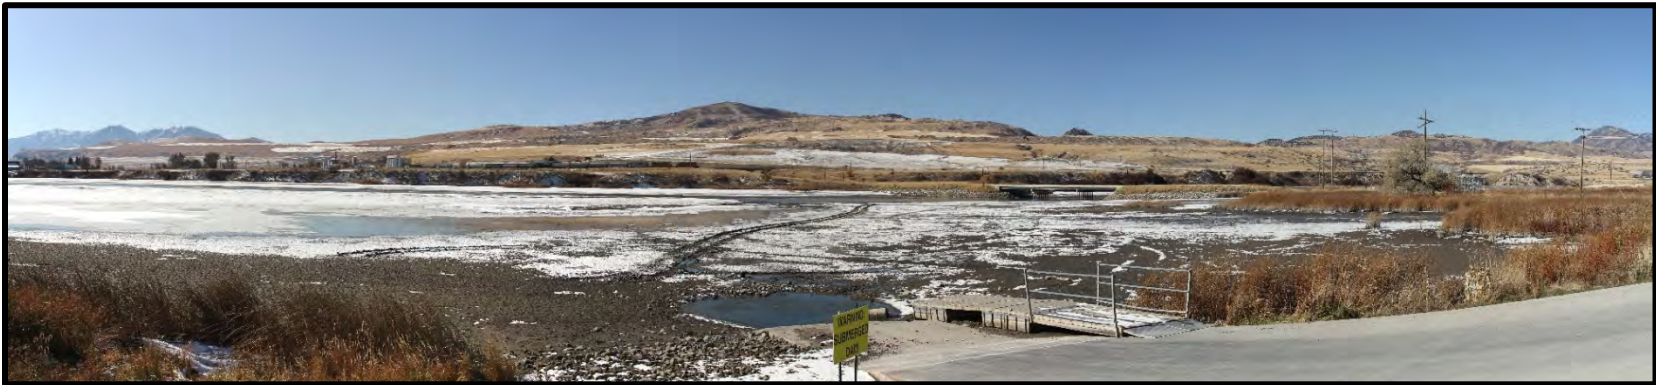
**FIGURE D-23. HIGHWAY 23 (NEWTON) BRIDGE, DOWNSTREAM SIDE, PANORAMA VIEW CENTERED WEST.**

Note: October 24, 2019, baseline.  
Elevation at Cutler Dam 4,407.3 feet

Note: November 1, 2019, drawdown  
Elevation at Cutler Dam 4,392.4 feet.

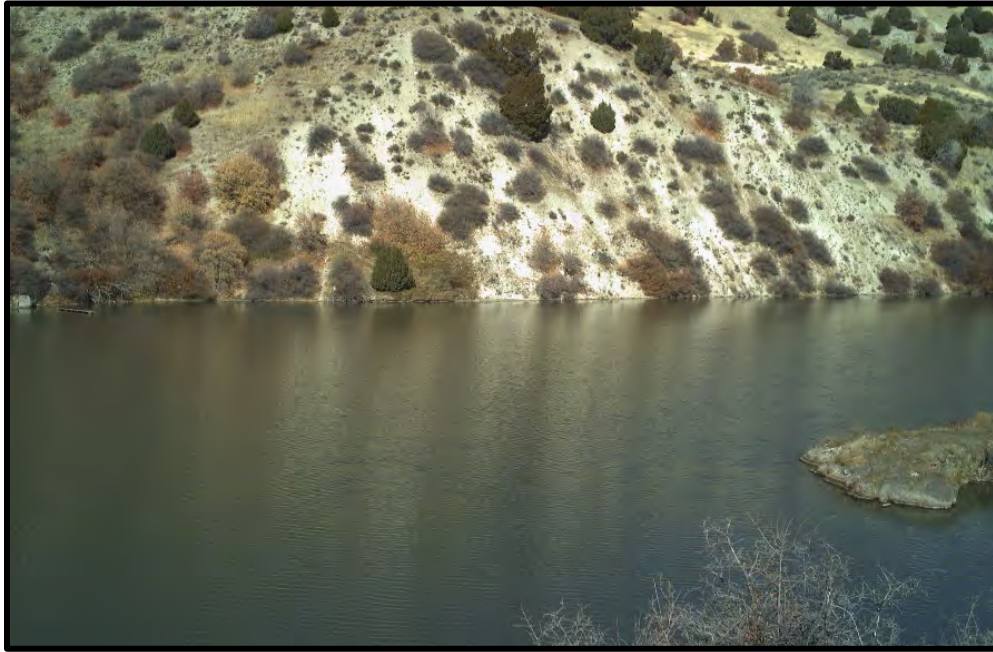
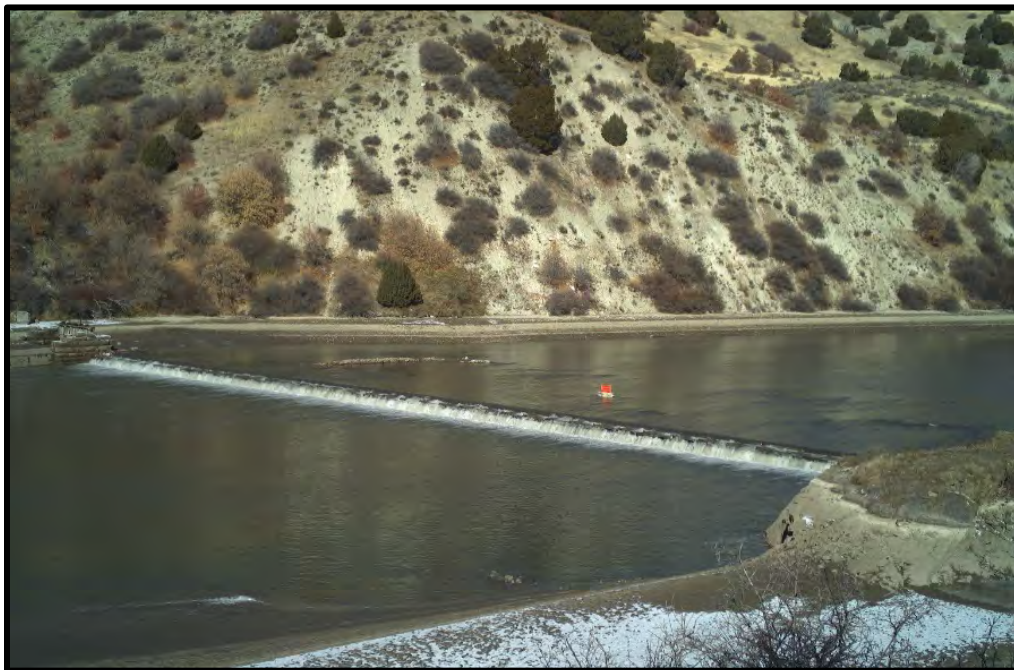
**FIGURE D-24. CUTLER CANYON MARINA, PANORAMA VIEW CENTERED SOUTHWEST, UPSTREAM TO THE LEFT.**

Note: October 24, 2019, baseline.  
Elevation at Cutler Dam 4,407.3 feet

Note: November 1, 2019, drawdown  
Elevation at Cutler Dam 4,392.4 feet.

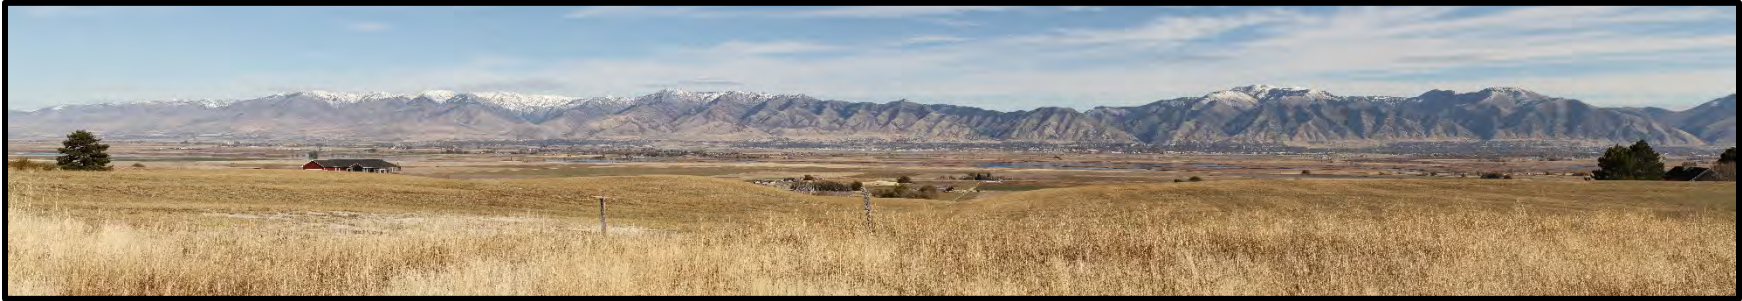
**FIGURE D-25. SOUTH BOAT-IN ISLAND FROM SOUTH SIDE, LOOKING NORTH (WHEELON DAM SUBMERGED IN BASELINE PHOTO).**

Note: October 24, 2019, baseline.  
Elevation at Cutler Dam 4,407.3 feet

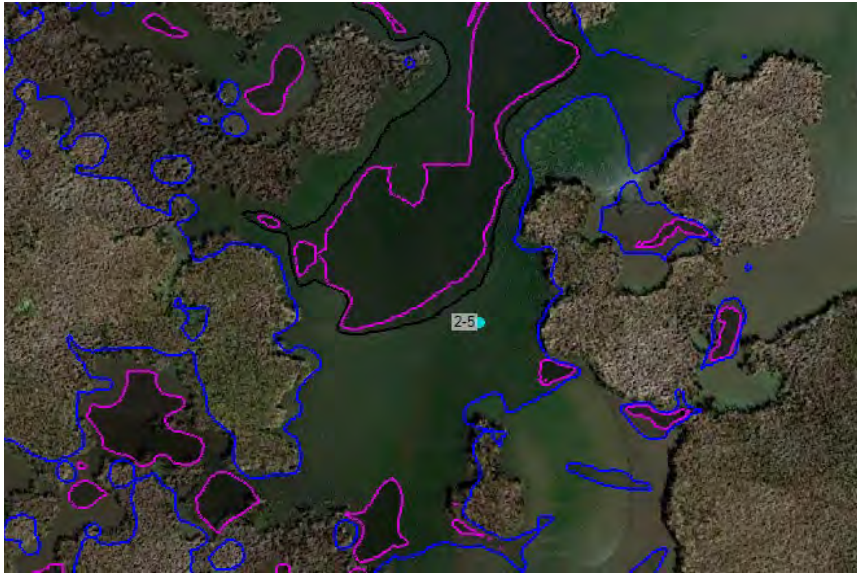
**FIGURE E-1: SITE 2-2**

Figures 1–11, below, illustrate fish isolation sites observed during the 2019 drawdown event in relation to inundation boundaries for the proposed normal operating range (4,407.5- 4,406.5 feet, 85 percent of the time) and proposed extended range (elevation 4,407.5-4,405.0, 15 percent of the time). The pink line shows the boundary at elevation 4,405.0 feet, the black line shows the boundary at elevation 4,406.5 feet, and the blue line shows the boundary at elevation 4,407.5 feet.

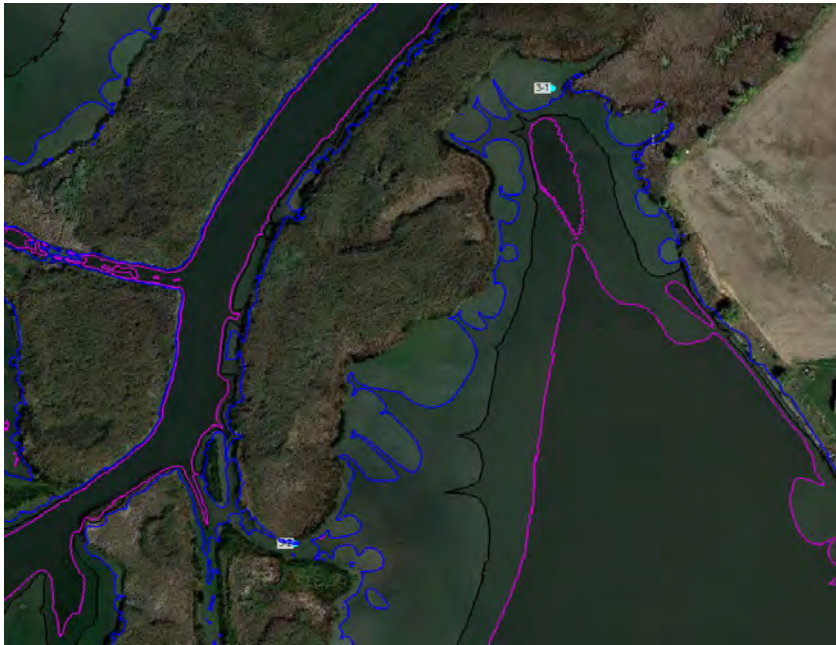
**FIGURE E- 4: SITE 3-5**

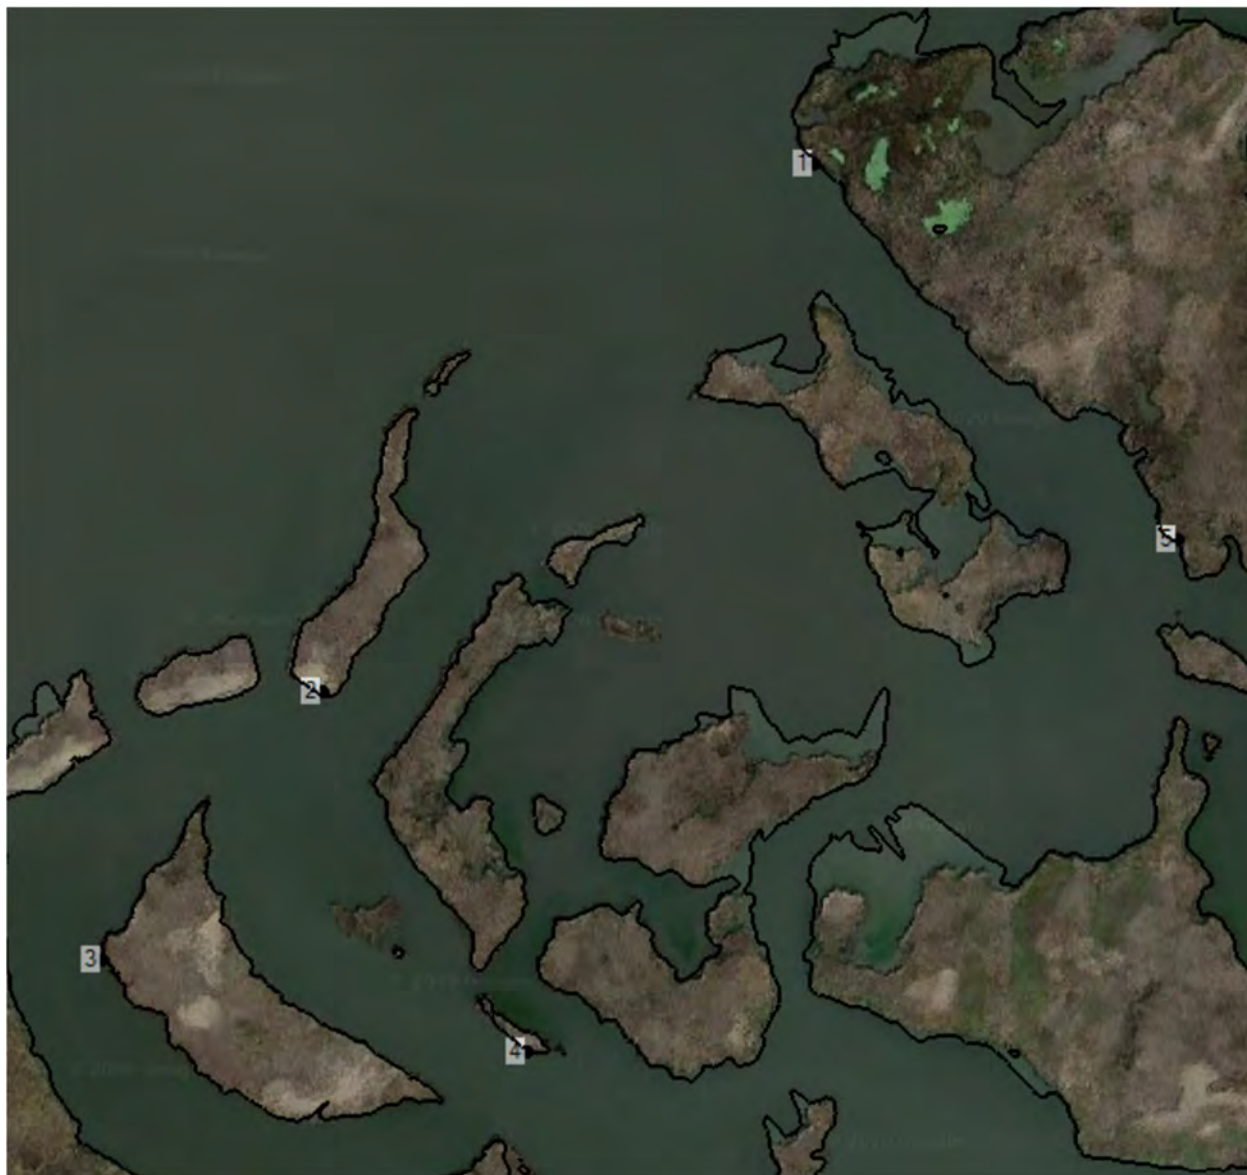
*Figure 1 October 26th, 2019 12:00pm Inundation Boundary*

During the drawdown event photos were taken at 1-minute intervals at 13 sites throughout the reservoir. These photos were used as a qualitative data points and were visually compared to the resulting inundation boundaries from the Hydraulic model overlaid on aerial imagery in order to verify if inundation boundaries matched what was shown in the photo log at the time the photo was taken. Particular attention was paid to five photo site locations near Cutler marsh given that Cutler marsh contains a significant amount of wildlife habitat that is sensitive to the quantity and timing of exposed shoreline. Figure 1, and Photos 1 through Photo 5 compare the inundation boundary model results and photos taken during the drawdown on October 26<sup>th</sup>, 2019. Figure 2 and Photos 6 through Photo 10, compare the inundation boundary model results and photos taken during the drawdown on November 4<sup>th</sup>, 2019.

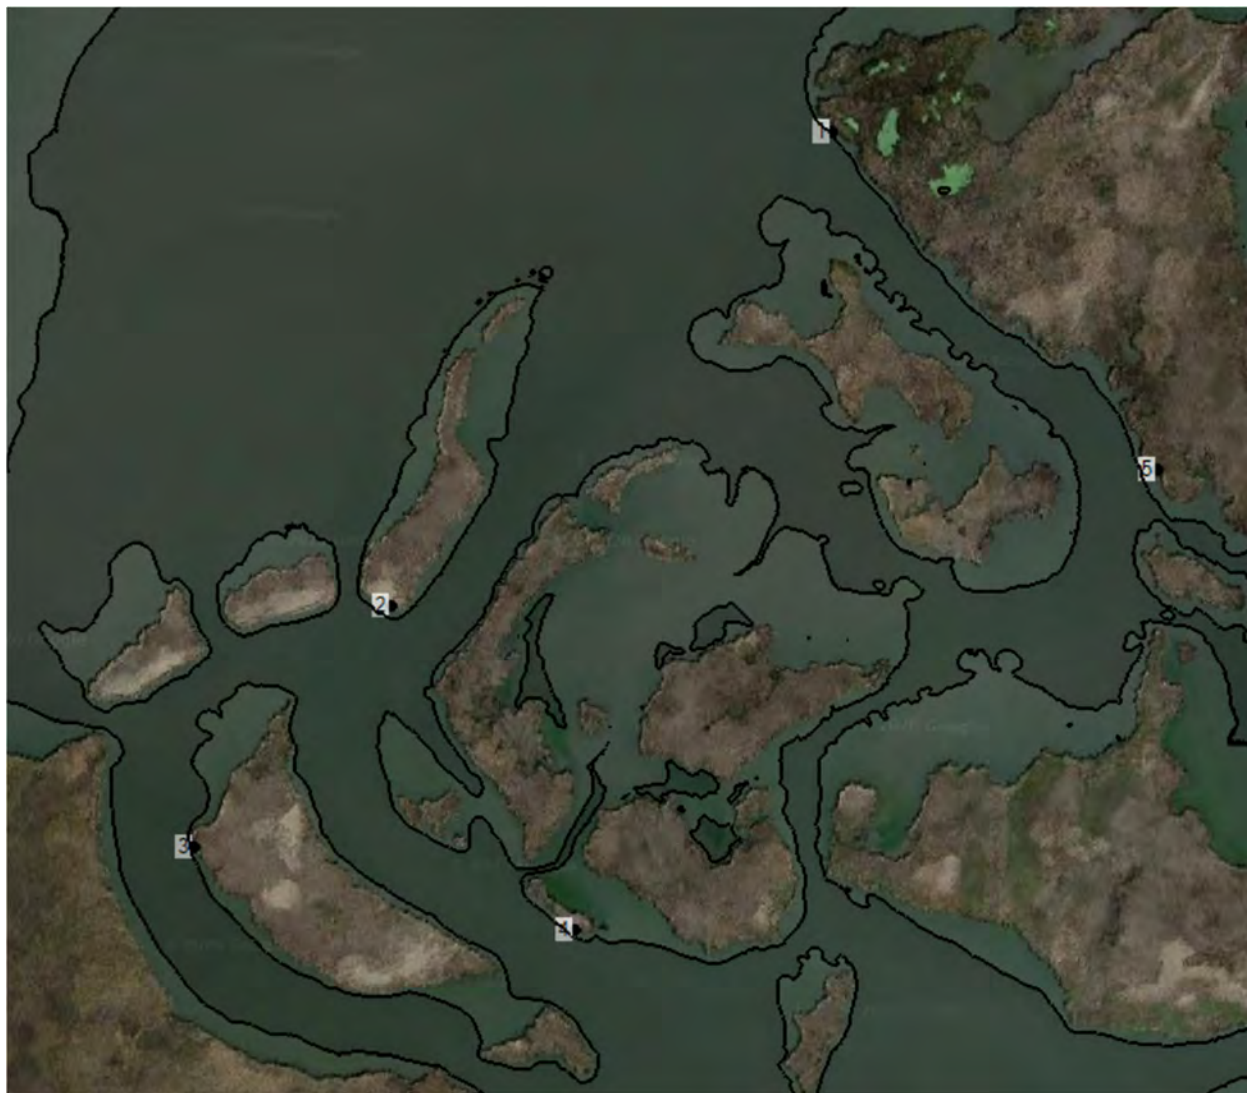
*Figure 2 November 4th, 2019 12:00pm Inundation Boundary*

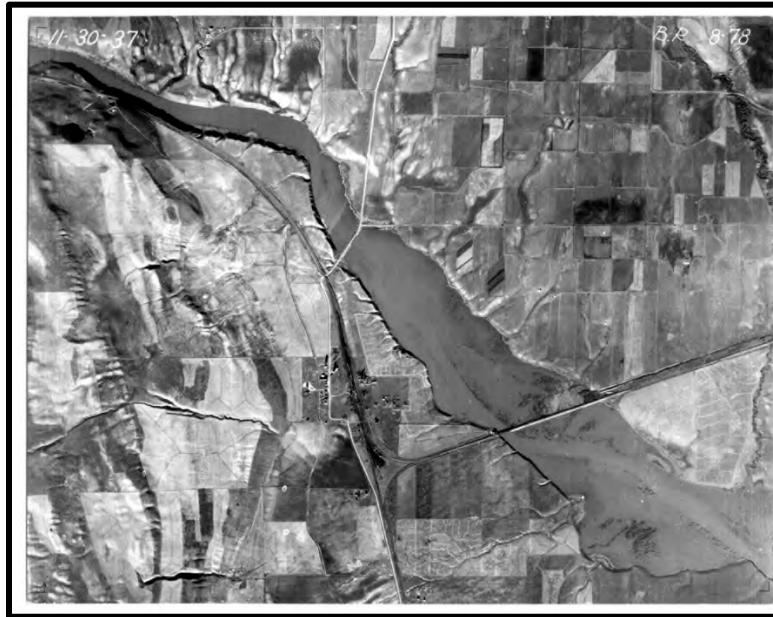
The area shown in Photo 2-1 is Cutler Reservoir near Newton Bridge (center), the railroad (center right), and Cutler Canyon (upper left). Note the Bear River main channel meandering through the reservoir.

**PHOTO 2-1      AERIAL PHOTOGRAPH TAKEN BY UTAH GEOLOGICAL SURVEY (NOV. 1937)**

Cutler Reservoir can be characterized as a shallow reservoir with two distinct areas, the southern reach, which comprises most of the inundated lands, and the northern reach, which is mostly Cutler Canyon. The southern reach of the reservoir is a flooded shallow river valley bounded by low-angle valley slopes. The Logan and Bear rivers, the two main tributaries to this portion of the reservoir, meander through the valley in a sinuous manner forming long bends and cutoff oxbows. This southern area comprises the majority of inundated areas forming Cutler Reservoir. These long historic (i.e., pre-construction) tributary meanders and river bends terminate near the Newton (Highway 23) Bridge as the Bear River enters Cutler Canyon. Some of the earliest known aerial photographs of Cutler Reservoir were taken by the Utah Geological Survey in 1937 (UGS 1937) (Photo 2-1 and Photo 2-2) and highlight the meanders and oxbows throughout the main body of the reservoir.

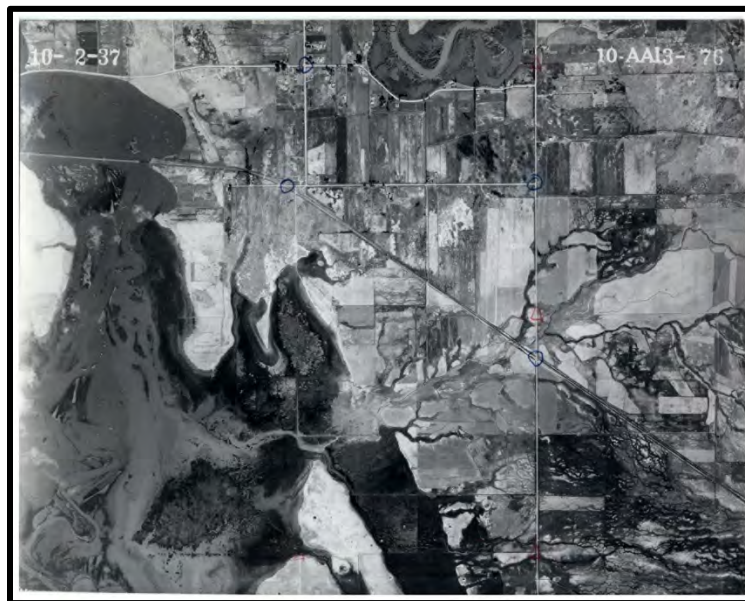
The area shown in Photo 2-2 is the North Marsh unit south of Benson Marina. The Logan River (left side of photograph), and Swift Slough (middle draining to Cutler from the right) converge near what is now the Railroad Trail Fishing Bridge (upper left side of photograph).

**PHOTO 2-2      AERIAL PHOTOGRAPH TAKEN BY UTAH GEOLOGICAL SURVEY (OCT. 1937)**

The Logan River channel meanders through the historic river floodplain under what is now Cutler Reservoir. The meander can be seen from 1937 aerial photographs in areas of the study reach (Photo 2-2). A number of oxbow channels can be seen in this area as well. A total of 14 cores were drilled to characterize the Logan River from the South Marsh to the confluence with the Bear River, north of Benson Marina.

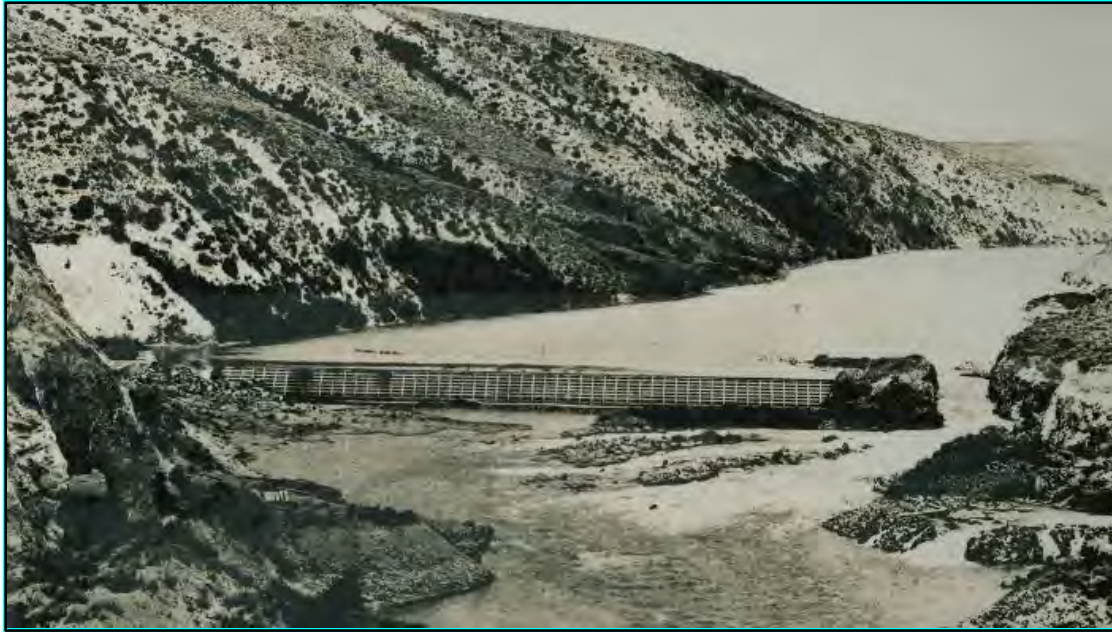
In Photo 2-3, note the flow through left of dam (right side of photograph). No headworks are in place for the Hammond (East) Canal.

**PHOTO 2-3     LOOKING UPSTREAM AT WHEELON DAM (1894)**
