# **CUTLER HYDROELECTRIC PROJECT**

**FERC NO. 2420**

## **INITIAL STUDY REPORT**

### **VOLUME I**

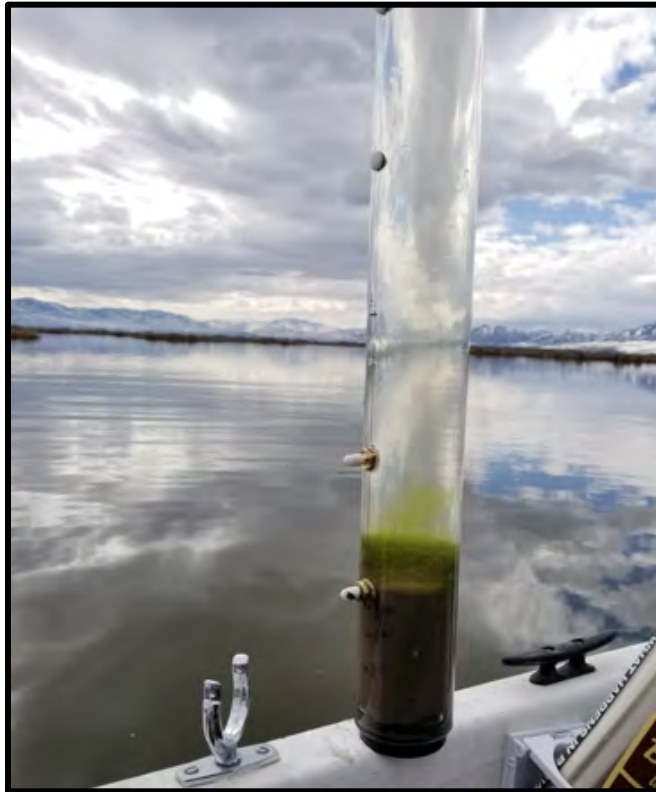
Beginning at the sediment-water interface down to 4 inches, sediment samples were placed in large containers. Each of the four sediment samples was roughly equal in volume. Samples were then sealed and placed in a cool dark area until pore water was extracted.

**PHOTO 4-1** EXAMPLE OF INTEGRATED COLUMN SAMPLE FOR THE SEDIMENT STUDY TAKEN FROM CUTLER IN MARCH 2020

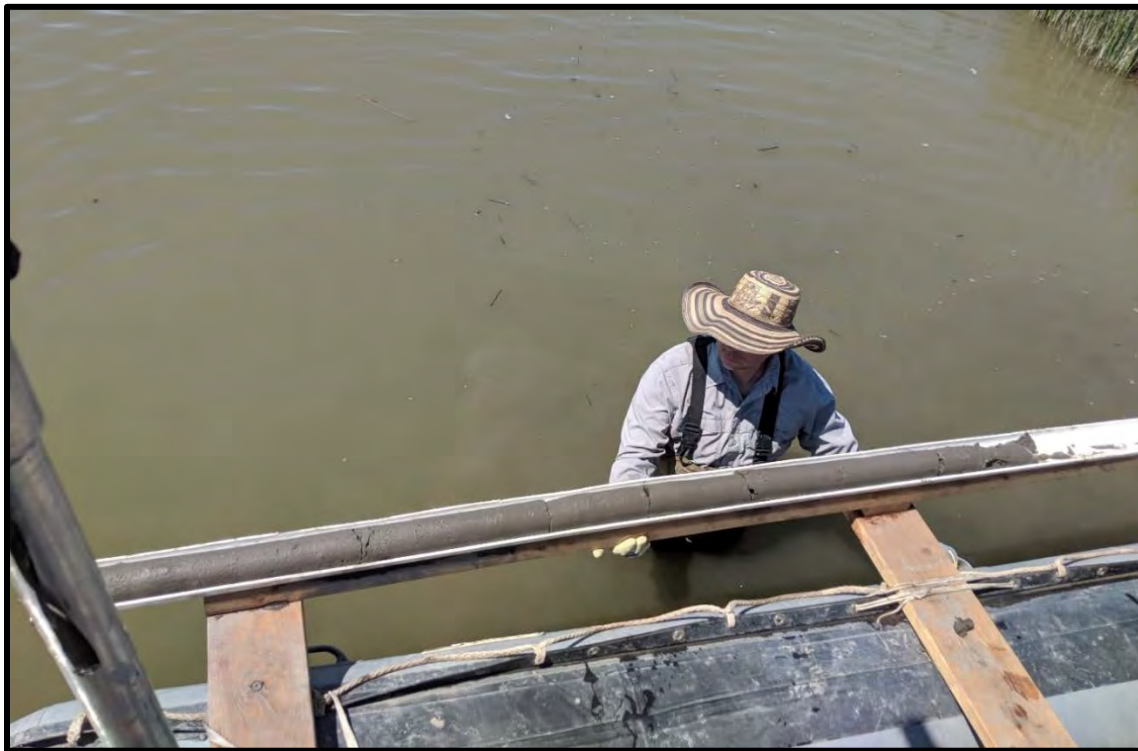
**PHOTO 5-1 SECTION OF CORE SAMPLE REMOVED AT SITE 11 IN NORTH MARSH**

Core samples throughout this study reach consistently had upper deposits of silt with an unconsolidated and highly mobile top layer. Sediment deposits tended to become firmer, bear structure, and gain plasticity with depth (Photo 5-1). Within the river channels and oxbows, sand gradually became dominant, with the deepest cores being well graded fine to medium-fine sand (Note: classified as SM silty sands Photo 5-2). Attachment H-1 illustrates the gradient of each core drilled.

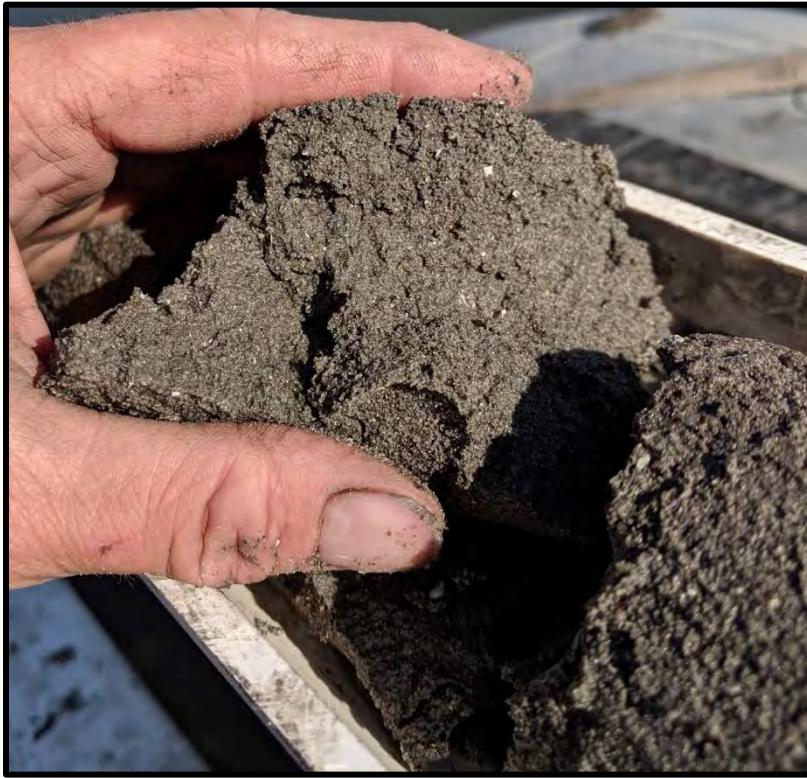
**PHOTO 5-2 DEEPER DEPOSITS OF FINE SAND WITH SILT INTERMIXED**

Note: classified as SM silty sands

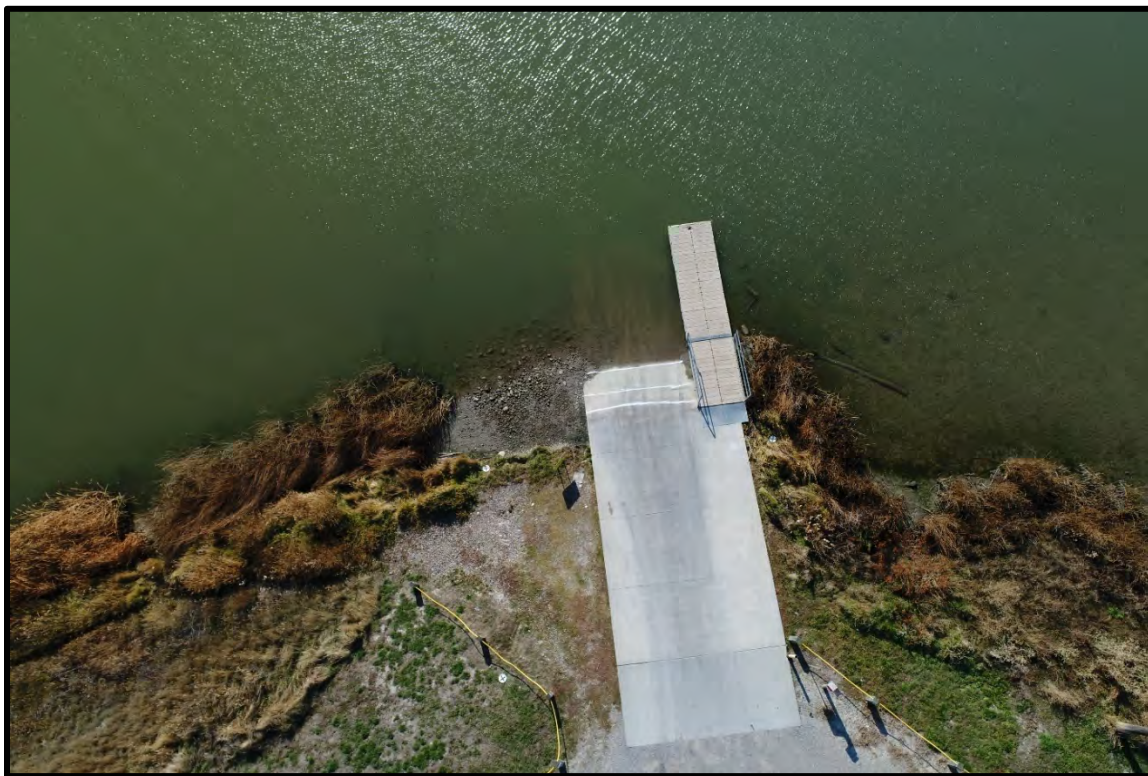
**PHOTO 6-2 CUTLER CANYON MARINA BOAT RAMP AND DOCK, OCTOBER 27, 2019 (JUST BELOW MINIMUM NORMAL OPERATION ELEVATION RANGE)**

The ramp and boat dock continued to function as intended under the proposed normal range of Project operations based on field observations on October 27, 2019 (Photo 6-2) when Cutler Dam elevation was 4406.24, slightly below the proposed normal range of proposed operations (elevation 4407.5 to 4406.5 feet). The wetted perimeter, marked with white survey paint in the photo, receded approximately 7 linear feet on October 27 compared to October 25, 2019. Water depth was still sufficient at the ramp for launching boats and using the boat dock.

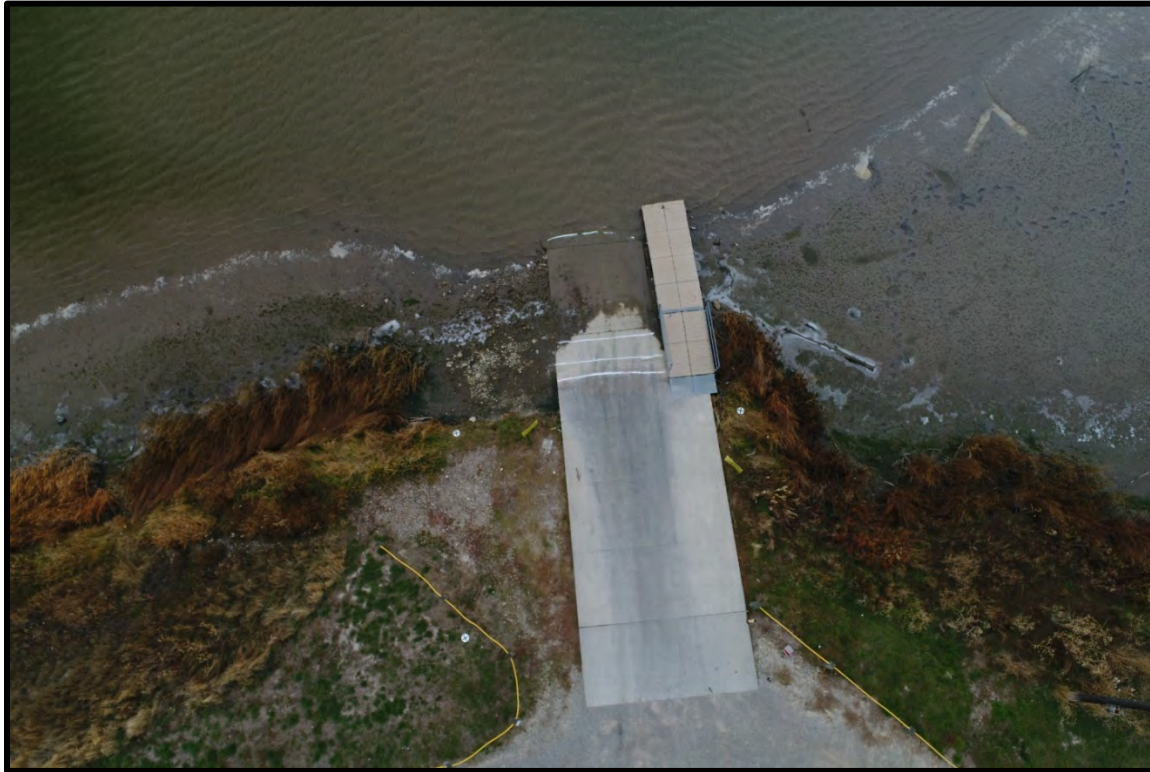
**PHOTO 6-3 CUTLER CANYON MARINA BOAT RAMP AND DOCK, OCTOBER 28, 2019 (JUST BELOW MINIMUM EXTENDED OPERATION ELEVATION RANGE)**

On October 28, 2019, the wetted perimeter receded approximately 25 feet 8 inches linearly compared to October 25, 2019 (Photo 6-3). The end of the boat ramp was exposed at the wetted perimeter. Small boats were able to launch into 18 inches of water at the end of the ramp but larger boats could no longer launch. The last third of the dock was floating for boats to utilize. Using the 2D hydraulic model, the minimum WSE at Cutler Canyon Marina during proposed operations will be 4405.1 feet, 0.2 foot higher than conditions observed on October 28, 2019.

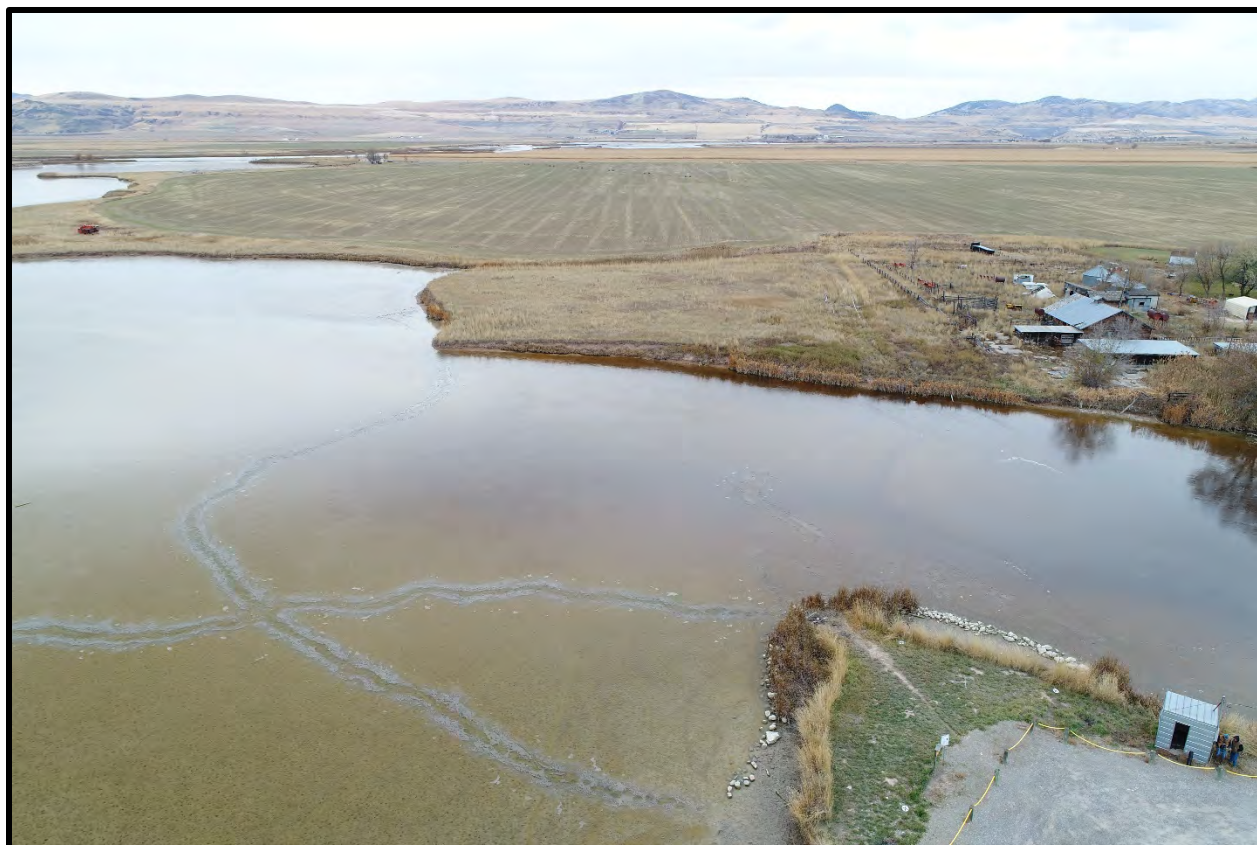
**PHOTO 6-5 CLAY SLOUGH, OCTOBER 28, 2019 (JUST BELOW MINIMUM EXTENDED OPERATION ELEVATION RANGE)**

The wetted perimeter decreased 3 feet 7 inches on October 28, 2019 (just below the minimum proposed operating range) compared to the wetted perimeter on October 25, 2019 (at full pool). Bank stabilization rocks and mud were exposed along the shoreline on October 28, 2019 (Photo 6-5). The site continued to provide access for carry-in boats on the October 28, 2019 field visit.

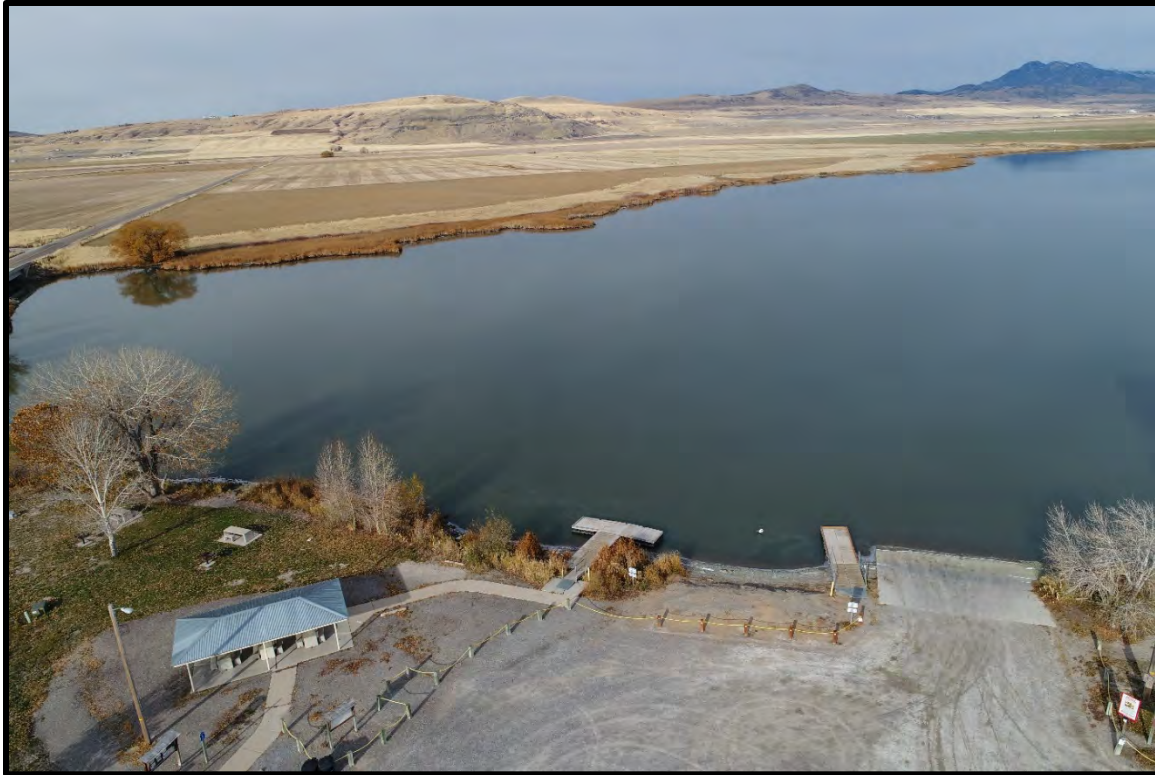
**PHOTO 6-7 BENSON MARINA BOAT RAMP AND SWIMMING AREA, OCTOBER 28, 2019 (JUST BELOW MINIMUM EXTENDED OPERATION ELEVATION RANGE)**

The boat ramp and swim area continued to function as intended under the proposed normal and extended range of Project operations based on field observations during the fall 2019 drawdown period (Photo 6-7). Water depth was sufficient at the ramp for launching boats and using the boat dock at all levels in the proposed range. The dock at the swim beach was partially exposed but depths were sufficient for swimming. The wetted perimeter decreased 10 feet 9 inches (linearly) on October 28, 2019 compared to the wetted perimeter on October 25, 2019 prior to the drawdown (at reservoir full-pool elevations). Cutler Dam elevation on October 28, 2019 was 4,404.58 feet, approximately 0.4 feet lower than the proposed extended range elevation.

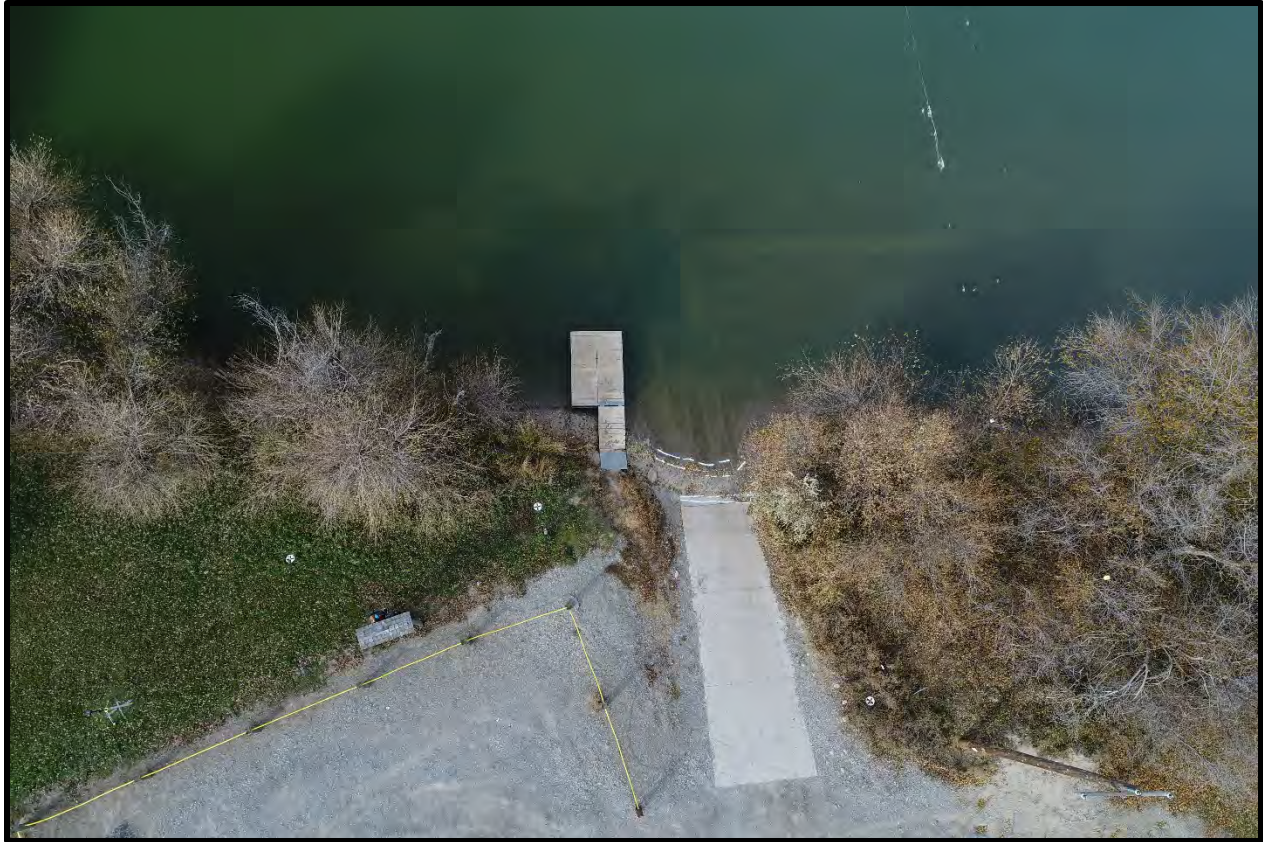
**PHOTO 6-9** UPPER BEAR RIVER BOAT RAMP, OCTOBER 28, 2019 (JUST BELOW MINIMUM EXTENDED OPERATION ELEVATION RANGE)

Future proposed Project operations in the normal and extended range are not expected to influence WSE at the Upper Bear River Access. The Upper Bear River Access was visited daily during the fall 2019 drawdown period to document potential changes in wetted perimeter and evaluate the usability of the boat ramp and dock providing access to the Bear River. The wetted perimeter width, delineated with white survey paint in Photo 6-9, decreased 6 feet linearly at the launch shoreline between October 25, 2019 (at essentially full pool) and October 28, 2019 (just

below the minimum elevation of the proposed extended operation range). The concrete boat ramp was covered with mud up to the ordinary highwater mark. The mud bottom was exposed as the wetted perimeter receded, but the ramp continued to function for launching trailered boats. The dock also continued to function as intended on October 28, 2019.

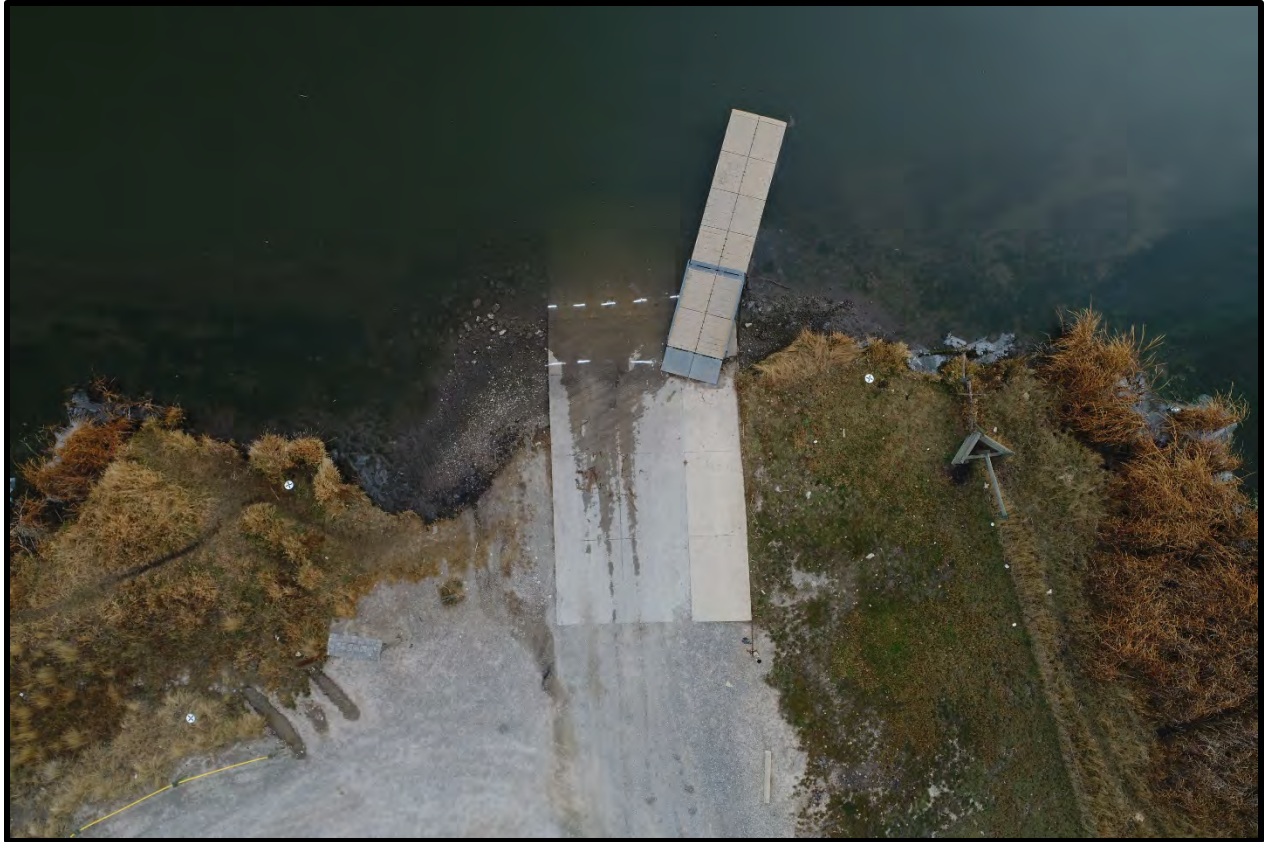
**PHOTO 6-11 CUTLER MARSH MARINA BOAT RAMP, OCTOBER 28, 2019 (JUST BELOW MINIMUM EXTENDED OPERATION ELEVATION RANGE)**

The boat ramp continued to function as intended under the proposed normal and extended range of Project operations based on field observations during the fall 2019 drawdown period (Photo 6-11). Water depth was sufficient at the ramp for launching boats and the boat dock. Boats were observed launching at Cutler Marsh Marina during data collection efforts on October 28, 2020, which was at an elevation just below the proposed extended minimum reservoir elevation range.

The wetted perimeter decreased 8 linear feet on October 28, 2019 compared to the wetted perimeter on October 25, 2019 prior to the drawdown (at essentially full pool). Areas of previously submerged shoreline were exposed on the downstream side of the boat ramp.

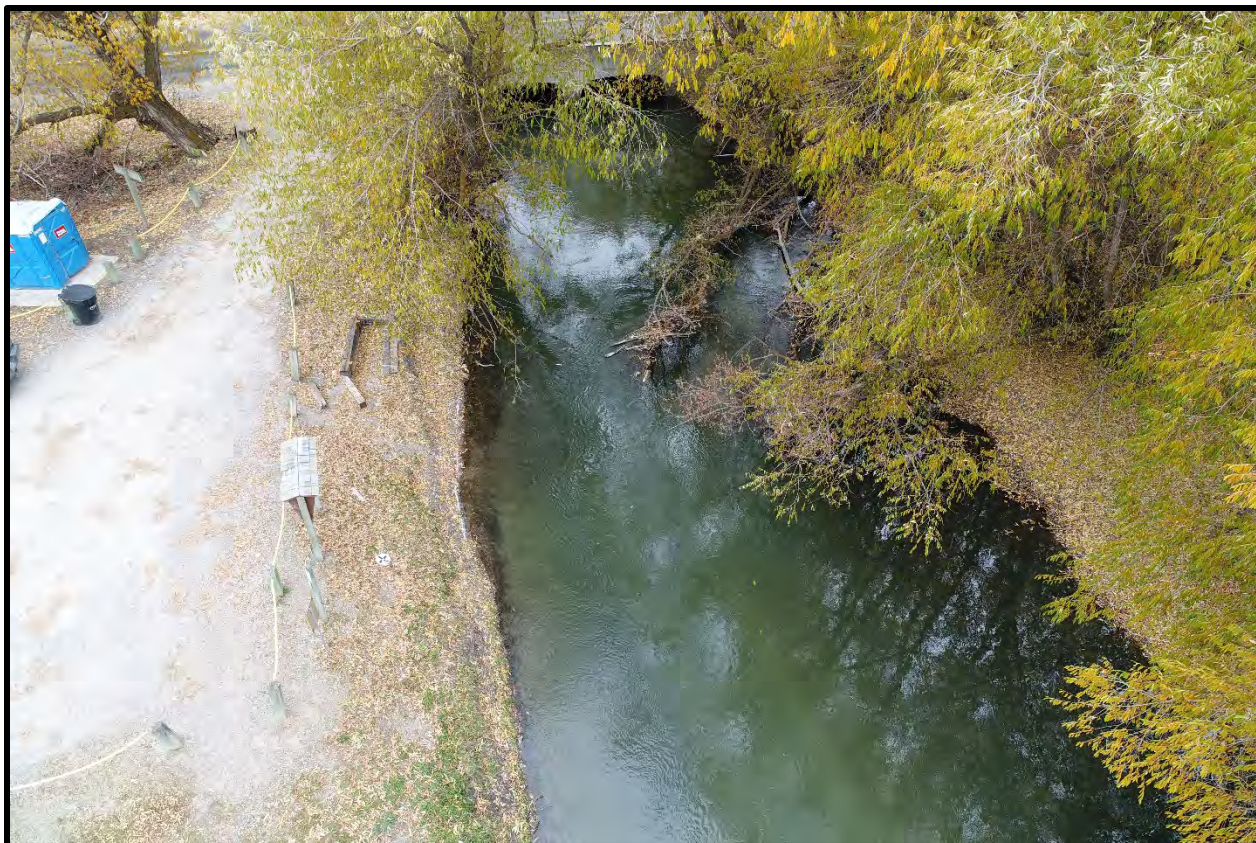
**PHOTO 6-13** LITTLE BEAR RIVER ACCESS, OCTOBER 28, 2019 (JUST BELOW MINIMUM EXTENDED OPERATION ELEVATION RANGE)

Future proposed Project operations in the normal and extended range are not expected to influence WSE at Little Bear River Access. The Little Bear River Access was visited daily during the fall 2019 drawdown period to document potential changes in wetted perimeter and water depth resulting in potential access limitations. The carry-in boat launch at Little Bear River Access continued to meet the design function during fall 2019 through the minimum proposed extended range for future Project operations. The wetted perimeter width, delineated with white survey paint in Photo 6-13, decreased 2 linear inches at the launch shoreline between October 25, 2019, and October 28, 2019.

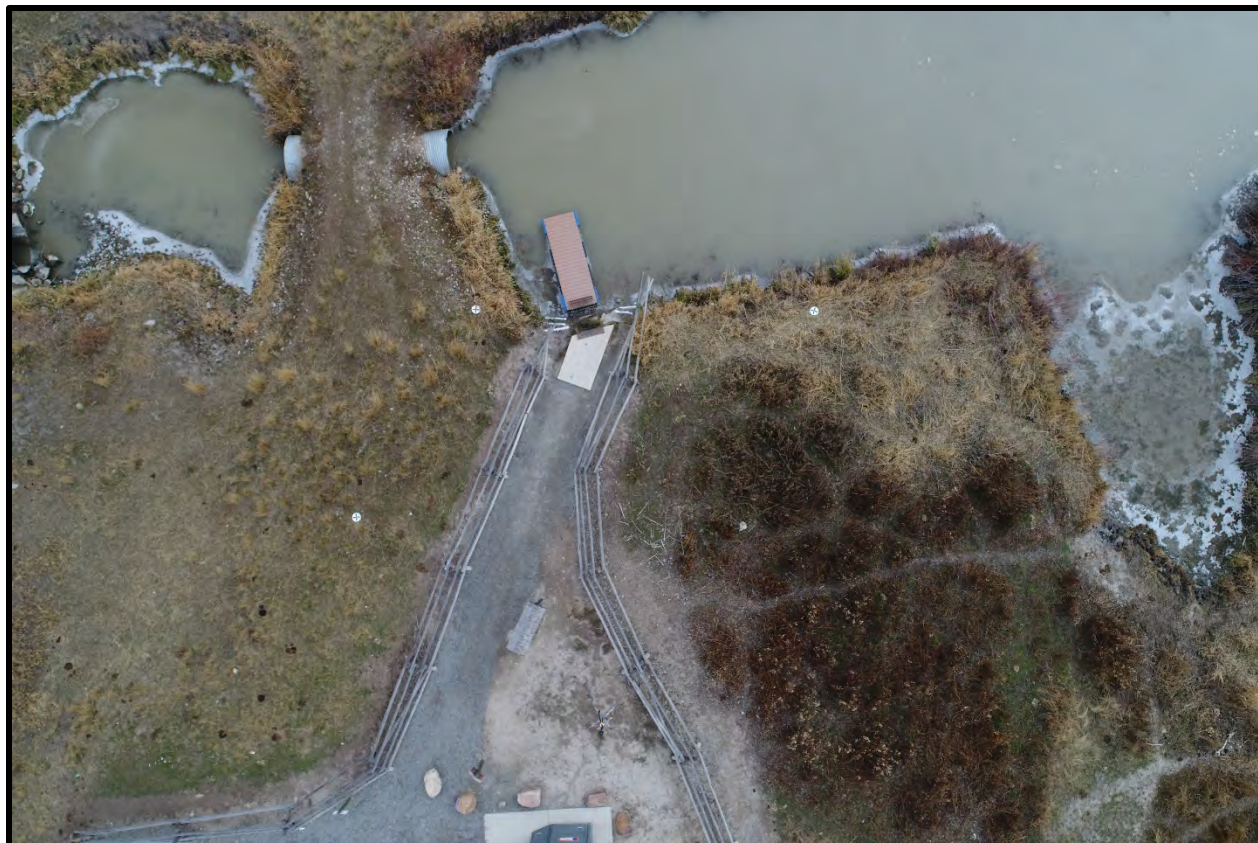
**PHOTO 6-15** LOGAN RIVER ACCESS SITE, OCTOBER 28, 2019 (JUST BELOW MINIMUM EXTENDED OPERATION ELEVATION RANGE)

The Logan River Recreation Site remained useable for launching carry-in boats throughout the drawdown period. The wetted perimeter reached the maximum drawdown on October 28, 2019 (Photo 6-15). The wetted perimeter decreased 1 foot 7 inches linearly. The change in WSE increased the angle of the ramp to the floating dock but did not deter use. Areas of submerged shoreline were exposed near the ramp. The site remained useable for carry-in watercraft.
