Cutler Hydroelectric Project

FERC Project No. 2420

Resource Management Plan Five-Year Monitoring Report 2013-2017

March 29, 2018 - Corrected Appendix E April 2020

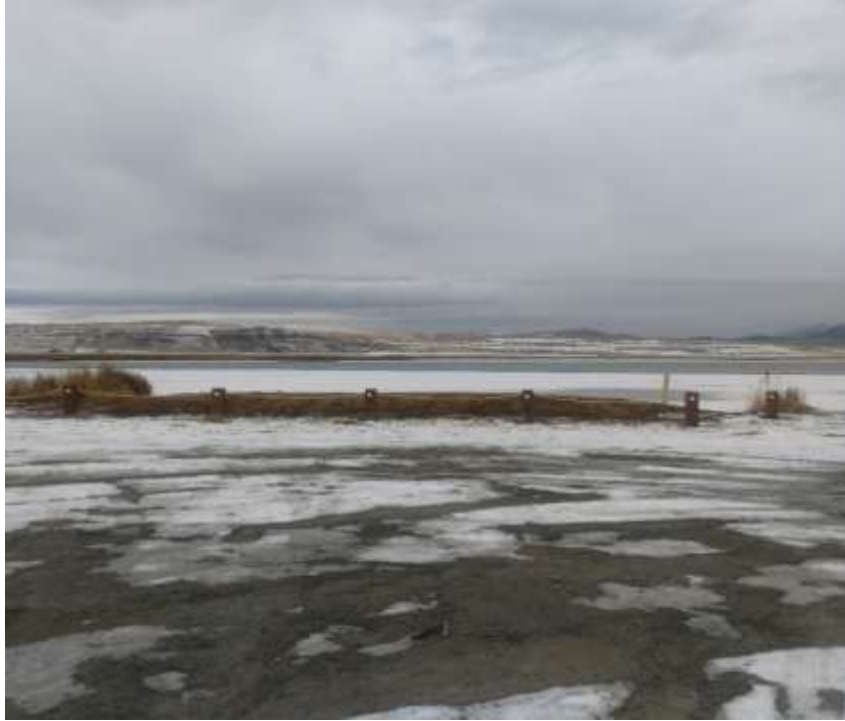
Photo D-1. Benson Marina Improvements

Photos D-1 through D-7 depict non-routine recreation site maintenance completed during the 2013-2017 monitoring period.

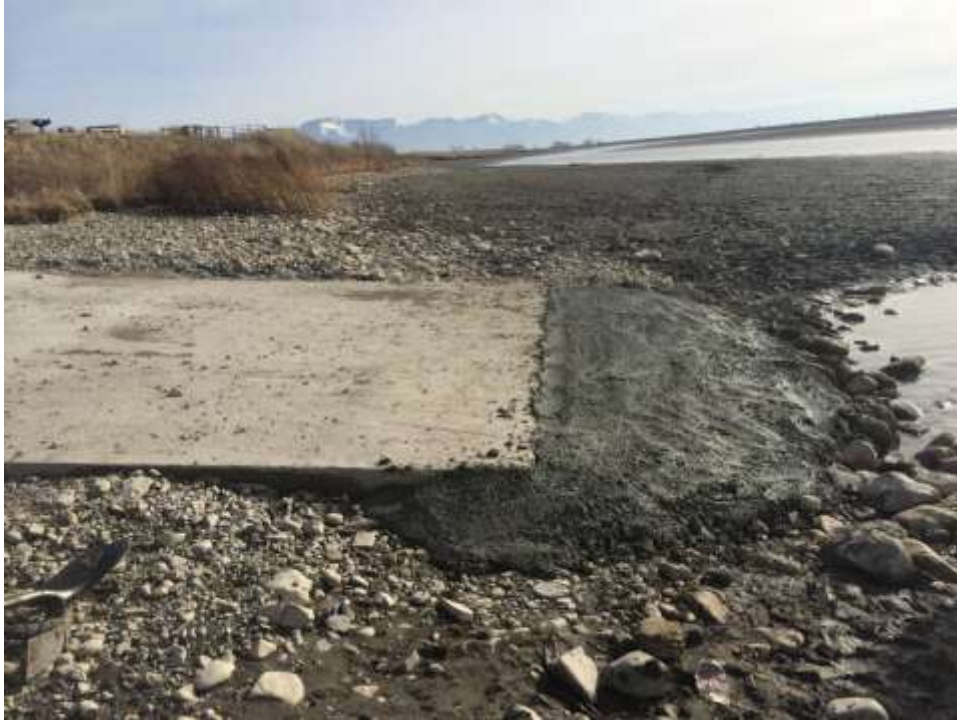
Photo D-5. Ramp repair work at Cutler Canyon during reservoir draw down.

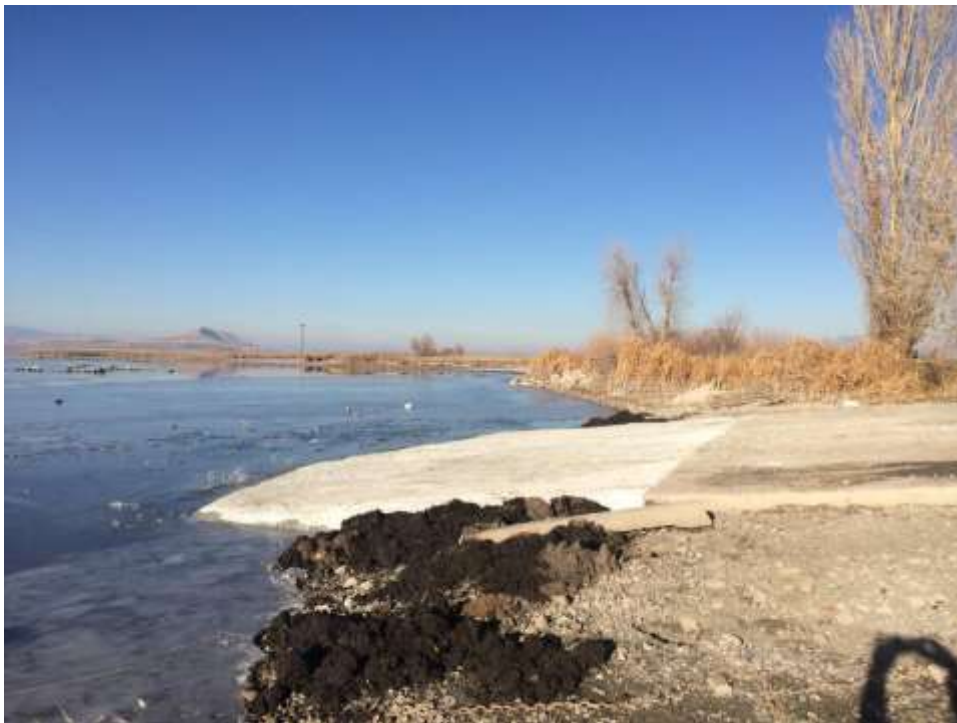
Photo D-6. Major ramp repair work at Benson Marina during reservoir draw down.

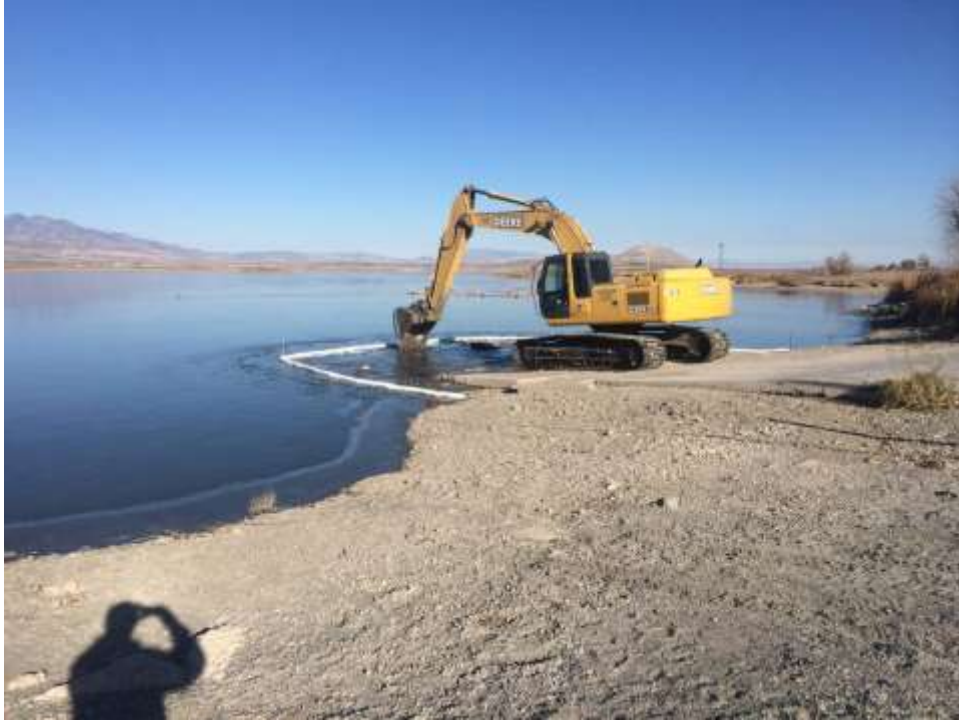
Photo D-7. Major ramp repair work at Benson Marina during reservoir draw down.

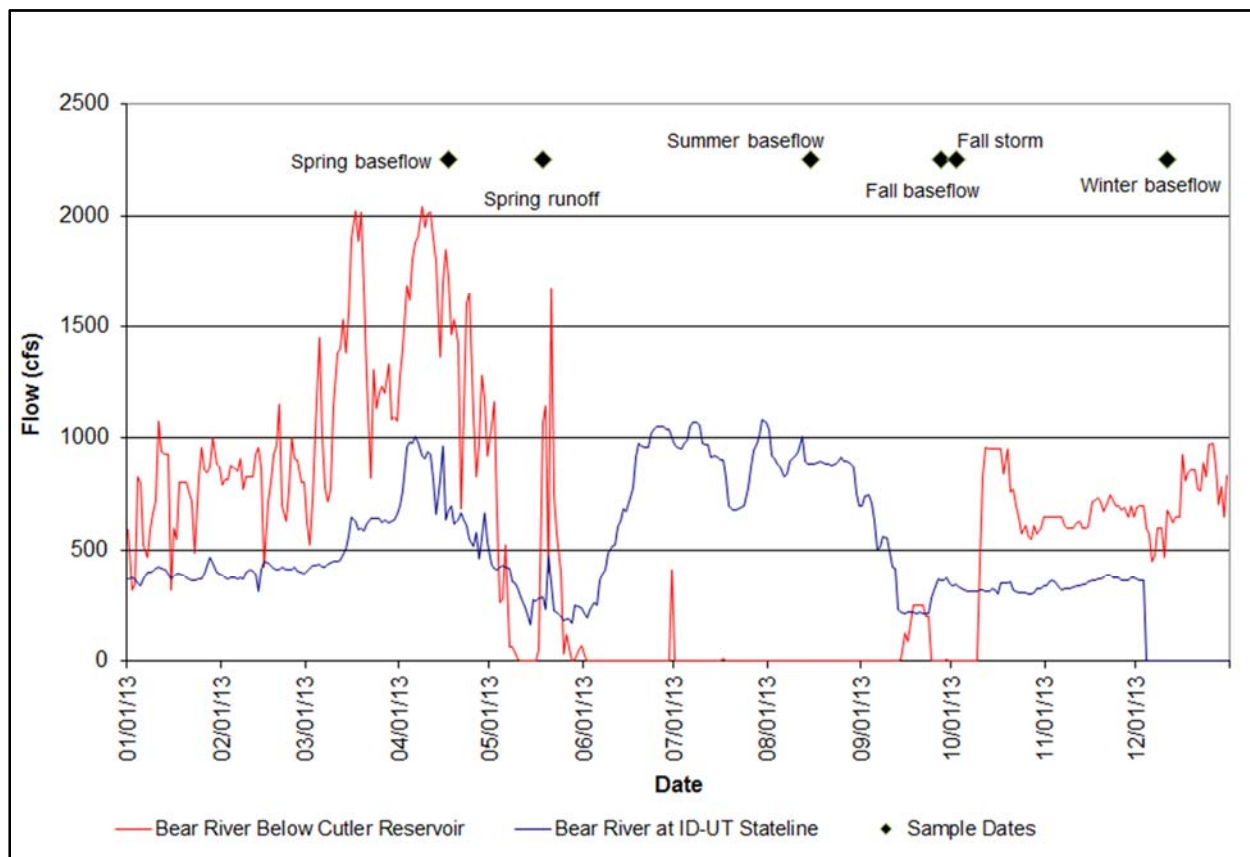
Figure 1. Bear River hydrograph for the 2013 calendar year.

To maintain the quarterly sampling plan established by PacifiCorp, seasonal baseflow (defined by at least three dry days prior) samples were collected during spring, summer, fall, and winter. A spring baseflow sample (April 18, 2013) was taken prior to irrigation, and a summer baseflow sample (August 15, 2013) was taken during irrigation activity. A fall baseflow sample (October 2, 2013) was taken following peak irrigation activity, followed by a winter baseflow sample (December 11, 2013). In addition, water quality samples were collected during a fall storm (September 27, 2013) that resulted in 0.33 inches of rainfall, as well as at the peak of spring melt runoff (May 17, 2013). Note that many of the tributaries are not gaged, thus runoff from these tributaries is not well represented in Figure 1. No summer storms were captured in 2013 sampling efforts.

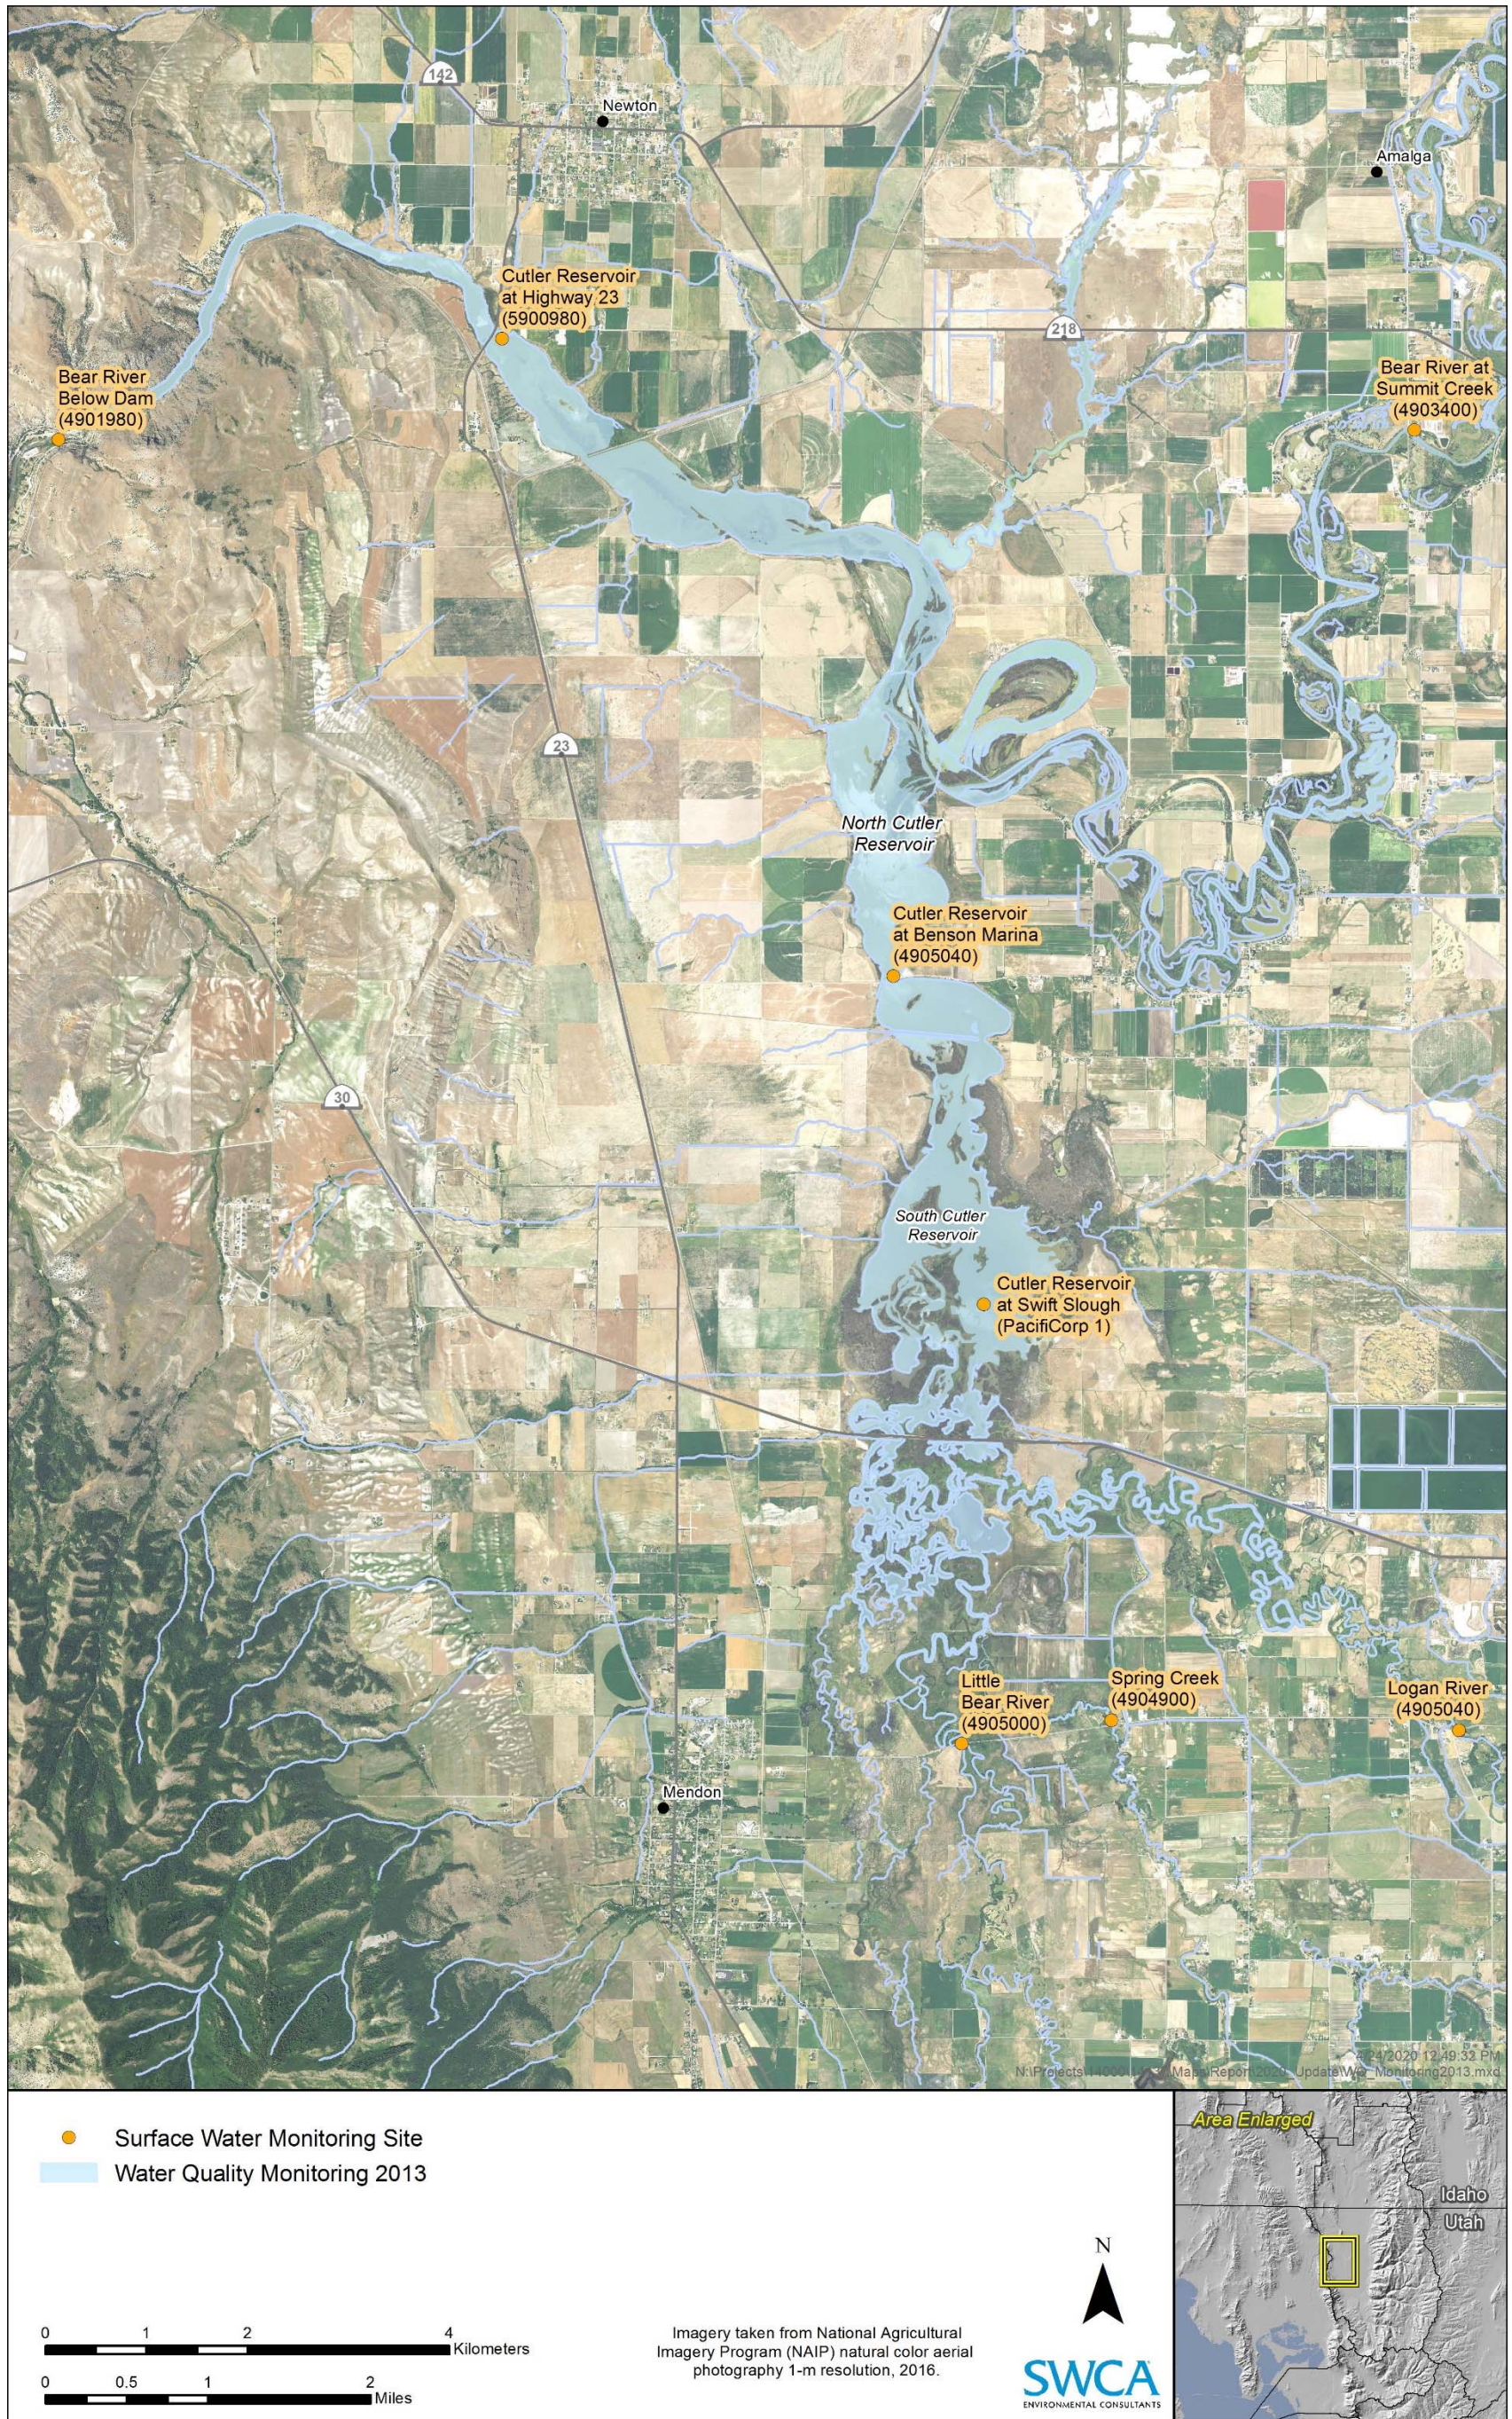
Figure 2. Cutler Reservoir surface water monitoring sites.

River), and at the Bear River below Cutler Dam (Figure 2). In 2008, two additional reservoir monitoring sites were added: one in the northern section of the reservoir (Cutler Reservoir at Highway 23) and one in the southern section of the reservoir, above the confluence with Swift Slough (Cutler Reservoir at Swift Slough). The northern site was added to assess the influence of the Bear River, while the southern site was added to assess the influence of the southern tributaries on water quality in Cutler Reservoir. Unfortunately, reservoir drawdown and boat access prevented sample collection from the Swift Slough site on September 27, 2013, and December 11, 2013 (a sample was taken from the Highway 30 bridge during the December sample event). All sampling sites are shown on Figure 2 and listed in Table 4.

In past sampling periods, water quality samples were collected from Cutler Reservoir at Benson Marina, from four tributary sites entering the reservoir (Logan River, Little Bear River, Spring Creek, and Bear

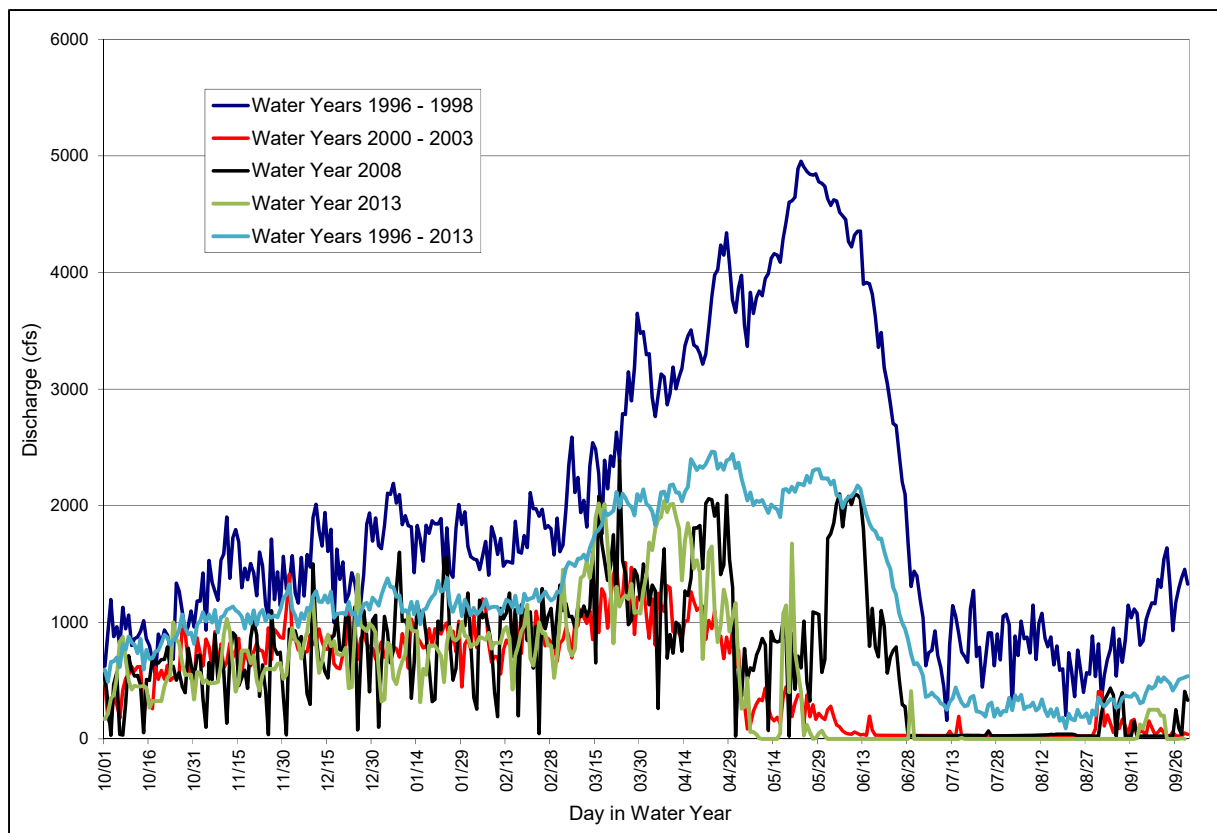
The hydrographs of average daily discharges from Cutler Reservoir during water quality monitoring periods are shown in Figure 3, which illustrates the variability in the timing and magnitude of flow releases to the Bear River. Comparing releases from Cutler Reservoir only during monitoring periods, the 1996–1998 monitoring period were characterized by high average flows (1,959 cfs), whereas the 2000 to 2003 monitoring period was characterized by average low flows (534 cfs), while 2008 and 2013 water years were relatively low flow years (699 cfs and 555 cfs). The magnitude of releases during the 1996–1998 period were between 52% (2008), and 69% greater (2000–2003) than peak releases during the other sampling periods. Minimum daily releases or the lowest recorded flows across the sampling periods range from 0 cfs (2013) to 159 cfs (1996–1998). Average precipitation totals during the four sampling periods are presented in Table 6 and reflect the trend in flows shown in Figure 3 (Utah State University Climate Center 2014).

Figure 3. Hydrograph for average daily releases from Cutler Reservoir (cfs) during four monitoring periods.

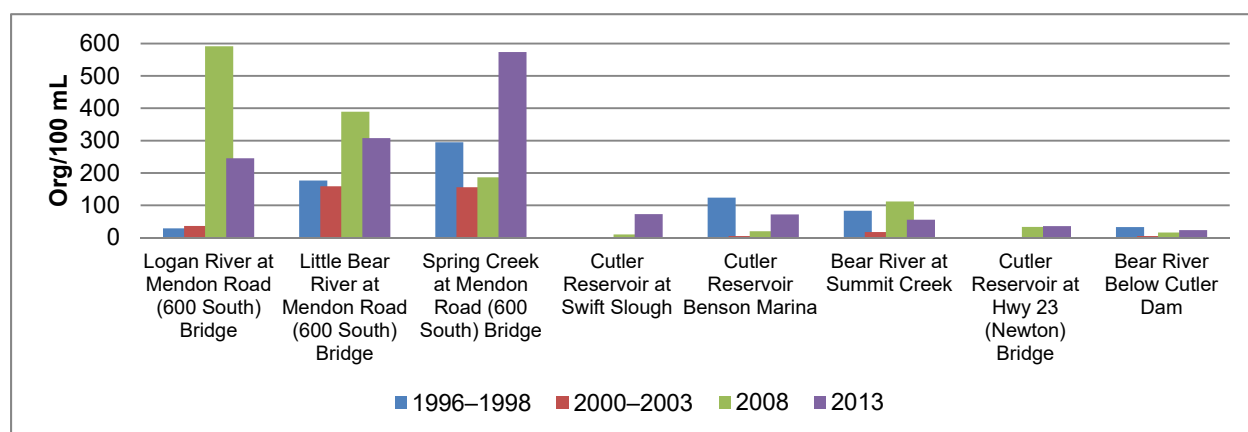
Figure 5. *E. coli* concentrations in the Cutler Reservoir system during baseflow for all monitoring periods.

plant, management practices, or from some other source. Although average *E. coli* concentrations in 2013 did not exceed the State of Utah pathogen instantaneous maximum standard of 668 org/100mL designated for secondary recreation, samples collected from spring Creek, Little Bear River and Logan River exceed the 30-day standard. Additional sampling over a 30-day period is needed to determine if the waterbody exceeds that standard.

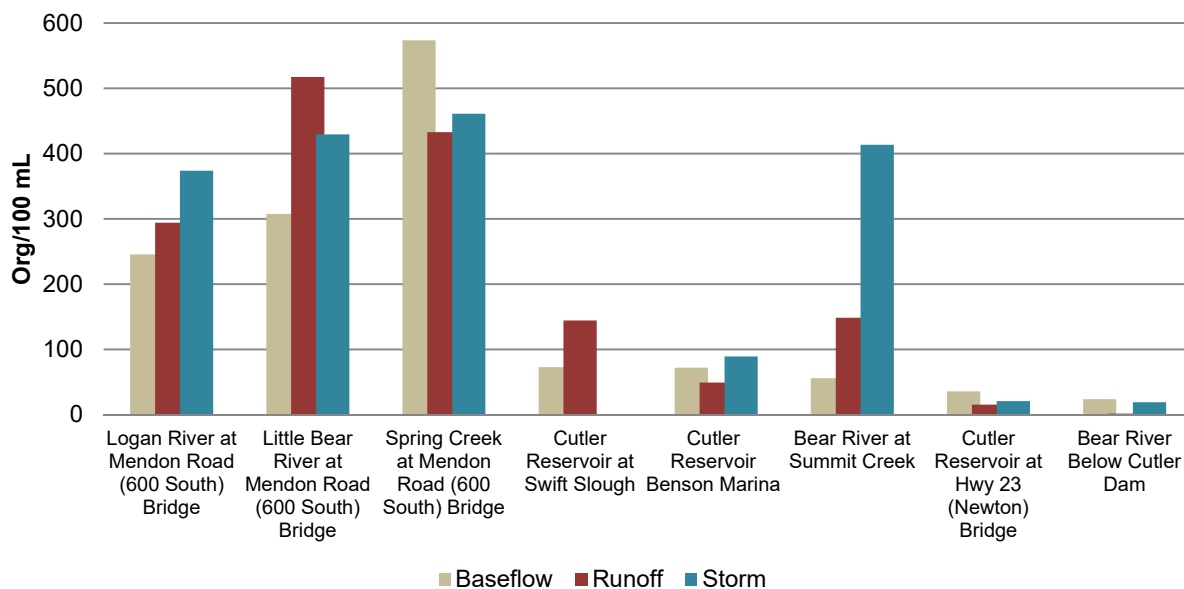
E. coli concentrations in the Cutler Reservoir system varied throughout the 2013 sampling period. In general, average *E. coli* concentrations were lowest during baseflow periods, and increased during runoff and storm conditions by 16% and 42%, respectively (Figure 6). The general increase in *E. coli* from baseflow conditions is expected because surface runoff, including storms, is the process that can transport bacteria to surface waters (e.g., runoff from agricultural sources). Additionally, high concentrations during fall storms are also expected due to surface runoff and warmer temperatures, which increase the survivability of bacteria relative to colder runoff conditions. However, at three of the sampling sites, baseflow concentrations were greater than runoff or storm concentrations. The most notable of these sites is Spring Creek, which, as discussed, is located near the EA Miller meat-packing plant. Average *E. coli* concentrations at tributary sites during baseflow, runoff, and storm events were 391%, 400%, and 664% higher than the average concentrations at Cutler Reservoir sites during the same conditions. These results suggest that the flushing of terrestrial areas, especially during storms, can concentrate bacteria prior to subsequent dilution in Cutler Reservoir.

Figure 6. *E. coli* concentrations in the Cutler Reservoir system during the 2013 sampling period.

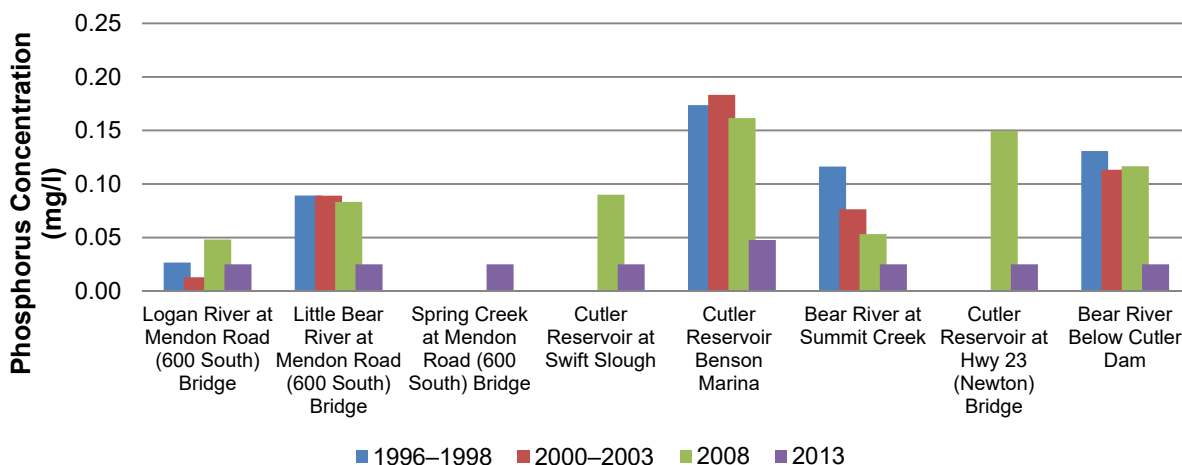
depending on the collection date, they do suggest a marked decrease in phosphorus loading of Cutler Reservoir, as compared to previous monitoring periods. The 2018 PacifiCorp data collection currently underway will be reviewed specifically in light of this question regarding potential phosphorus load decreases in Cutler. The 2013 results may also be anomalous; future Cutler water quality monitoring periods conducted in 2018 and 2023 will help to address this question.

Figure 7. Total phosphorus concentrations in the Cutler Reservoir system during baseflow for all monitoring periods. The TMDL standard in Cutler Reservoir for total phosphorus targets is 0.07 mg/l for the northern reservoir and 0.09 mg/l for southern reservoir the and an annual target of 0.075 mg/l for reservoir outfall.

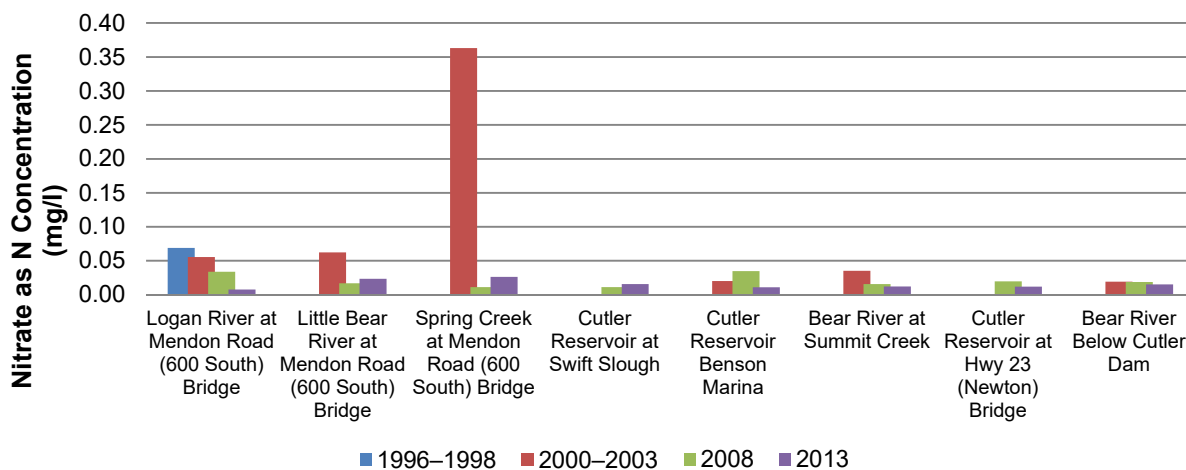
Figure 8. Nitrate-Nitrogen concentrations in the Cutler Reservoir system during baseflow for the 2008 and 2013 monitoring periods. The Utah state standard is no greater than 4 mg/L.

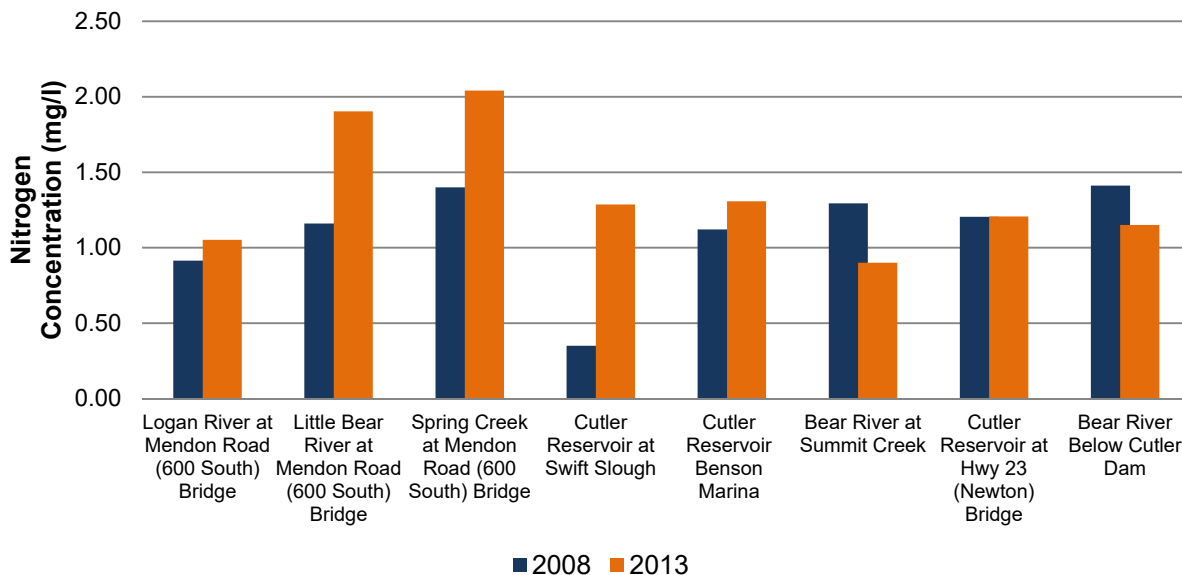
Figure 9. Total nitrogen concentrations in the Cutler Reservoir system during baseflow for the 2008 and 2013 monitoring periods.

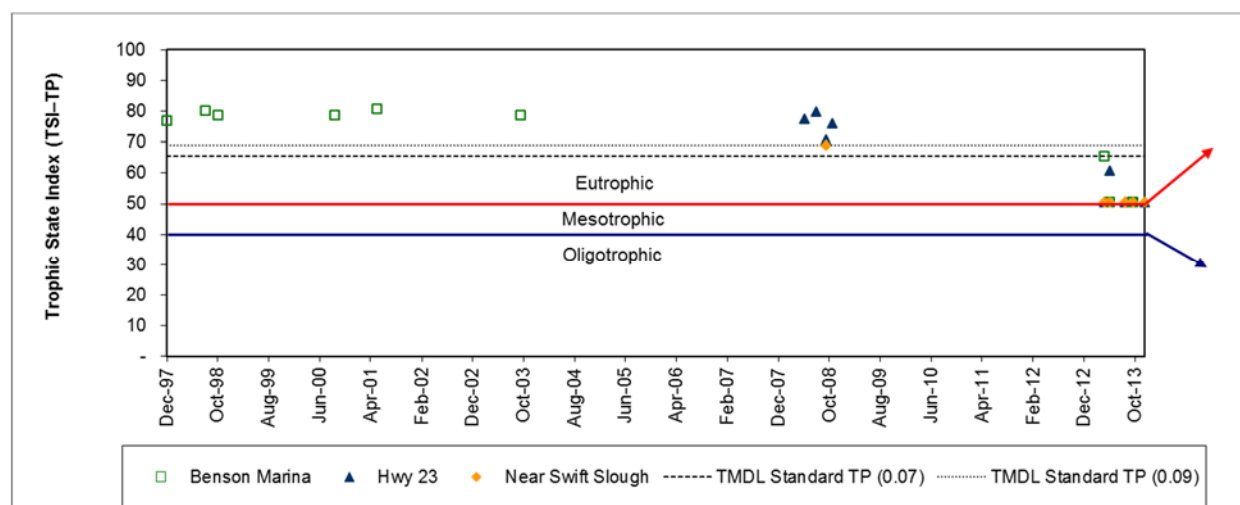
The trophic scale illustrates these general classifications, as well as the midrange conditions that occur between each major category. However, each water body is unique and will exhibit site-specific characteristics based on the water quality conditions identified in the lake or reservoir, and over specific time periods, seasons, or water-flow conditions. The identification of TSI values for a specific water body allows a general classification and provides insight into overall water quality trends and seasonality. Figure 12 illustrates a decrease in TSI values over time at three sites from a eutrophic state in 1996–1998, 2000–2003, and 2008 to borderline mesotrophic conditions in 2013.

Figure 12. TSI predicted based on total phosphorus concentrations in Cutler Reservoir.
