Klamath Hydroelectric Project
FERC Project No. 2082

Klamath Hydroelectric Settlement
Agreement
Interim Measure 7
J.C. Boyle Gravel Monitoring Report
2011

**KLAMATH HYDROELECTRIC PROJECT SETTLEMENT AGREEMENT
INTERIM MEASURE 7
J.C. BOYLE 2011 GRAVEL MONITORING REPORT**

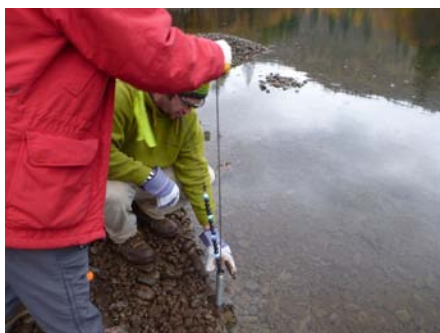
Four sliding bead scour monitors (Shuett-Hames et al. 1999) were inserted within the gravel along/close to the transect intersecting each gravel placement area on November 16-17, 2011 (Figure 2.1-1). Depth of scour and fill were recorded for each monitor on July 10-11, 2012.

Figure 2.1-1. Scour monitor placement.

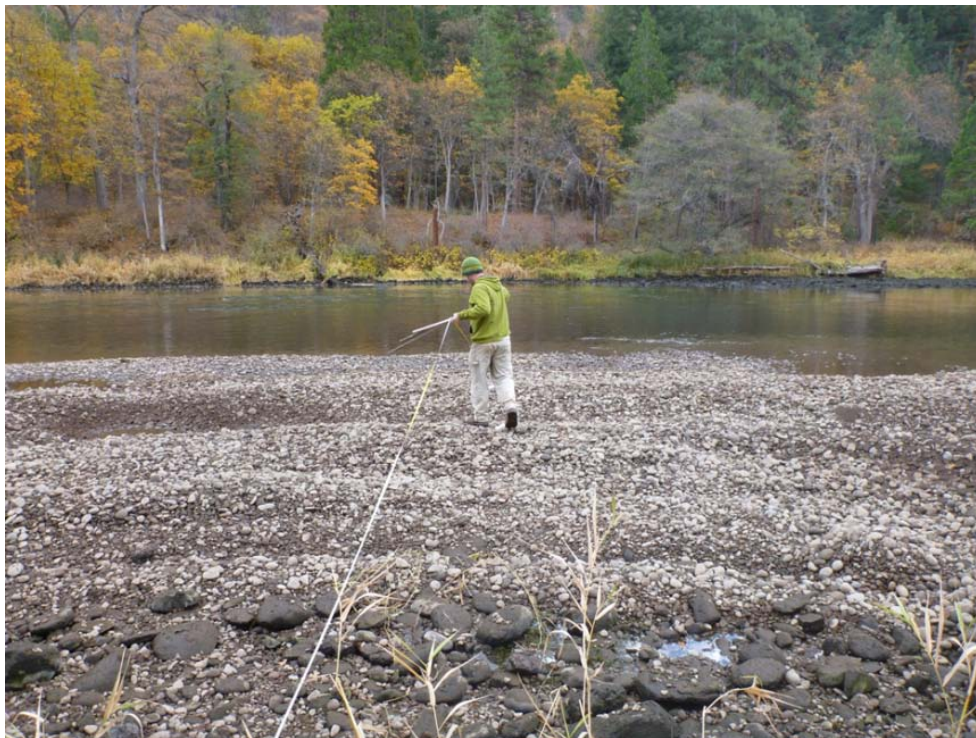
The RM 217.3 site is located at the BLM Klamath Campground (Figures 3.1-1 and 3.3-1).

Figure 3.3-1. Photo of placed gravel at RM 217.3.

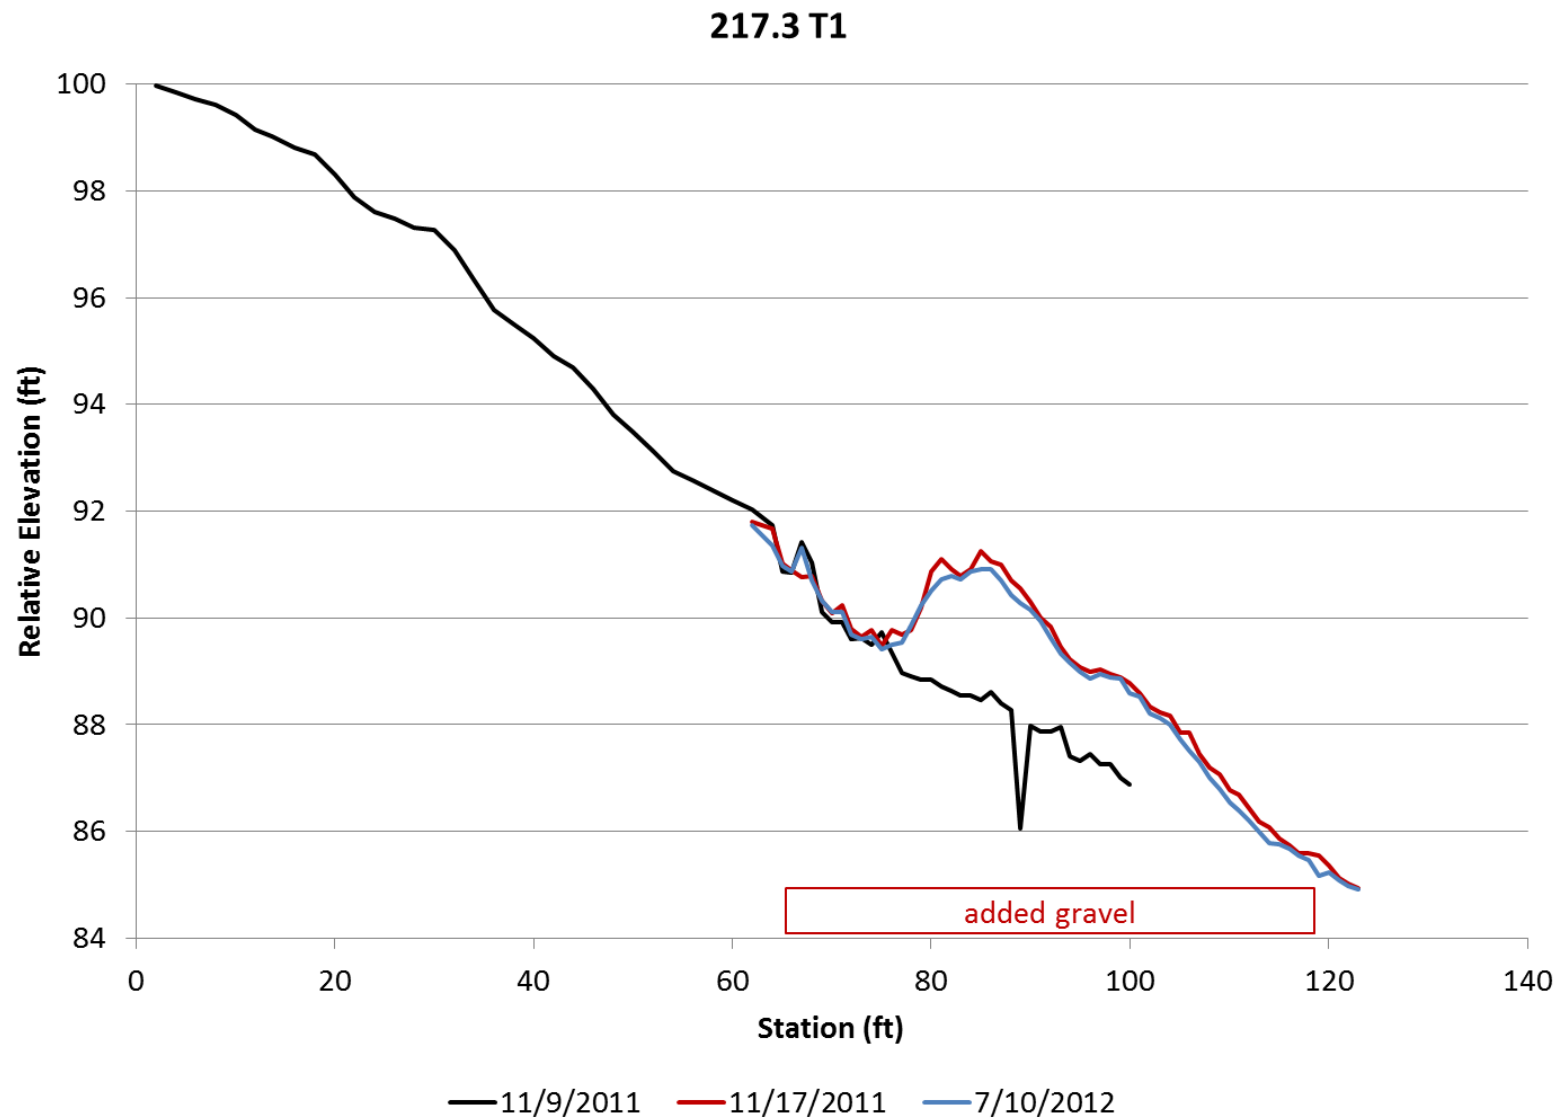
Three transects were monitored at the RM 217.3 site; one transect across the gravel placement area (T1), one transect approximately 80 feet downstream (T2), and a third transect another 250 feet downstream (T3). Pre- and post- gravel placement cross sections (November 9 and 17, 2011, respectively) showed gravel was placed 1-1.5 feet deep across T1. The post-monitoring survey results suggest that minimal transport of placed gravel occurred during spring high flows (Figure 3.3-2). Elevations on the placed gravel were 0.5 to 4 inches lower in July 2012 than in November 2011. Scour monitors were placed at T1 stations 81, 86, 89, and 92. Only the scour monitor at station 92 was found in July; the others were likely removed by recreationalists from the campground. The scour monitor at station 92 indicated 5.75 inches of scour; the survey indicated 3 inches of scour took place. This is not unusual since some disturbance of the gravel bed takes place during insertion of the monitors, so the bed is looser and more mobile at the top of the scour monitor location.

Figure 3.3-2. Cross section at T1 (across gravel placement) at RM 217.3.

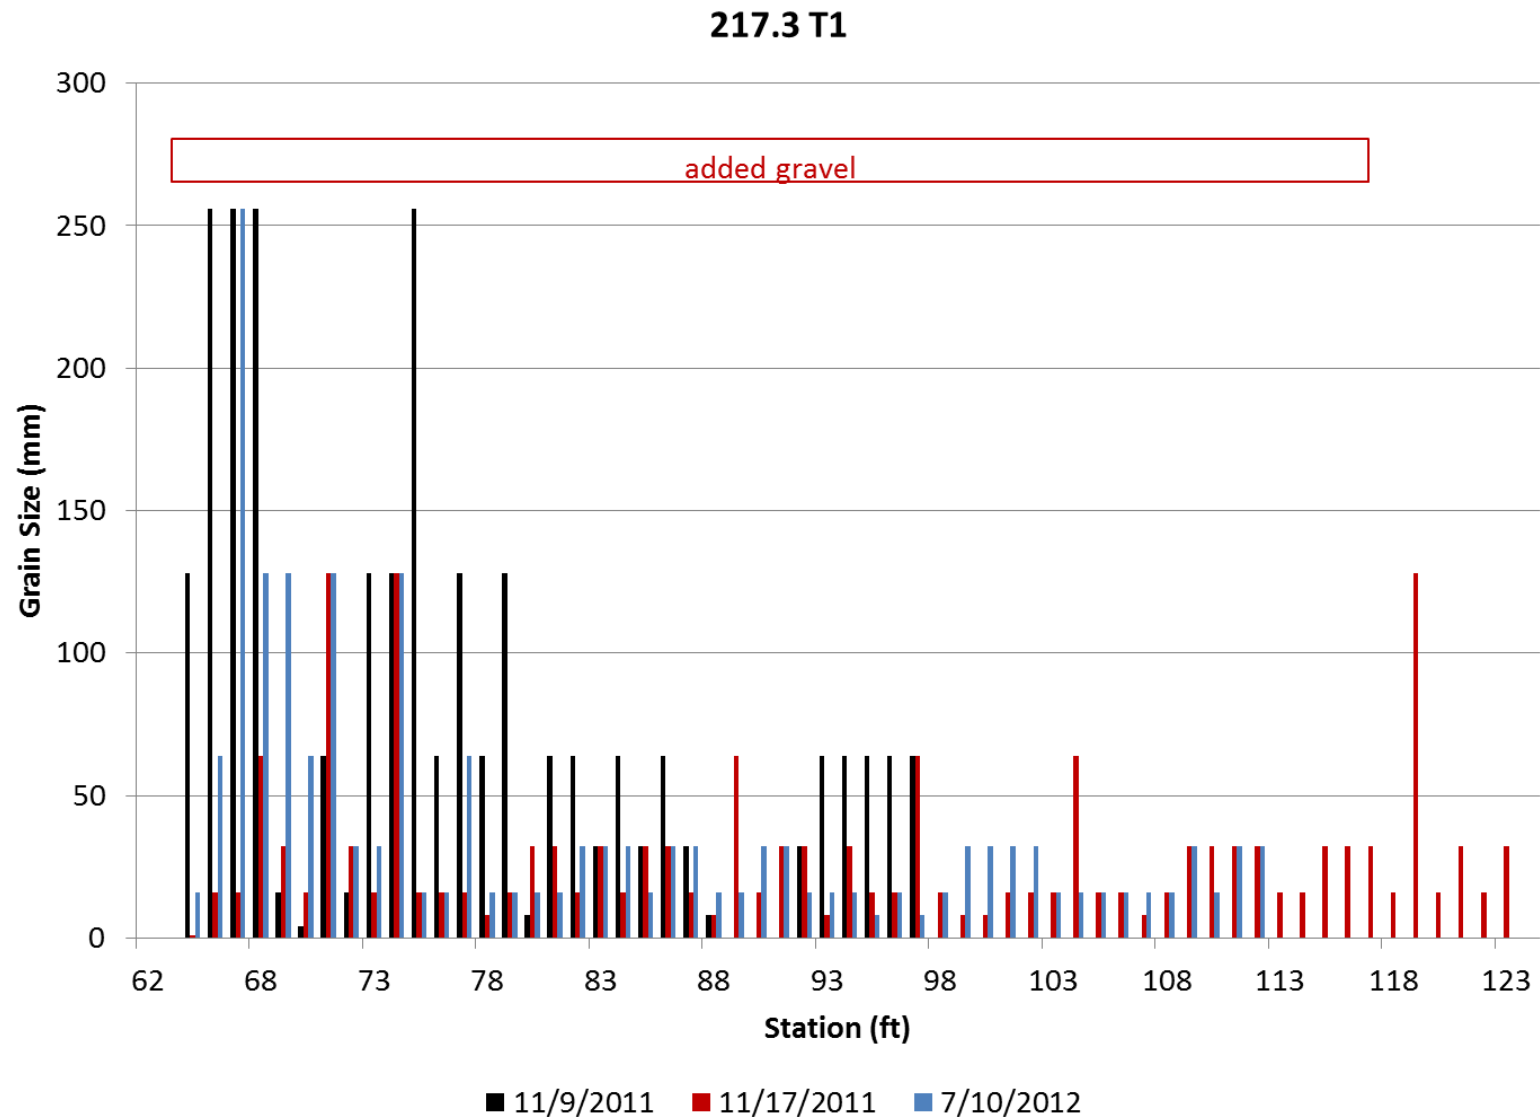
Substrate size was assessed at each wetted cell (Figure 3.3-3). The added gravel (post-placement) was much finer than the pre-placement substrate size (Table 3.3-1). There was a slight coarsening of grain size during the July 2012 assessment, suggesting that some of the smaller particles in the added gravel were transported away from the site.

Figure 3.3-3. Grain size at T1 (across gravel placement) at RM 217.3.

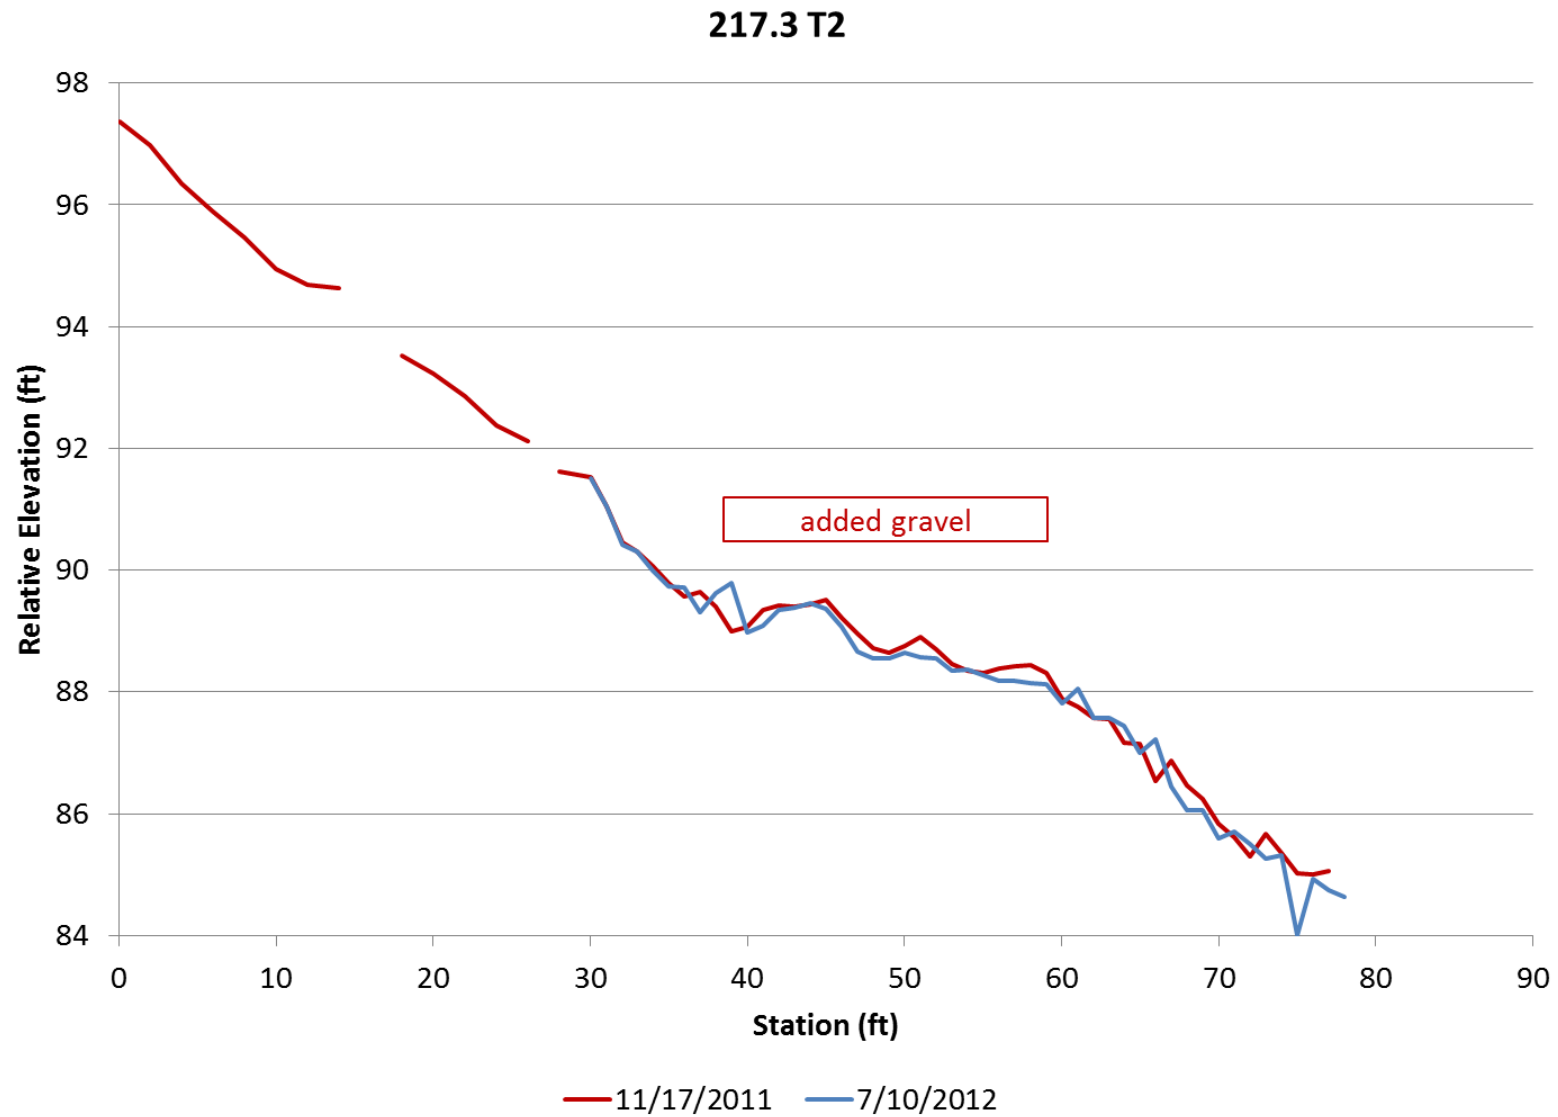
Transect 2 at the RM 217.3 site is located 80 feet downstream of T1. This transect was at the downstream end of the range of the gravel shooter truck and a small amount of gravel was placed on 20 feet of the transect. Pre-placement measurements were not made at the T2 site since it was not anticipated that gravel would be placed here; the post-placement and July cross sections are shown in Figure 3.3-4. There was little movement of the substrate between November and July; up to 4 inches of change in elevation were measured, similar to the T1 transect. Grain size at T2 showed a minor amount of coarsening between November 2011 and July 2012 (Figure 3.3-5 and Table 3.3-1).

Figure 3.3-4. Cross section at T2 (80 feet downstream) at RM 217.3.

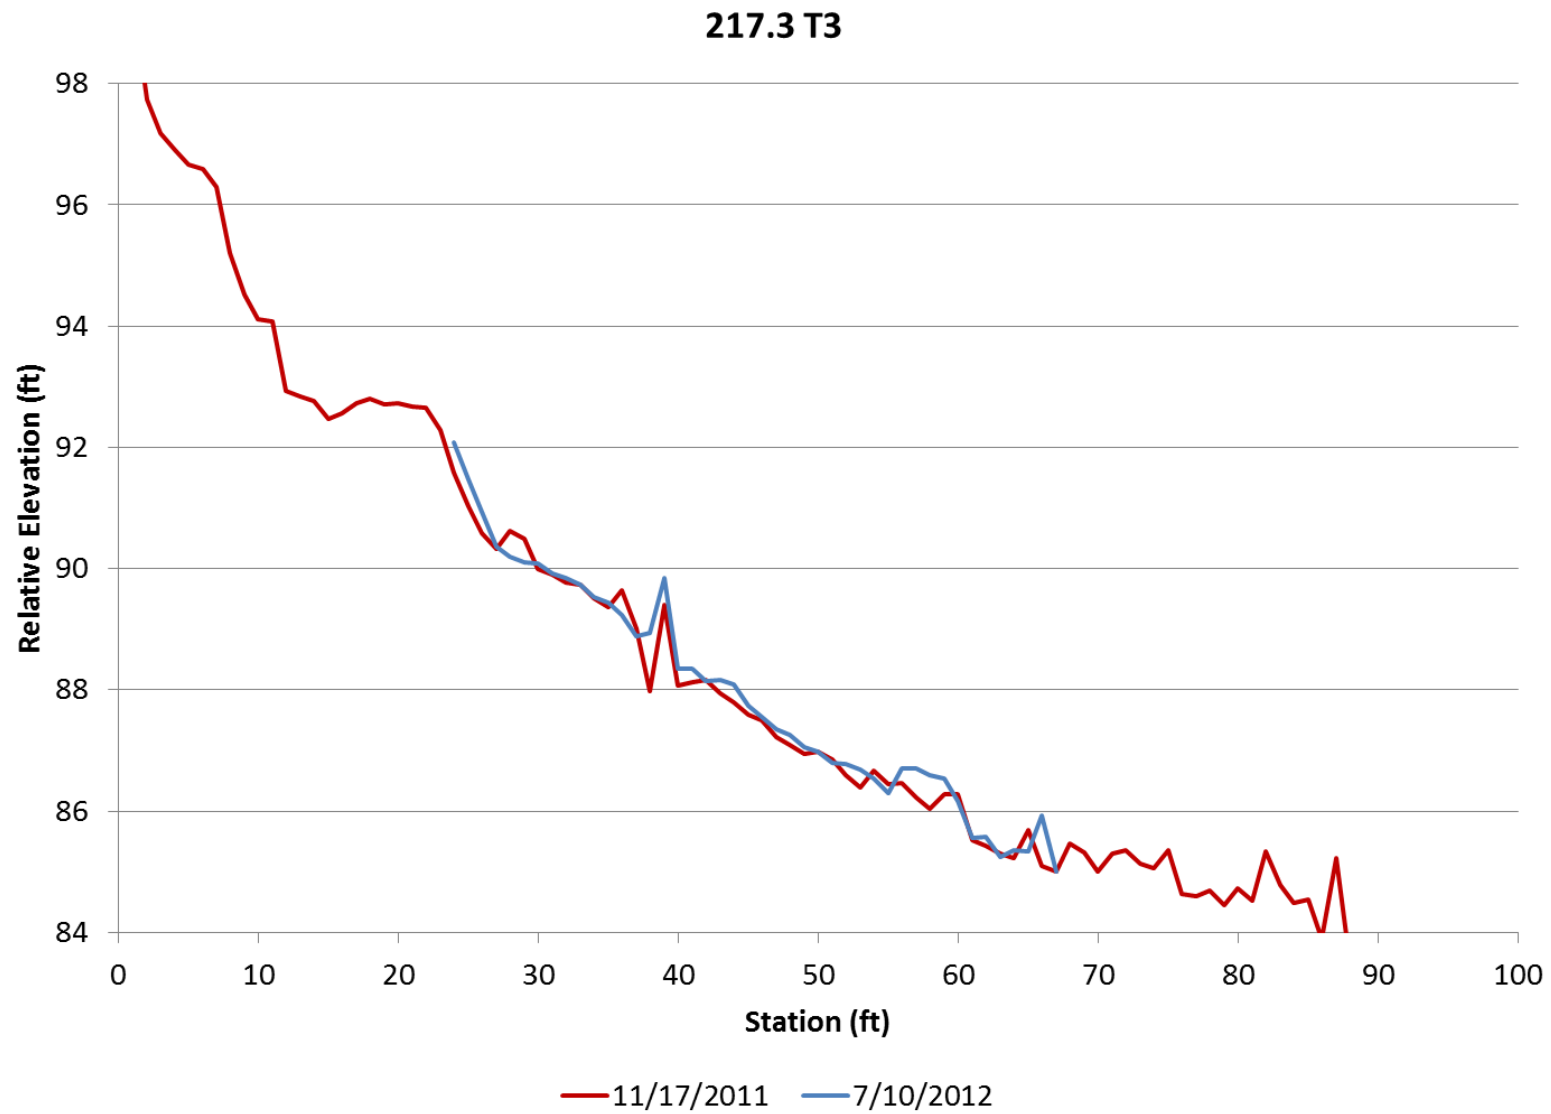
The T3 transect is located 250 feet downstream from T2. Survey and grain size measurements were taken as far into the middle of the stream as possible during each survey period given the deep, fast water at the site. Post-placement and July cross sections at T3 are shown in Figure 3.3-6. A thick layer of algae on the rocks in July suggests that the substrate at T3 was not mobile during spring high flows. The majority of variations in elevation are likely due to placement of the survey rod on or off the large cobble and boulder substrate during the surveys. Grain size at T3 showed a minor amount of fining (average grain size across transect is decreasing) between November and July (Figure 3.3-7 and Table 3.3-1). It is possible that some of the measured fining of grain size could be the result of transport of small gravel from the upstream gravel placement site.

Figure 3.3-6. Cross section at T3 (250 feet downstream) at RM 217.3.

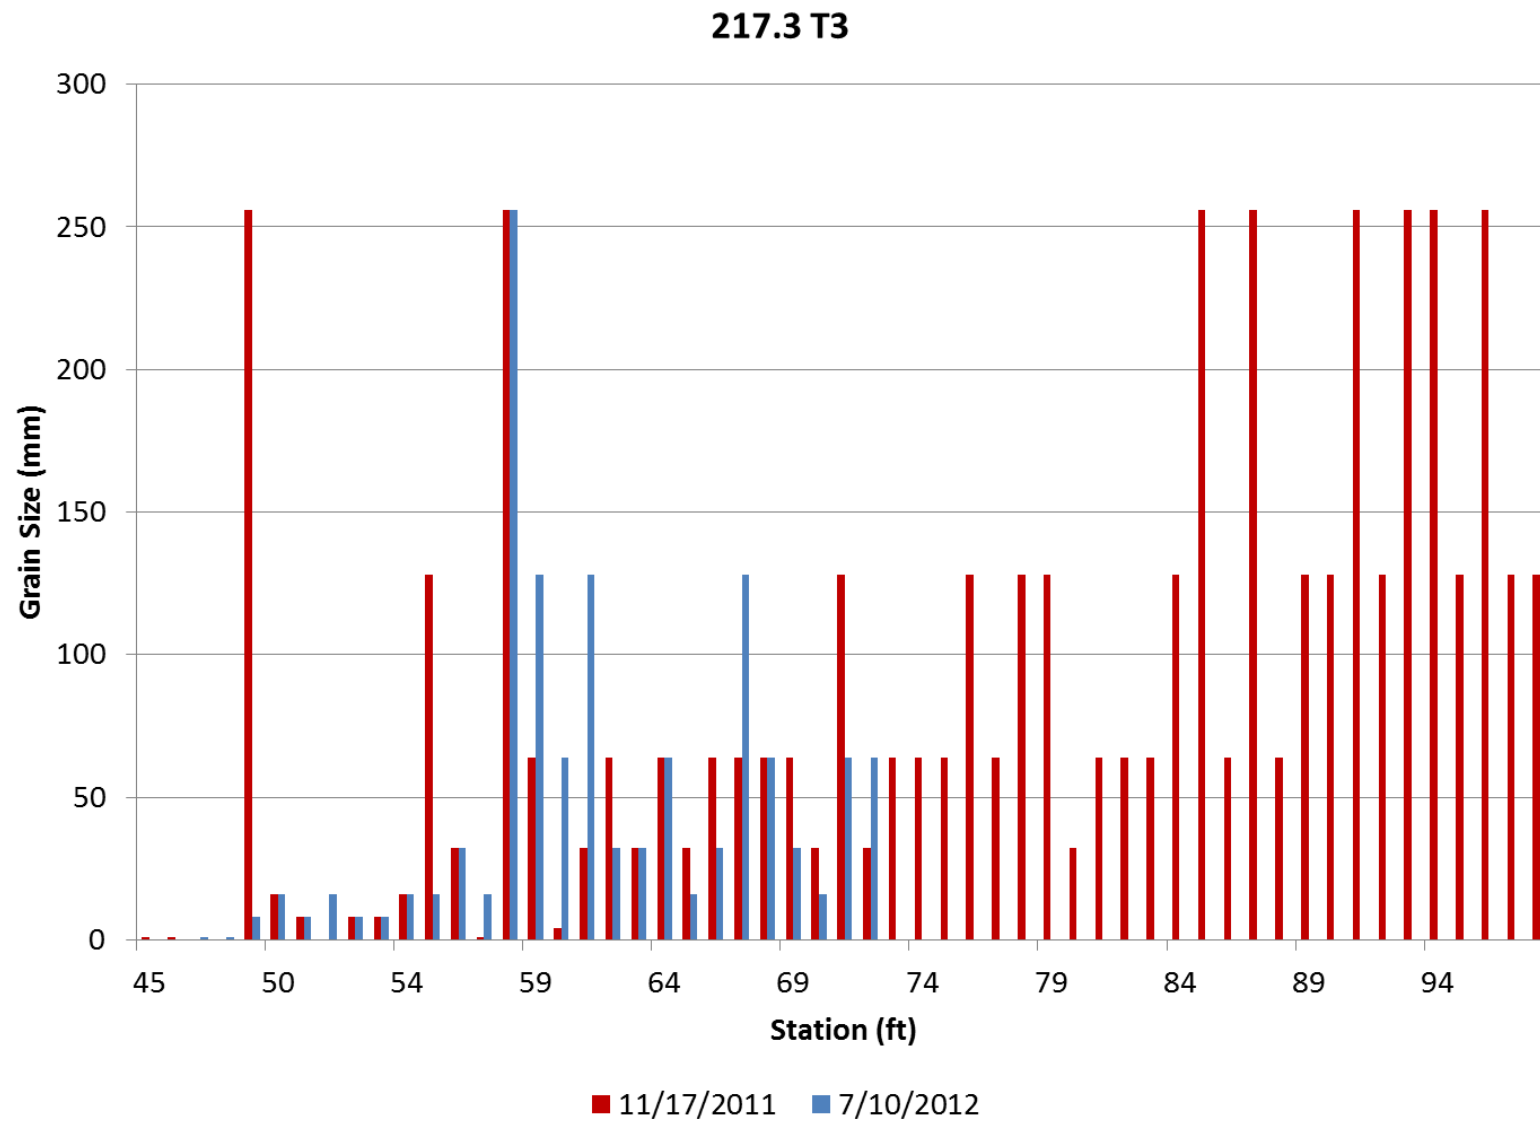
Figure 3.3-7. Grain size at T3 (250 feet downstream) at RM 217.3.

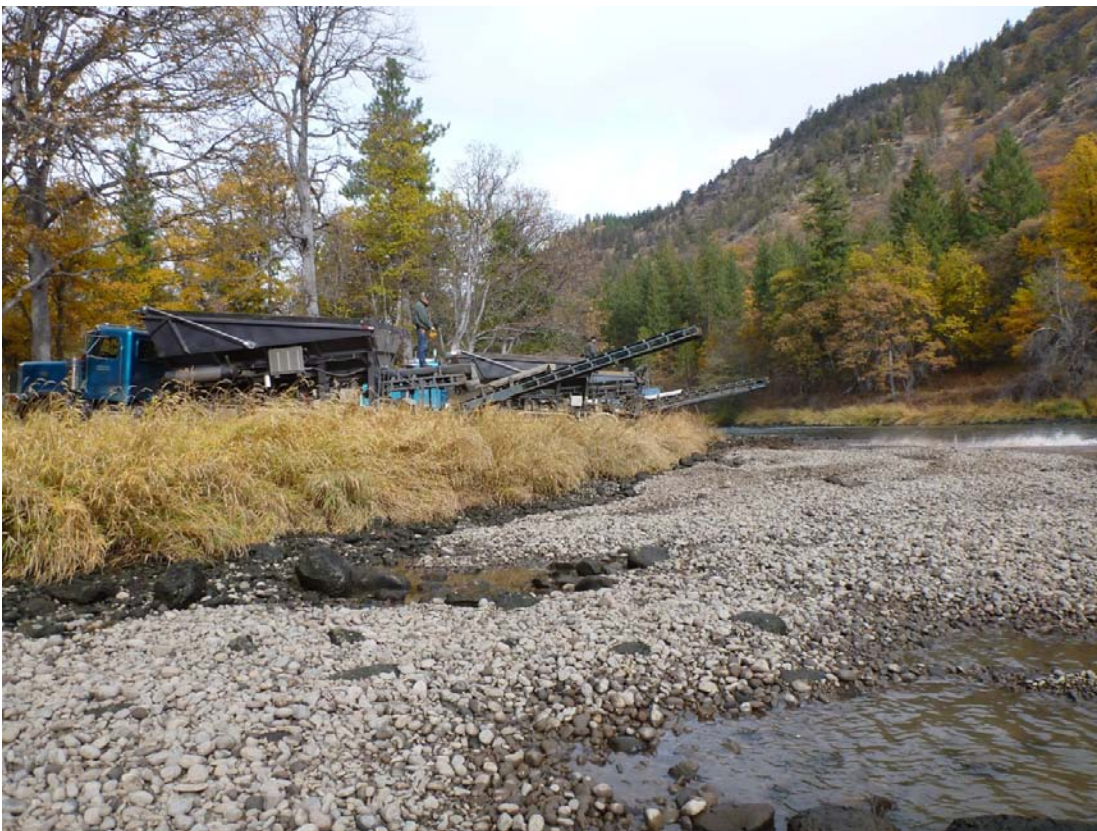
The RM 216.3 site is located in a dispersed use campground upstream from Frain Ranch (Figures 3.1-1 and 3.3-8).

Figure 3.3-8. Gravel being placed at RM 216.3, November 2011.

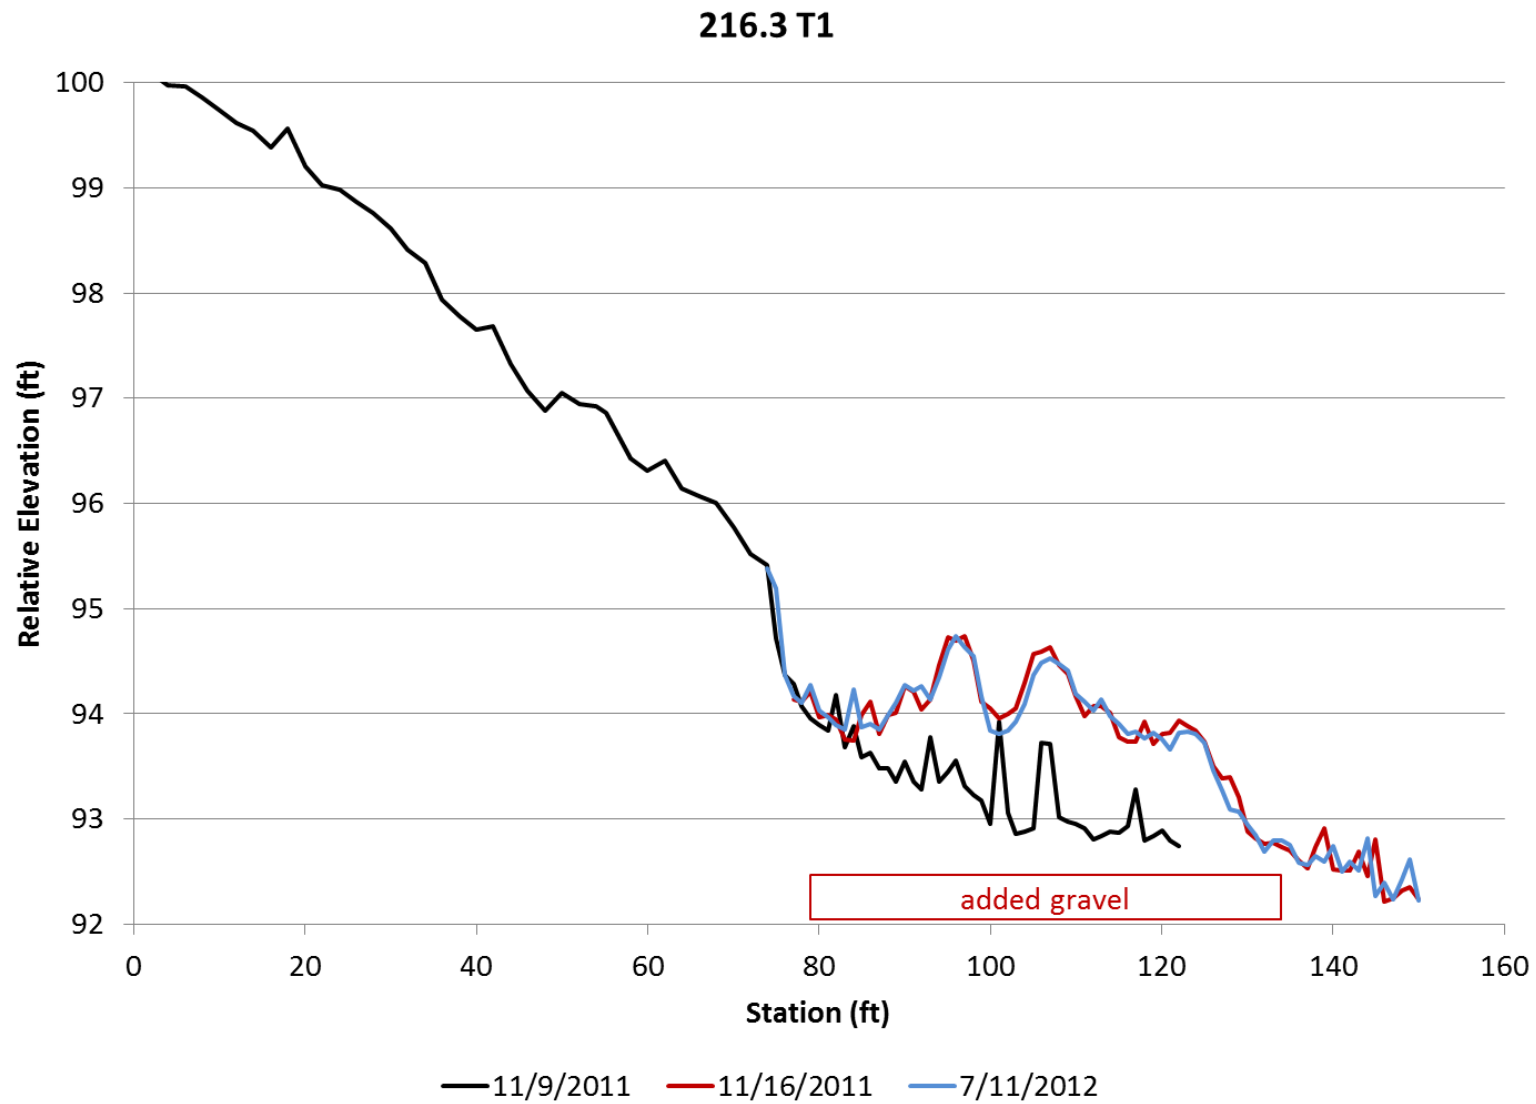
At the transect across the gravel placement area (T1), cross sections and grain size were surveyed prior to gravel placement (November 9, 2011), immediately following gravel placement (November 16, 2011), and in July (July 7, 2012). The surveyed cross section showed gravel was placed 0.5 to 1 foot deep at T1; minimal transport of gravel took place during spring high flows (Figure 3.3-9). Following spring high flows, elevations on the

placed gravel were up to 3 inches lower than in November. Scour monitors were placed near stations 96, 106 (2 monitors, one on transect and one upstream) and 108. The scour monitor at station 96 showed 1.5 inches of scour; the survey indicated 0.5 inches of scour. The scour monitor at station 106 was not found. The scour monitor 11 feet upstream from station 106 showed 3.75 inches of scour. The scour monitor near station 108 indicated 9 inches of scour; the survey data indicate less than an inch of scour took place at this station. The discrepancy in scour depths at station 108 could be caused by local scour and subsequent fill as the gravel re-distributed at the site, or as a result of loosened substrate at the scour monitor locations that occurred during monitor installation.

Figure 3.3-9. Cross section at T1 (across gravel placement) at RM 216.3.
