### Klamath Hydroelectric Project FERC Project No. 2082

# KLAMATH HYDROELECTERIC PROJECT SETTLEMENT AGREEMENT INTERIM MEASURE 7 J.C. BOYLE 2012 GRAVEL MONITORING REPORT

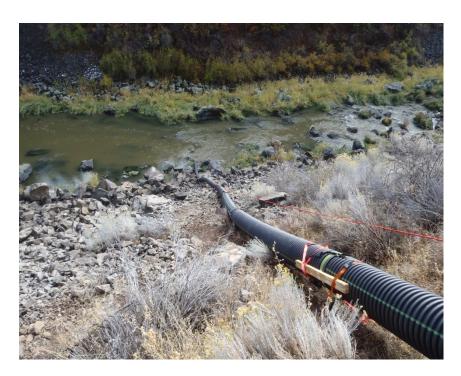
Figure 3.2-1. Gravel placement at RM 223.8 using a pipe.

223.8 site. A modified pipe/sluicing method
	was used to place gravel at the RM 223.8 site,
	and an alternate site was chosen close to the
	original RM 224.5 site.
Were any safety issues encountered?	No; did encounter bad weather (snow/rain).
Were any problems encountered during placement?	Gravel shooter could not reach two of the
	originally chosen sites. Gravel pipe/sluicing
	method was an issue at locations where there
	was a flat bench at the base of the slope (gravel
	would get stuck in pipe).
Are there any recommendations to improve placement	Select placement sites that trucks can access
methods in the future?	easily (within 50 feet) or sites with a straight
	slope down to the placement site.

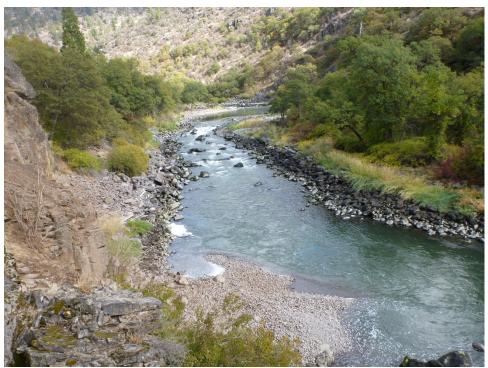
The RM 219.9 site is located along the road just downstream of the Spring Island Boat Launch (Figures 3.1-1 and 3.3-1). Gravel was shot from a truck on the road into the river.

Figure 3.3-1. Photo of placed gravel at RM 219.9.

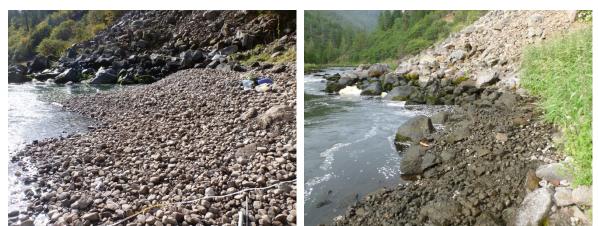
Visual observations at the RM 219.9 site were consistent with the measurements; the majority of placed gravel had been transported away from the site during the monitoring period (Figure 3.3-3).

Figure 3.3-3. Photos of placed gravel at RM 219.9 in October 2012 (L) and June 2013 (R).

Based on the placement and monitoring of gravel at the sites, it appears that gravel can again be added to the RM 219.9 site in the peaking reach; operating flows are capable of transporting added gravel from this site. No additional gravel should be placed at the RM 223.8, 224.5 (bypass reach) or RM 217.3 or 216.3 (peaking reach) sites until higher flows occur that have the opportunity to move the placed gravel. In addition to the RM 219.9 site, gravel placement for 2013 is also proposed at a site immediately below the powerhouse at approximately RM 220.3

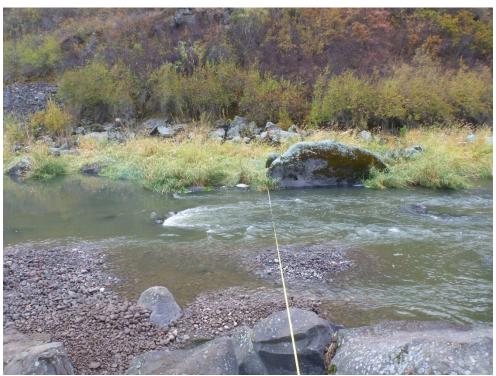
The RM 223.8 site is located in the upper bypass reach (Figures 3.1-1 and 3.3-5). Gravel was placed at this site through a pipe because the distance from the road to the river was too far to effectively use the gravel shooter.

Figure 3.3-5. Gravel placed at RM 223.8.

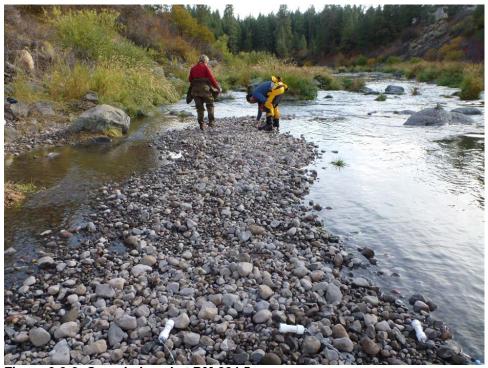
The RM 224.5 site is located in the upper bypass reach in a riffle below the USGS gage site (Figures 3.1-1 and 3.3-9). Gravel was placed at this site using the gravel shooter. The RM 224.5 site was originally envisioned to be approximately 350 feet downstream of the site where gravel was placed, but the original site was too far away from the road to be reached by the gravel shooter, and a bench at the base of the slope precluded use of the pipe method, so the alternate site was used.

Figure 3.3-9. Gravel placed at RM 224.5.
