Klamath Hydroelectric Project
FERC Project No. 2082

Klamath Hydroelectric Settlement
Agreement
Interim Measure 7
J.C. Boyle Gravel Monitoring Report
2015-2016

**KLAMATH HYDROELECTRIC PROJECT SETTLEMENT AGREEMENT
INTERIM MEASURE 7
J.C. BOYLE 2015-2016 GRAVEL MONITORING REPORT**

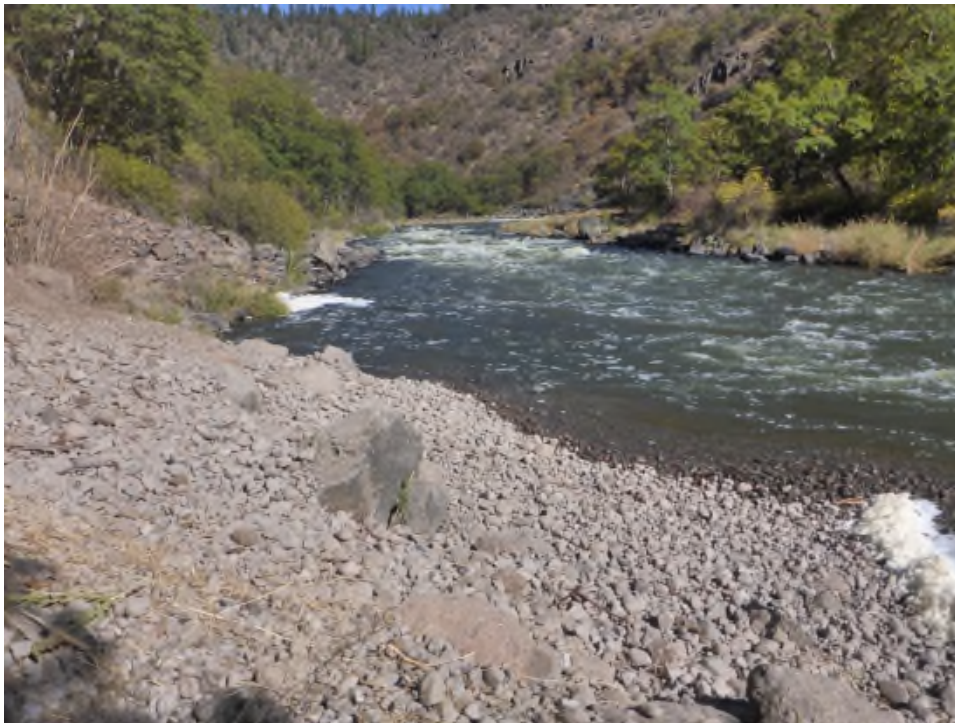
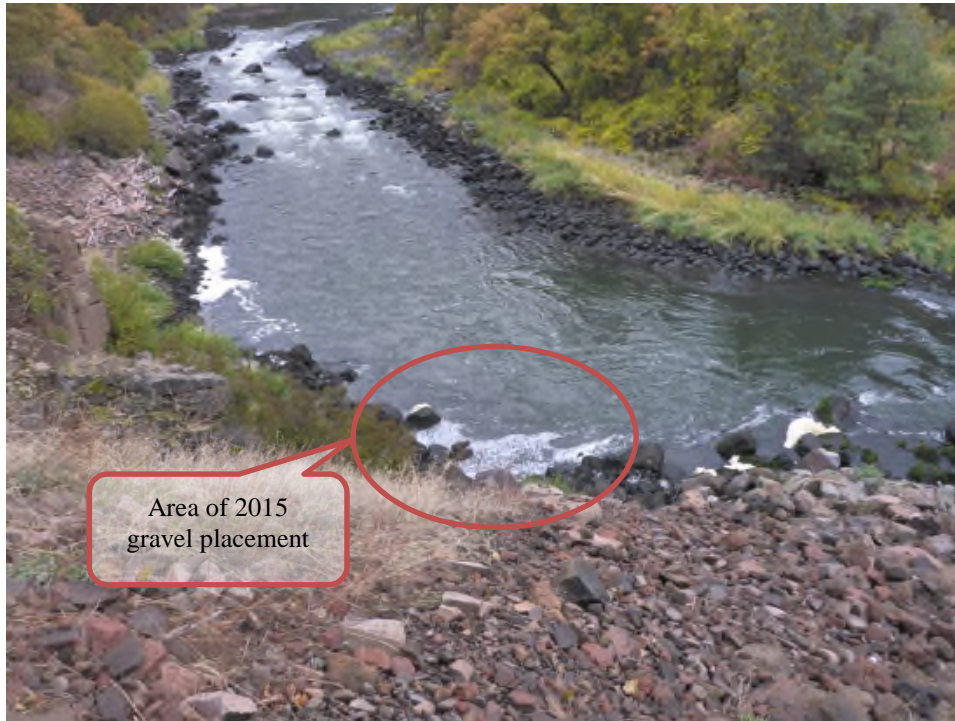
Scour monitors were not placed at this site since previous monitors (2012) disappeared when the gravel moved. Visual observations at the RM 219.9 site showed the majority of 2015 placed gravel had been transported away from the site during the monitoring period (Figure 3.3-1 and 3.3-2). This is consistent with measurements and observations in previous years that indicated the majority of gravel was transported away from this site on a regular basis.

Figure 3.3-1. Photo of placed gravel at RM 219.9, October 2015 (just after placement).

Figure 3.3-2. Photo of placed gravel at RM 219.9, October 2016 (post-flows).

Note: 2016 photo taken from a higher elevation than 2015 photo

Based on the placement and monitoring of gravel at the sites, it appears that gravel can be added to the peaking reach RM 220.2, RM 219.9, and RM 216.8 sites in the future; normal operating flows are capable of transporting added gravel from these sites. Gravel can also be added to the RM 223.8 and 224.5 sites (bypass reach) because previously added gravel has been transported away from these sites by the high flows in March 2016. However, gravel placement at RM 224.5 in 2012 was difficult because of the distance from the road. It was too far for CAD trucks to shoot gravel so a culvert was used for placement which, while successful, was difficult to implement.

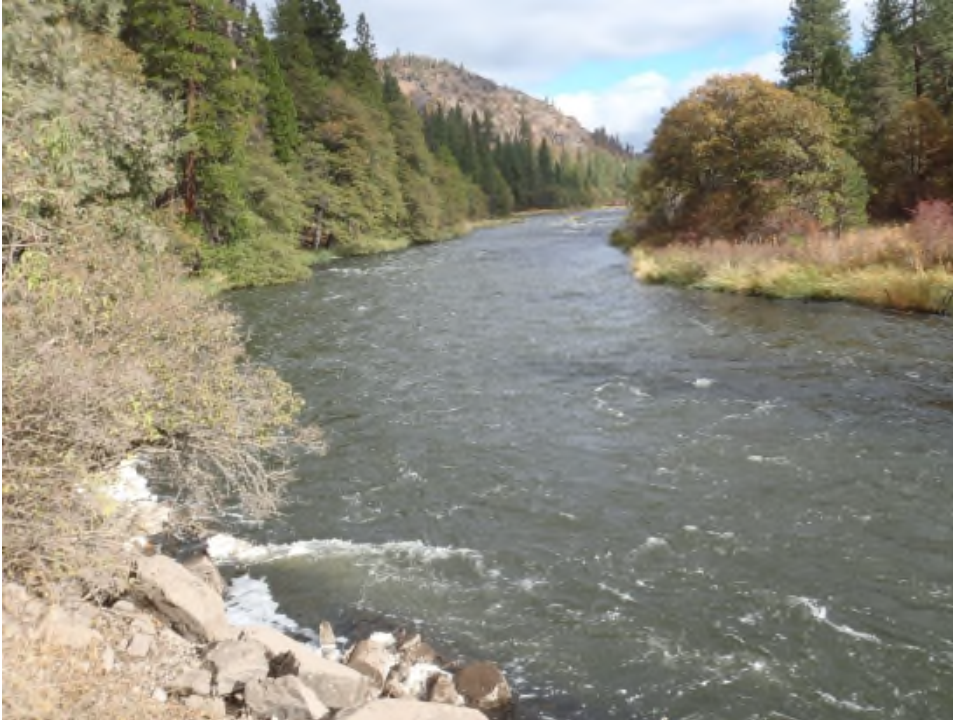
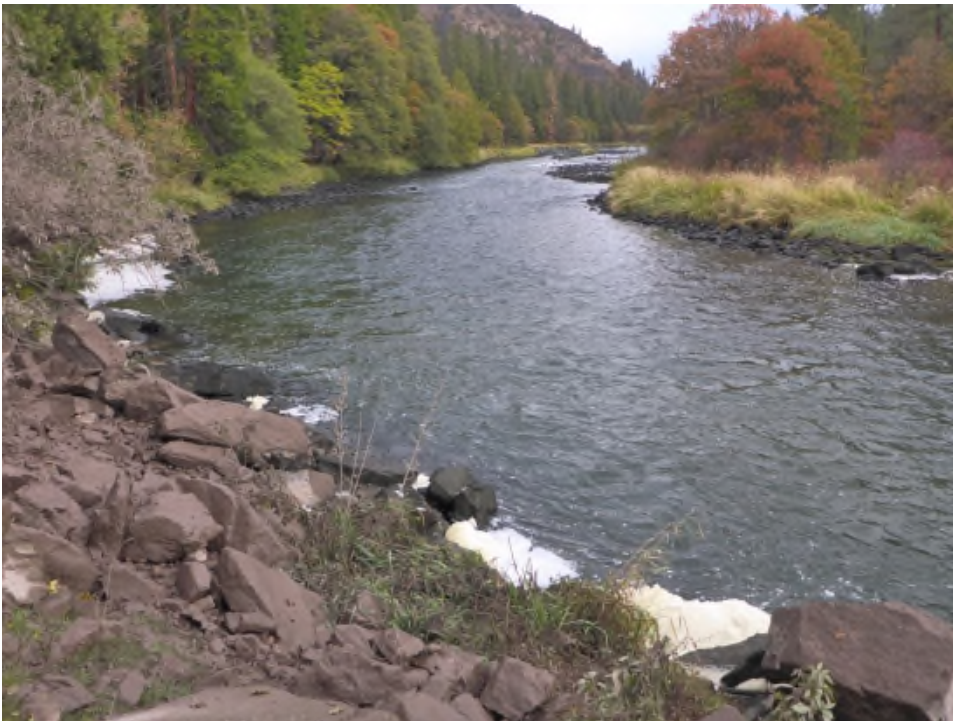
The gravel that was placed at the RM 216.8 site was not visible because visibility was reduced by the deep water and swift current; it is assumed that all gravel was moved from the site by high flow conditions.

Figure 3.3-3. Photo of placed gravel at RM 216.8, October 2015 (after placement).

Figure 3.3-4. Photo of placed gravel at RM 216.8, October 2016 (post-flows).

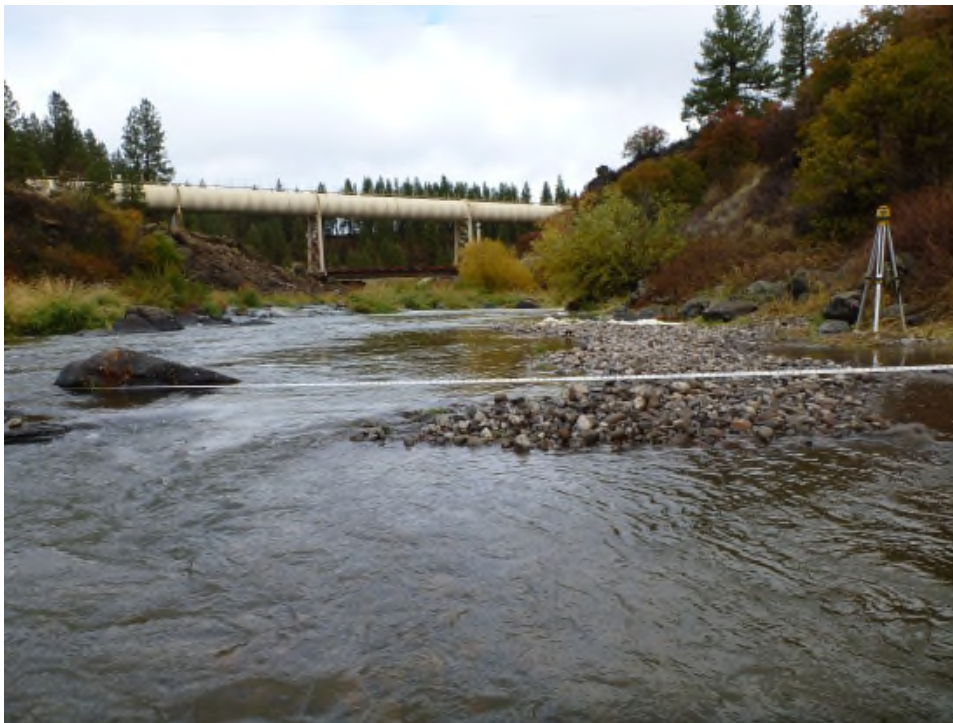
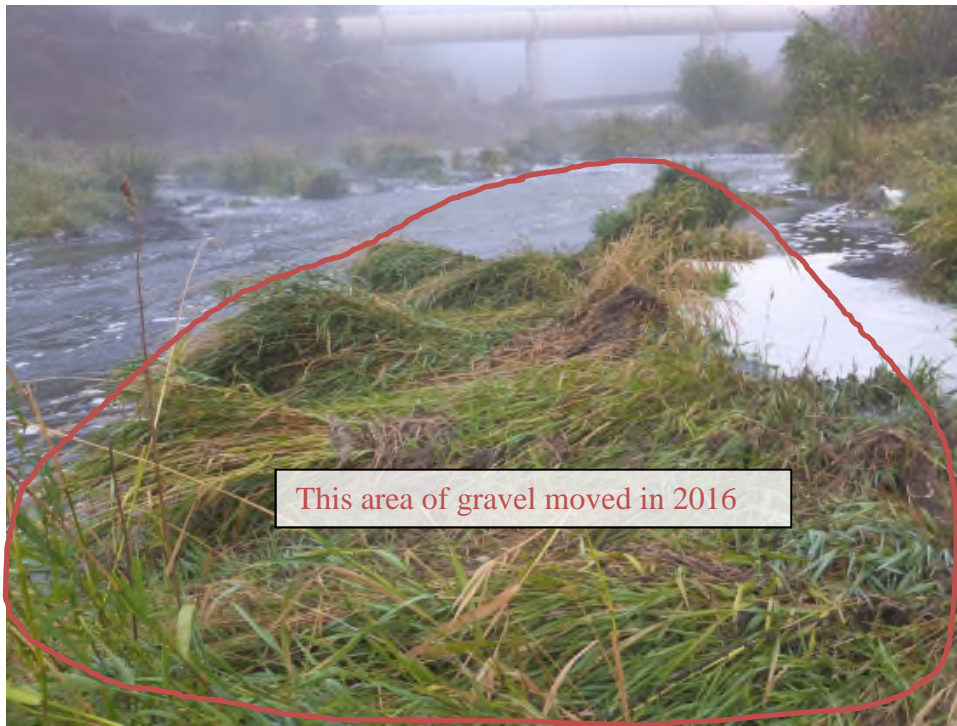
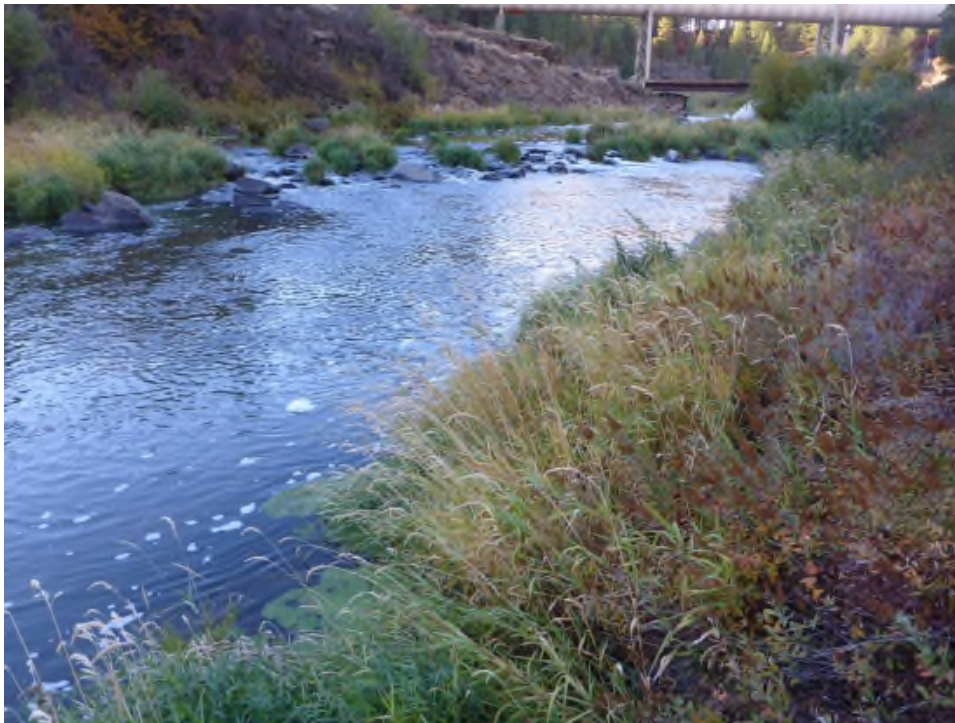
Gravel was placed at the RM 224.5 site in 2012. During previous checks at this site (2013, 2014, and 2015), the gravel did not appear to have moved, scour monitors did not record any scour, and grass had grown over the gravel deposits (Figure 3.5-1). As observed in October 2016, most of the gravel had been transported away from the site, and no scour monitors were found.

Figure 3.5-1. RM 224.5 Site showing much of placed gravel in 2012 (a) had not moved by October 2015 (b) but had moved by October 2016 (c).

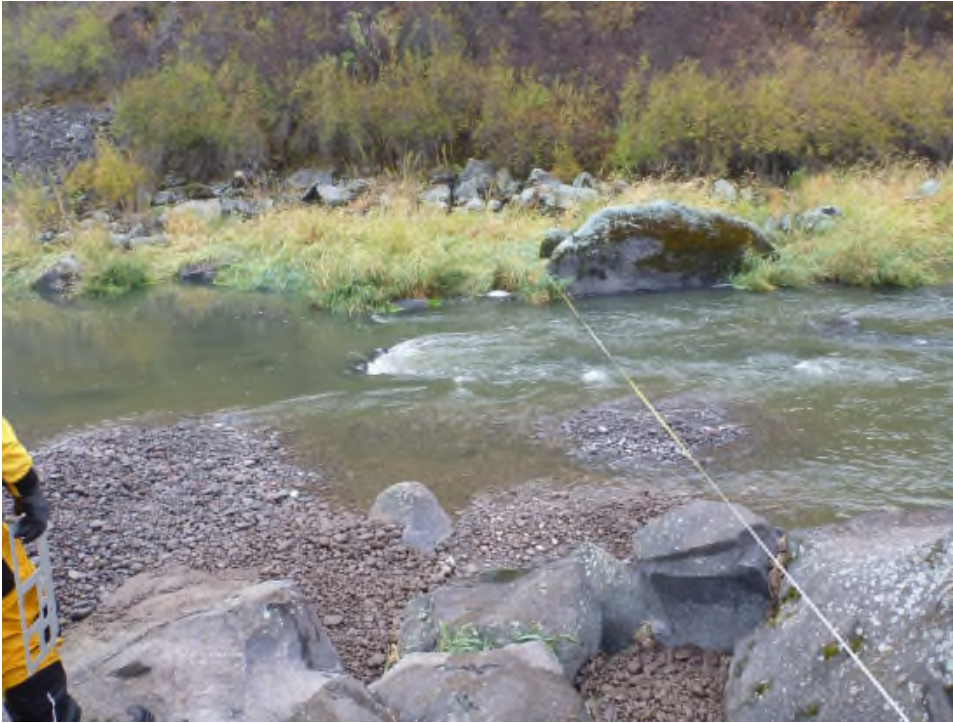
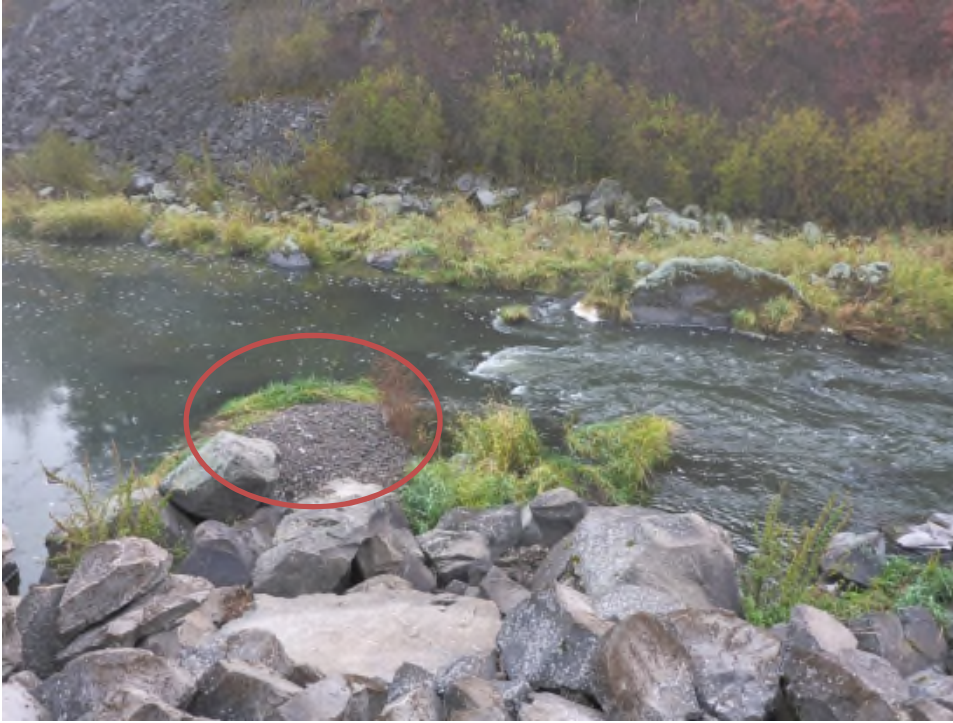
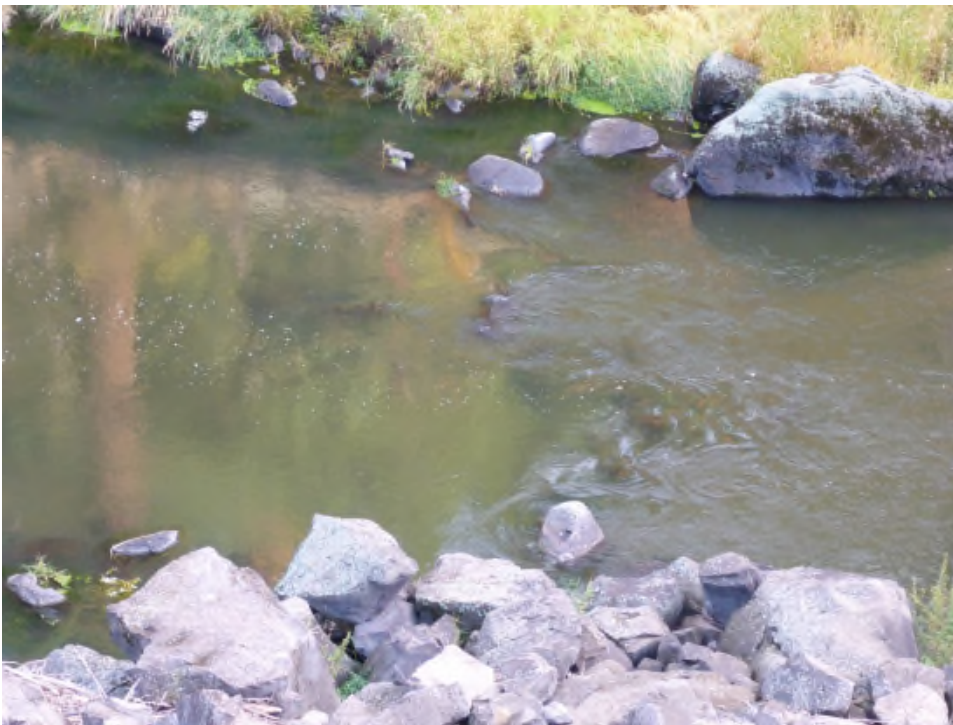
Gravel was placed at the RM 223.8 site in 2012. Little movement was noted during previous years (2013, 2014, and 2015). As observed in October 2016, none of the placed gravel was found, and high water marks were approximately 10 feet above normal water surface elevations (Figure 3.5-2).

Figure 3.5-2. RM 223.8 Site showing gravel placed in 2012 (a) has not moved from the site by October 2015 (b) but had moved by October 2016 (c).

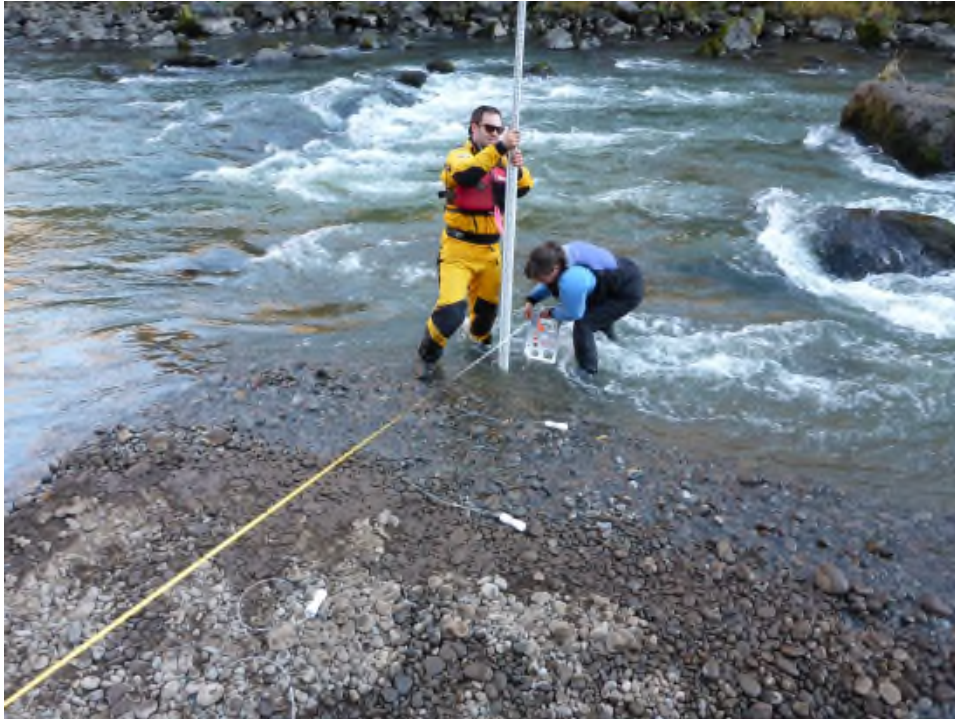
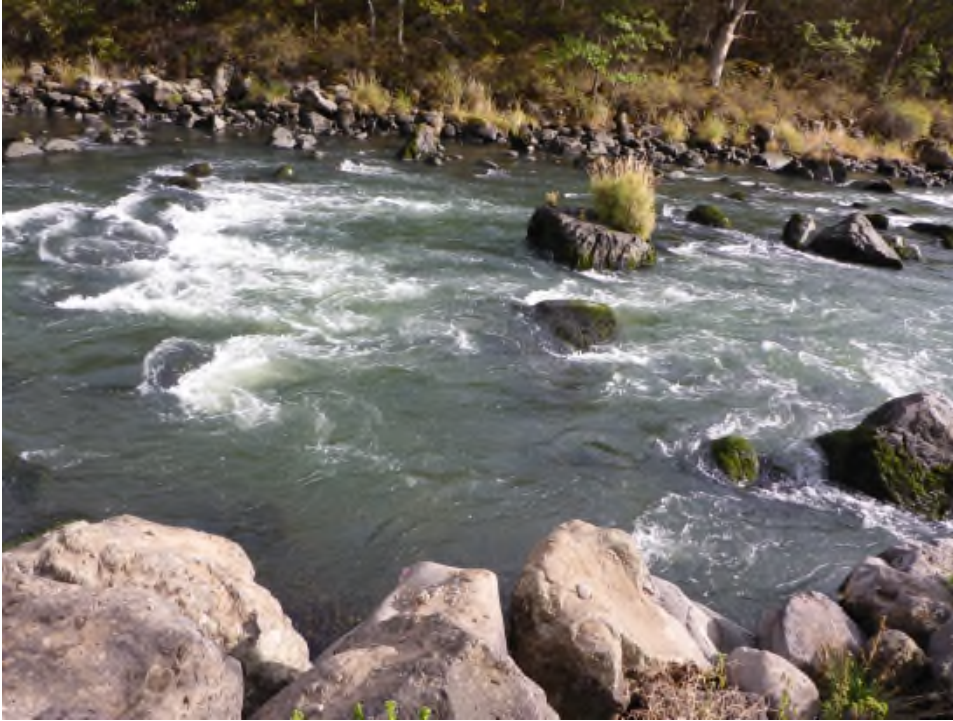
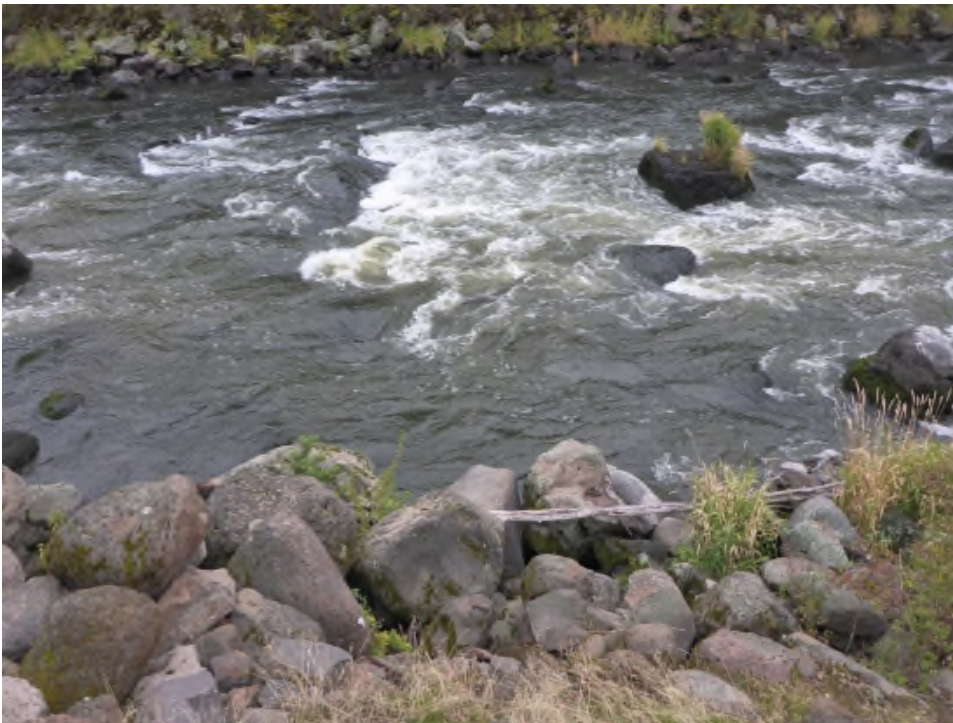
Gravel was added to the RM 220.2 site in 2013. The majority of the gravel at this site was transported downstream by October 2014 but some remained on the shoreline. All remaining shoreline gravel had been transported by October 2016 (Figure 3.5-3).

Figure 3.5-3. RM 220.2 Site showing gravel placed in 2013 (a) had moved from site by October 2014 (b) and 2016 (c).

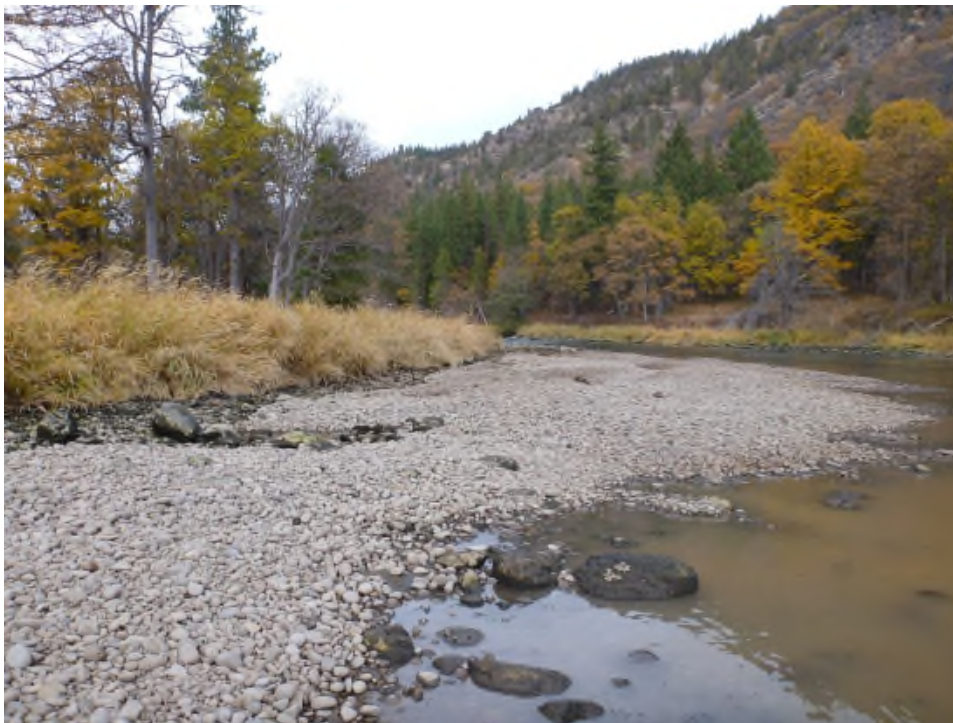
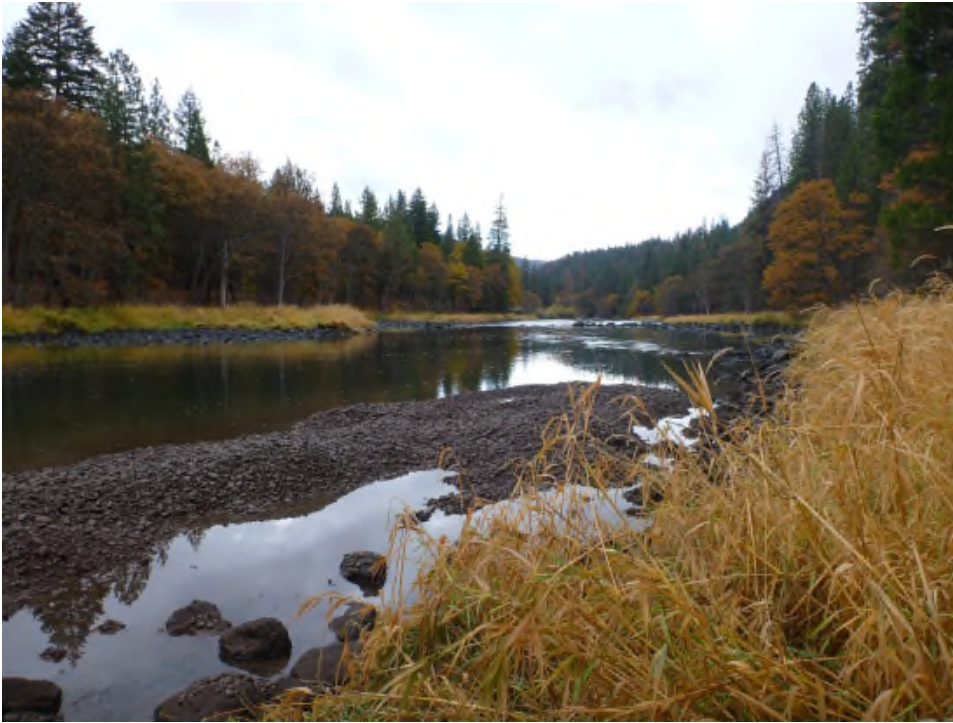
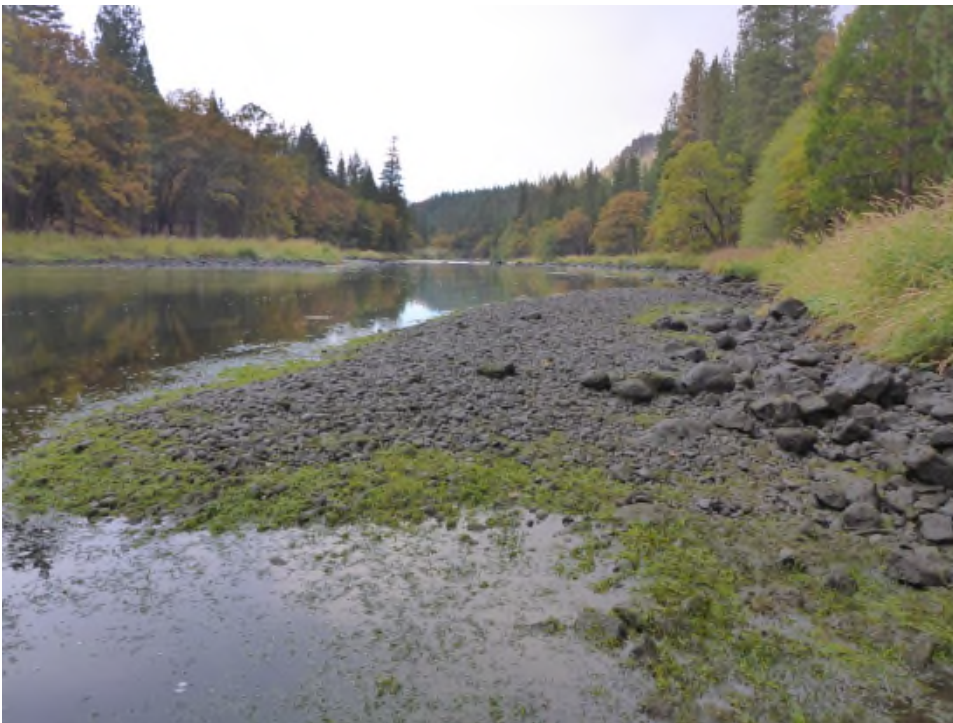
Gravel was placed at RM 217.3 in 2011. Previous checking of this site in 2012, 2013, 2014, and 2015 showed little gravel movement. In 2016, some of the gravel had been transported downstream, but much of the gravel close to the river bank remained (Figure 3.5-4).

(Note 2011 this photo taken looking upstream)

Figure 3.5-4. RM 217.3 Site showing some gravel placed in 2011 (a and b) has moved from site by October 2016 (c).

No additional gravel should be placed at the RM 217.3 or 216.3 (peaking reach) sites until higher flows (e.g., very large spill) occur that have the opportunity to move the placed gravel. Considering that flows over 10,000 cfs in March 2016 moved only a portion of the gravel at these sites, it may not be advisable to place additional gravel here in the future.

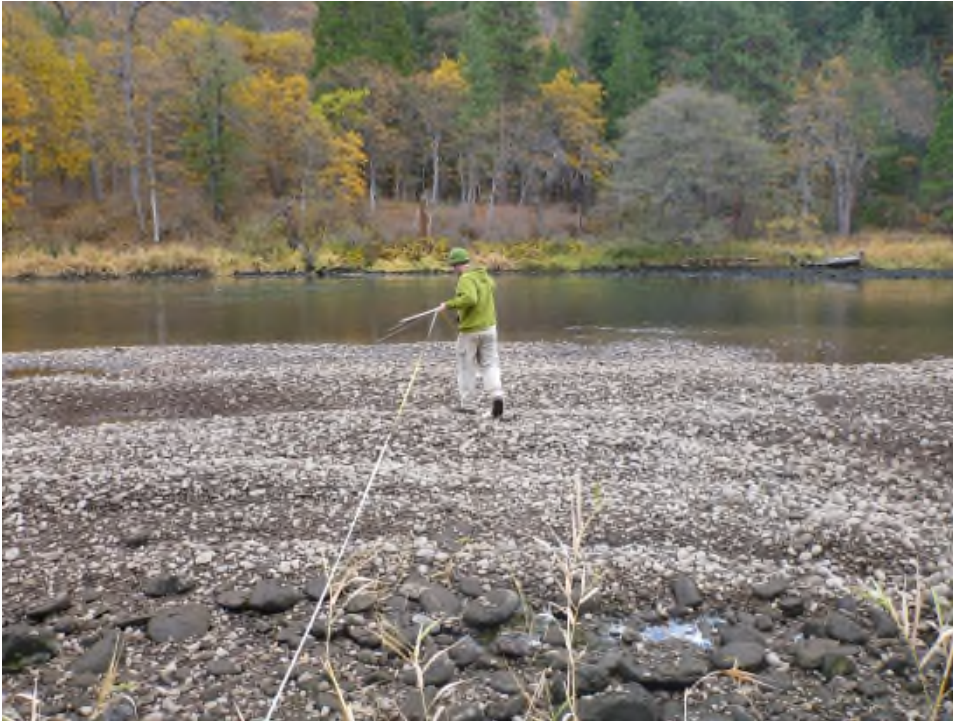
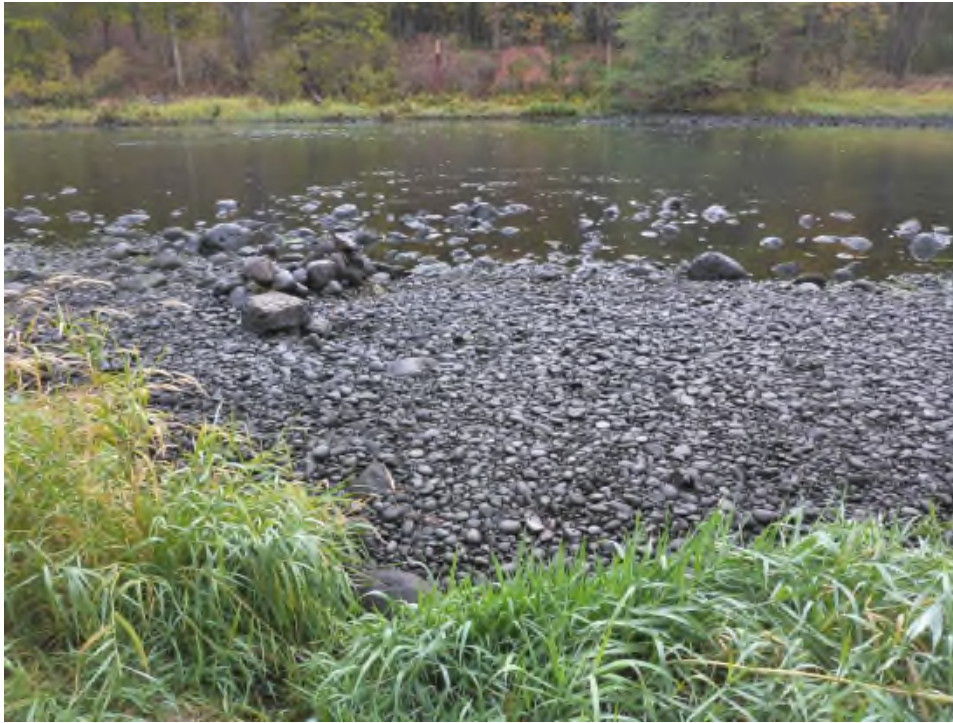
Gravel was placed at RM 216.3 in 2011 and has been checked annually since then. Little movement of gravel at this site has been noted previously. In October 2016, following the high flow event, some of the gravel was moved from areas in the middle of the channel, but there was still a substantial amount along the shore (Figure 3.5-5).

Figure 3.5-5. RM 216.3 Site showing some gravel placed in 2011 (a) has moved from site by October 2016 (b).
