## TECHNICAL MEMORANDUM

**To:** Demian Ebert, PacifiCorp  
**From:** Todd McDonnell, E&S Environmental Chemistry, Inc.  
**Date:** November 8, 2023  
**Subject:** Repair of cattle exclusion fence at Spencer Creek, Klamath County, Oregon

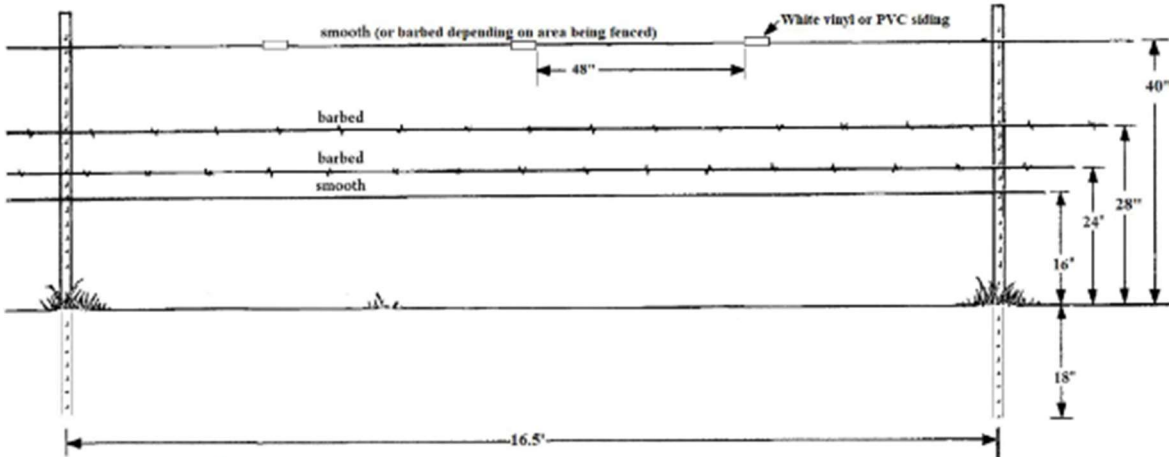
Figure 2. Schematic of wildlife-friendly fence (modified after Page 2012).

A wildlife-friendly fence design (Figure 2) was used to replace the pre-existing five-strand barbed wire fence for lengths of fence in need of replacement. Fencing specifications were developed in coordination with ODFW using Natural Resource Conservation Service (NRCS) documentation (NRCS 2010). The goal of the fence design was to exclude free-ranging cattle from entering the creek while allowing wildlife unimpaired access to the exclusion areas. These designs include wildlife-friendly features such as an elevated and smooth lower wire to allow for passage of small animals underneath the fence, a smooth top wire spaced accordingly from the second wire to prevent animals from getting caught in the fence while traversing, and white vinyl markers to increase fence visibility.

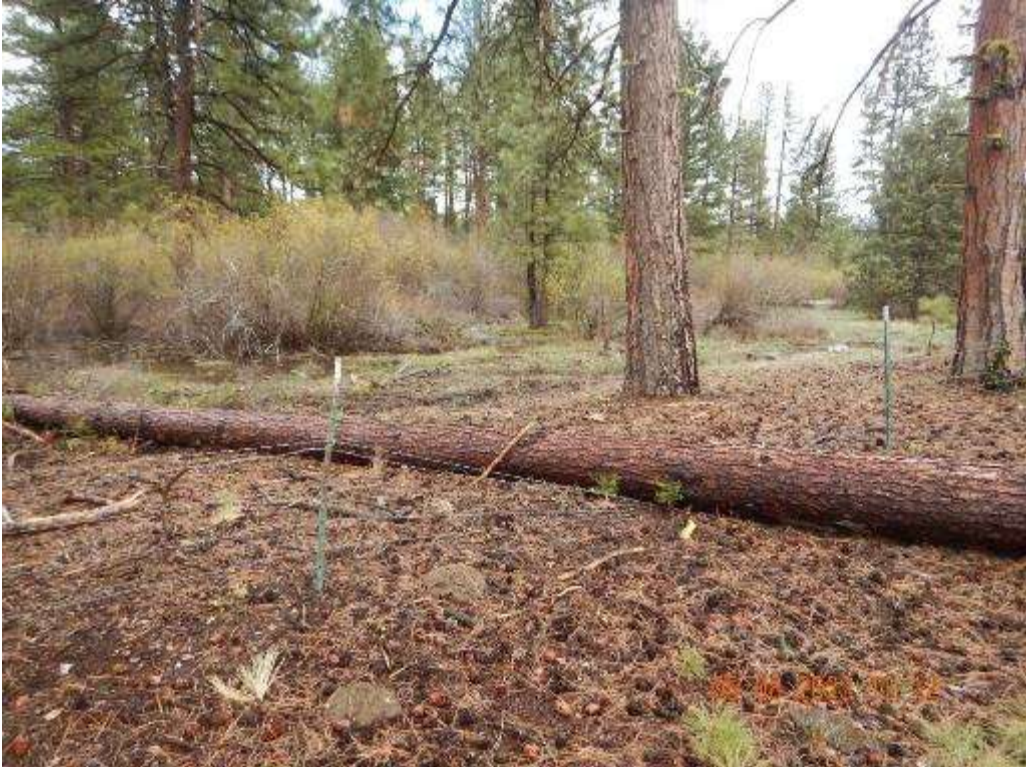
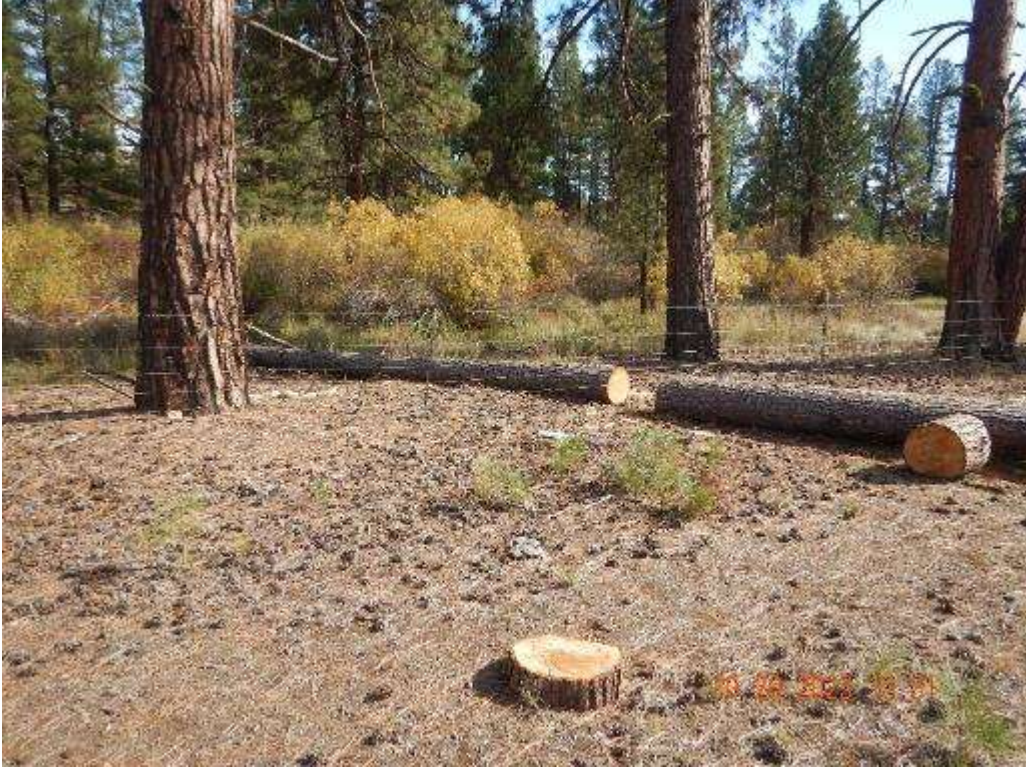
Figure 3. Fallen tree damage in Area 1. A fallen tree was removed from the fence and fence wires were reattached to T-posts and retensioned.

Because of increased wildfire risk, fence repair work started on September 27, 2023. All work was completed on October 19, 2023. In most areas, the existing fence was repaired and re-tensioned (e.g., Figure 3 and Figure 4). New steel corner braces were installed where necessary (Figure 5). In areas where the fence needed to be completely replaced, the wildlife-friendly fence design (Figure 2) was installed. In addition to fence repair and replacement, a new drive-through gate was installed on the Area 4 fence where the old fence had been cut and posts removed (Figure 6), creek crossings were improved (Figure 7), and additional hog paneling was installed along the Area 1 fence at the confluence with the Klamath River.

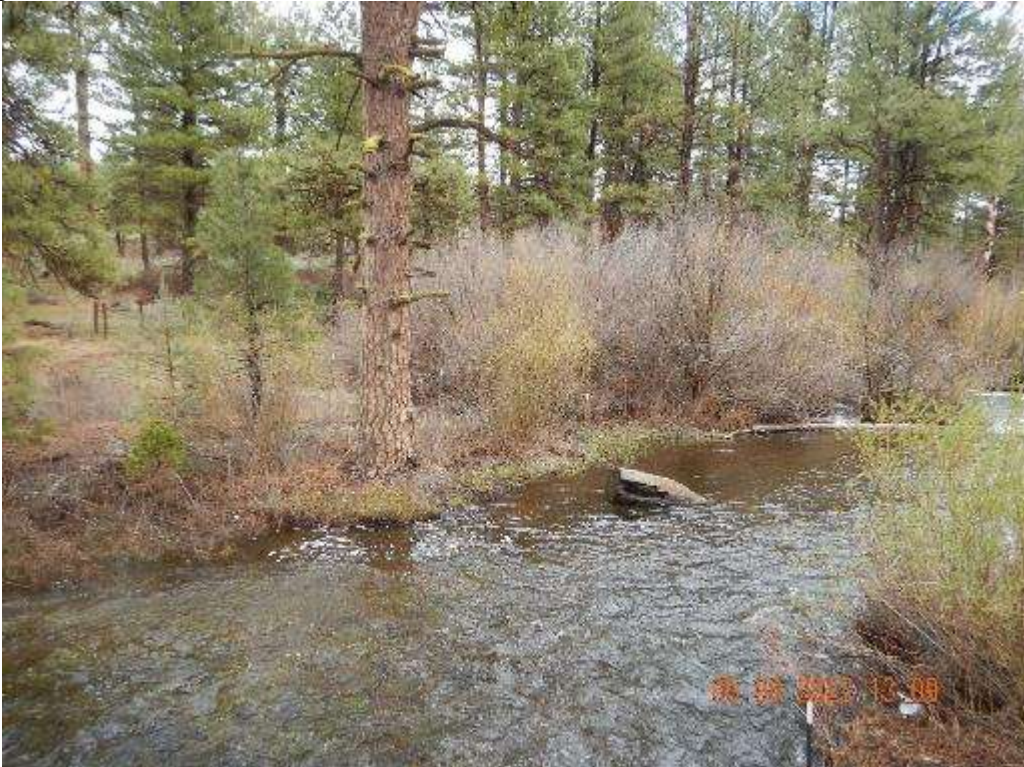
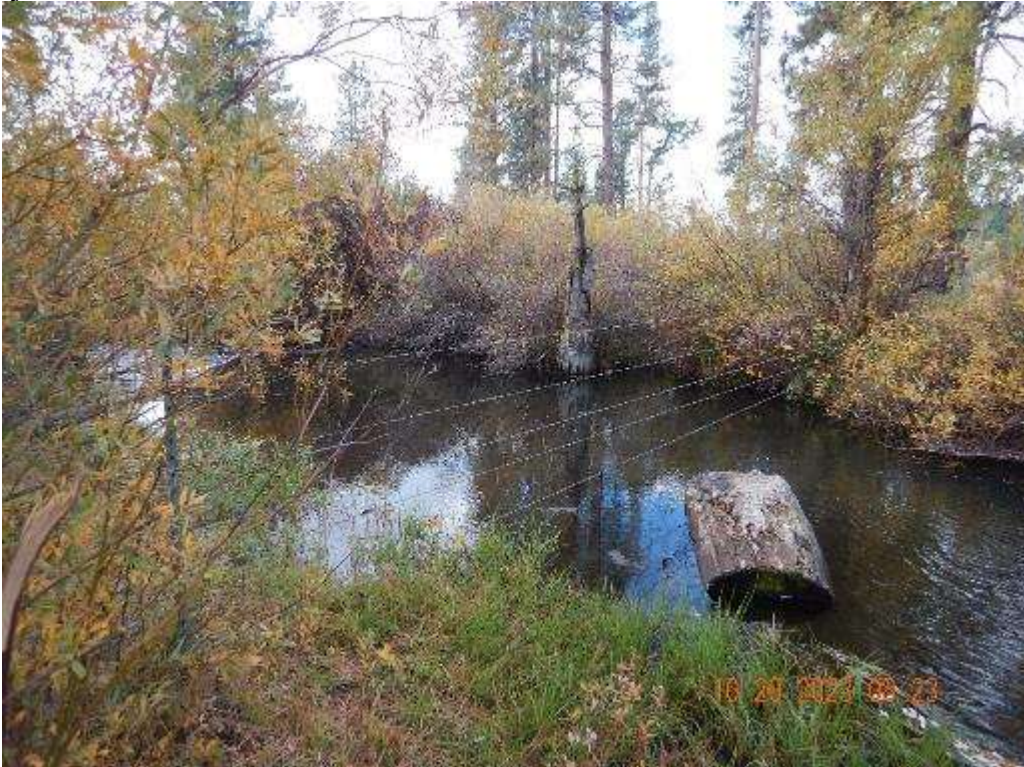
Figure 4. View of the northern intersection of Area 1 fence with Spencer Creek. Fence wires spanning the creek were reattached to T-posts and retensioned.

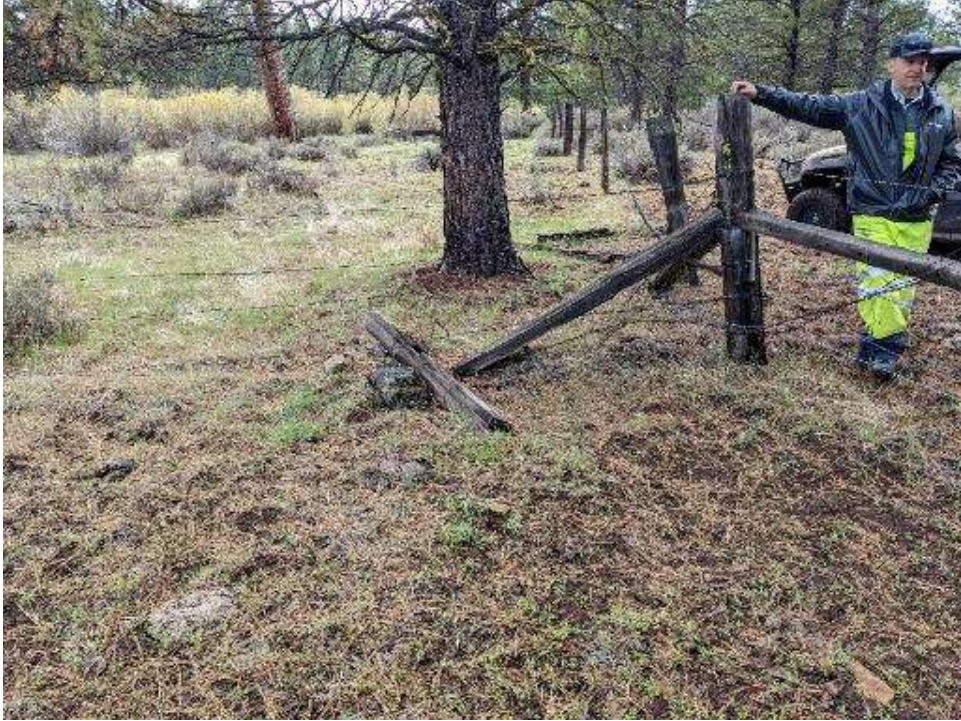
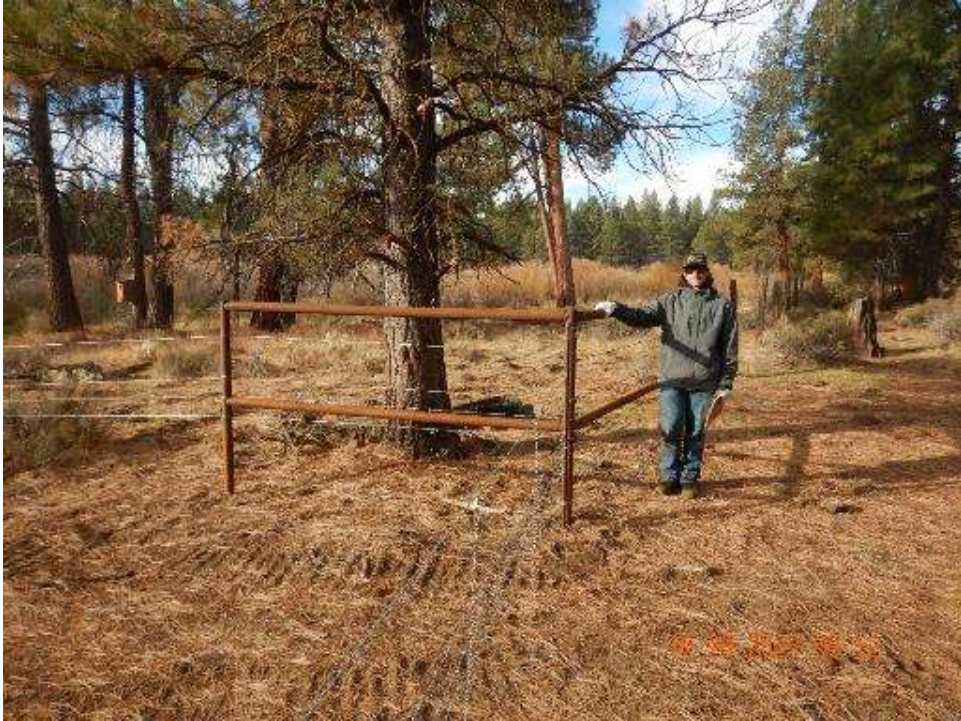
Figure 5. View of the northeastern corner of Area 2 fence. The aged wooden corner brace was replaced with steel pipe and the wires were retensioned and reset. New wildlife-friendly fence was installed leading to the northwestern crossing of Area 2 with Spencer Creek (visible at left side of the post-project photo).

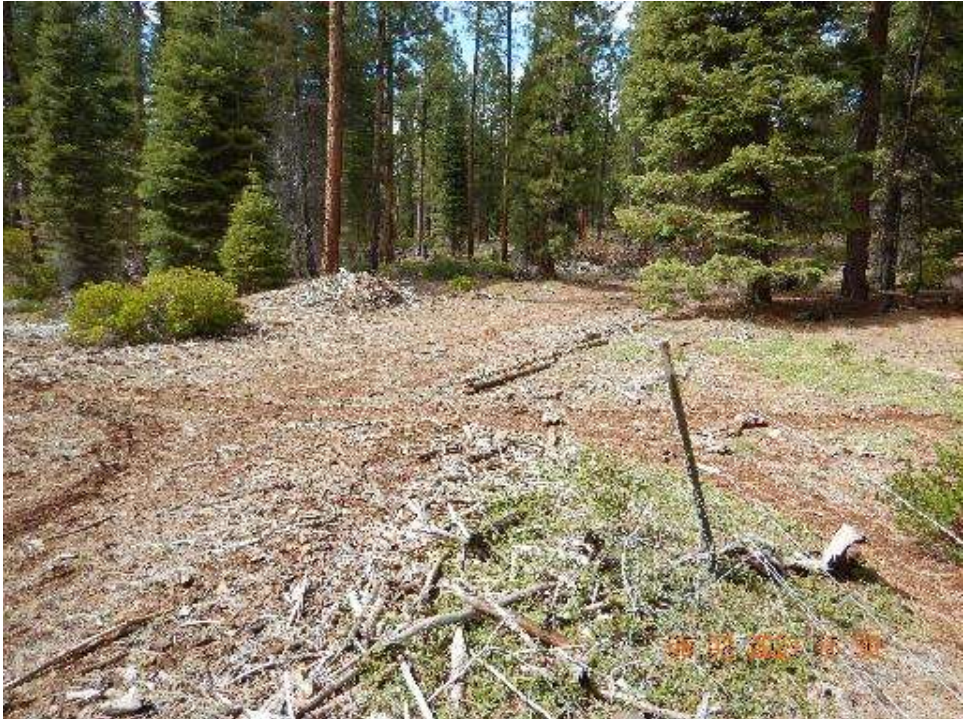
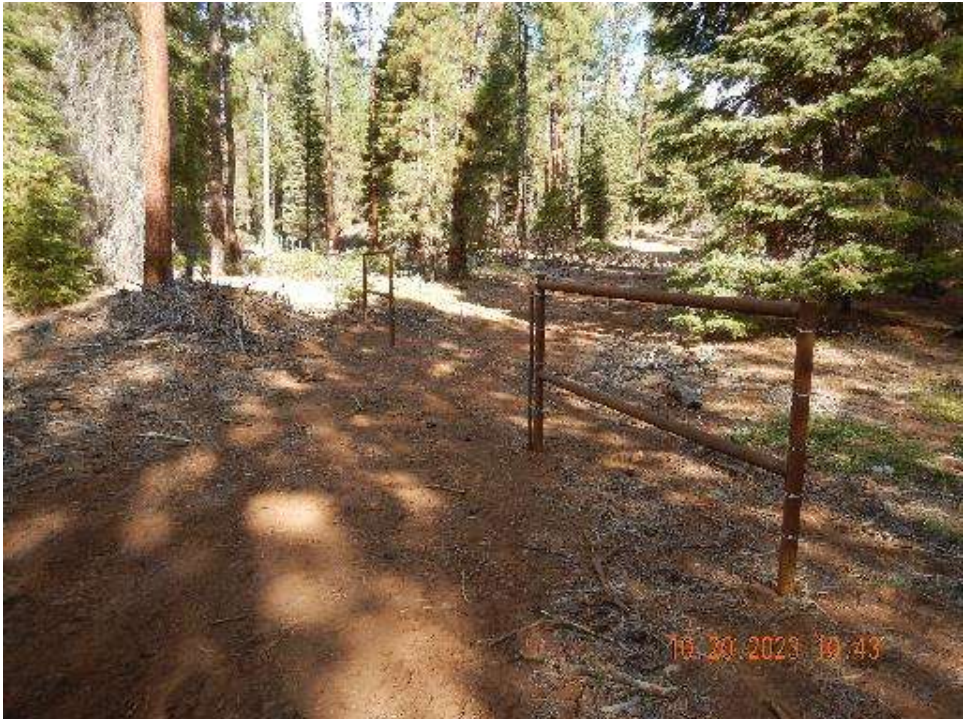
Figure 6. Location of new drive-through gate in southwestern portion of Area 4. Pre-project fence had been torn down to allow for passage on logging road; new drive-through gate with steel pipe bracing was installed allowing for vehicle access.

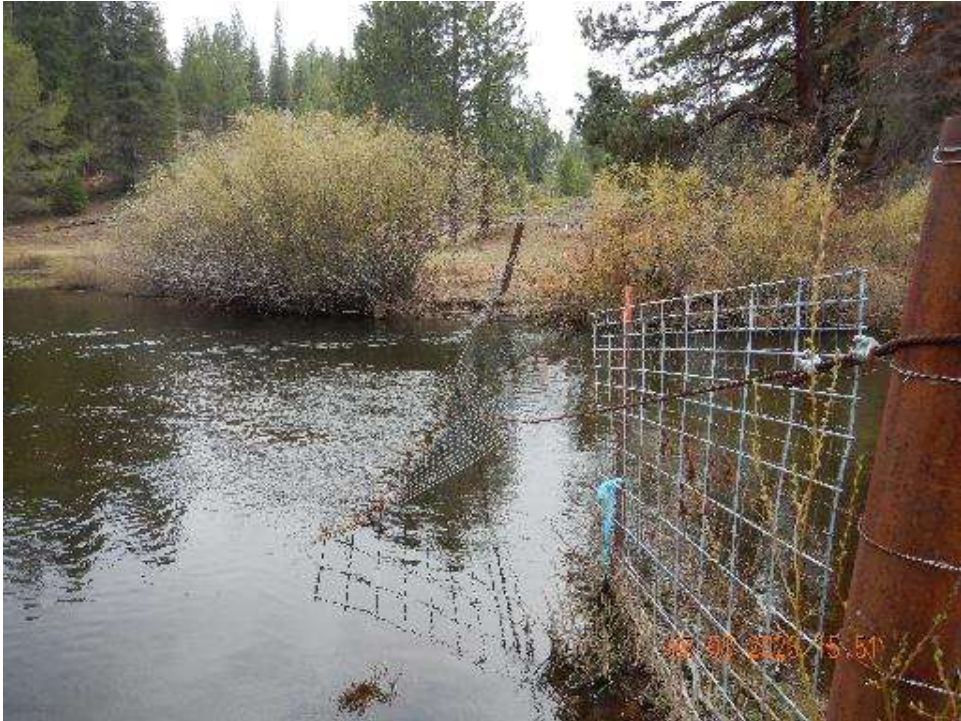
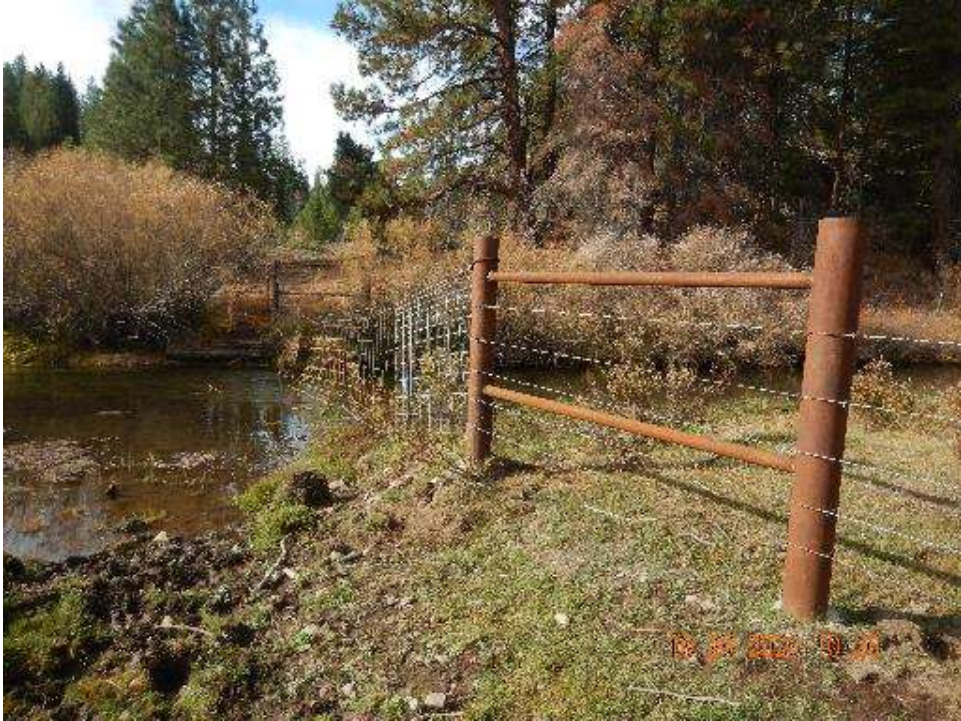
Figure 7. View of the southern intersection of Area 4 fence with Spencer Creek. H-braces were repaired and the cable was retensioned to establish proper hog fence positioning; new steel pipe bracing was installed on the far bank).
