**Lewis River Hydroelectric Projects Settlement Agreement
Aquatic Coordination Committee (ACC)
Meeting Agenda**

FINAL Meeting Notes
Lewis River License Implementation
Aquatic Coordination Committee (ACC) Meeting
October 11, 2018
Merwin Hydro Control Center

Update of Floating Surface Collector (FSC); facilities adjustments

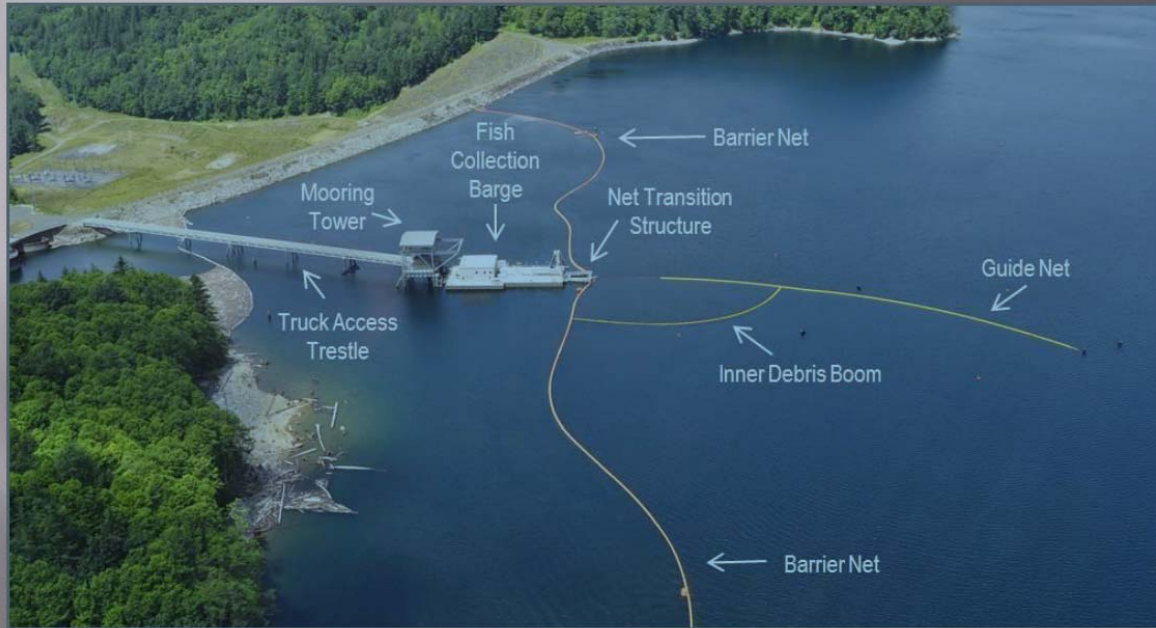
Layout of Swift Reservoir FSC

Chris Karchesky (PacifiCorp) provided the ACC with a status report for the Swift FSC. Karchesky reviewed the structural changes made since the Swift FSC was brought on-line in December 2012. Most notably was the addition of the 600’ guide net installed at the entrance of the FSC in spring 2016. Before the net was installed, it appeared from behavioral data using radio and acoustic telemetry that out-migrates were having a difficult time finding the entrance of the FSC. Once the guide-net was installed, it appeared that most fish entering the forebay were now concentrating at the entrance of the FSC, but not going in. (This information was presented in the 2017 acoustic telemetry evaluation of out-migrant collection efficiencies located in Appendix B – Lewis River Fish Passage Program 2017 Annual Report). Karchesky provided an excerpt from the report (Figure 17 below) that showed the area in which all tagged fish concentrated just outside the Net Transition Structure (NTS) during the study.

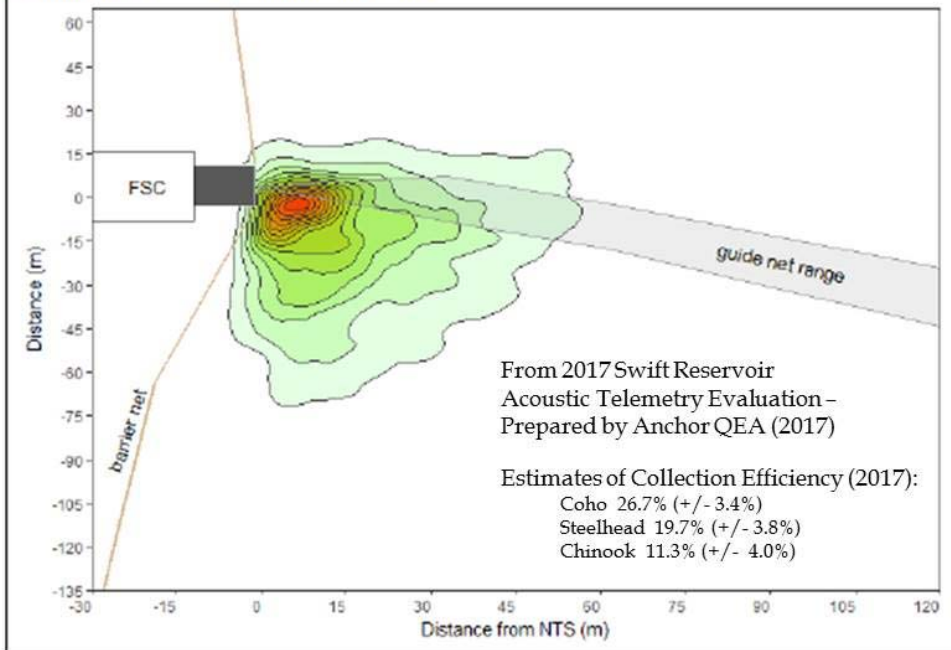
Figure 13
Density of Detected Positions, All Species

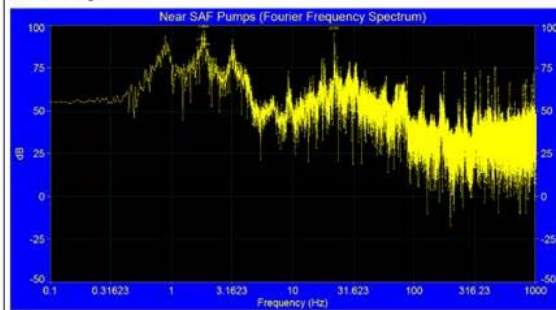
Figure 3
Frequency Versus Amplitude for One 50-Second Interval When Sorting Area Flow Pumps Were Running

Notes:
X-axis: Frequency (hertz [Hz])
Y-axis: Amplitude (decibels [dB])

Karchesky described that following the 2017 collection efficiency evaluation, PacifiCorp evaluated the acoustic noise in and around the Swift FSC. From this evaluation, it was apparent that the Swift FSC was “acoustically noisy” from the standpoint of low vibrations in frequency that fish could detect. These vibrations were isolated to the facilities Sort Area Flow (SAF) Pumps. In December 2017, PacifiCorp modified how these pumps operated to reduce that amount of low frequency vibration and acoustic noise omitted. Karchesky provided excerpts of the 2017 report showing the spikes in low frequency vibration present before the pumps were modified (left) and the more constant vibration after the operational change (right). Karchesky indicated that it was these spikes that have been show to trigger fish avoidance behavior.

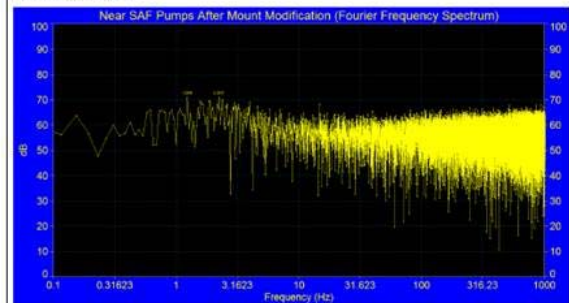
Figure 5
Frequency Versus Amplitude Near the Sorting Area Flow Pumps While Running, After Mount Modification

Notes:
X-axis: Frequency (hertz [Hz])
Y-axis: Amplitude (decibels [dB])

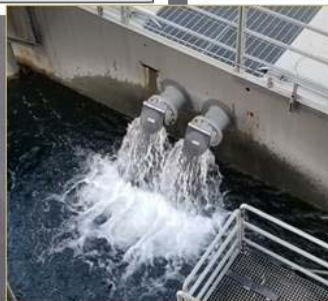
Before
(Low frequency
vibration present)

After
(Low frequency vibration
no longer present)

From 2017 Swift Reservoir Acoustic
Telemetry Evaluation – Prepared by
Anchor QEA (2017)

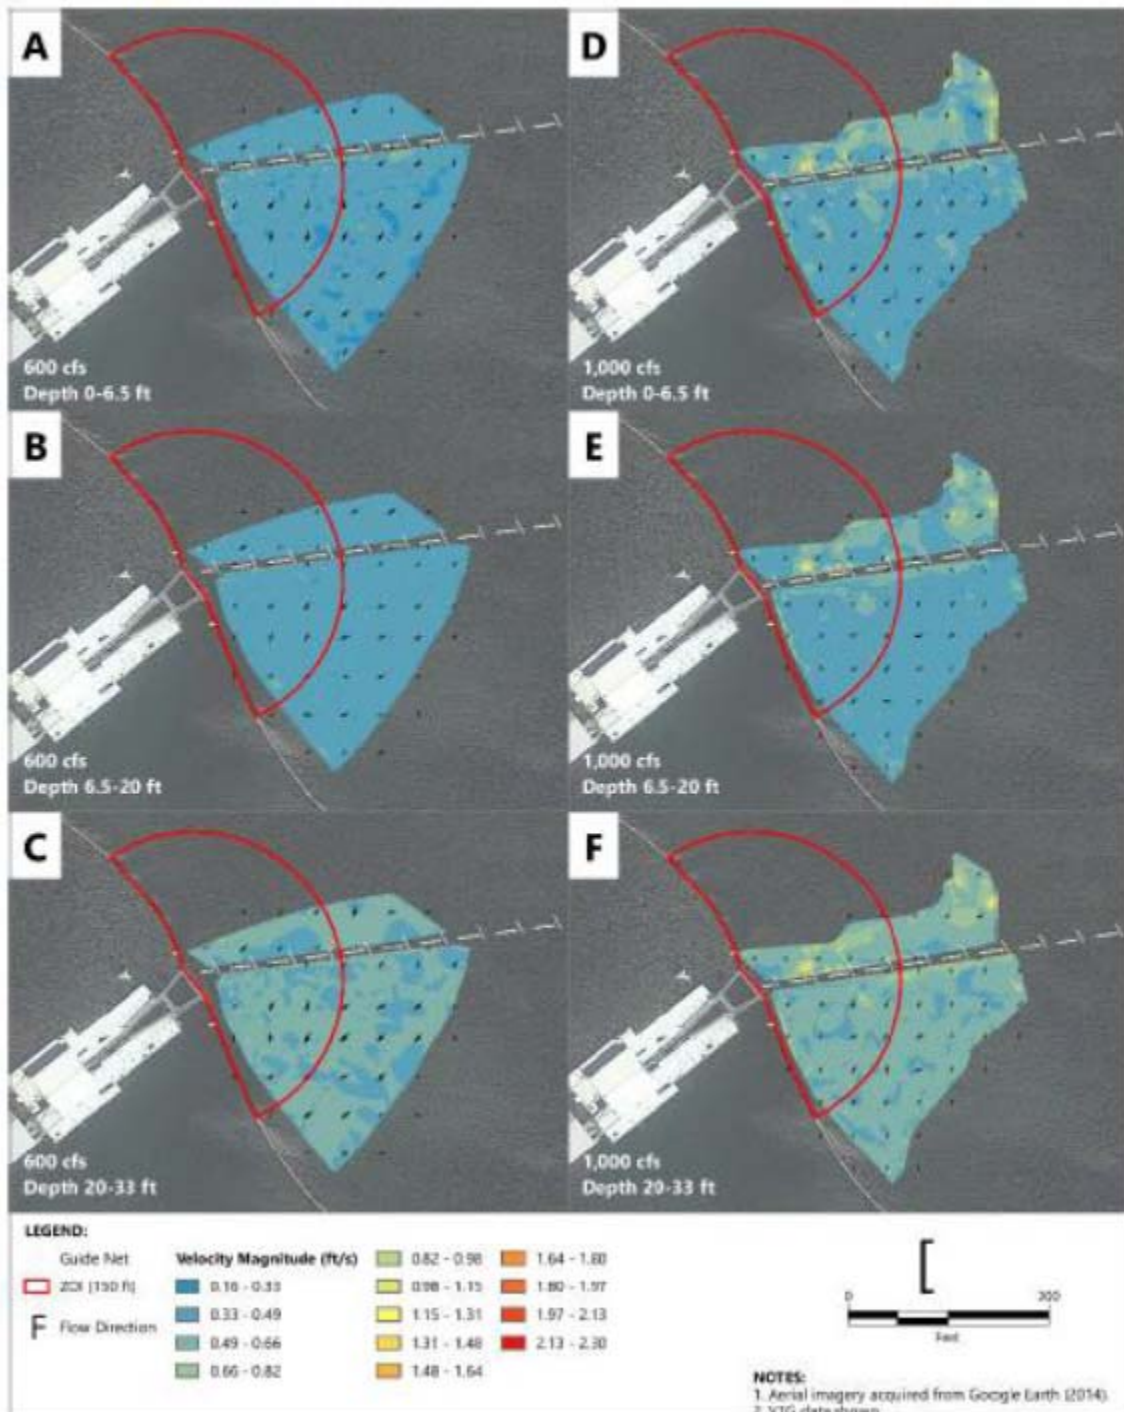
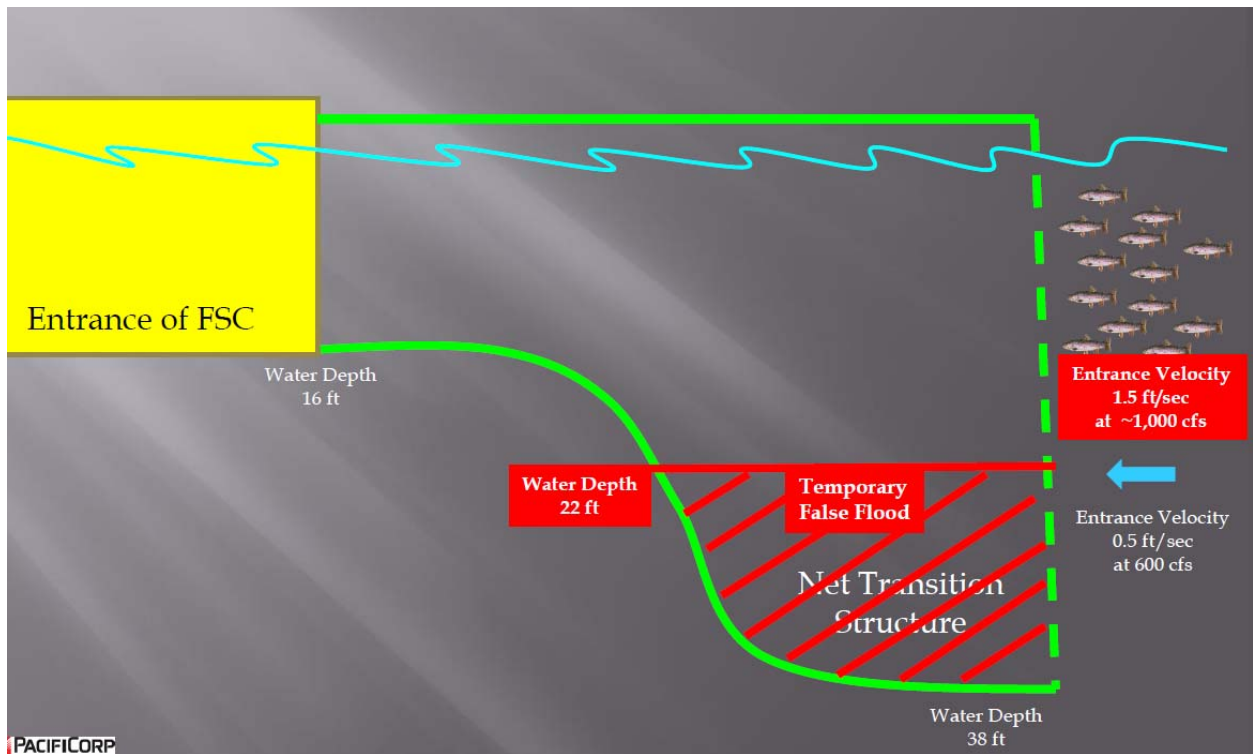
Figure 16
Acoustic Doppler Current Profiler Velocity Data Collection Results in Front of the Floating Surface Collector at Swift Reservoir

Note: Panels A through C show water velocity and direction at the 600 cfs operating condition in the 0- to 6.5-foot, 6.5- to 20-foot, and 20- to 33-foot depth bins. Panels D through F show the same depth bins at the 1,000 cfs operating condition.

Karchesky then discussed recent work PacifiCorp had completed measuring the entrance velocities immediately outside the Swift FSC and verifying the current zone of influence. Based on this work (completed in December 2017) it was found that current velocities were relatively slow (< 0.5 ft/sec) and were consistent with design intent. Karchesky reminded the ACC it was originally thought that juvenile spring Chinook would require a deeper entrance than out-migrating coho or steelhead. Consequently the entrance of the FSC (Net Transition Structure - NTS) was designed with an entrance of 38 ft, which resulted in the slower approach velocity. However, recent acoustic work (2017) found that all three species generally migrate in upper 25 ft of the water column in the forebay of Swift Reservoir. Karchesky also indicated that recent work verifying water velocity and flow trajectories outside the NTS show little to no discernable attraction flow in front of the FSC at 600 or 1,000 cfs (Figure 16 of the report provided below).

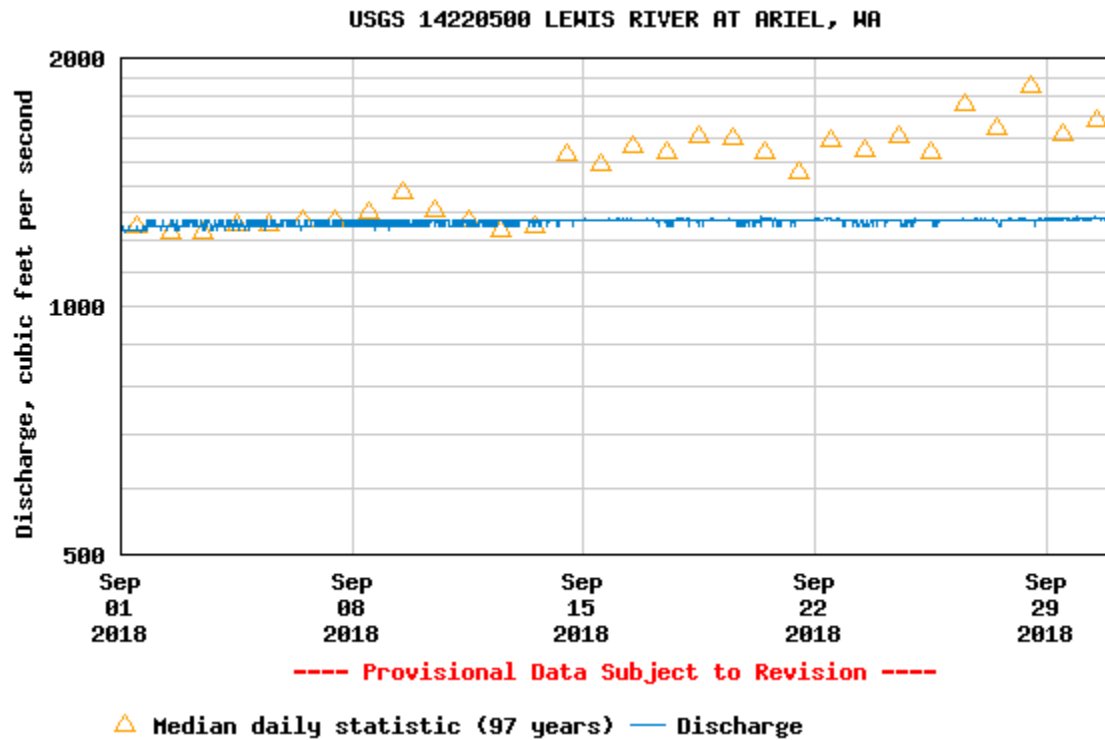
River flow below Merwin Dam remained near the minimum flow requirement of 1,200 cfs throughout the month.

Discharge, cubic feet per second

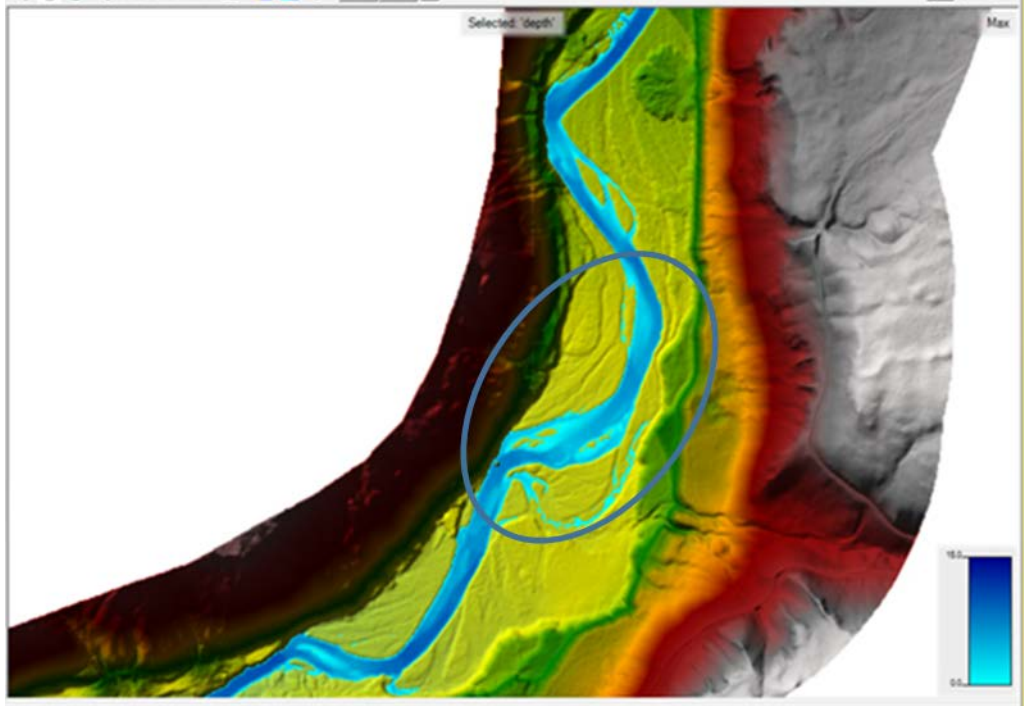
The Lewis River 21 Phase III site is a moderately confined reach with a relatively low gradient (<1%) with the river being mostly contained within the river banks at bankfull flows (Figure 2). Residual pool depths are shallow (<3') for a large river and contributes to the observed high bankfull width to depth ratios. The average bankfull width of the project area is approximately three hundred and eighty feet. Recently deposited large wood complexes from the 2015 high flow event have improved channel conditions along the outside meander of

Figure 2. Preliminary 2D HEC-Ras model of bankfull flow in proposed Lewis River 21 Phase III project area (blue circle).

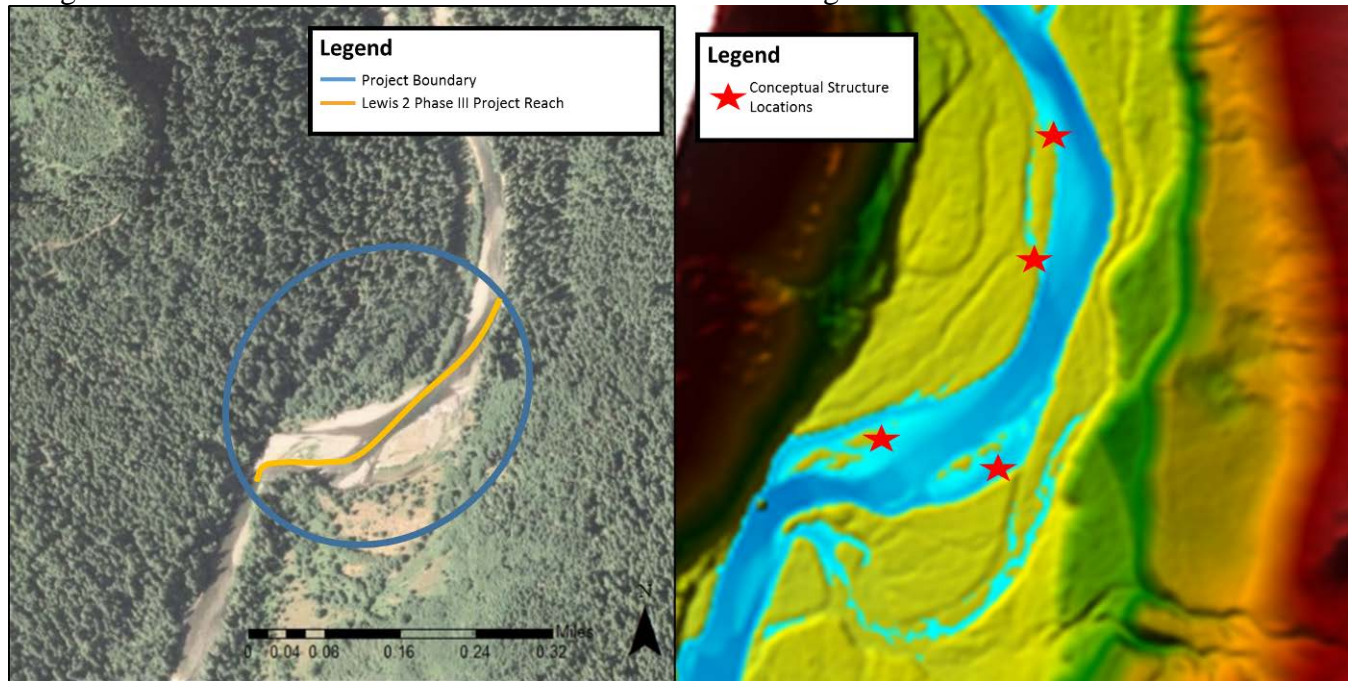
Conceptual project designs to achieve these goals and objectives are to form four large wood structures (Figure 3) within 1600 feet (0.3 miles) of river channel using 400 pieces of large wood from a USFS harvest unit and/or 15-20 whole trees from the adjacent riparian area. Large wood would also be added to the lower energy side channels to promote and maintain pool scour, high and low flow juvenile refugia, and spawning gravel sorting for spring Chinook (primary), coho (contributing) and steelhead (contributing). Wood added to the side

Figure 3. Conceptual log complex structure locations within the Lewis River 21 Phase III project area.

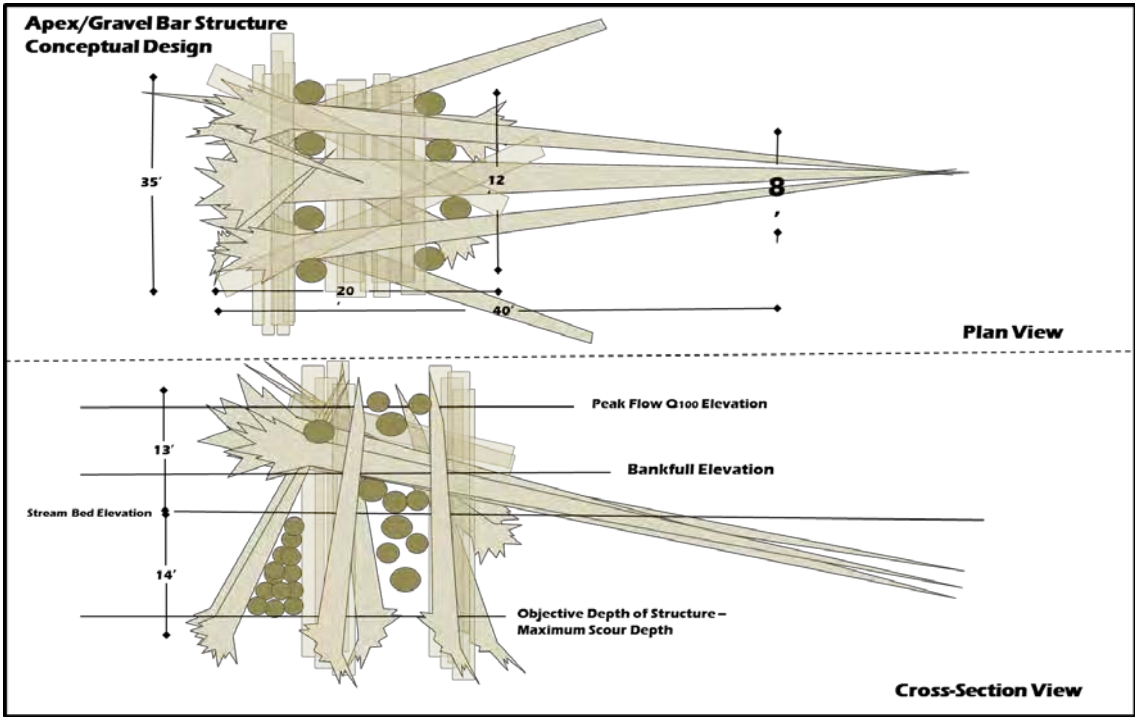
Figure 4. Conceptual apex/gravel bar structure showing proposed structure heights, widths, and scour depths.

Log complex structures will be built to exceed the elevation of the southern terrace bank which is approximately 10 feet above the channel bed (Figures 4, 5 and 6). The additional two feet of structure height is designed to exceed the highest floodplain surface elevation of the eroding terrace and approximately seven feet higher than the lower floodplain surface elevation to the north. Final structure dimensions will be determined using a 2D HEC-Ras model.

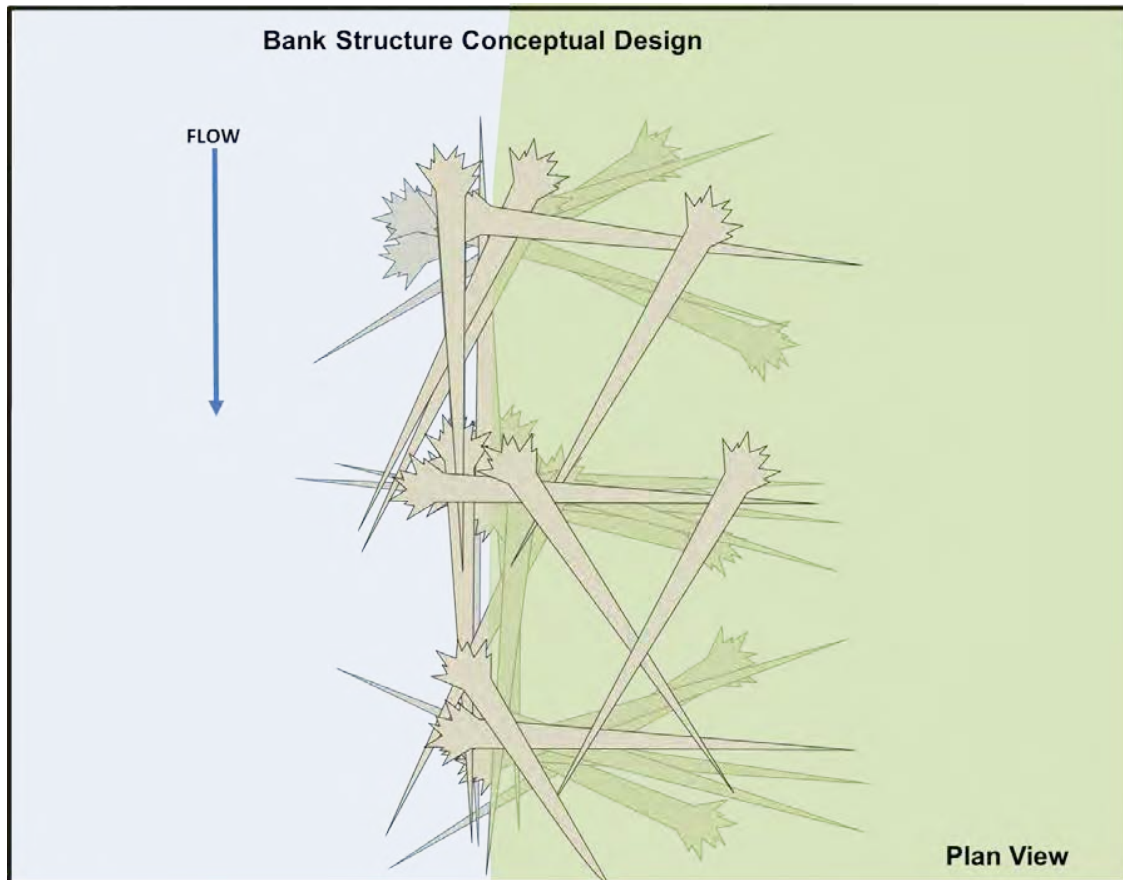
Figure 5. Conceptual design of proposed bank structure base layer framework.

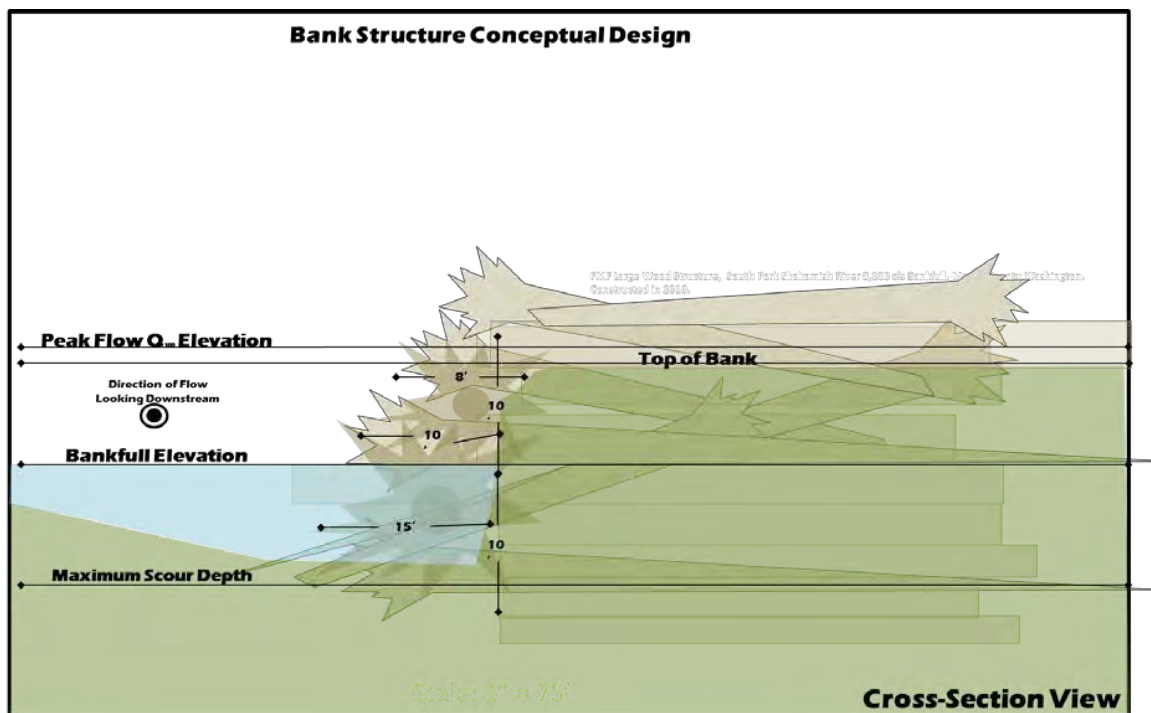
Figure 6. Conceptual bank structure showing proposed structure height and projection.

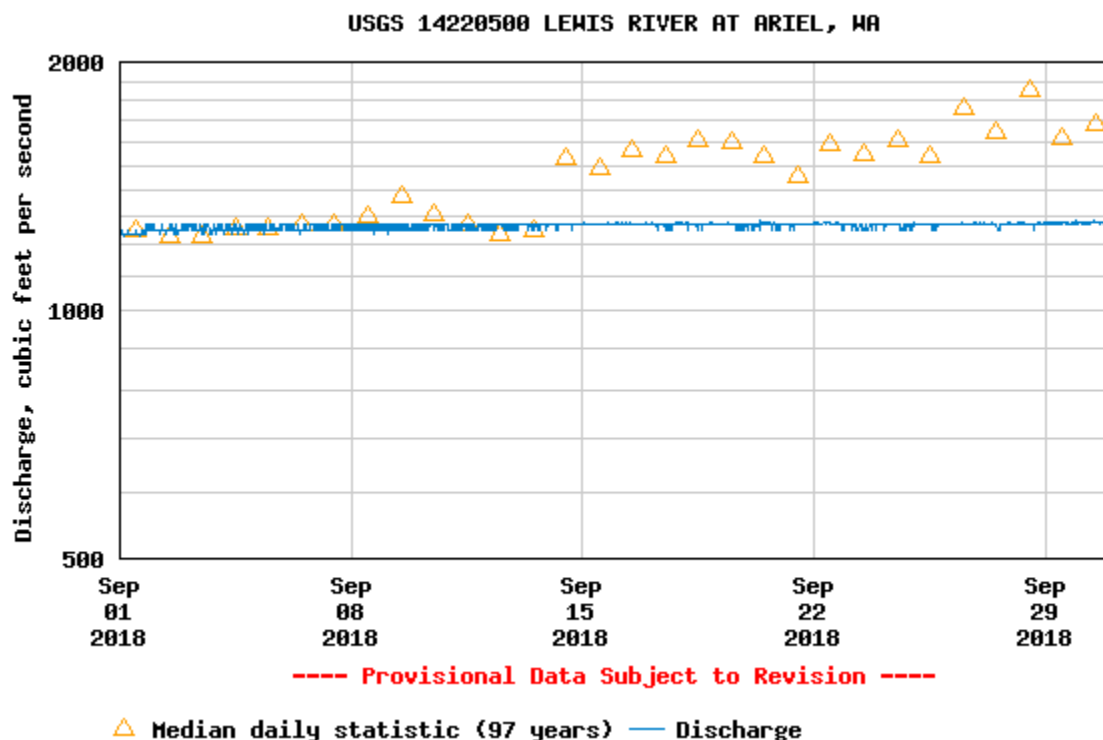
River flow below Merwin Dam remained near the minimum flow requirement of 1,200 cfs throughout the month.

Discharge, cubic feet per second
