**Lewis River Hydroelectric Projects Settlement Agreement
Aquatic Coordination Committee (ACC)
Meeting Agenda**

FINAL Meeting Notes
Lewis River License Implementation
Aquatic Coordination Committee (ACC) Meeting
December 12, 2019
Merwin Hydro Control Center

2020 Upper Lewis River Reach 21 Phase III and Rush Creek Project Proposals

Eagle Island Chum Salmon Spawning Channel Project

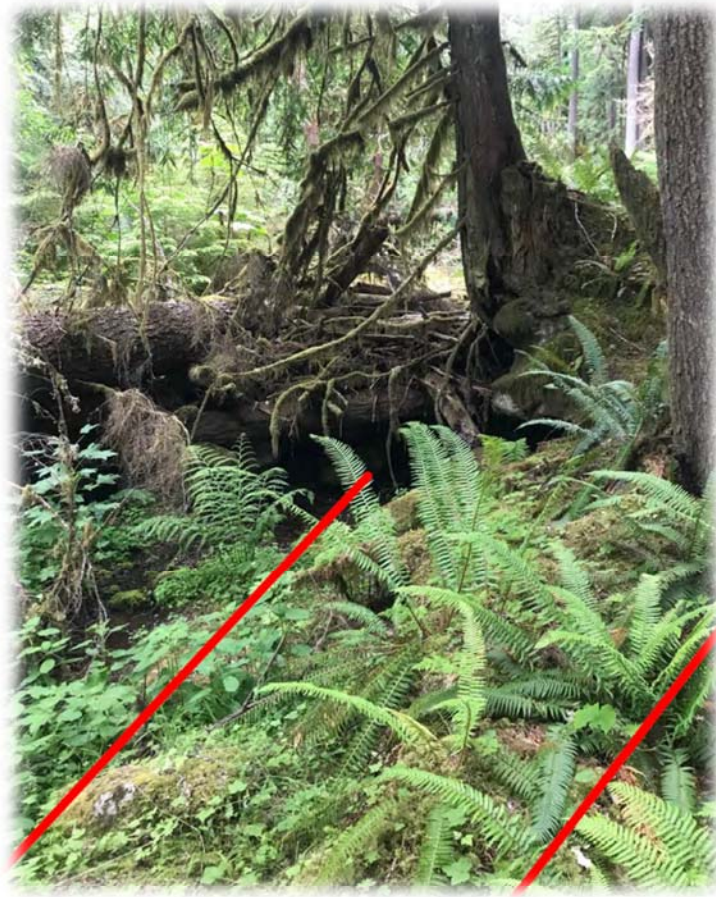
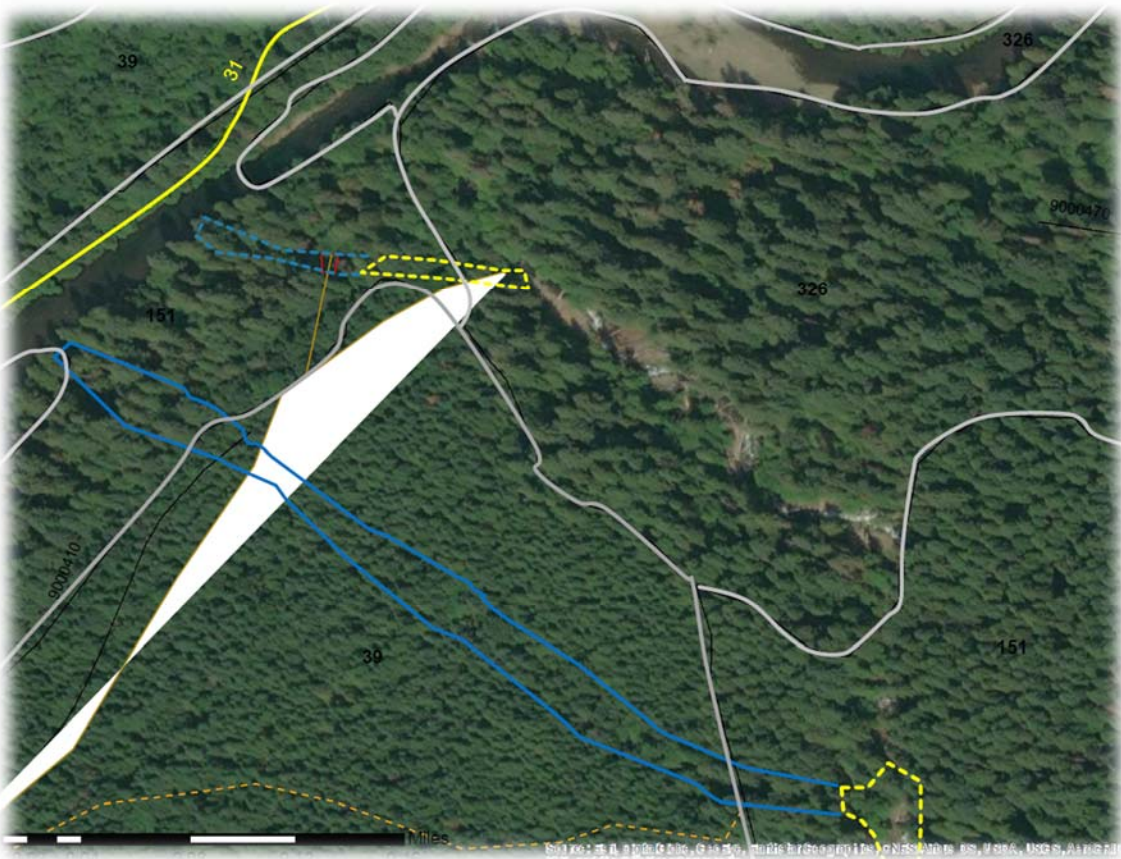
This project will require tipping approximately 800 trees; existing wood will be used. The area in blue polygon will be thinned by ½ and 800 trees will be laid into the channels. Redline is the pushup berm blocking the channel. A representative from the bull trout subgroup also reviewed the site. See attached presentation for further detail.

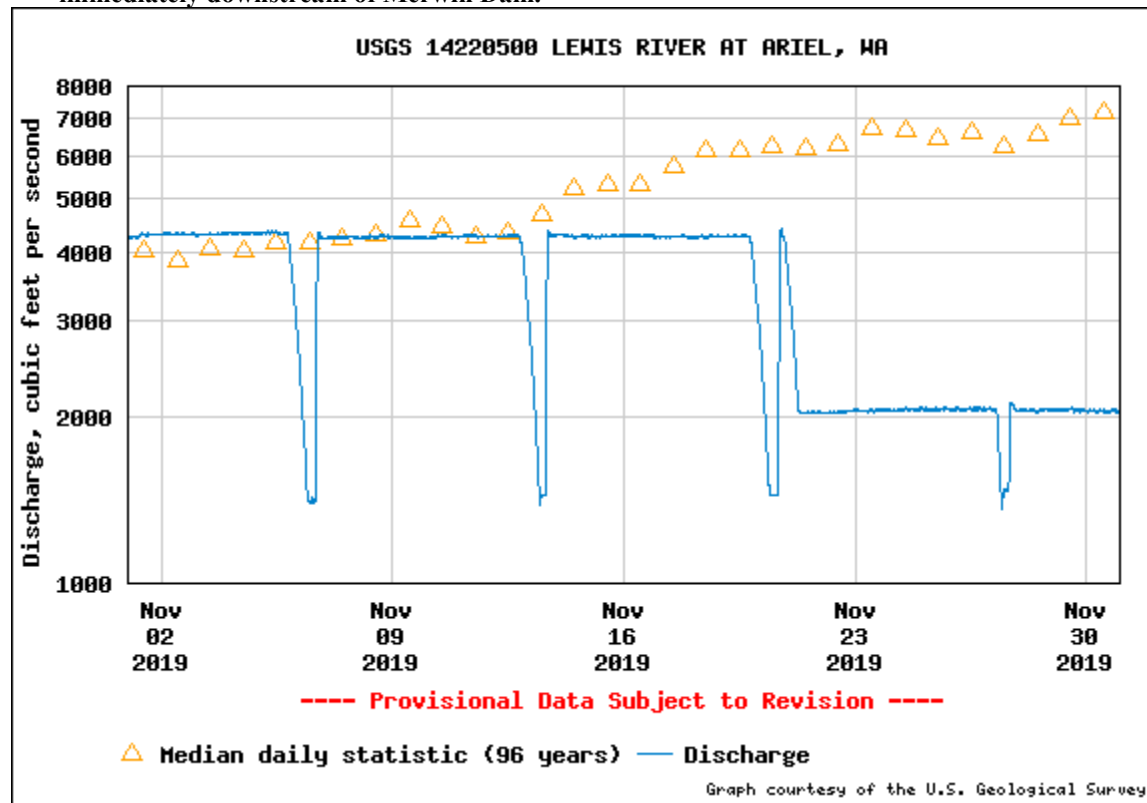
Table 1. Discharge in cubic feet per second recorded at the USGS Ariel, WA gauge (14220500) located immediately downstream of Merwin Dam.

As a reminder, the Merwin Dam Fish Collection Facility was shutdown unexpectedly on October 12, 2019 due to extensive damage to the automatic fish crowding system. Repairs were administered, and the trap was put back in service on November 4, 2019. The MFCF ran continuously for the remainder of the month. Flow below Merwin Dam was maintained at approximately 4,250 cfs until November 19th, and then decreased to approximately 2,050 cfs. River flow remained near this level for the remainder of the month. Similar to previous years, weekly scheduled drawdowns occurred every Wednesday in order to accommodate fall spawning surveys for adult fall Chinook in the Lewis River below Merwin Dam. (Table 1).

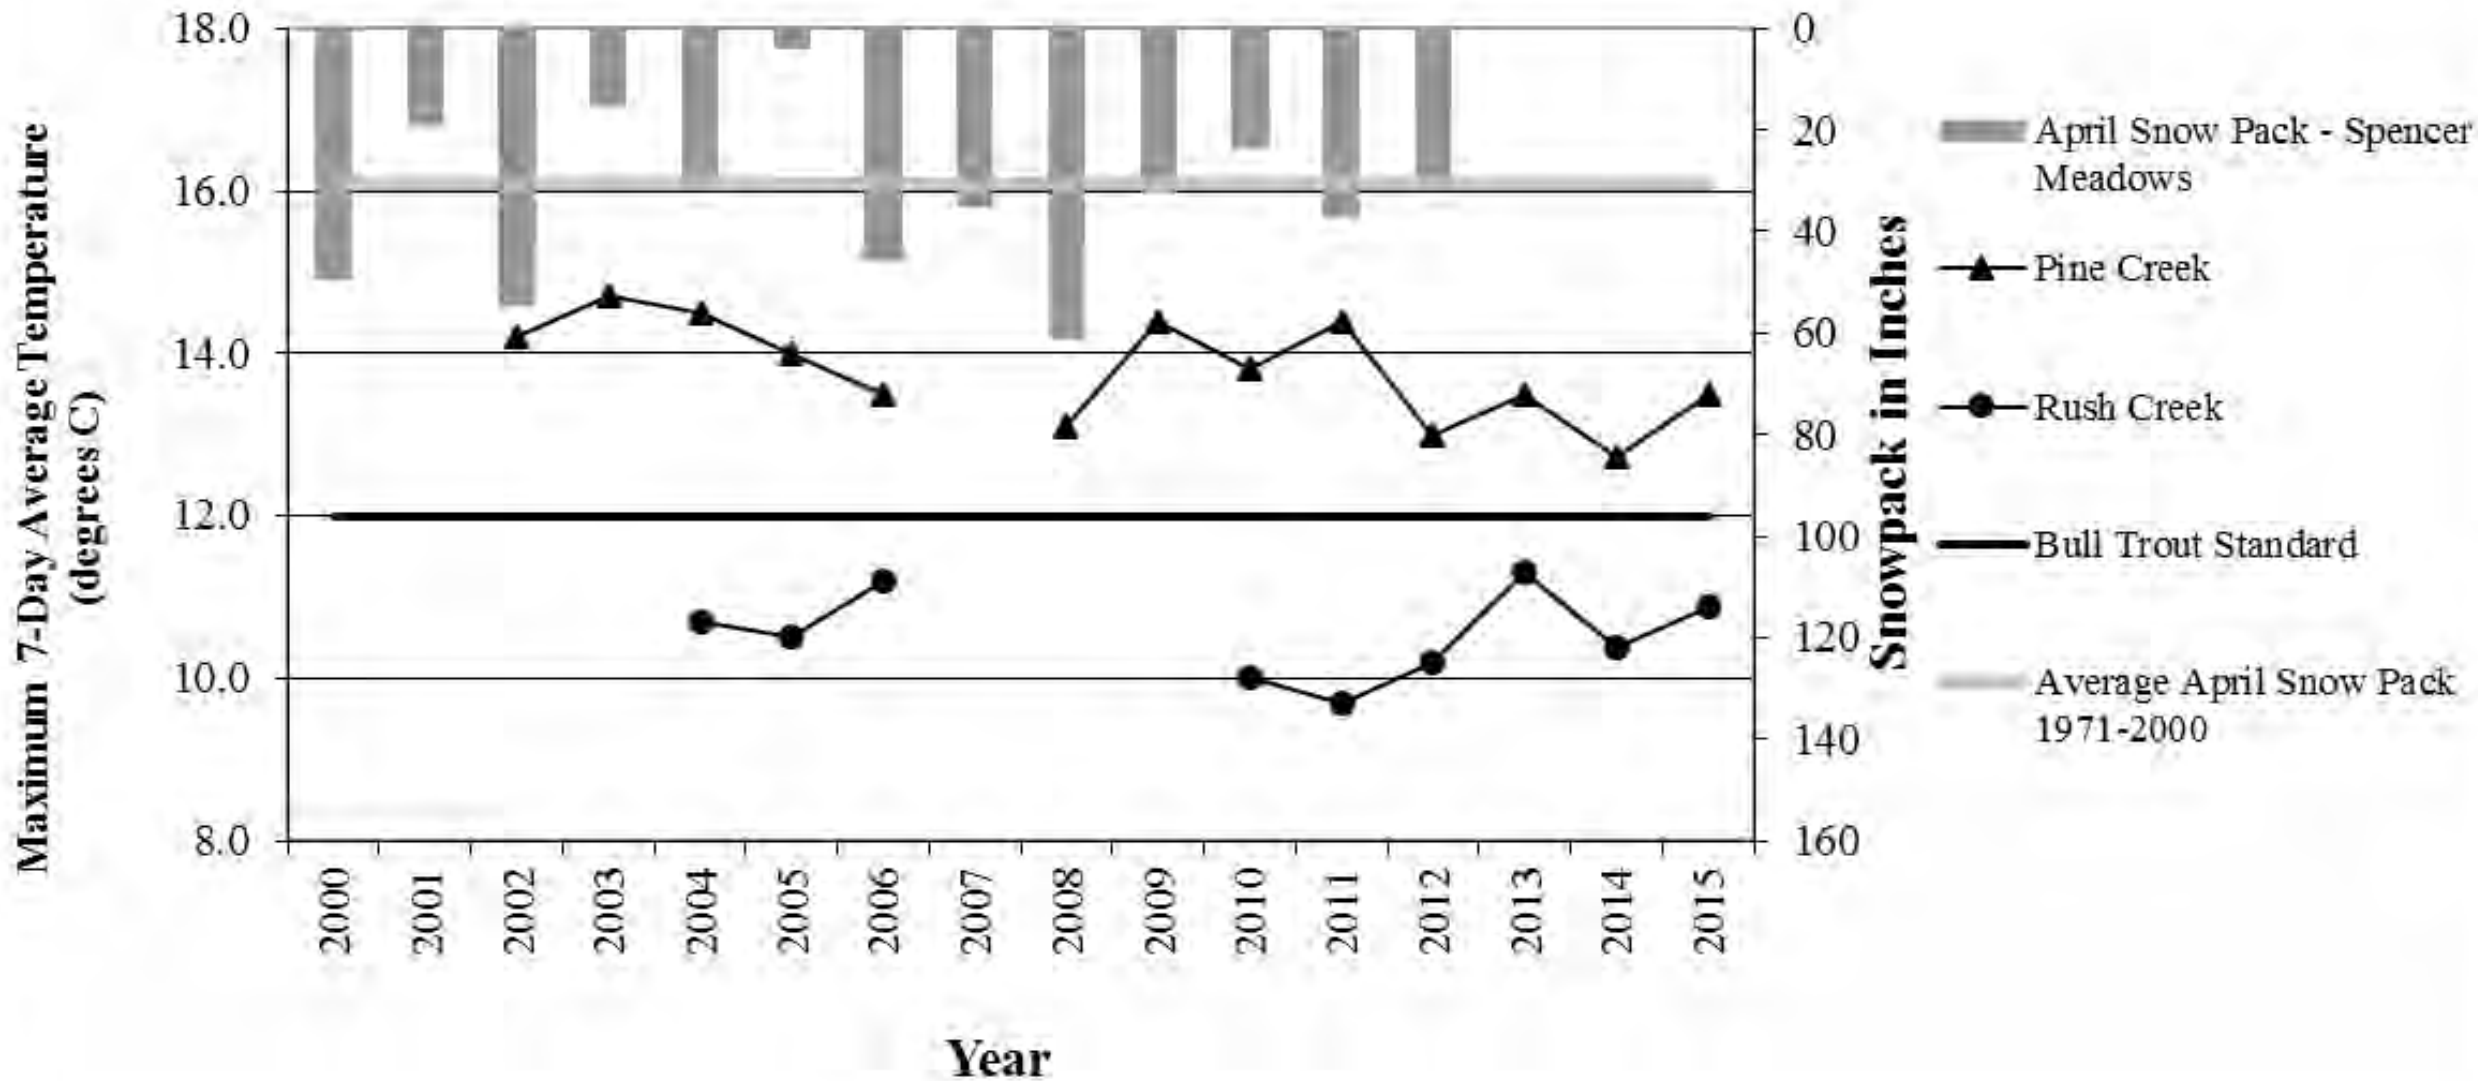
Rush Creek Temperature

- Rush Creek Temperatures were monitored and remain cool

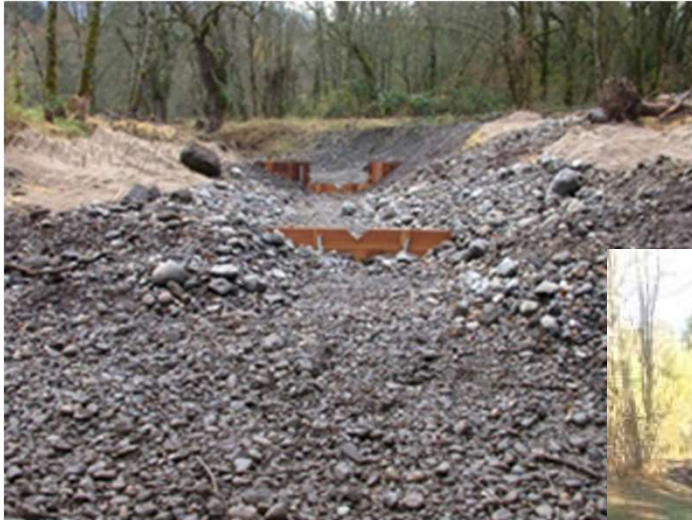
Duncan Creek spawning channels constructed in 2001 & upgraded in 2008, extended in 2011

Hilson provided a number of examples of completed spawning channels constructed and/or upgraded in years 2001, 2008, 2011 and 2017. Hilson noted that the project has been delayed considerably due to landowner easement disputes and no funding path with BPA so the project has been pushed out until 2021. The maintenance expected is unknown at this time. Protected channels have a better life span and less maintenance. The objective is to design to specifically benefit chum salmon spawning and juvenile rearing.

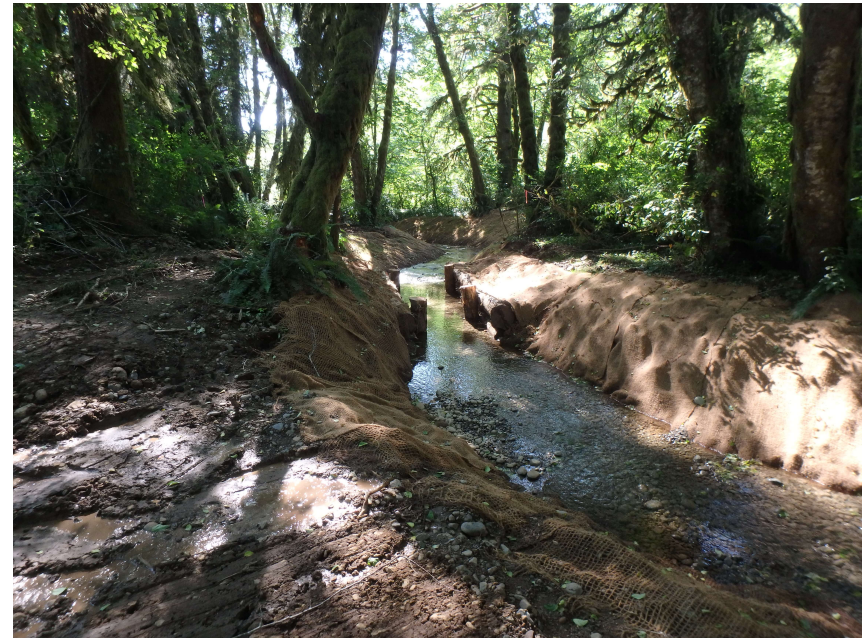
- Completed in summer of 2017
- ELJ and small berms installed to protect two spawning channels (Emlen & McNally)

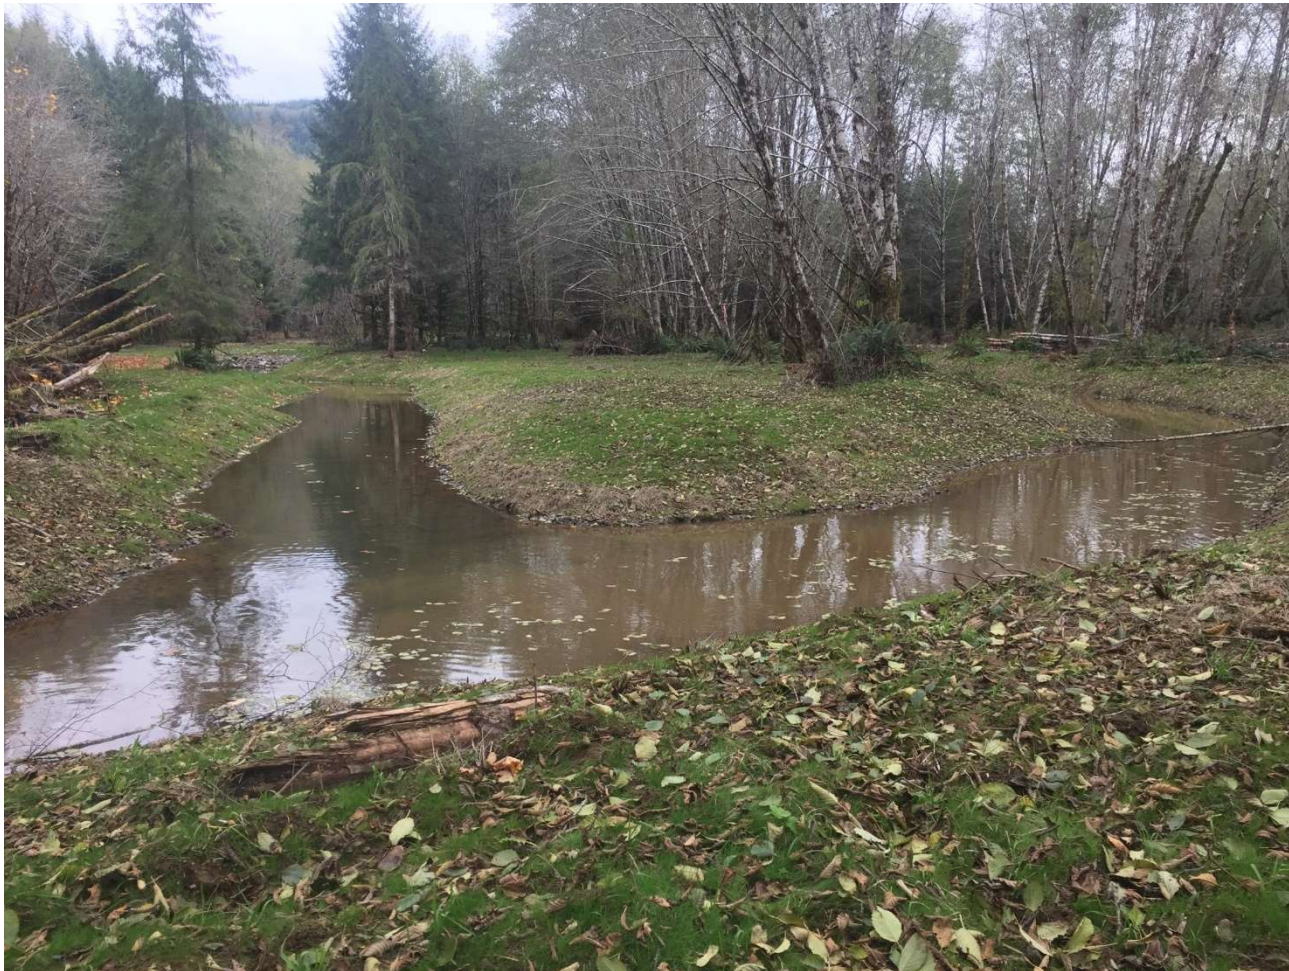
Crazy Johnson Spawning Channels

- Completed in fall of 2017 by the LCFEG

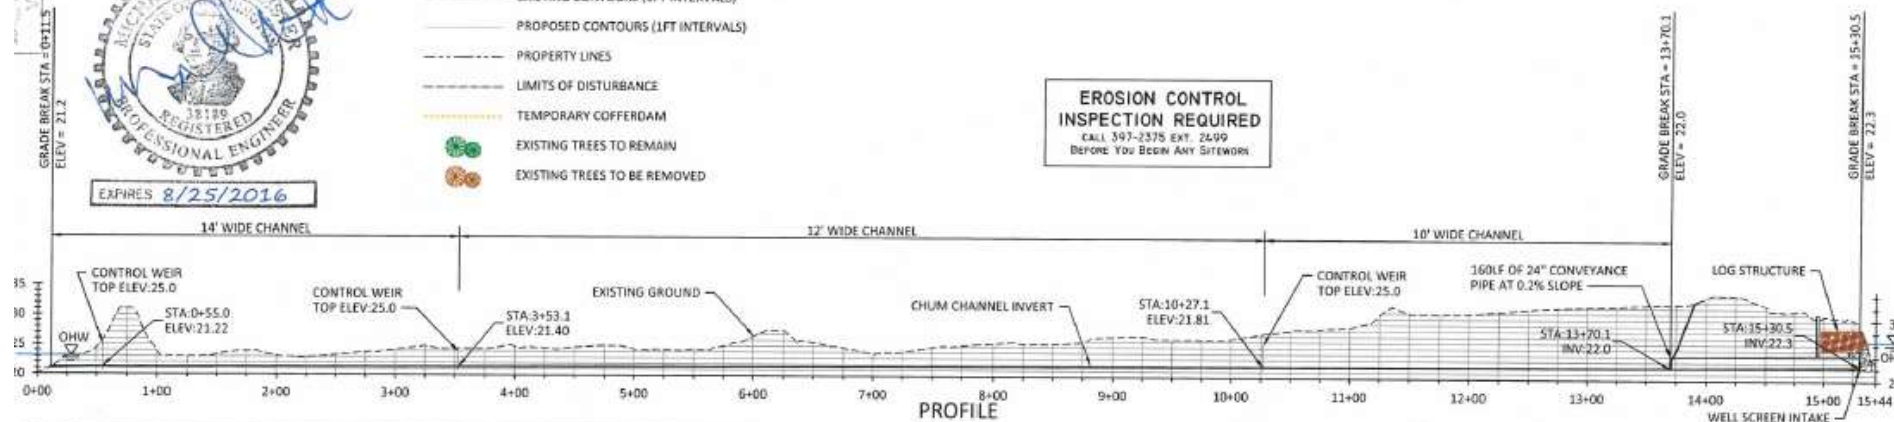
**SHEET INDEX AND PROPOSED
CONDITIONS PLAN & PROFILE**

LEWIS RIVER - EAGLE ISLAND
CHUM SPAWNING CHANNEL
WOODLAND, WASHINGTON

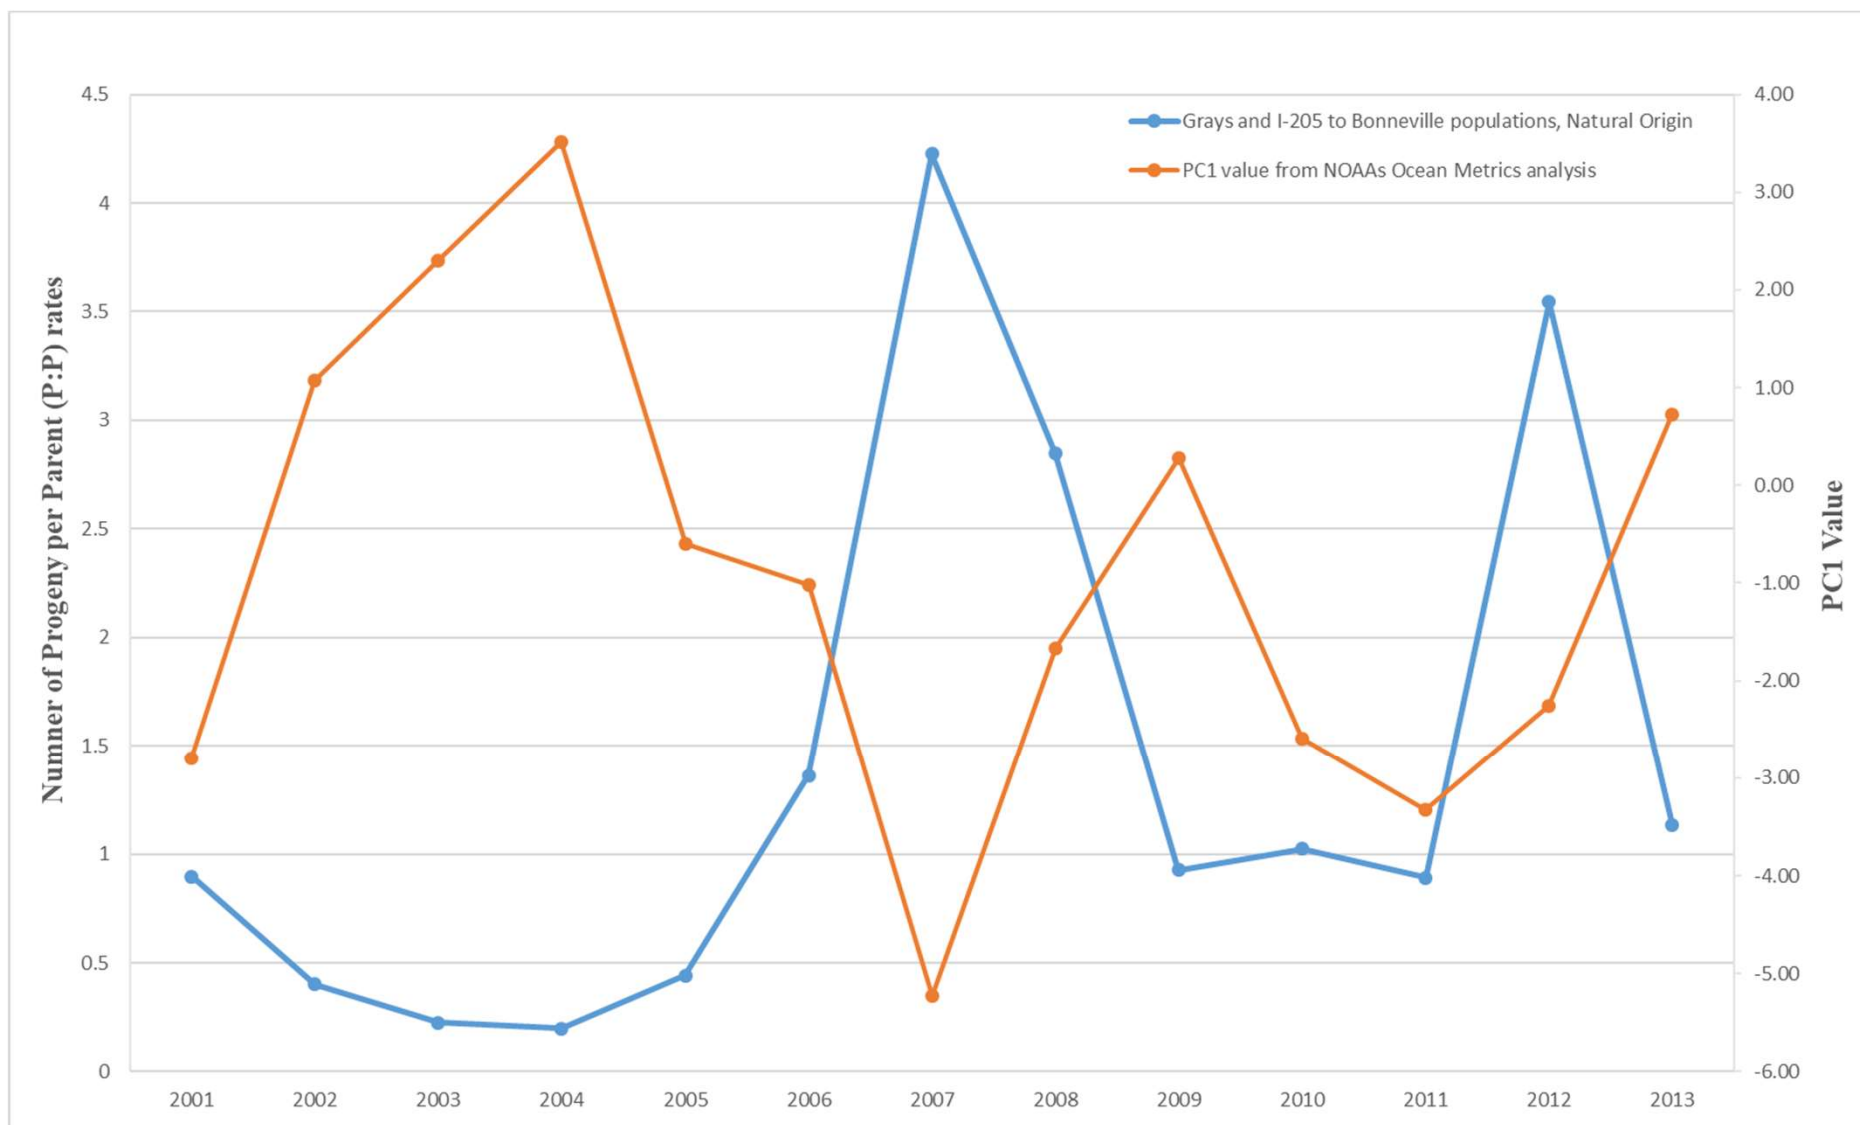
Progeny Per Parent Values by BroodYear and corresponding PC1 values (negative is better) for outmigration year from NOAAs Ocean Metrics Analysis.

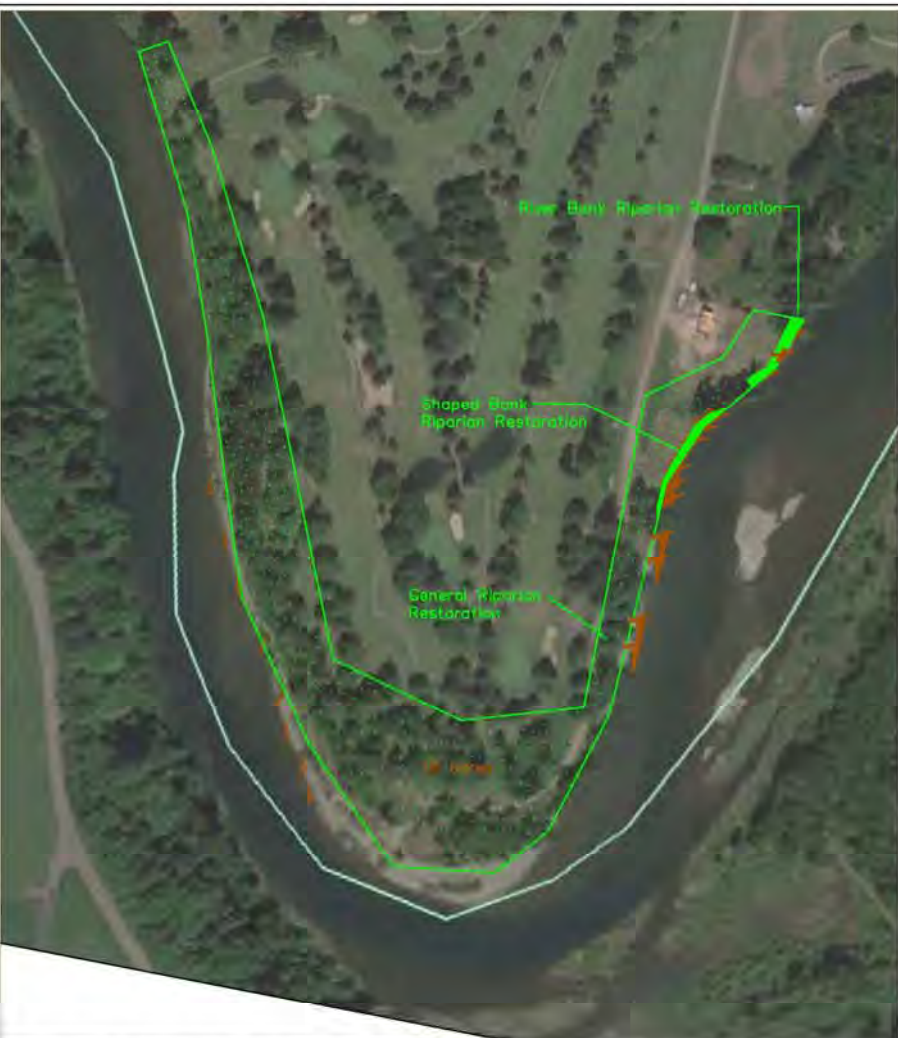
EROSION CONTROL BANKS

- Objectives:**
- Establish root strength as quickly as possible to protect river bank soils from continued erosion
 - Utilize plant materials on foundation to aid in securing erosion control fabric(s).

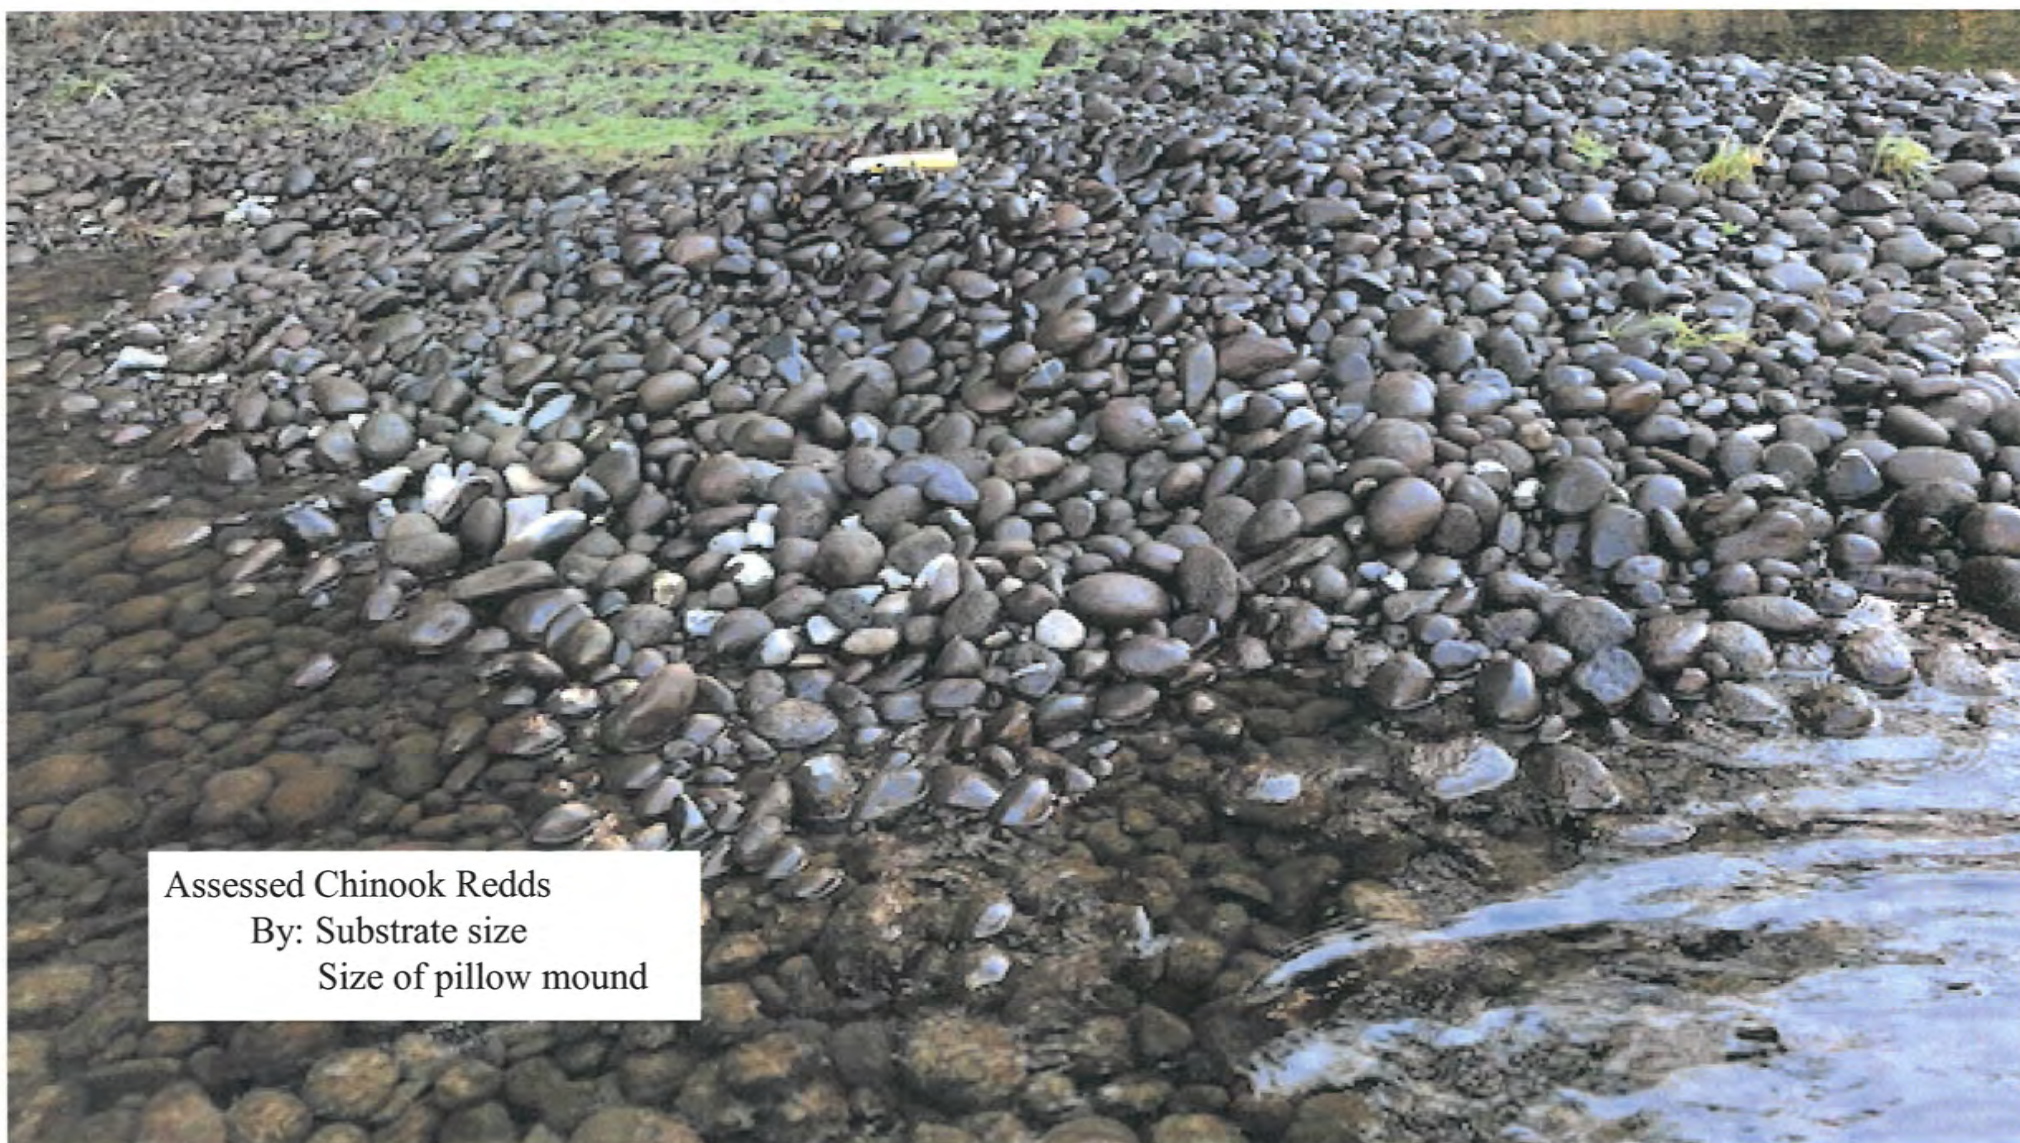
Lower Lewis River Redd Dewatering Locations

Assessed Chinook Redds
By: Substrate size
Size of pillow mound

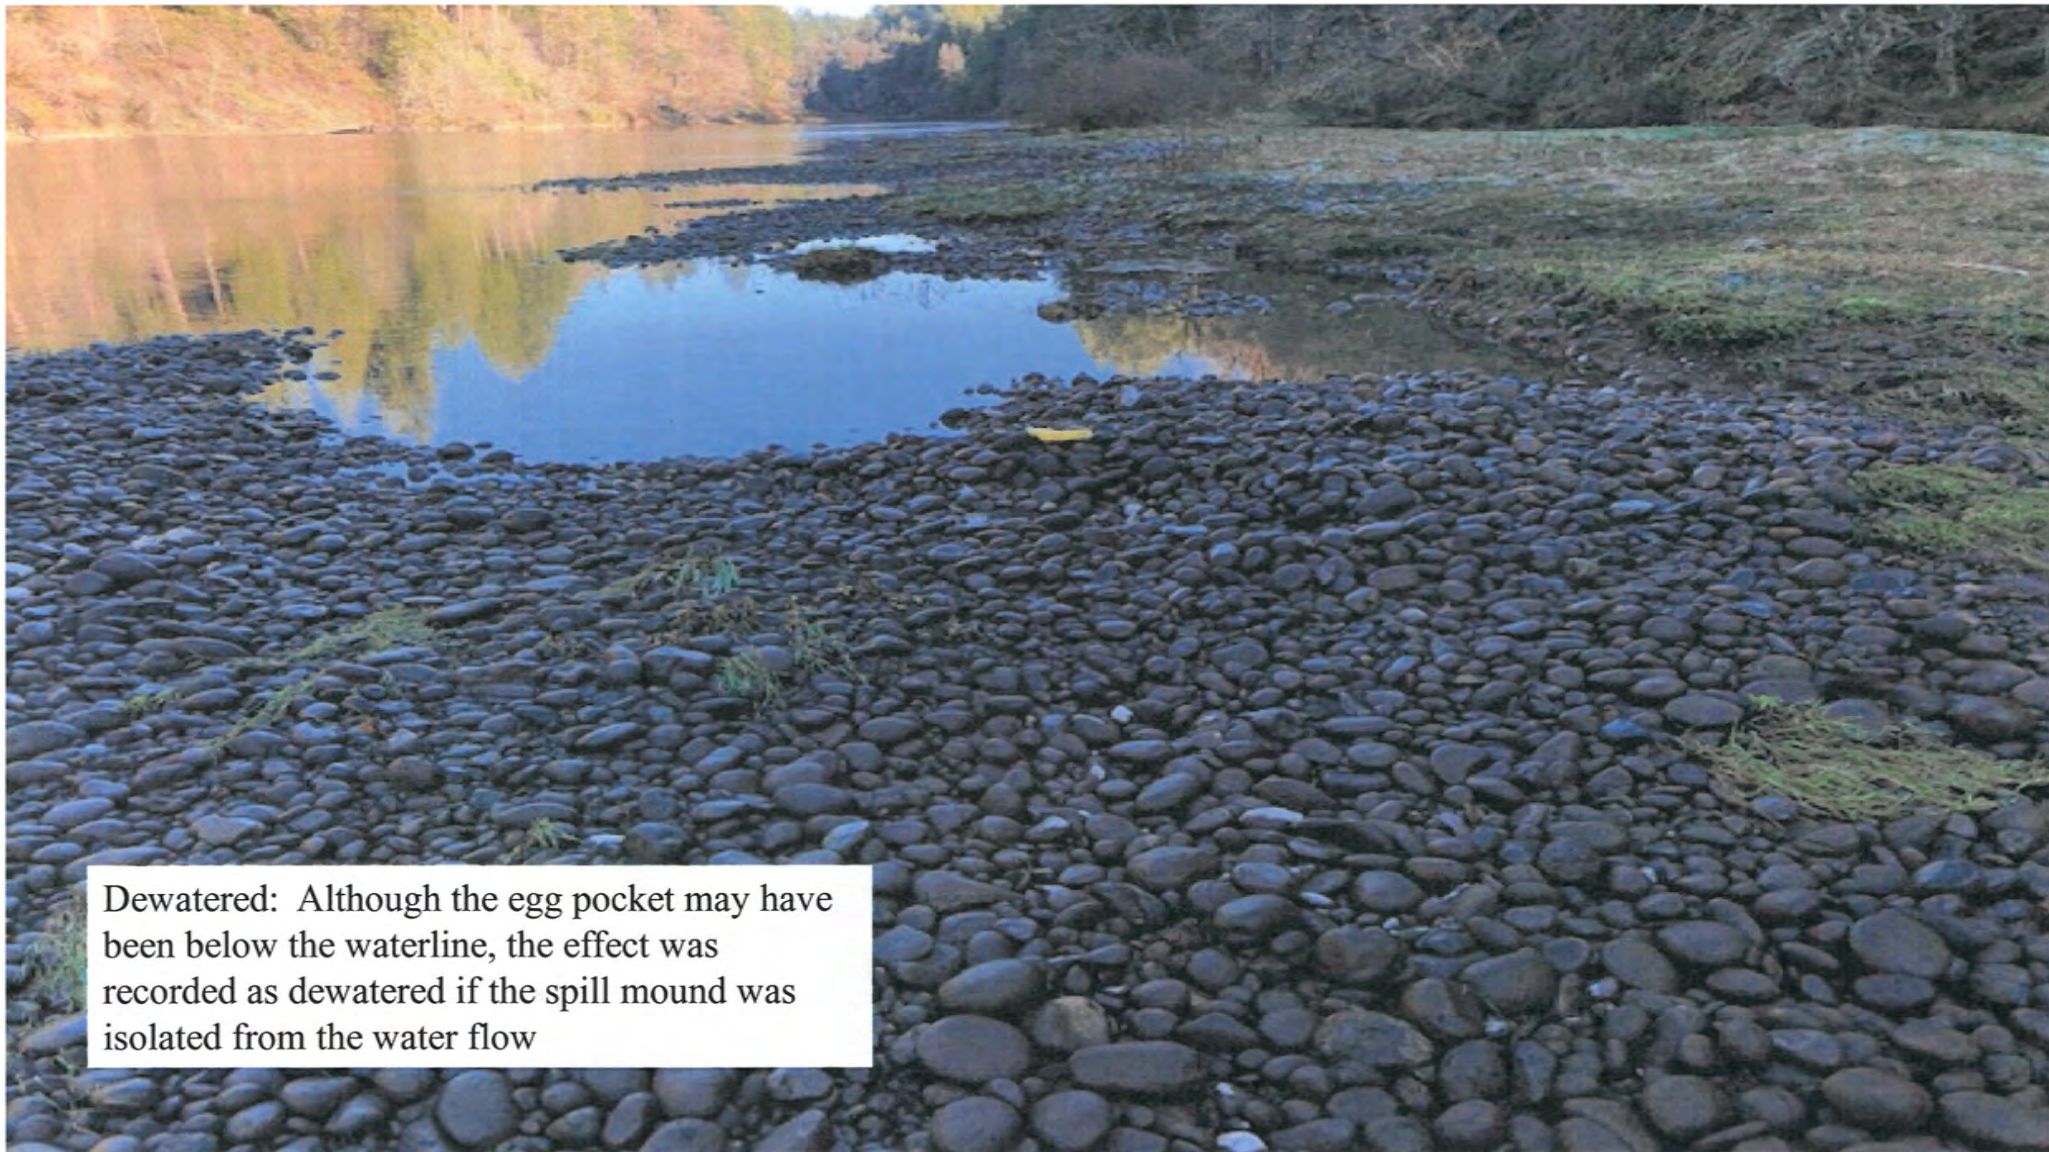
Dewatered: Although the egg pocket may have been below the waterline, the effect was recorded as dewatered if the spill mound was isolated from the water flow

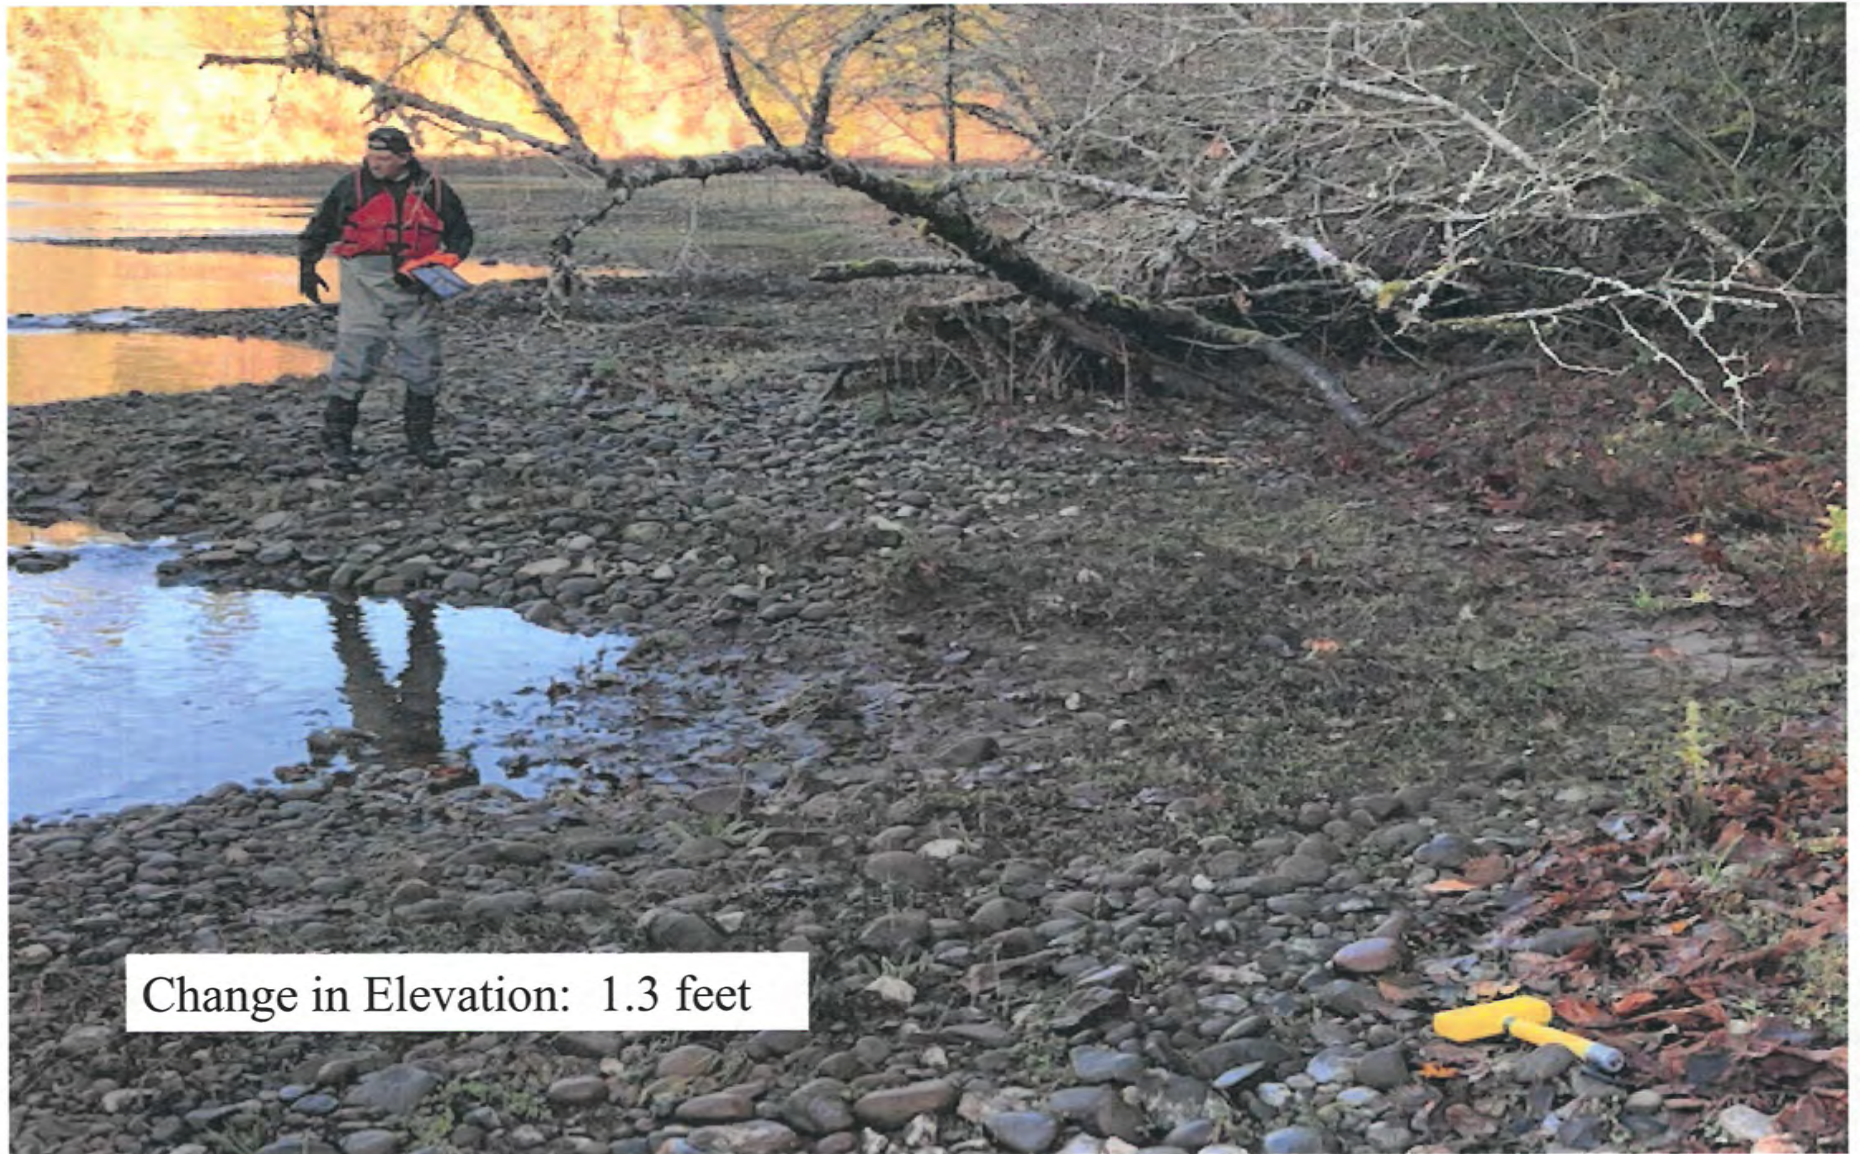
Change in Elevation: 1.3 feet

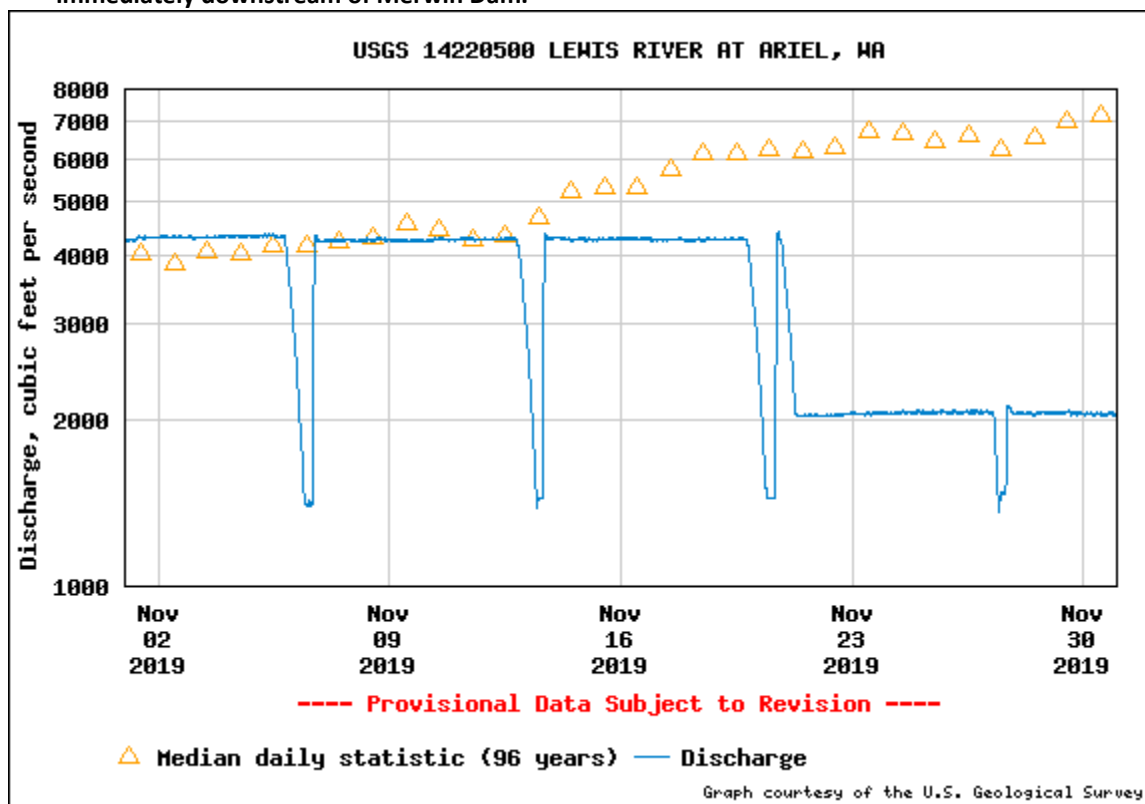
Table 1. Discharge in cubic feet per second recorded at the USGS Ariel, WA gauge (14220500) located immediately downstream of Merwin Dam.

The Merwin Dam Fish Collection Facility was shutdown unexpectedly on October 12, 2019 due to extensive damage to the automatic fish crowding system. Repairs were administered, and the trap was put back in service on November 4, 2019. The MFCF ran continuously for the remainder of the month. Flow below Merwin Dam was maintained at approximately 4,250 cfs until November 19th, and then decreased to approximately 2,050 cfs. River flow remained near this level for the remainder of the month. As in previous years, weekly scheduled drawdowns occurred every Wednesday in order to accommodate spawning survey efforts in the Lewis River below Merwin Dam. (Table 1).

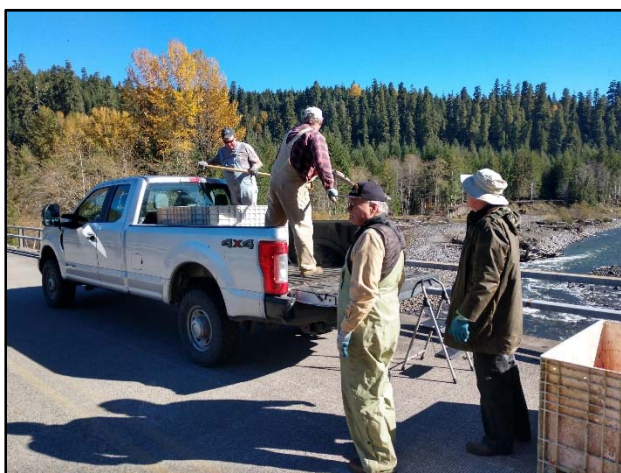
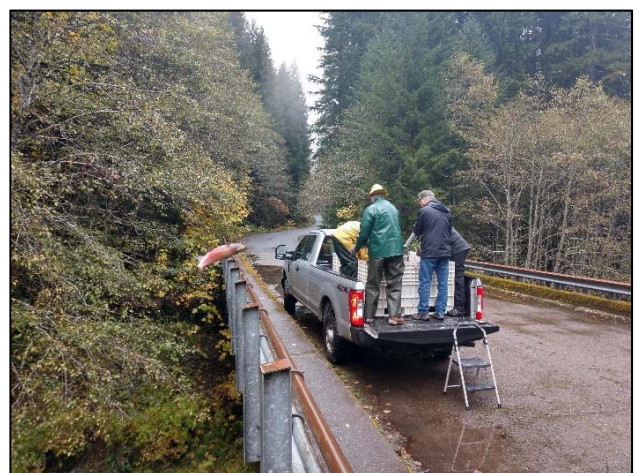
Figure 1. Volunteers with the LCFEB distributing carcasses off the Muddy River Bridge (photo left) and near Lower Falls, North Fork, Lewis River (photo right).

The carcasses were prepared and distributed through the support of the Lower Columbia Fish Enhancement Group (LCFEG) volunteers and Washington Department of Fish and Wildlife Hatchery Staff. Three locations were selected to receive carcasses. These locations were: 1) Clear Creek Bridge Site; 2) Lower Lewis River Falls - Crab Creek Bridge Site; and 3) Muddy River Bridge Site. All fish were marked by having their tails removed prior to seeding so that deposited carcasses would not impact spawning surveys.
