Clear Creek Instream Habitat Restoration Project Closeout Report

Project Title: Clear Creek In-stream Habitat Restoration

Agency: US Forest Service
Gifford Pinchot National Forest
Mount St. Helens Ranger District

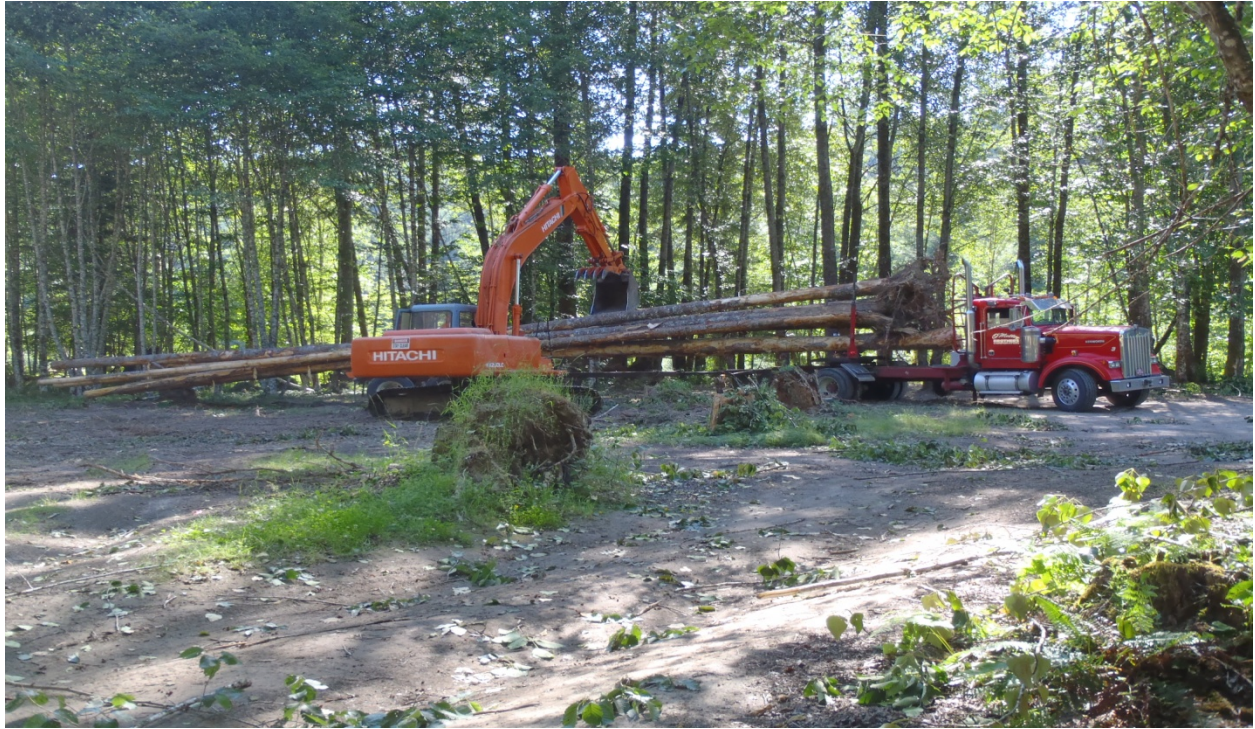
Unloading full lengths trees with rootwads

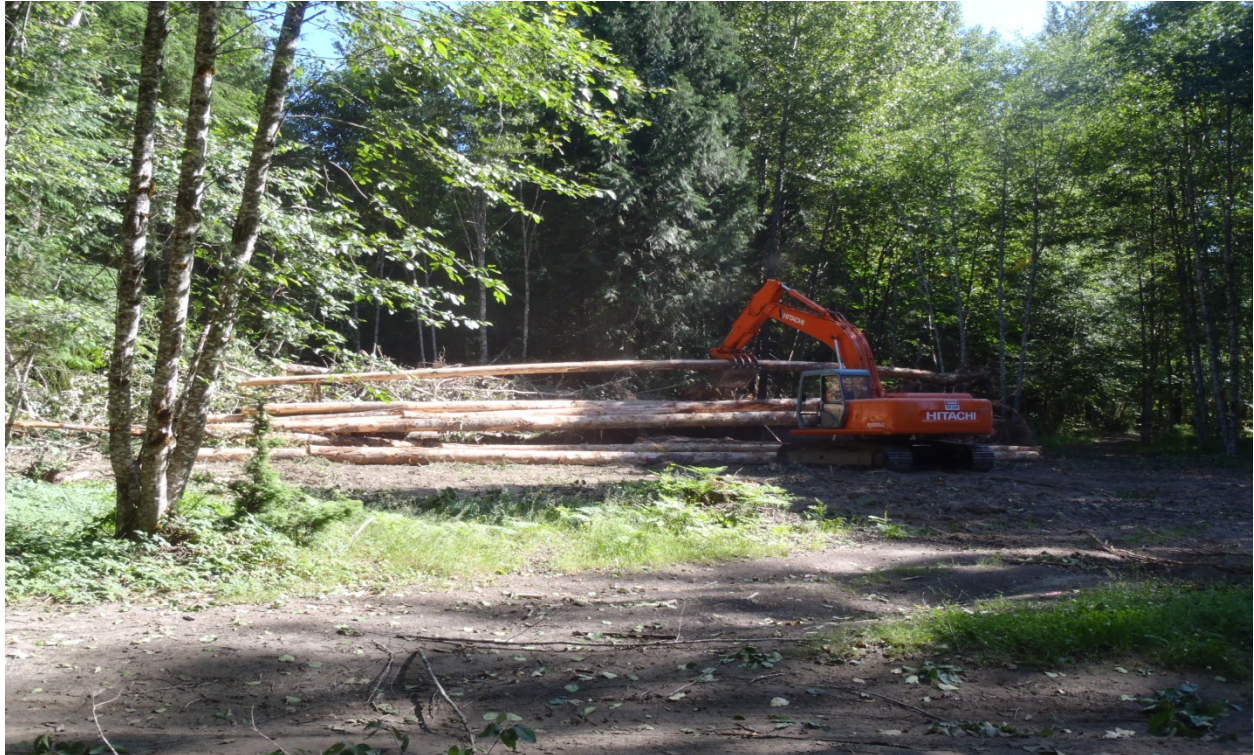
Stockpiling logs at the staging area

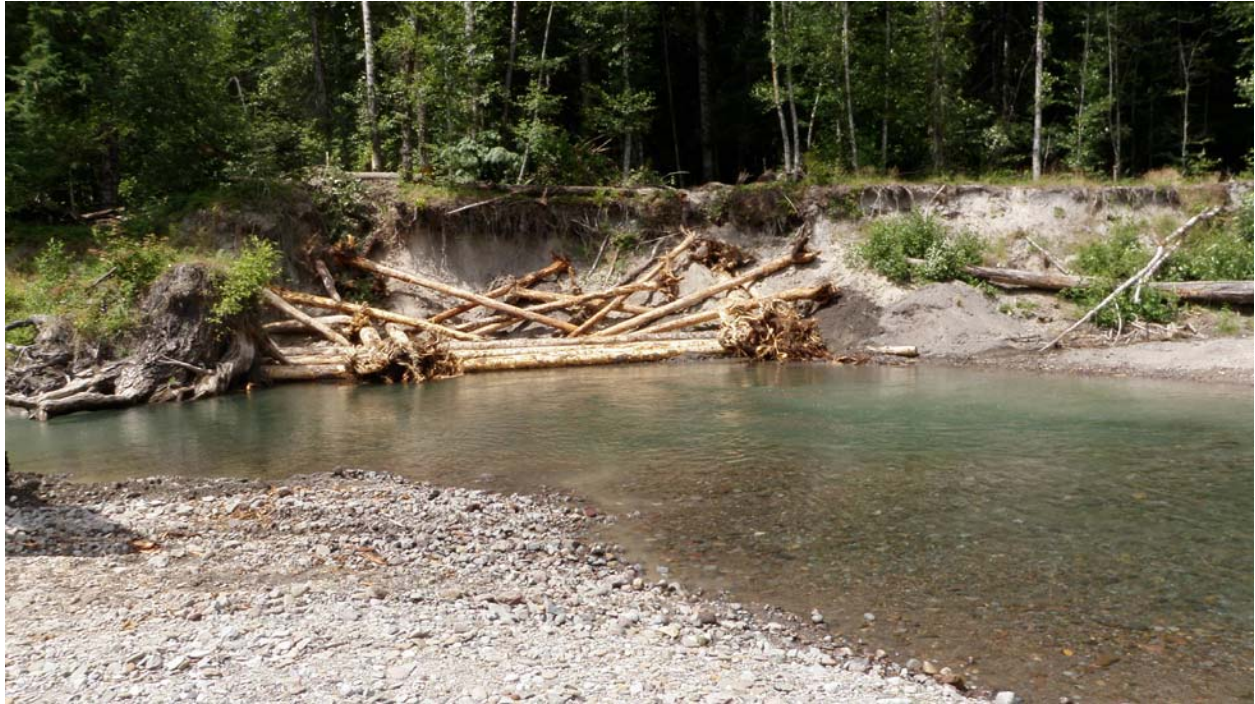
Looking down stream at bank stabilization structure 50 logs were placed in structure ST#2

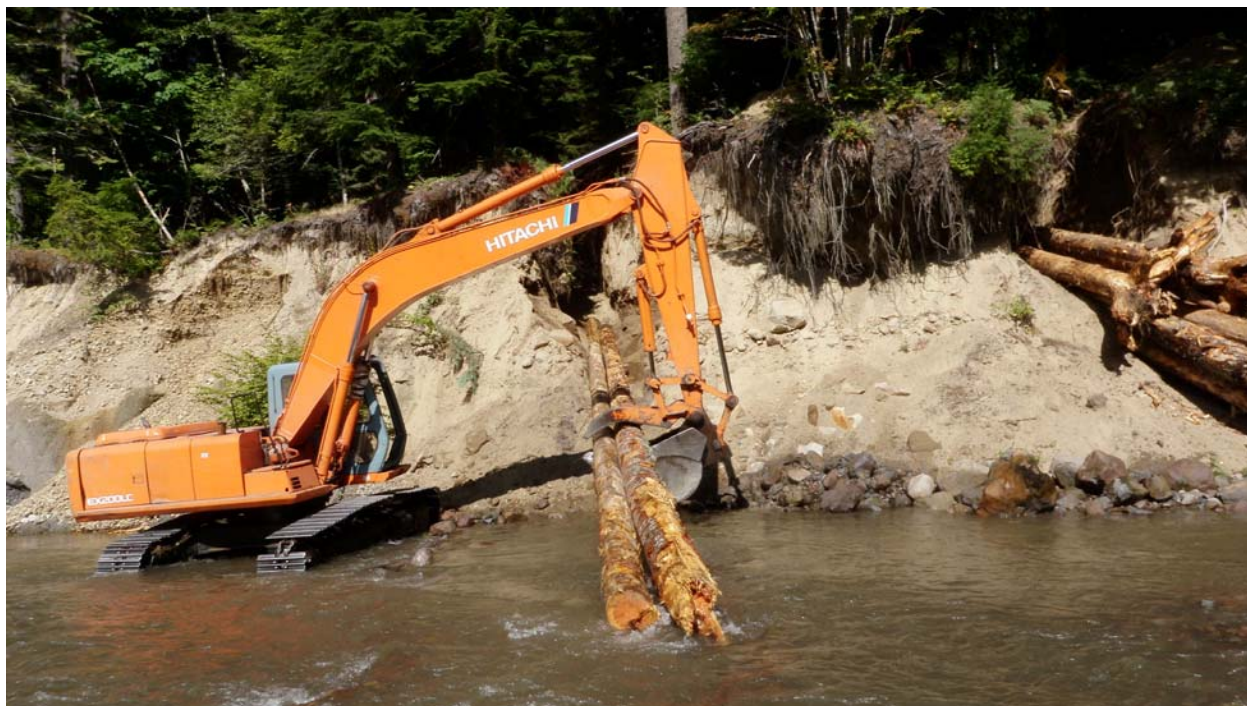
Excavator placing logs into banks ST#10

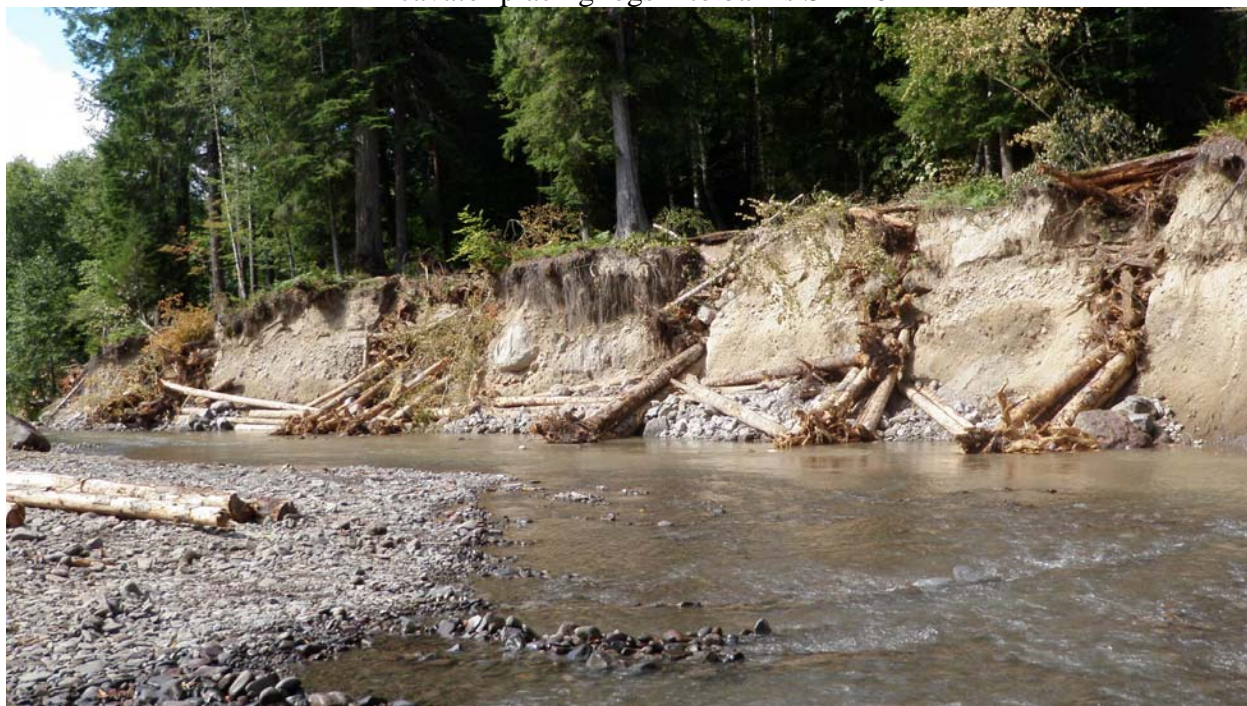
Completion of bank stabilization 87 logs was placed in eroding banks. Gravel bar on river left was shaved back 15-20 feet to help reduce flow on banks. ST#10

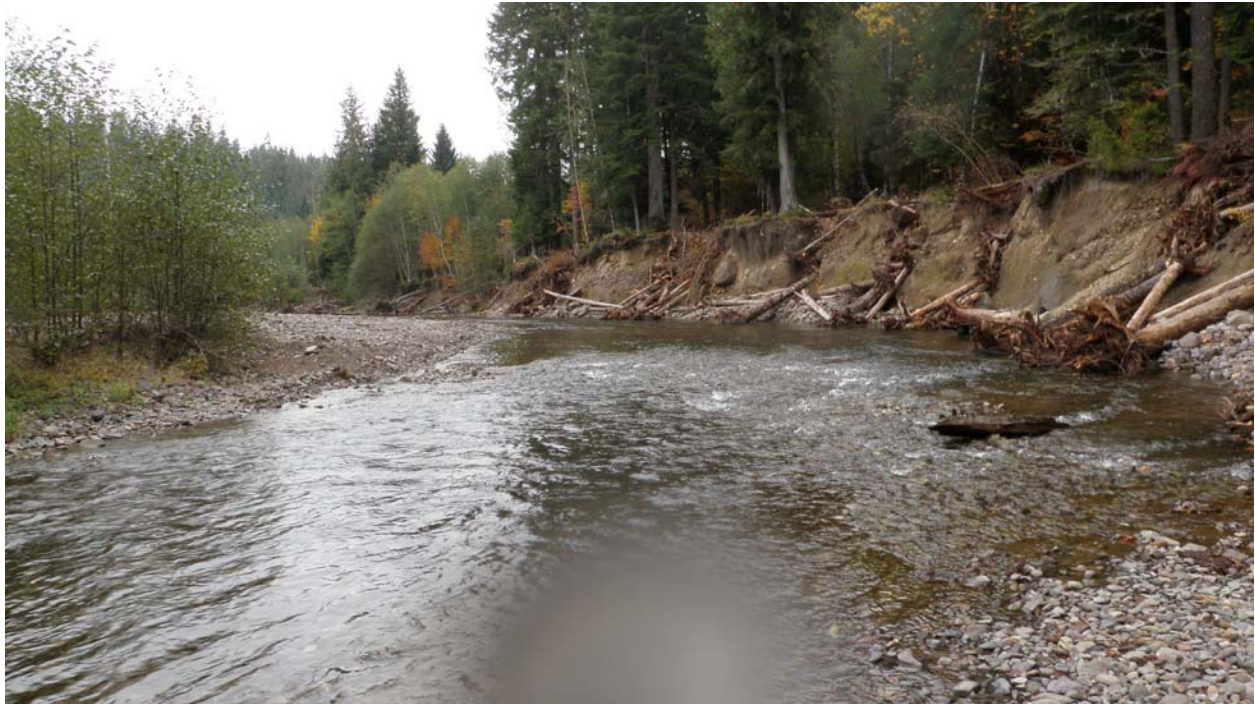
Looking down stream at ST#10, the gravel bar on river left has been shaved back 20 ft.

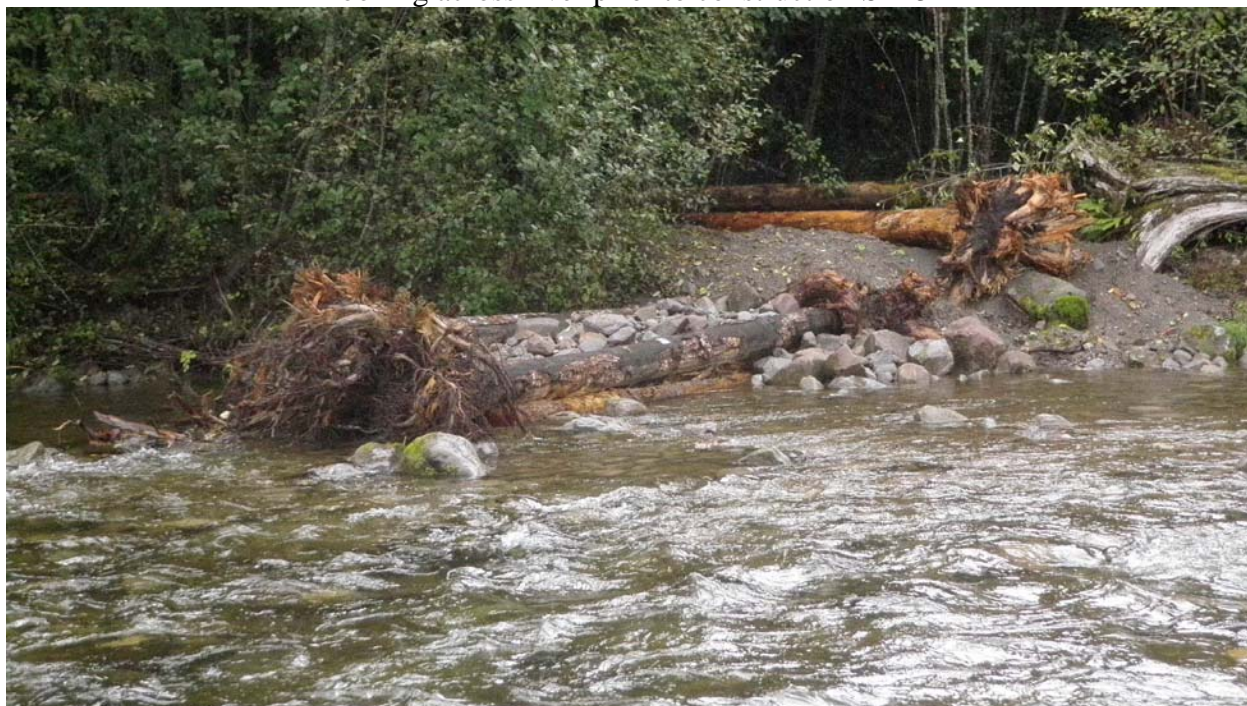
A series of structures were placed to reduce flow on river left ST#5

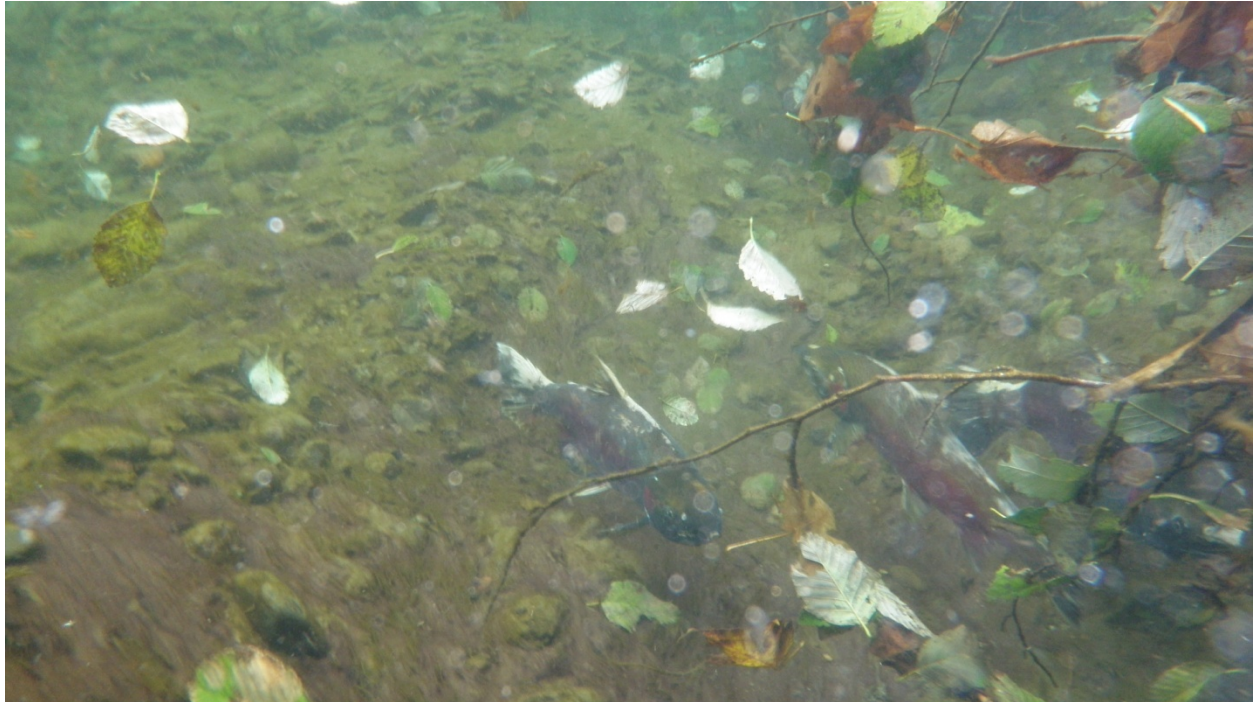
Four coho hiding in scour pool at ST#12

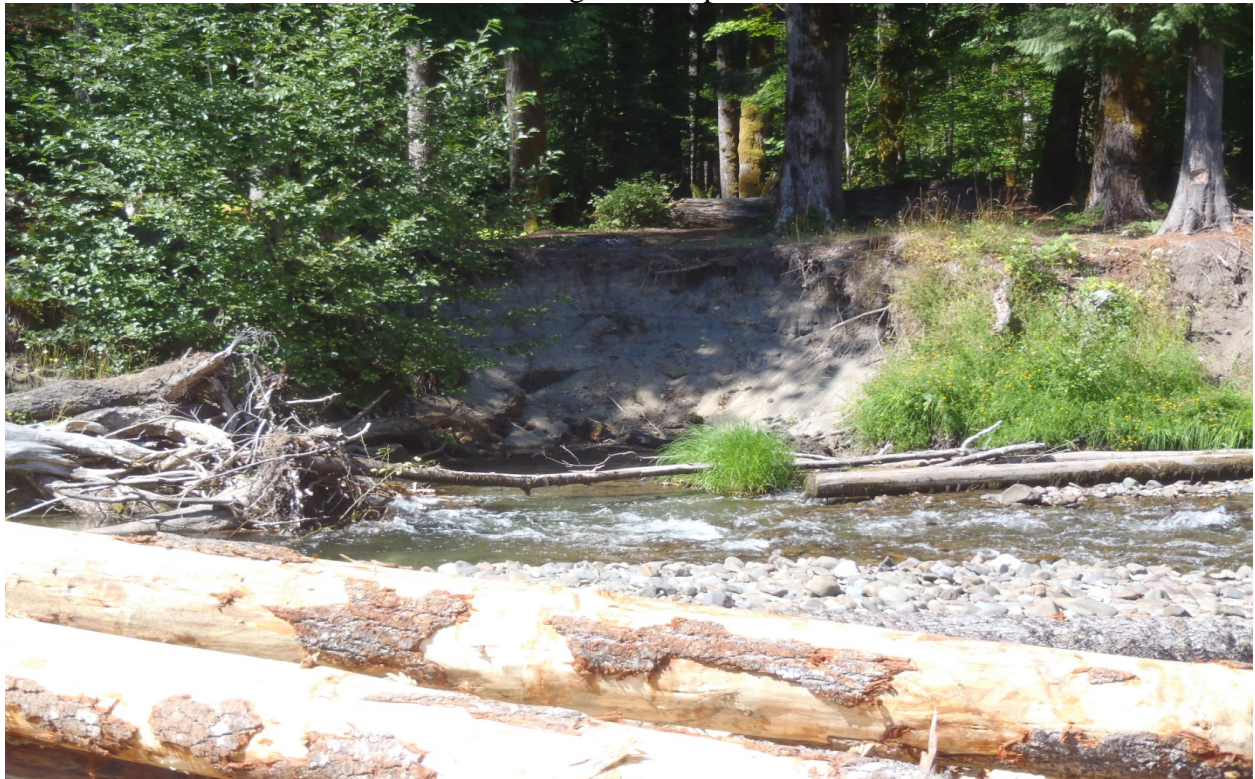
Looking across at eroding bank at ST#15 prior to construction

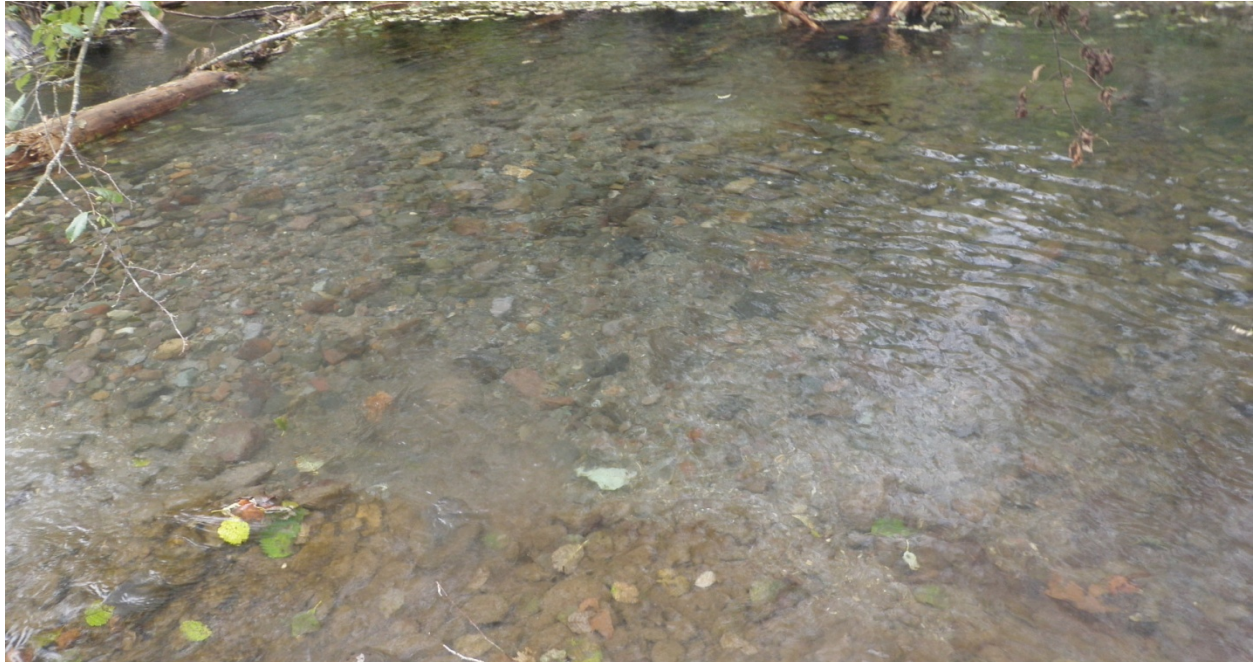
Coho redd directly above ST#16

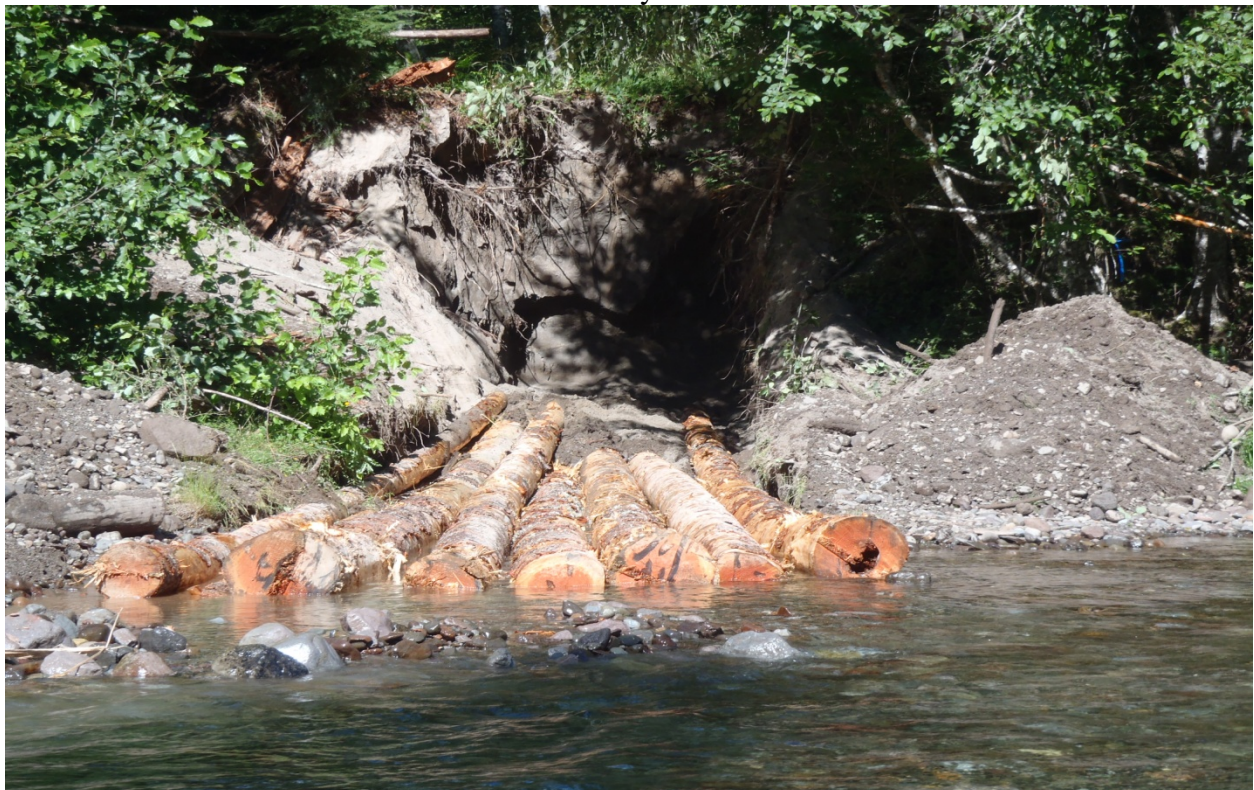
Logs buried 30-40 feet to increase stability, 7 logs in structure so far, a 5ft deep scour pool was created with this structure. Coho have were observed using this structure.

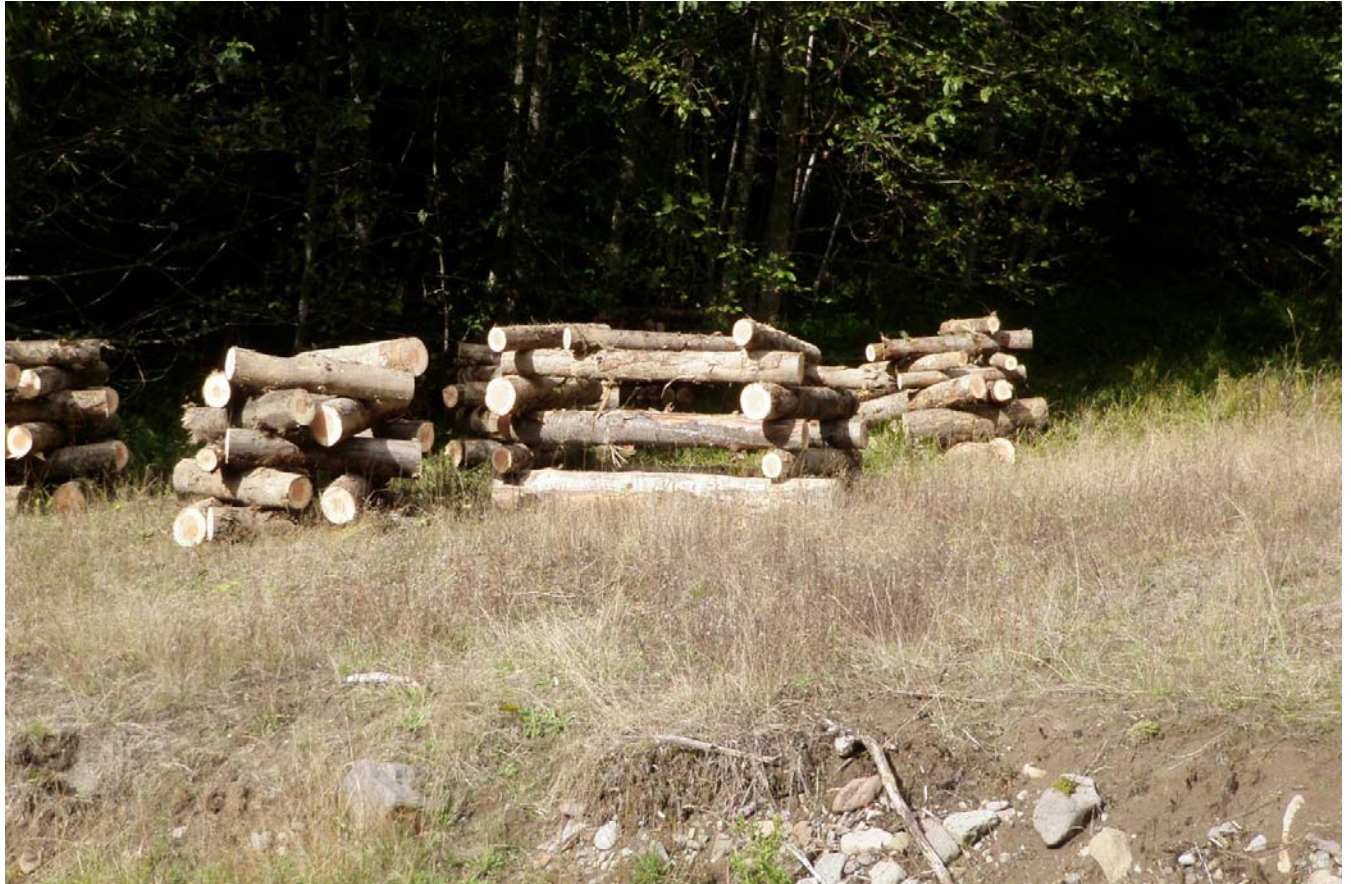
Seeding enclosure, a conifer seedling is planted in the middle of log cribbing to discourage elk and deer browsing.

Funding from Ecotrust was used to plant Several species of conifers and hardwoods over a two year period in the riparian zone to help stabilize streambanks and floodplains. Over 500 seedlings were planted covering an area of approximately 10 acres. Experimental seedling enclosures were built to help trees survive elk and deer browsing. Logs were cut into six and eight foot lengths and stacked to enclose seedlings.
