Mud Creek Enhancement

PacifiCorp -- ACC 2008
Cowlitz Indian Tribe

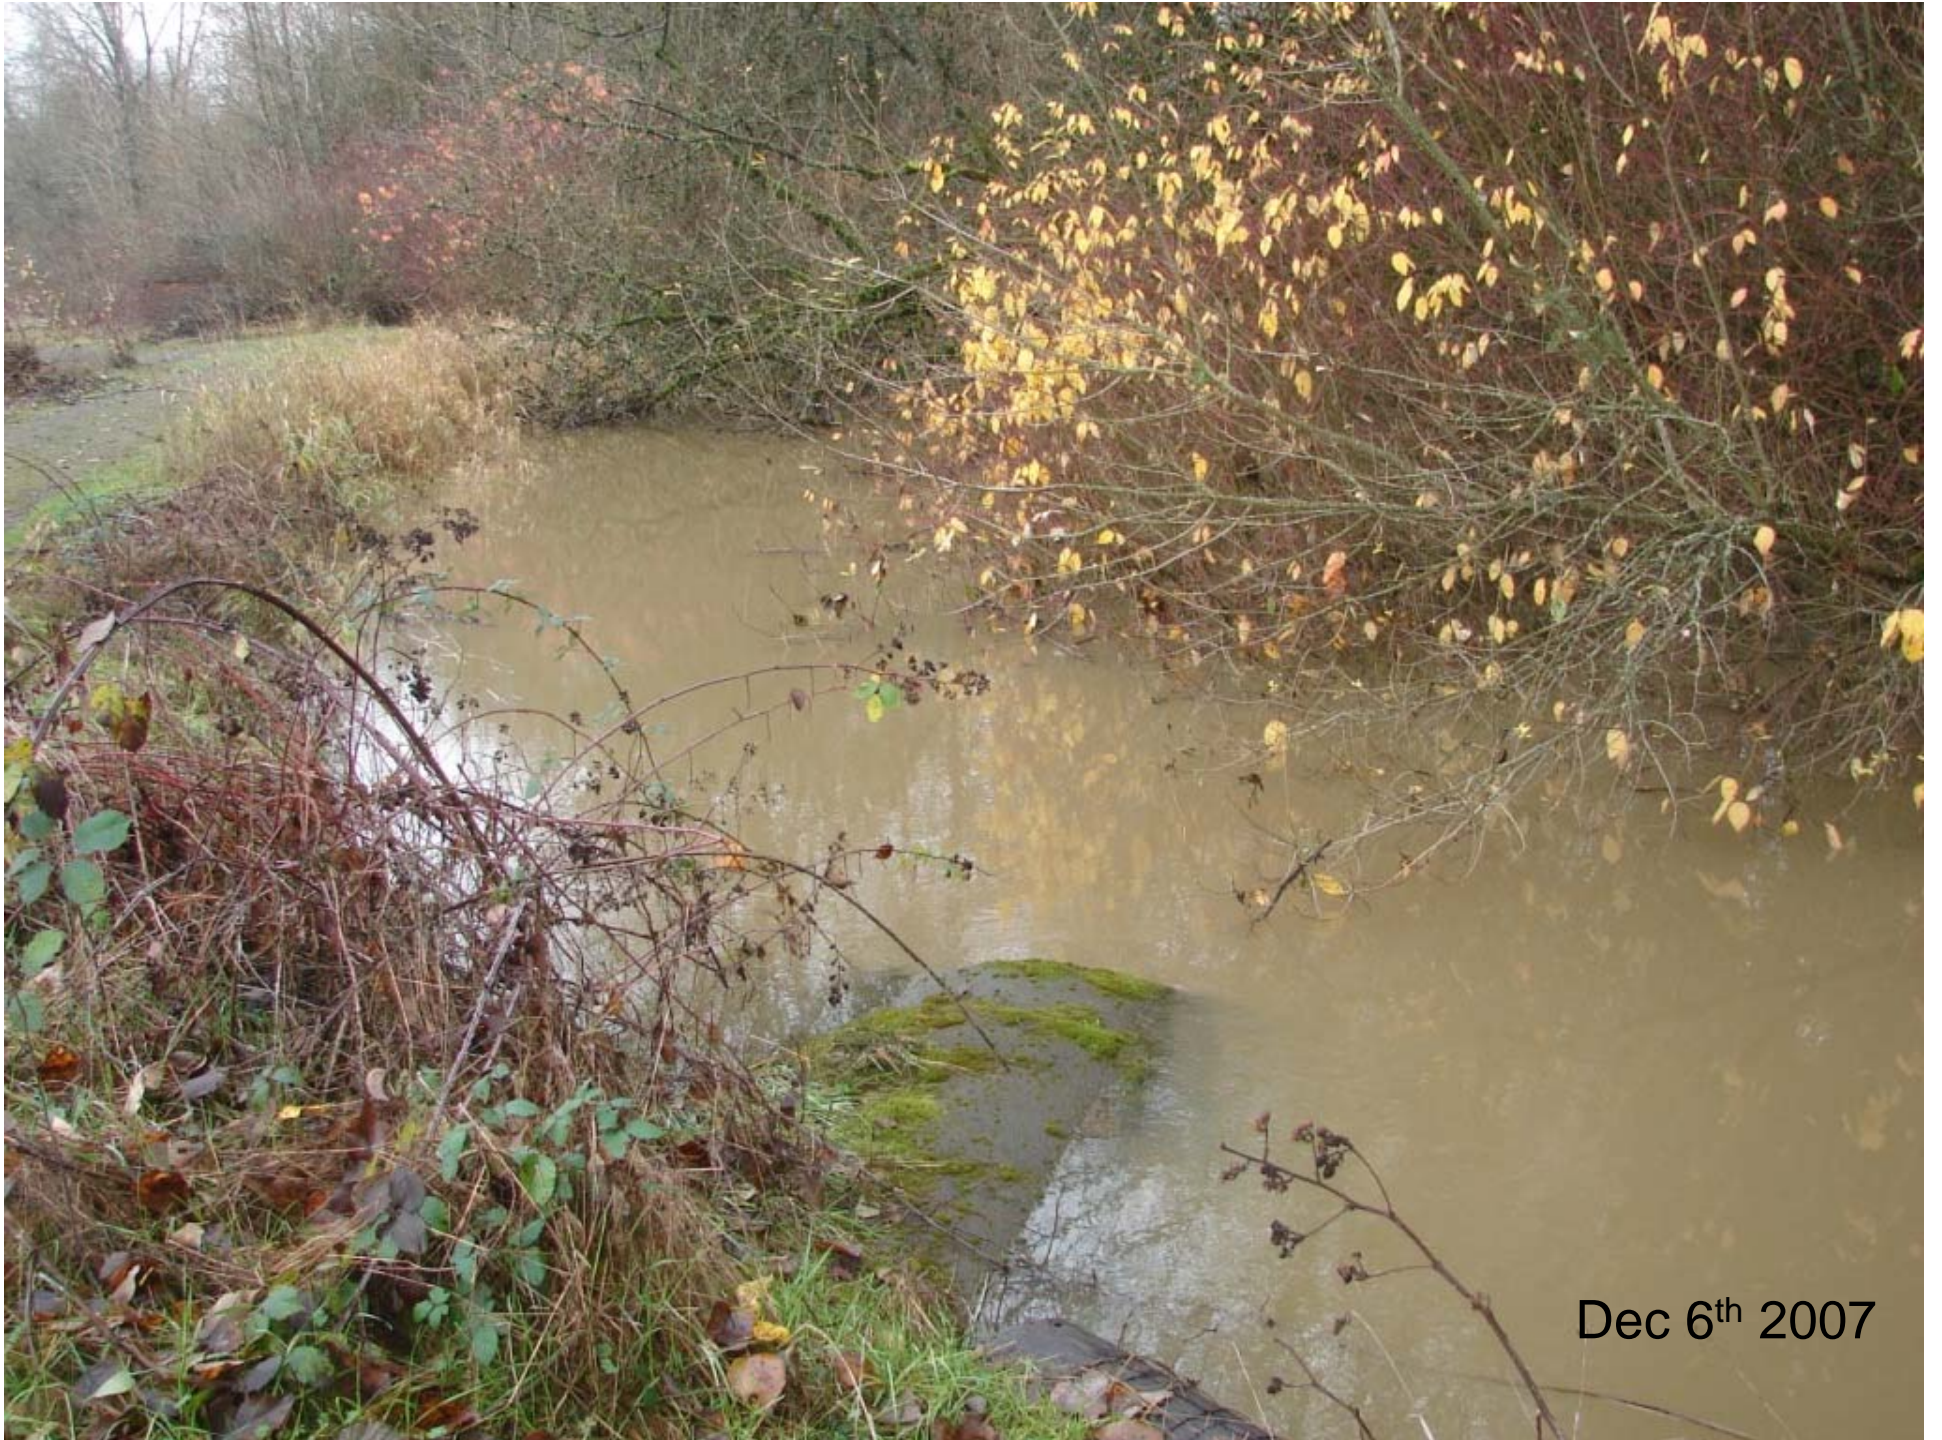
Dec 6th 2007

- November 19th 2007
 - Cary Armstrong, Clark County Water Resources, reported “Circle C is spending a lot of money to totally redesign their sediment control system with the goal being zero discharge...100% infiltration.”
 - “Mud Lake looked better Monday afternoon than I've seen it for sometime.”
 - However...

- Likely no new sediment inputs to the system
- Sediments in the lake appear to be settling out, lake water quality appears to be improving
- However, sediments in the ~0.5 mile Mud Creek channel have reactivated with winter rains, and are being discharged to the Lewis, subject to tidal effects.

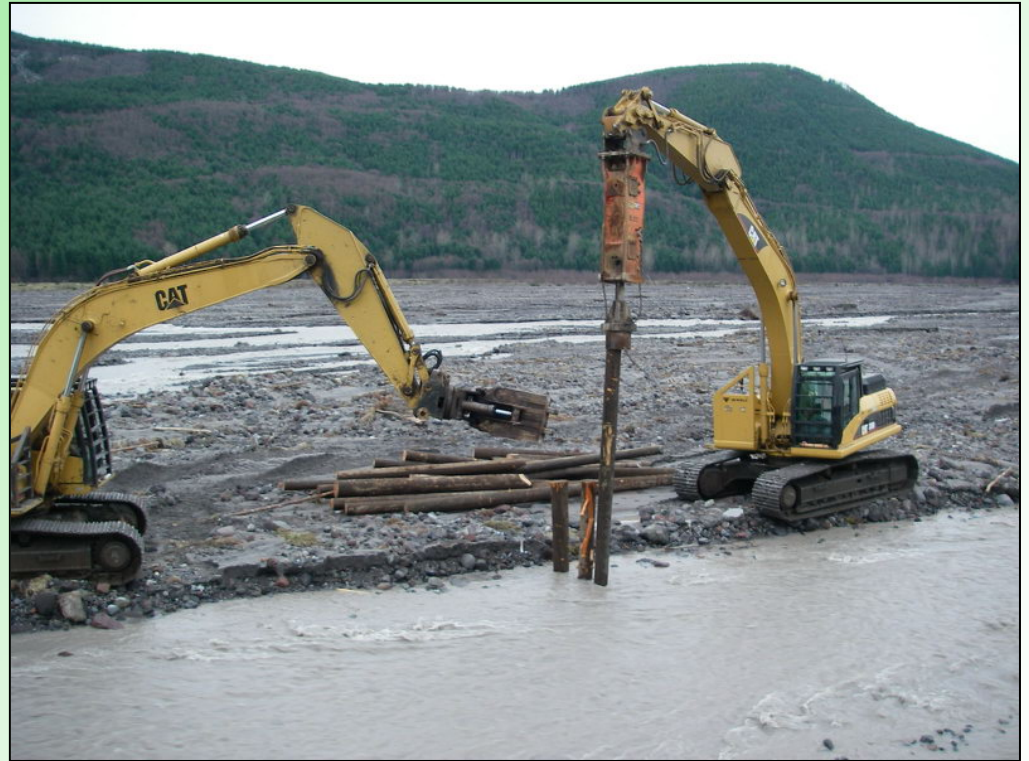
LCFEG 2007

Quick-drive pilings?

- 15' pilings in 3 min in unconsolidated sediments (Toutle)
- 12' pilings in 5 minutes in cobbles (Washougal)

- Install 25-30 rootwads/LWD in the lower section of the Mud Creek
- Placing LWD in a soft-bottom stream bed will increase scour, and help incise a channel through the sediments
- Because of the potential for flood and tidal influence to relocate LWD, pieces will be anchored to quick-drive wood pilings
