North Fork Lewis River
Haapa Fish Habitat Restoration Project
Final Design Report

PREPARED FOR
Lower Columbia Fish Enhancement Group

JUNE 2014

Inter-Fluve, Inc.

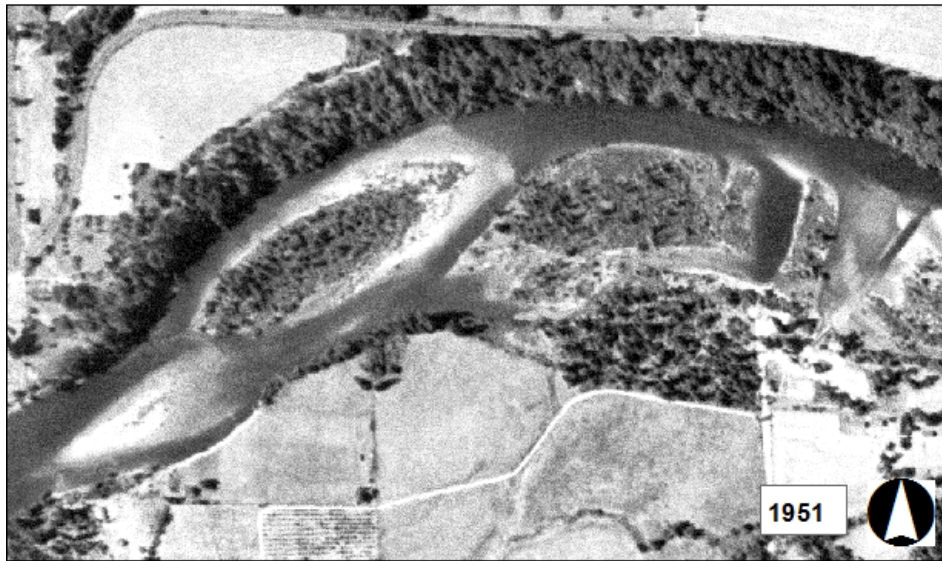
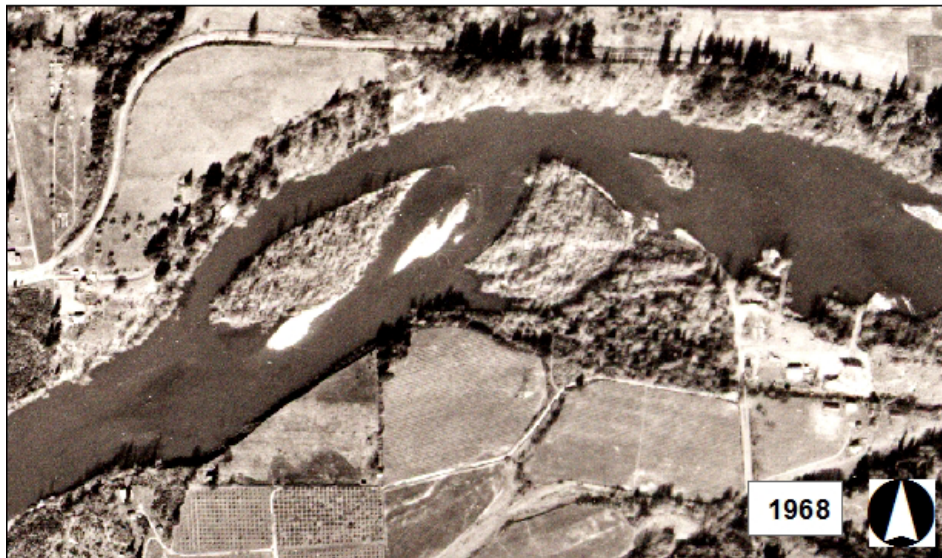
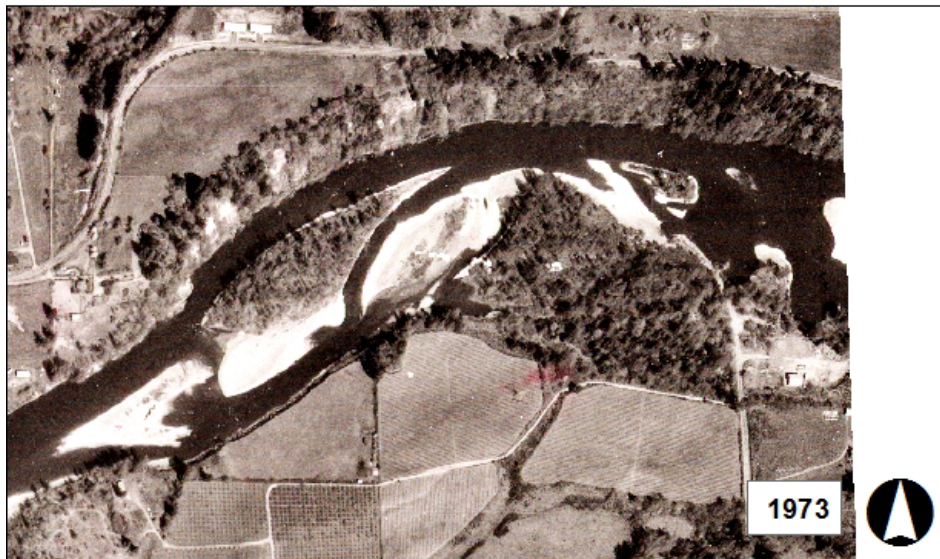
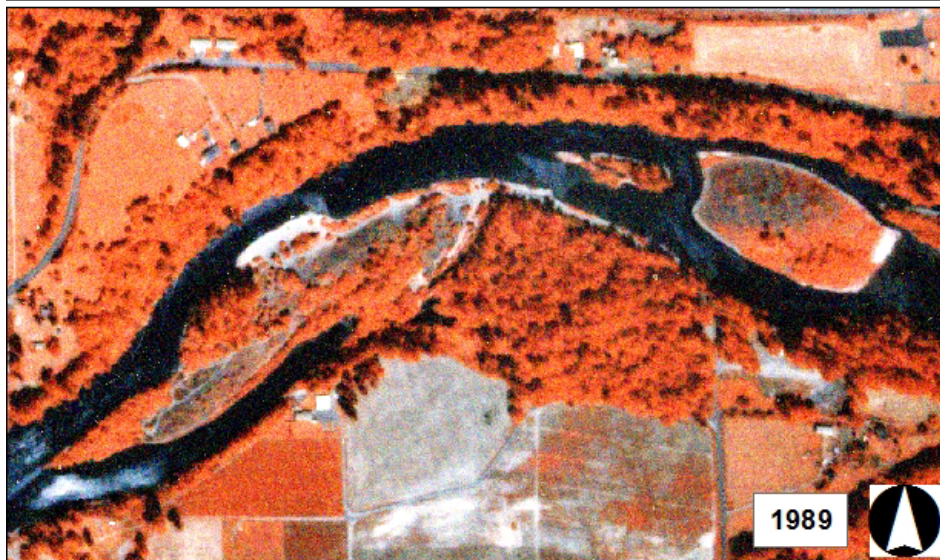
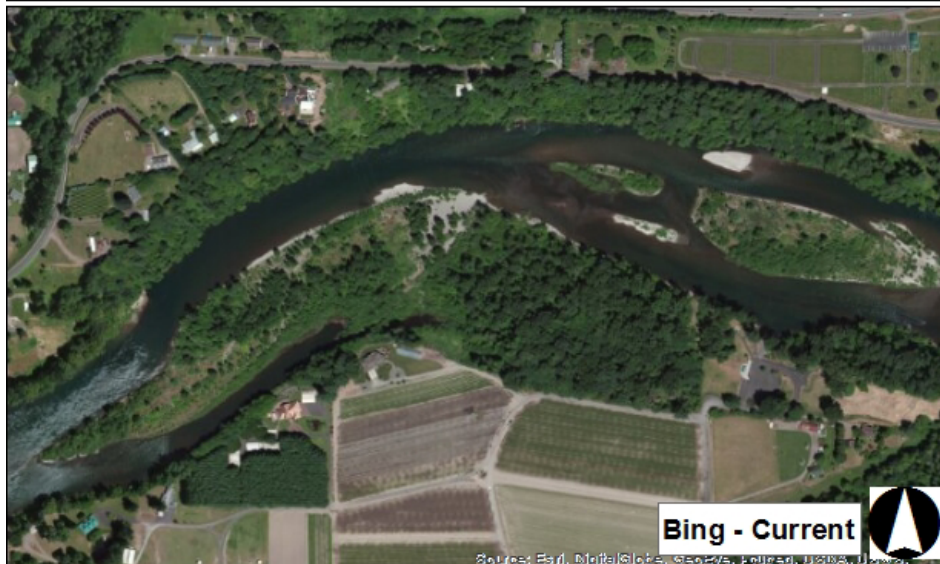
Figure 4. Historical aerial photography for the project site, including years 1938, 1951, 1968, 1973, 1989, current.

Figure 4. continued (source: Source: Esri, DigitalGlobe, GeoEye, i-cubed, USDA, USGS, AEX, Getmapping, Aerogrid, IGN, IGP, swisstopo, and the GIS User Community).

Aerial photography was acquired for years including 1938, 1968, 1973, 1981, 1989 and a current image. The photo record was used to evaluate trends in channel dynamics and planform. The aerial photography was also used to develop a history of human use in the vicinity of the project area.

The channel and floodplain features in the vicinity of the project area has been dynamic over the air photo record, as a result of the complex interaction of direct modification of the channel, flood events and watershed scale changes resulting from the construction of upstream dams. Historical air photos and landowner reports indicate the presence of a large gravel mining operation at the Haapa Site in the 1950s. This site is also known as the “Haapa Crusher” site. Stream gravel extraction removed a significant amount of material and likely contributed to channel simplification and disconnection of off-channel habitat. The interruption of sediment transport processes caused by upstream impoundments may also affect channel complexity and availability of spawning and rearing habitat. The earliest aerial photos examined in this study (1938) show the active gravel mining going on in the vicinity of the current boat ramp location (see Figure 4). There is a split flow around a mid-channel vegetated island downstream of the bar. The next photo, from 1951, shows the vegetation maturing on the surfaces created by the gravel mining operation. These surfaces in the vicinity of the gravel mining operation were eroded by the November 1962 flood event, the 3rd largest flood on record (approximately a 20-year event). In the years following the 1962 flood, the air photo record shows deposition of bars and subsequent vegetation colonization. In the 1973 photo, the valley-left channel in the flow split around the island is filling in and slowly becoming more and more disconnected. The series of 3 distinct islands evolved to become the large 3,500- foot long floodplain surface seen in the 1989 and present photos. The trajectory of the channel and floodplain conditions seem to be the evolution of the downstream portion of the project area from multiple channels and distinct islands to a large, stable vegetated floodplain surface effectively narrowing the flow into a single channel. The stability of vegetation of the floodplain surface, reduced sediment supply, and altered hydrology may be causing some degradation where the river is narrowed into one channel. Future channel adjustments will be a function of hydrology (i.e. flooding), sediment dynamics and feedbacks with riparian processes.

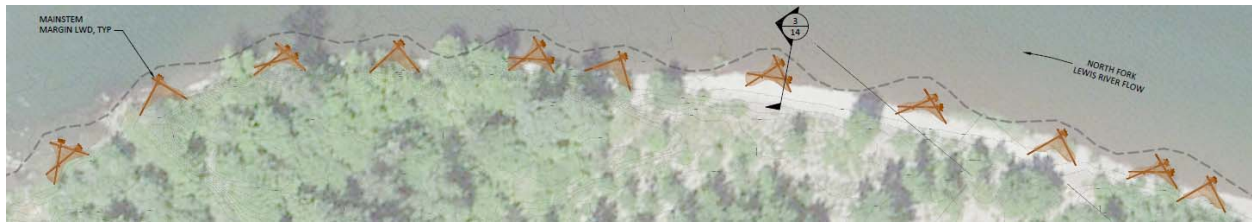
Figure 14. Plan view showing a portion of Component 3 Main Channel Margin LWD.

Component 3 includes margin wood enhancements increasing the amount of margin cover habitat in the mainstem (see Figure 14). As described in previous sections, historical modifications to both aquatic and upland habitats have reduced the delivery of large wood to the North Fork Lewis River. The margin LWD placements have been designed to provide habitat complexity and provide suitable rearing habitat during low flow that would historically be provided by naturally occurring LWD in the system. Furthermore, proposed LWD margin wood placement locations have been selected to avoid existing shallow shoreline high quality juvenile Chinook rearing habitat, and in consideration of recreational boat traffic in the river. The margin LWD component also includes the treatment of a section of eroding

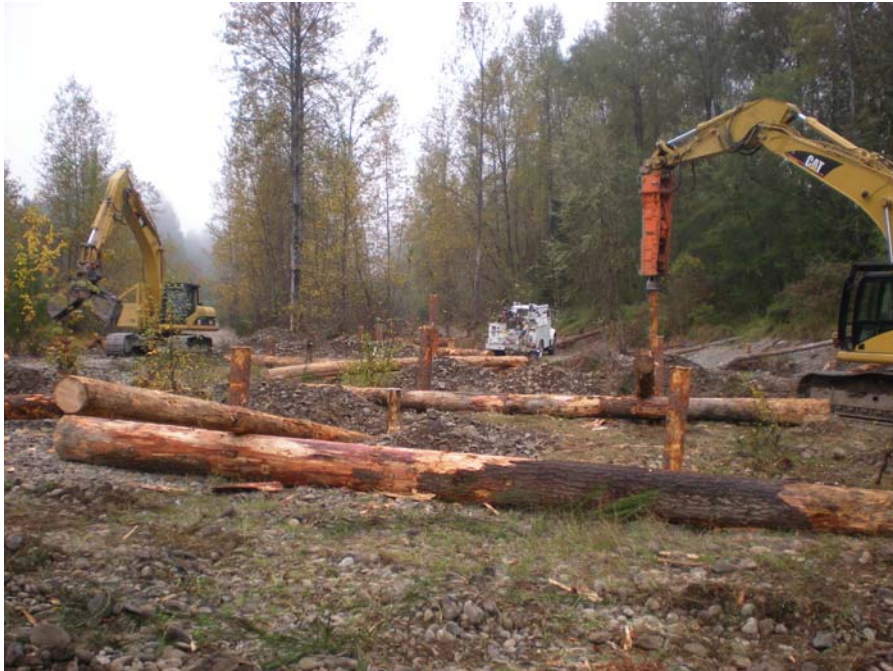
Figure 16. Installation of floodplain roughness LWD on the Cowlitz River (Inter-Fluve).

Component 4 includes the installation of floodplain roughness LWD in order to influence geomorphic and biological processes. Floodplain roughness LWD will provide winter refuge habitat for salmonids during flood flows (see Figure 16). Additionally, the proposed roughness elements will interact with the movement of water and sediment to encourage riparian processes on the floodplain. The riparian plantings will be implemented in a way that will benefit from the effects of the floodplain roughness LWD. Roughness LWD may provide some protection from high flows and encourage fine sediment deposition and provide a boost to pedogenesis on the floodplain.

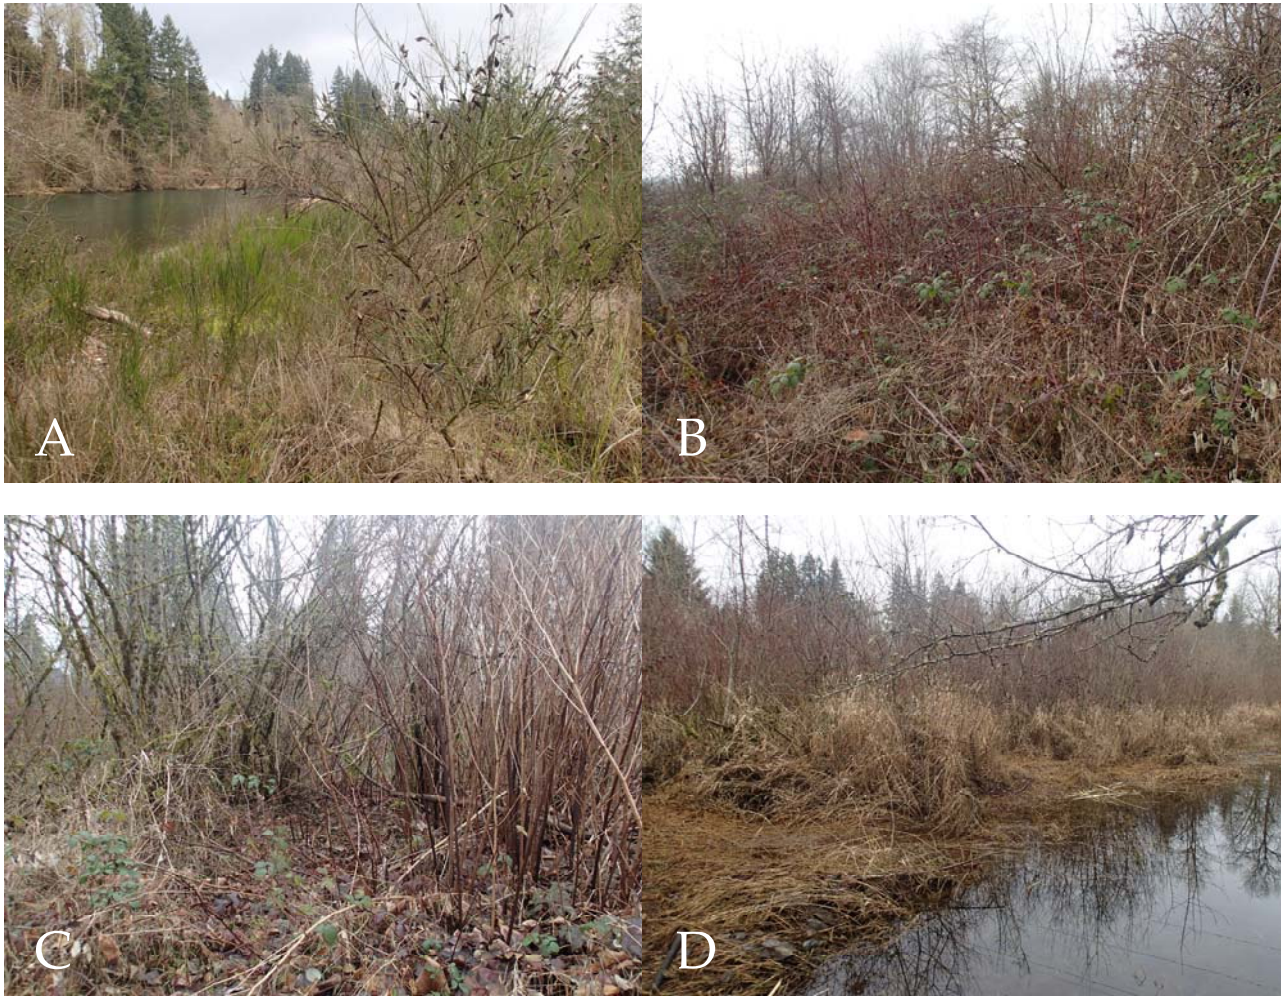
Figure 17. Invasive species present on site. A) Scotch broom in treatment zone 6, B) blackberry in treatment zone 1 and 2, C) knotweed present along the edge of treatment zones 8 and 9, D) reed canary grass along the Component 1 channel alignment.

Invasive species are a serious problem in the project area. Controlling invasives and re-establishing a native vegetation community will be an important component of this project and will support long-term ecological processes and habitat formation. Invasives present at that site include Scotch broom (*Cytisus scoparius*), Himalayan blackberry, reed canary grass (*Phalaris arundinacea*), and Japanese knotweed (*Fallopia japonica*) (Figure 17). Removal of invasive species will require several years of effort and continued maintenance. Because the area is used frequently by the community, seeds of invasive plants will likely continue to enter the site via visitors' shoes and clothing. In addition, Japanese knotweed and reed canary grass are present in other parts of the Lewis River and these species are likely to arrive in the area from upstream sources. Finally, the BPA transmission corridor is subject to regular maintenance program and there are limitations to what activities can occur in this part of the project area. It will be necessary to work closely with the agency to ensure the planting and invasive species control efforts are compatible with BPA's operations and maintenance. Initial discussions with BPA suggest that any plantings in the transmission line corridor would need to be a maximum of 10 feet tall. To control invasives on the site various options are available, but an integrated management strategy is recommended which includes mechanical and chemical treatments timed to coincide with appropriate growing seasons, heavy mulch and dense replanting and closely monitored and maintained sites.
