October 20, 2024

Submitted by Columbia Land Trust and Cramer Fish Sciences

Pine Creek Reach 5 Restoration Design Implementation

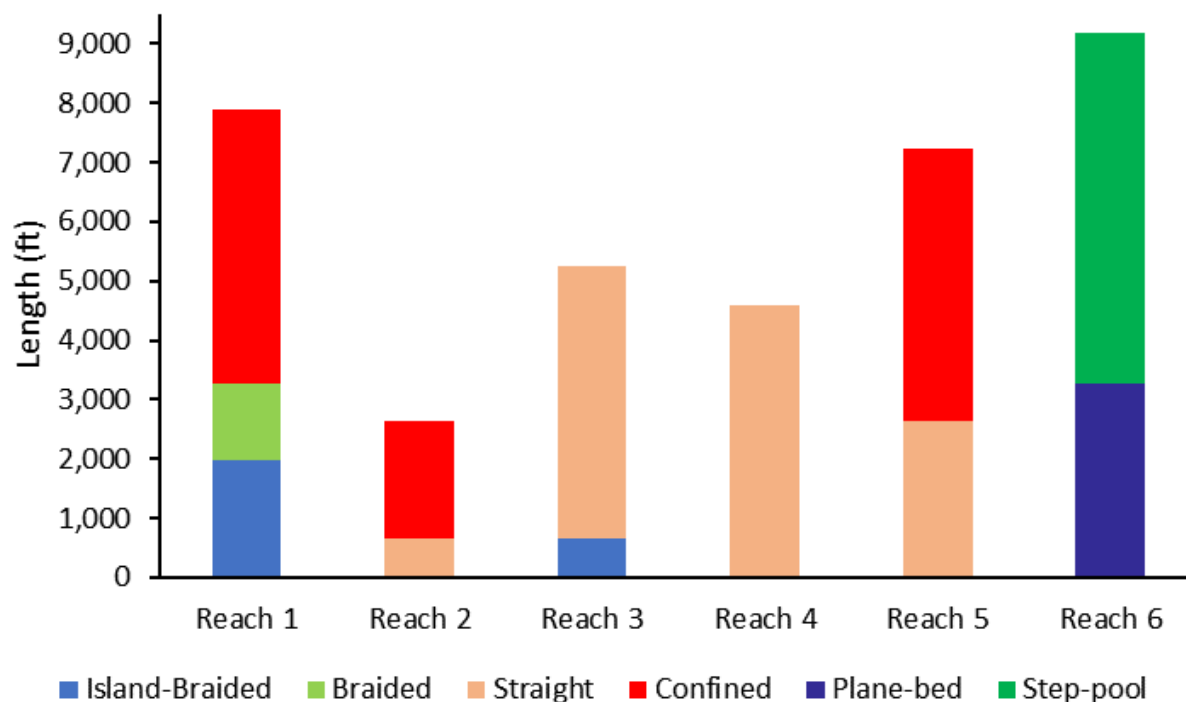
Figure 11. Distribution of dominant channel type lengths by reach in Pine Creek (Beechie and Imaki 2014).

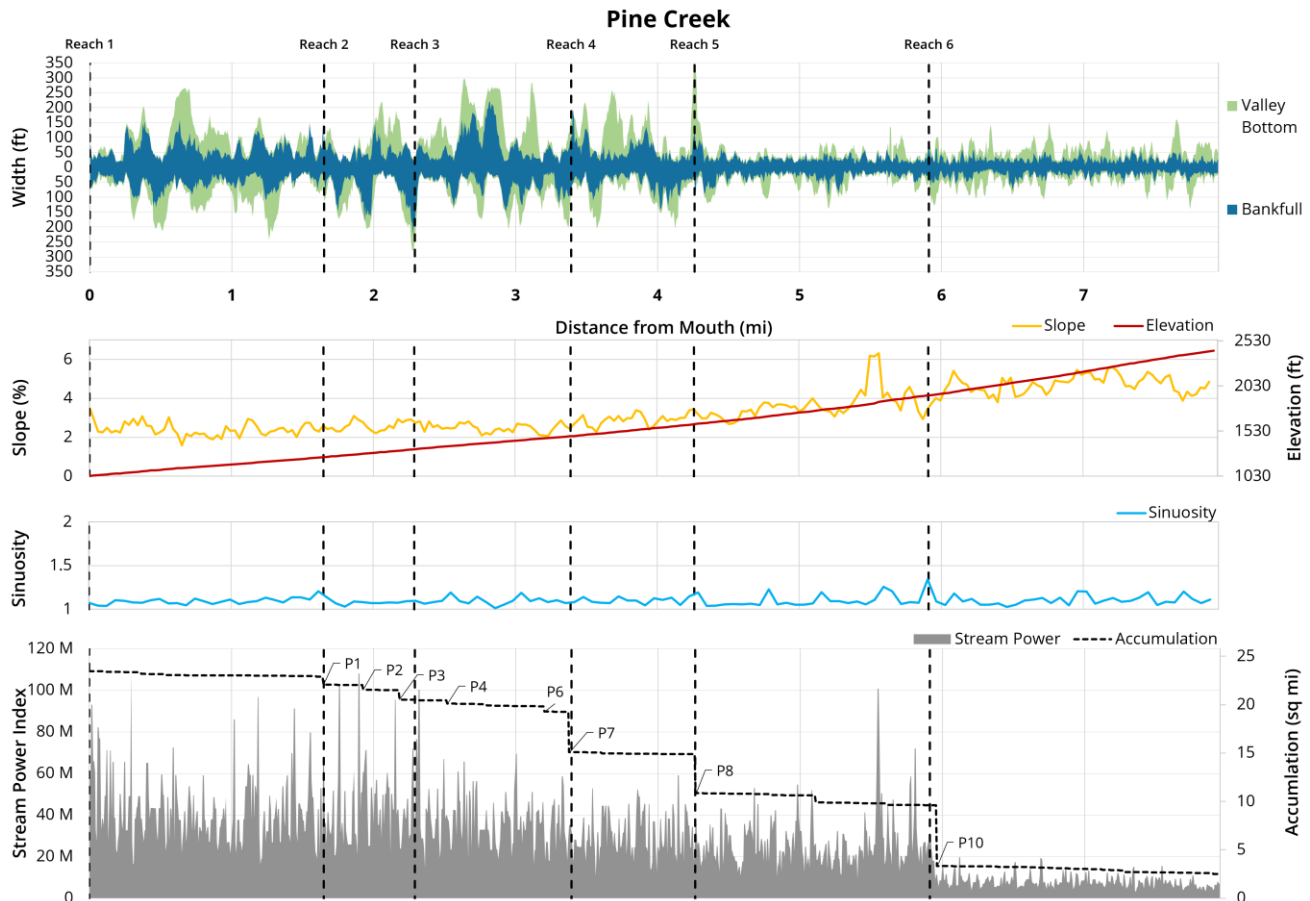
Figure 15. Stacked longitudinal profile of Pine Creek including bankfull width, valley bottom width, channel slope, elevation, sinuosity, stream power, drainage area, reach breaks, and tributaries.

for most of the mainstem and increases upstream of Reach 5. There is a large spike in slope near the upstream extent of Reach 5 where bedrock from the Marbel Mountain basalt flows is shallow and exposed. Sinuosity fluctuates with valley bottom width but remains relatively low which is typical of wandering cobble/gravel bed rivers. Pine Creek accommodates energy from high flows through the creation of secondary channels and avulsions, rather than developing full meanders. As expected, stream power correlates with changes in gradient and confinement; however, there is a noticeable decrease upstream of the confluence with tributary P10 in Reach 6.

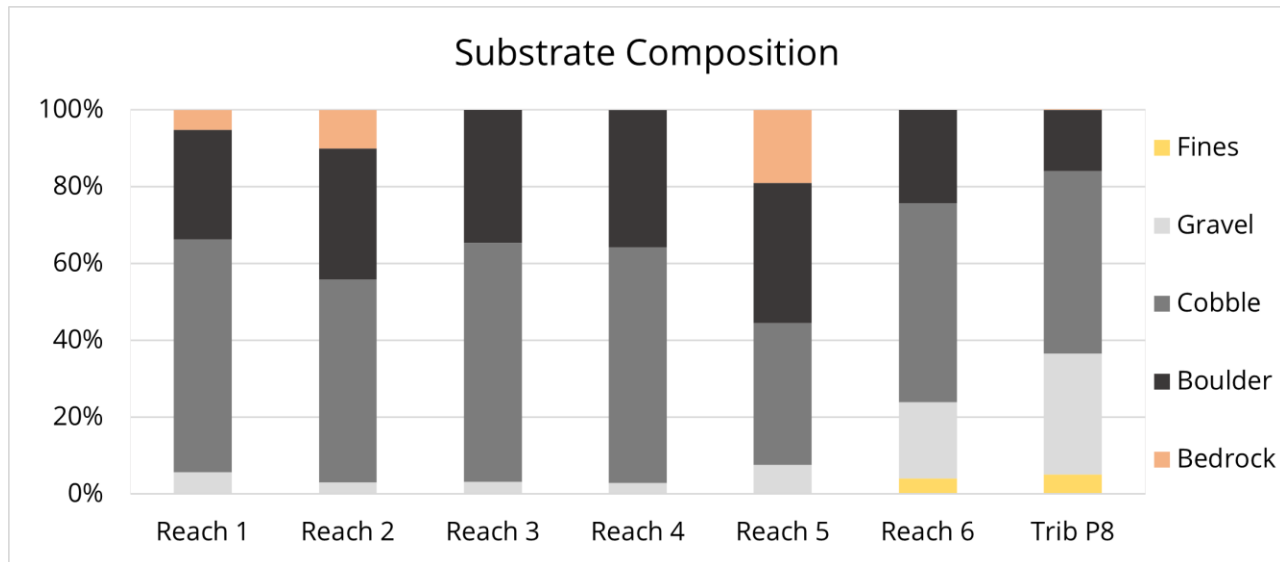
Figure 17. Graph of dominant substrate composition by reach observed during site visits in 2023.

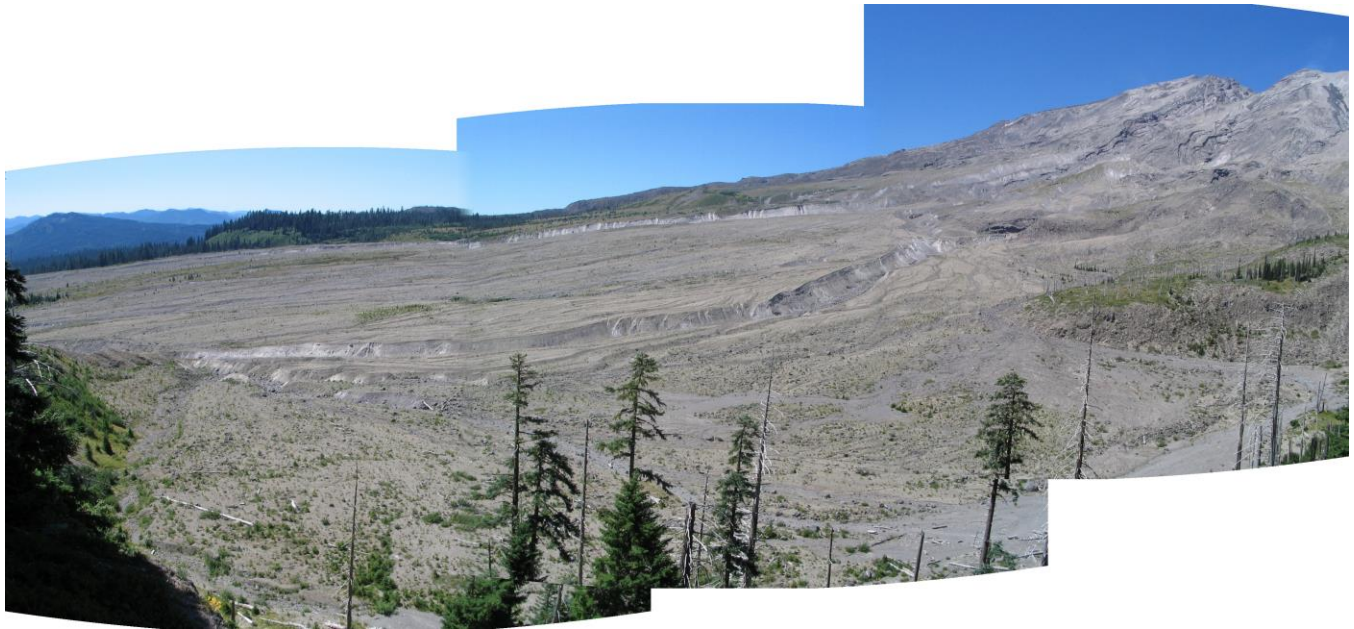
Figure 25. Photograph of the upper Pine Creek watershed taken in 2009 by David Anderson.

The Pine Creek watershed has also been heavily impacted by the eruption of Mt. St. Helens. The upper portion of the watershed was denuded of trees and covered by a layer of volcanic ash (Figure 25). Additionally, a volcanic debris flow (lahars) was triggered by the eruption of Mt. St. Helens that flowed down the Muddy-Pine fan, reaching speeds of up to 30 meters per second and depositing randomly sorted particles up to small boulder size, up to 2.5 meters deep (Pierson 1985). The impacts of Mt. St. Helens have continuing effects on the Pine Creek watershed; however, streamflow from impacted basins increased by only a few percent for a period of up to 10 years (Major and Marks 2006).

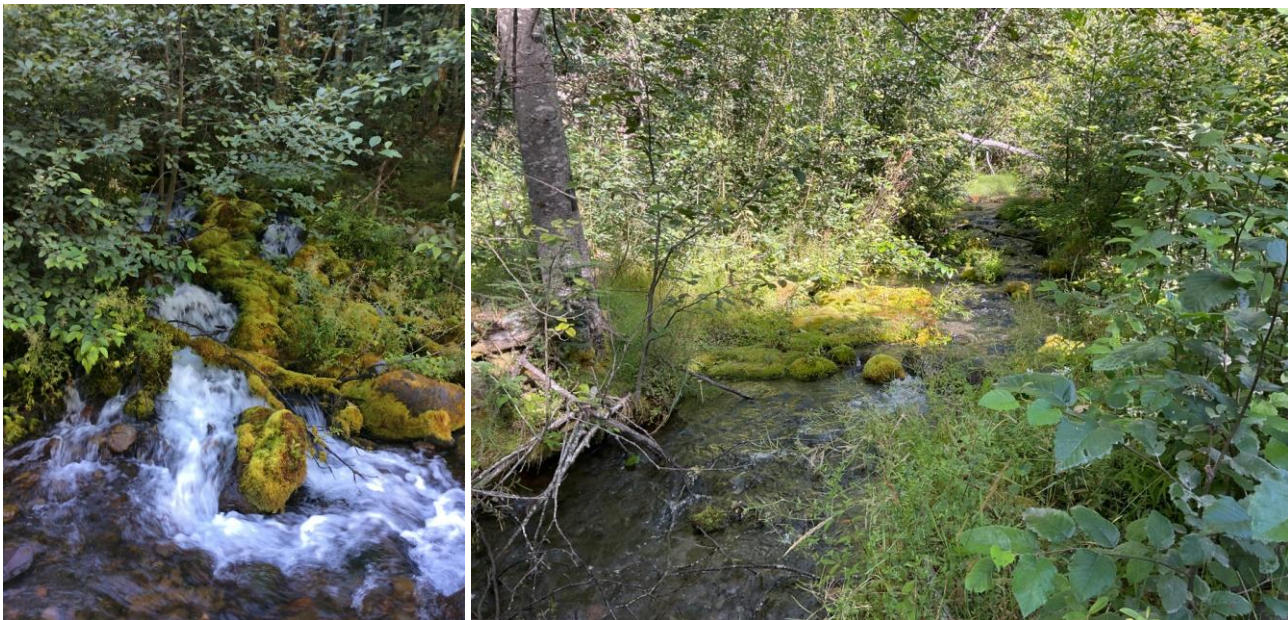
Figure 27. Example photographs of springs associated with forested hillsides in the headwaters during the summer.

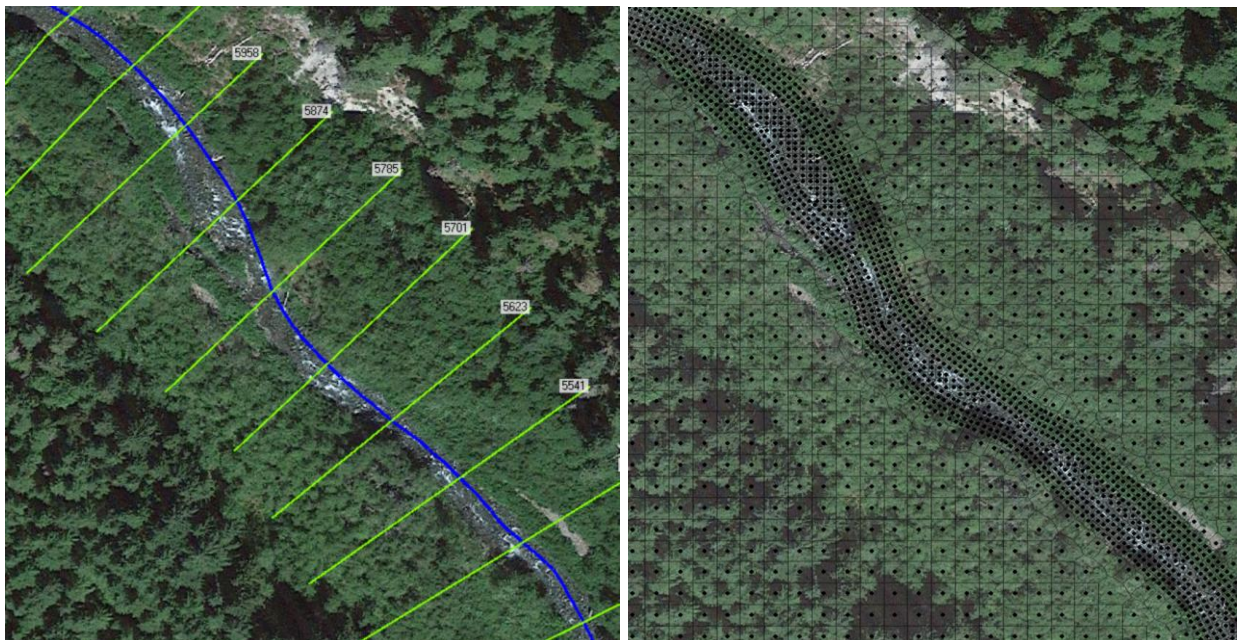
Figure 33. Hydraulic model geometry for 1D (left) and 2D (right).

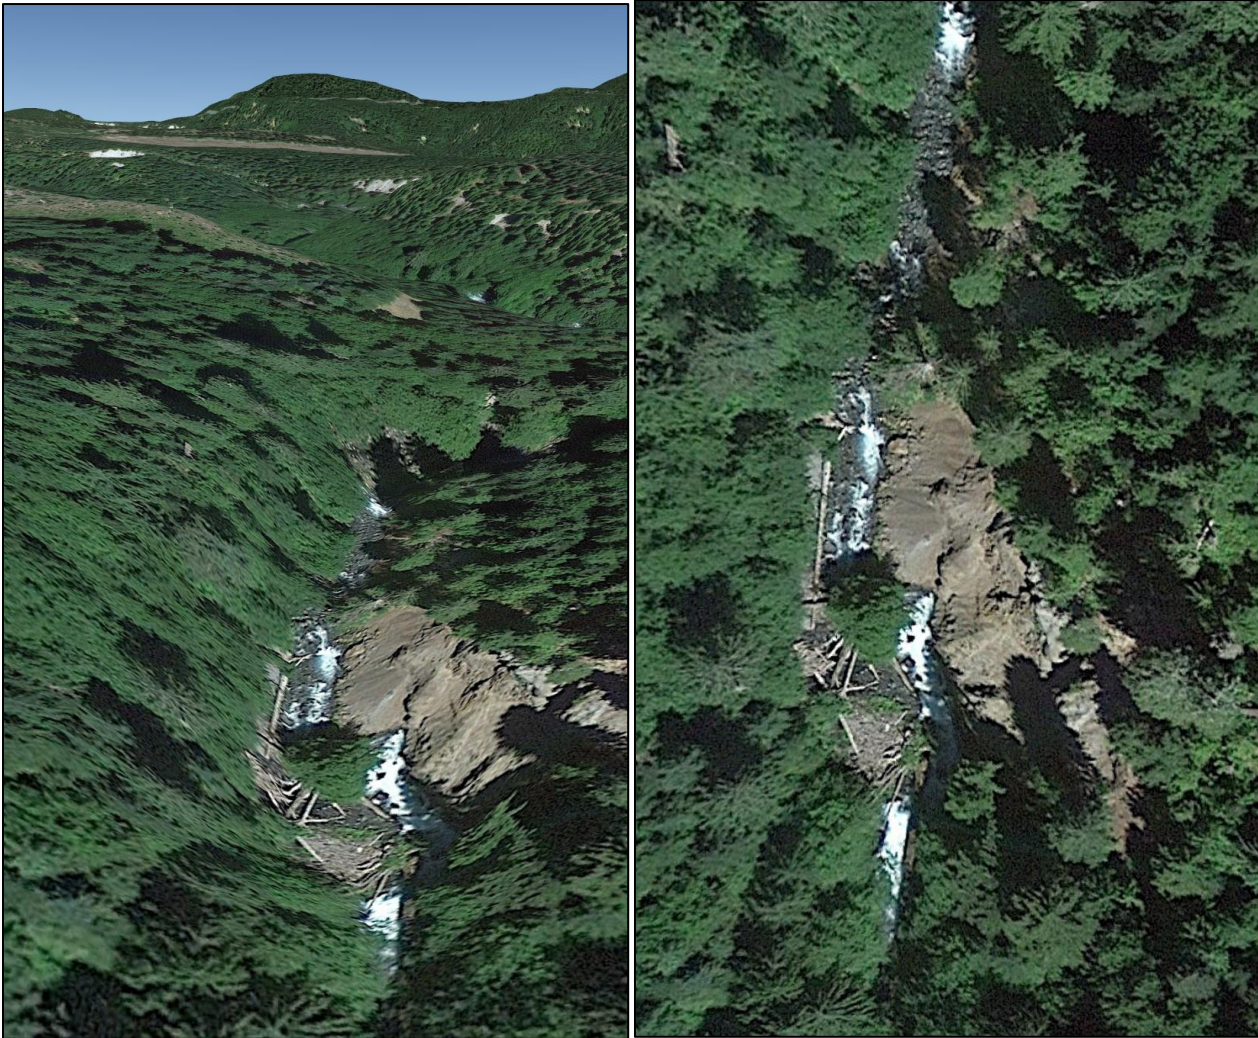
Figure 35. Oblique (left) and plan (right) view of potential partial barrier in Pine Creek Reach 5.

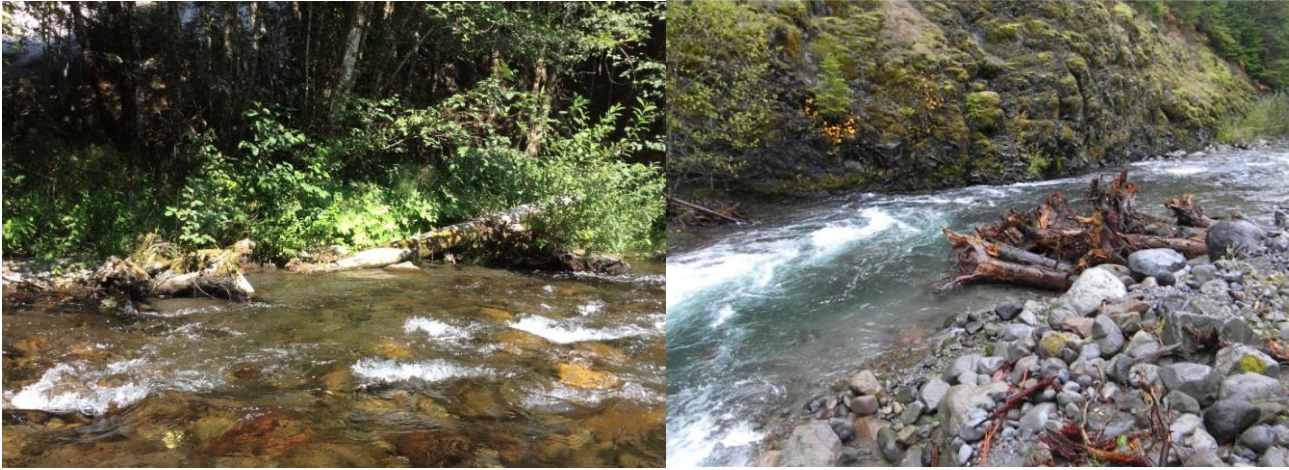
Figure 37. Photos of Structure 13 as labeled in the USFS report; the photo on the left was included in the 2013 report, and the photo on the right was taken by CFS field staff in August of 2023.
