# Two Data Questions 1) Are all the targets actual fish? 2) Are all the fish within the detection area actually entrained?

## Hydroacoustic Results

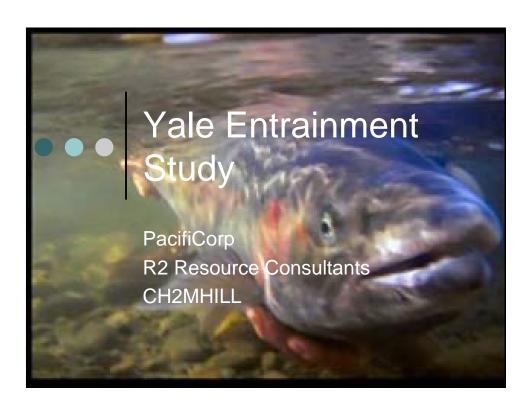
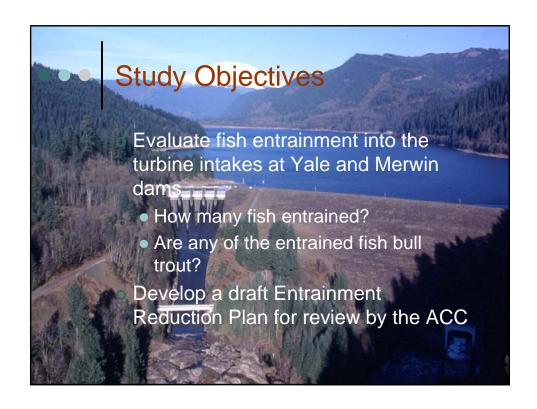
- Hydroacoustic detection
  - 2 transducers one over each turbine intake
  - 24/7 monitoring from Nov. 2005 to July 2006
- Video recording
  - Two 4-hour blocks per day
