LEWIS RIVER ADA FISHING SITE FEASIBILITY STUDY

LEWIS RIVER HYDROELECTRIC PROJECTS, WASHINGTON
JUNE 2016

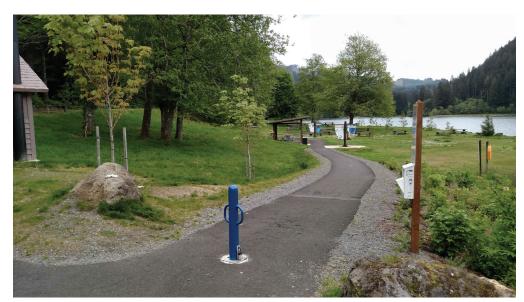
ADA ACCESSIBLE PATH FROM PARKING LOT THROUGH PICNIC AREA

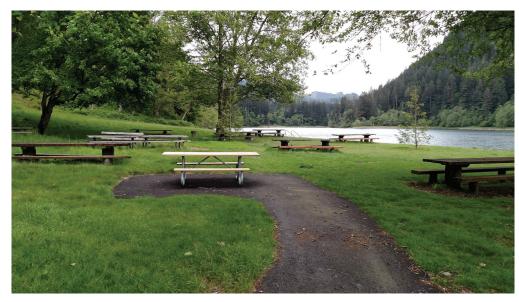
END OF EXISTING ADA ACCESSIBLE PATH, WHERE PATH TO NEW FISHING PIER WOULD POTENTIALLY START

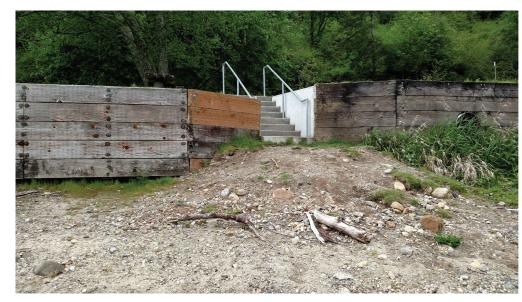
EXISTING WOOD BULKHEAD AND STAIRS

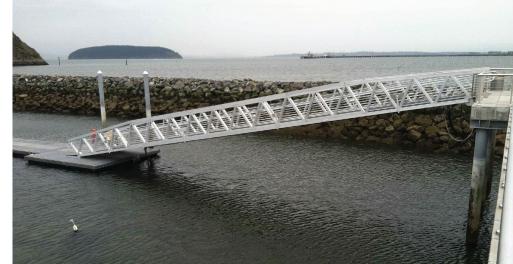
GANGWAY AND LANDING FLOAT, TYPICAL

WHEN THE RESERVOIR WATER LEVEL IS LOWER THAN 232.1 FEET,

3. FISHING ACCESS FROM THE FLOAT IS 100% OF THE TIME FOR GENERAL PUBLIC AND 78% OF THE TIME FOR ADA ACCESS. THE ADA SLOPE LIMIT OF 12H:1V IS EXCEEDED ON THE GANGWAY

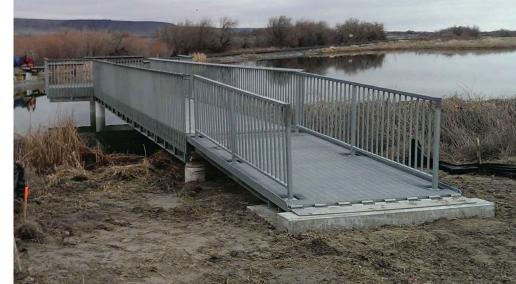
CONCEPT 2

FISHING PIER AT BURKETT LAKE

- 1. TOPOGRAPHIC AND BATHYMETRIC CONTOURS ARE FROM THE BASE MAP "16476 SPEELYAI SITE BASE.DWG", BY MACKAY SPOSITO, RECEIVED 5-10-2016.
- 2. FISHING ACCESS IS 100% OF THE TIME FOR BOTH GENERAL PUBLIC AND ADA ACCESS.

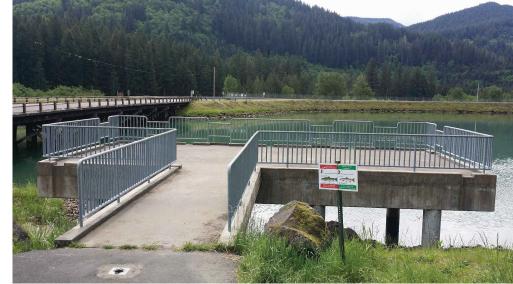
CONCEPT 3

FISHING PIER AT SWIFT 2 CANAL

- THE BASE MAP "16476 SPEELYAI SITE BASE.DWG", BY MACKAY SPOSITO, RECEIVED 5-10-2016.
- FISHING ACCESS IS 99% OF THE TIME FOR BOTH GENERAL PUBLIC AND ADA ACCESS. WATER LEVEL BELOW 225.0 FEET, NGVD29, APPROXIMATE 1% OF THE TIME.
