Lewis River Aquatic Fund Projects (SA 7.5.3.2)

Project Closeout Report

Project Title: Lewis River Hydroelectric Project
Lewis River Side Channel 5

Lewis River Mainstem Fish Habitat Restoration 2016

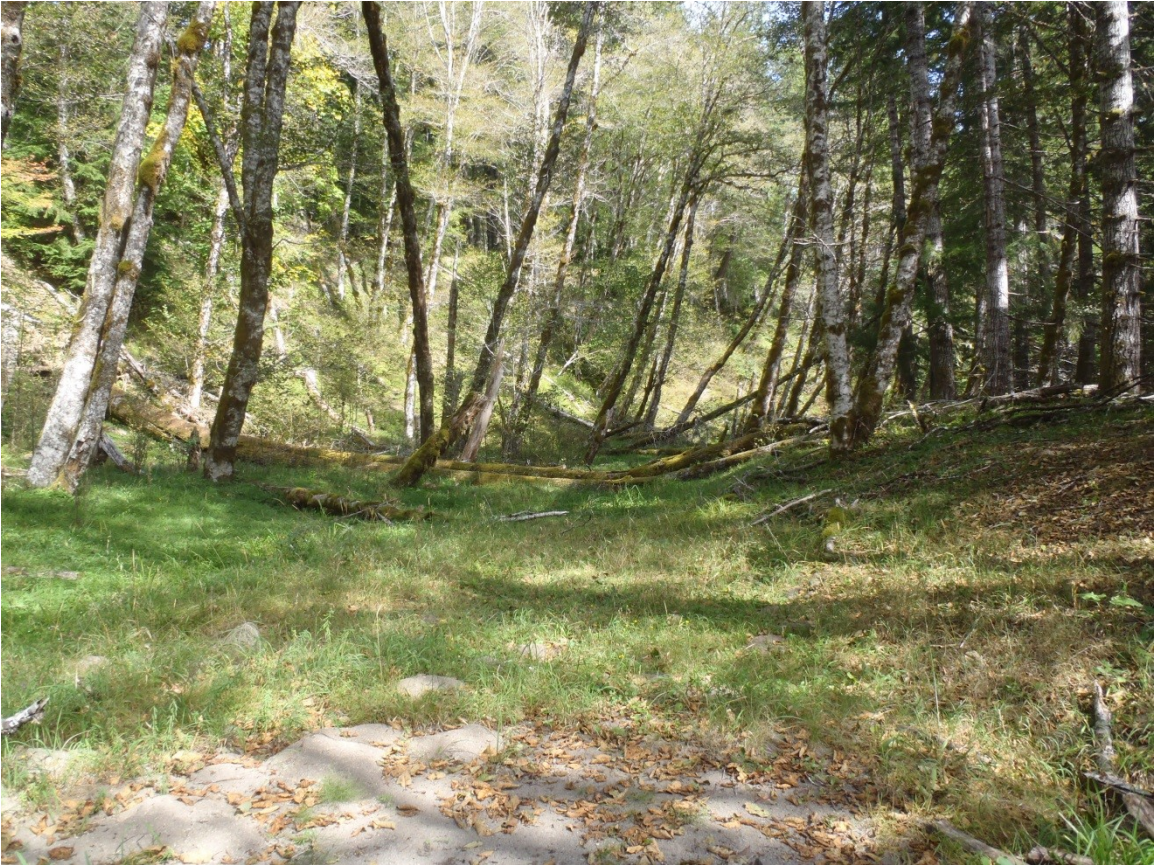
Photo 1. Lewis River side channel 5 project pre-implementation conditions on 8/2016 (Photo B. Michaelis).

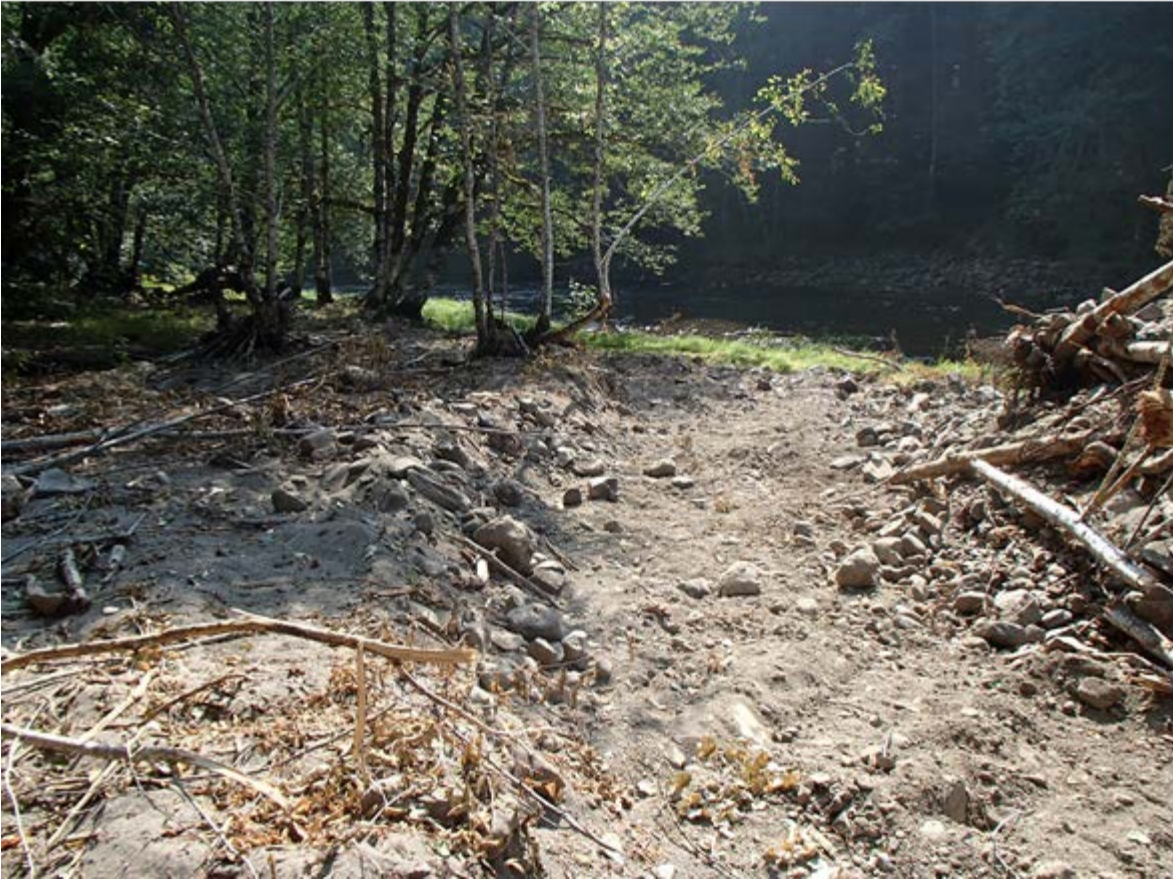
Photo 2. Lewis River side channel 5 project post implementation on 8/15/2017 (Photo B. Michaelis).

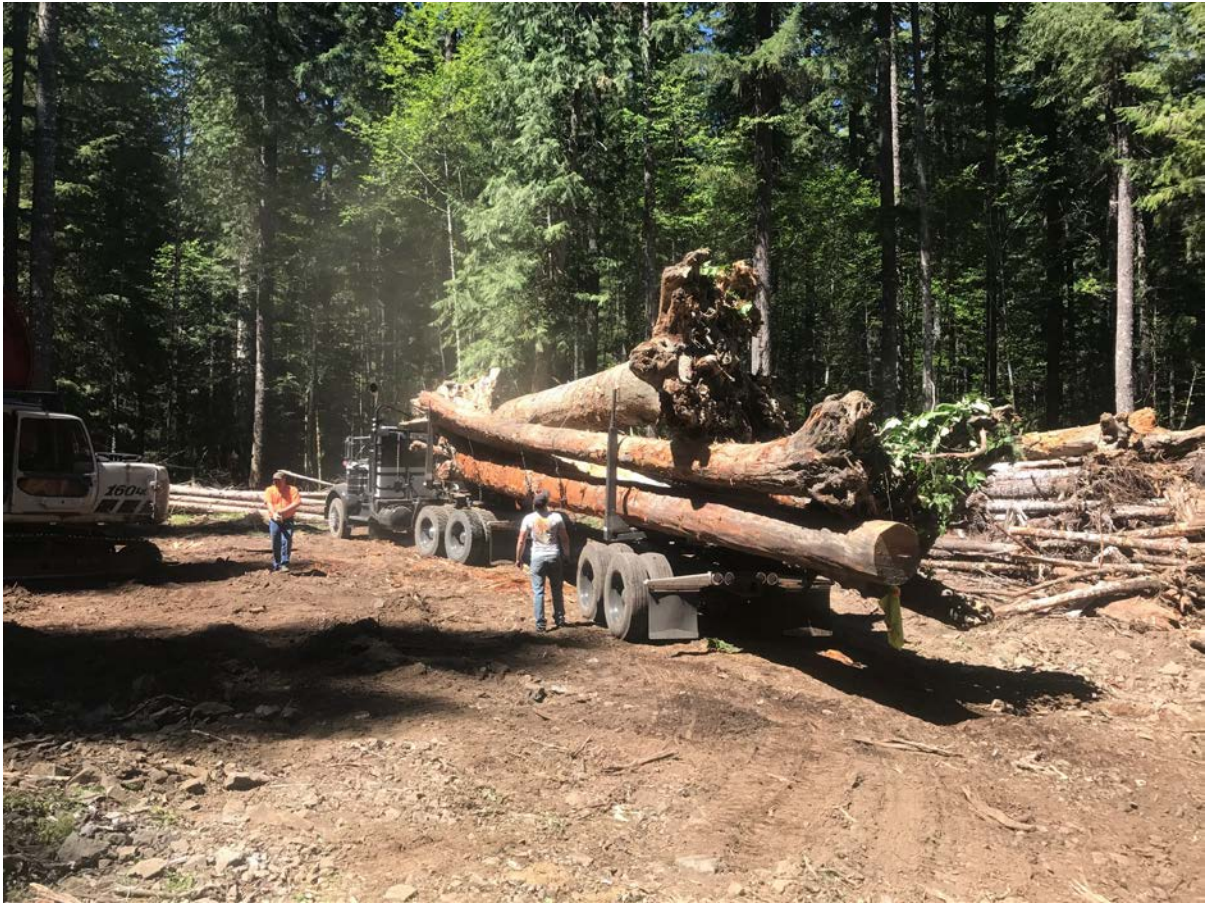
Photo 3. Lewis River side channel 5 project unloading large wood obtained from PacifiCorp forebay cleaning operations

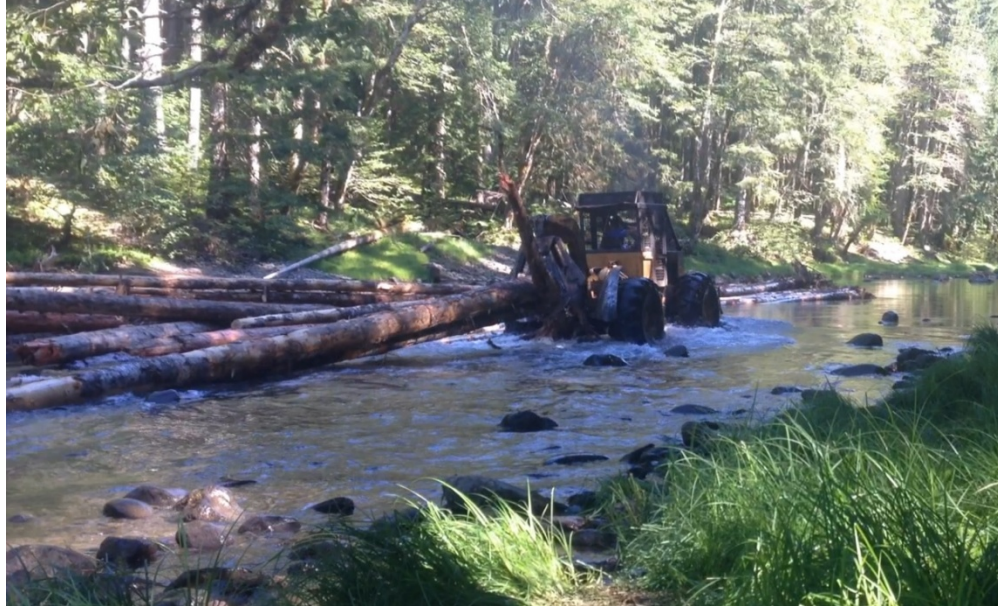
LWM being hauled into place on the North Fork Lewis River

Construction of the structures occurred during the summer of 2016. Approximately 200 trees 60+ feet long with root wads were harvested from Forest Service land and trucked to a clearing adjacent to the access road and near the Lewis River. Trees were moved into place near the structure locations using a skidder. Seven (7) structures were located on river-left and one island apex jam was located on a rocky island in the middle of the channel. The excavator was used to dig trenches in the bank and place 12-20 trees per structure in the trenches. 30-50 feet of the trees were buried, leaving 10-30 feet including the root wads protruding into the channel. The trenches were then backfilled. The excavator was also used to dig pools where the root wads would be placed in order to accelerate the process of pool creation. Additional trees were strategically placed on the bank and interwoven through and between the structures. On the rocky island, a large hole approximately 20 feet wide and 10 feet deep was dug with the excavator. Approximately 25 trees were strategically placed to maximize complexity, durability, and overall habitat quality. Rocks and soil were backfilled onto the trees for ballast. USFS protocol to avoid the introduction of non-native species was implemented, including pressure washing machinery and mulching exposed areas.

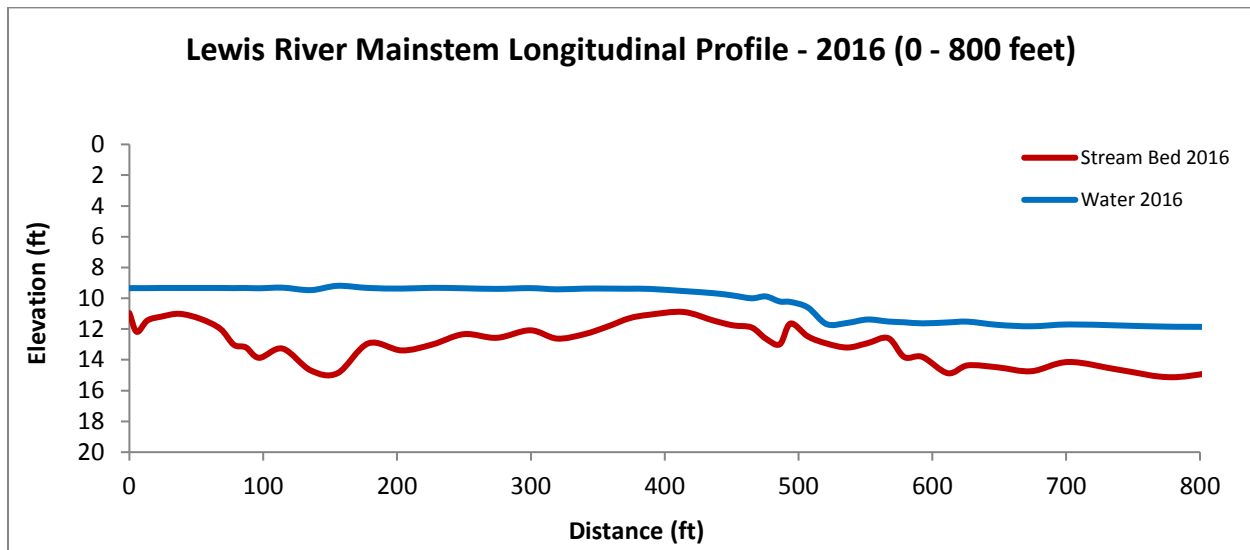
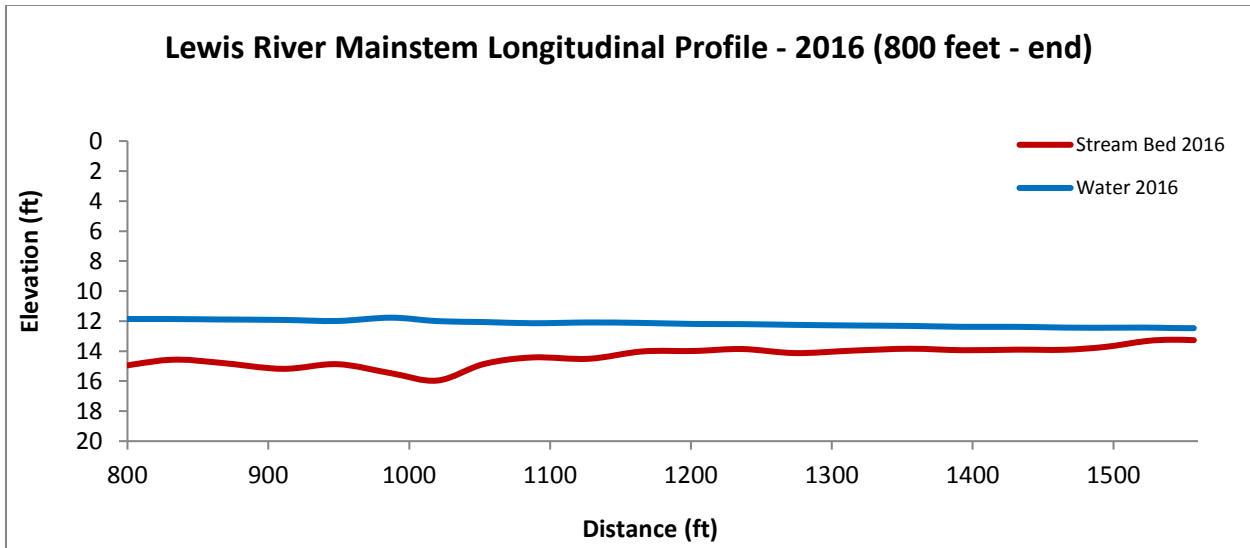
Longitudinal Profile - Before Installations

A longitudinal profile was created using methods closely adapted from Harrelson et al (1994). The longitudinal profile measures the elevation changes of the thalweg - the deepest continuing line in the stream channel. The longitudinal profile is not only a measure of distance and elevation, but also of sinuosity; however, this section is relatively straight. From the longitudinal profile, one can assess stream type, pool depth, and pool:riffle ratio.

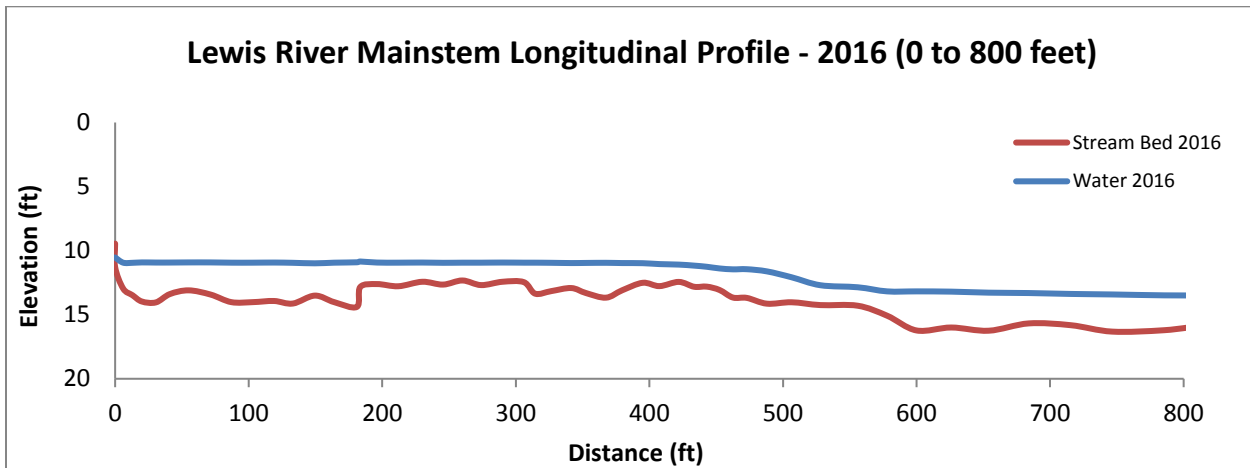
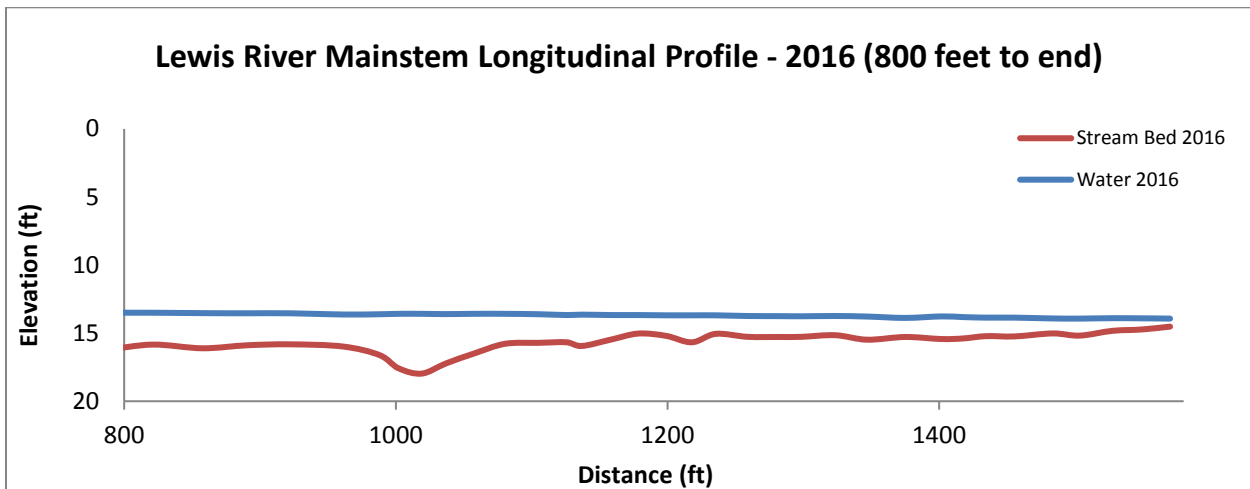
Longitudinal Profile - After Installations

It is important to note that the longitudinal profile from after the installations surveyed further from the shore than the longitudinal profile from before the installations due to surveying variability, possibly accounting for the differences in certain statistics such as the decrease in number of pools over 1.00 feet and the stream bed depth.

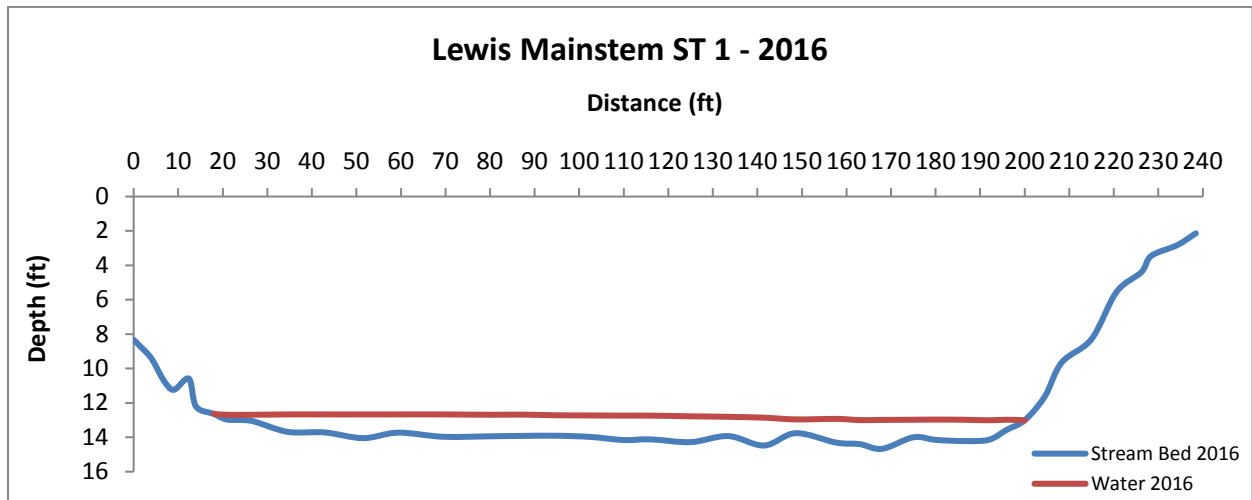
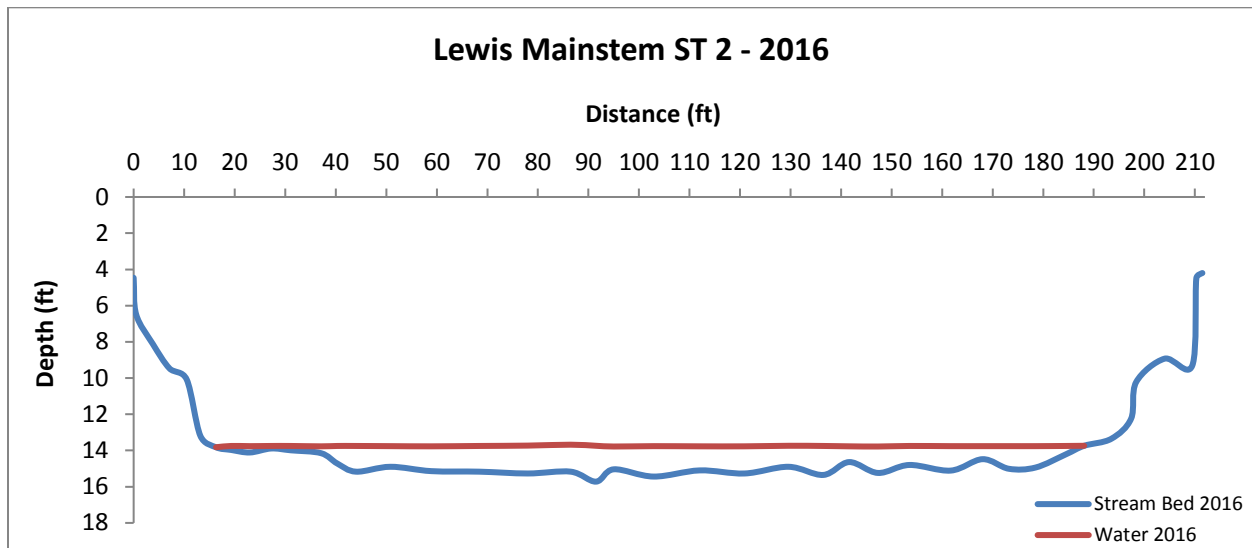
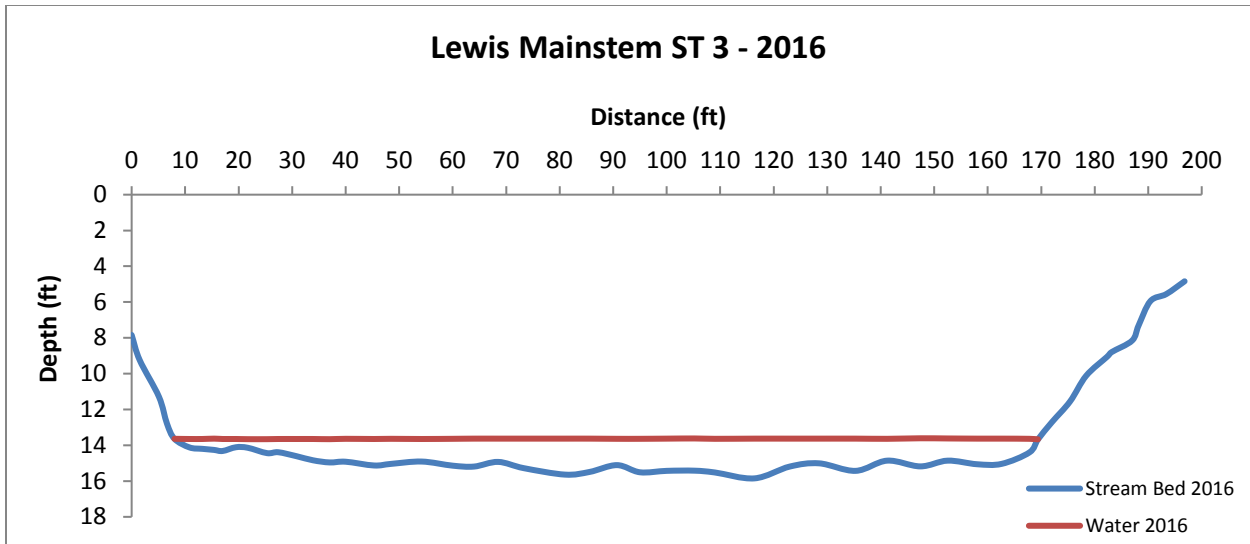
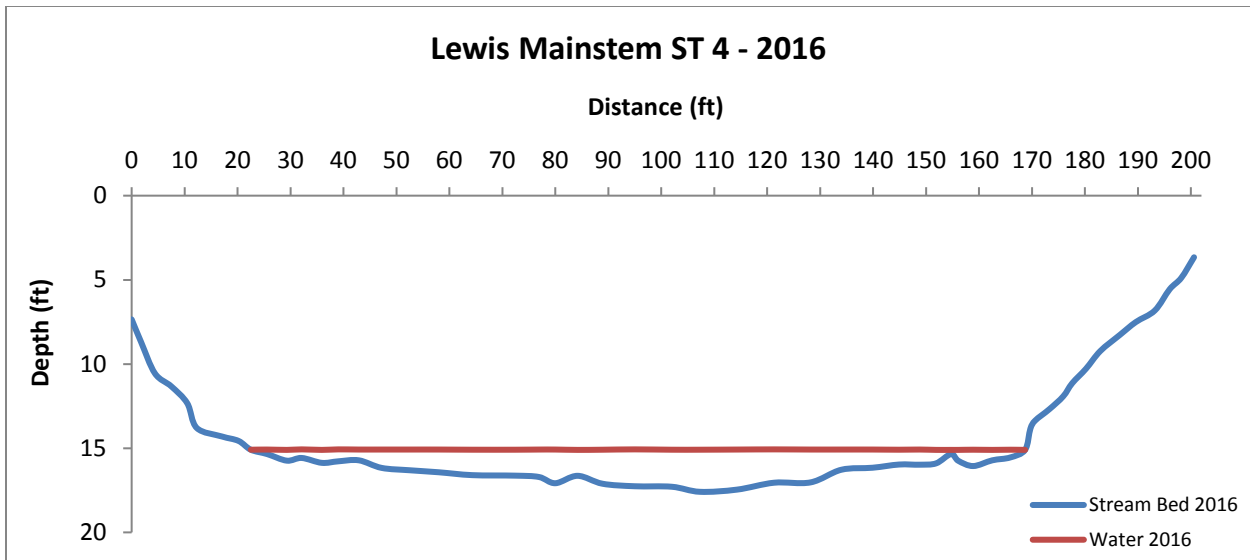
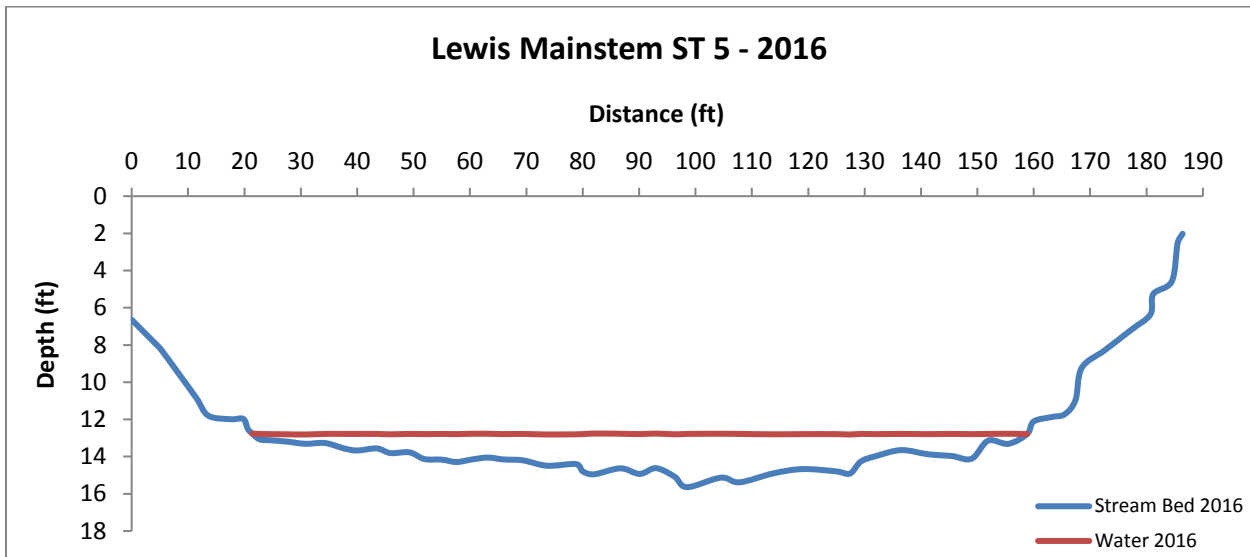
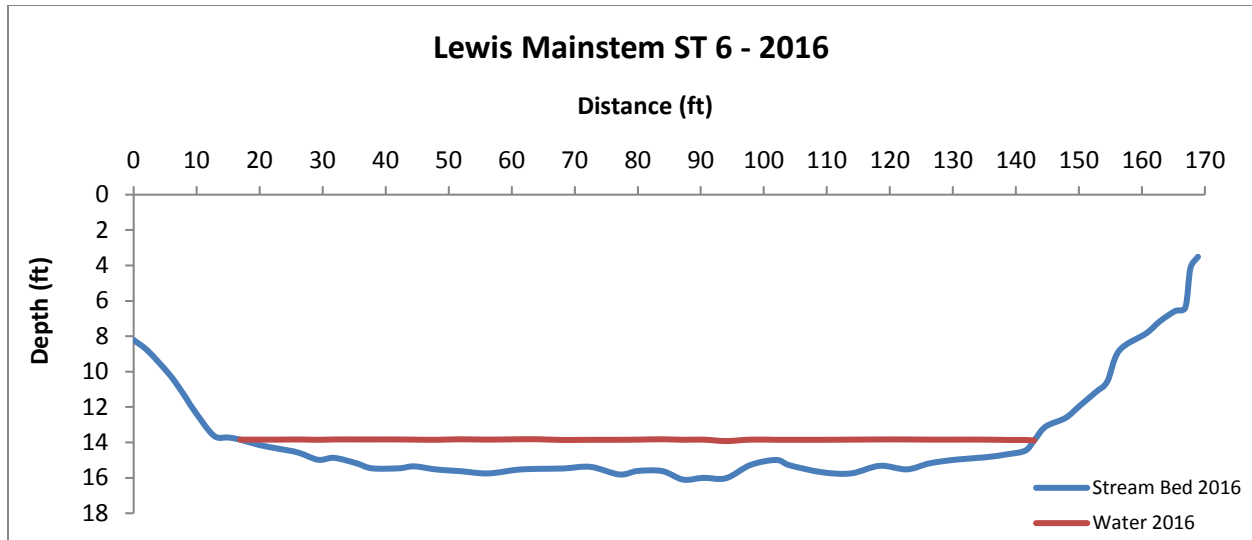
Cross Section Profiles

To monitor the effects of each LWM structure, cross section profiles were obtained immediately downstream of each structure. The methods for measuring these cross sections were adapted from methods described by Harrelson et al (1994). A long-lasting benchmark in the form of a nail hammered into a tree was installed on each side of the channel such that the cross section was directly perpendicular to the angle of water flow. The benchmarks ensure that all surveys, present and future, would be conducted at precisely the same spot. Labeled flagging tape identifies each structure and improves visibility. Due to measuring tape limitations, two measuring tapes were tied together, stretched tightly across the channel and attached to each benchmark. A laser level and was used to map the topography of the bank and stream bed along the measuring tape. Measurements were taken as frequently as needed to capture all significant topographical features. The height from the ground to the nail was recorded in the notes so that the nail could be used as the fixed reference point. In addition to mapping the topography of the stream bed, the survey also recorded the water level, locations of water edges (shown on the profiles), and bankfull locations (not shown on the profiles).

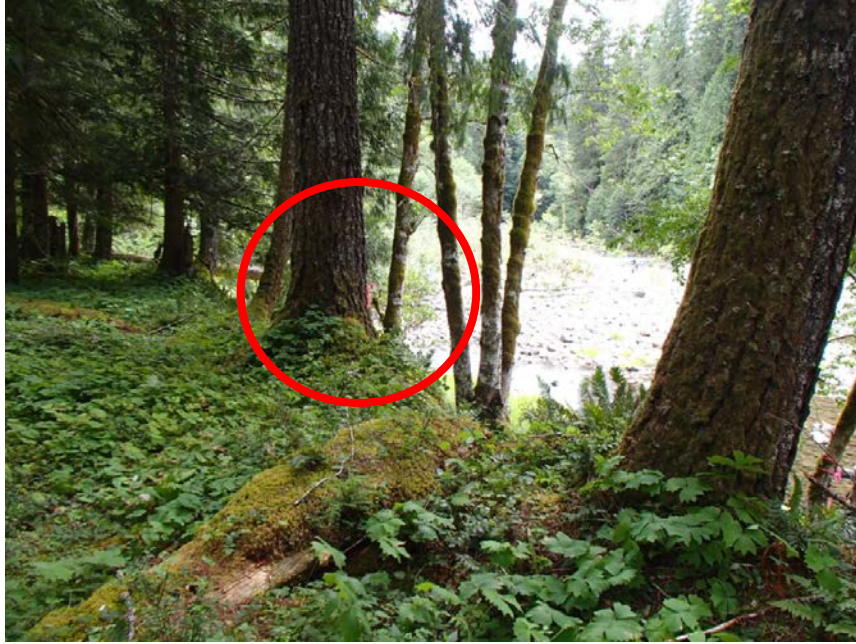
Lower benchmark of longitudinal profile

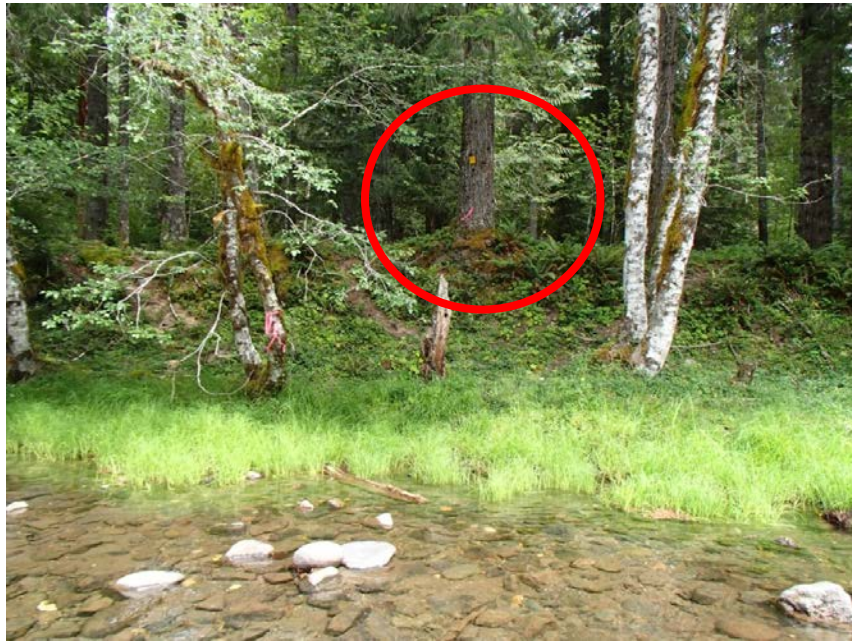
Lower benchmark of longitudinal profile

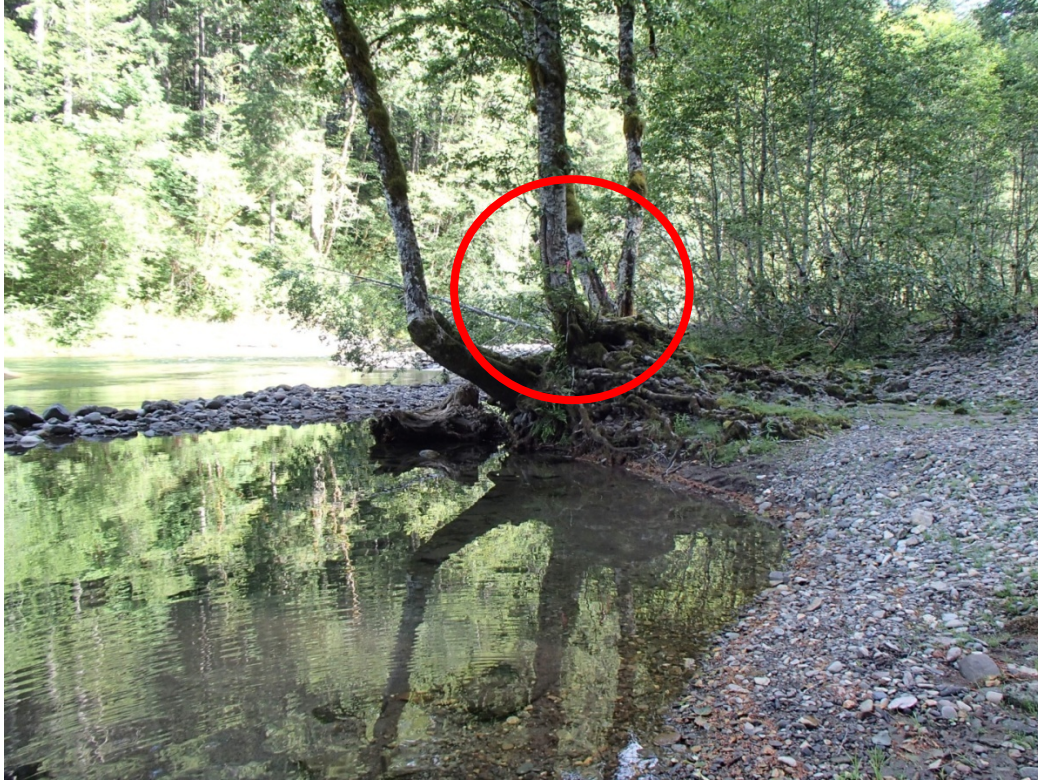
Upper benchmark of longitudinal profile

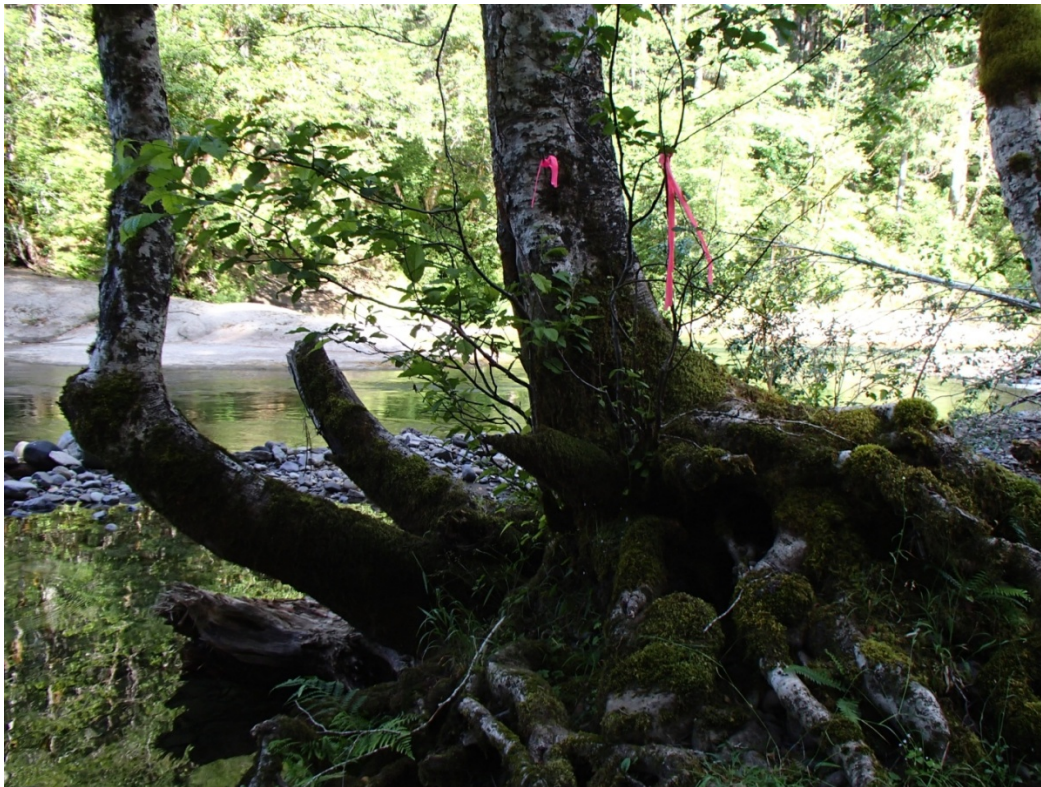
Upper benchmark of longitudinal profile

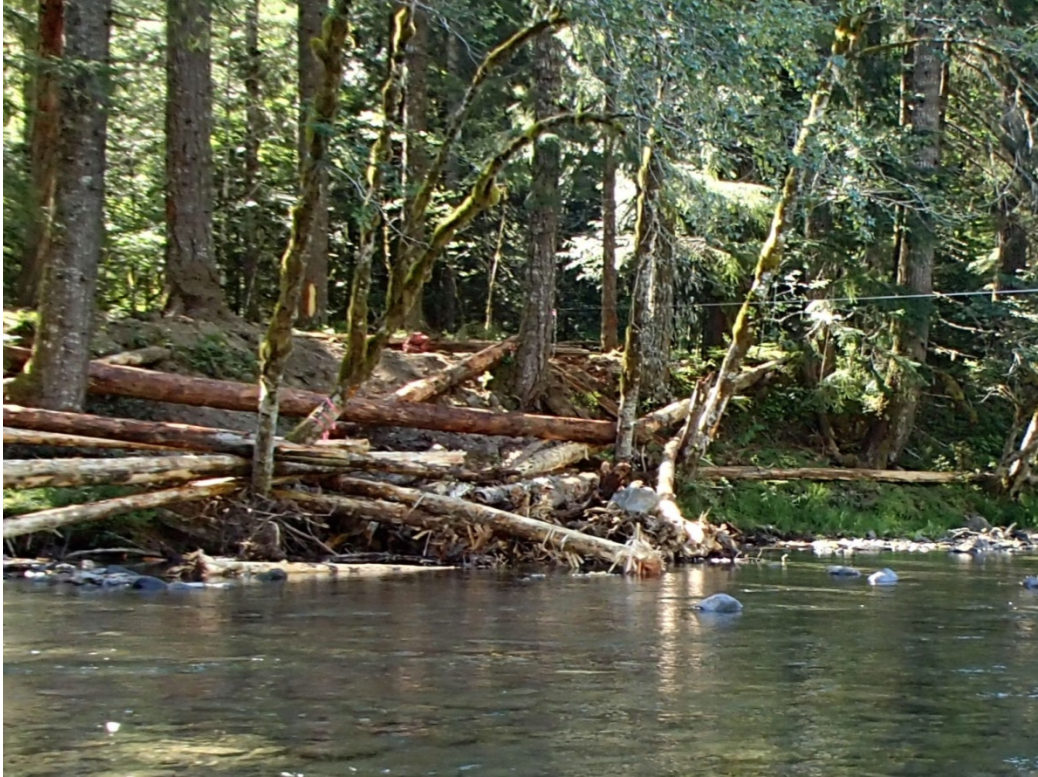
Structure 1 - Looking right bank to left bank

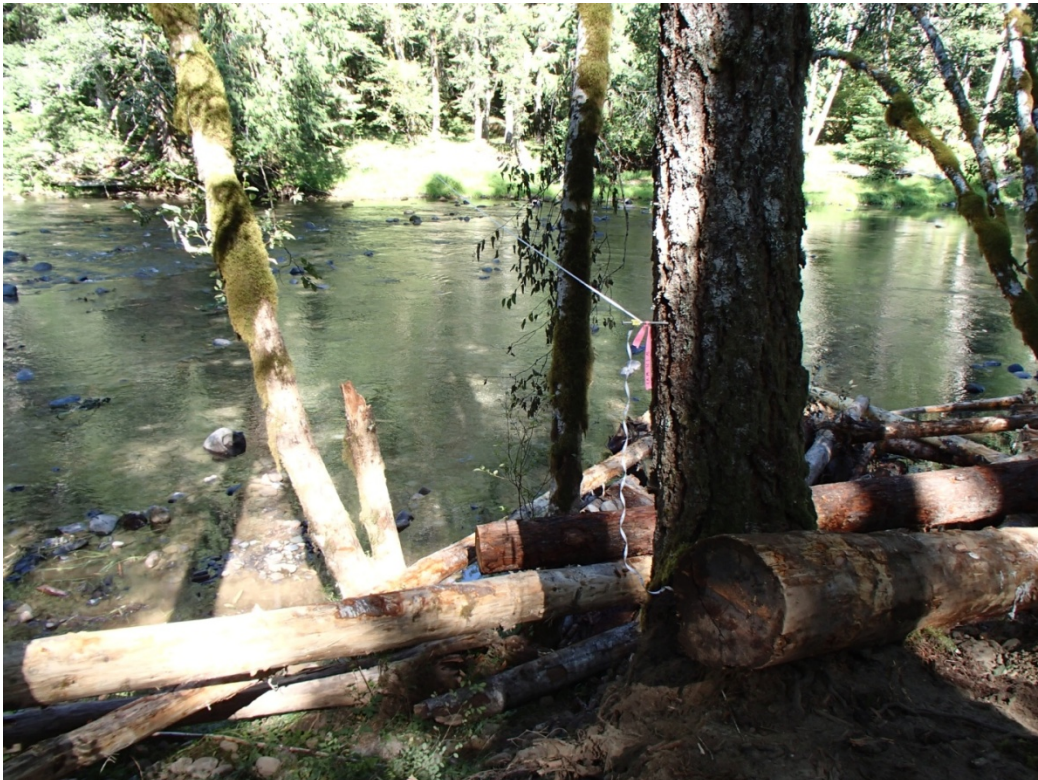
Structure 1 - Looking left bank to right bank

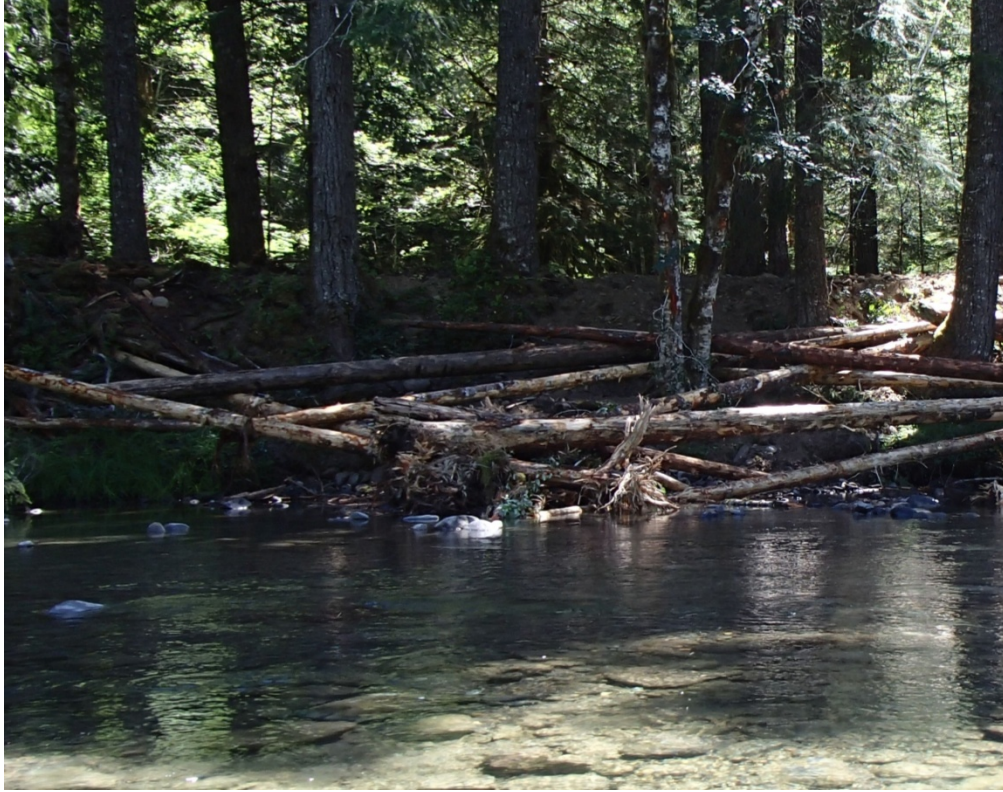
Structure 2 - Looking right bank to left bank

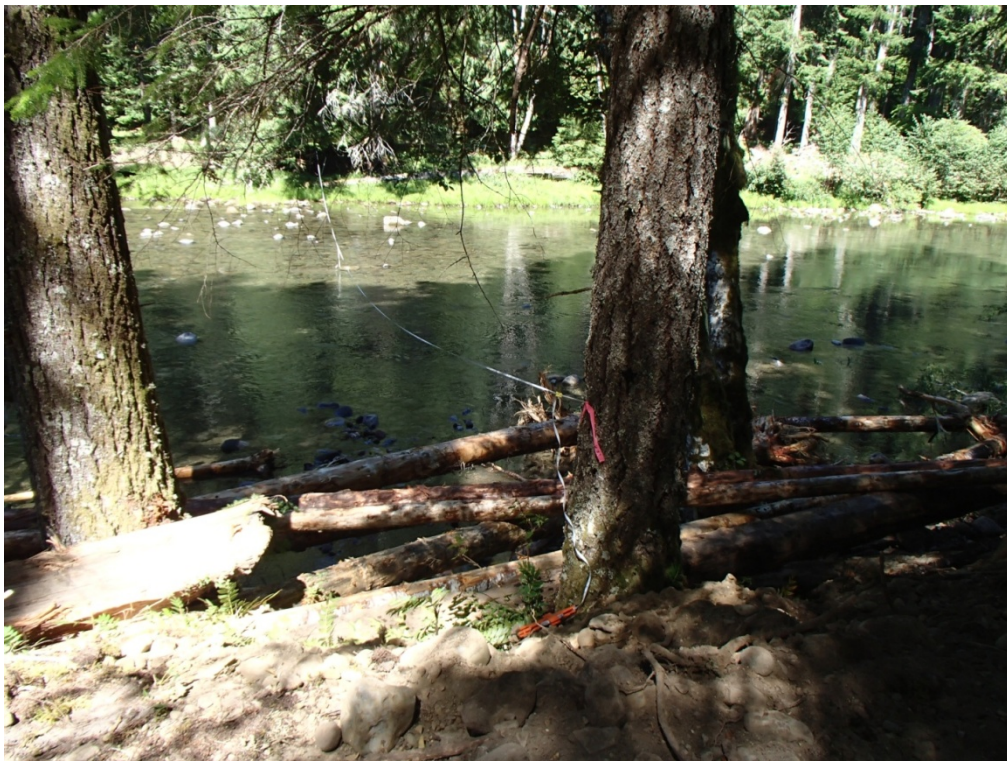
Structure 2 - Looking left bank to right bank

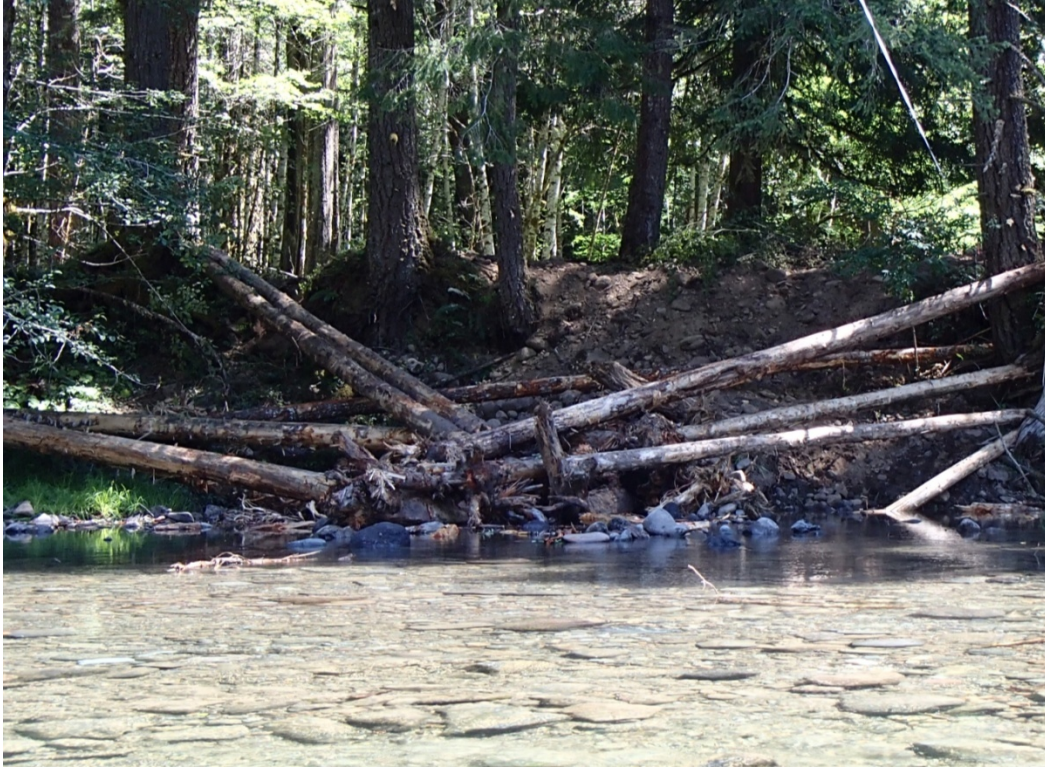
Structure 3 - Looking right bank to left bank

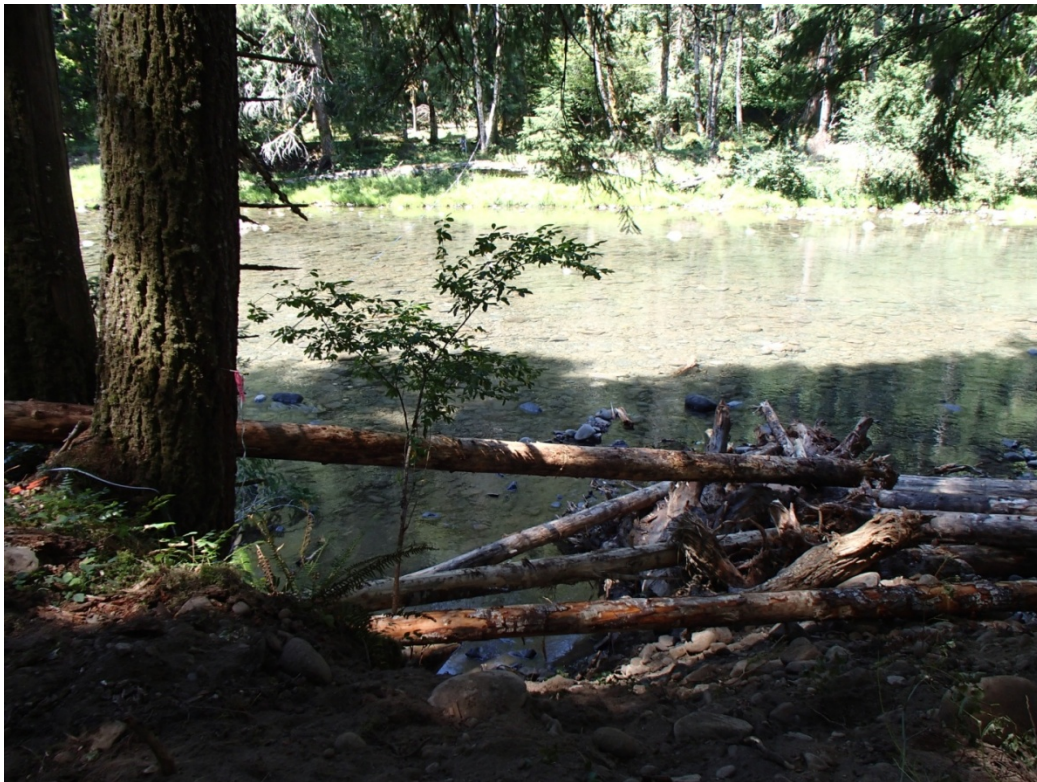
Structure 3 - Looking left bank to right bank

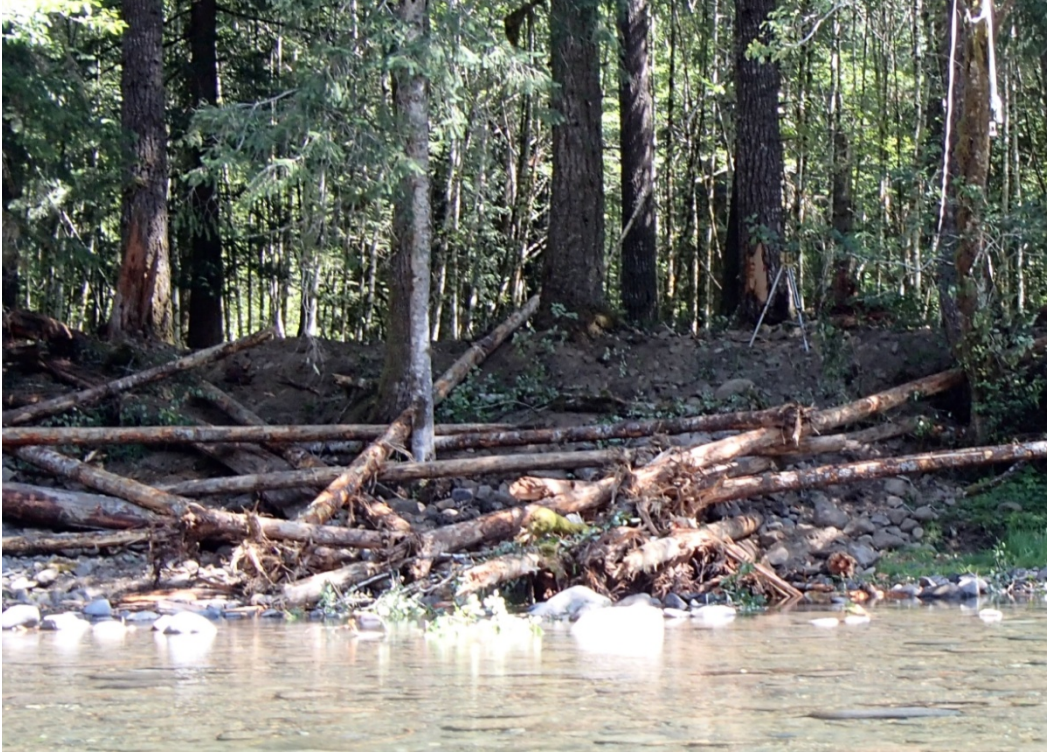
Structure 4 - Looking right bank to left bank

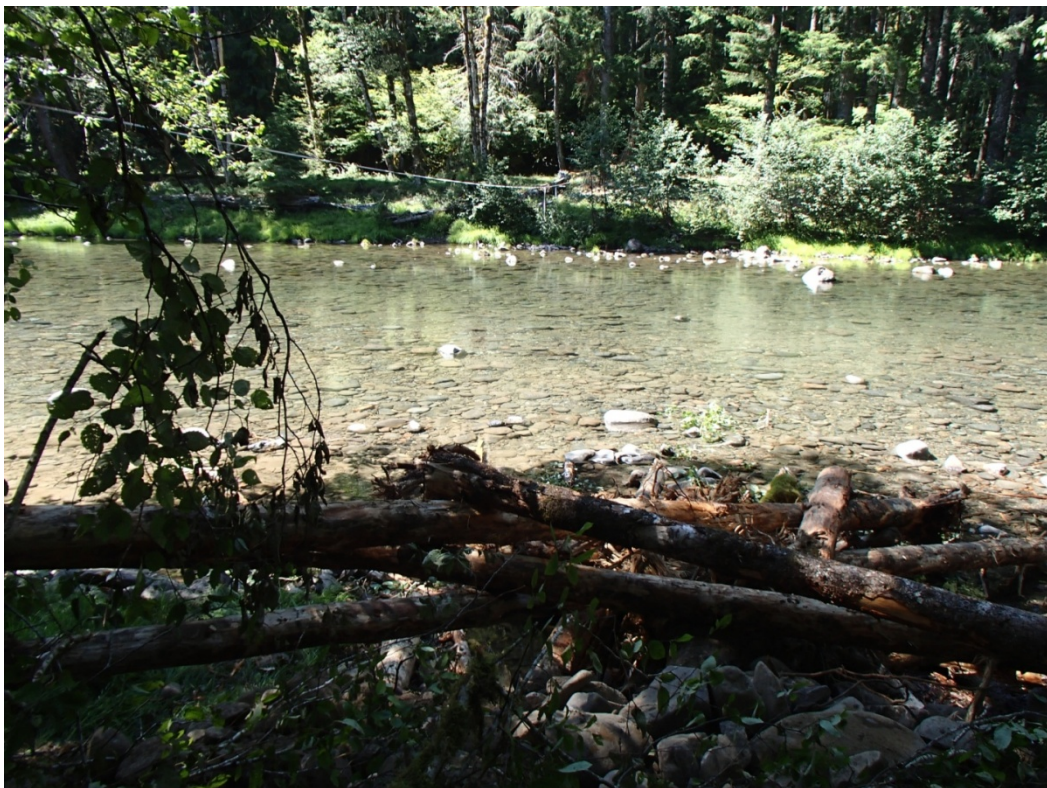
Structure 4 - Looking left bank to right bank

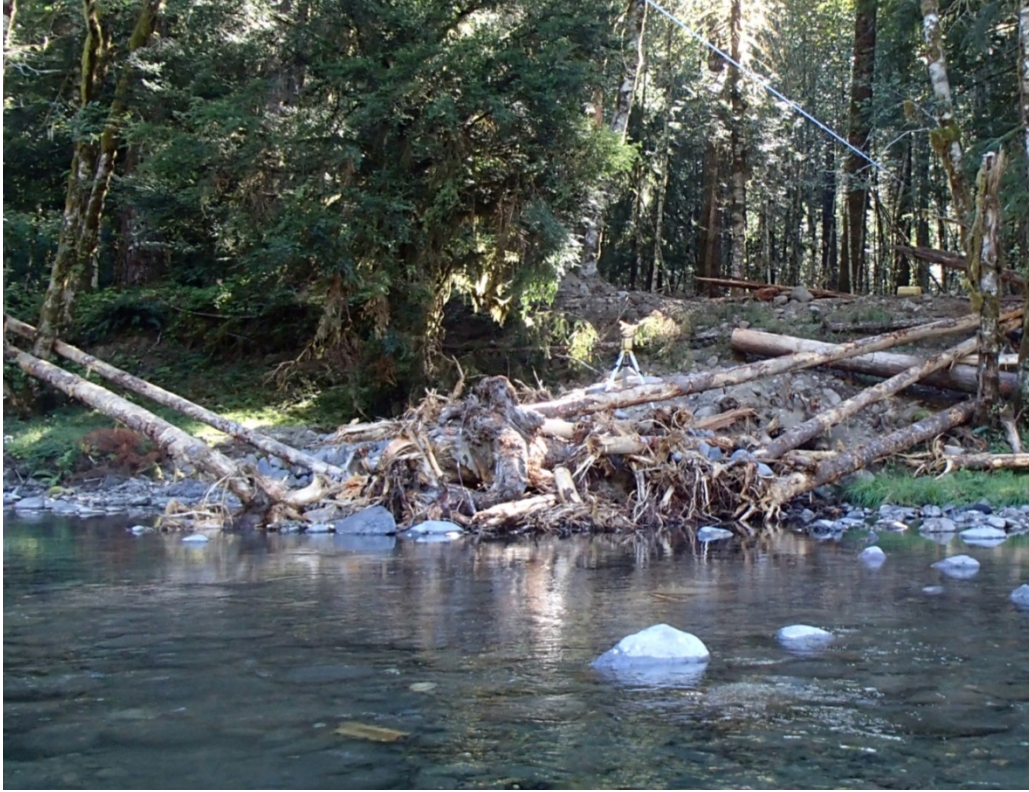
Structure 5 - Looking right bank to left bank

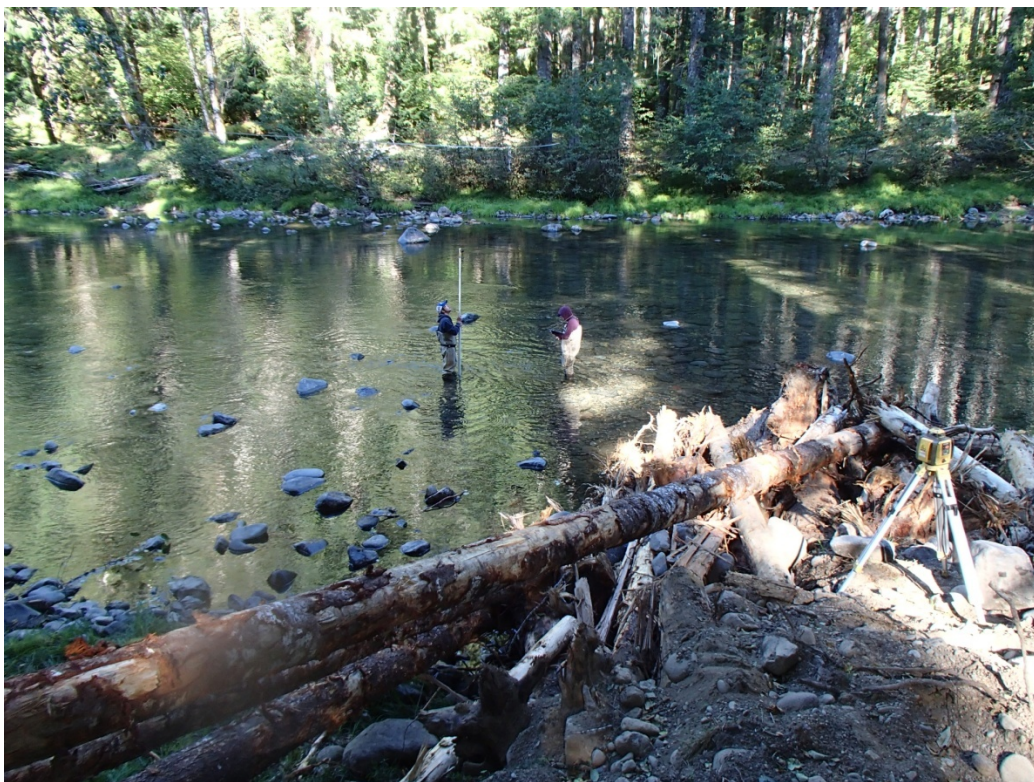
Structure 5 - Looking left bank to right bank

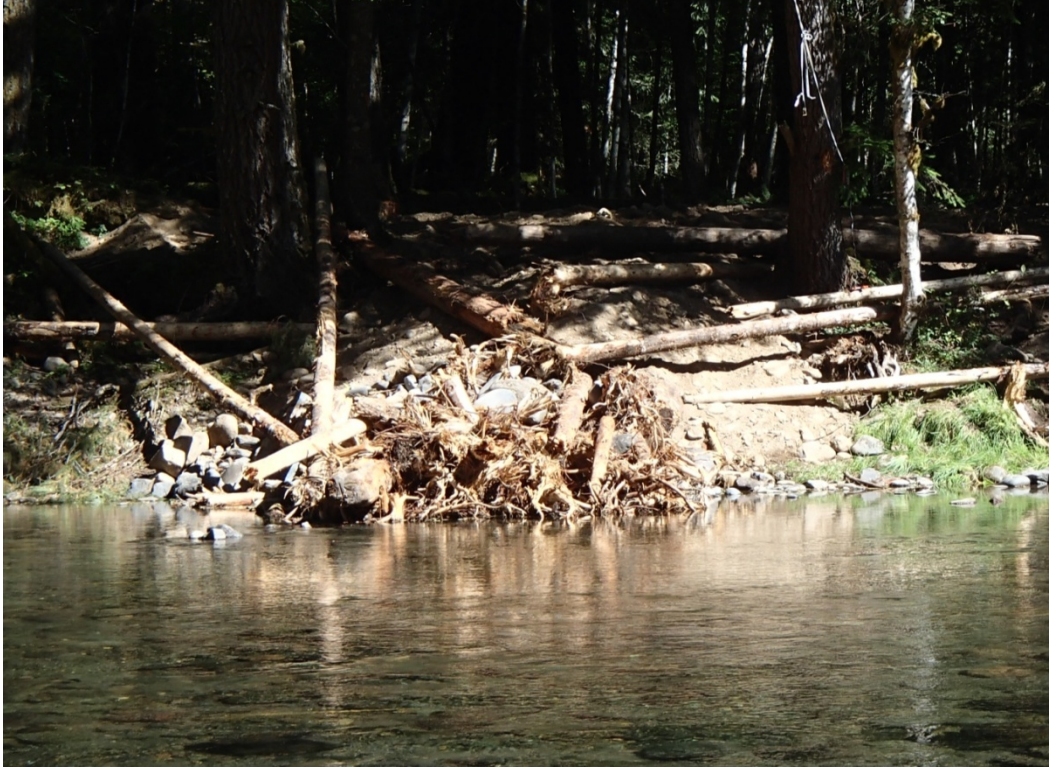
Structure 6 - Looking right bank to left bank
