Lewis River Aquatic Fund Projects (SA 7.5.3.2)

Project Closeout Report

Project Title: Lewis River Hydroelectric Project
Lewis River Side Channel 5

Lewis River Mainstem Fish Habitat Restoration 2016

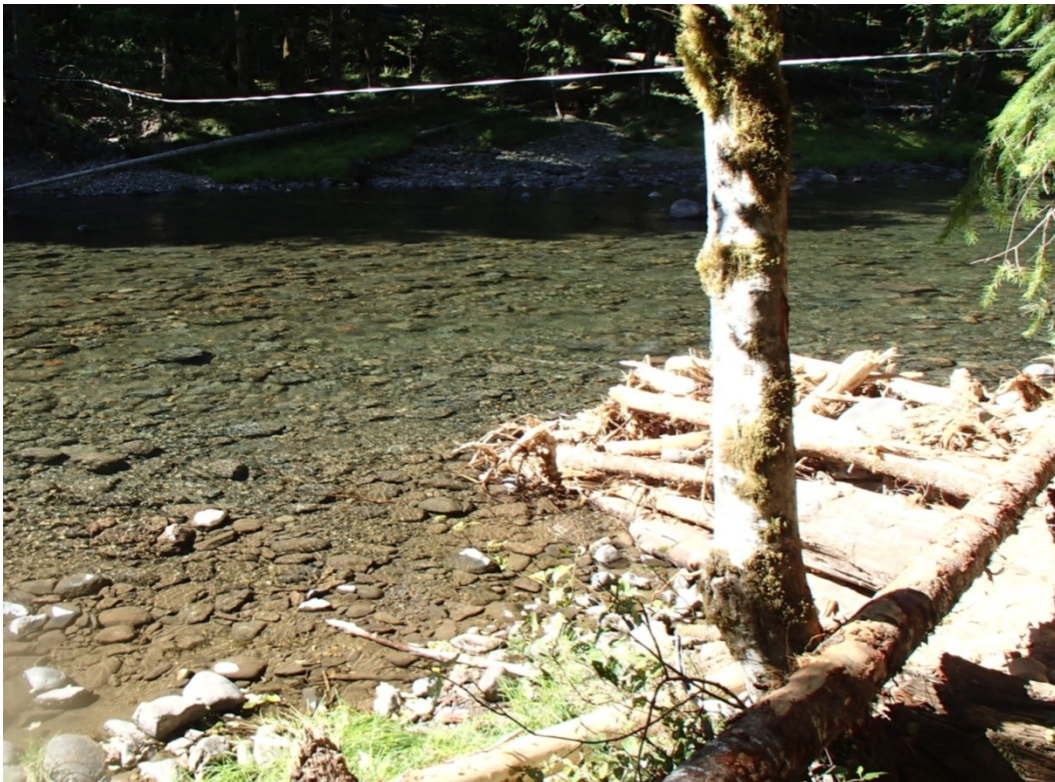
Structure 6 - Looking left bank to right bank

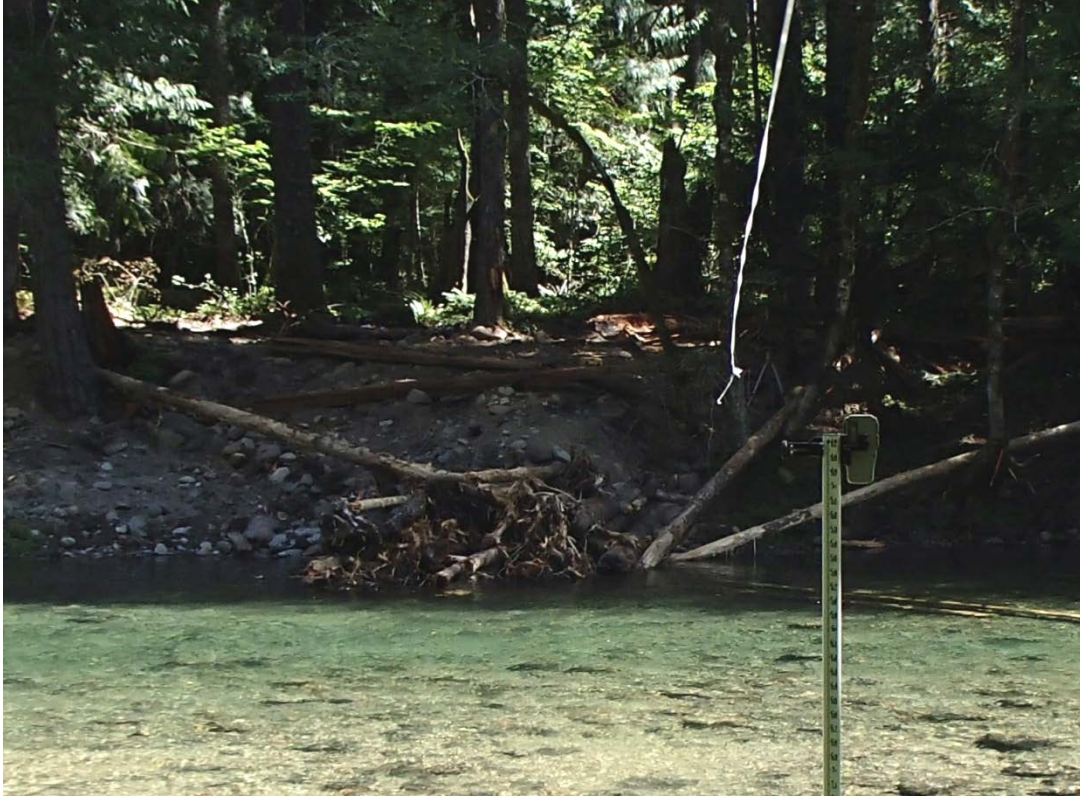
Structure 7 - Looking right bank to left bank

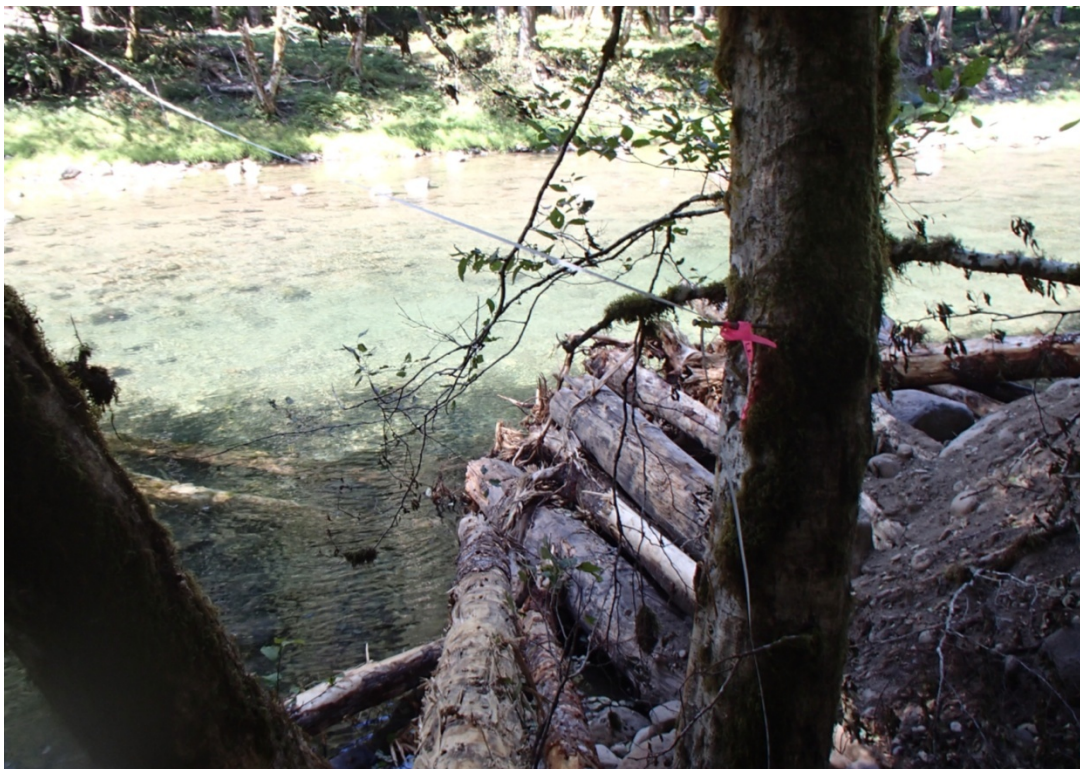
Structure 7 - Looking left bank to right bank

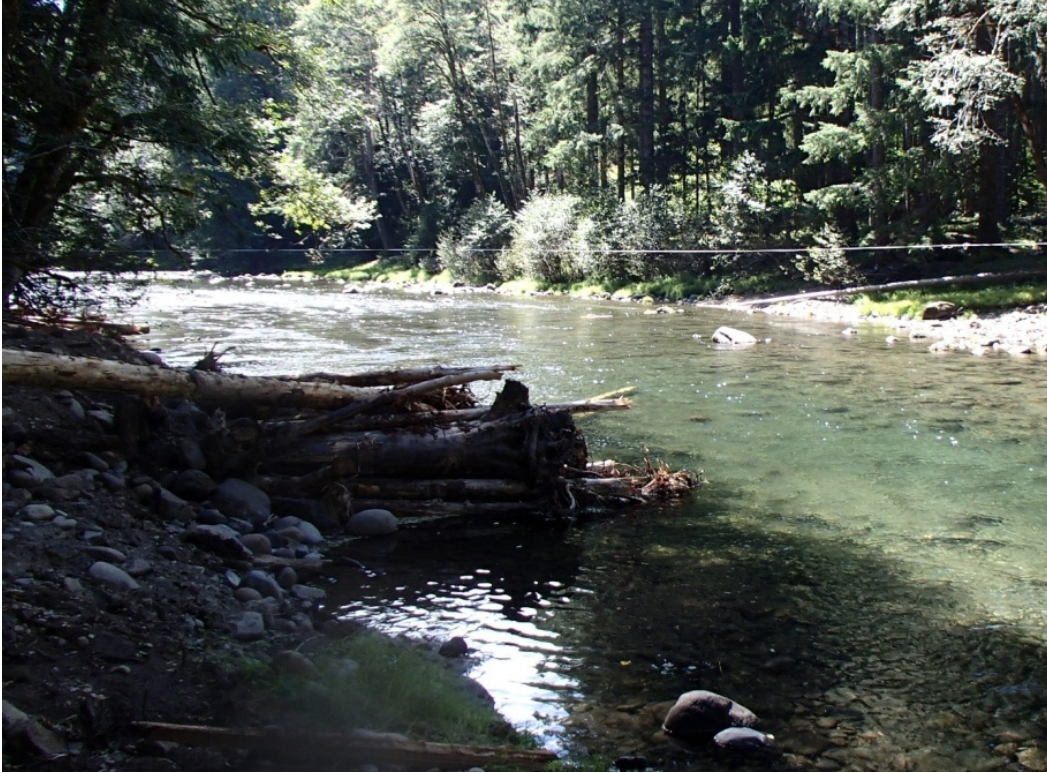
Structure 7 - Looking upstream to downstream along the left bank

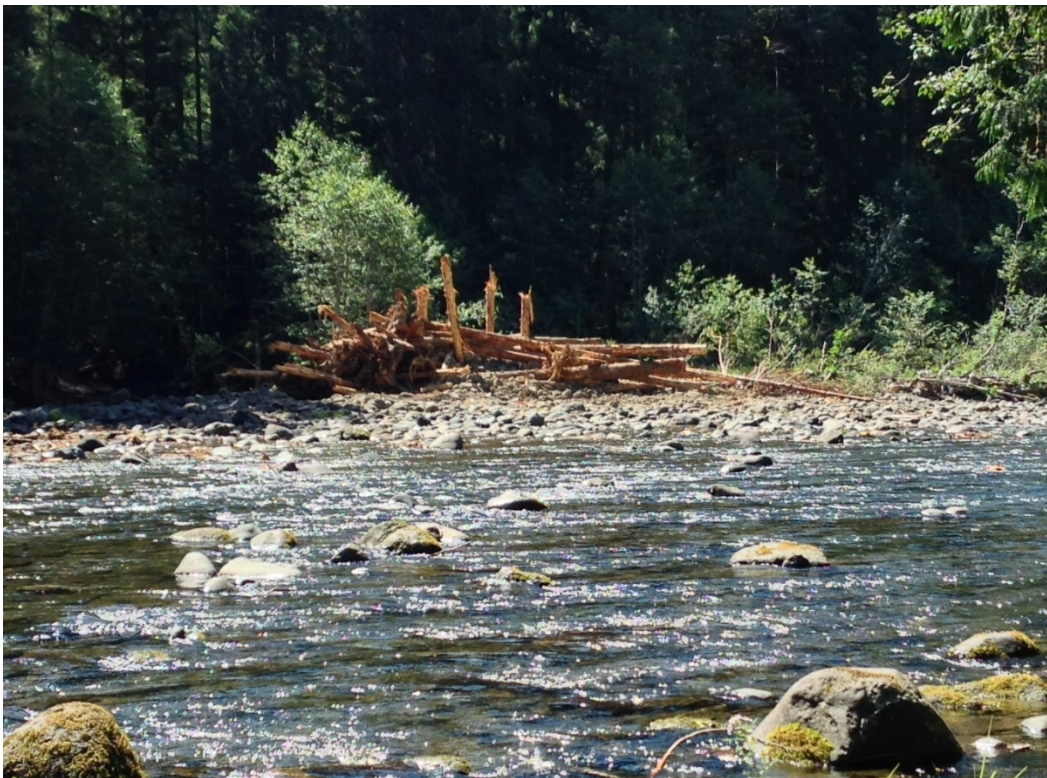
Non-numbered structure apex log jam on rocky island in center of channel, below other structures

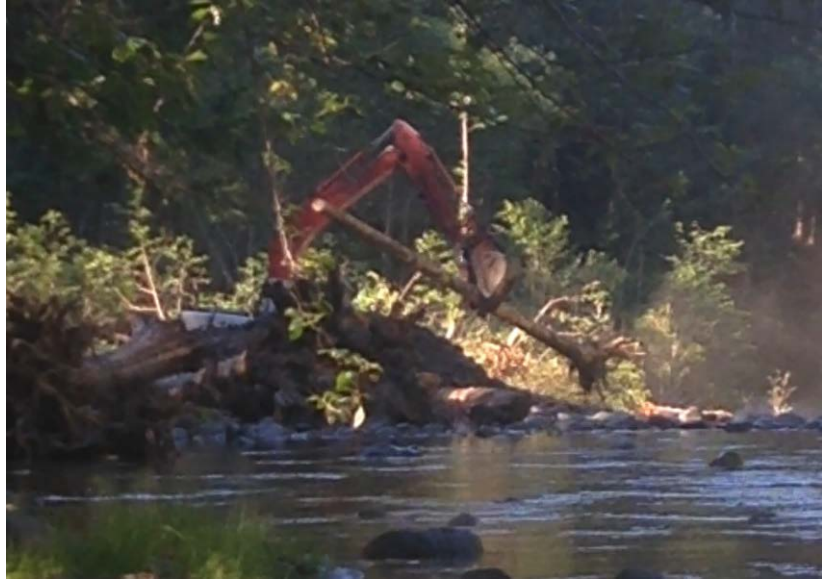
Excavator creating apex log jam

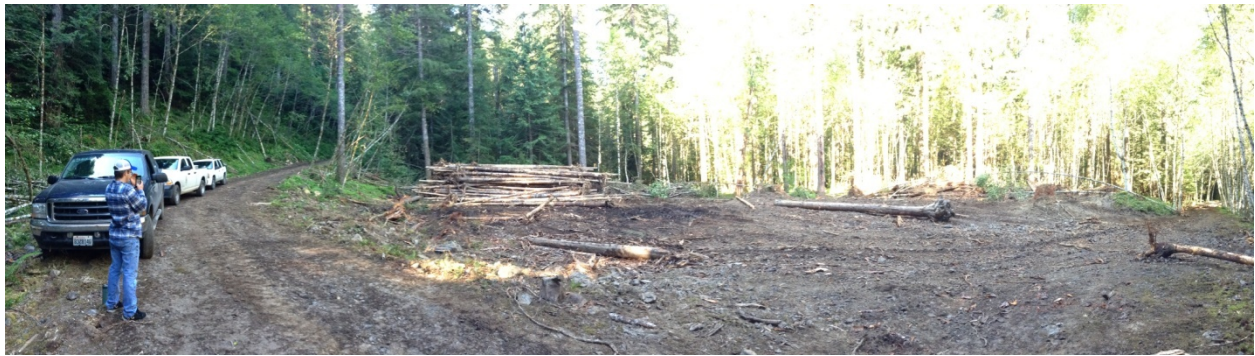
Storage area for logs and machinery at the end of spur road 9000480

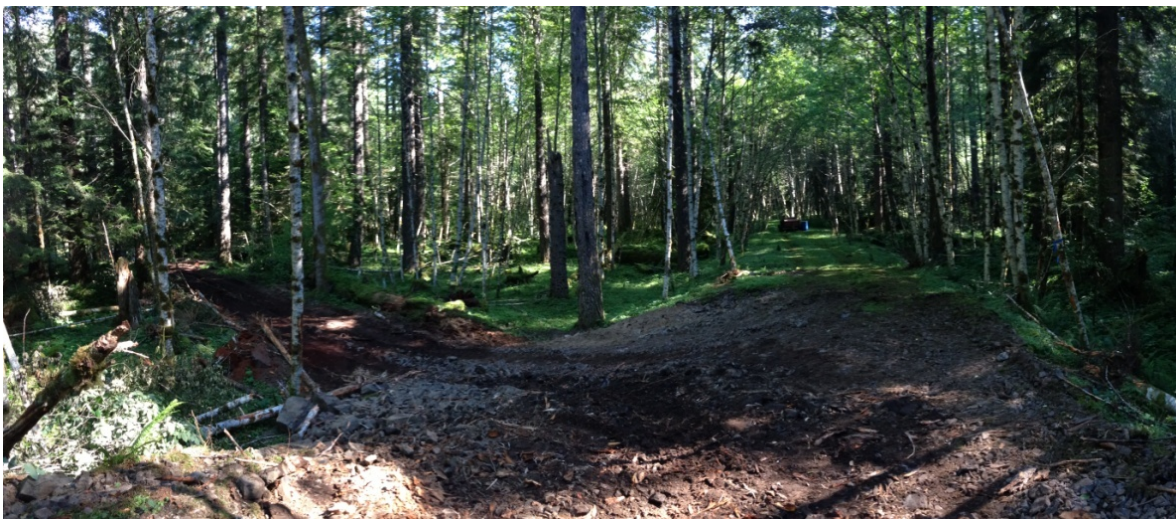
End of spur road 9000480 and beginning of skid trail to North Fork Lewis River

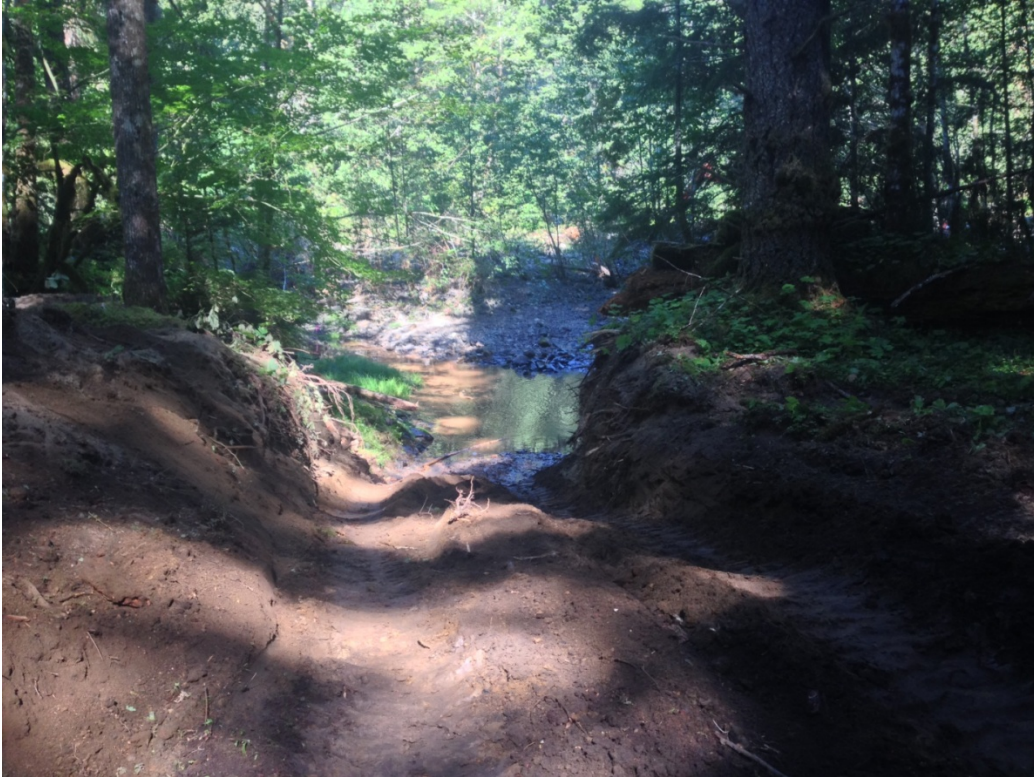
Skid trail accessing the North Fork Lewis River

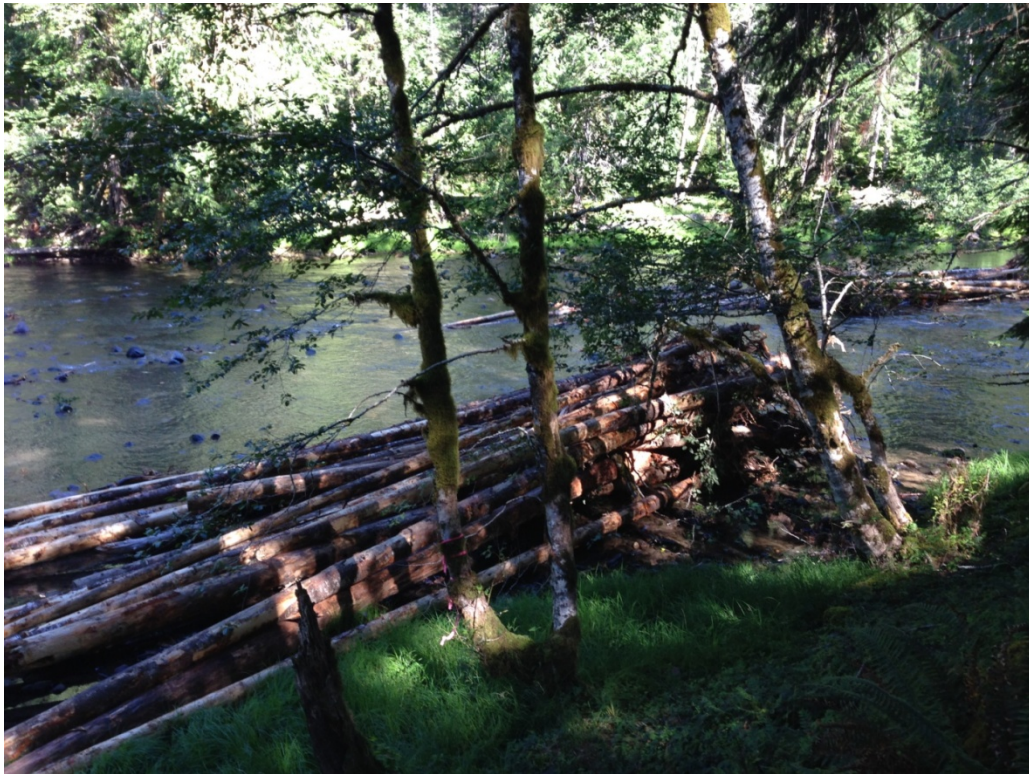
Logs placed into piles in the river before installation

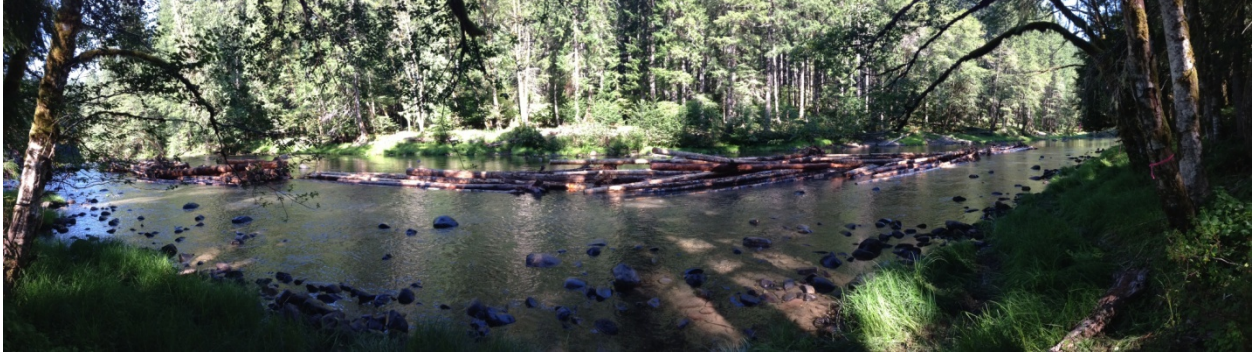
Logs placed into piles in the river before installation

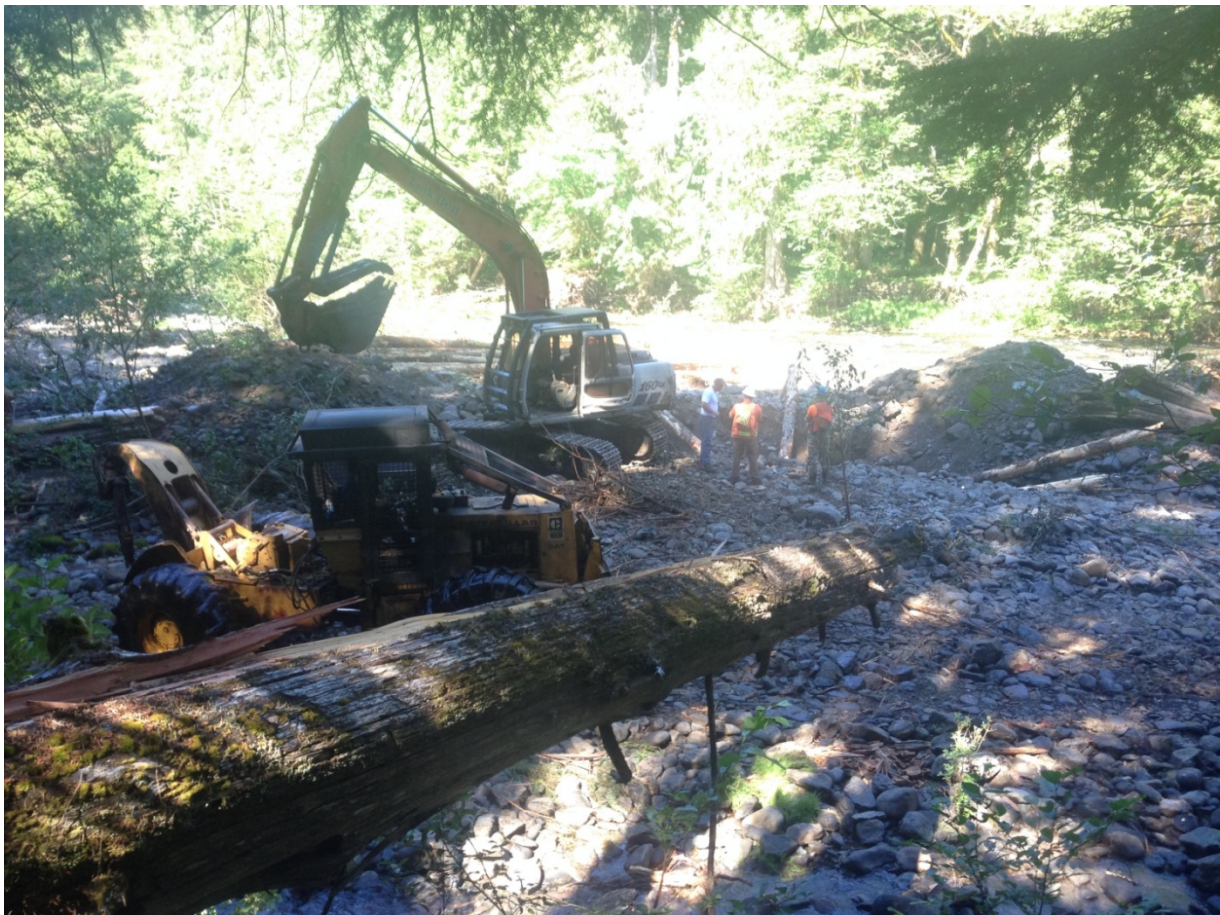
Skidder placing logs, excavator building apex log jam

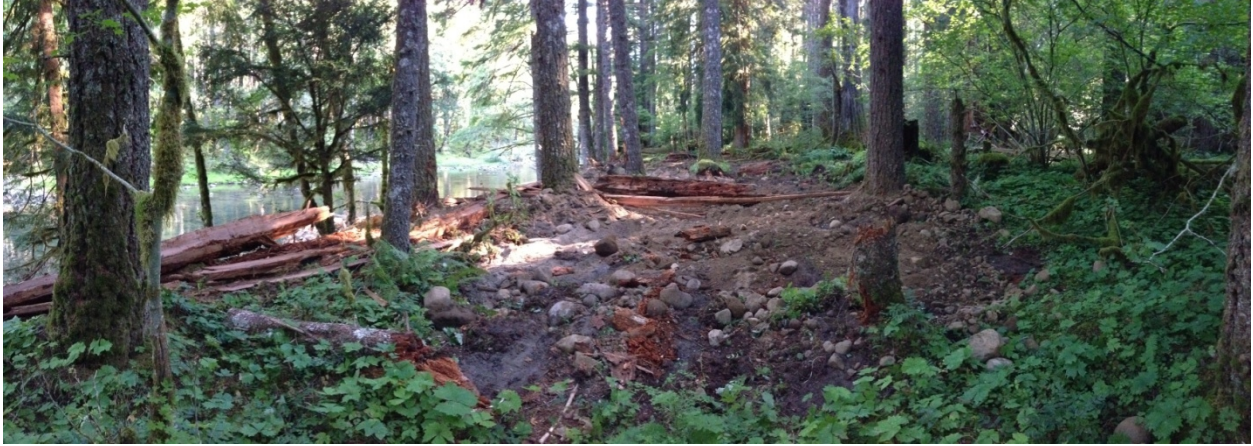
Top of river bank after installation of structures, trenches have been backfilled to maintain level ground

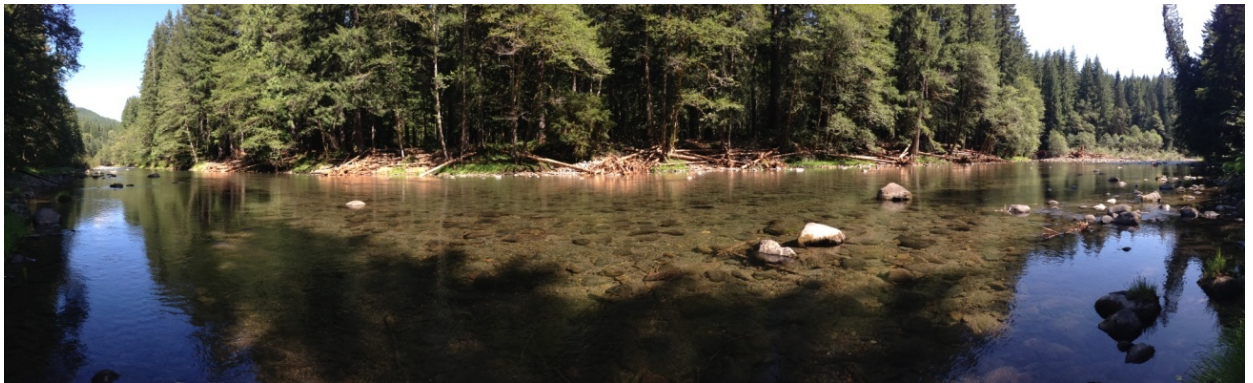
Panorama from right bank showing all 8 structures
