5.0	TER	TERRESTRIAL RESOURCES
5.1	TER 1	Vegetation Cover Type Mapping
5.2	TER 2	Habitat Evaluation Procedure (HEP) Study
	Appendix 1	HEP Team Meeting Notes
	Appendix 2	Lewis River HEP Models
	Appendix 3	Datasheets
	Appendix 4	Snag and Shrub Statistics
	Appendix 5	Successional Rules
	Appendix 6	AAHU Calculations by Habitat Segment
5.3	TER 3	Analysis Species Assessment
	Appendix 1	Species / Habitat Associations
5.4	TER 4	Botanical Surveys
	Appendix 1	TES Plant Species
5.5	TER 5	Wetland Information Synthesis
5.6	TER 6	Reservoir Fluctuation Study
5.7	TER 7	Tributary Stream Study
5.8	TER 8	Forest Harvest Practices Assessment
	Appendix 1	Glossary of Terms
	Appendix 2	Fire Ecology and History
5.9	TER 9	Riparian Habitat Information Synthesis

5.9 RIPARIAN HABITAT INFORMATION SYNTHESIS (TER 9)

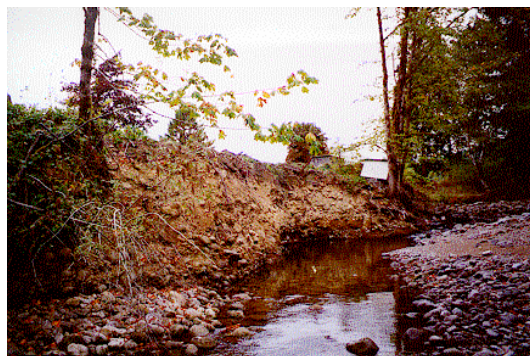
Erosion upstream of Speelyai canal diversion

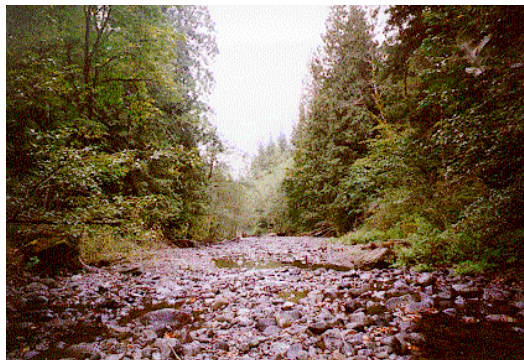
Channel upstream of Speelyai canal diversion

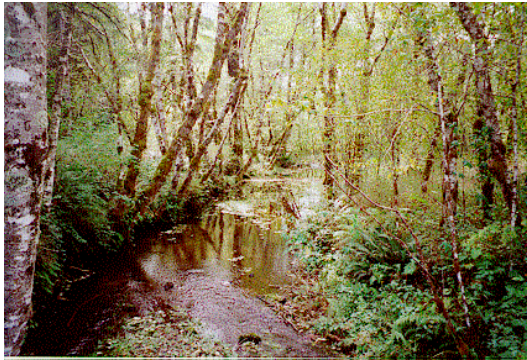
Riparian habitat downstream of Beaver Pond Rd.

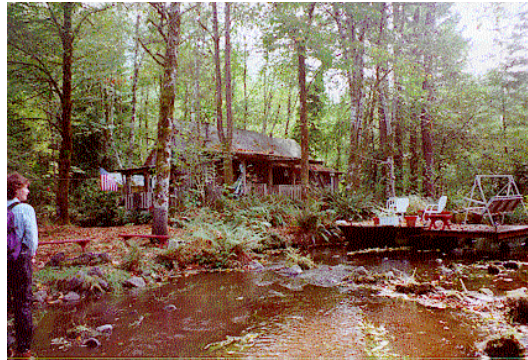
Development upstream of SR 503 bridge

The bankfull width of the channel between the canal diversion and the SR 503 bridge averages 27.3 ± 15.7 feet (8.3 ± 4.8 m), which is substantially narrower than the width upstream of the diversion (Table 5.9-4), likely the result of lower overall flows. The wetted channel under low flow conditions covers approximately 56 percent of the entire channel width. This reach is bordered by substantially more riparian vegetation than upstream of the diversion, averaging 20.1 ± 12.7 feet (6.1 ± 3.9 m) for both sides combined. On average, there are about 10.1 ± 14.1 feet (3.1 ± 4.3 m) of riparian vegetation growing in the channel between the bankfull and wetted levels. There are also some off-channel areas with well-developed riparian and wetland habitats, some of which include houses (see photos above). Much of the upper half of this reach (from approximately the transmission line right-of-way [ROW] to Beaver Pond Road) is bordered by clearcuts. Although most of these occur on terraces above the riparian zone, some have clearly resulted in erosion and contributed sediment to the creek.

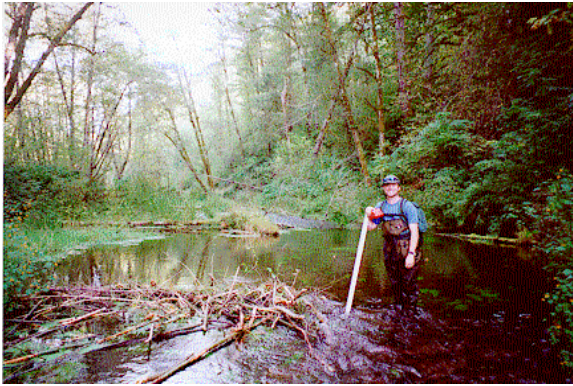
Beaver dam downstream of SR 503 bridge

This lower section of Speelyai Creek has more than 28 beaver dams (>10.8/mile [6.7/km]), which created complex, and often very wide, areas of riparian habitat (see photo below). There are also large amounts of instream wood, logjams, and root wads (Table 5.9-5). The combined width of riparian vegetation along both sides of this reach averages 86.9 ±123 feet (26.5 ± 37.4 m) and ranges up to 524 feet (160 m) just below the SR 503 bridge (Table 5.9-4). In this area, the combination of a series of beaver dams and flat topography has resulted in a large, complex of wetlands and stands of riparian deciduous forest.

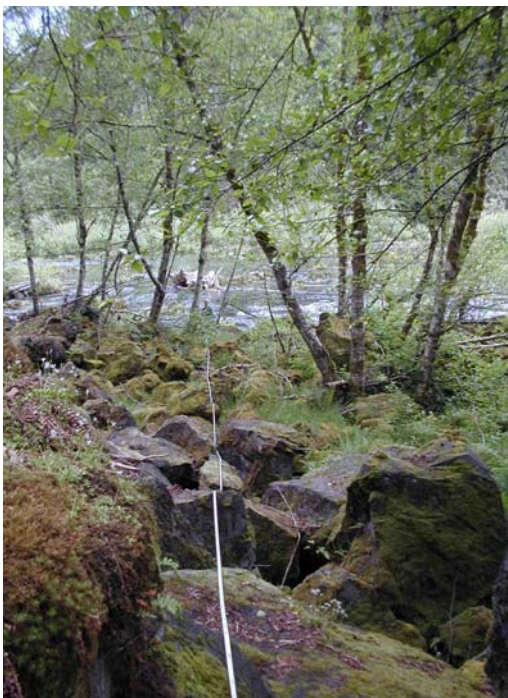
Alder stand along Transect No. 1

Left Bank. Vegetation along the left bank of Transect No. 1 was divided into 3 major zones: (1) a band of red alder with salmonberry, lady fern, three-square bulrush (*Scirpus americanus*), rushes, and trailing blackberry; (2) a bench of talus with lady fern and reed canarygrass; and (3) a steep bedrock/talus area with red alder and moss (Figure 5.9-5). The lowermost alder-dominated zone is about 25.5 feet (7.8 m) wide and extends from approximately 0.8 foot (0.25 m) below to 1.3 feet (0.4 m) above normal water surface level. The IFIM data indicate that a small berm forms the shoreline within this zone. The middle zone is approximately 21.2 feet (6.5 m) wide and is 1.3 to 2 feet (0.4 to 0.6 m) above the normal water surface level. The uppermost zone is 36.4 feet (11 m) long and ranges between 2 and 11.1 feet (0.6 and 3.4 m) above the current water level.

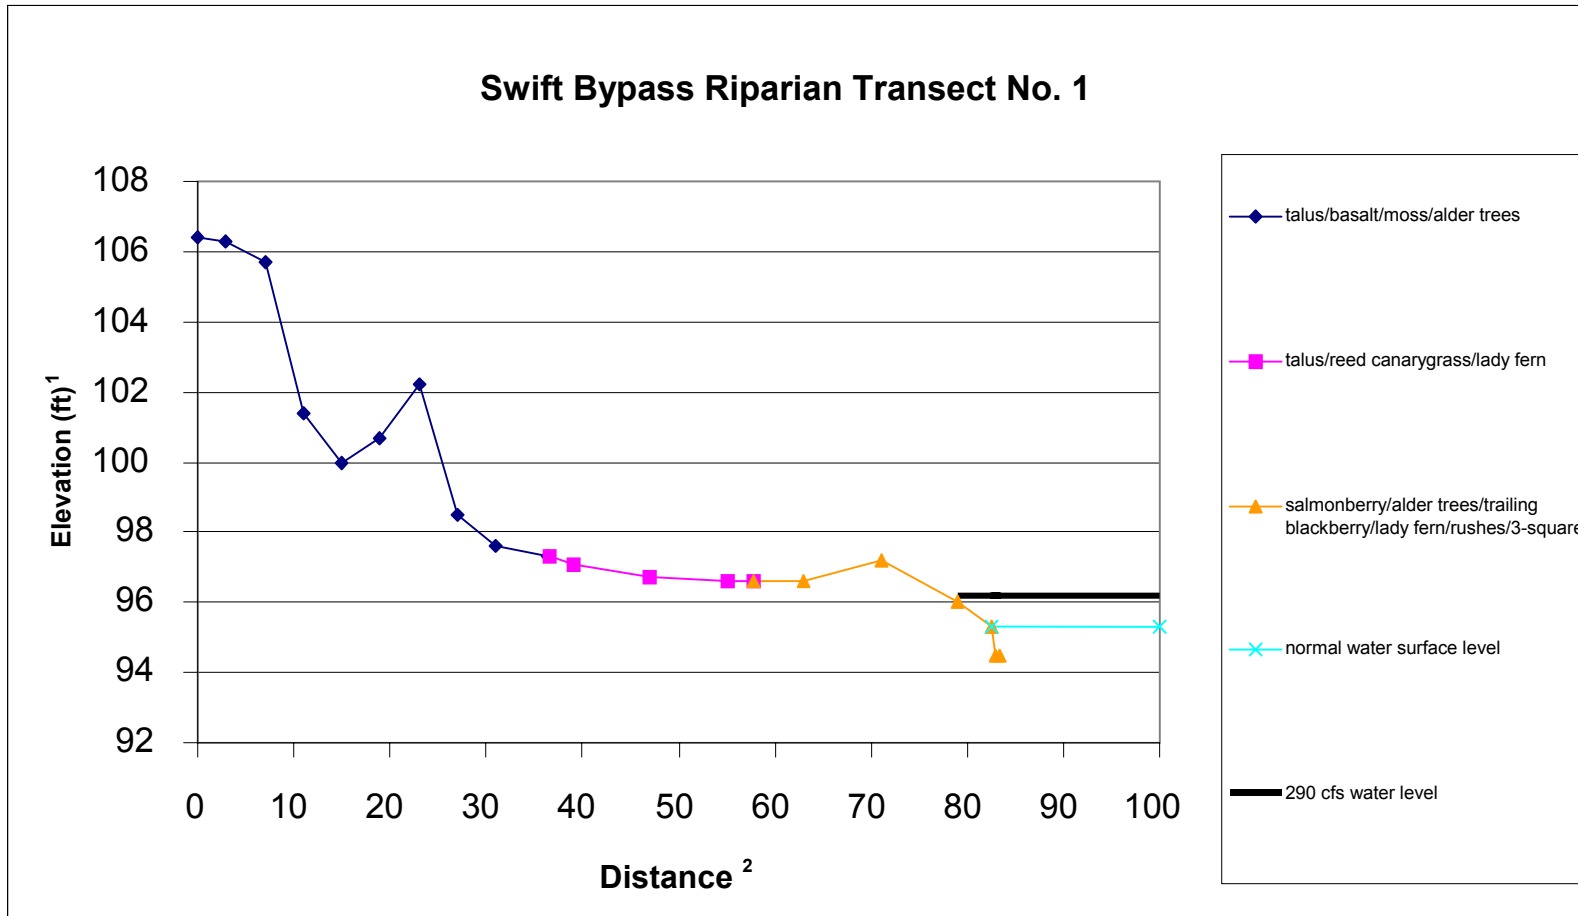
Figure 5.9-5. Vegetation cross section along left bank of Swift bypass reach Riparian Transect No. 1 with normal surface and 290 cfs release water levels.

¹ Elevations are standardized to 100 feet; corrected elevations (above sea level) are not available for this transect.

² Linear distance along the transect starting at farthest point from the main channel left bank.

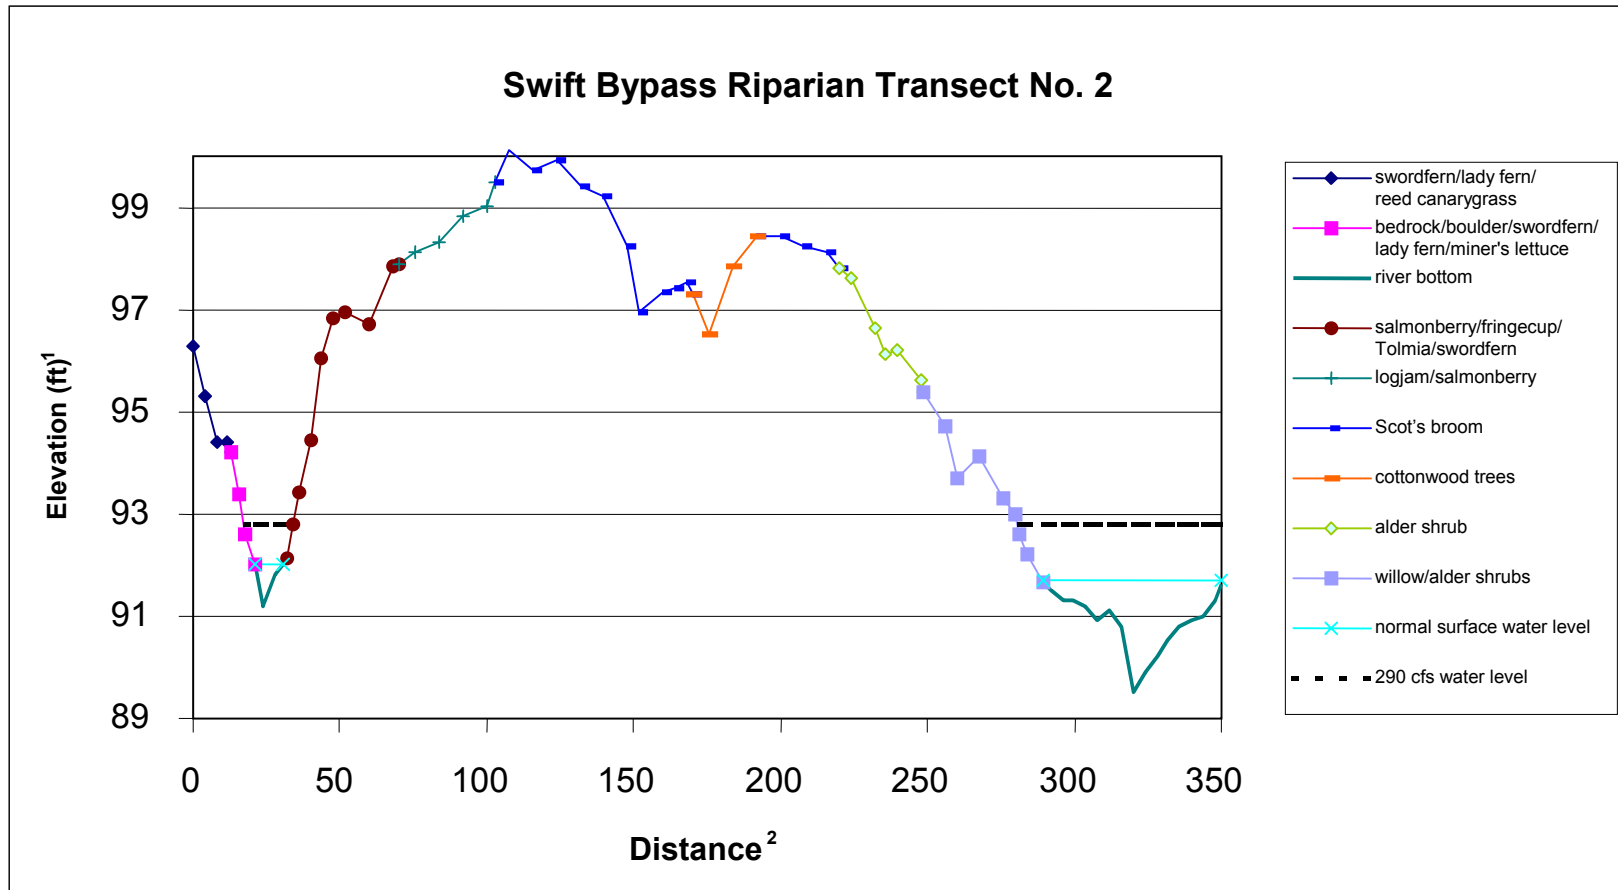
Figure 5.9-6. Vegetation cross section along left bank of Swift bypass reach Riparian Transect No. 2 with normal surface and 290 cfs release water levels.

¹ Elevations are standardized to 100 feet; corrected elevations (above sea level) range from 500.5 to 511.1 feet.

² Linear distance along the transect starting at farthest point from the main channel left bank.

Riparian Transect No. 2. Riparian Transect No. 2 is located approximately 0.1 mile (0.2 km) upstream of the bridge at the upper end of Yale Lake, just upstream of a sharp northerly bend in the river (Figure 5.9-4). In all, the transect covered 289 feet (88 m) between the upland end and the left bank (looking upstream) of the main river channel. The transect crosses 1 small side channel near the riparian/upland boundary. Much of the vegetation consists of species that occur both in upland and riparian habitats. Riparian shrubs and trees (salmonberry, willow, and alder) occupy nearly 108 feet (33 m), or 37 percent, of this transect (Figure 5.9-6). A combination of willow and alder shrubs are found in a 41 foot (12 m) wide band immediately adjacent to the main channel. The willows range between 0 and 3.7 feet (1.1 m) above the normal water surface level. Alder shrubs dominate a 29 foot (8.8 m) wide band just upslope of the willows. Mature cottonwood trees occupy a zone that is 22 feet (6.7 m) wide and 5 to 6 feet (1.5 to 2 m) above the 0 cfs release water level (Figure 5.9-6). The highest zones along the transect have been severely scoured and have large accumulations of coarse woody material, presumably deposited by the 1996 flood. Most of this zone is infested with Scot's broom.

Increasing releases to 290 cfs raised the water levels by about 1.2 feet (0.4 m) in the river channel. This increase would flood approximately 6.5 feet (2 m) (horizontal distance) or 16 percent of the willow/alder shrubs along the left bank of the main channel (Figure 5.9-6). The increase would also inundate about 1.8 feet (0.5 m) of salmonberry-dominated shorelines along the side channel. The increased water levels could increase cover of

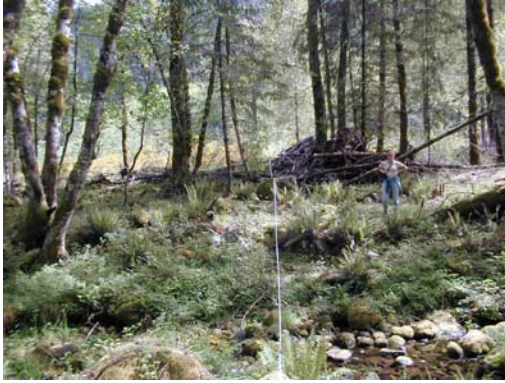
Riparian habitat along Transect No. 2

hydrophytic plant species at the higher elevations along the transect. No data were collected on the right bank, but it appears that approximately 10 feet (3 m) of riparian habitat would be inundated by a 290 cfs release.

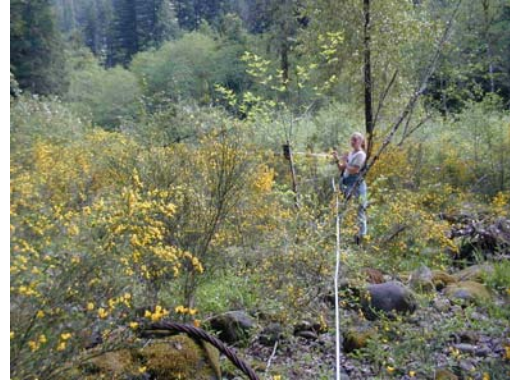
Scot's broom infestation along Transect No. 2

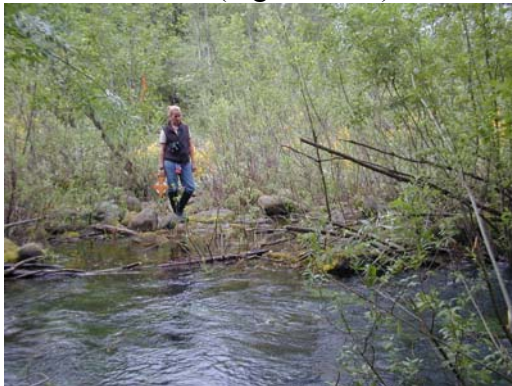
Flooded riparian shrubs along Transect No. 3 during a 300 cfs release

It is also likely that higher flows, particularly 400 cfs, would result in the formation of additional side channels in the bypass reach. A new side channel was observed at Riparian Transect 3 during the controlled release of 290 cfs.

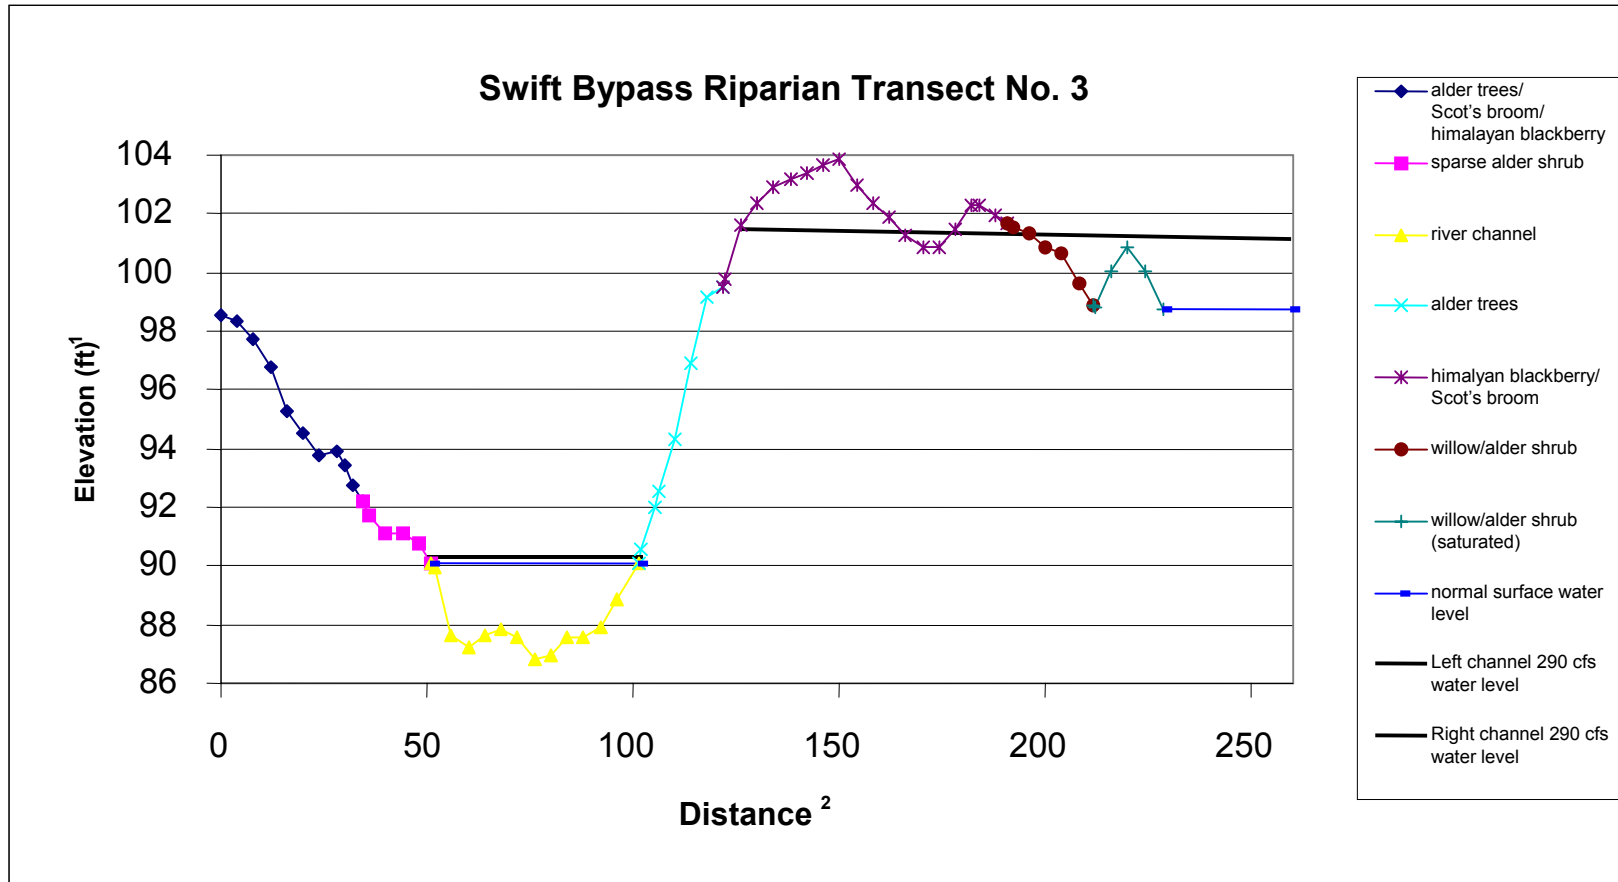
Figure 5.9-7. Vegetation cross section along left bank of Swift bypass reach Riparian Transect No. 3 with normal and 290 cfs release water levels.

¹ Elevations are standardized to 100 feet: corrected elevations (above sea level) range from 555.0 to 573.0 feet.

A 38-foot-wide (12 m) band of alder and willow shrubs borders the main channel and is within 2 feet (0.7 m) of the water surface elevation; a portion of the band has a saturated substrate (Figure 5.9-7). Immediately adjacent to this densely vegetated band is a 69-foot-wide (21 m) zone dominated by Scot's broom and Himalayan blackberry. The 10-foot-high (3 m) embankment along the right bank of the side channel is vegetated with alder trees; the left side also supports alder but includes areas of Scot's broom and blackberry as well.

The IFIM Study predicts that a 290 cfs release would increase the water level in the main channel by approximately 2.7 feet (0.8 m) from the normal water surface level (Figure 5.9-4). However, the water level in the side channel would only increase by approximately 2.4 inches (6.1 cm). It is possible that a permanent increase in the main channel minimum flow would result in accretion flow into the side channel as groundwater levels rise. A 290 cfs increase would inundate essentially all of the willow/alder

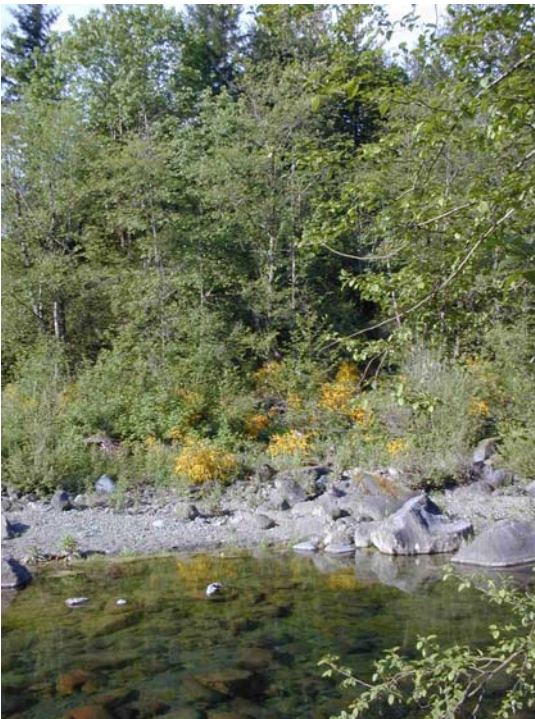
Riparian habitat at Transect No. 4

Riparian Transect No. 4. Transect 4 is near the stream gaging station just downstream of Swift Dam (Figure 5.9-4). The channel is not divided, and the left bank is confined by the artificially contoured slope of the Swift canal. Numerous large boulders occur along the transect line. The transect on the left bank was 27 feet (8.2 m) long. An 11-foot-wide (3.4 m) band of willow borders the river channel and extends from the water's edge to about 2 feet (0.6 m) above that level (Figure 5.9-8). The remainder of the transect is dominated by boulders and various upland herbaceous plant species.

Increasing flows by 290 cfs raises the water level at Transect No. 4 by 2.6 feet (0.8 m), and inundates the entire shrub community, as well as a small portion of the toe slope of the Swift canal (Figure 5.9-8). On May 18, 2000 when 290 cfs flows were released from Swift Dam, the shrub zone was flooded to a depth of 0.4 feet (0.1 m) (Figure 5.9-8).

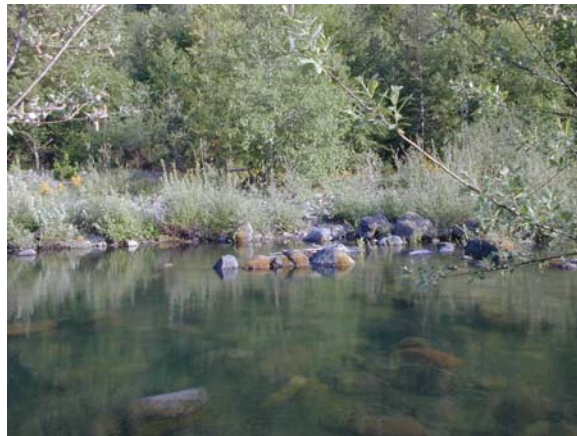
Side channel along Transect No. 4

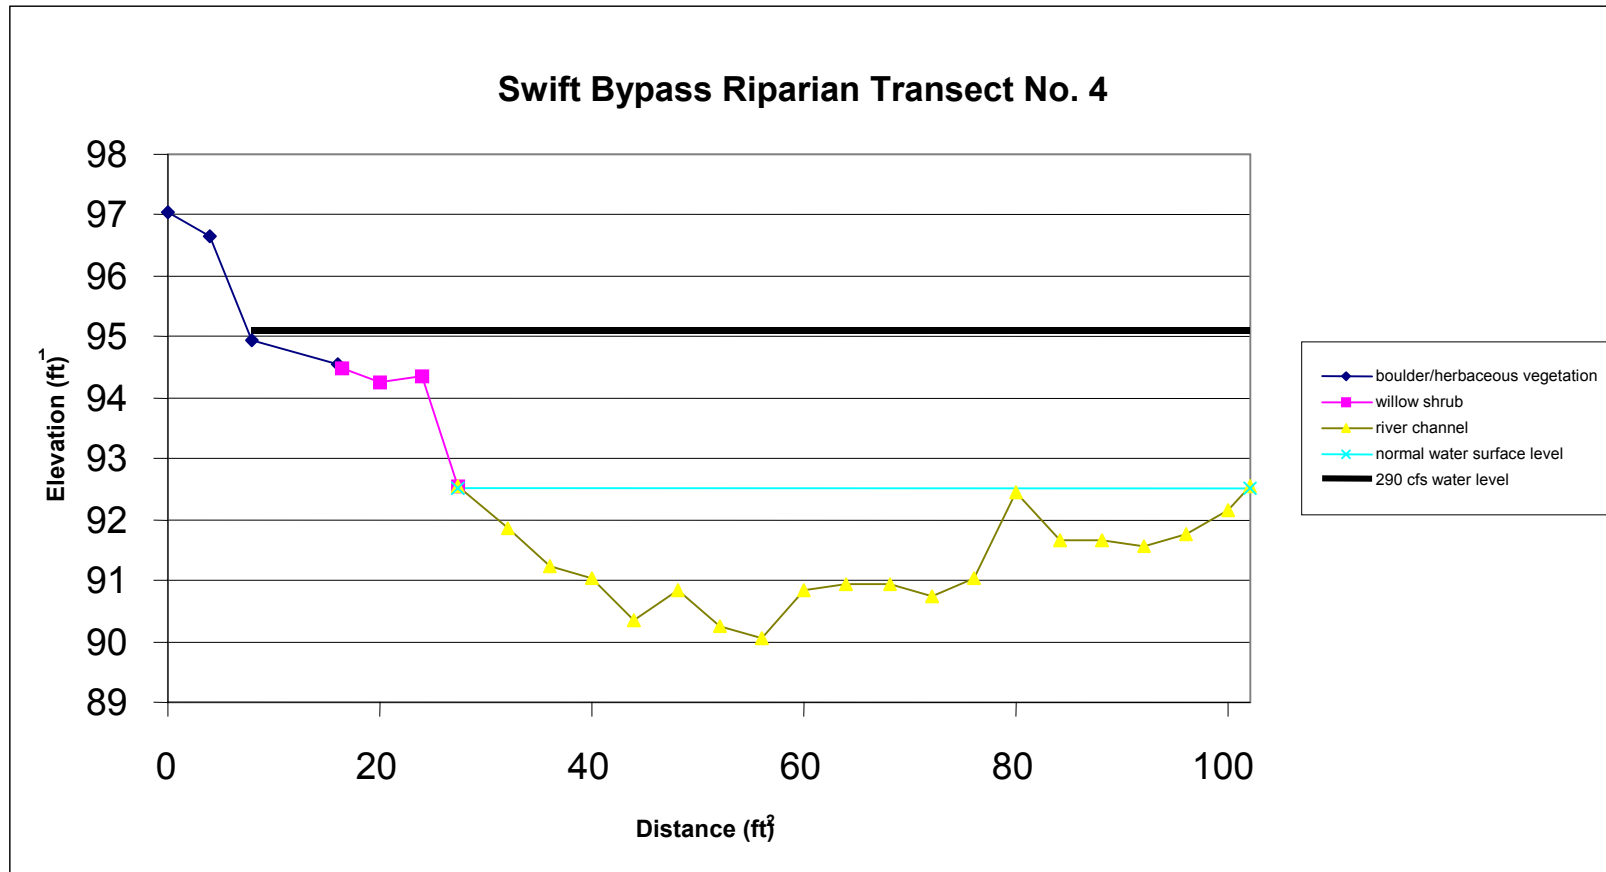
Figure 5.9-8. Vegetation cross section along left bank of Swift bypass reach Riparian Transect No. 4 with normal surface and 290 cfs release water levels.

¹ Elevations are standardized to 100 feet; corrected elevations (above sea level) are not yet available for this transect.
