WAQ 1 Appendix 7

*Plots of Vertical Profile In Situ Data for Swift and Merwin Reservoirs,
May 1999 – April 2000*

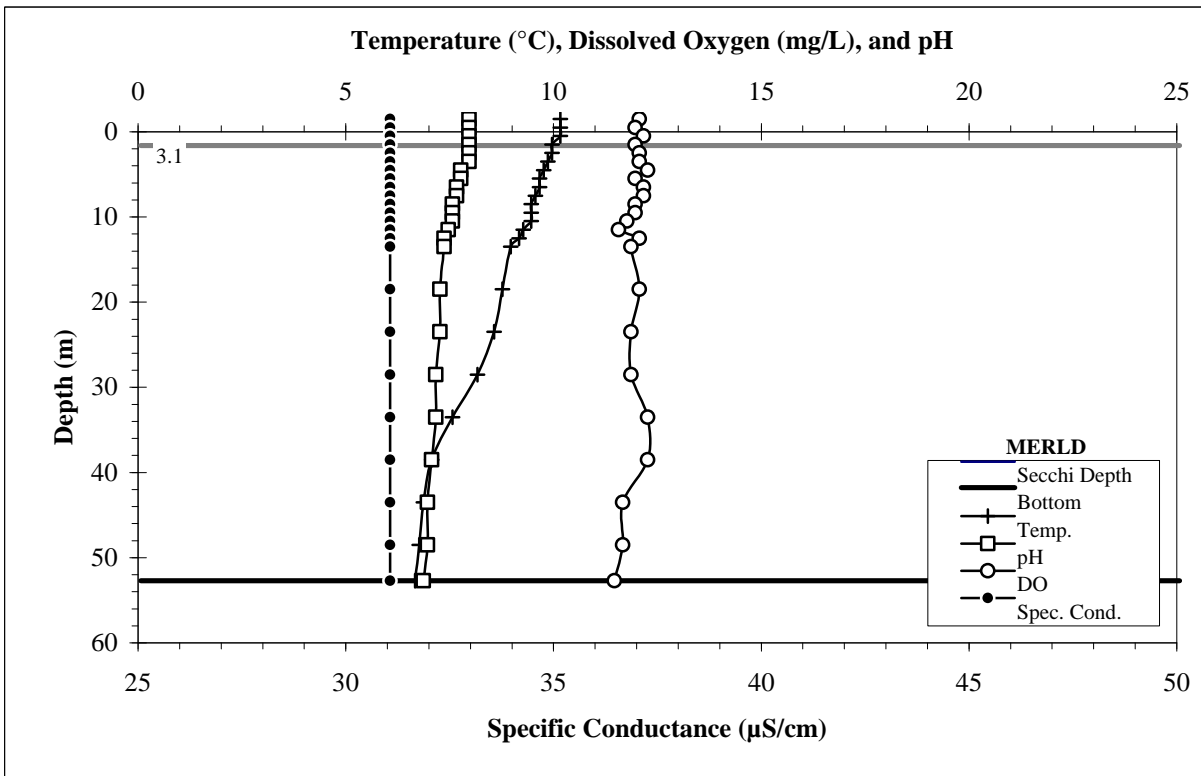
Figure WAQ1 Appendix 7(a). Vertical profile of periodic measurements at Merwin Lake near the dam (MERLD) in May 1999. Note: Could not monitor Swift Reservoir in May.

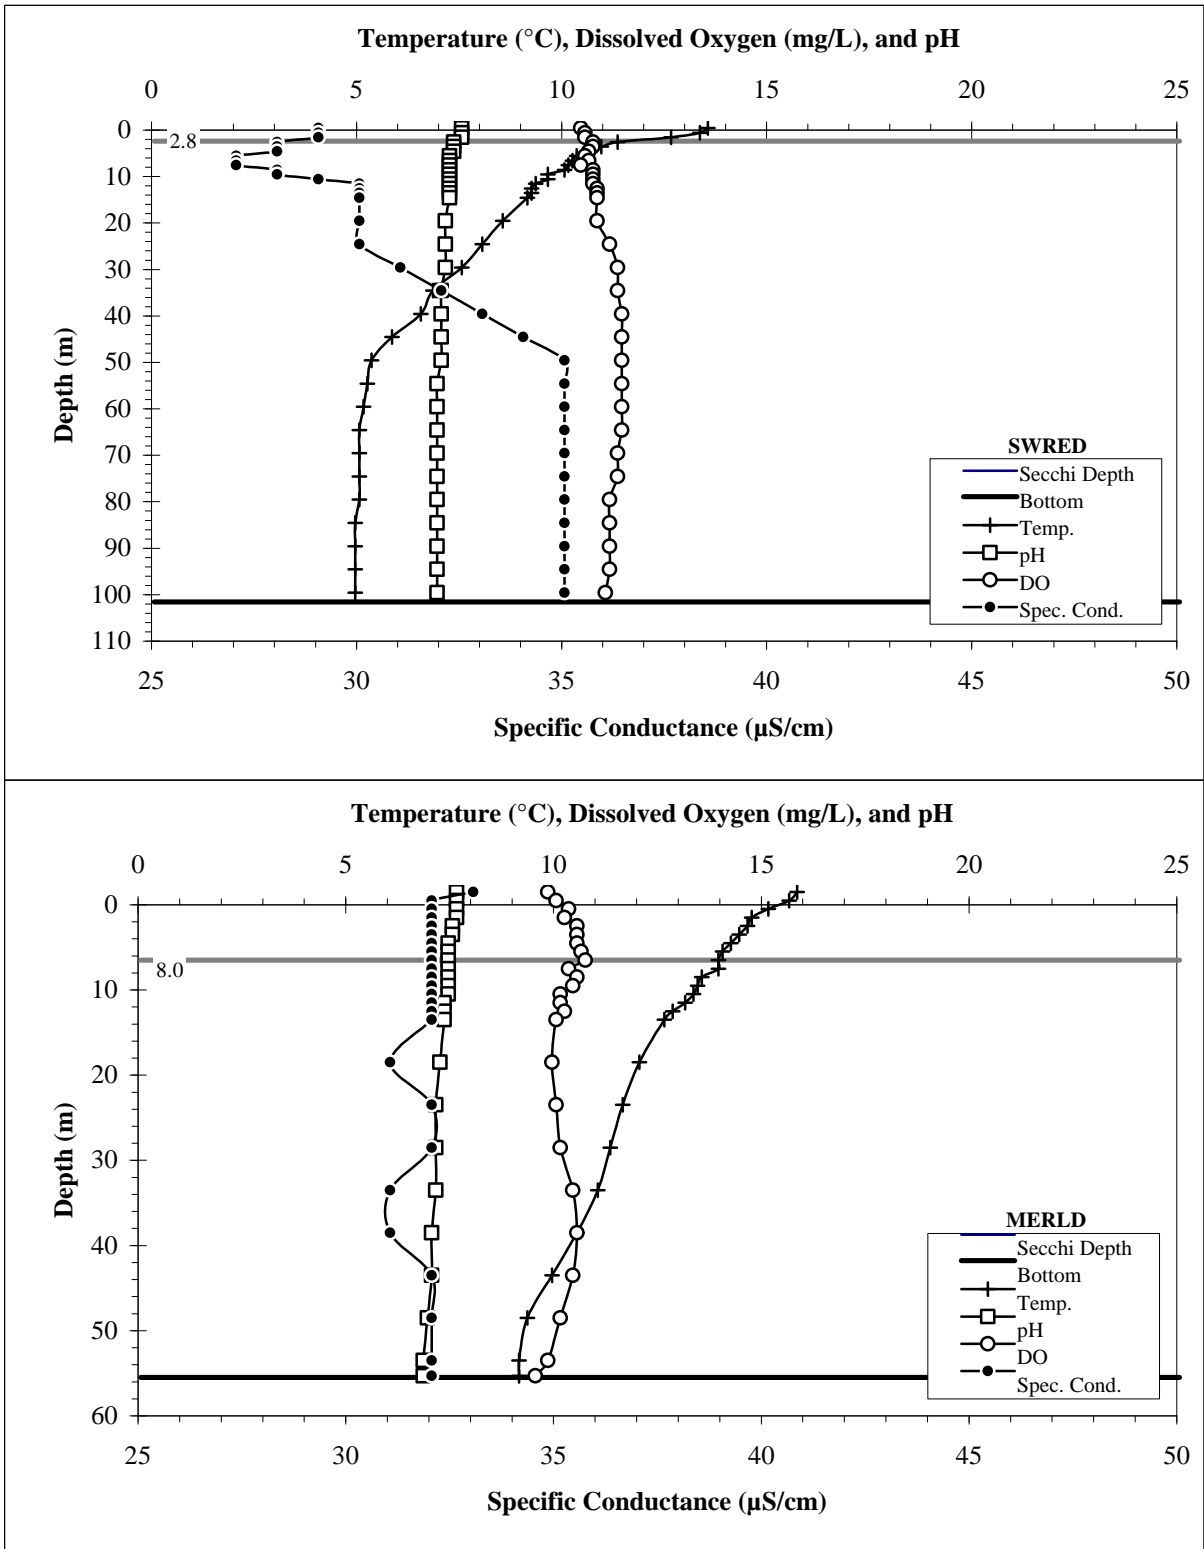
Figure WAQ1 Appendix 7(b). Vertical profile of periodic measurements at Swift Reservoir near the dam (SWRED) and Merwin Lake near the dam (MERLD) in June 1999.

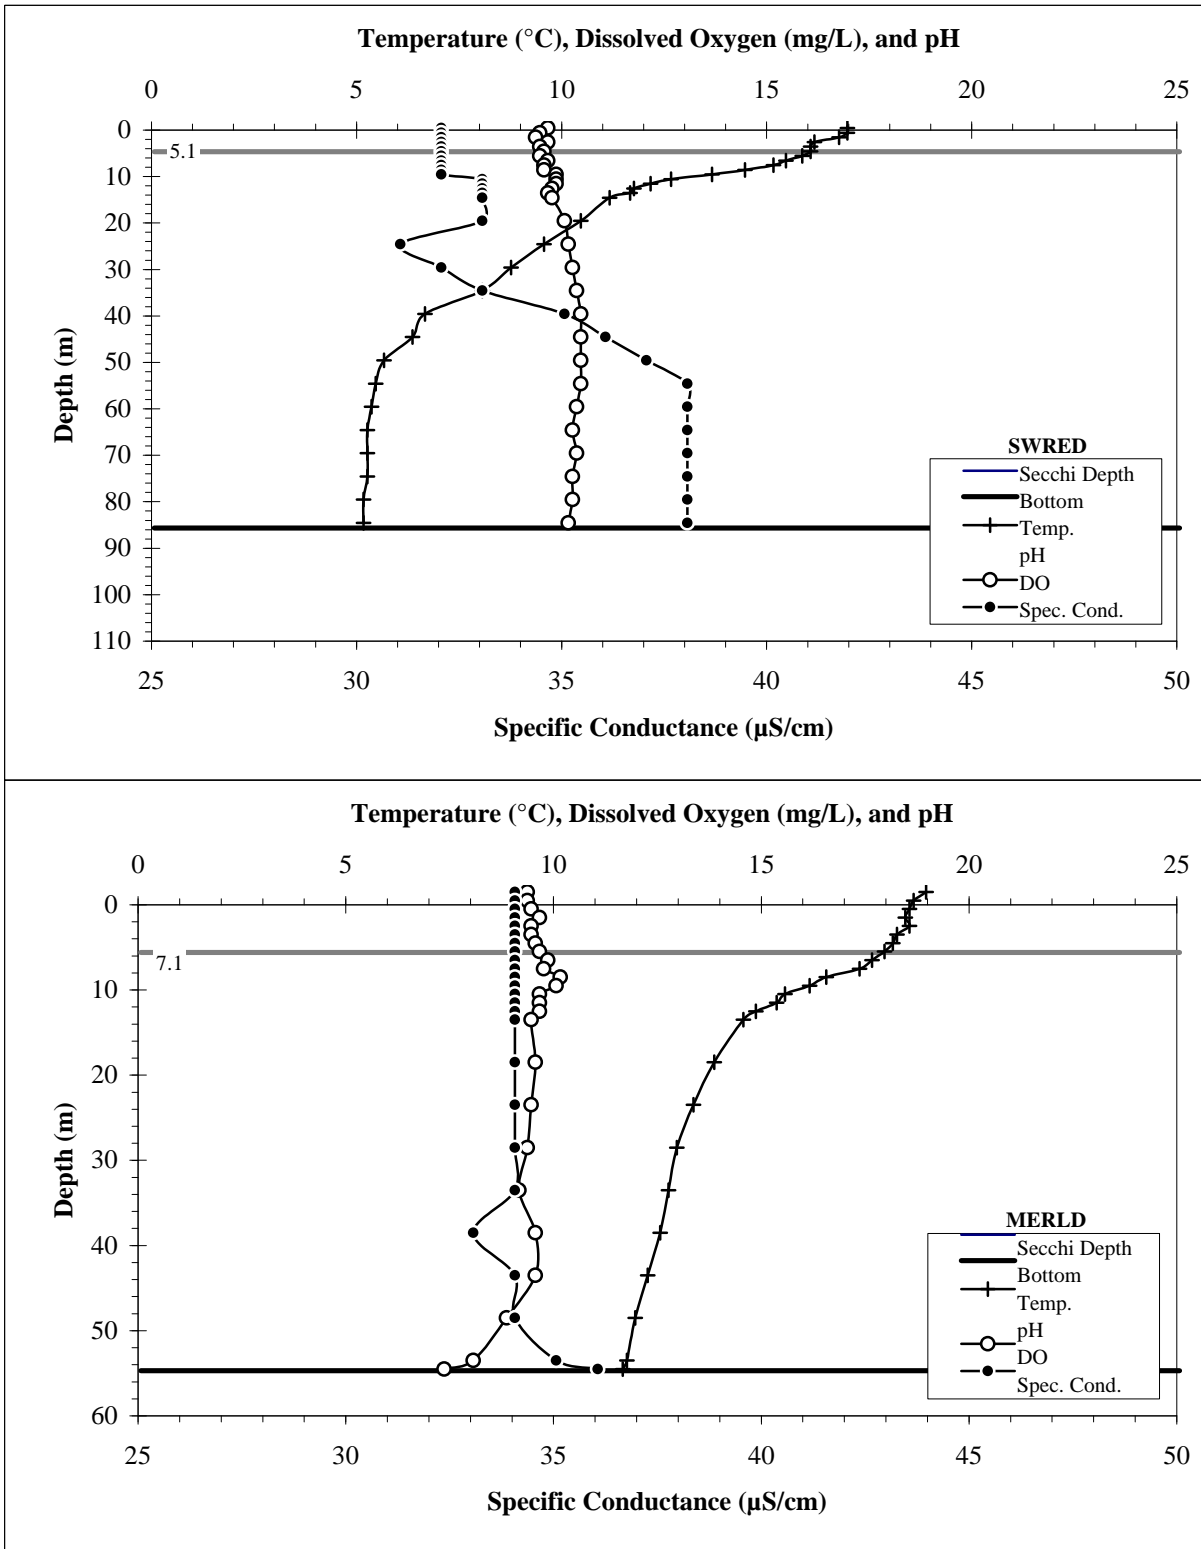
Figure WAQ1 Appendix 7(c). Vertical profile of periodic measurements at Swift Reservoir near the dam (SWRED) and Merwin Lake near the dam (MERLD) in July 1999. Note: Hydrolab pH unreliable, not incorporated.

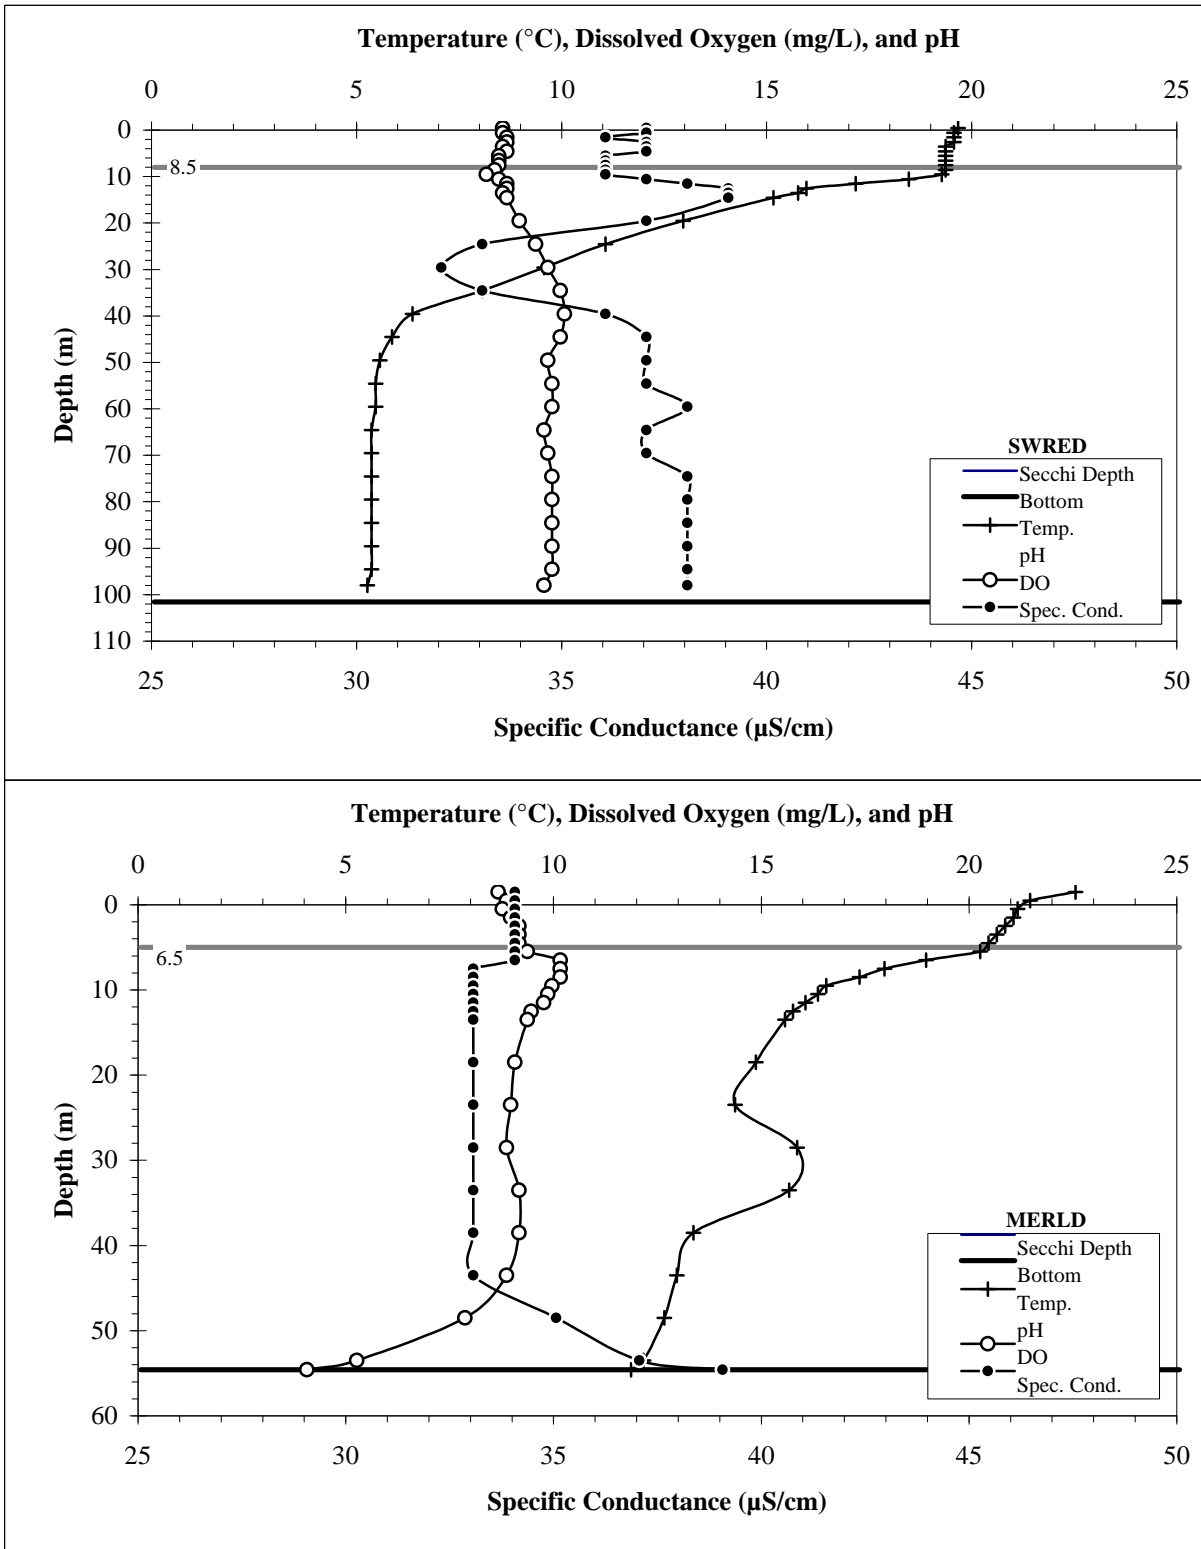
Figure WAQ1 Appendix 7(d). Vertical profile of periodic measurements at Swift Reservoir near the dam (SWRED) and Merwin Lake near the dam (MERLD) in August 1999. Note: 1) pH unreliable, not incorporated, 2) temperatures at Merwin for 30 and 35 meters appear incorrect; suspect 13.8 and 13.6°C instead of 15.8 and 15.6°C, respectively.

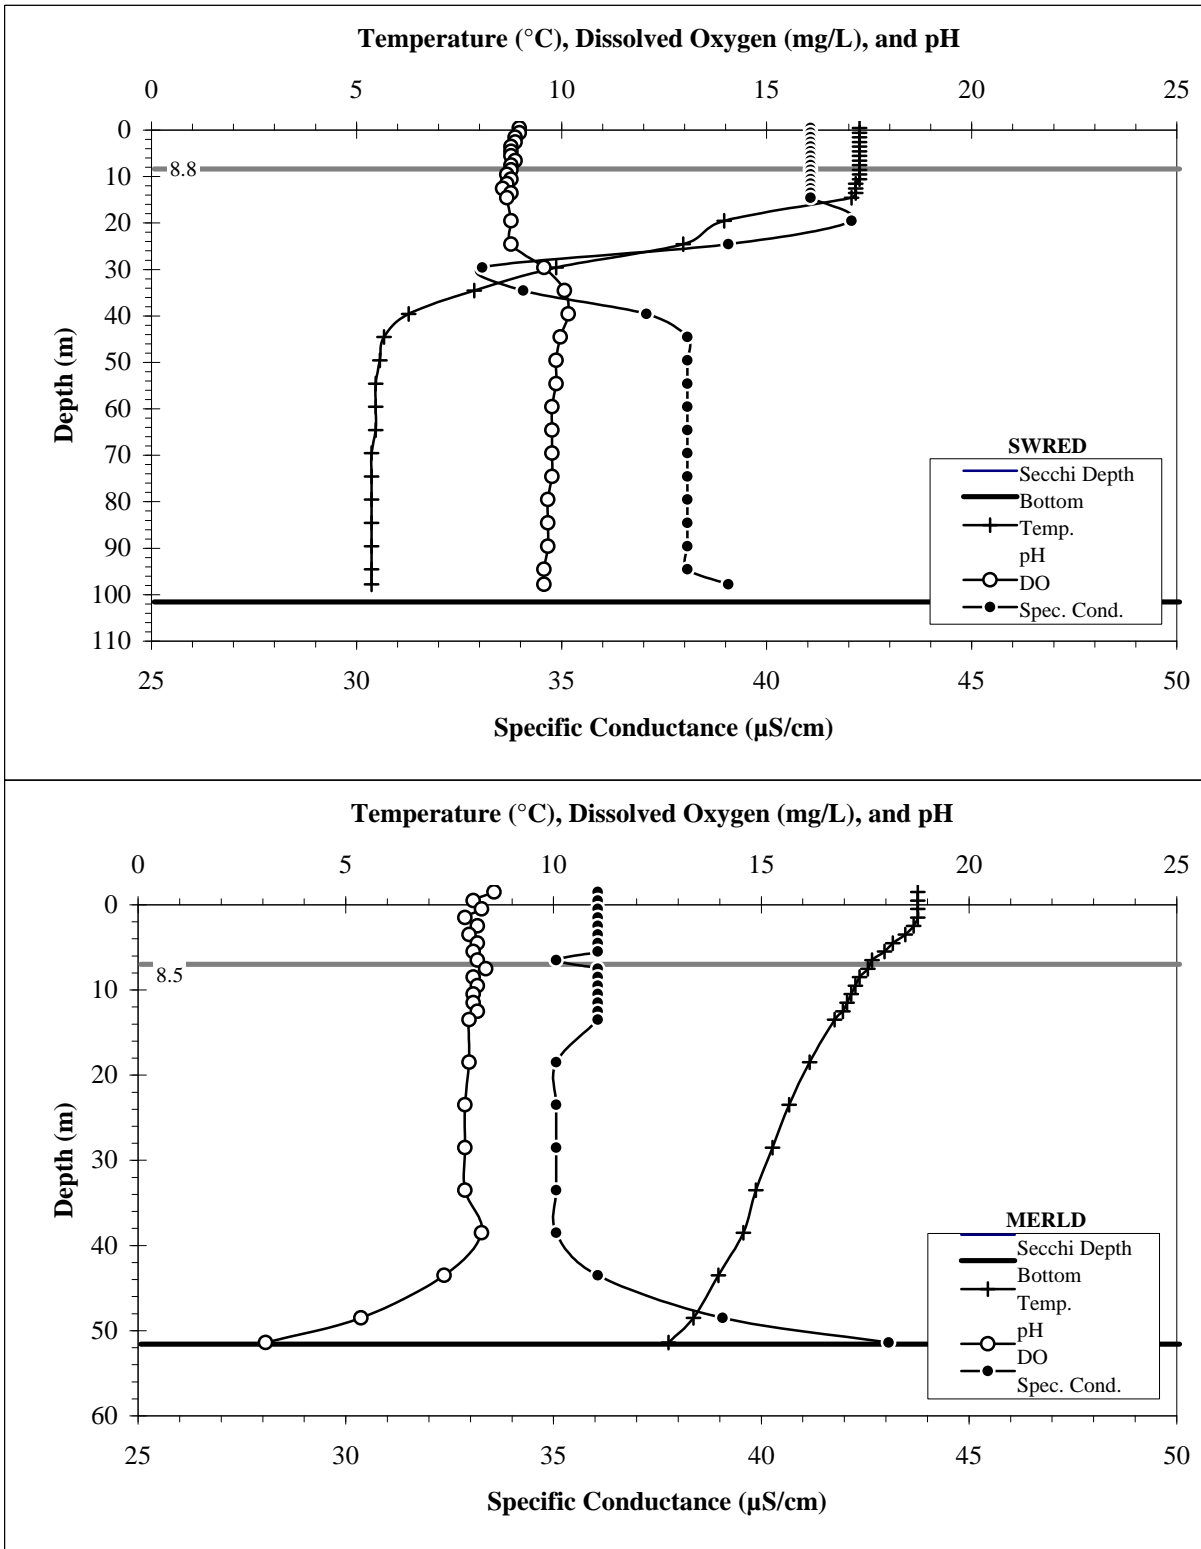
Figure WAQ1 Appendix 7(e). Vertical profile of periodic measurements at Swift Reservoir near the dam (SWRED) and Merwin Lake near the dam (MERLD) in September 1999. Note: Hydrolab pH unreliable, not incorporated.

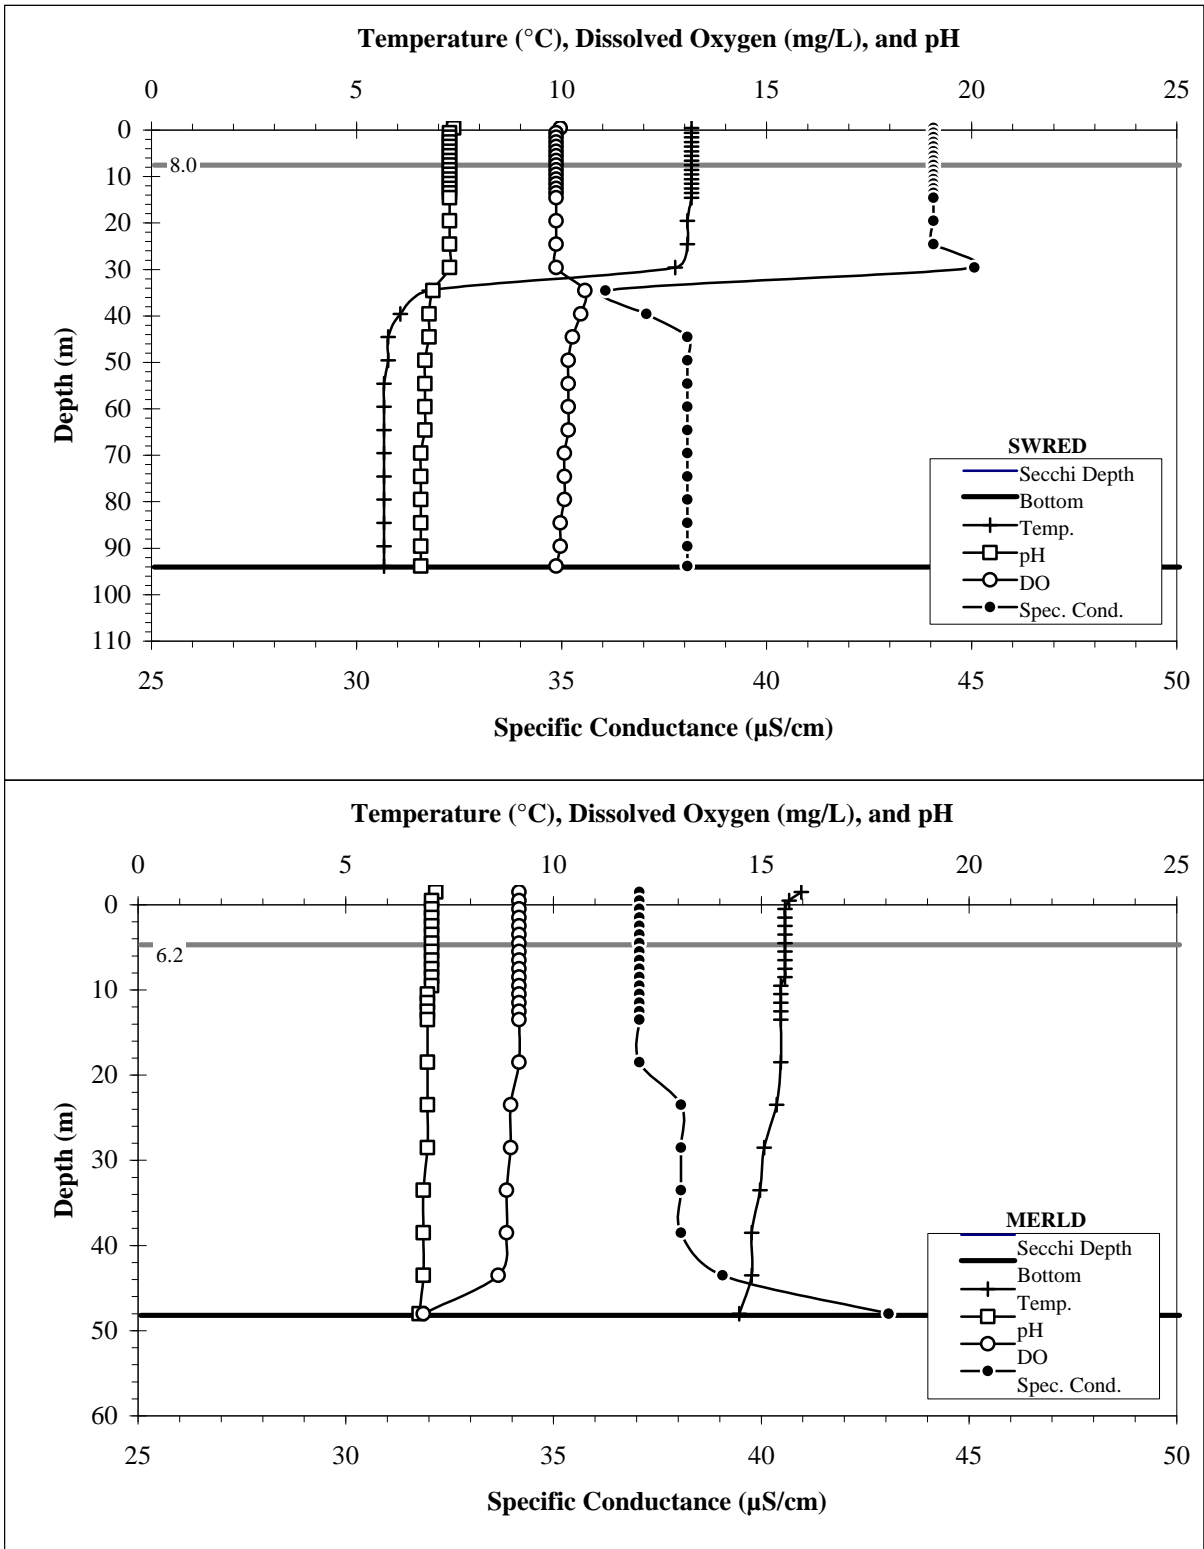
Figure WAQ1 Appendix 7(f). Vertical profile of periodic measurements at Swift Reservoir near the dam (SWRED) and Merwin Lake near the dam (MERLD) in October 1999.

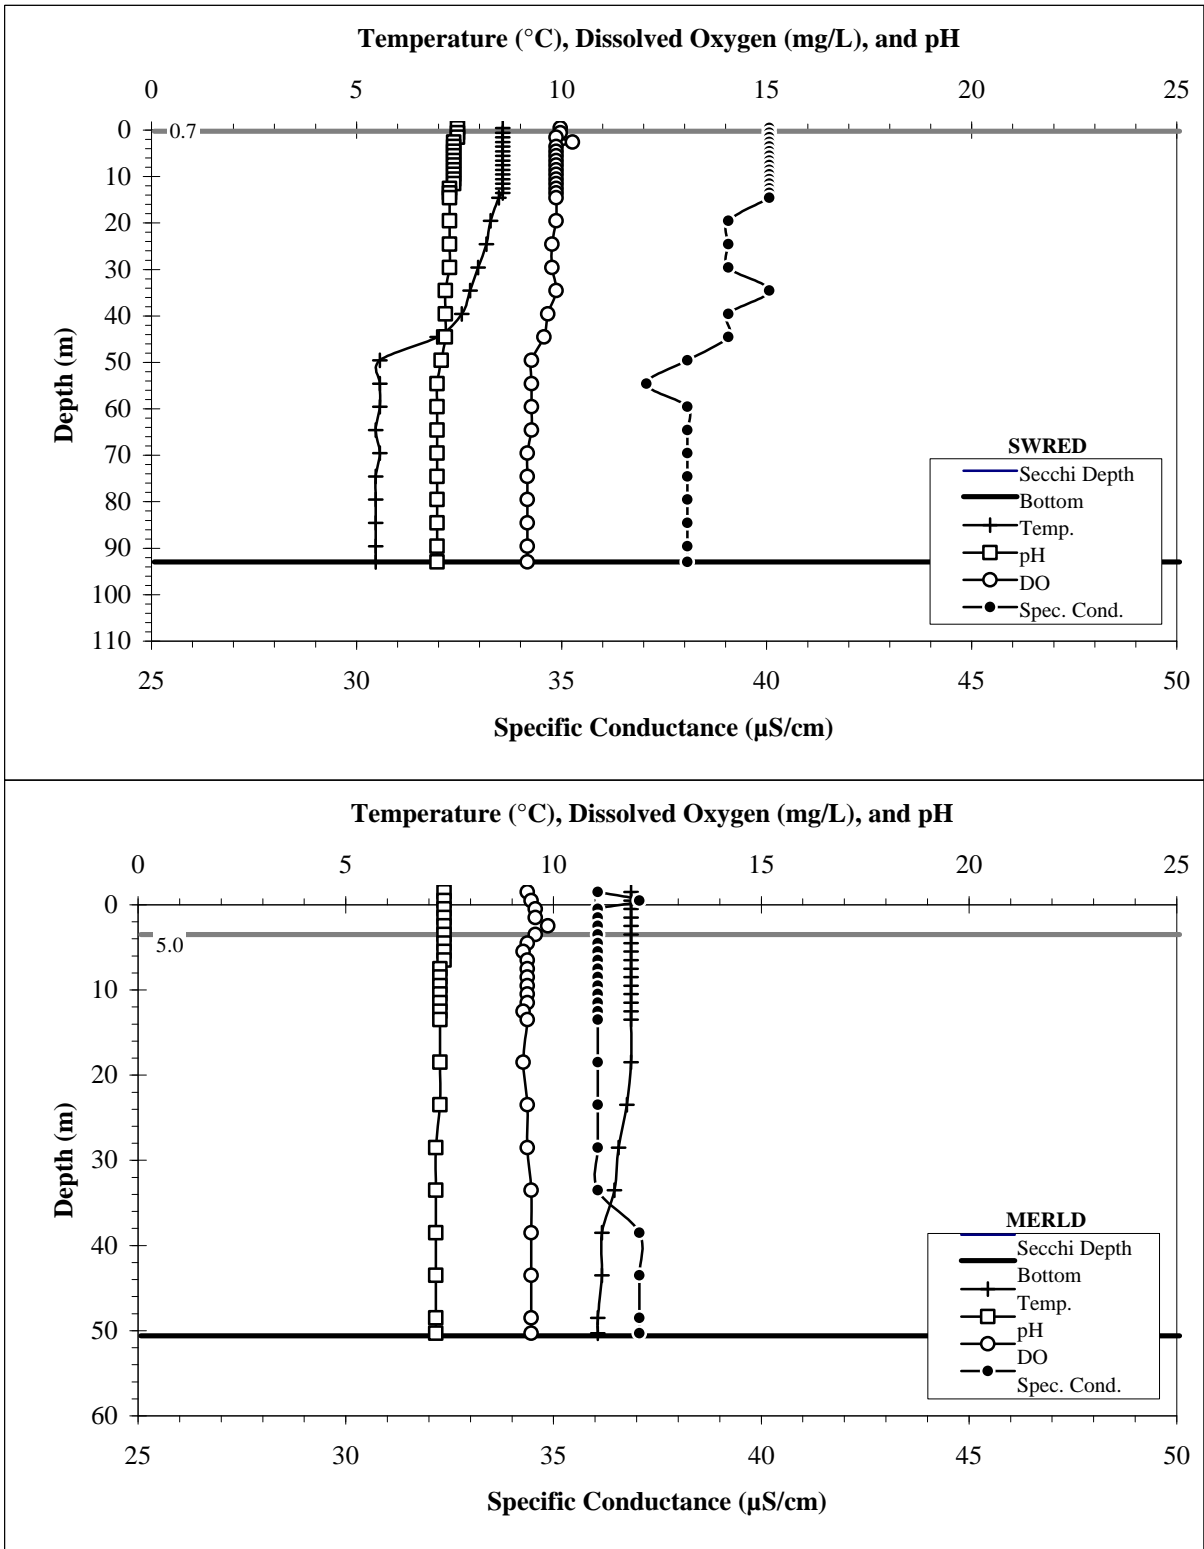
Figure WAQ1 Appendix 7(g). Vertical profile of periodic measurements at Swift Reservoir near the dam (SWRED) and Merwin Lake near the dam (MERLD) in November 1999.

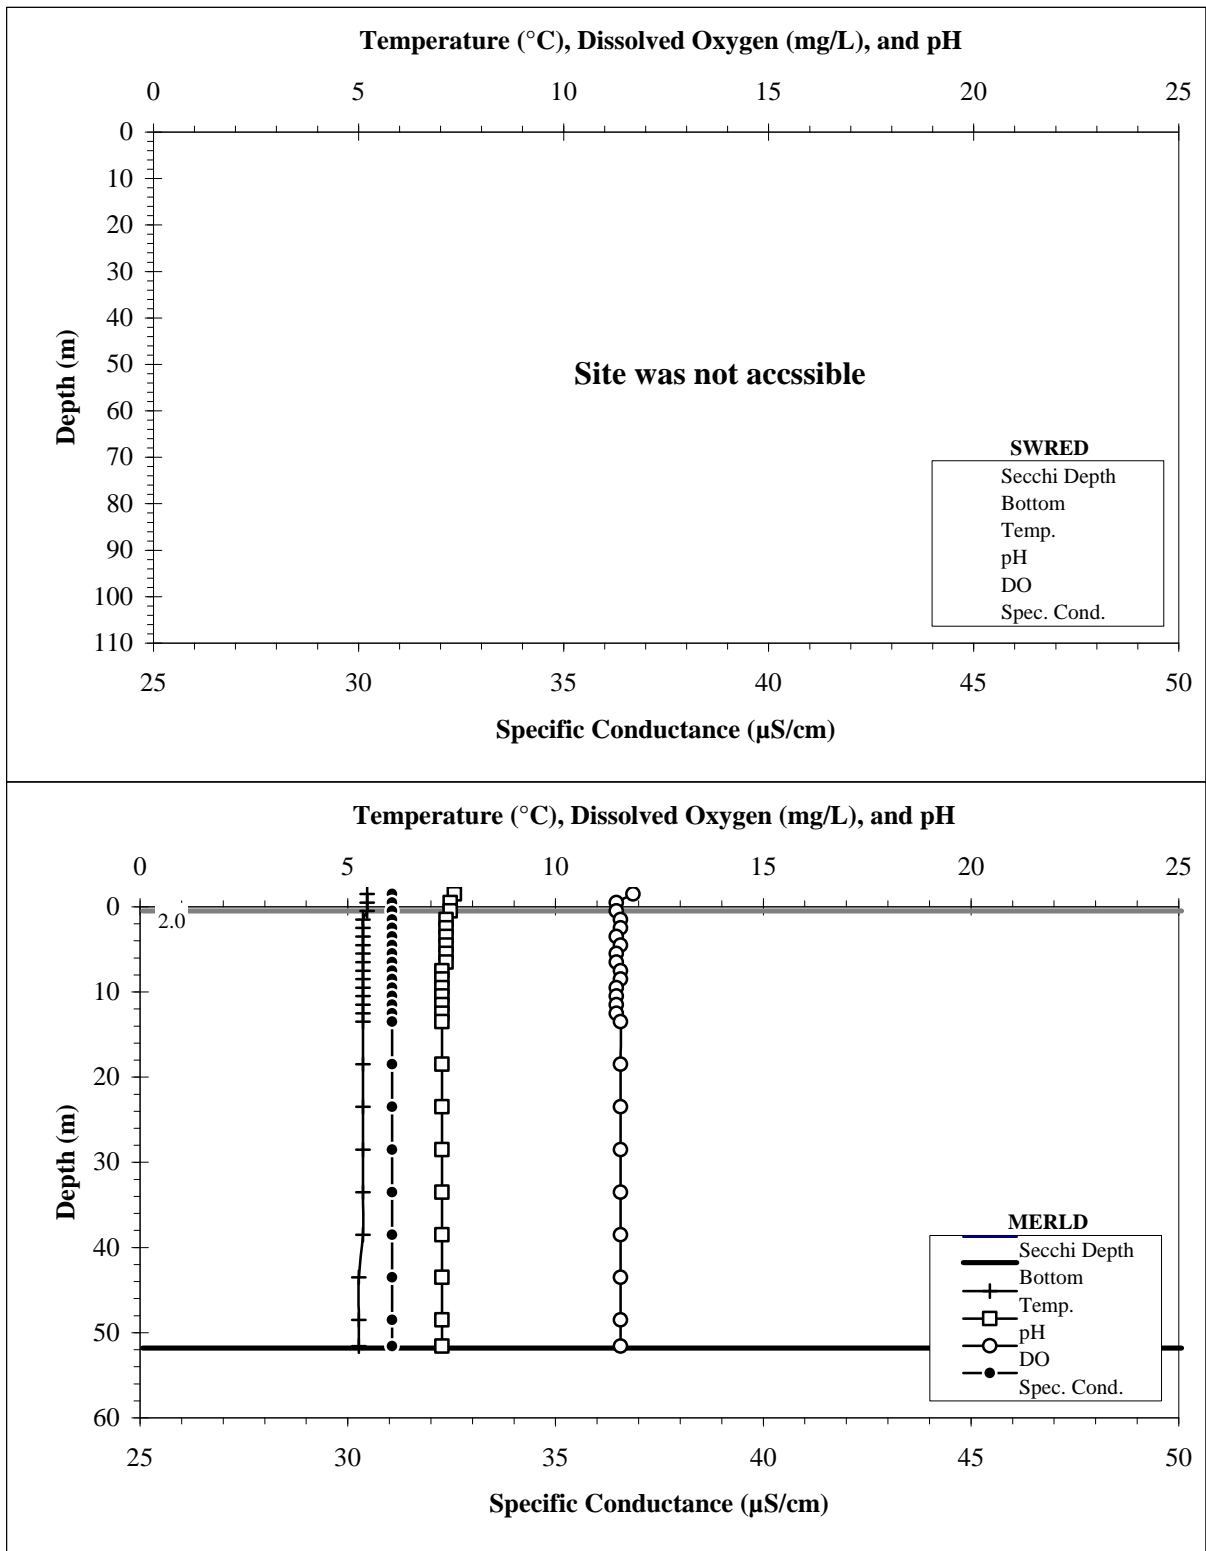
Figure WAQ1 Appendix 7(h). Vertical profile of periodic measurements at Swift Reservoir near the dam (SWRED) and Merwin Lake near the dam (MERLD) in January 2000.

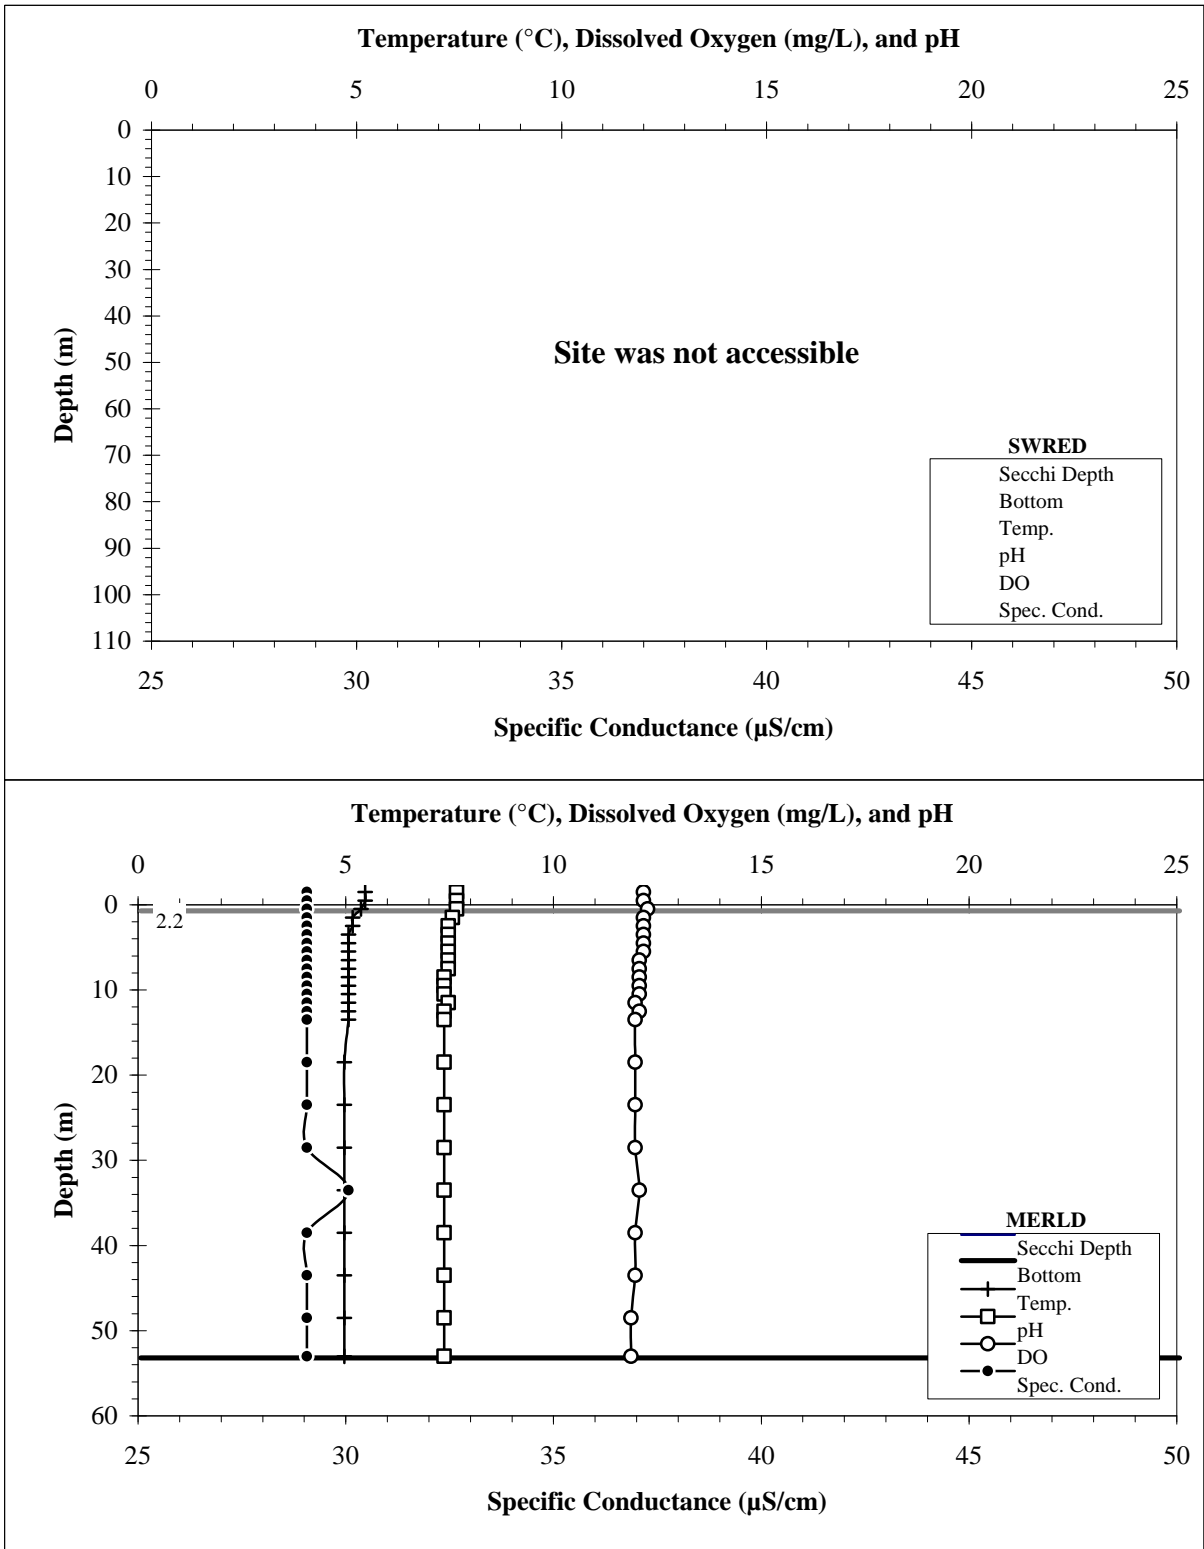
Figure WAQ1 Appendix 7(i). Vertical profile of periodic measurements at Swift Reservoir near the dam (SWRED) and Merwin Lake near the dam (MERLD) in February 2000.

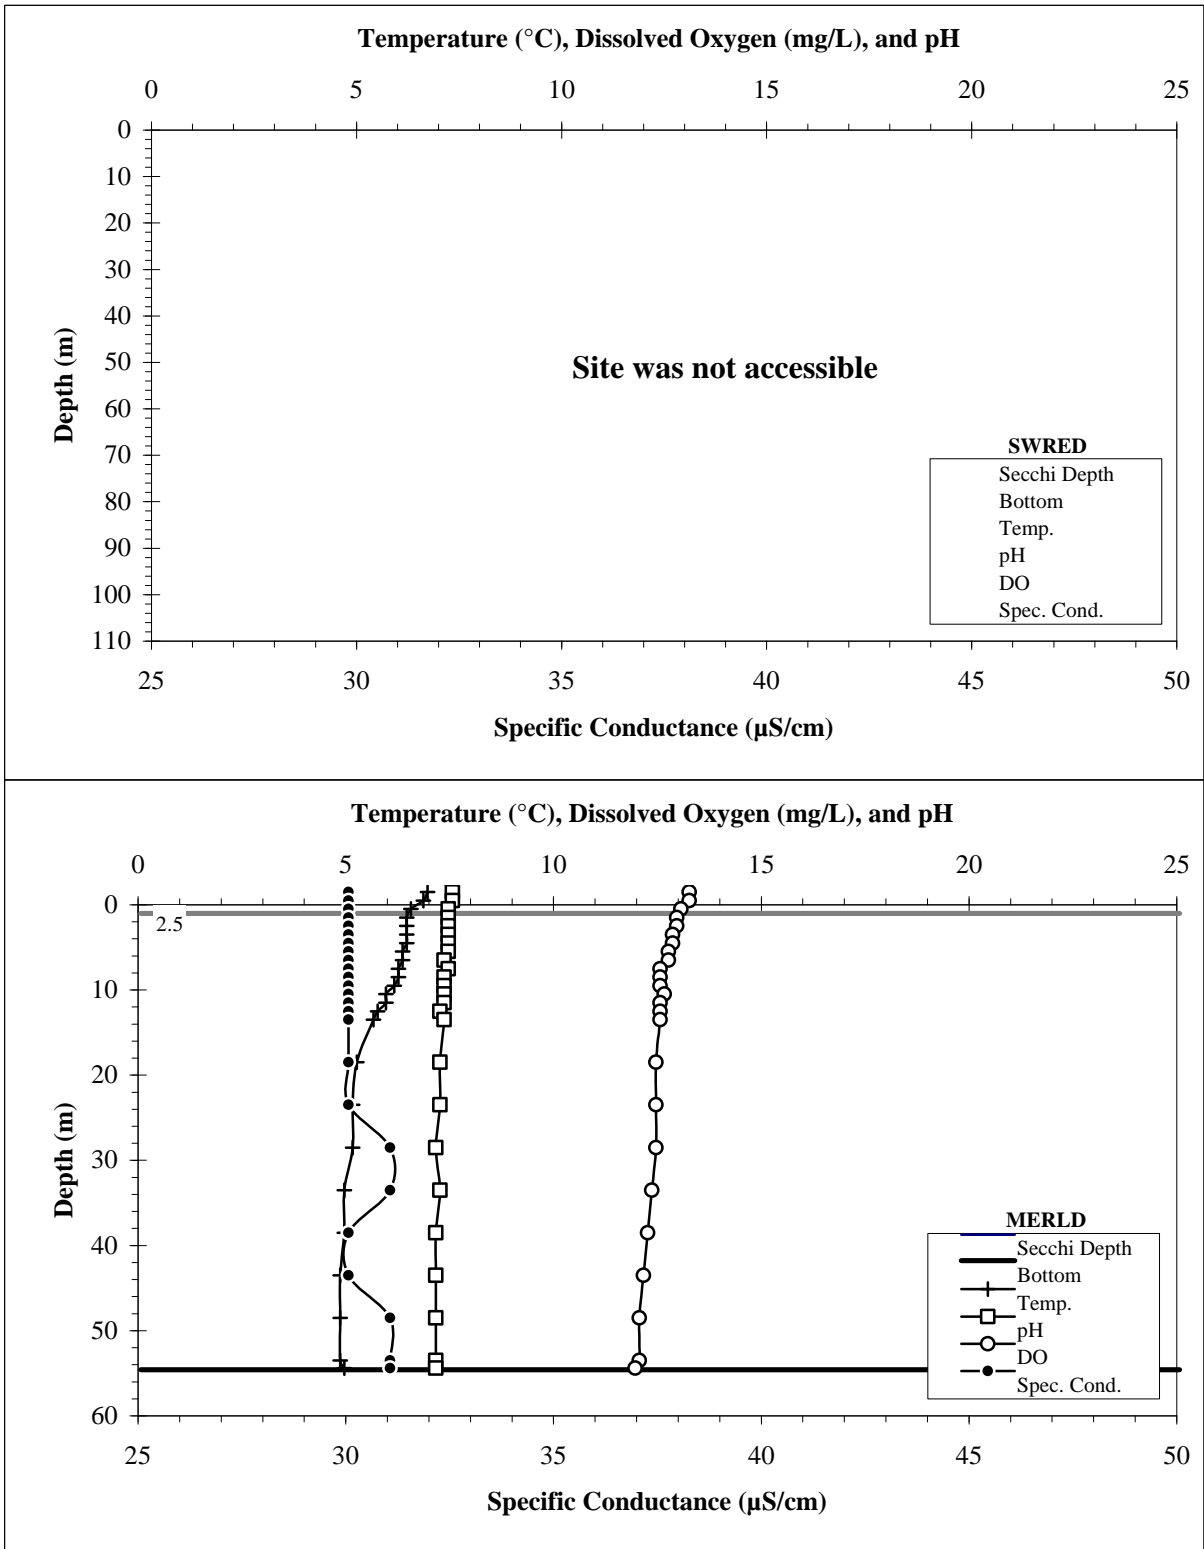
Figure WAQ1 Appendix 7(j). Vertical profile of periodic measurements at Swift Reservoir near the dam (SWRED) and Merwin Lake near the dam (MERLD) in March 2000.

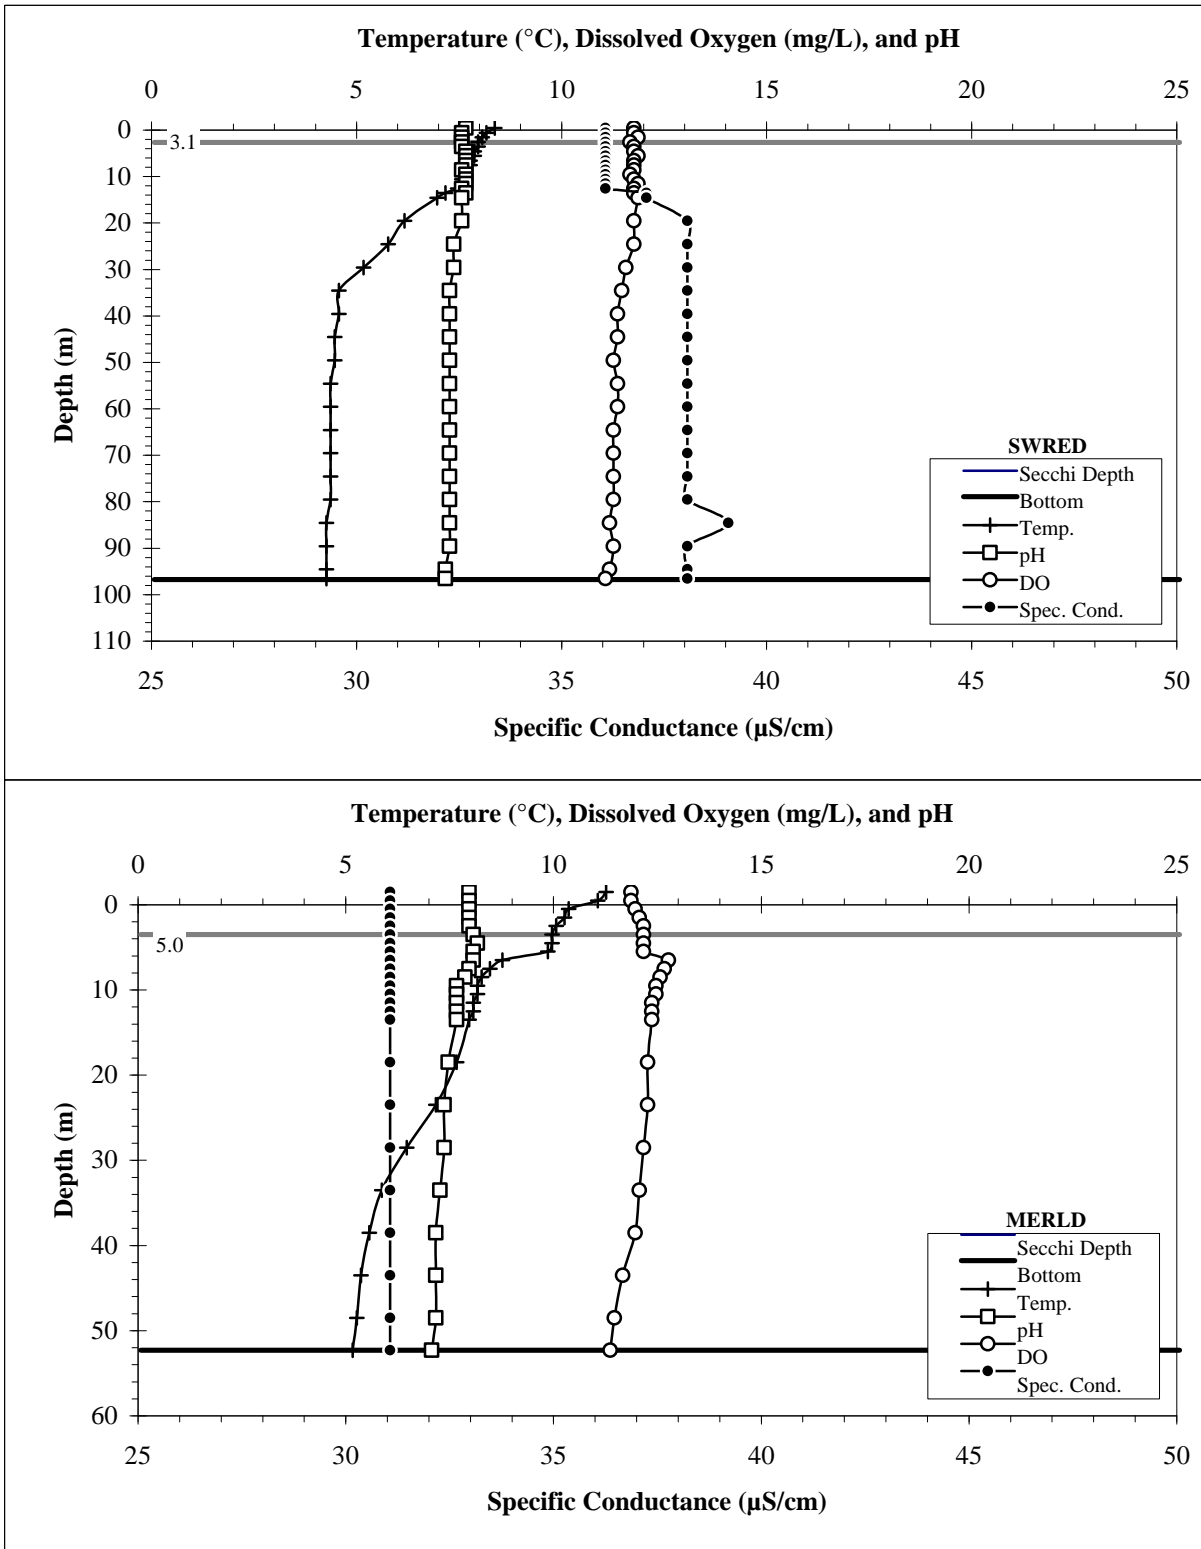
Figure WAQ1 Appendix 7(k). Vertical profile of periodic measurements at Swift Reservoir near the dam (SWRED) and Merwin Lake near the dam (MERLD) in April 2000.
