9.0 AESTHETICS/VISUAL RESOURCES

PacifiCorp Yale Hydroelectric Project FERC Project No. 2071

9.1.2 Visual Assessment of Lake Level Fluctuations

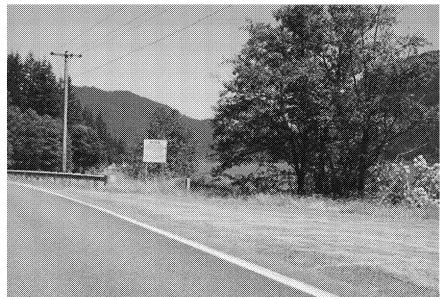
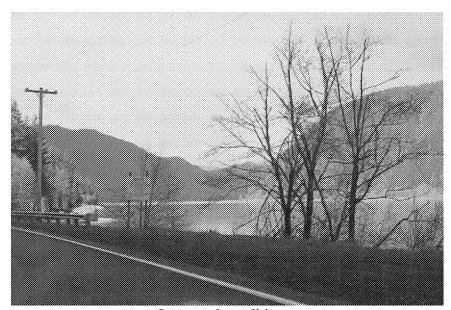
Figure 9.1-4. Comparative photographs of high and low pool conditions from Highway 503.

High pool conditions.

Low pool conditions.

As mentioned previously, views of the lake from the Lewis River Road are limited by trees and brush. In locations where openings occur and the lake is in view, areas of exposed lake bottom can be seen, including some that contain groves of tree stumps. Conditions associated with drawdown, however, are much less evident from the road than from recreation sites located at the shore.
