North Umpqua
Hydroelectric Project
(FERC Project No. 1927)

HISTORIC STRUCTURES PLAN

**(A component of the
Historic Properties Management Plan)**

**Prepared by
EDAW, Inc.
Seattle, Washington**

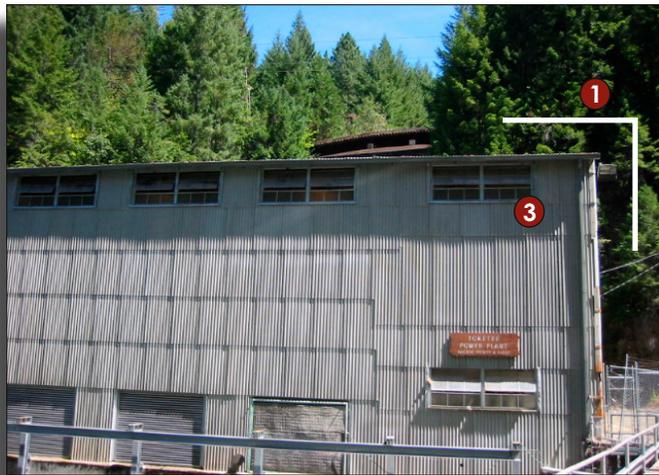
Toketee Powerhouse (2006)

- Any maintenance improvement conducted inside the Toketee Powerhouse where alterations are not visually detected from the exterior of the building.
- Cleaning and maintaining exterior surfaces and repairs to exterior structural elements that continue the color and character of the existing siding and roofing materials.
- Removal/replacement of corrugated asbestos siding with fiberglass materials of similar color, dimension of corrugation (4.25 inches ridge to ridge), panel alignment, and appearance.
- Window maintenance/replacement that continues the existing character, function, and historically appropriate colors.

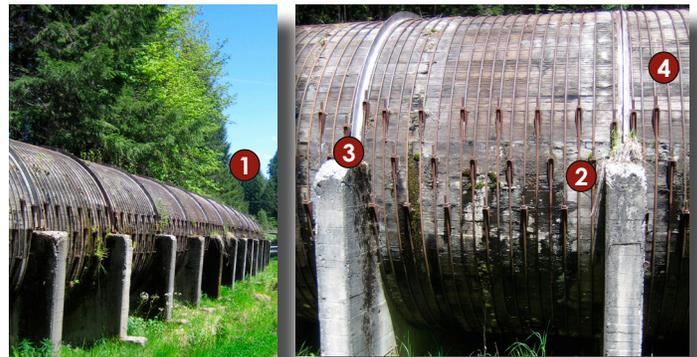
Toketee Wood Stave Flowline (2007)

- 1 Wood-stave pipe waterway
- 2 Cone saddles with steel fabricated T band strap
- 3 Threaded rods with nuts and bracket
- 4 Redwood stave

- Replacement of the waterway with a different material or design. HABS/HAER documentation would be required prior to removal.

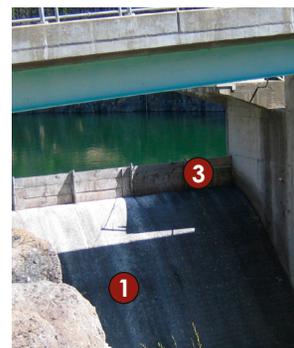
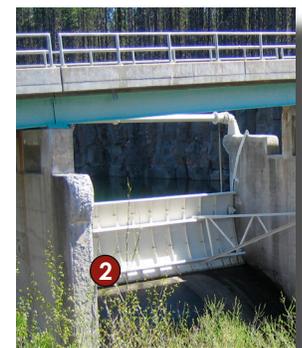
Lemolo No. 1 Dam (2007)

- 1 Concrete "ogee crest"
- 2 Steel Tainter gate
- 3 Two sets wooden flashboards
- 4 Concrete slabface over rock fill on upside face of dam
- 5 Exposed rock fill with no abutment on downstream side of dam

- Replacement or redesign of the steel tainter gate, concrete “ogee crest”, rock fill concrete slabface, or wooden dam flashboard.

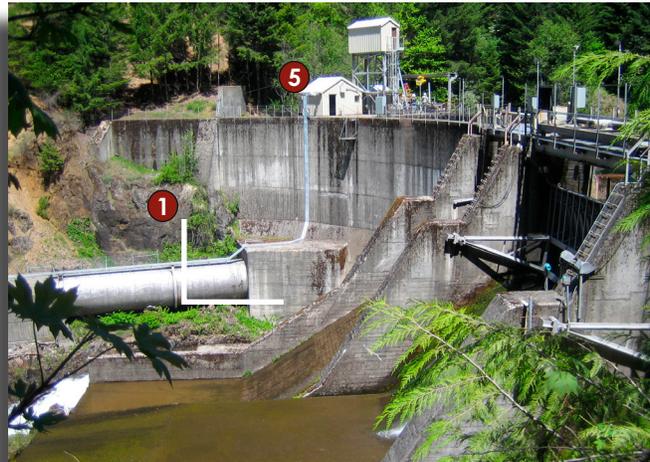
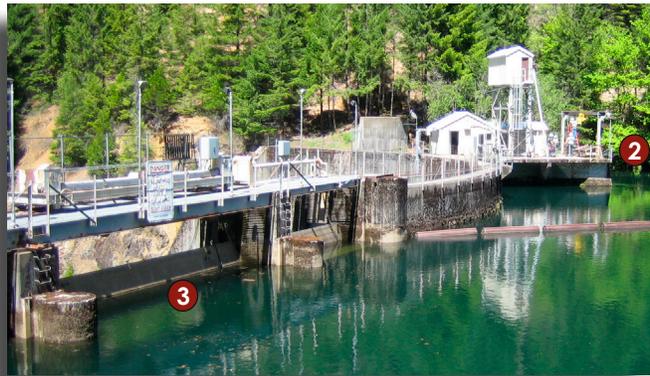
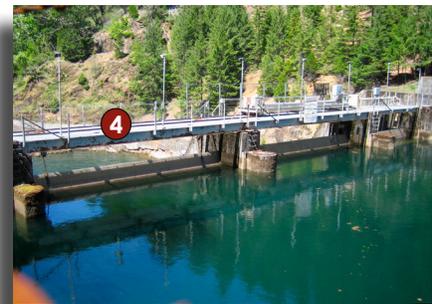
Soda Springs Dam (2007)

- Installation of a new fish ladder and screen in 2009 will change the appearance of the dam considerably. Remaining historical elements will be protected through replacement and repair using in-kind materials and cleaning of the dam, tainter gates, spillgates, and intake with non-abrasive materials on an as-needed basis.
- Replacement or redesign of thin arch dam. HABS/HAER documentation would be required prior to alterations.

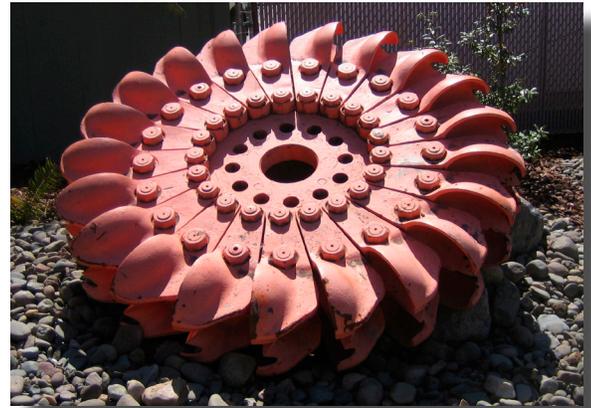
Spare Pelton Wheel Runner (2007). This wheel was purchased to back up the original in the event of failure and is currently on display at the Clearwater Maintenance Shop.

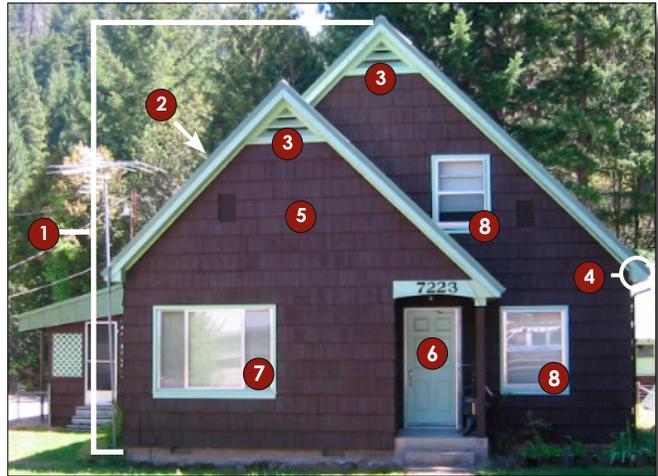
- 1 Rectangular one- to two-story structure with pitched gable roof and a shed roof porch
- 2 Pressed metal roof
- 3 Vent in gable
- 4 Eave returns and boxed soffits
- 5 Wood shingle or vertical wood board and batten siding
- 6 Six-panel door
- 7 Front picture window (originally)
- 8 Wood frame, double-hung windows (2 or 3 over 1)
- 9 Brick chimney and detail on chimney cap
- 10 Shutters on windows
- 11 Fencing: scalloped-wire or basket-weave

- 1 Structural repairs that use in-kind (or the same) materials as the original that do not alter the original shape, size, or roof pitch of the home (including shed roofs). Examples of materials include wood framing, wood shingle, or vertical board and batten siding.

- 3 Repair of vents and trim using wood material. Trim may be primed and finished with paint of light green, consistent with the historical color theme of the village.

- 4 Repair of eave returns and boxed soffits using wood material. Trim must be primed and finished with paint of light green, consistent with the historical color theme of the village.

- 5 Repair or replacement of the home's wood shingle or vertical wood board and batten siding with the same materials. Siding must be finished with the same dark brown historical color theme of the village.

- 6 Door repair or replacement using a six-panel door of any material. Doors must be primed and finished with paint of light green.
- 7 Front window repair or replacement with a wooden- or vinyl-framed picture window, so long as the frame can be painted to match the light green historical trim color used for employee housing within the historic district.

- 8 House or garage window repair or replacement with a wooden- or vinyl-framed double hung window of the same style, so long as the frame can be painted to match the light green historical trim color used for employee housing within the historic district. Replaced windows should be consistent with window types of other village housing.

- 10 Repair or replacement of window shutters with shutters of the same style that would be painted to match the light green historical trim color of the village.

- 11 Fencing maintenance, replacement, or additions that provide scalloped-wire fencing at approximately 40 inches in height, or a consistent height with adjacent fencing. Existing basket-weave fencing may be maintained using the same wood materials and kept to the same style, but should not be added to other areas.

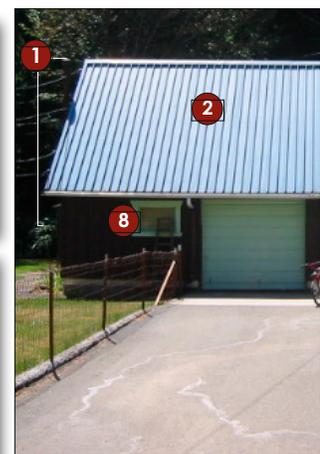
Garages associated with employee residences

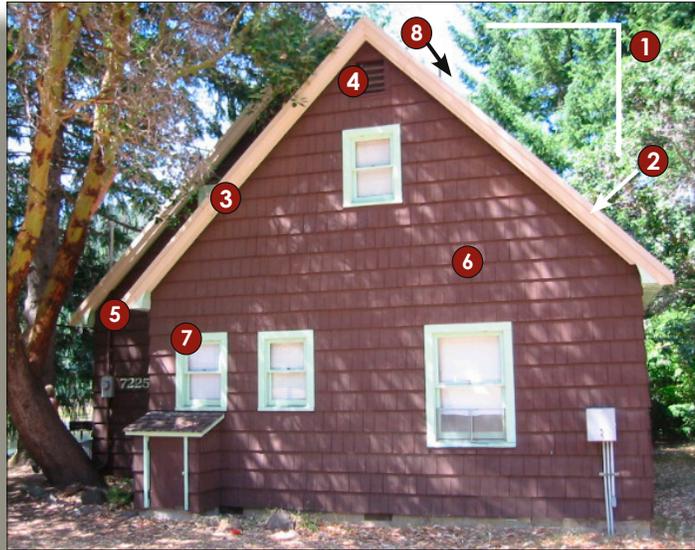
Clearwater Guest House (2006)

- 1 Rectangular two-story structure with front gable, steep pitched roof
- 2 Wood trim pressed metal roof
- 3 Exposed fascia board
- 4 Vent in gable
- 5 Scalloped eaves returns with boxed soffits
- 6 Wood shingle or vertical wood board and batten siding
- 7 Wood frame, double-hung windows with butt joints
- 8 Brick chimney (*not visible*)
- 9 Stone fireplace (*internal*)

- 1 Structural repairs that use in-kind (or the same) materials as the original that do not alter the original shape, size, or roof pitch of the home (including shed roofs). Examples of materials include wood framing, wood shingle, or vertical board and batten siding.

- 3 Repair of fascia boards using wood material. Trim must be primed and finished with paint of light green, consistent with the historical color theme of the area.

- 4 Repair of vents and trim using wood material. Trim may be primed and finished with paint of light green, consistent with the historical color theme of the area.

- 5 Repair of eave returns and boxed soffits using wood material. Trim must be primed and finished with paint of light green, consistent with the historical color theme of the area.

- 6 Repair or replacement of wood shingle or vertical wood board and batten siding with the same materials. Siding must be finished with the same dark brown historical color theme of the area.

- 7 Window repair or replacement with a wooden- or vinyl-framed double hung window of the same style, so long as the frame can be painted to match the light green historical trim color used for employee housing. Replaced windows should be consistent with window types of the Toketee Village housing.

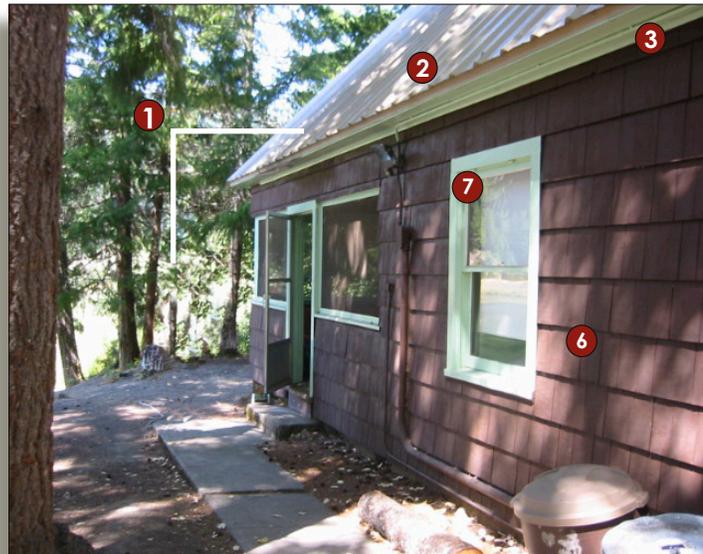
Clearwater Guest House, front entrance (2006)

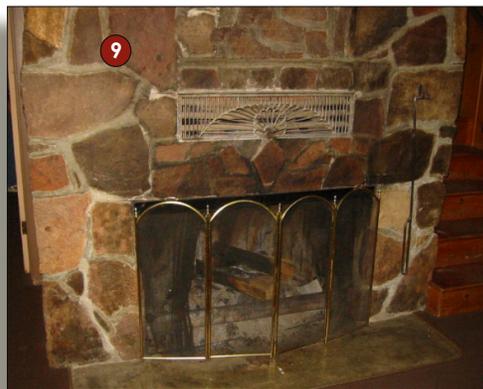
Clearwater Guest House, interior fireplace (2006)

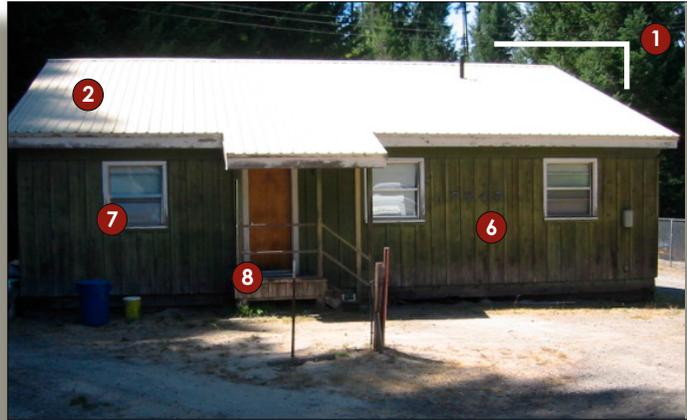
Bunkhouse (2006)

- 1 Rectangular one-story structure with front gable, low pitch roof
- 2 Wood trim pressed metal roof
- 3 Vent in gable
- 4 Horizontal weatherboard in gable
- 5 Boxed soffits
- 6 Vertical wood board and batten siding
- 7 Wood frame window
- 8 Vestibule with shed roof

- 1 Structural repairs that use in-kind (or the same) materials as the original that do not alter the original shape, size, or roof pitch of the building (including shed roofs). Examples of materials include wood framing, wood shingle, or vertical board and batten siding.

- 3 Repair of vents using wood material. Trim may be primed and finished with green paint, consistent with the historical color theme of the area.
- 4 Repair of weatherboards and trim using wood material. Trim must be primed and finished with light green paint, consistent with the historical color theme of the area.

- 5 Repair of boxed soffits using wood material. Trim must be primed and finished with green paint, consistent with the historical color theme of the area.

- 6 Repair or replacement of the building's vertical wood board and batten siding with the same materials. Siding must be finished with the same dark brown or green historical color theme of the area.

- 7 Window repair or replacement with a wooden- or vinyl-framed double hung window of the same style, so long as the frame can be painted to match the light green or white historical trim color used for buildings in this area. Replaced windows should be consistent with window types of other historic structures in the area.

- 8 Structural repairs to the vestibule must use in-kind (or the same) materials as the original and do not alter the original shape, size, or roof pitch of the building. Examples of materials include wood framing, wood shingle, or vertical board and batten siding.

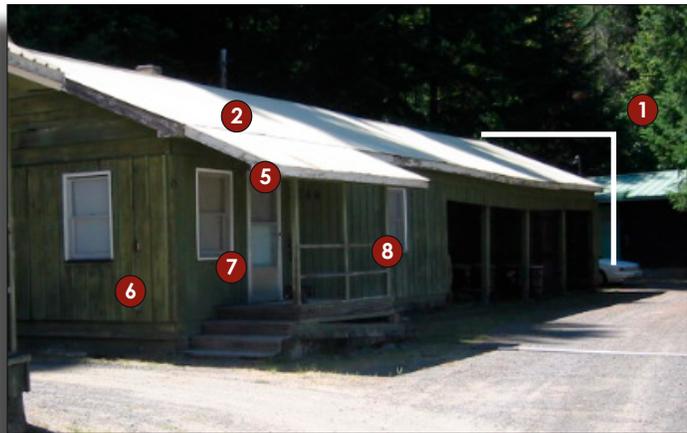
Cook's Quarters and Sheds (2006)

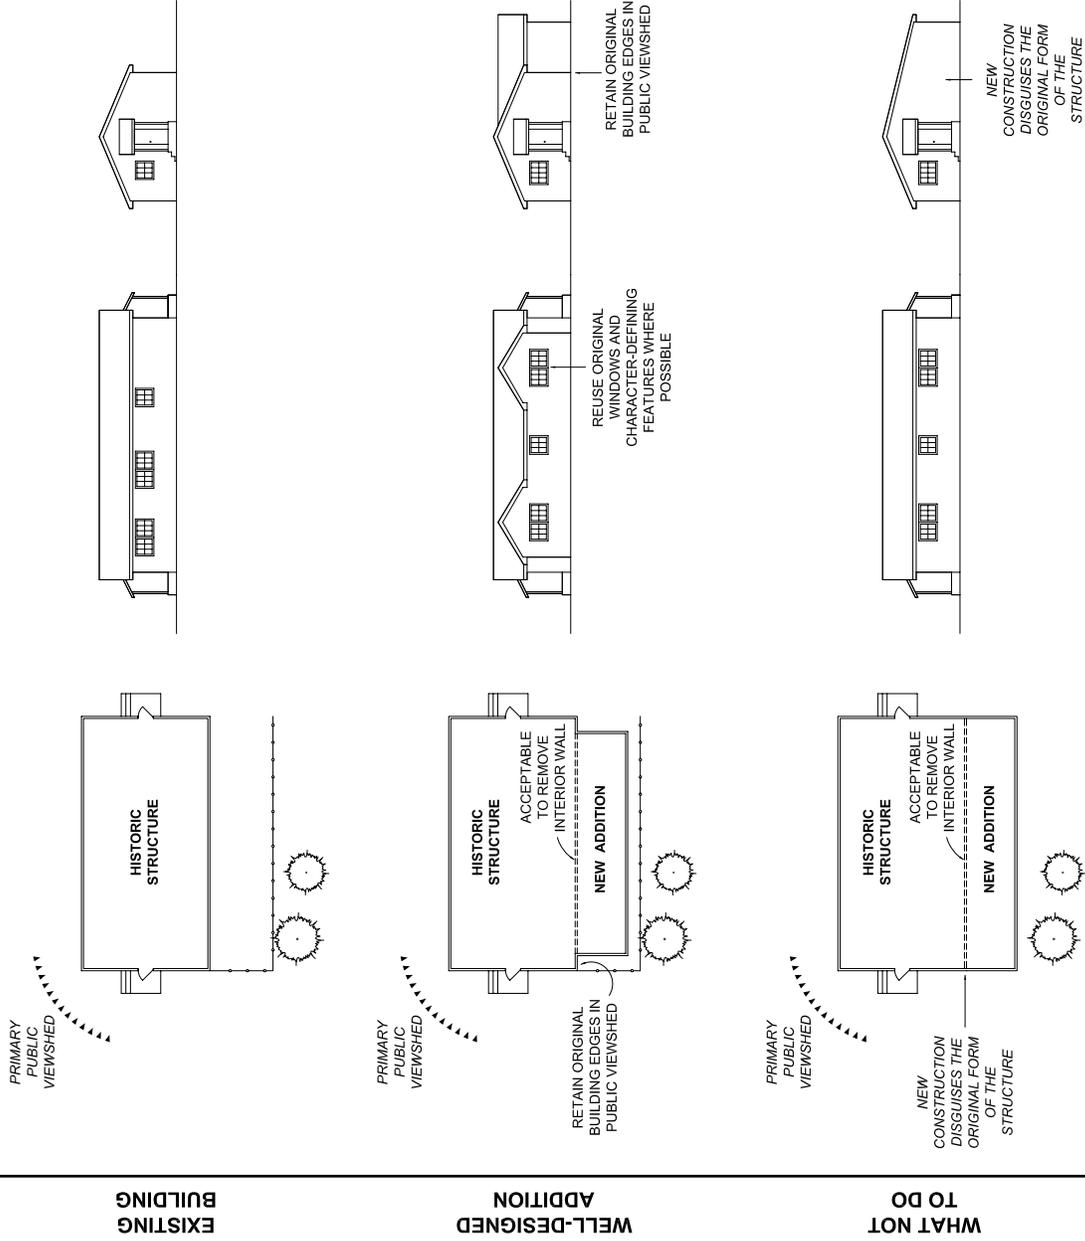
PLAN VIEW SIDE ELEVATION END ELEVATION

Figure 5.5-1
Building plans to preserve
historic character of an existing structure
