**PROSPECT NO. 3 HYDROELECTRIC PROJECT
FERC PROJECT NO. P-2337**

**Final License Application
for Major Project—Existing Dam**

**Volume II
Exhibit E—Environmental Exhibit**

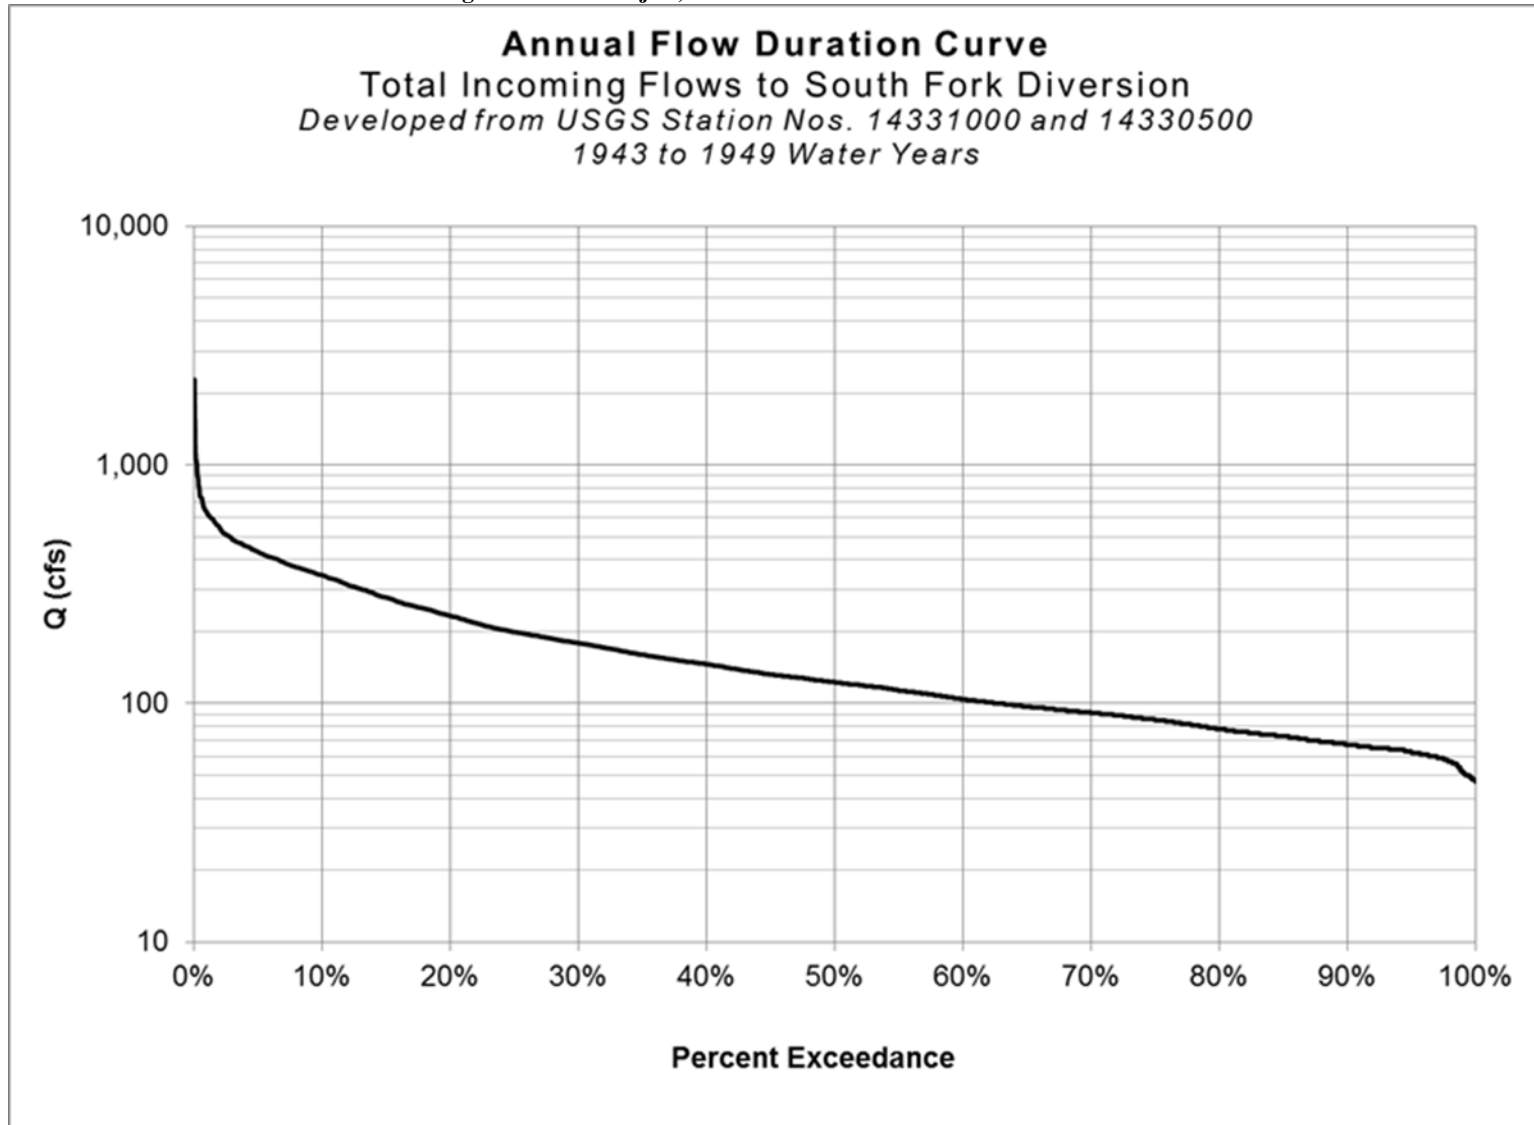
Figure 4. Annual flow duration curve of total incoming flows to the Project, WY 1943 to 1949

Percentile	Oct	Nov	Dec	Jan	Feb	Mar	Apr	May	Jun	Jul	Aug	Sep
5	108	228	352	391	278	309	533	608	456	200	127	107
10	97	155	258	307	249	266	470	544	408	174	120	101
20	87	117	185	225	199	220	383	464	344	154	109	93
30	80	102	146	180	178	199	335	425	295	142	101	87
40	75	94	125	155	158	181	281	385	258	130	96	80
50	73	86	110	137	147	154	232	356	221	123	90	76
60	69	80	100	118	135	141	202	302	192	116	85	71
70	65	74	92	103	126	131	182	253	174	107	78	67
80	62	69	82	93	109	122	163	201	145	98	72	64
90	59	66	69	88	86	101	130	152	97	73	61	58
95	55	62	65	66	68	88	117	115	84	67	55	51

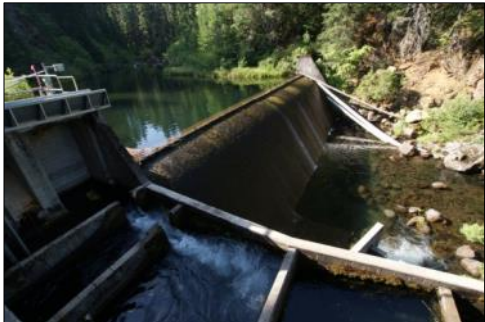
South Fork Diversion Dam and Spillway	1932	Structure	Contributing

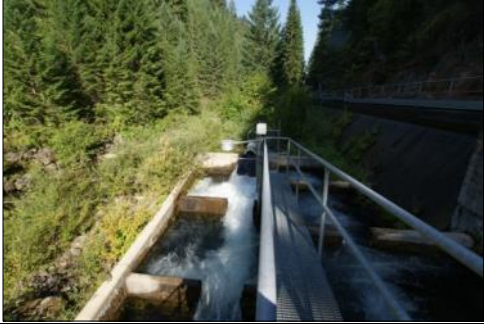
South Fork Diversion Dam Fish Passage (Ladder, Fish Screen, Return Pipe)	1932, altered 1996	Structure	Contributing

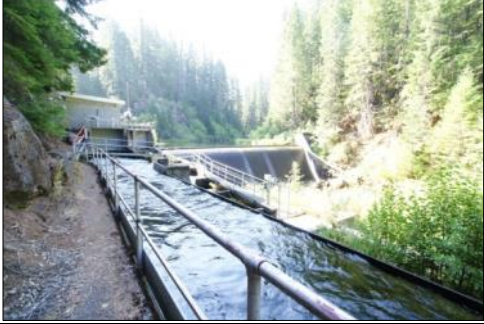
South Fork Conduit (Water Conveyance System)	1932	Structure	Contributing

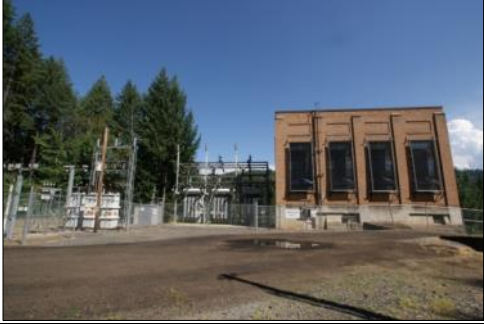
Prospect No. 3 Powerhouse	1932	Building	Contributing

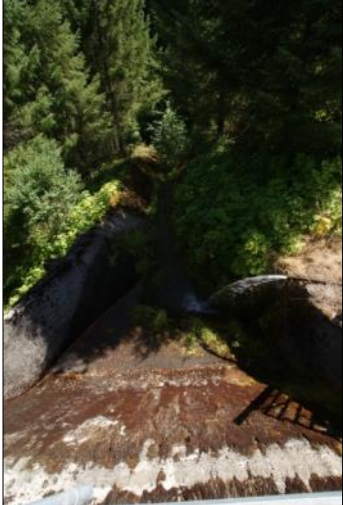
Prospect No. 3 Powerhouse Tailrace and Spillway	1932	Structure	Contributing
