# **Project Status Meeting Wallowa Falls Hydroelectric Project FERC Project No. 308**

November 4, 2014

## **Purpose of Meeting:**

- to review PacifiCorp's Additional Information Request-Response filed with FERC on October 22, 2014
- to discuss enhancement measures proposed in the Final License Application
- to discuss recreation interests in the Project area

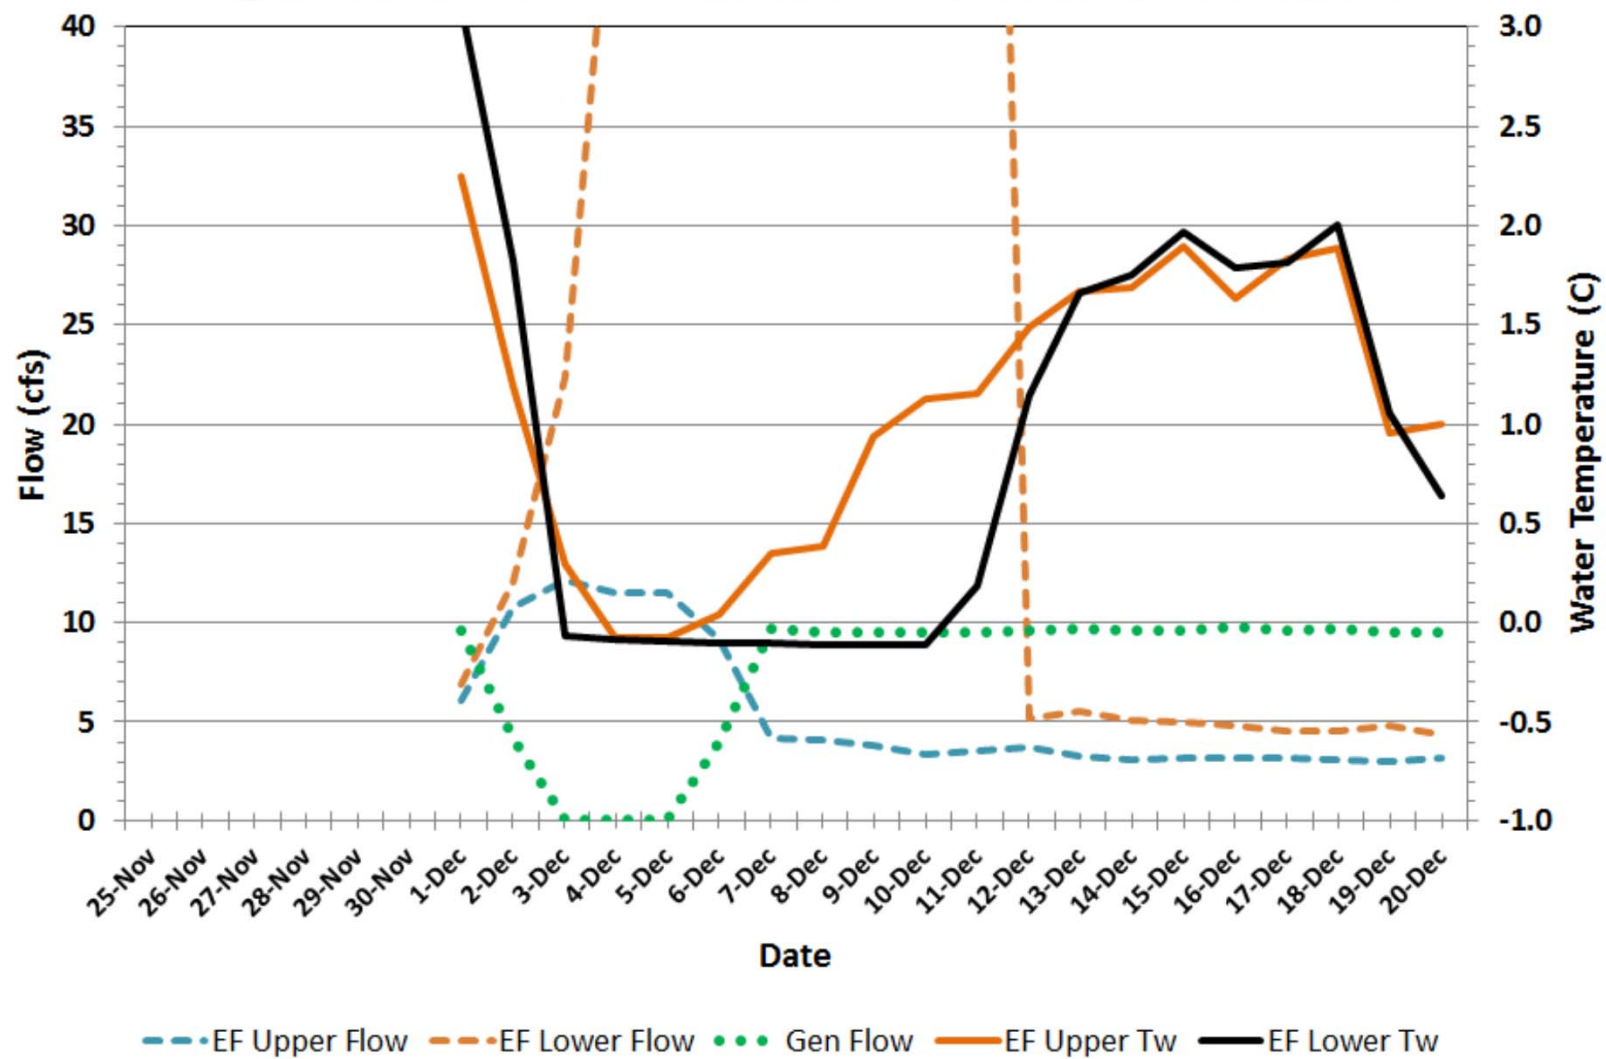
Figure B-2. Flow and Tw Conditions for November 25-December 20, 2013

- *While Project operations may not have a significant effect on occurrence and duration of freezing water temperatures (and ice formation) in the vicinity of BPL, it is likely that changes in flow related to powerhouse operations could affect the magnitude of backwater effects when significant ice formation (“ice damming”) occurs. For example, the December 2013 flow data from the BPL site (Figure B-2) shows a precipitous increase in flow about December 3 that is coincident with the onset of the freezing of the water at that site.*

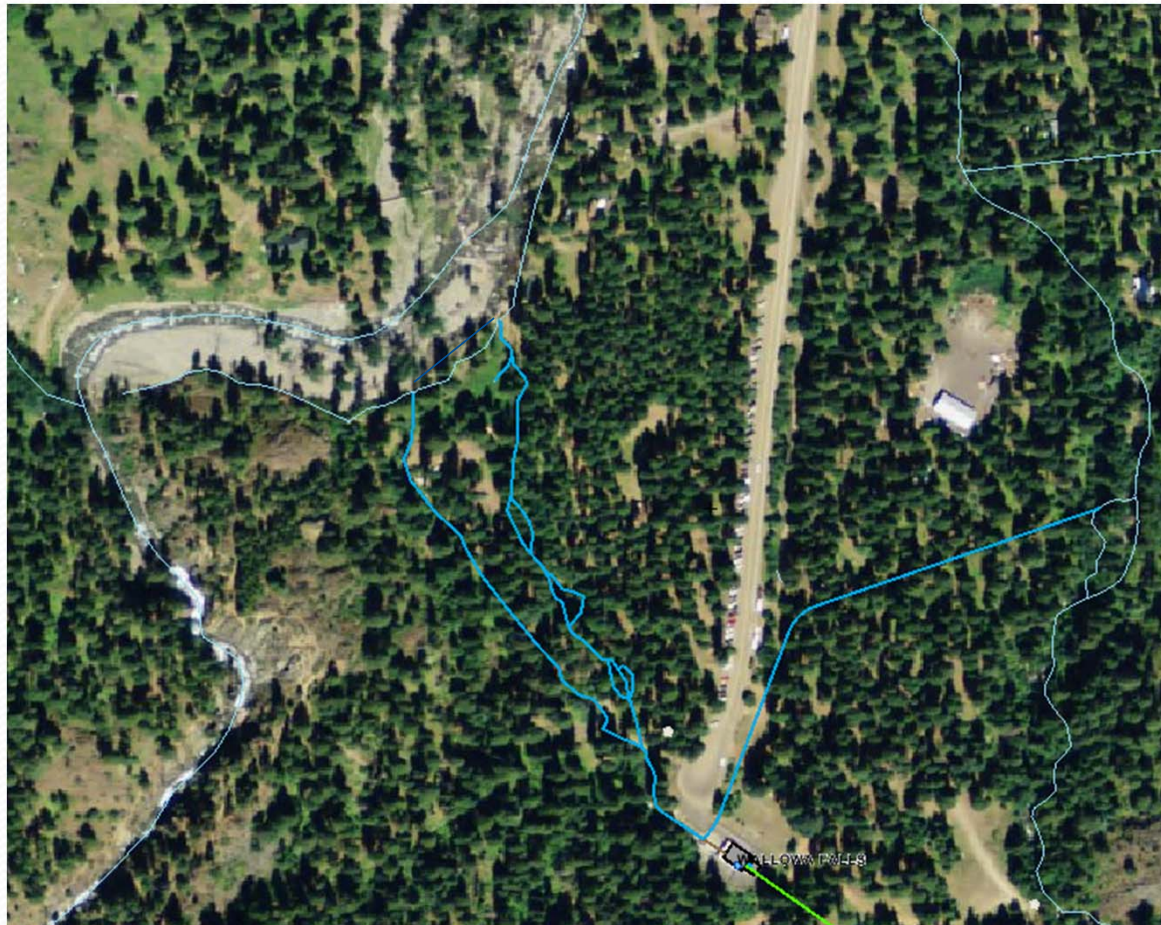
(1) permanently dewatering the existing tailrace channel and constructing a pipe along the existing tailrace channel alignment to convey powerhouse flows to the West Fork

- FERC alternatives 1, 2, and 3 all entail construction of new facilities in the active West Fork Wallowa River channel in order to eliminate risk of stranding ESA protected bull trout and/or bull trout redds.
- The capital costs associated with alternatives 1, 2 and 3 are prohibitively high considering the risk to damage from seasonal high flows the water conveyance system and/or outfall structure would be subject to.

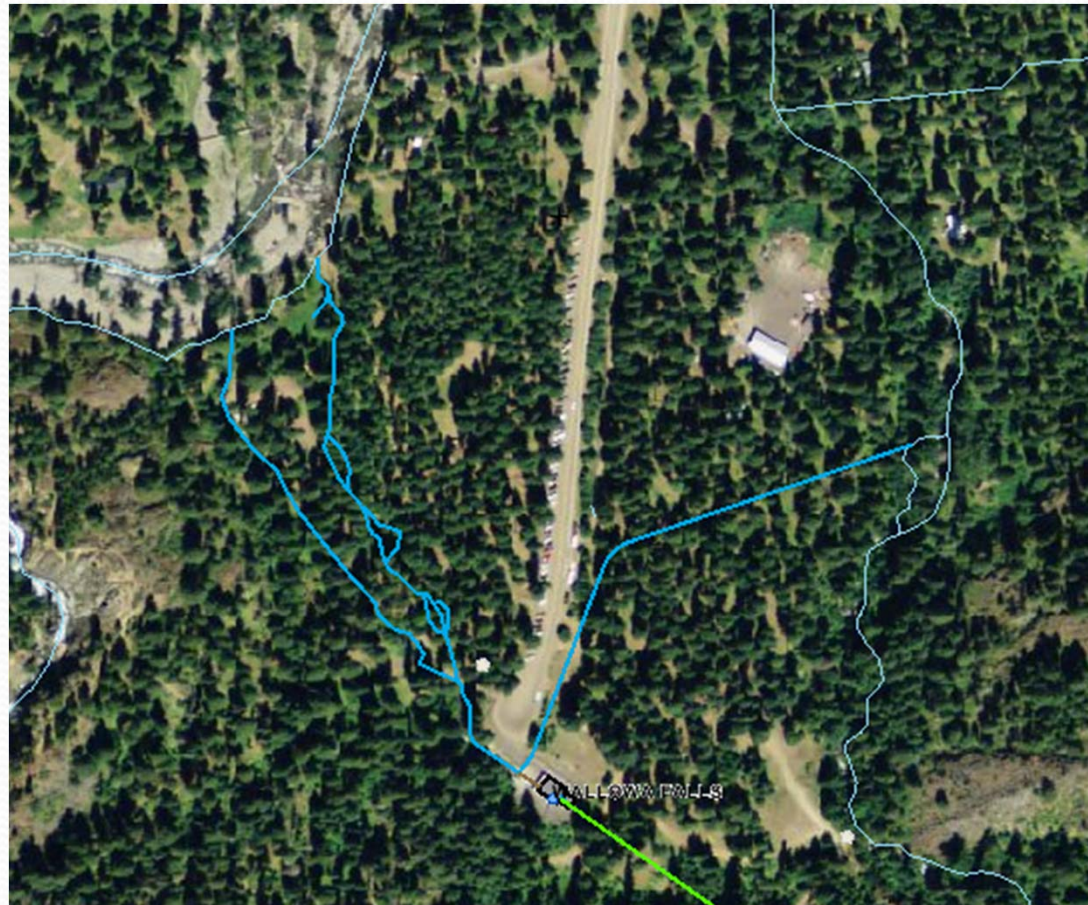
(4) seasonal shutdown of the proposed tailrace pipe with a discharge of powerhouse flows to the existing tailrace channel during winter periods of channel ice formation in the bypassed reach

- Shutdown of the tailrace discharge into the East Fork Wallowa River would need to occur from November through March, which is the period when potential channel ice formation can occur from particularly cold weather events;
- During the shutdown period, all powerhouse flow would be discharged into the existing tailrace channel;
- A temporary barrier (picket-weir or similar) would seasonally be constructed at the mouth of the existing tailrace channel to prohibit fish from entering it;
- Under the new license, the required instream flow release into the East Fork bypassed reach during the shutdown period would be 4 cfs as measured at the proposed compliance gage location.
