**ANNUAL REPORT for CY2018 and
ROLLING 4-YEAR PROJECT ACTIVITIES
CALENDAR YEARS 2018 - 2021**

**Wallowa Falls Hydroelectric Project
FERC No. P-308**

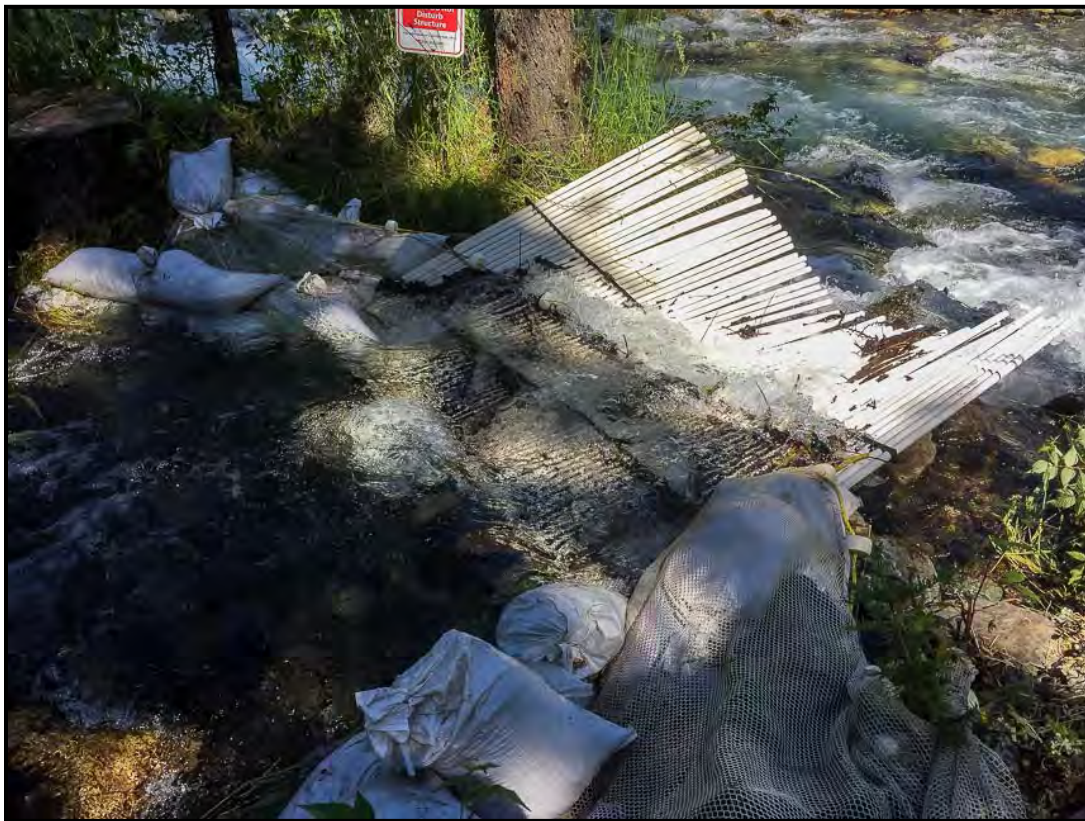
Figure 2. Photo of Wallowa Falls tailrace barrier in operation. Photo taken on August 2, 2018.

Also in 2018, a resistance type weir was constructed to serve as a temporary fish exclusionary device at the outlet of the tailrace channel and it’s confluence with the West Fork Wallowa River. The resistance weir utilized 25.4 millimeter (mm) diameter polyvinyl chloride (PVC) set to a length of 2.4 meters (m) and spaced apart 6.35 mm by mechanically constructed stringers, the weir was stream-spanning (Figure 2). As extra precaution, a barrier net was also laid across the entire bottom of the upstream side of the weir. The openings of this barrier net were also 6.35 mm and the net was held in place by large sandbags placed end to end along the stream bottom and spanning the entire stream-width.

opportunity to test the effectiveness of the tailrace barrier as the tailrace channel was drained dry prior to maintenance activities. No fish were captured or observed during fish salvage activities as the tailrace was dewatering and no fish mortalities were observed after the channel was completely dewatered.

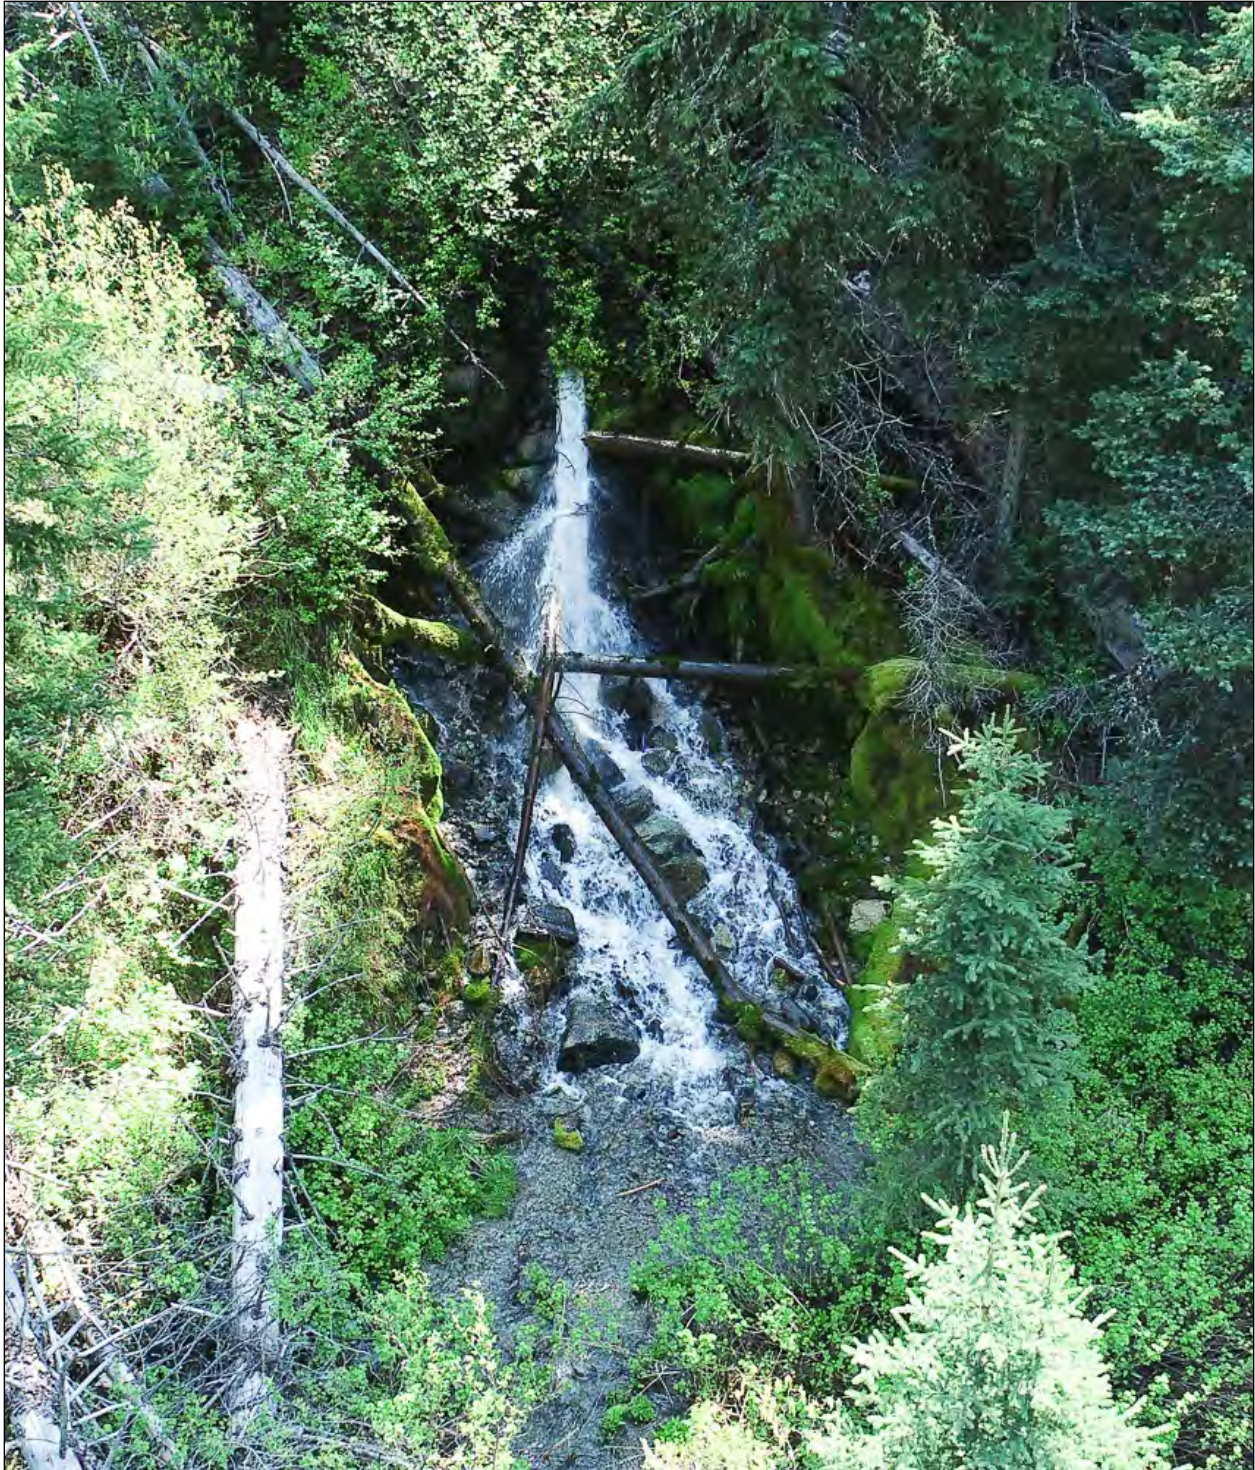
Figure 3. Aerial photo of Royal Purple diversion discharge (UAS, June 2018).

Water is diverted at the project's 2-foot-high, 9-foot-long concrete Royal Purple Creek Diversion Dam on Royal Purple Creek into a 240-foot-long, 8-inch-diameter partially-buried pipeline. The pipeline empties into a 20-foot-long open channel that discharges to the East Fork Wallowa River just upstream of the project's East Fork Dam and impoundment (figures 2 and 3). The FERC license requires that PacifiCorp extend the Royal Purple Creek Diversion pipeline by an additional 20 feet so it discharges directly to the East Fork Wallow River, thereby minimizing erosion along the existing open channel between the pipeline terminus and the East Fork (see design sheet 7).

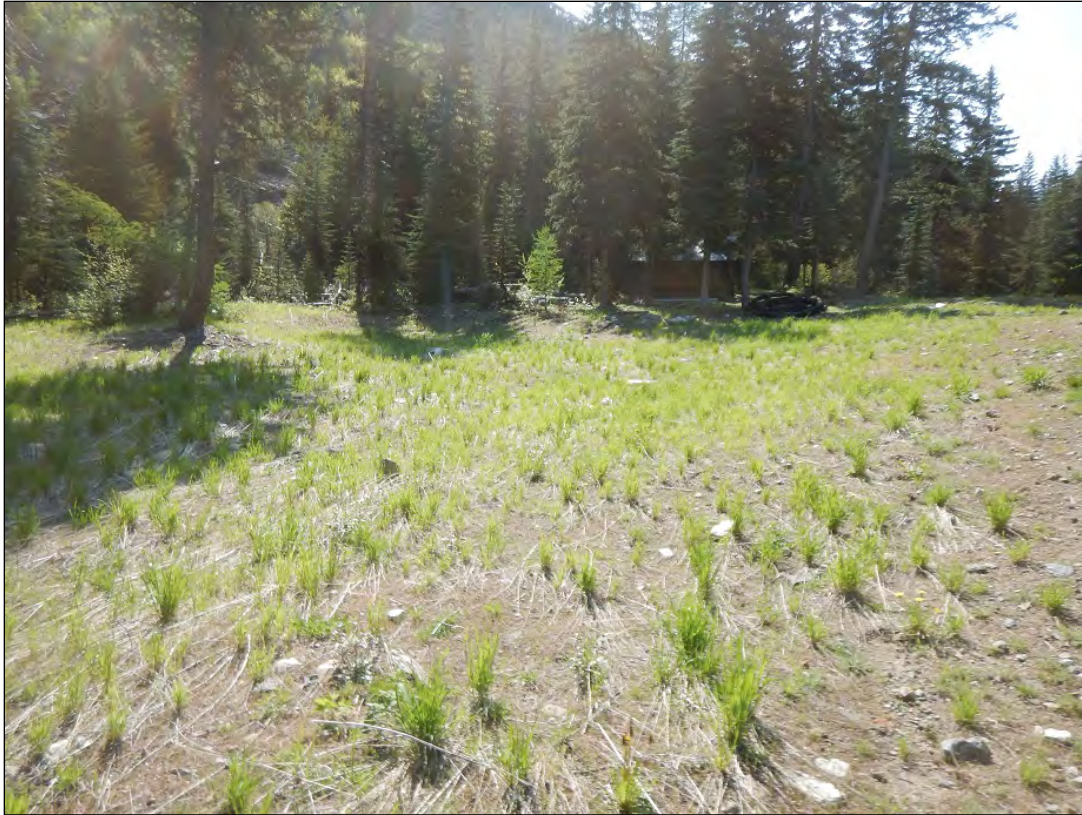
Figure 4. Staging area adjacent to the East Fork diversion.

The staging area is located in an upland area and is currently sparsely vegetated with herbaceous grasses (Figure 4). After the work is complete, the staging area will be re-seeded with a native seed mix. The in-water work zone in the forebay is not vegetated under existing conditions; and therefore, re-vegetation below the ordinary high water line after construction is not proposed.

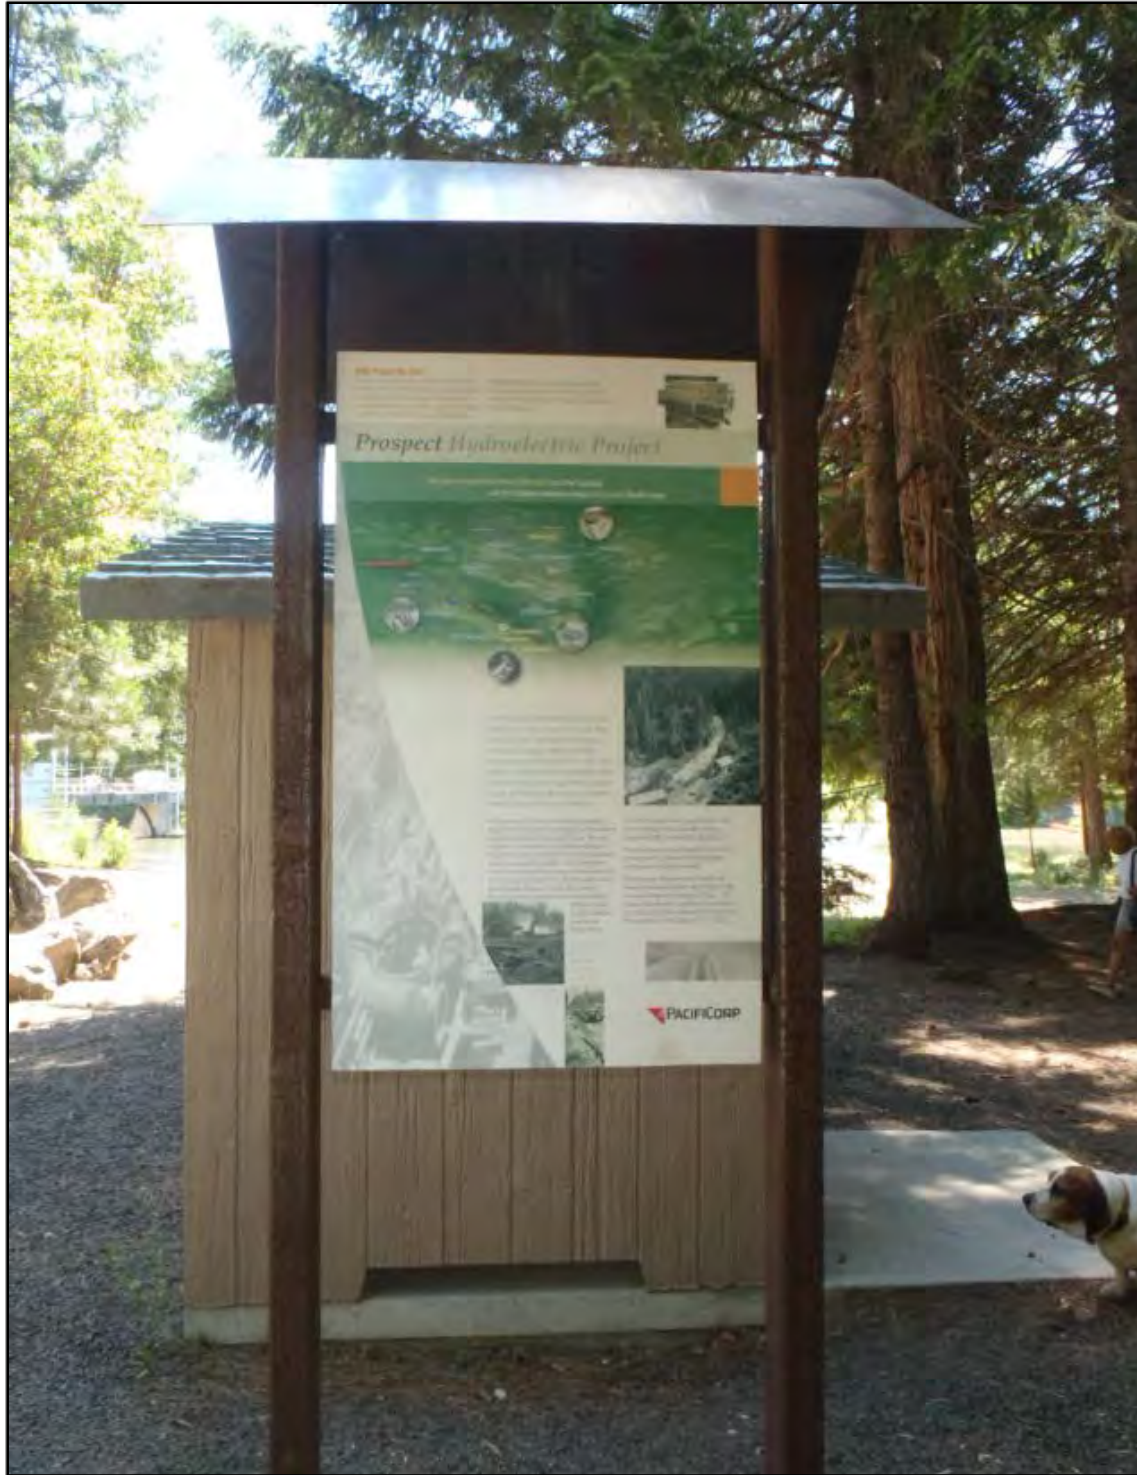
Figure 6. Example interpretive sign design.

Signs will be pre-fabricated offsite and installed with hand tools and if necessary, small quantities of hand-poured concrete for post footings. Any trail drainage improvements have not yet been designed.

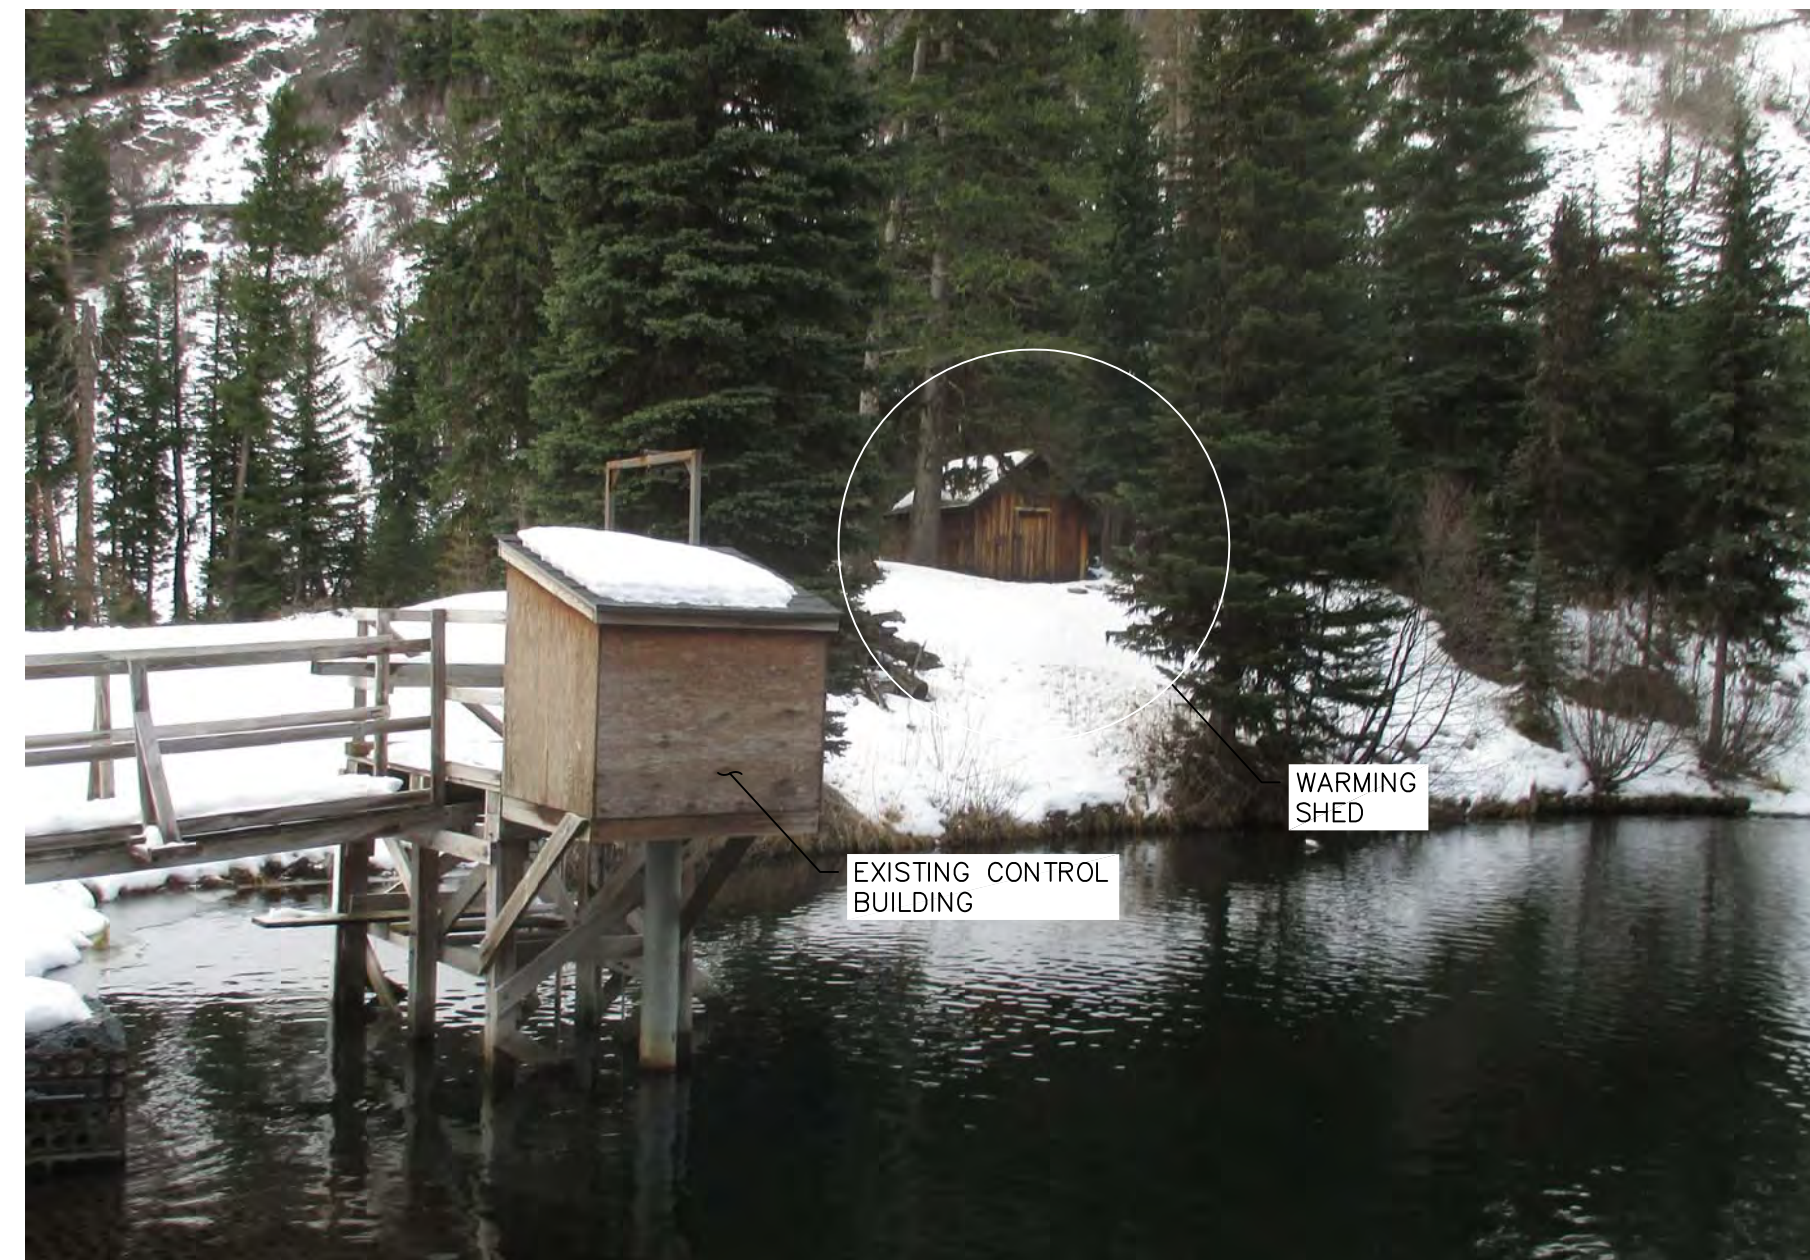
SAP#			WALLOWA FALLS HYDROELECTRIC INTAKE & TAILRACE MODIFICATIONS INTAKE PLATFORM CONTROL BUILDING PLAN AND SECTIONS			
PL#						
DATE FEBRUARY 2019						
ENG CCB		DES CCB				
DR WJZ	CH CCB					
APPROVAL			  PACIFICORP <small>A MEMBER OF THE NORTHWEST ENERGY COMPANY</small>

4. COLUMN BASE DETAILS 7 AND 8 ARE DESIGNED TO ALLOW FOR FIELD ADJUSTMENTS TO AS-BUILT CONDITIONS. CONTACT THE ENGINEER IF COLUMNS CANNOT BE WELDED TO THE SUPPORT PLATES SIMILAR TO DETAILS SHOWN.

BOTTOM PLAN
SCALE: 1" = 1'-0"

TOP PLAN

SECTION
SCALE: 1" =
