**2018 ANNUAL REPORT and  
ROLLING 3-YEAR PROJECT MANAGEMENT ACTIVITIES  
CALENDAR YEARS 2017 - 2019**

**Wallowa Falls Hydroelectric Project  
FERC No. P-308**

The Federal Energy Regulatory Commission (Commission) issued a new operating license for the Wallowa Falls Hydroelectric Project (Project) January 5, 2017. The Operation Compliance Monitoring Plan (OCMP) was developed to satisfy Article 408 and Condition 1e) of Appendix A: Oregon Department of Environmental Quality (ODEQ) Water Quality Certification, of the license. The OCMP was approved by the October 11, 2017 Commission Order Modifying and Approving Operational Compliance Monitoring Plan Pursuant to License Article 408. This Annual Report satisfies the reporting requirements of Section 3.1.2 of the OCMP (PacifiCorp 2017a) and license Article 408.

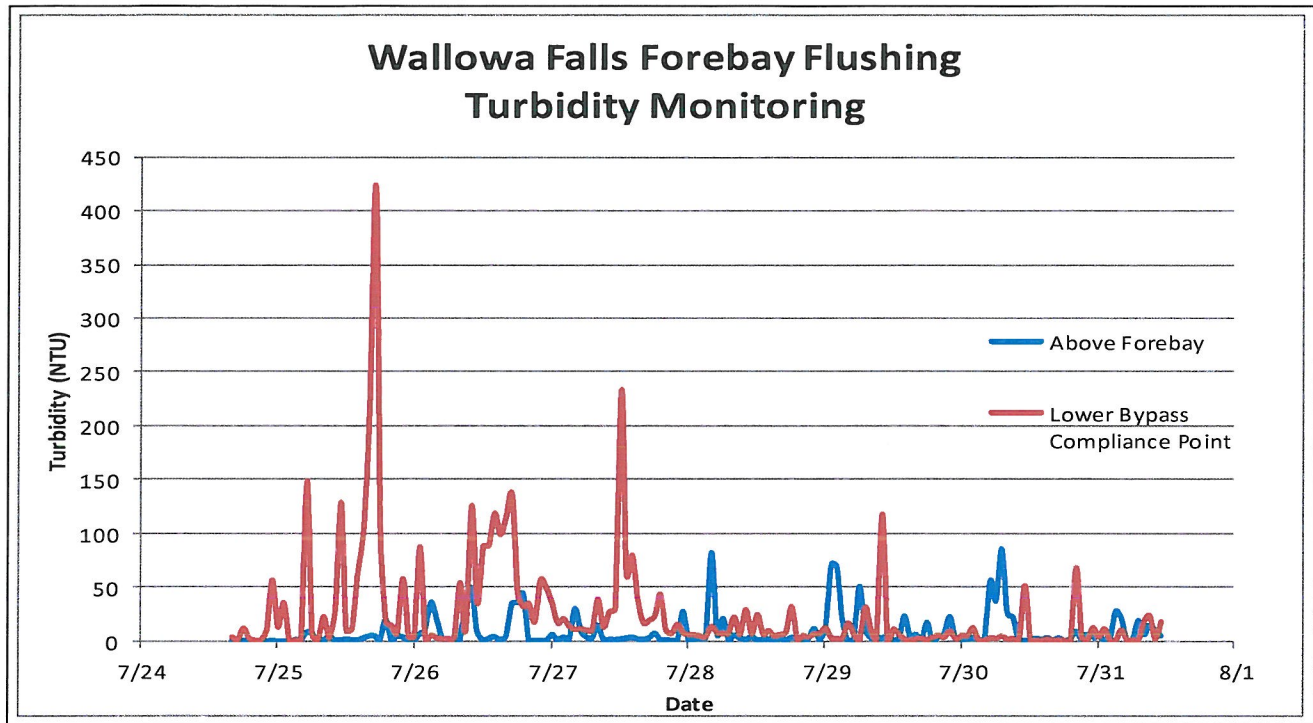
Attachment 1 - Wallowa Falls Hydroelectric Project  
2017 Forebay Flushing Turbidity Data

Date	Turbidity (NTU)	
	Above Forebay	Lower Bypass Compliance Point
7/24/2017 16:00	0.6	2.7
7/24/2017 17:00	0.6	0
7/24/2017 18:00	0.6	11
7/24/2017 19:00	0.7	1.8
7/24/2017 20:00	0.2	0
7/24/2017 21:00	0.1	0
7/24/2017 22:00	0.1	8.9
7/24/2017 23:00	0.2	55.9
7/25/2017 0:00	0	12.4
7/25/2017 1:00	0.1	34.8
7/25/2017 2:00	0.1	0
7/25/2017 3:00	1.4	0
7/25/2017 4:00	0.8	0
7/25/2017 5:00	8.4	147.9
7/25/2017 6:00	6.9	5
7/25/2017 7:00	0.7	0
7/25/2017 8:00	0.9	21.6
7/25/2017 9:00	4.5	2.5
7/25/2017 10:00	0.9	28.6
7/25/2017 11:00	1.2	128
7/25/2017 12:00	1.9	9
7/25/2017 13:00	1.3	10
7/25/2017 14:00	1.2	62.9
7/25/2017 15:00	2.7	102.6
7/25/2017 16:00	4.8	214.9
7/25/2017 17:00	5	422
7/25/2017 18:00	1.8	96.5
7/25/2017 19:00	20.3	17.7
7/25/2017 20:00	1.8	13.8
7/25/2017 21:00	4.6	6.7
7/25/2017 22:00	3.8	57.6
7/25/2017 23:00	0.8	3.7
7/26/2017 0:00	0.7	3.3
7/26/2017 1:00	6.5	87
7/26/2017 2:00	11.3	1.3
7/26/2017 3:00	36	4.6
7/26/2017 4:00	20	2.1
7/26/2017 5:00	1.7	1.3

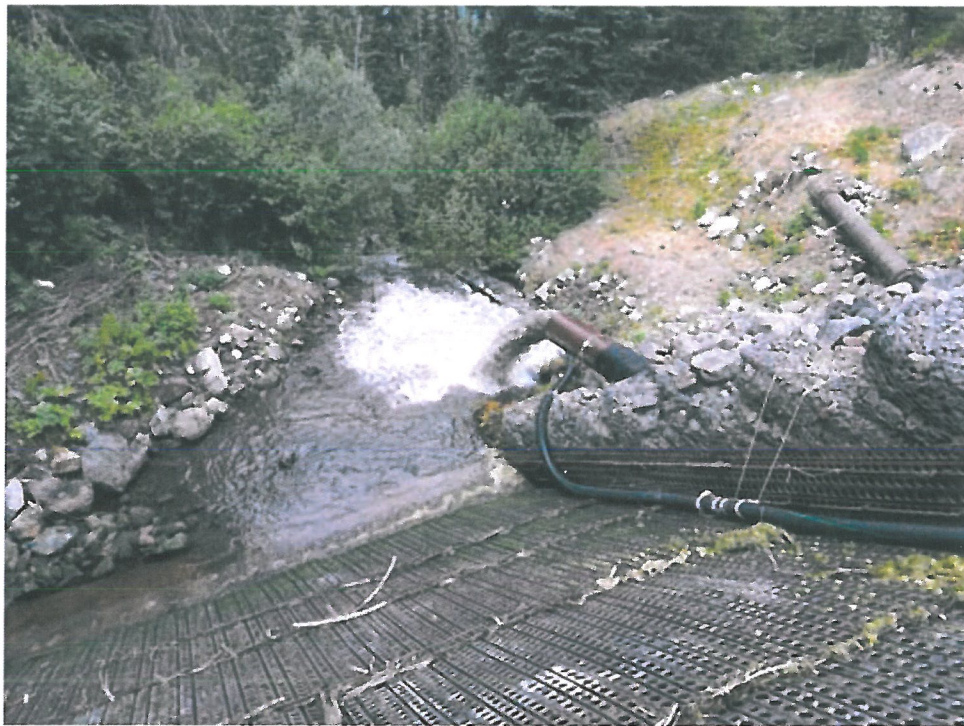
Photo 1 – Dredge hose installed over spillway

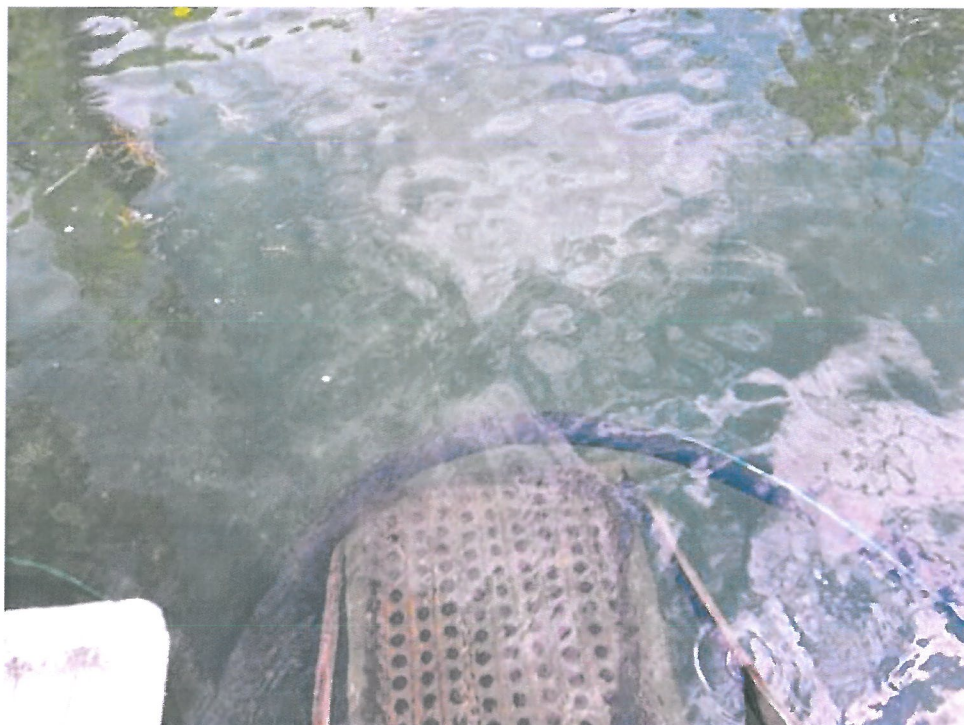
Photo 2 – Dredge hose upstream of penstock intake

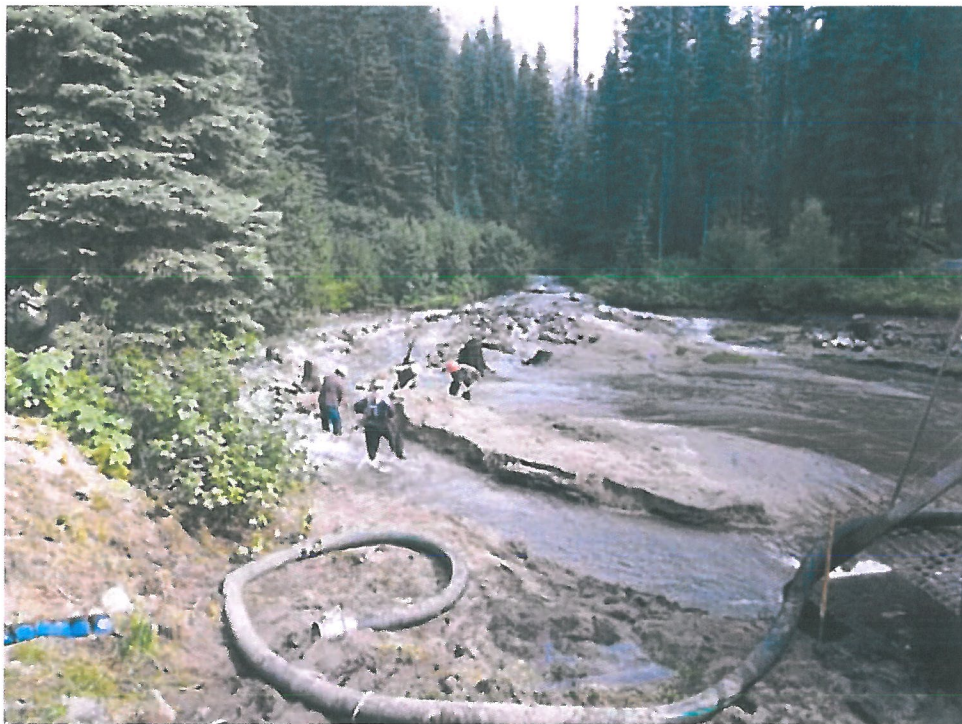
Photo 3 – Crew working to direct stream flow for sediment transport

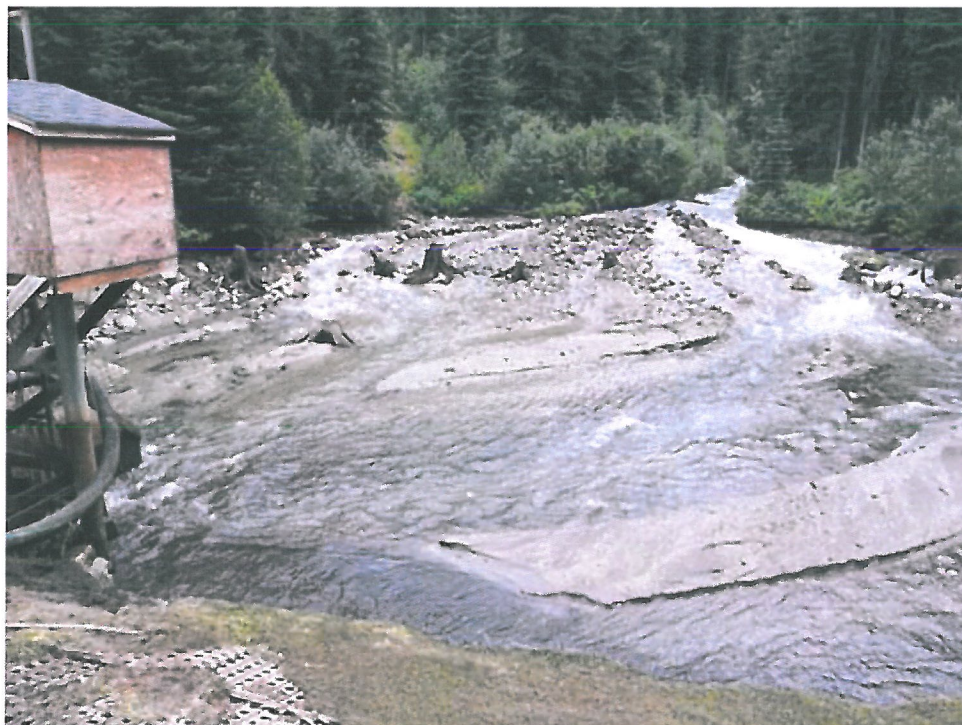
Photo 4 – Stream flow through forebay redirected using rocks in forebay

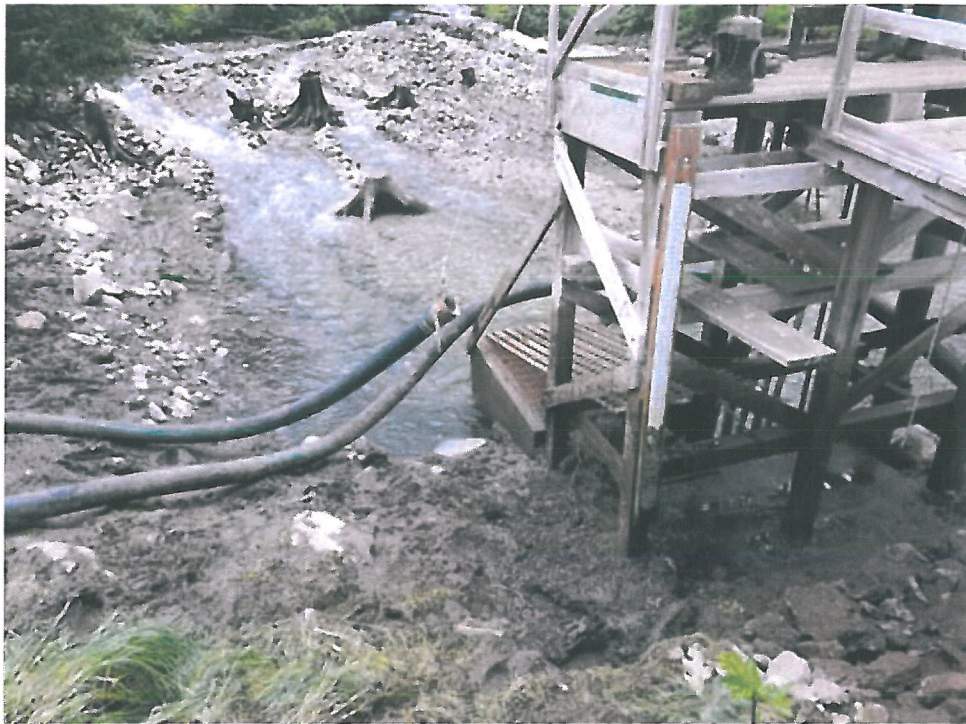
Photo 5 – Channels dredged out to increase sediment transport out of forebay

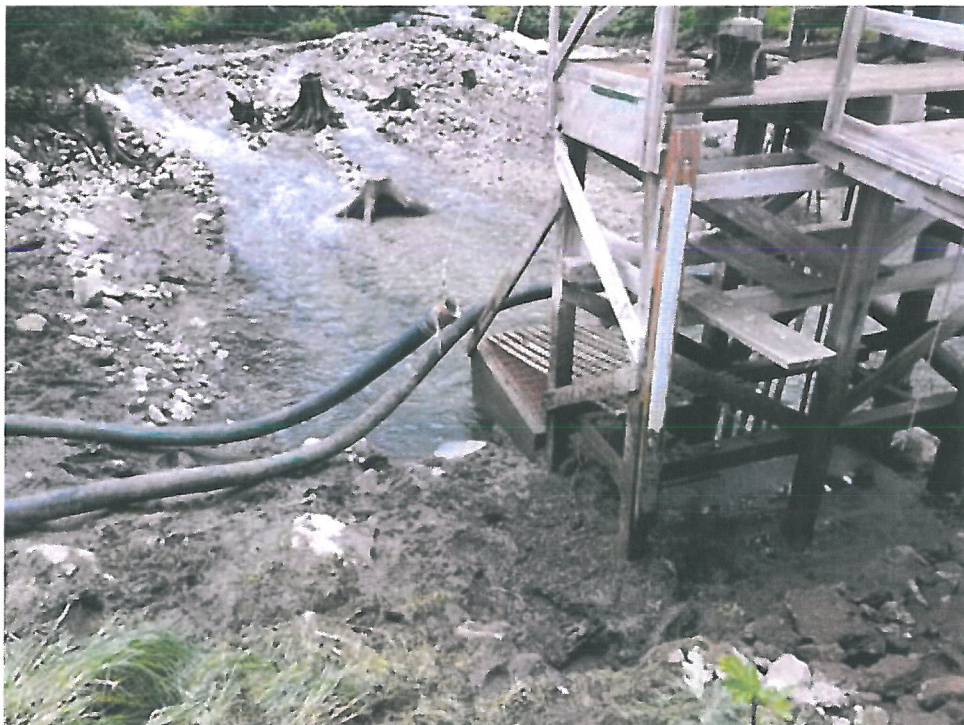
Photo 6 –Forebay after dredging and flushing operation

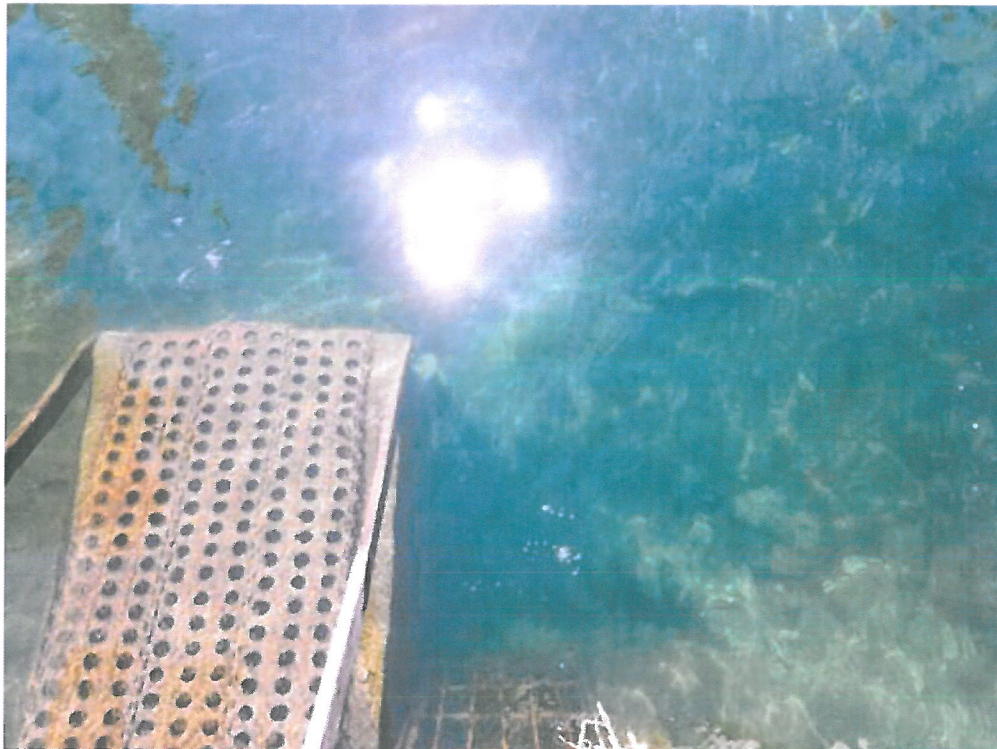
Photo 7 – Penstock intake and low level outlet trash rack after dredging and flushing operation

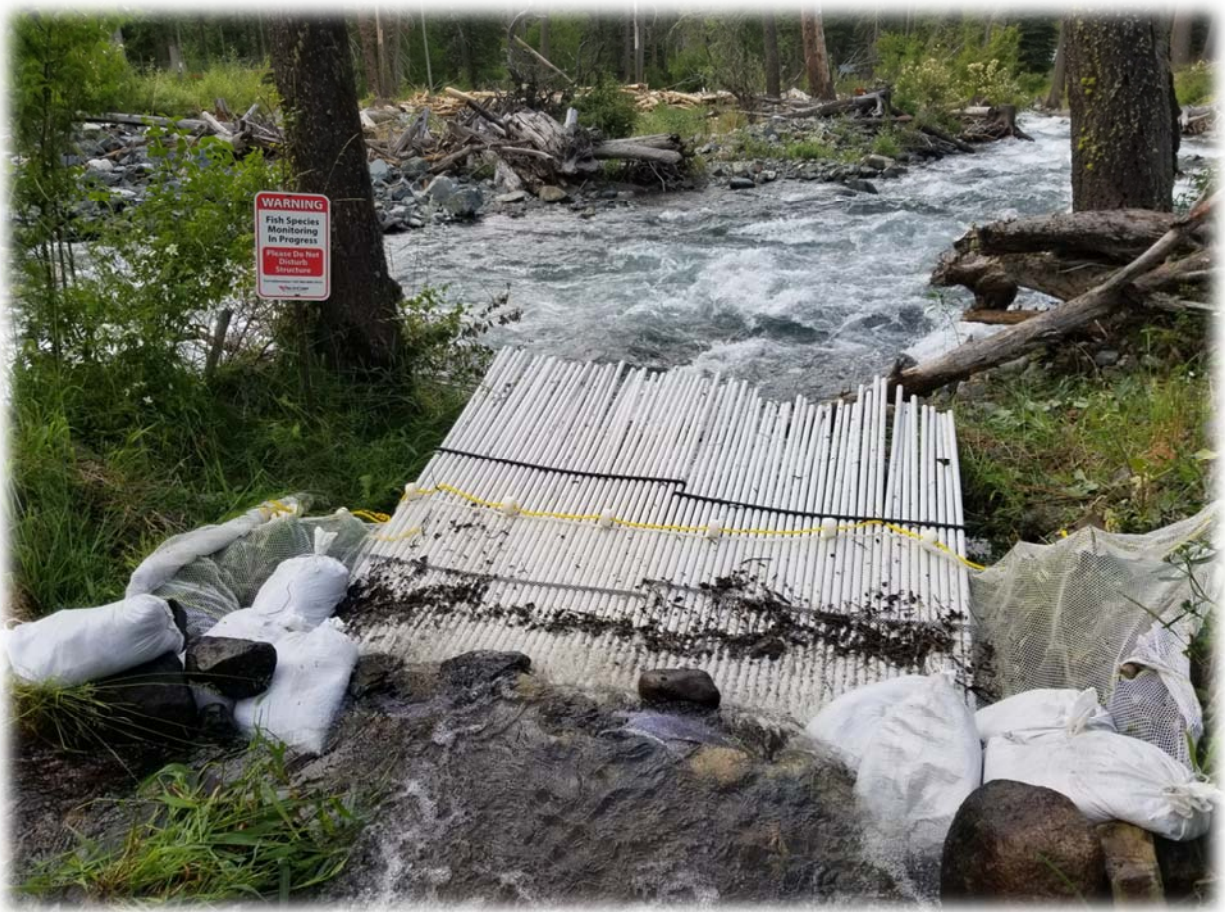
**Figure 2**

Also in 2017, a resistance type weir was constructed to serve as a temporary fish exclusionary device at the outlet of the tailrace channel and it's confluence with the West Fork Wallowa River. The resistance weir utilized 25.4 millimeter (mm) diameter polyvinyl chloride (PVC) set to a length of 2.4 meters (m) and spaced apart 6.35 mm by mechanically constructed stringers, the weir was stream-spanning (Figure 2). As extra precaution, a barrier net was also laid across the entire bottom of the upstream side of the weir. The openings of this barrier net were also 6.35 mm and the net was held in place by large sandbags placed end to end along the stream bottom and spanning the entire stream-width.

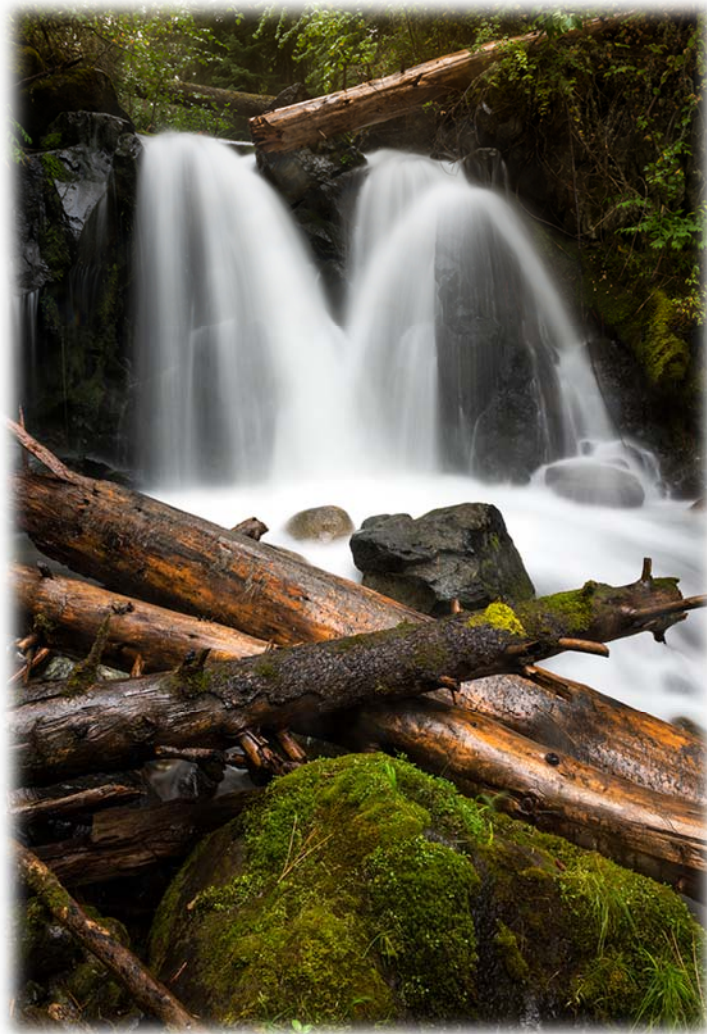
East Fork Wallowa River barrier to upstream fish migration, photo courtesy of Kendrick Moholt

The bypassed portion of the East Fork Wallowa River within and near the Project area is approximately 2,800 meters (m) long from the Project diversion dam to its confluence with the Wallowa River. Gradient in this reach is high, with the upper 1,600 m averaging 19 percent and the lower 1,200 m averaging 8.5 percent. Channel morphology within most of the upper reach is dominated mainly by steep bedrock, vertical waterfalls, and cascades over boulders; though the upper reaches are steep, the lower 800 m to the confluence with the Wallowa River has a shallower gradient, consisting of numerous riffles and pools. Over the course of its length, the bypassed East Fork Wallowa River drops approximately 365 m from the dam to the confluence with the Wallowa River. The upper and lower portions are divided by a 3.7 m vertical falls (Report cover photo), an impassible upstream migration fish barrier.

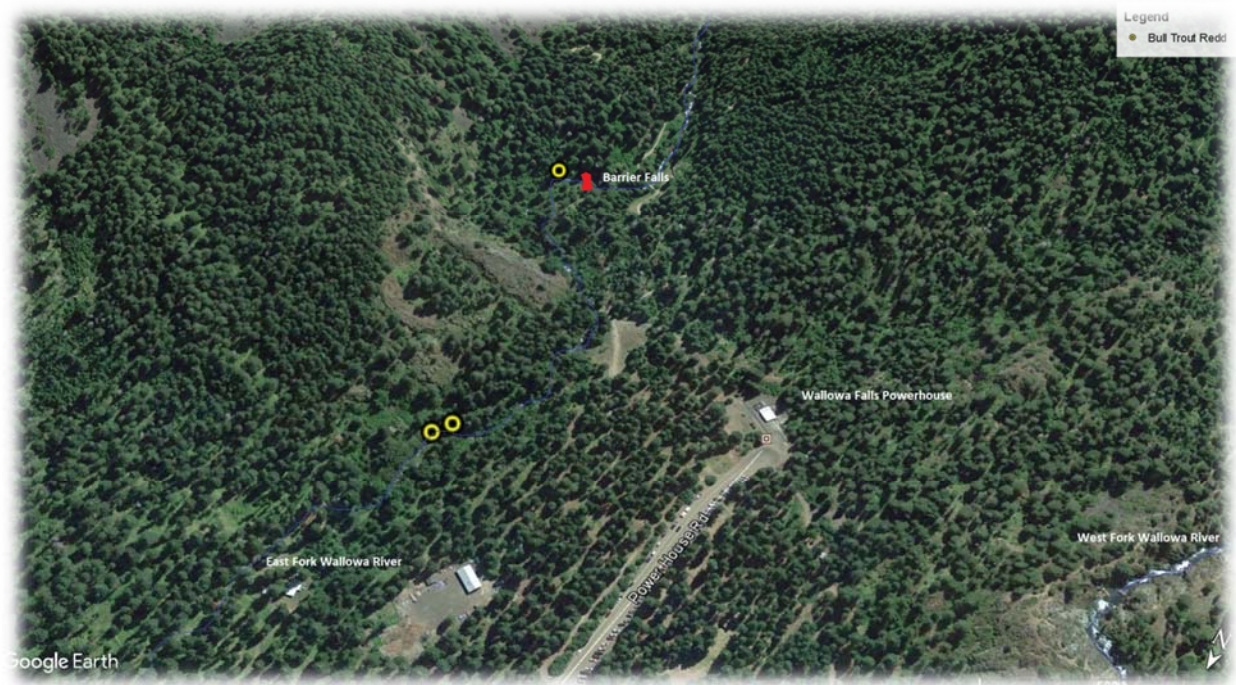
**Figure 1 – Courtesy of E. Lesko**

Three bull trout redds were identified and marked by GPS during the nine redd surveys performed of the East Fork Wallowa River in 2017 (Figure 1). All three bull trout redds were large and indicative of being constructed by large migratory-sized fish. Two of the three redds were identified during the very first survey on September 12. Both of these redds had a single bull trout in very near proximity. Four other bull trout lives were also observed during the September 12 survey, all six observed live bull trout were estimated to range in fork length between 350 millimeters - 600 millimeters (Figure 2 and Figure 3). The third redd was identified on September 25 and was found to also have a pair of bull trout actively over the top and in the process of constructing the redd, these fish were estimated to have been ~400 millimeters in fork length. An additional bull trout live was observed during a survey on October 2 and was estimated to have been ~350 millimeters in fork length. No other bull trout redds or lives were observed during the study period.
