**Subject: Wallowa Falls Hydroelectric Project (FERC No. P-308)
 2020 Forebay Flushing Report**

Attachment 1 – Wallowa Falls Forebay Flush Turbidity Data

Attachment 2 – Wallowa Falls Forebay Flush Photos

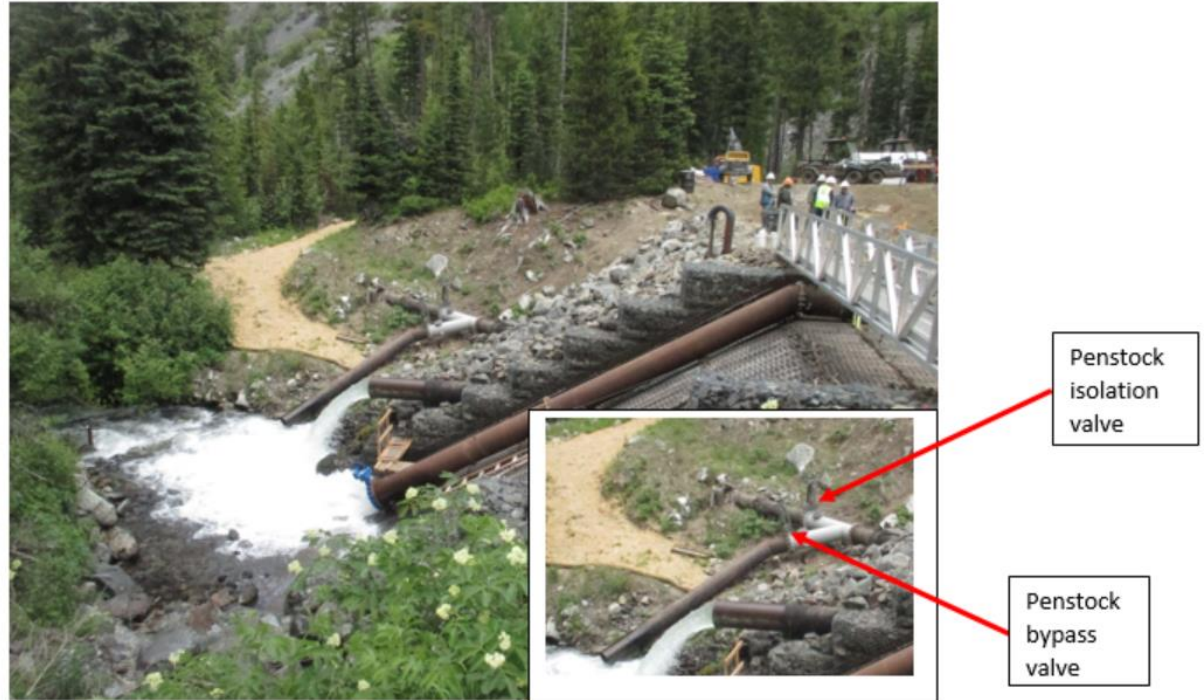
Figure 1: penstock wye with knife gate valves

The penstock wye with knife gate valves (penstock isolation and bypass valves) was installed during the intake rebuild project of 2019 to allow more water to be bypassed through the dam during annual forebay flushing (Figure 1).

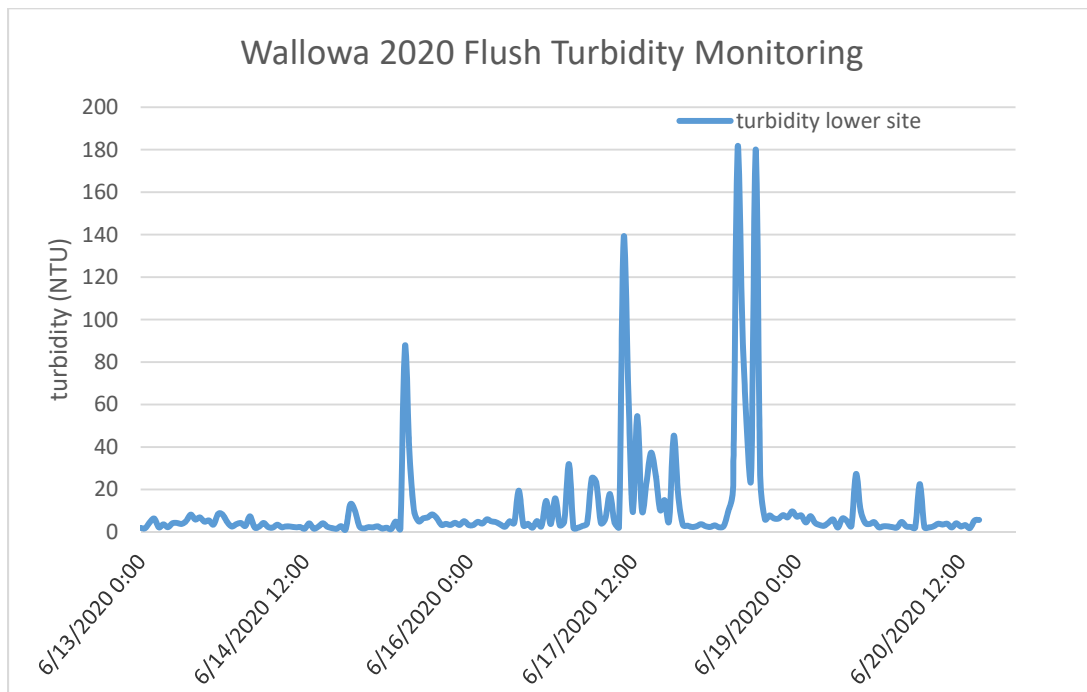
June 13, 2020: PacifiCorp's contract biologist mobilized to site and deployed In-Situ datasondes in the East Fork Wallowa River upstream of the inlet to the Project forebay and downstream of the Project dam at the USGS gage site. A graph and hourly turbidity data recorded at the lower monitoring site for the period of June 13, 2020 through June 29, 2020 are provided in Attachment 1 to this letter report.

Throughout the flushing period hourly turbidity was recorded at the downstream monitoring site (see Attachment 2: Turbidity Data).

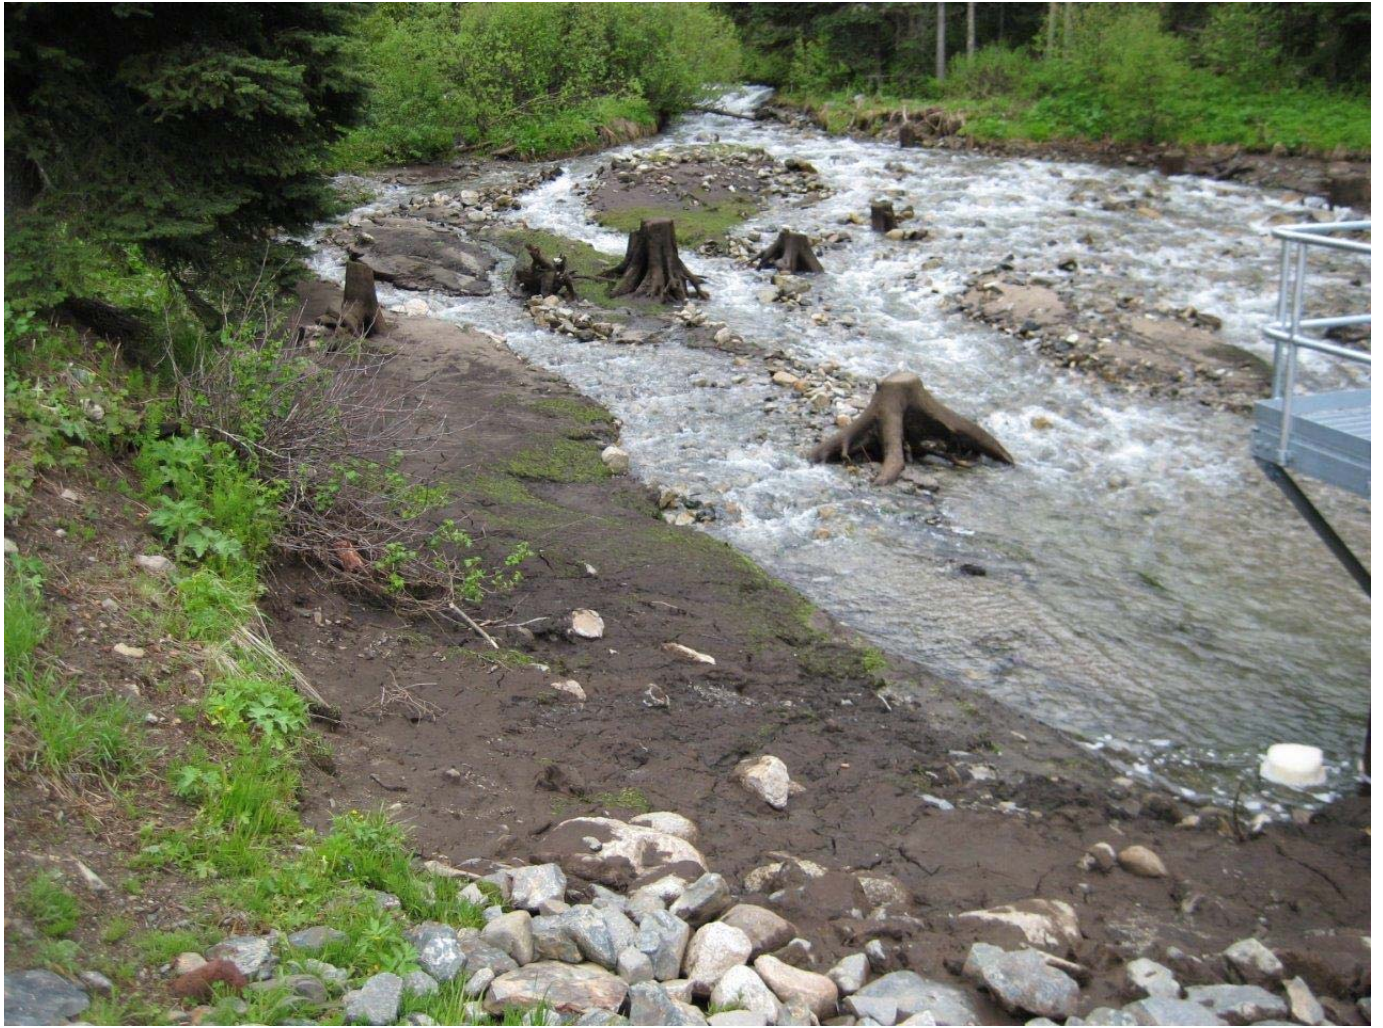
Photo 2: Wallowa Falls Forebay - drained for flushing on June 15, 2020

With the use of both the low level outlet pipe and the penstock with the wye installed in 2019, we were able to drain the Project forebay and successfully mobilize accumulated sediment into the East Fork Wallowa River below the Project dam (see Attachment 1: Photos).
