# **2018 Annual Operational Compliance Report**

**Wallowa Falls Hydroelectric Project**

**(FERC No. P-308)**

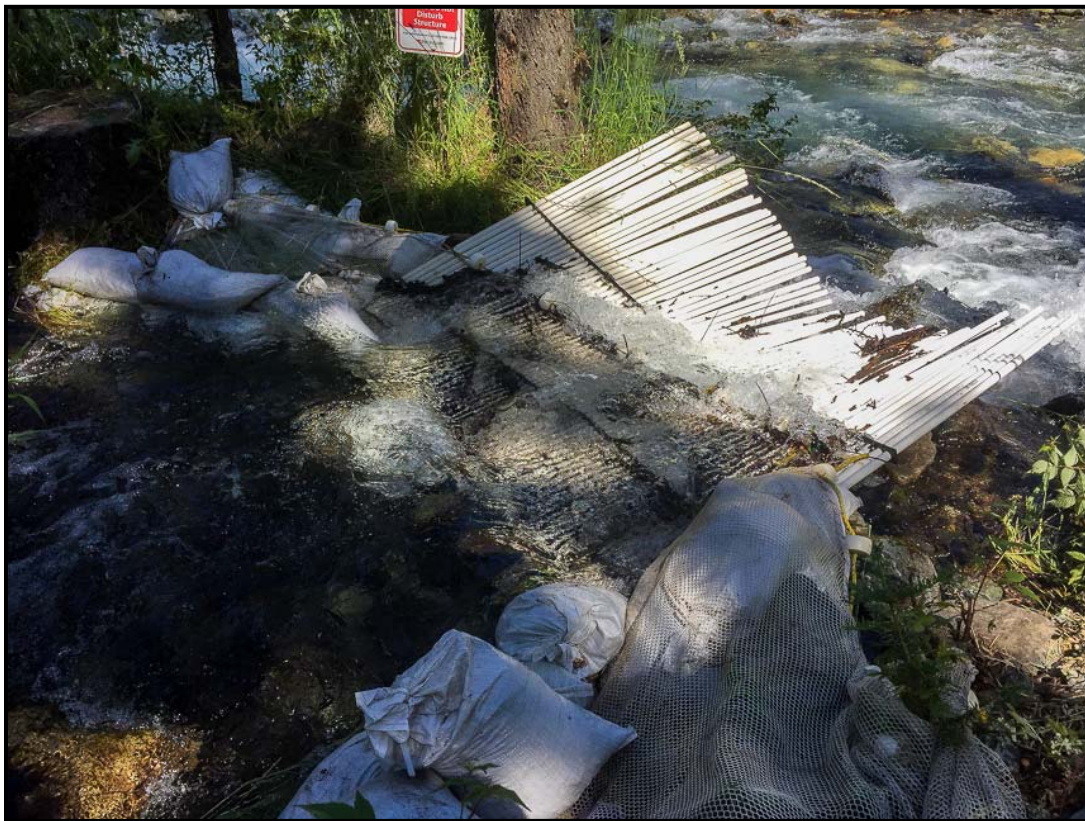
Also in 2018, a resistance type weir was constructed to serve as a temporary fish exclusionary device at the outlet of the tailrace channel and it's confluence with the West Fork Wallowa River. The resistance weir utilized 25.4 millimeter (mm) diameter polyvinyl chloride (PVC) set to a length of 2.4 meters (m) and spaced apart 6.35 mm by mechanically constructed stringers, the weir was stream-spanning (Figure 2). As extra precaution, a barrier net was also laid across the entire bottom of the upstream side of the weir. The openings of this barrier net were also 6.35 mm and the net was held in place by large sandbags placed end to end along the stream bottom and spanning the entire stream-width.

**Figure 2. Photo of Wallowa Falls tailrace barrier in operation. Photo taken on August 2, 2018.**

opportunity to test the effectiveness of the tailrace barrier as the tailrace channel was drained dry prior to maintenance activities. No fish were captured or observed during fish salvage activities as the tailrace was dewatering and no fish mortalities were observed after the channel was completely dewatered.

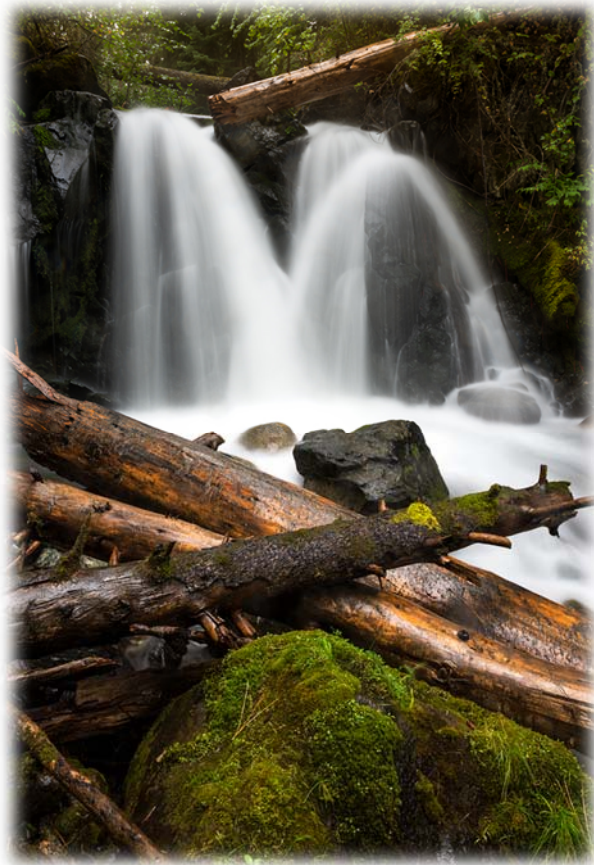
East Fork Wallowa River barrier to upstream fish migration, photo courtesy of Kendrick Moholt
