**Fish Salvage & Temporary Fish Barrier Report for the
Wallowa Falls Hydroelectric Project Tailrace**

(FERC No. P-308)

December 15, 2021

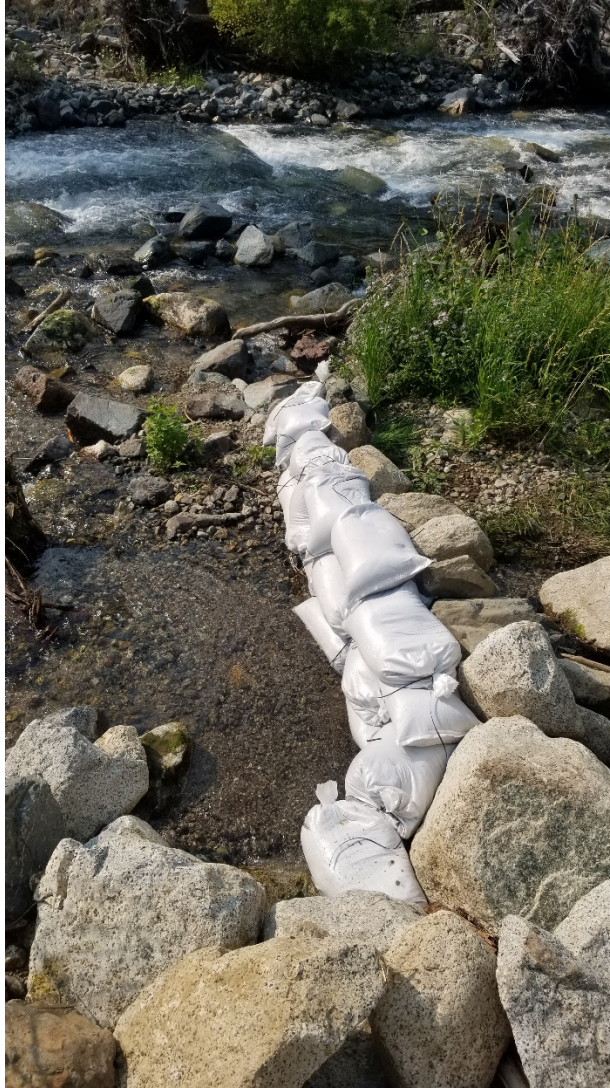
Figure 2. Photo of Wallowa Falls side-channel barrier on upstream end.

Additionally, in 2021, as stipulated within the Introduction, a sandbag and block net barrier were constructed to serve as a temporary fish exclusionary device at the top, middle, and bottom end of the small West Fork Wallowa River side-channel located immediately downstream of the tailrace barrier discharge plume. The fish barrier at the upstream end, and middle of the side-channel utilized sandbags, stacked one on top the other for the entire width of the side-channel (Figure 2 and Figure 3). A barrier net was strung across the entire bottom end exit of the side-channel (Figure 4). The openings of this barrier net were 6.35 mm, and the net was held in place by large sandbags placed end to end along the stream bottom and spanning the entire stream-width. Further specifics to the Emergency Action Plan concerning this side-channel can be found in Appendix A.

Per the Action Plan submitted to stakeholders on August 17, 2020, a temporary fish barrier was installed at the upstream and downstream end of the West Fork Wallowa River side-channel immediately downstream of the Project tailrace barrier discharge plume on July 14, 2021. The tailrace fish barrier was visually inspected twice per week until taken out on November 15, 2021. At no time during weekly inspections was the barrier visually assessed to be ineffective in precluding fish from entering the side-channel.

To prohibit fish and tailrace discharge from accessing the stranding side-channel from the top end immediately below the weir (Figure 1), a diversion (using sandbags, bio-blocks, or similar) will be built. The planned construction method is a sandbag berm approximately 3 meters (10 feet) long and 0.75 meter (2.5 feet) high. The diversion will prohibit water flow and connection between the West Fork Wallowa River, and the stranding side-channel, while diverting water from the tailrace discharge to the main thalweg of the West Fork.

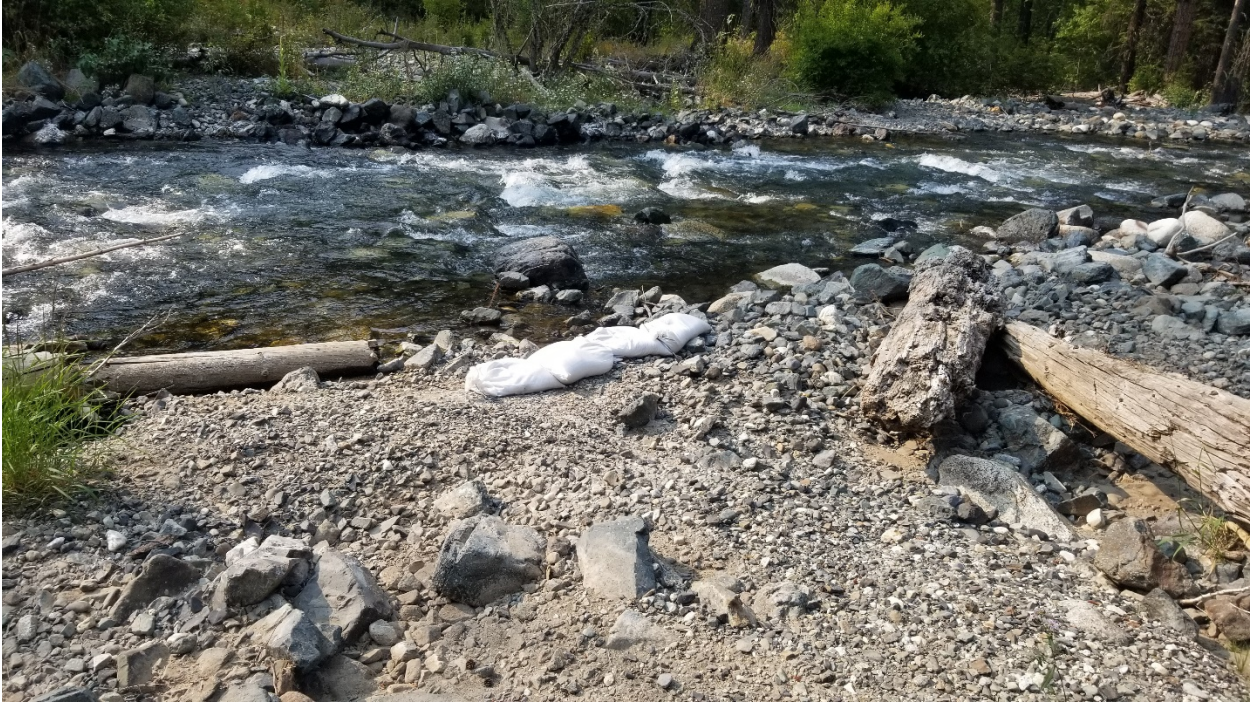
Figure 3. Photo of Wallowa Falls side-channel barrier of small channel halfway down the main side-channel.

To prohibit fish and main West Fork channel water from entering the stranding side-channel at Location 2 (Figure 2), a diversion using sandbags will be built. The planned construction method is a sandbag berm approximately 1.5 meters (5 feet) long and 0.6 meter (2 feet) high. After the three side-channel temporary barriers are placed, all fish will be salvaged from the stranding side-channel and liberated to the main channel West Fork Wallowa River by means of electrofishing. All side-channel barriers will be dismantled and taken out of the river no earlier than November 15, 2020, after conclusion of the bull trout and kokanee spawn season.

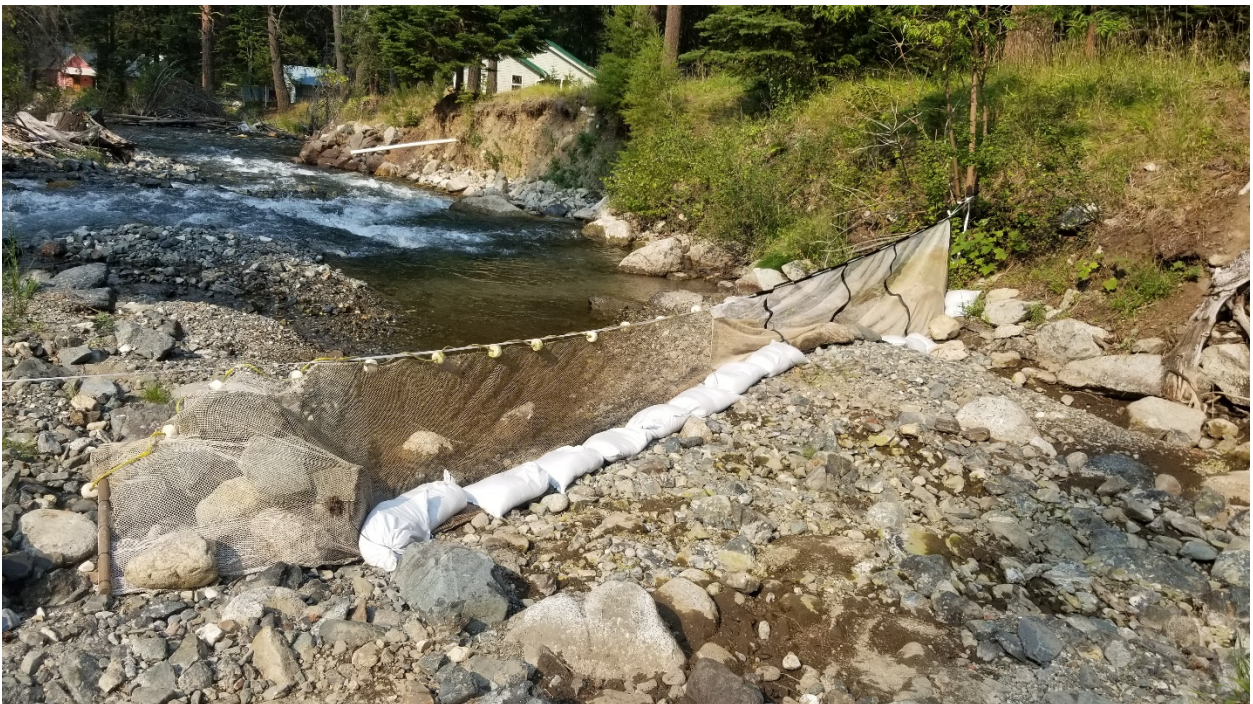
Figure 4. Photo of Wallowa Falls side-channel barrier at the downstream end.

To prohibit fish from entering the stranding side-channel immediately below the Project tailrace discharge outlet from the downstream side during the bull trout and kokanee spawn, a block net (barrier net) will be installed by August 24, 2020 to serve as a temporary fish exclusionary device (Figure A, Location 3). The barrier net will be laid across the entire bottom of the upstream side of the side channel (Figure 3). The openings of the barrier net will be 6.35 mm. The net will be held in place by large sandbags placed end to end along the stream bottom and spanning the entire stream-width. The net will span the entire wetted-width of the side channel, rise above the water surface, and be pinned to the stream bank on either side with rebar to hold it in place in the event of higher than anticipated flows. The barrier net will be visited on a bi-weekly basis to clean debris and assess it is functioning as intended.
