**Fish Salvage & Temporary Fish Barrier Report for the
Wallowa Falls Hydroelectric Project Tailrace**

(FERC No. P-308)

December 27, 2022

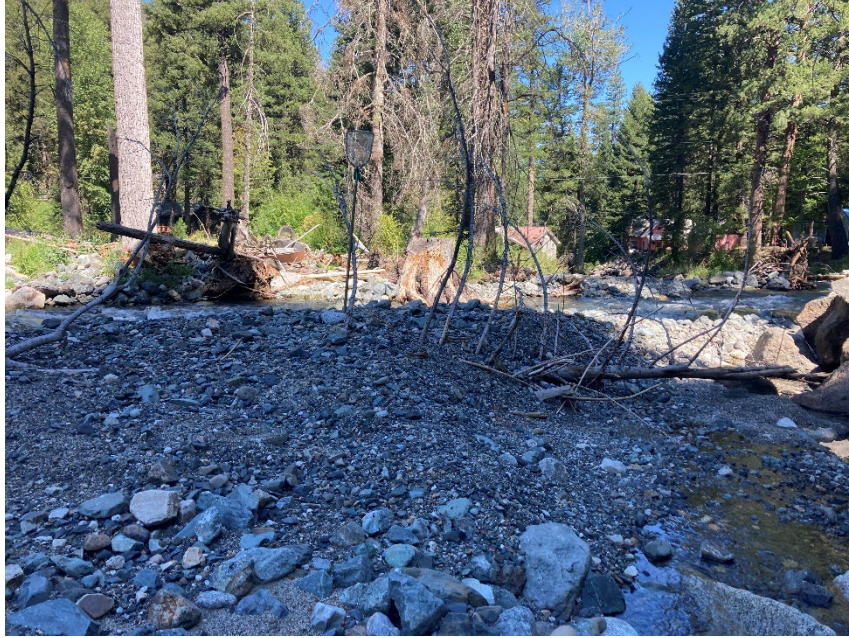
Figure 3. Bottom end of side-channel showing deposited gravel bar and no hydraulic connectivity.
