**Fish Salvage & Temporary Fish Barrier Report for the
Wallowa Falls Hydroelectric Project Tailrace**

(FERC No. P-308)

November 20, 2023

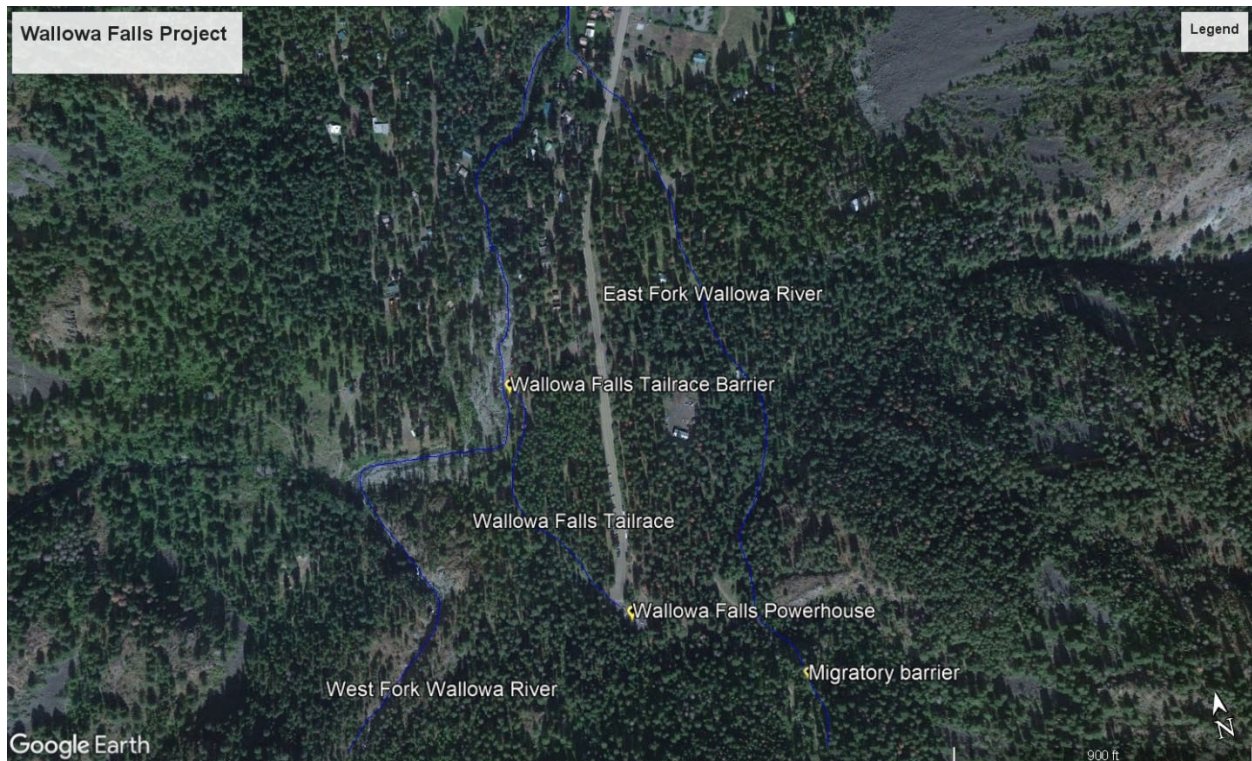
The Project is located on the East Fork Wallowa River (EFW) approximately 11 miles (17 kilometers) outside of the City of Joseph in Northeastern Oregon. The Project (Figure 1) reservoir/forebay lies over 5,200 feet (1,600 meters) above mean sea level (msl) and is approximately 0.2 surface acres (0.08 ha) in size and averages 5 feet (1.5 m) deep. Because the Project operates as run of river, there is no measurable storage. Though no measurable storage is present in the forebay, habitat in this area is lacustrine, and given the shallow water depth no thermal stratification is present. Substrate in the forebay consists of deposited silt, sand, and other glacial fines.

Water diverted at the forebay travels through the flow line and penstock to the generating turbine in the Project powerhouse. Water exits the turbine and is discharged into an approximately 985-foot (300 m) long tailrace discharge channel that empties into the West Fork Wallowa River. This channel has an average wetted-width of 10 feet (3.1 m) and an average depth of one foot (0.3 m).

Figure 1 Wallowa Falls Hydroelectric Project.

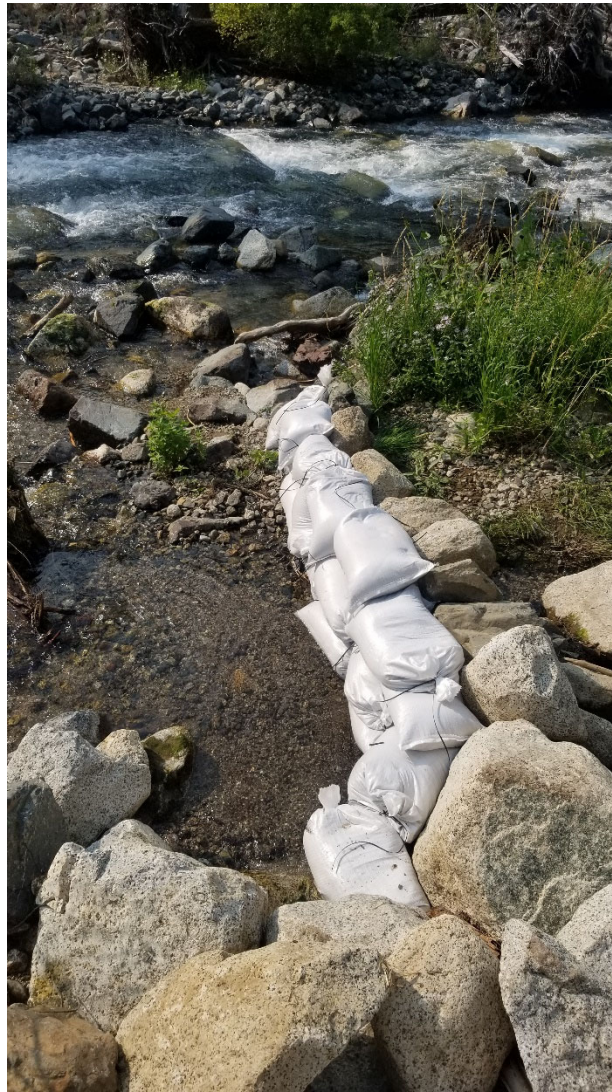
In 2023, per the agreed upon Emergency Action Plan submitted in August of 2020, a sandbag barrier was constructed to serve as a temporary fish exclusionary device at the top of the small WFW side-channel located immediately downstream of the tailrace barrier discharge plume. The fish barrier at the upstream end utilized sandbags, stacked one on top the other for the entire width

of the side-channel (Figure 2). This sandbag berm diverted all water from the tailrace channel into the WFW, effectively dewatering the side-channel for the entirety of the survey period. A large bank of gravel from upstream erosion was deposited at the downstream end of the side-channel at its confluence with the WFW (Figure 3), this and further channel incision of the West Fork at this location made it unnecessary during the survey period to string a net at this location as there was no surficial hydraulic connectivity after the side-channel was dewatered. Further specifics to the Emergency Action Plan concerning this side-channel can be found in Appendix A.

Figure 2. Photo of Wallowa Falls side-channel barrier on upstream end.

Per the Action Plan submitted to stakeholders on August 17, 2020, a temporary fish barrier was installed at the upstream end of the WFW side-channel immediately downstream of the Project tailrace barrier discharge plume on August 15, 2023. The tailrace fish barrier was visually inspected twice per week until taken out on November 15, 2023. At no time during weekly inspections was the barrier visually assessed to be ineffective in precluding fish from entering the side-channel.
