**2023 Annual Operation Compliance Report**

**Wallowa Falls Hydroelectric Project**

**(FERC No. P-308)**

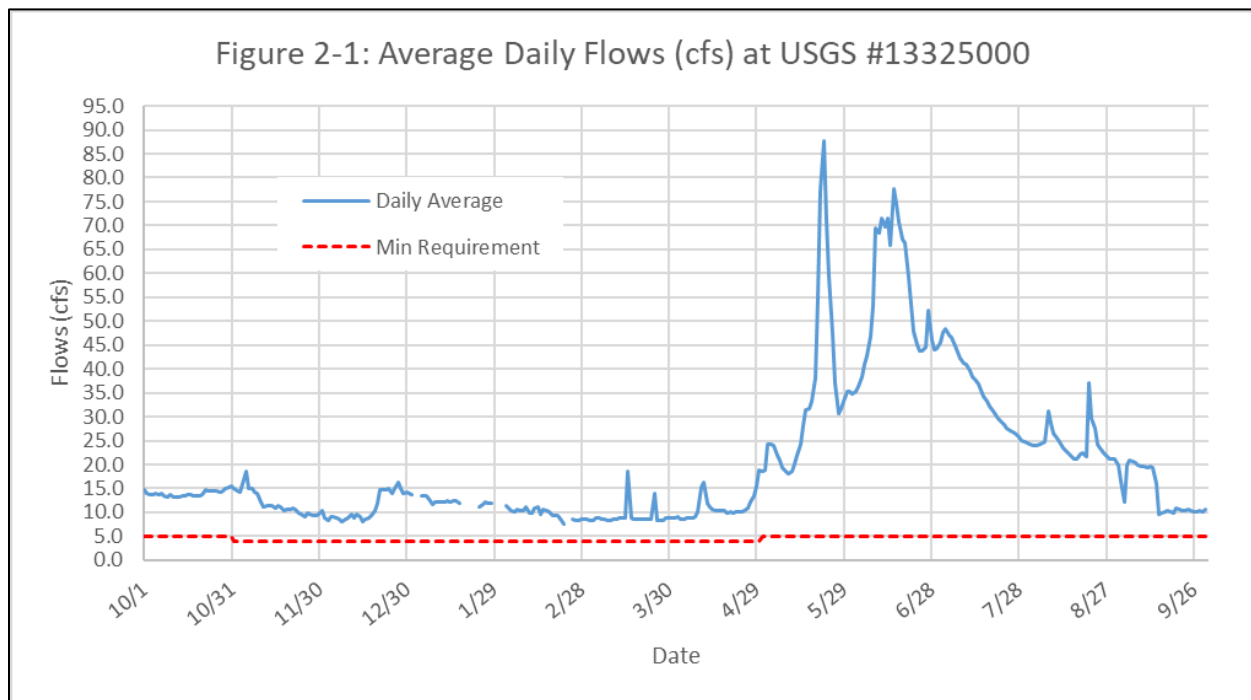
Figure 2-1: Average Daily Flow (cfs)

From October 1-31, 2022, and May 1, through September 30, 2023, the Project operated with 5 cfs or greater in the bypassed reach of the East Fork Wallowa River as measured at the compliance gage. From November 1, 2022, through April 30, 2023, the Project operated with 4 cfs or greater in the bypassed reach of the East Fork Wallowa River as measured at the compliance gage. There were 4 periods (January 1-3, January 18-23, January 29-February 1 and February 23-24) when the gauge equipment froze, and no flow data is available. Figure 2-1 shows the average daily flow during the 2023 water year.

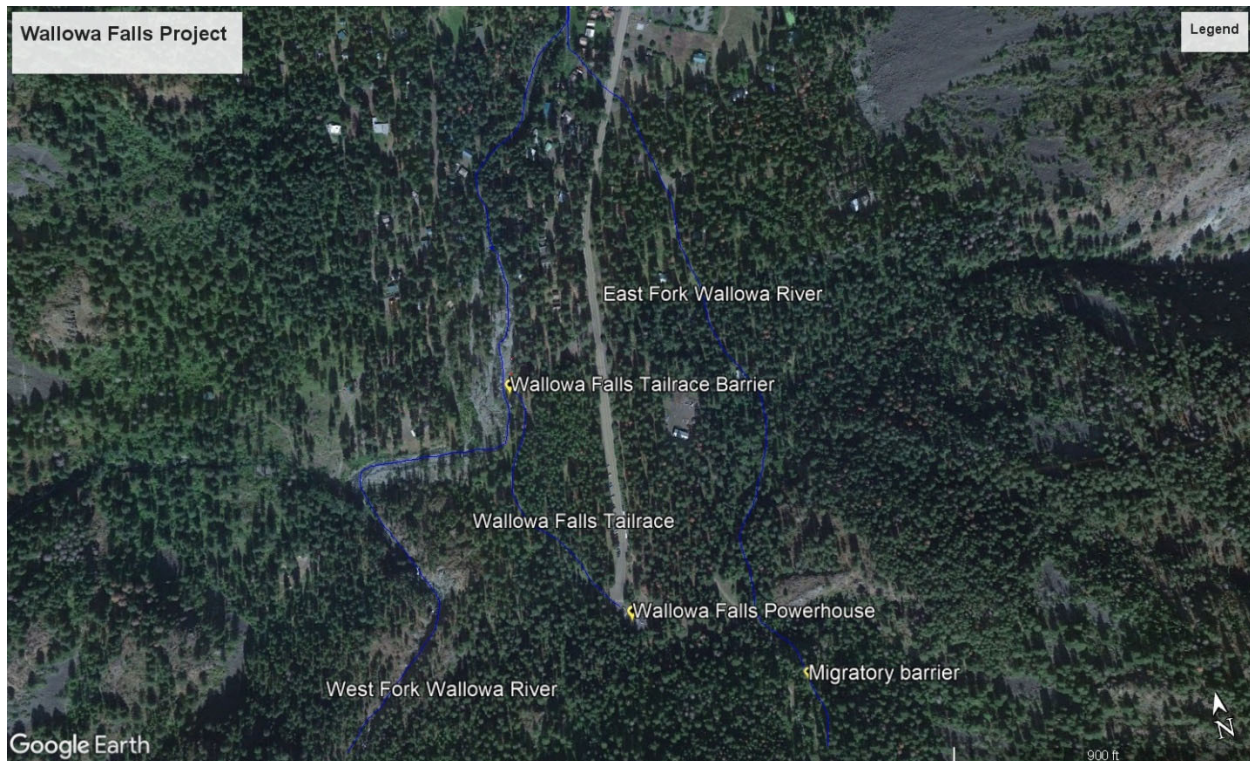
**Figure 1 Wallowa Falls Hydroelectric Project.**

The Project is located on the East Fork Wallowa River (EFW) approximately 11 miles (17 kilometers) outside of the City of Joseph in Northeastern Oregon. The Project (Figure 1) reservoir/forebay lies over 5,200 feet (1,600 meters) above mean sea level (msl) and is approximately 0.2 surface acres (0.08 ha) in size and averages 5 feet (1.5 m) deep. Because the Project operates as run of river, there is no measurable storage. Though no measurable storage is present in the forebay, habitat in this area is lacustrine, and given the shallow water depth no thermal stratification is present. Substrate in the forebay consists of deposited silt, sand, and other glacial fines.

Water diverted at the forebay travels through the flow line and penstock to the generating turbine in the Project powerhouse. Water exits the turbine and is discharged into an approximately 985-foot (300 m) long tailrace discharge channel that empties into the West Fork Wallowa River. This channel has an average wetted-width of 10 feet (3.1 m) and an average depth of one foot (0.3 m).

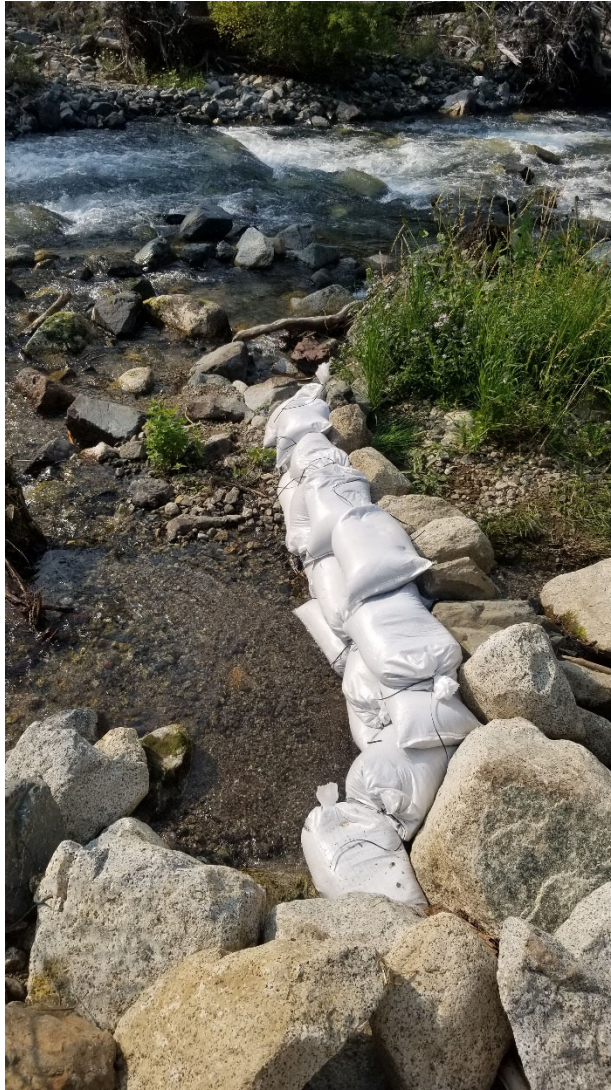
In 2023, per the agreed upon Emergency Action Plan submitted in August of 2020, a sandbag barrier was constructed to serve as a temporary fish exclusionary device at the top of the small WFW side-channel located immediately downstream of the tailrace barrier discharge plume. The fish barrier at the upstream end utilized sandbags, stacked one on top the other for the entire width

of the side-channel (Figure 2). This sandbag berm diverted all water from the tailrace channel into the WFW, effectively dewatering the side-channel for the entirety of the survey period. A large bank of gravel from upstream erosion was deposited at the downstream end of the side-channel at its confluence with the WFW (Figure 3), this and further channel incision of the West Fork at this location made it unnecessary during the survey period to string a net at this location as there was no surficial hydraulic connectivity after the side-channel was dewatered. Further specifics to the Emergency Action Plan concerning this side-channel can be found in Appendix A.

**Figure 2. Photo of Wallowa Falls side-channel barrier on upstream end.**

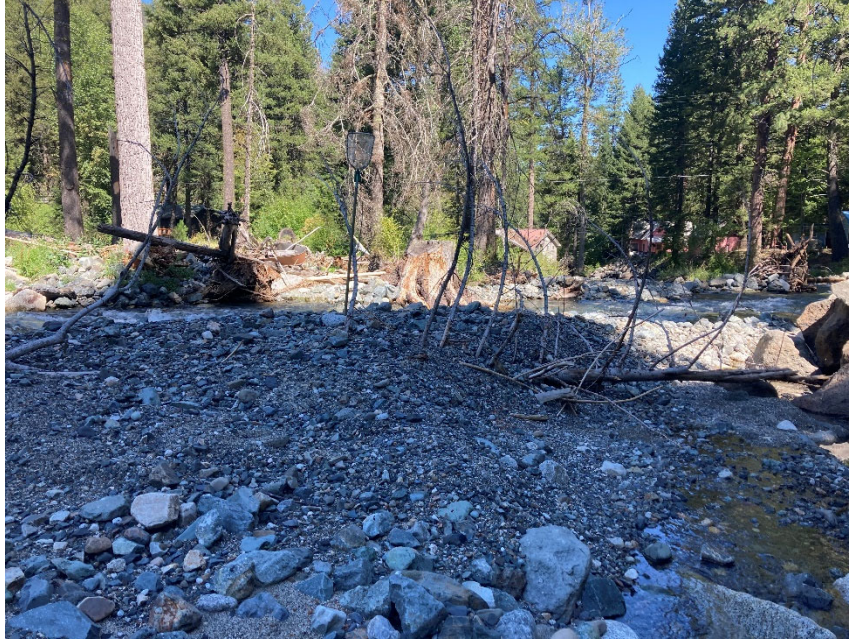
**Figure 3. Bottom end of side-channel showing deposited gravel bar and no hydraulic connectivity.**

No planned fish salvages occurred at the Project during 2023. Typically, a fish salvage would occur in the side-channel within the WFW prior to installation of the temporary fish barrier in mid-August. Due to the Project being off-line for repair June 14, to September 1, including the day of barrier installation along with naturally occurring receding seasonal flow in the WFW, the side-channel was completely dry, and a fish salvage was not necessary.

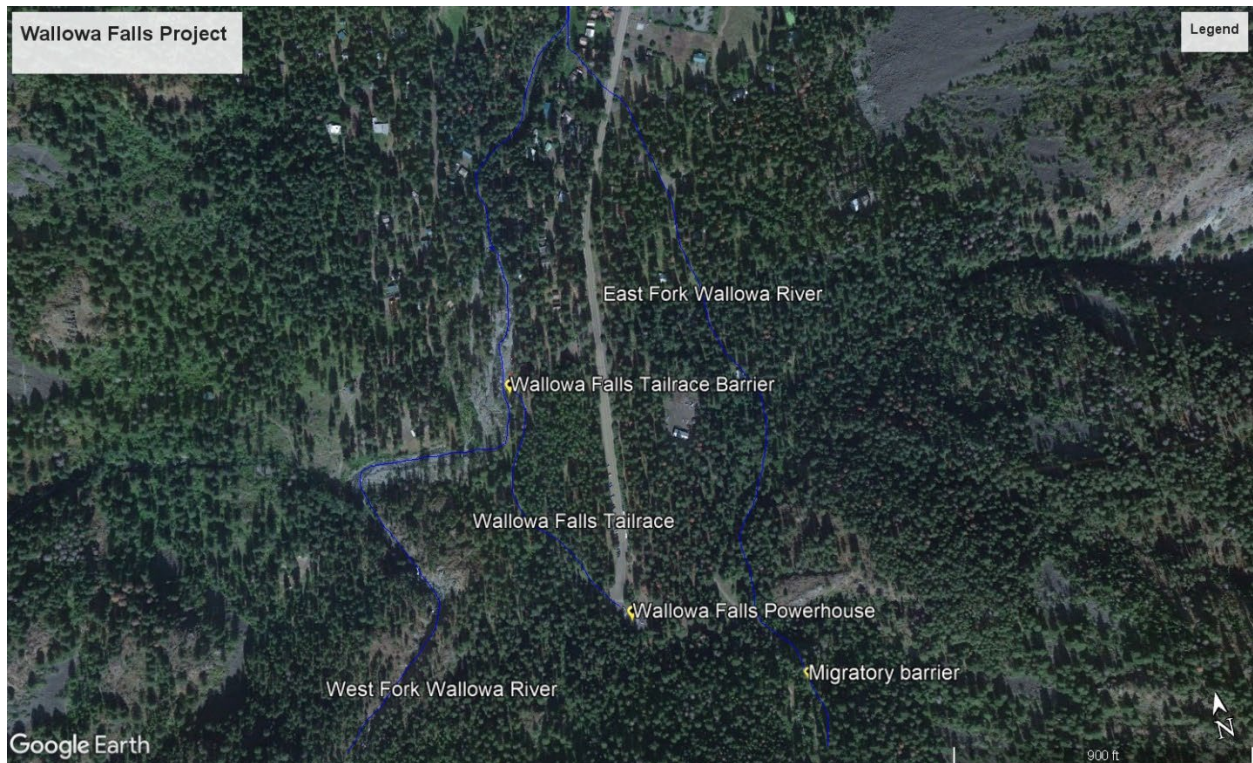
**Figure 1. Wallowa Falls Hydroelectric Project.**

The bypassed portion of the East Fork Wallowa River within and near the Project area is approximately 2,800 meters (m) long from the Project diversion dam to its confluence with the Wallowa River (Figure 1). Gradient in this reach is high, with the upper 1,600 m averaging 19 percent and the lower 1,200 m averaging 8.5 percent. Channel morphology within most of the upper reach is dominated mainly by steep bedrock, vertical waterfalls, and cascades over boulders; though the upper reaches are steep, the lower 800 m to the confluence with the Wallowa River has a shallower gradient, consisting of numerous riffles and pools. Over the course of its length, the bypassed East Fork Wallowa River drops approximately 365 m from the dam to the confluence with the Wallowa River. The upper and lower portions are divided by a 3.7 m vertical falls, an impassible upstream migration fish barrier.

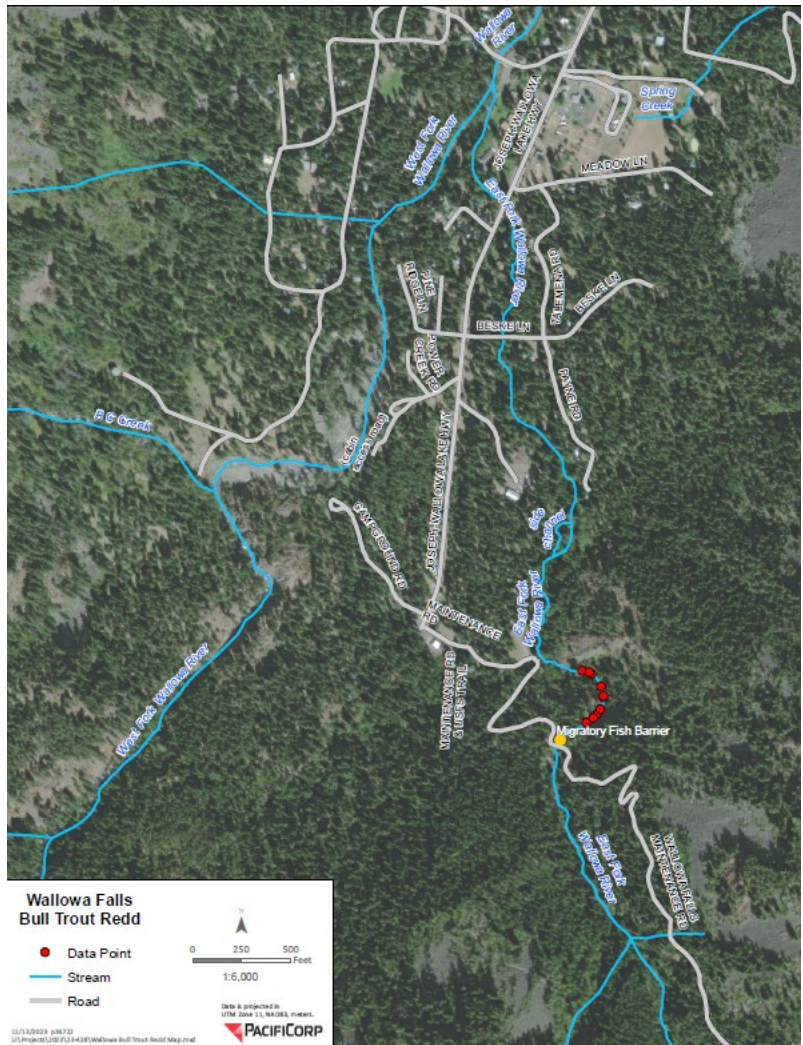
Ten bull trout redds were identified and marked by GPS during redd surveys performed in the East Fork Wallowa River in 2023 (Figure 2). All ten bull trout redds were large and indicative of being constructed by large migratory-sized fish (Table 1), and all were observed in the upper portion of available habitat in the East Fork Wallowa, just below and near to the natural migratory fish barrier. All redd observations in 2023 occurred between September 12 and October 6, with the peak of four counted on September 29 (Figure 3). Six of the ten identified redds had live bull trout either on the redd actively constructing, or in close proximity. Figure 4 graphically represents the established trend line based on historical redd counts in the East Fork Wallowa River to date (2017-2023).

**Figure 2. Marked GPS locations (red dots, n=10) of bull trout redds within the East Fork Wallowa River**

All ten bull trout redds were in the upper portion of available habitat below the barrier. No brook trout were definitively observed during any 2023 East Fork Wallowa River redd survey.

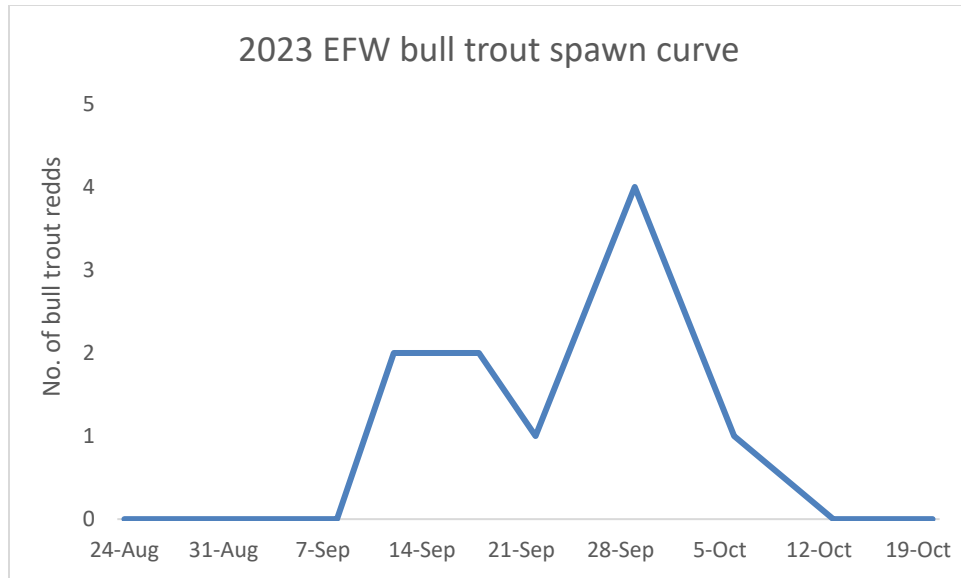
**Figure 3. 2023 bull trout spawn curve in the East Fork Wallowa River.**

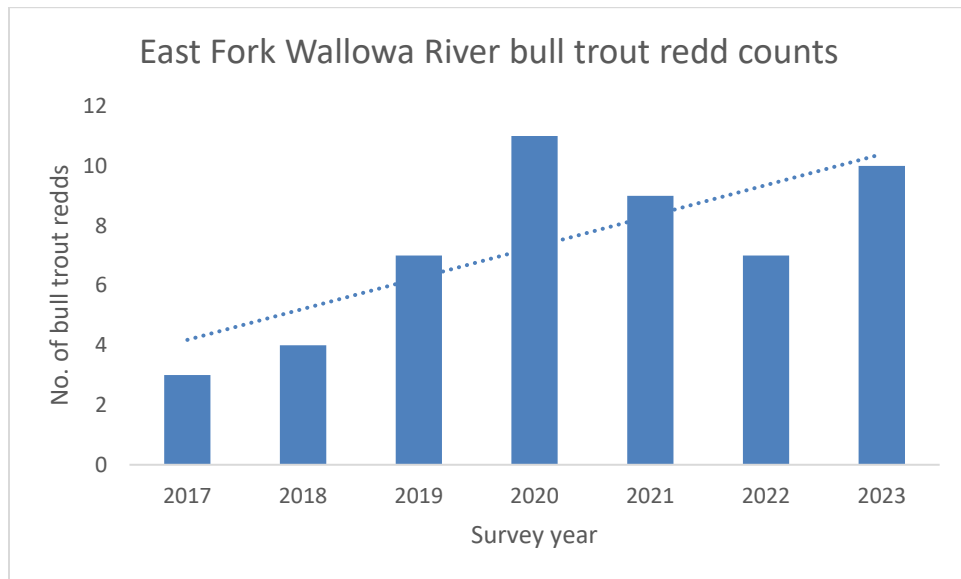
**Figure 4. Bull trout redd counts by survey year (2017-2023).**
