**ANNUAL REPORT for CY2020 and
ROLLING 4-YEAR PROJECT ACTIVITIES
CALENDAR YEARS 2020 - 2023**

**Wallowa Falls Hydroelectric Project
FERC No. P-308**

The Federal Energy Regulatory Commission (Commission) issued a new operating license for the Wallowa Falls Hydroelectric Project (Project) January 5, 2017. The Operation Compliance Monitoring Plan (OCMP) was developed to satisfy Article 408 and Condition 1e) of Appendix A: Oregon Department of Environmental Quality (ODEQ) Water Quality Certification, of the license. The OCMP was approved by the October 11, 2017 Commission Order Modifying and Approving Operational Compliance Monitoring Plan Pursuant to License Article 408.

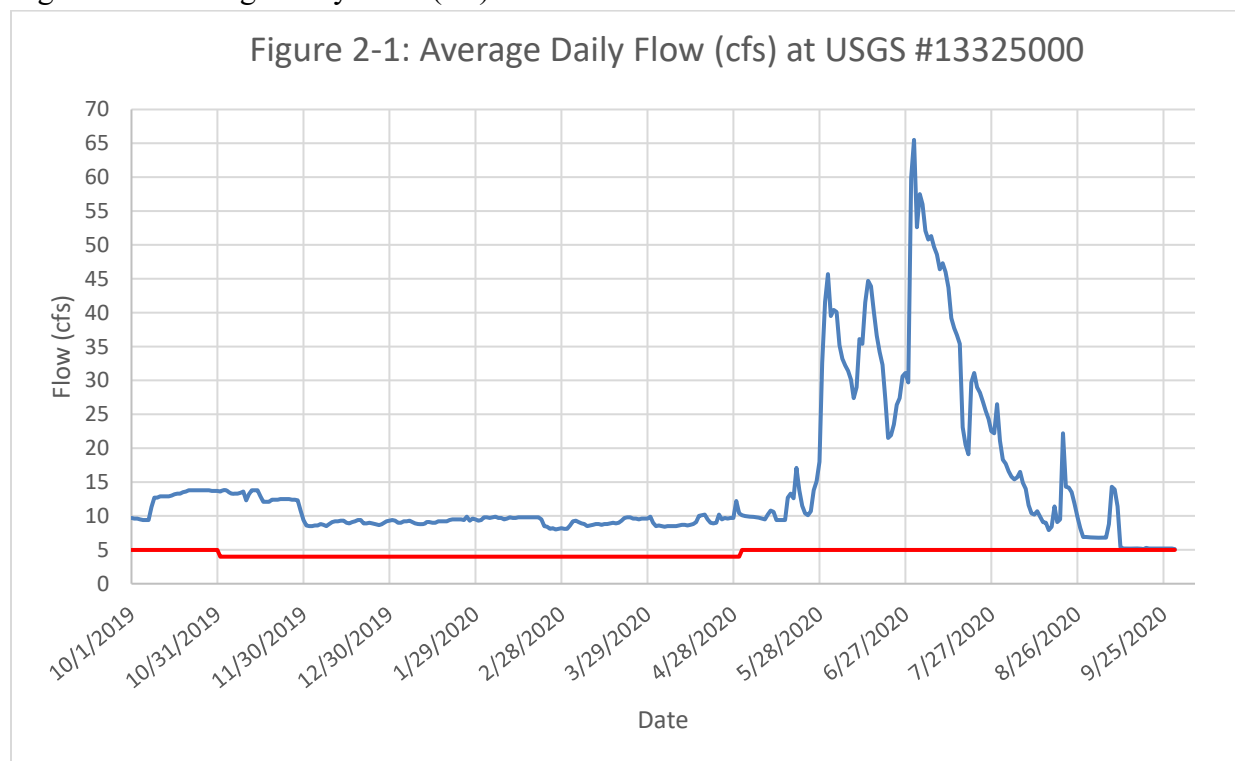
Figure 2-1: Average Daily Flow (cfs)

From October 1, 2019 through September 30, 2020, the Project operated with 5 cubic feet per second (cfs) or greater, as measured at the compliance gage in the bypassed reach of the East Fork Wallowa River. Figure 2-1 shows the average daily flow during the 2020 water year.

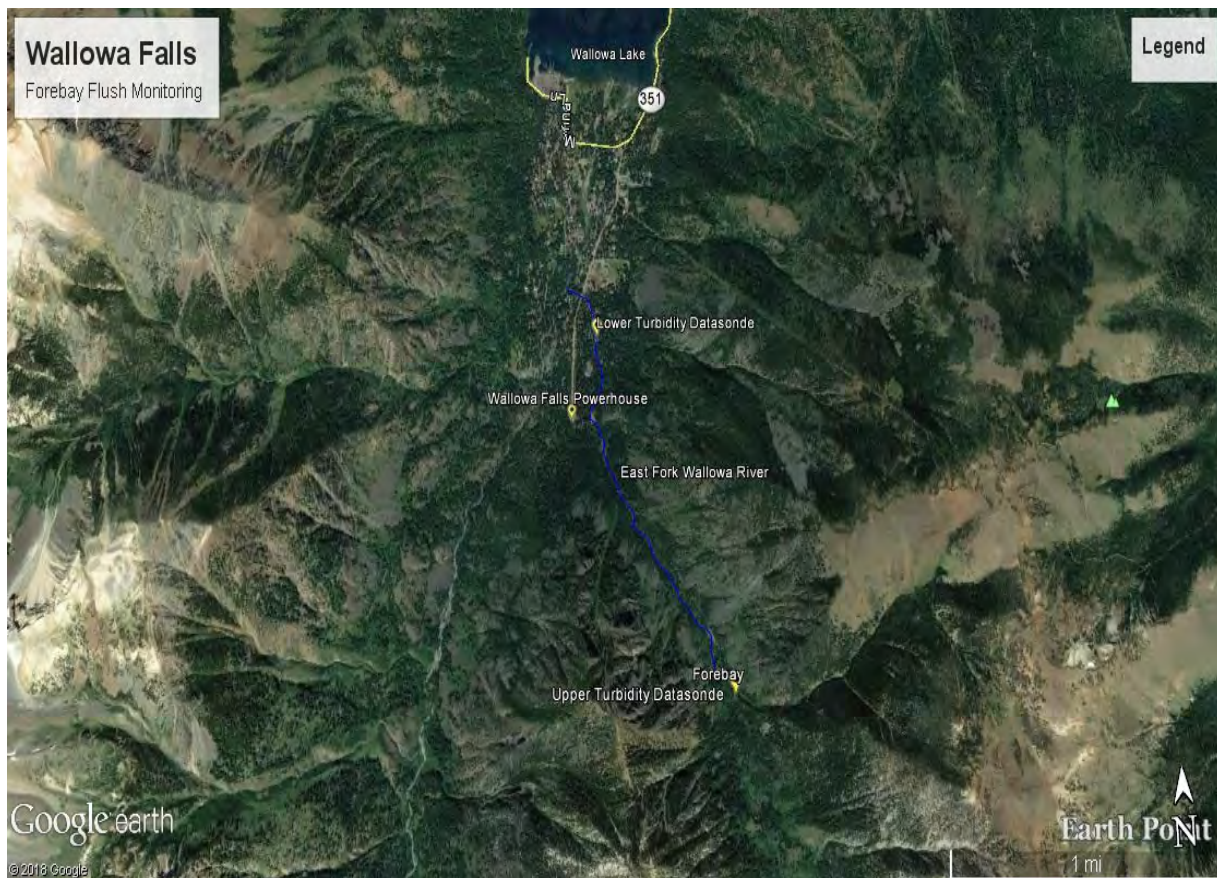
Figure 3.0. Location of Wallowa Falls forebay flush monitoring datasondes in 2020.

Prior to the flushing event In-Situ datasondes were deployed in the East Fork Wallowa River upstream of the inlet to the Project forebay and downstream of the Project dam at the USGS gage site. The upper datasonde (background) malfunctioned for unknown reasons and the data recorded was clearly not accurate. The background turbidity was way in excess of downstream turbidity throughout the monitoring period even before flushing started. There was no rain event or spike in flows to explain this and it has to be assumed that these were not accurate readings and they were therefore not reported. Visual inspection of the East Fork Wallowa River immediately following forebay flushing found no distressed or dead fish. A Forebay Flushing Report was filed with the Commission and the Oregon Department of Environmental Quality August 28, 2019 and is included as Appendix A to this report.

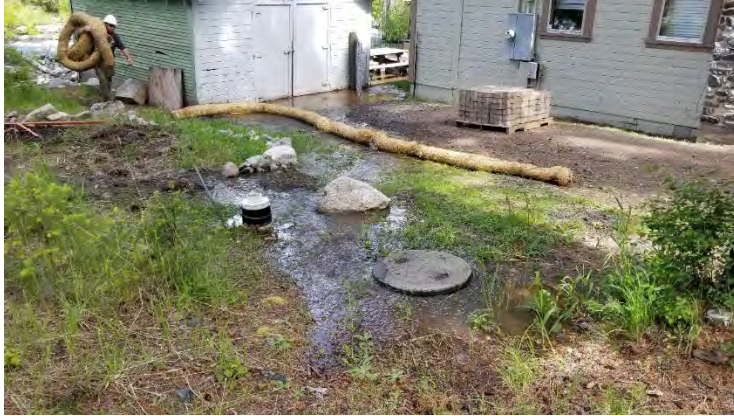
Photo 1: Active Discharge

At approximately 9:30 AM, PacifiCorp's contracted environmental inspector, who was located at the end of the tailrace channel, heard the sewer holding tank overflow alarm sound. The inspector made immediate notification to staff at the dam to close the headgate. The headgate was immediately closed, but it takes approximately one hour and forty-five minutes for water to completely drain from the water conveyance system and stop flowing through the tailrace channel. Water and sewage effluent was observed discharging from the concrete manhole cover on the sewage pump vault. The holding tank is capped and there were no sewage or solids discharges directly from the holding tank itself. Some water and sewage ran overland towards and into the West Fork Willowa River. Onsite erosion control materials were used to try and slow and redirect flow away from the river. The tailrace was completely dewatered, and all water and sewage stopped flowing at approximately 11:40 AM. Photos are provided below.

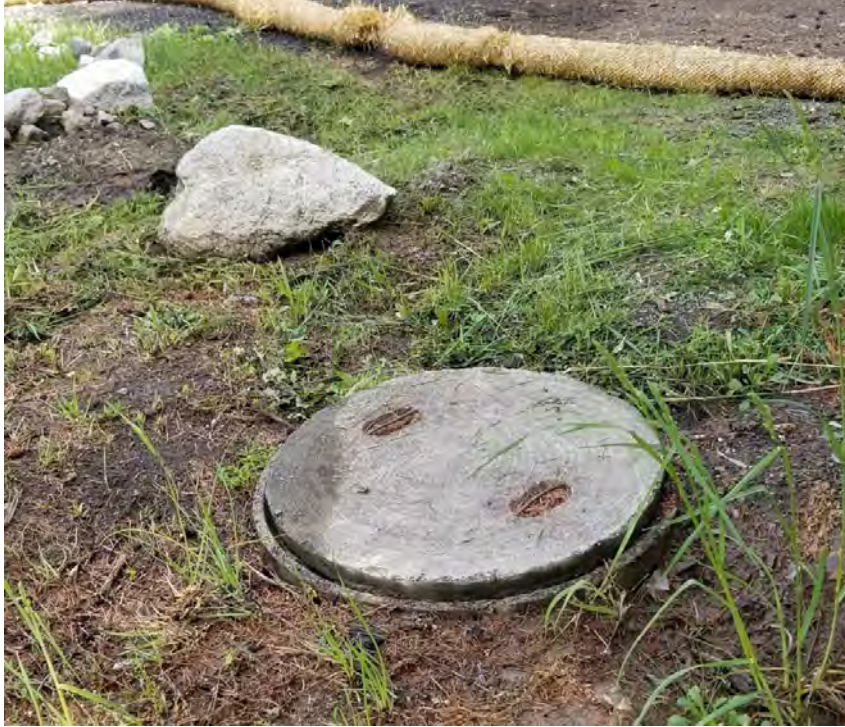
Photo 3: Septic holding tank pump vault cover: source of discharge

Weekly Brothers, Inc., onsite for the tailrace commissioning, determined that a T off of the ranger cabin sewer line crossed under the tailrace channel to an abandoned cabin just upstream of the ranger cabin. Hand excavation in the bottom of the tailrace channel indicated that this abandoned PVC sewer pipe was broken and providing a direct hydraulic conduit to the ranger cabin sewer system. The abandoned line was cut and permanently capped, removing any hydraulic connection to the ranger cabin's sewer system.

A pump truck was deployed to the site on the afternoon of June 3, 2020 to pump and clean the sewage holding tank. An electrician was also called out to inspect the sewage pump and verify that it was not damaged and was in good working order.

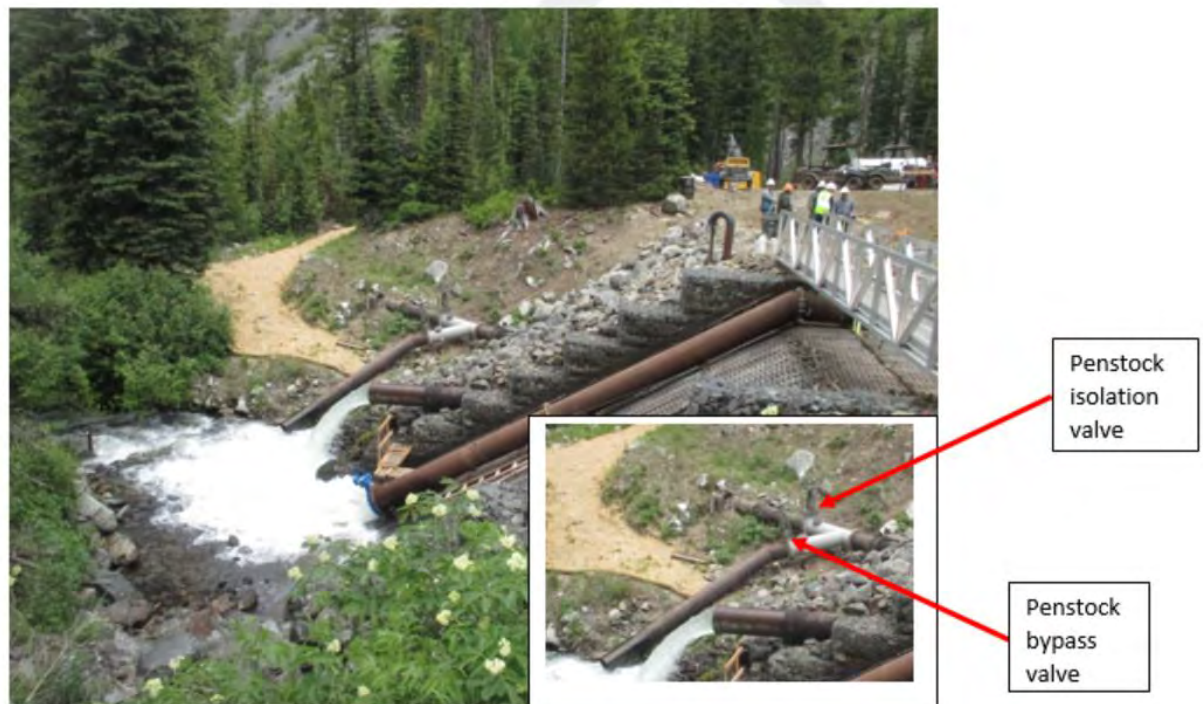
Figure 1: penstock wye with knife gate valves

The penstock wye with knife gate valves (penstock isolation and bypass valves) was installed during the intake rebuild project of 2019 to allow more water to be bypassed through the dam during annual forebay flushing (Figure 1).

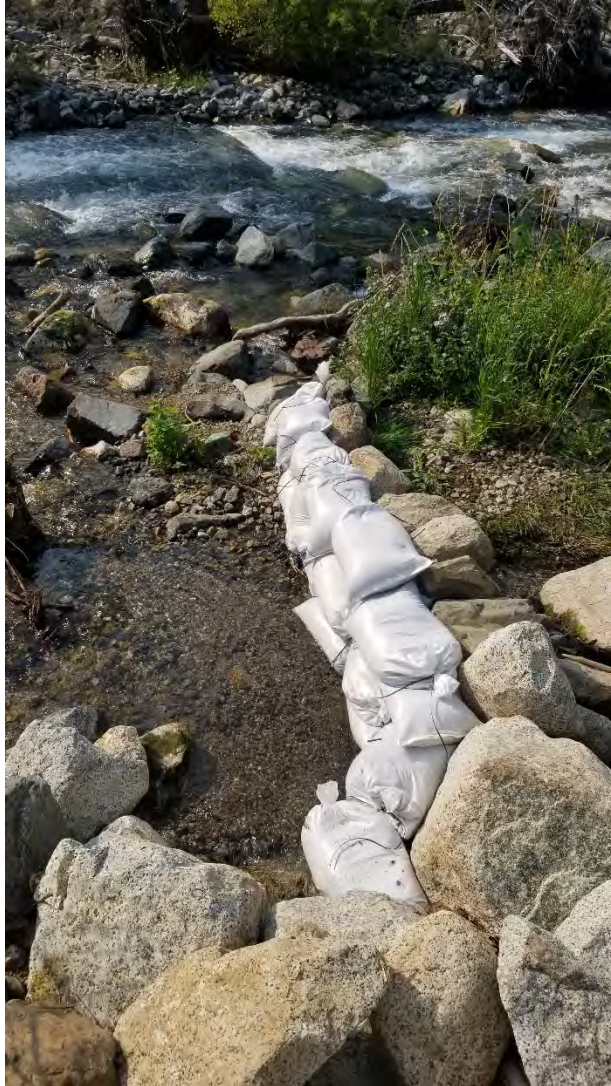
Figure 2. Photo of Wallowa Falls side-channel barrier on upstream end.

Also in 2020, as stipulated within the Introduction, a sandbag and block net barrier were constructed to serve as a temporary fish exclusionary device at the top, middle, and bottom end of the small West Fork Wallowa River side-channel located immediately downstream of the tailrace barrier discharge plume. The fish barrier at the upstream end, and middle of the side-channel utilized sandbags, stacked one on top the other for the entire width of the side-channel (Figure 2 and Figure 3). A barrier net was strung across the entire bottom end exit of the side-channel (Figure 4). The openings of this barrier net were 6.35 mm and the net was held in place by large sandbags placed end to end along the stream bottom and spanning the entire stream-width. Further specifics to the Emergency Action Plan concerning this side-channel can be found in Appendix A.

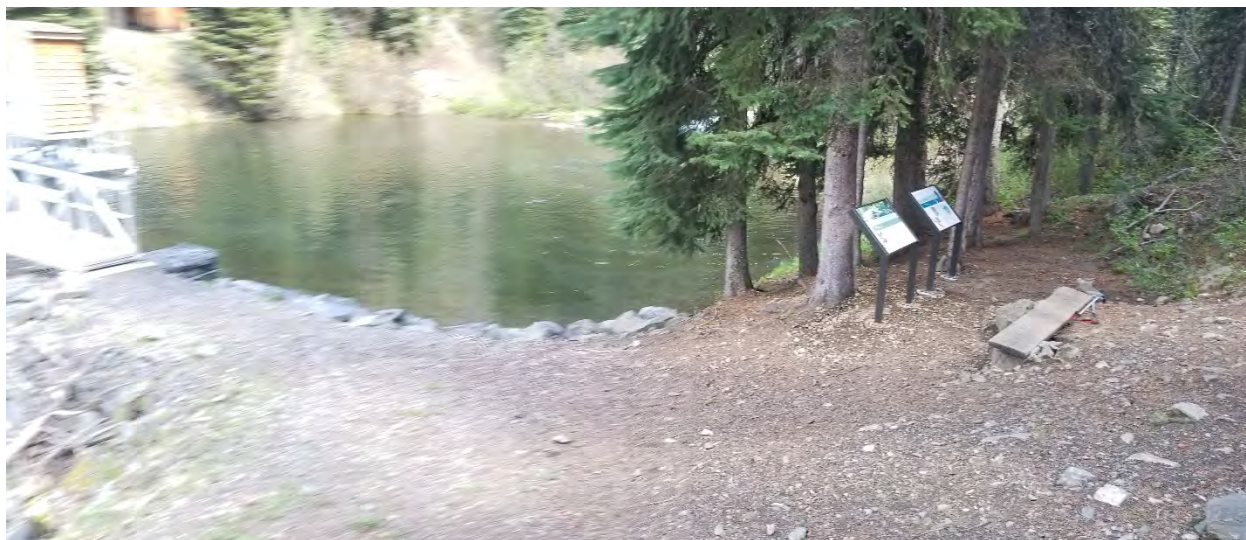
Photo 3: Forebay Interpretive Signs Installed

Requirement	2019 Action	Photo Reference
Recreation, Visual and Aesthetic Management Plan	The new interpretive sign panels were installed at the forebay.	Photos 1-3
FERC License, Appendix A – Condition 2(a)	Phase 2 – The northern tailrace channel and fish barrier at the tailrace confluence with the West Fork Wallowa River was commissioned. The southern tailrace channel was decommissioned and seeded.	Photos 3-7

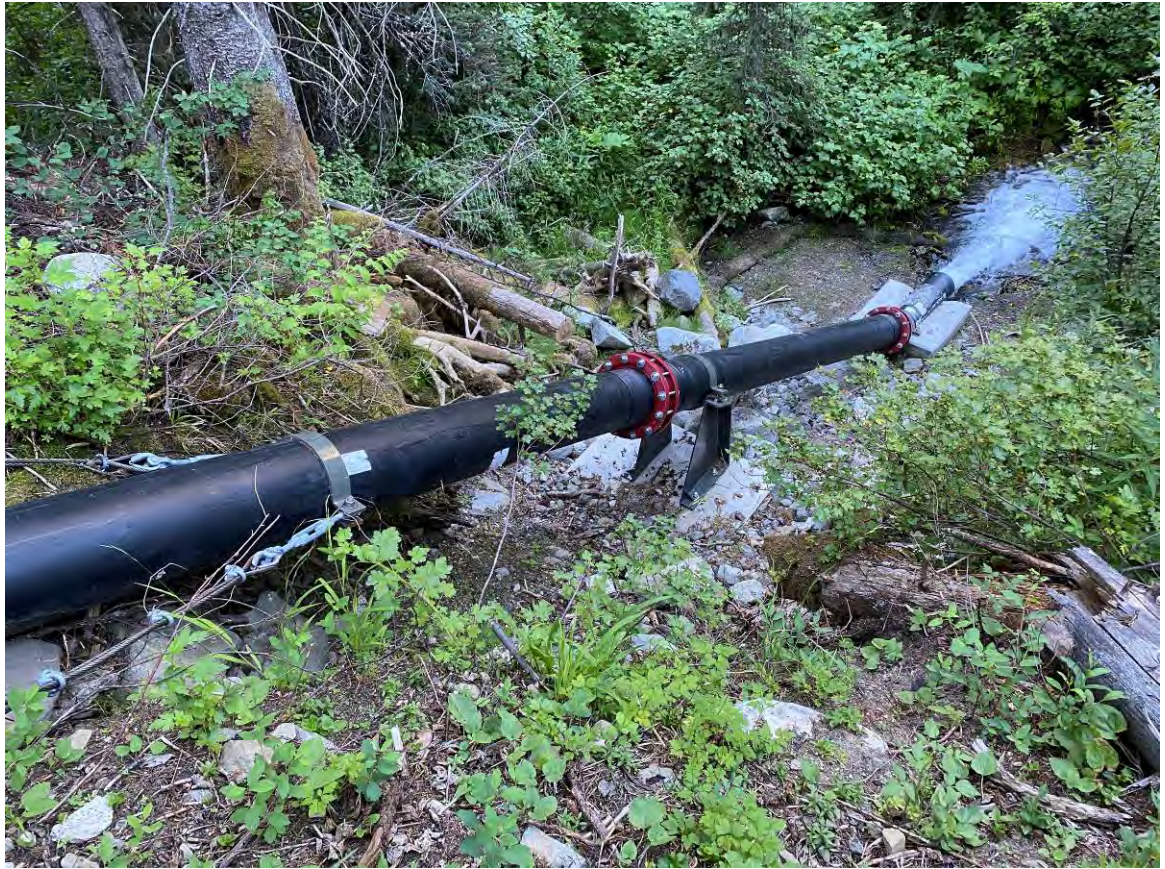
Figure 3. The discharge pipe from Royal Purple Creek installed 2019.
(photo- July 27, 2020).

Vegetative recovery of the disturbed area adjacent to the new discharge pipe from Royal Purple Creek (installed 2019) also appears adequate with no sign of erosion (Figures 3 and 4).
