ANNUAL REPORT for CY2022 and ROLLING 4-YEAR PROJECT ACTIVITIES CALENDAR YEARS 2022 - 2025

Wallowa Falls Hydroelectric Project
FERC No. P-308

**Two Erosion Repair Projects
2023-2024**

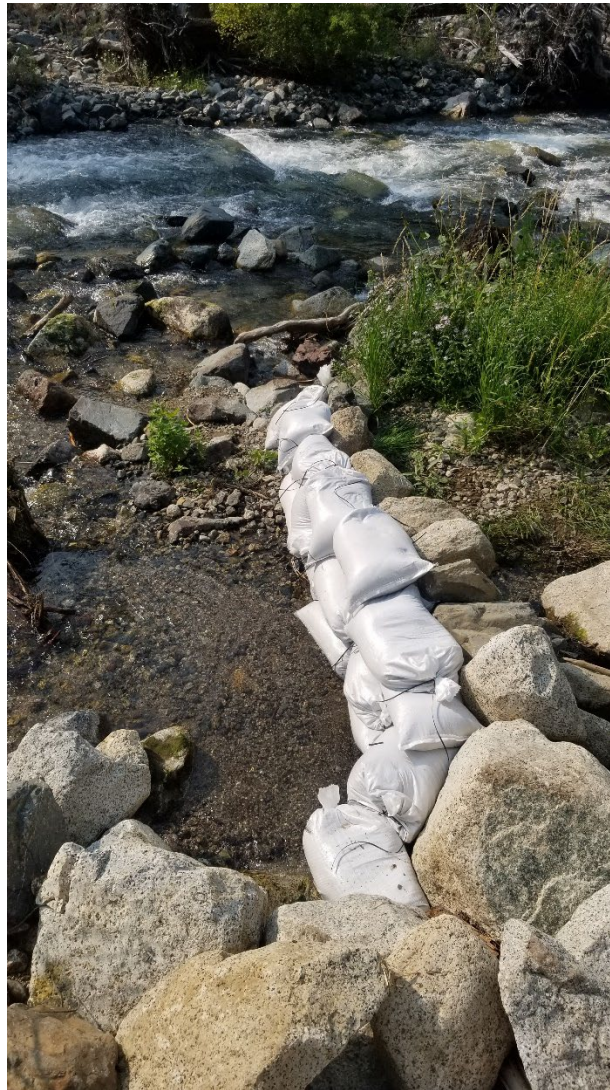
Figure 2. Photo of Wallowa Falls side-channel barrier on upstream end.

barrier at the upstream end utilized sandbags, stacked one on top the other for the entire width of the side-channel (Figure 2). This sandbag berm diverted all water from the tailrace channel into the West Fork Wallowa River, effectively dewatering the side-channel for the entirety of the survey period. A large deposit of gravel from erosion upstream was deposited at the downstream end of the side-channel where it again connects with the West Fork Wallowa (Figure 3), this and further incised channelization of the West Fork at this location made it unnecessary during the survey period to string a net at this location as there was no hydraulic connection after the side-channel was dewatered. Further specifics to the Emergency Action Plan concerning this side-channel can be found in Appendix A.

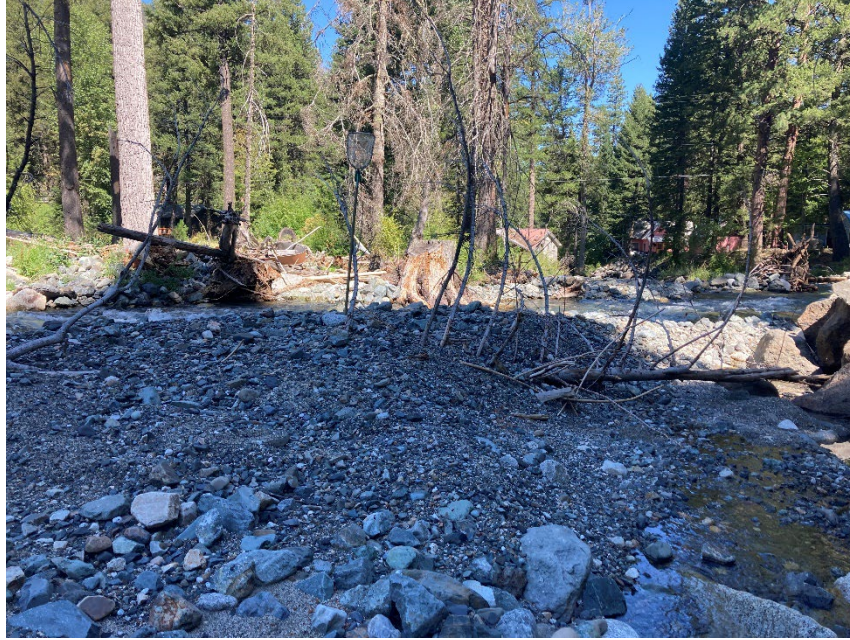
Figure 3. Bottom end of side-channel showing deposited gravel bar and no hydraulic connectivity.

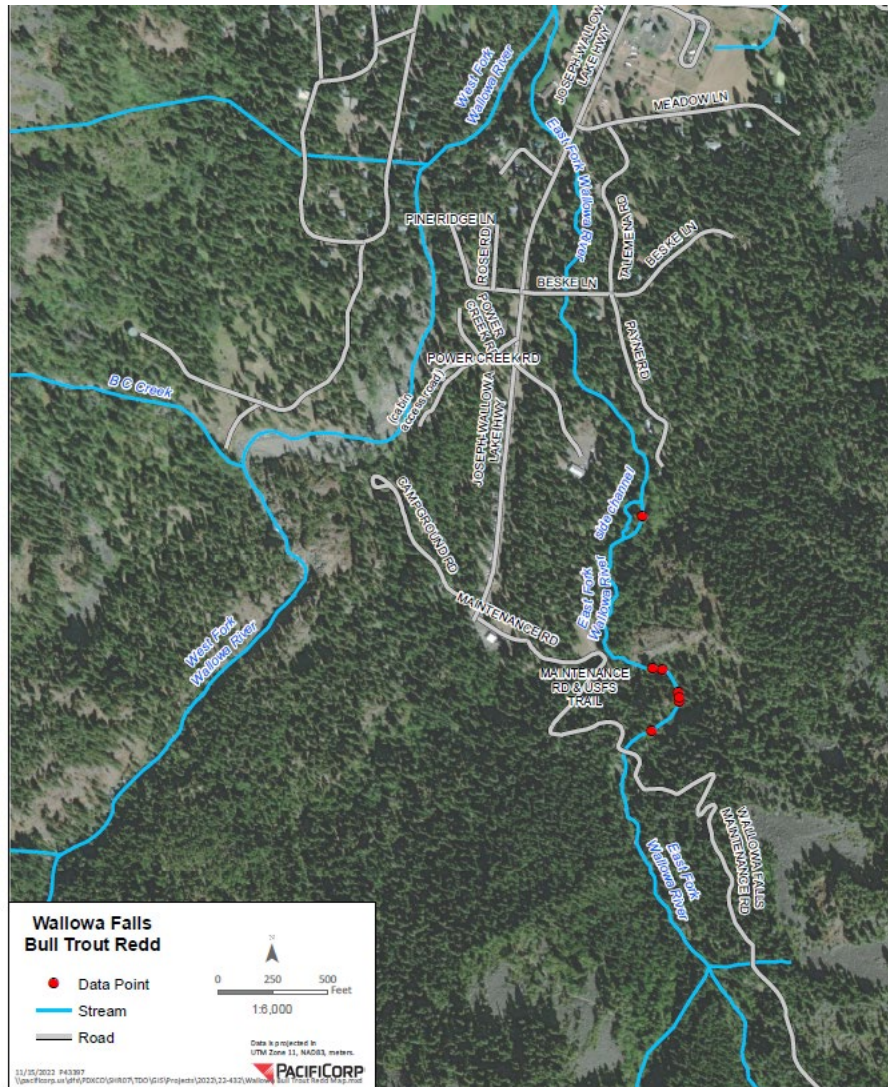
Figure 2. GPS marked locations (red dots, n=7) of bull trout redds within the East Fork Wallowa River

Seven bull trout redds were identified and marked by GPS during the nine redd surveys performed of the East Fork Wallowa River in 2022 (Figure 2). All seven of the bull trout redds were large and indicative of being constructed by large migratory-sized fish (Table 1). All redd observations in 2022 occurred between September 7 and September 30, with the peak of four counted on September 14. Five of the seven observed redds had bull trout either on, actively constructing or in very close proximity to, the redd. Pictures of all seven identified bull trout redds are included in Appendix A.

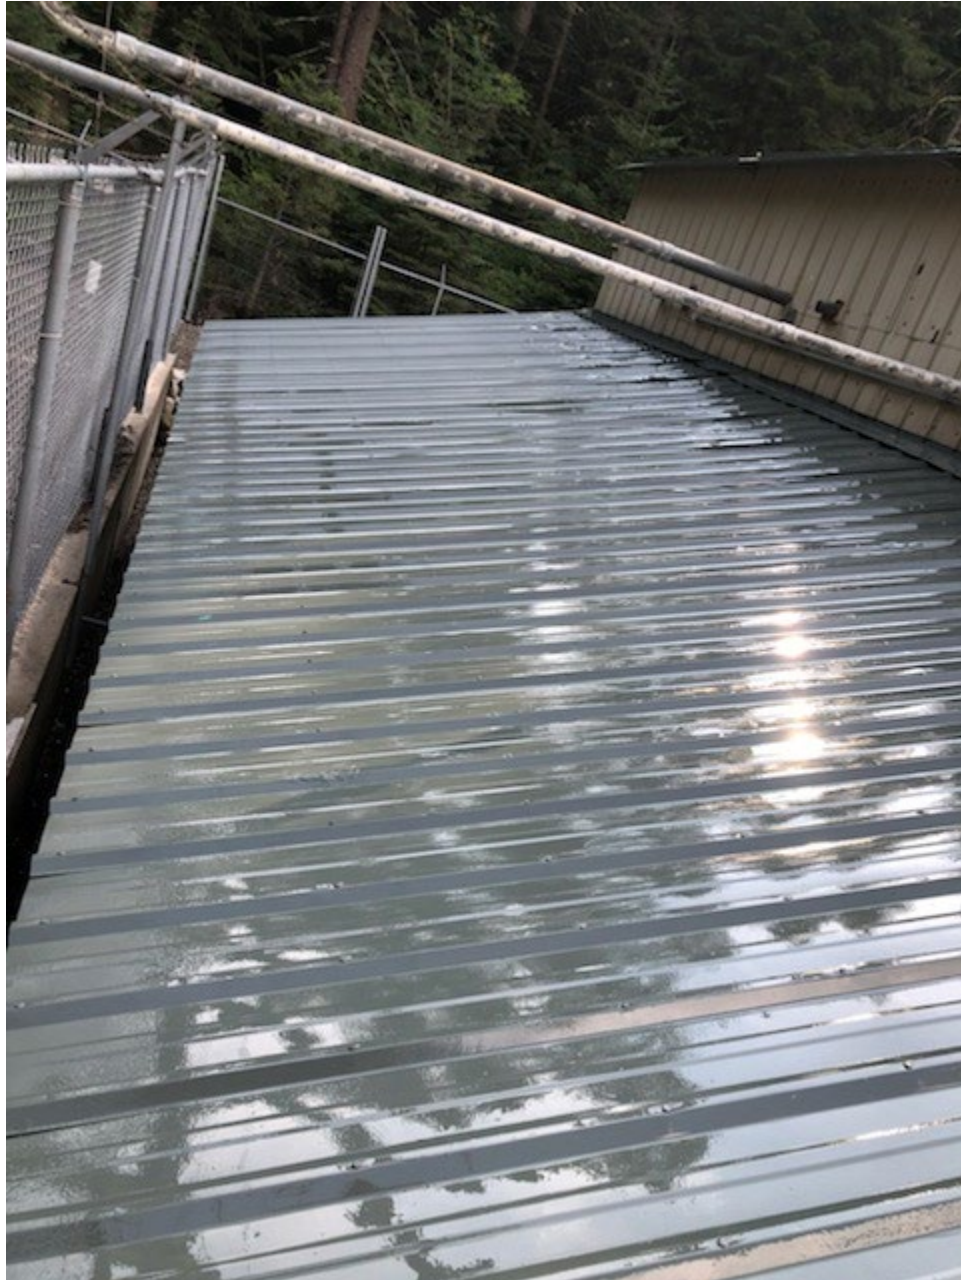
Figure 2: Recoated Powerhouse Roof

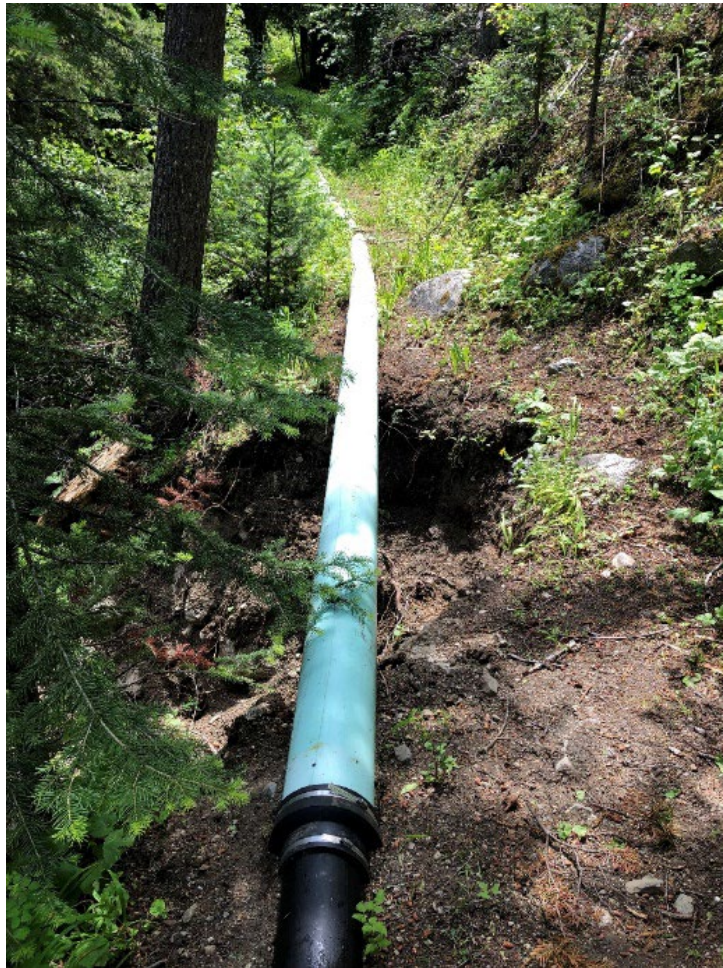
Photograph 1: Royal Purple Diversion Pipe Affected Area

The operator did not detect any erosion in this location or leakage from the pipe coupling during a prior inspection on March 21. Therefore, it is presumed that the incident occurred sometime between March 21, and April 26. The operator immediately removed the flashboard on the Royal Purple Creek diversion dam to stop any flow from going through the flowline and redirect all flow down the creek. Later the same week, the operator further isolated the flowline by placing plastic sheeting over the intake at Royal Purple diversion dam.

The exact cause of the pipe coupling failure is currently unknown. Heavy snow accumulation in early-mid April, on the steep slope above the flowline, may have resulted in a snow/debris slide which impacted the flowline causing the coupling to fail.

The pipe was repaired during the annual maintenance outage of June 8-17. A longer section of overlapping pipe was installed to prevent the coupling from separating in the future. PacifiCorp is currently developing an engineering design to repair the slope. Construction of the engineered repair is planned for the summer of 2023.
