**Fish Salvage & Temporary Fish Barrier Report for the  
Wallowa Falls Hydroelectric Project Tailrace**

**(FERC No. P-308)**

**December 22, 2020**

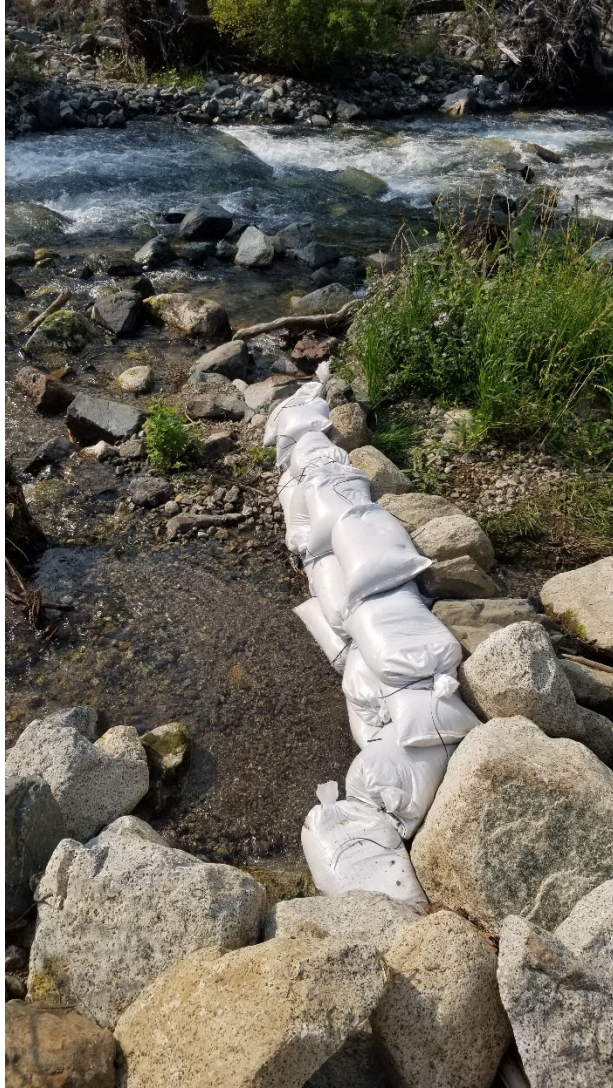
**Figure 2. Photo of Wallowa Falls side-channel barrier on upstream end.**

To prohibit fish and tailrace discharge from accessing the stranding side-channel from the top end immediately below the weir (Figure 1), a diversion (using sandbags, bio-blocks, or similar) will be built. The planned construction method is a sandbag berm approximately 3 meters (10 feet) long and 0.75 meter (2.5 feet) high. The diversion will prohibit water flow and connection between the West Fork Wallowa River, and the stranding side-channel, while diverting water from the tailrace discharge to the main thalweg of the West Fork.

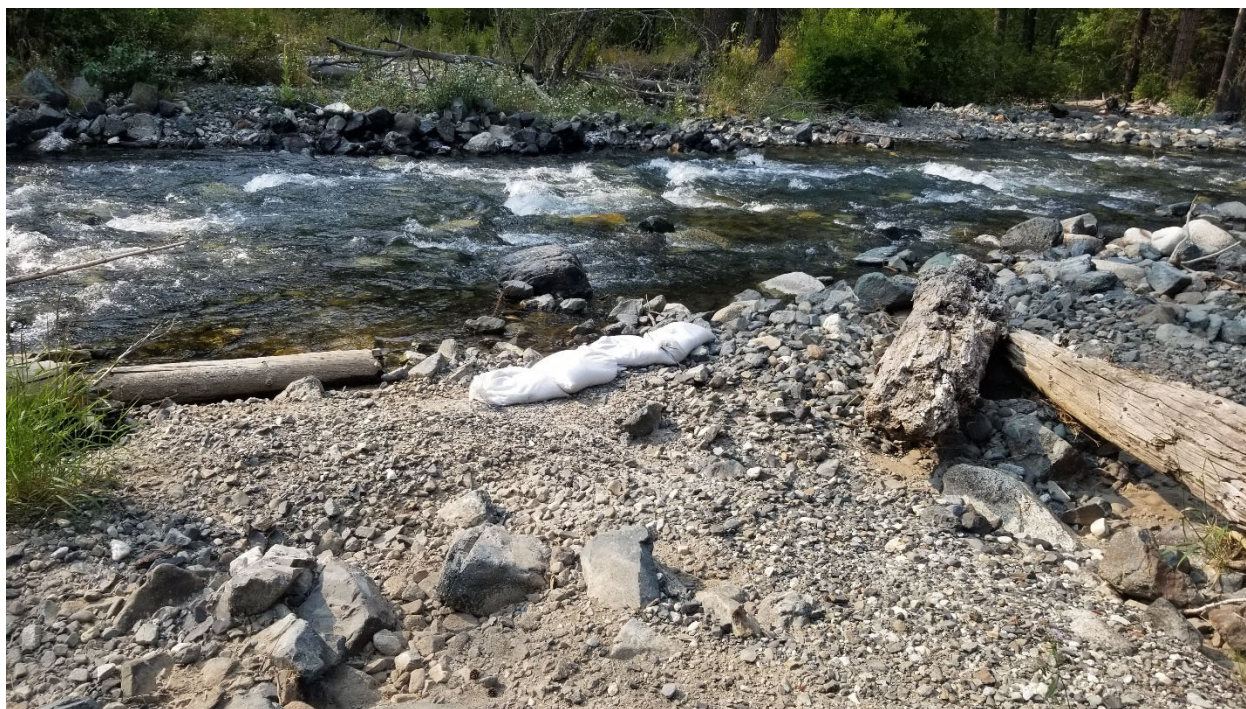
**Figure 3. Photo of Wallowa Falls side-channel barrier of small channel halfway down the main side-channel.**

To prohibit fish and main West Fork channel water from entering the stranding side-channel at Location 2 (Figure 2), a diversion using sandbags will be built. The planned construction method is a sandbag berm approximately 1.5 meters (5 feet) long and 0.6 meter (2 feet) high. After the three side-channel temporary barriers are placed, all fish will be salvaged from the stranding side-channel and liberated to the main channel West Fork Wallowa River by means of electrofishing. All side-channel barriers will be dismantled and taken out of the river no earlier than November 15, 2020, after conclusion of the bull trout and kokanee spawn season.

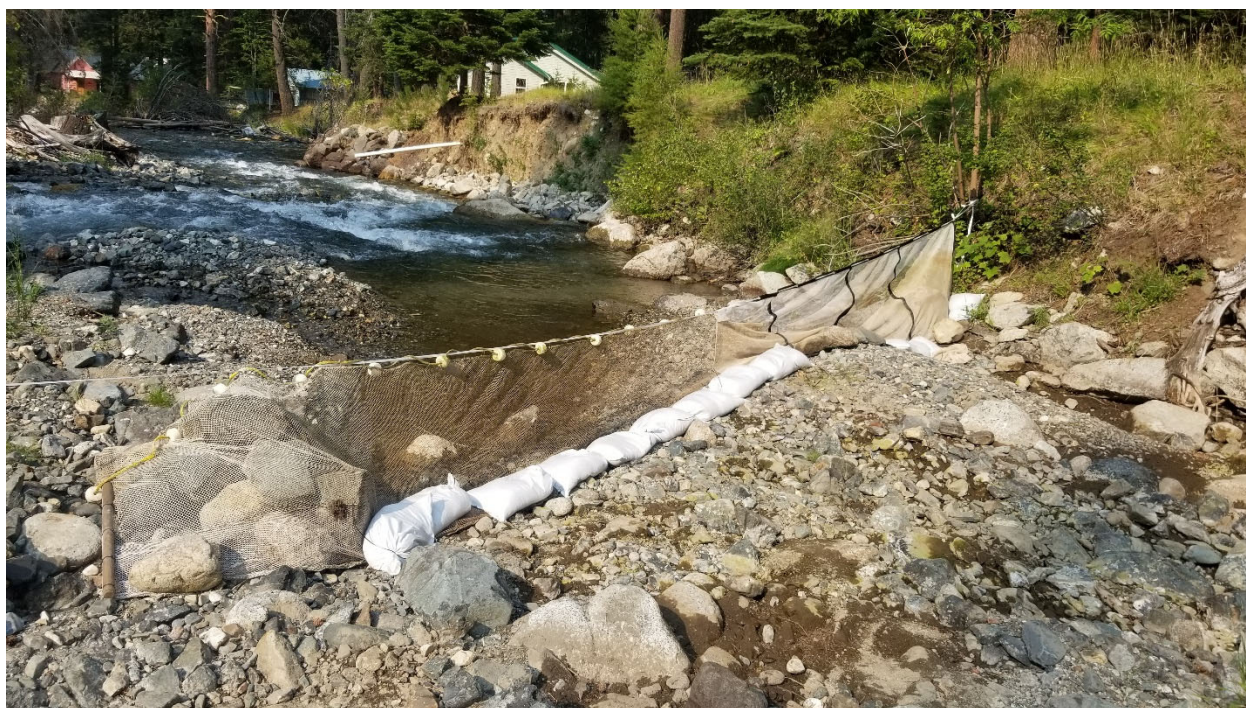
**Figure 4. Photo of Wallowa Falls side-channel barrier at the downstream end.**

To prohibit fish from entering the stranding side-channel immediately below the Project tailrace discharge outlet from the downstream side during the bull trout and kokanee spawn, a block net (barrier net) will be installed by August 24, 2020 to serve as a temporary fish exclusionary device (Figure A, Location 3). The barrier net will be laid across the entire bottom of the upstream side of the side channel (Figure 3). The openings of the barrier net will be 6.35 mm. The net will be held in place by large sandbags placed end to end along the stream bottom and spanning the entire stream-width. The net will span the entire wetted width of the side channel, rise above the water surface, and will be pinned to the stream bank on either side with rebar to hold it in place in the event of higher than anticipated flows. The barrier net will be visited on a bi-weekly basis to clean debris and assess it is functioning as intended.
