## **2021 Annual Operational Compliance Report**

### **Wallowa Falls Hydroelectric Project**

**(FERC No. P-308)**

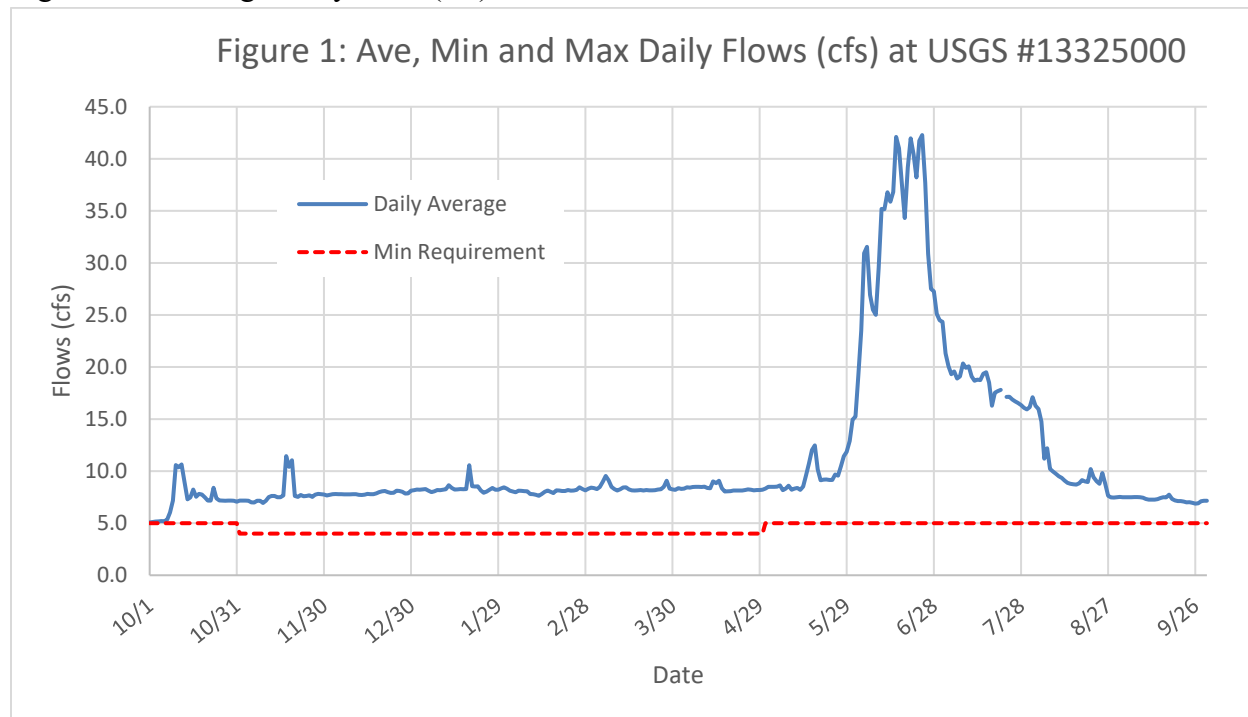
Figure 2-1: Average Daily Flow (cfs)

From October 1, 2020 through September 30, 2021, the Project operated with 5 cubic feet per second (cfs) or greater, as measured at the compliance gage in the bypassed reach of the East Fork Wallowa River. Figure 2-1 shows the average daily flow during the 2021 water year.

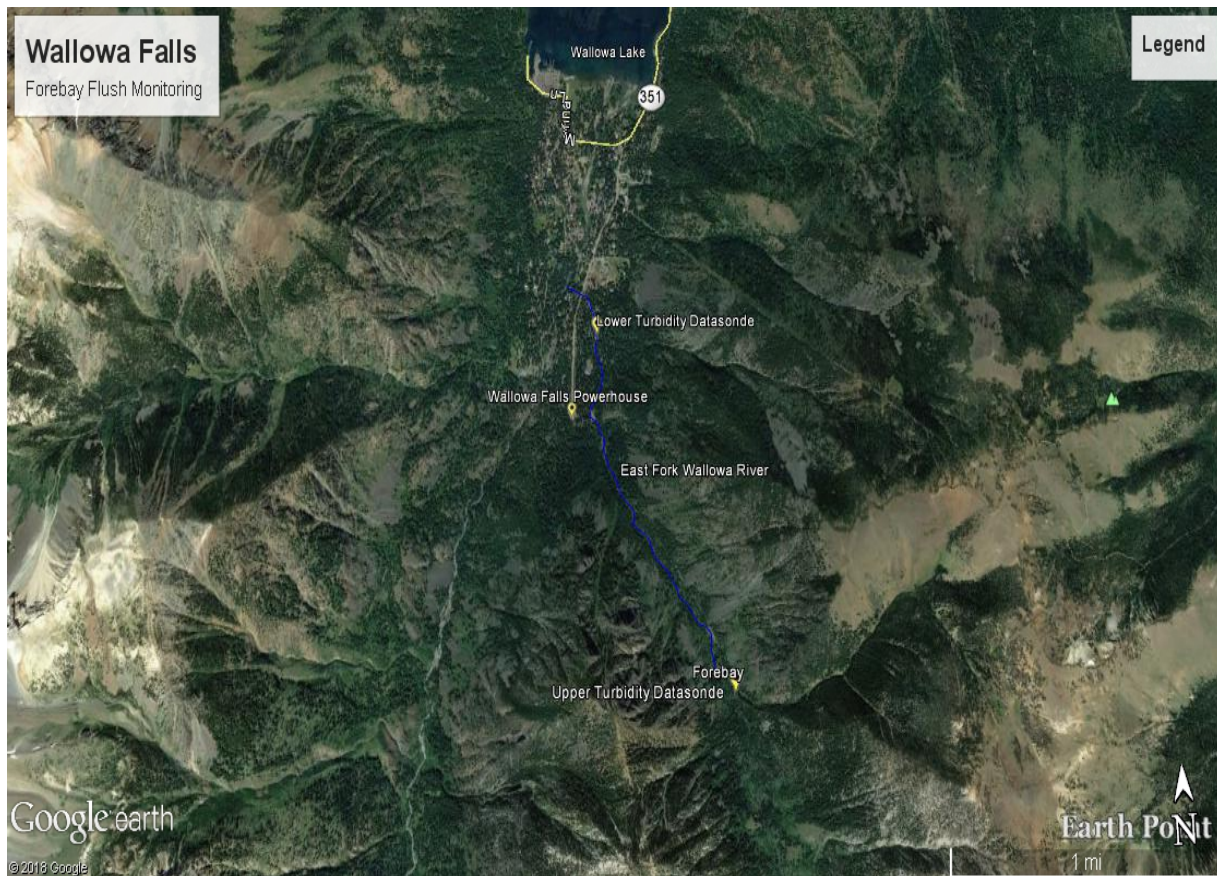
Figure 3.0. Location of Wallowa Falls forebay flush monitoring datasondes in 2021.

Prior to the flushing event two In-Situ data sondes were deployed in the East Fork Wallowa River upstream of the inlet to the Project forebay and downstream of the Project dam at the USGS gage site. Throughout the flushing period hourly turbidity data was recorded at the upstream and downstream monitoring sites. Visual inspection of the East Fork Wallowa River immediately following forebay flushing found no distressed or dead fish. A Forebay Flushing Report was filed with the Commission and the Oregon Department of Environmental Quality July 30, 2021 and is included as Appendix A to this report.

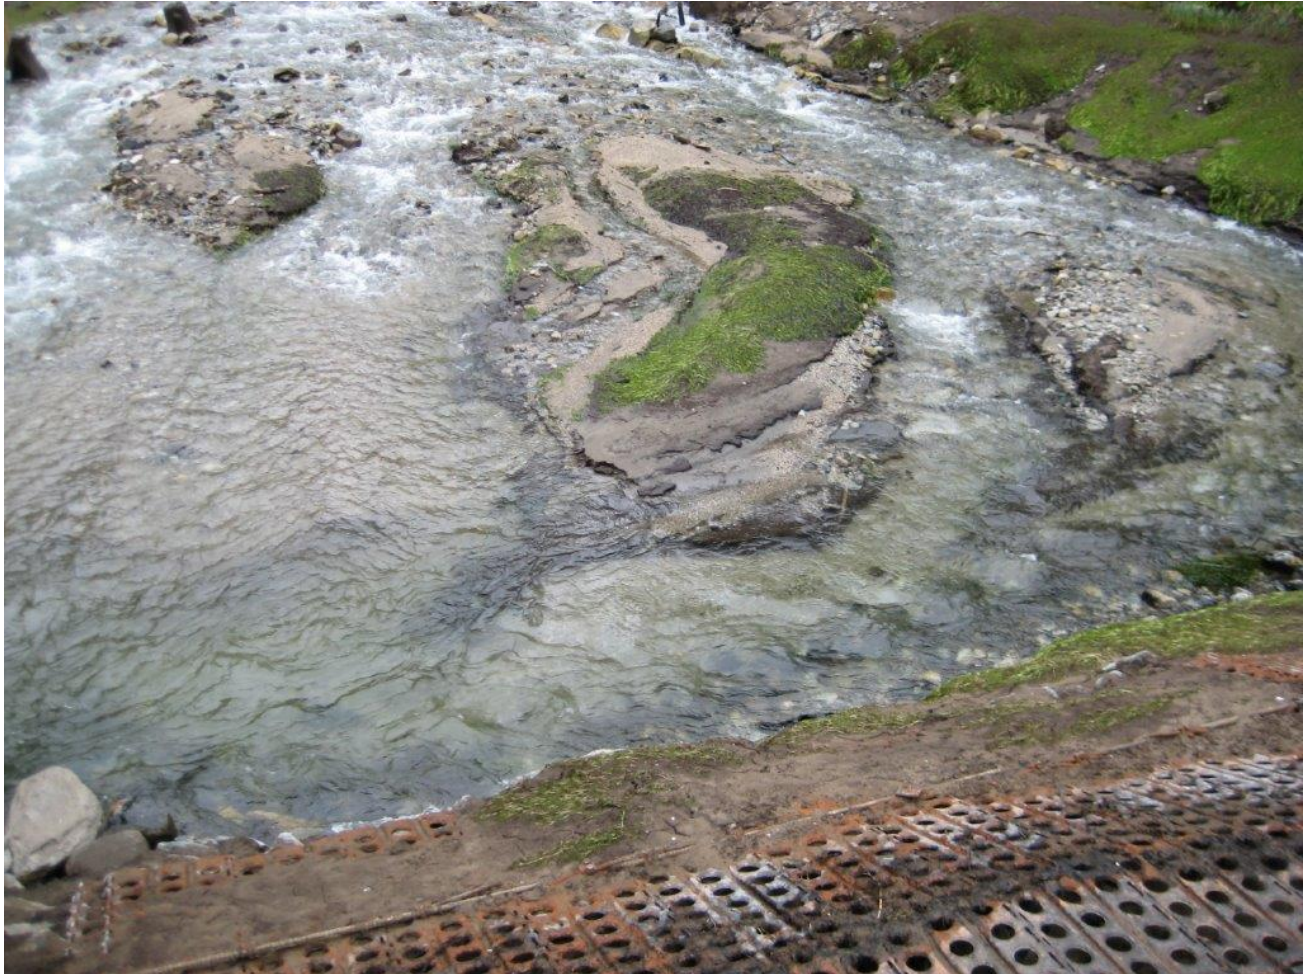
Photo 1 –Wallowa Falls Forebay – some sediment cutting along edges during draining on June 11, 2021

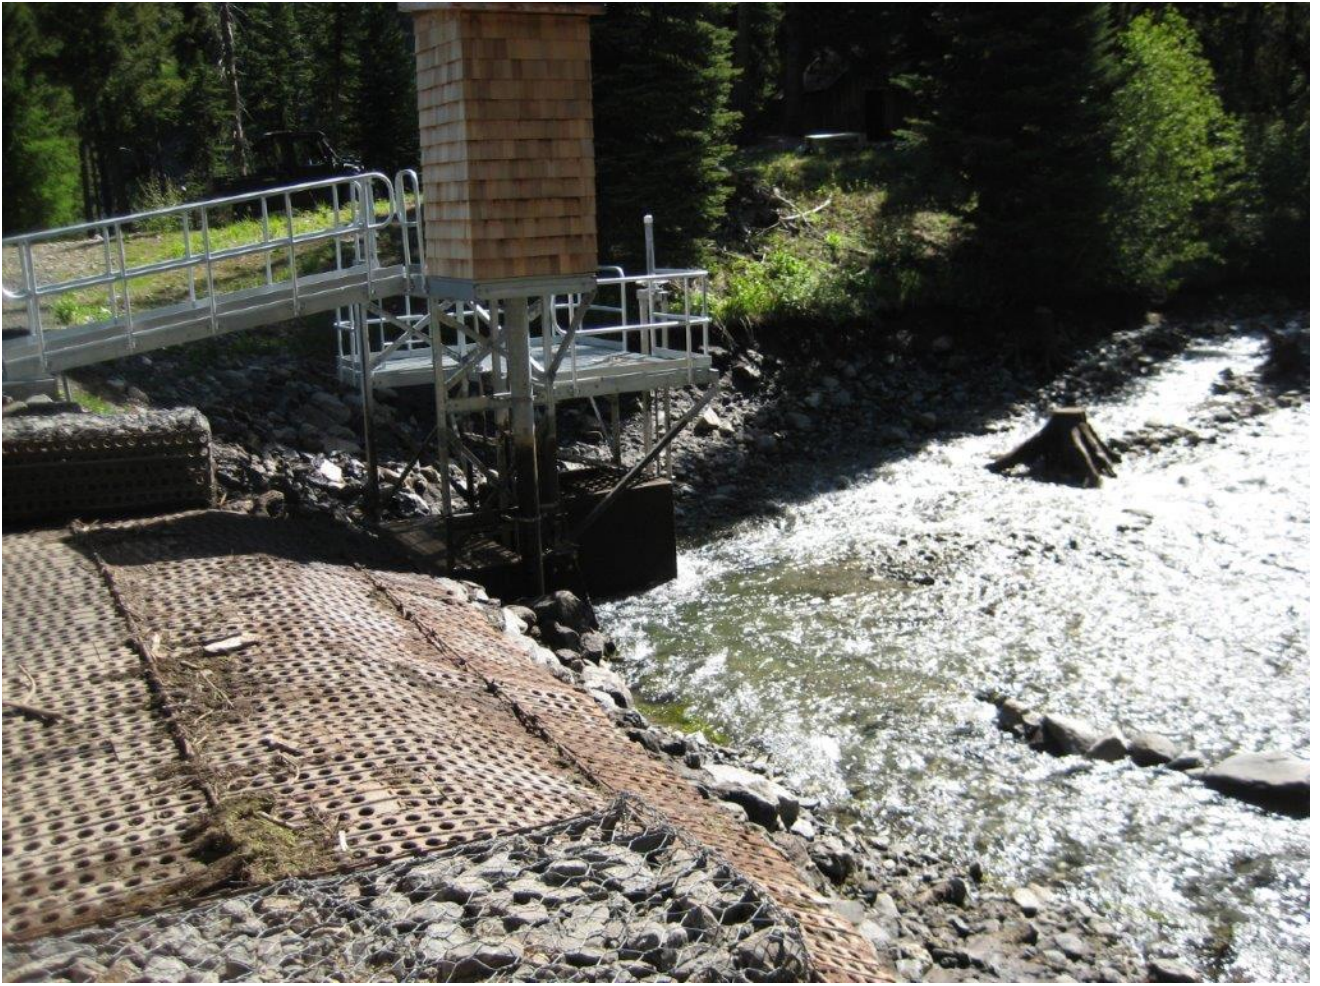
Photo 2 – Wallowa Falls Forebay: Low forebay June 11, 2021

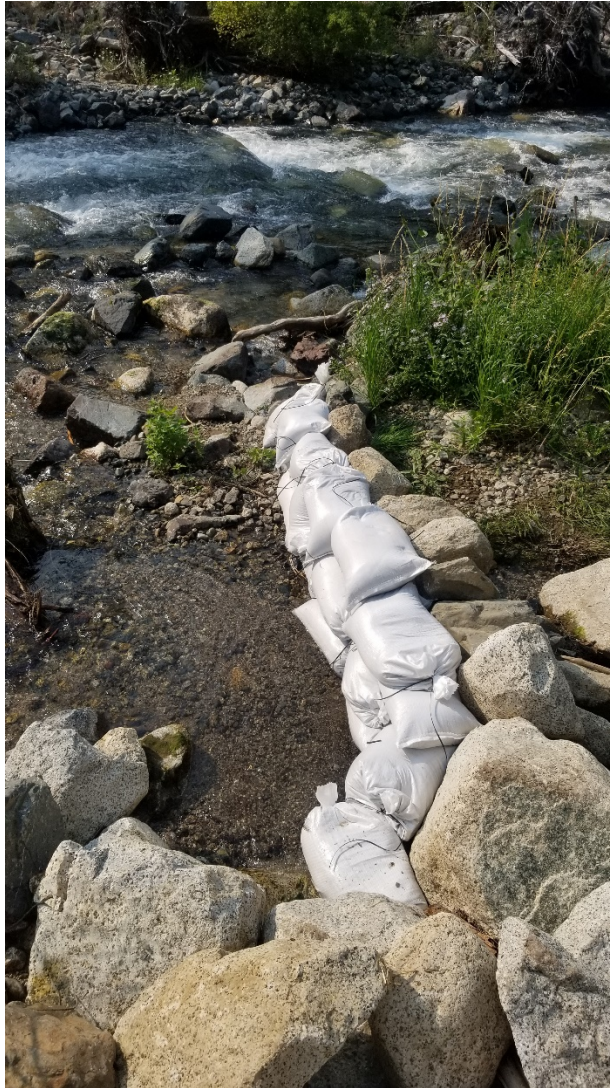
**Figure 2. Photo of Wallowa Falls side-channel barrier on upstream end.**

Additionally, in 2021, as stipulated within the Introduction, a sandbag and block net barrier were constructed to serve as a temporary fish exclusionary device at the top, middle, and bottom end of the small West Fork Wallowa River side-channel located immediately downstream of the tailrace barrier discharge plume. The fish barrier at the upstream end, and middle of the side-channel utilized sandbags, stacked one on top the other for the entire width of the side-channel (Figure 2 and Figure 3). A barrier net was strung across the entire bottom end exit of the side-channel (Figure 4). The openings of this barrier net were 6.35 mm, and the net was held in place by large sandbags placed end to end along the stream bottom and spanning the entire stream-width. Further specifics to the Emergency Action Plan concerning this side-channel can be found in Appendix A.

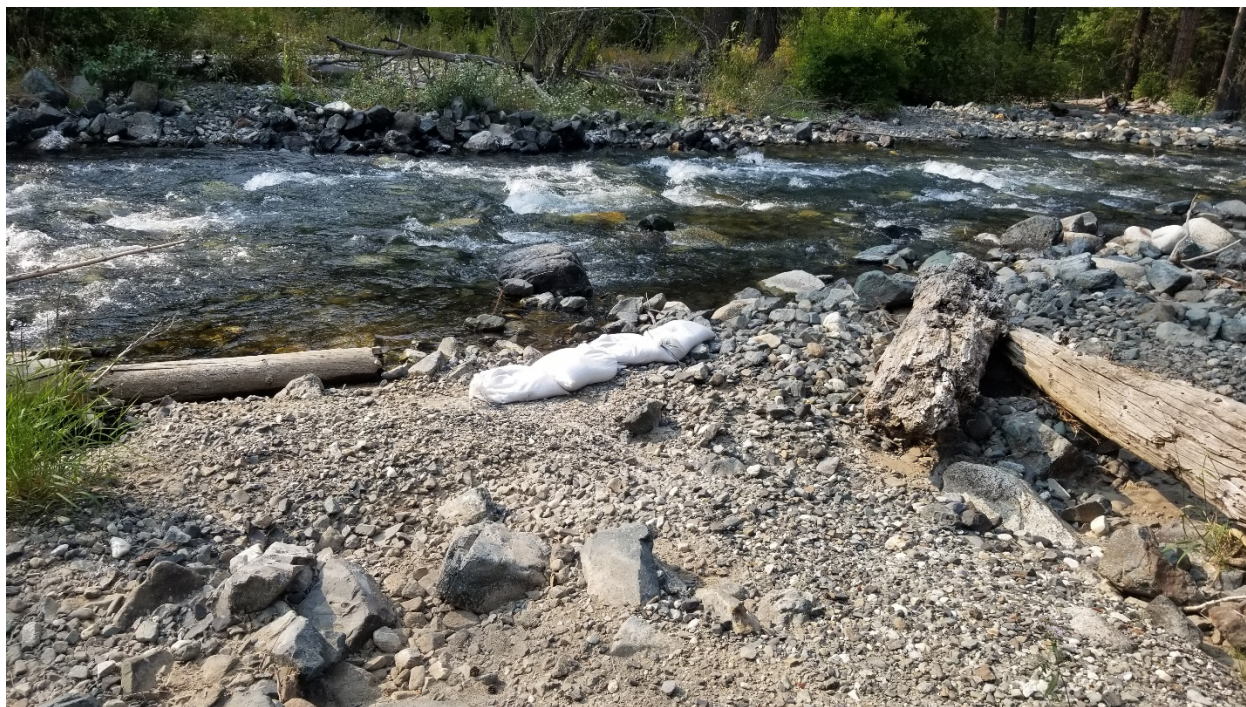
**Figure 3. Photo of Wallowa Falls side-channel barrier of small channel halfway down the main side-channel.**

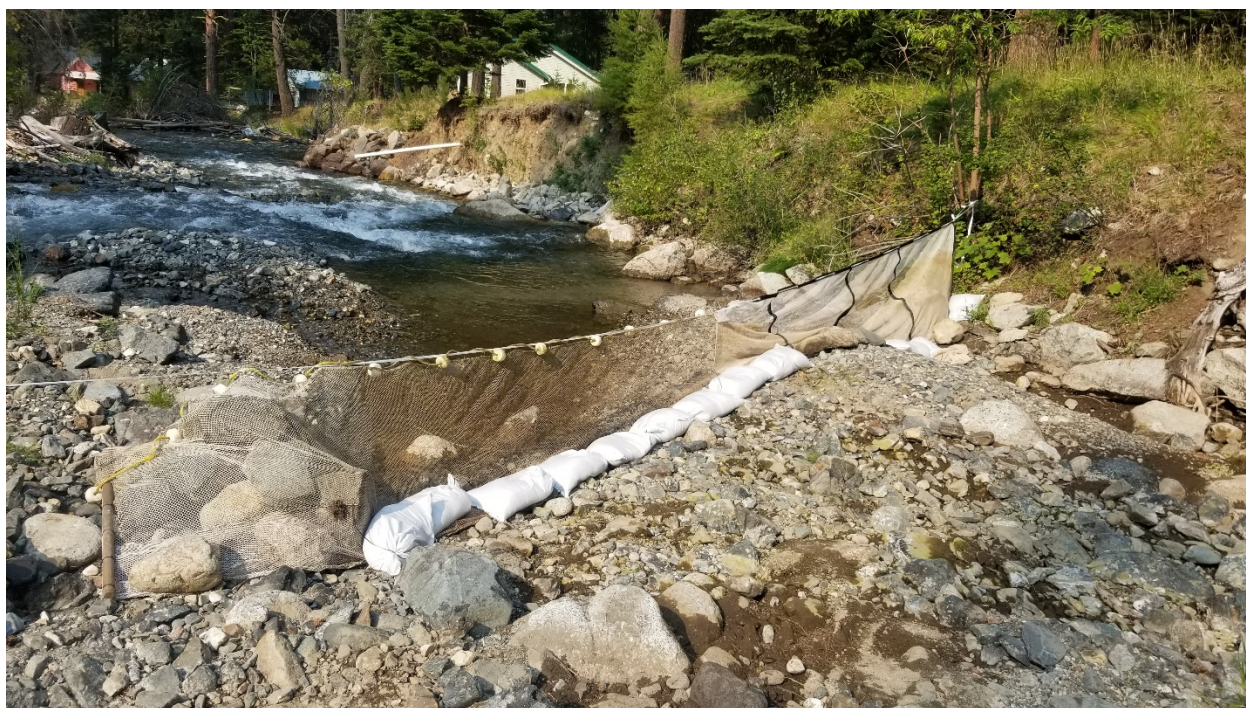
**Figure 4. Photo of Wallowa Falls side-channel barrier at the downstream end.**

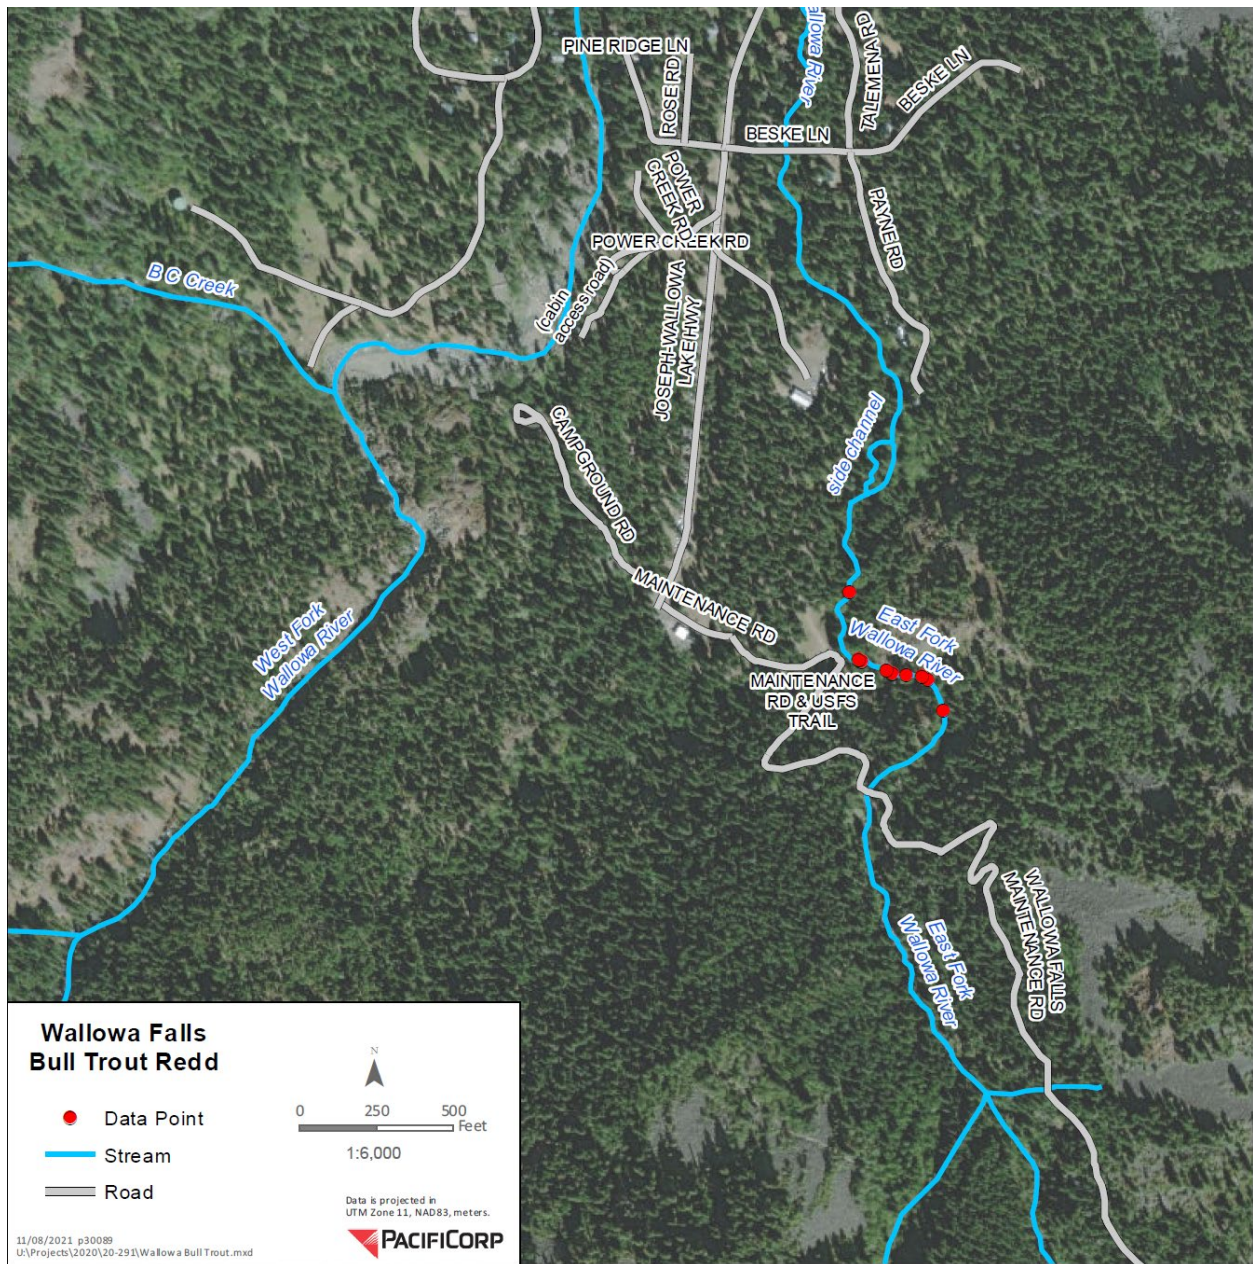
**Figure 2. GPS marked locations (red dots, n=9) of bull trout redds within the East Fork Wallowa River**

Nine bull trout redds were identified and marked by GPS during the nine redd surveys performed in the East Fork Wallowa River in 2021 (Figure 2). Four of the bull trout redds were large and indicative of being constructed by large migratory-sized fish, while five were smaller and possibly indicative of being constructed from smaller resident-sized fish (Table 1). All redd observations in 2021 occurred between September 10 and October 1, with the peak of six counted on September 24. Four of the nine observed redds had bull trout either on, actively constructing or in very close proximity to, the redd. Pictures of all nine identified bull trout redds are included in Appendix A.

All nine bull trout redds were in the upper portion of available habitat below the barrier. Redds in 2021 visually persisted for an average of 23 days, with the longest time a redd remained visible being 40 days, and the shortest 19 days. No brook trout were definitively observed during any 2021 East Fork Wallowa River redd surveys.

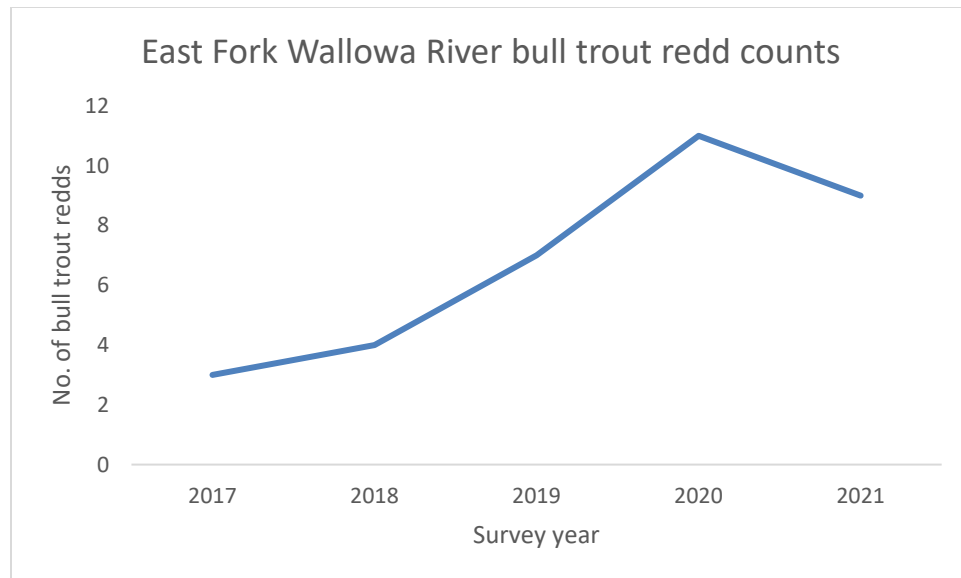
**Figure 3. Bull trout redd counts by survey year (2017-2021).**

Given length of redd persistence within the East Fork Wallowa observed for the first five seasons of these surveys (average time of 28 days, 2017-2021), in 2022 it is anticipated bull trout redd surveys will occur on a 10-day rotation during the months of September and October.
